EnCana Oil and Gas

C28 Pad

Location # 335200

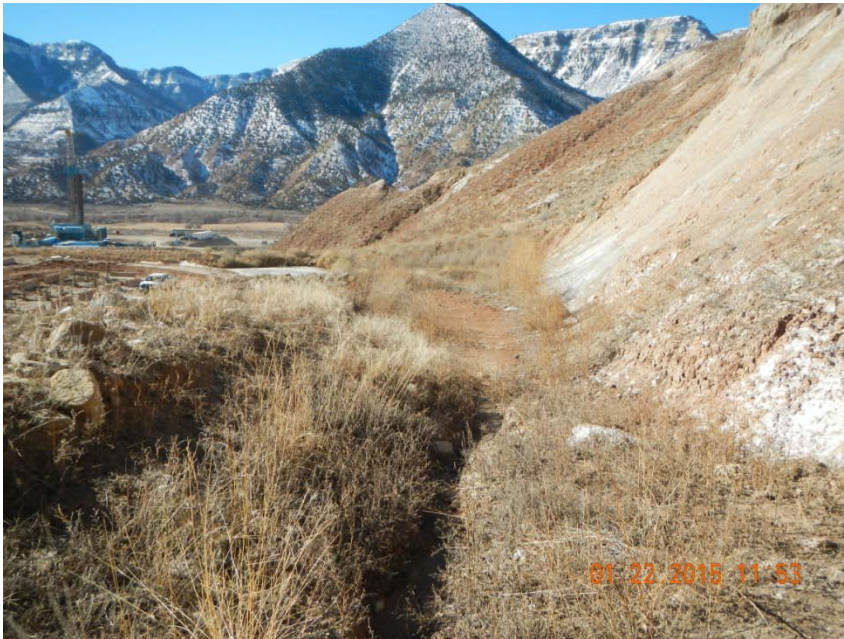
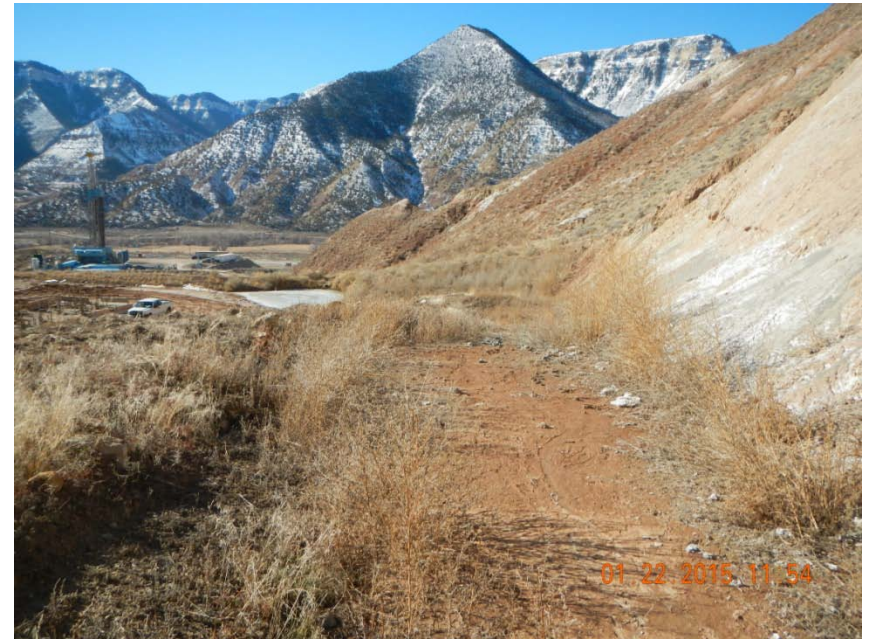
Run on diversion ditch is washing and traps are filling with sediment.

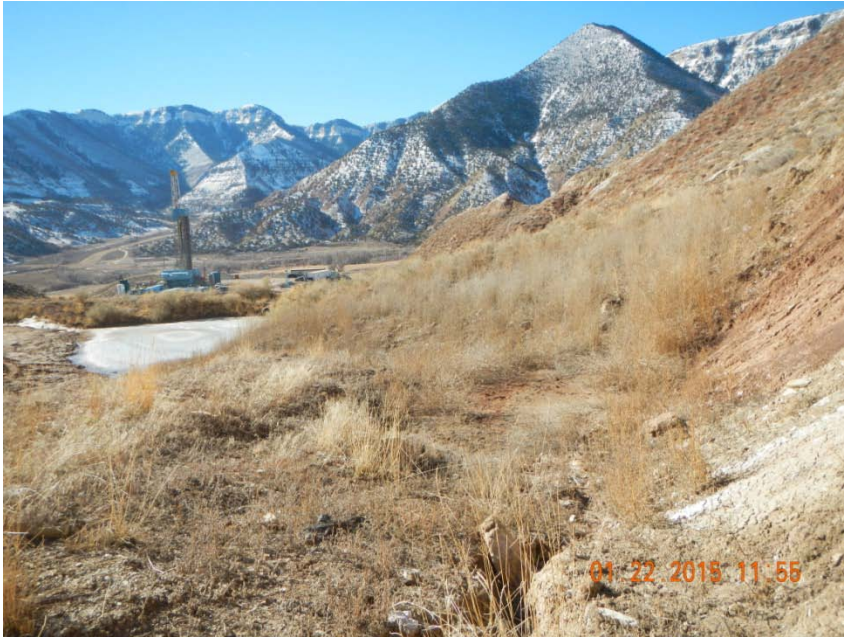
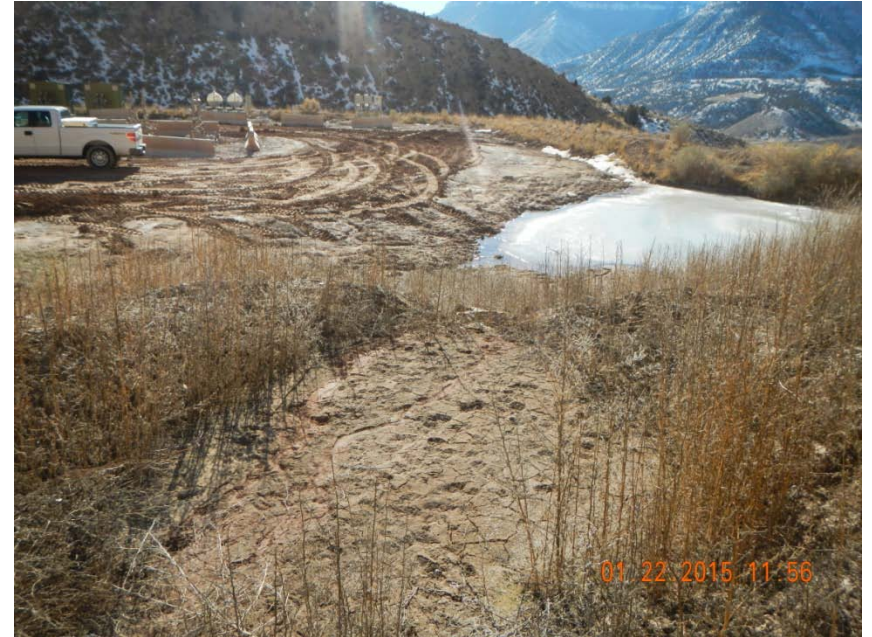
Run on diversion ditch is washing and traps are filling with sediment.

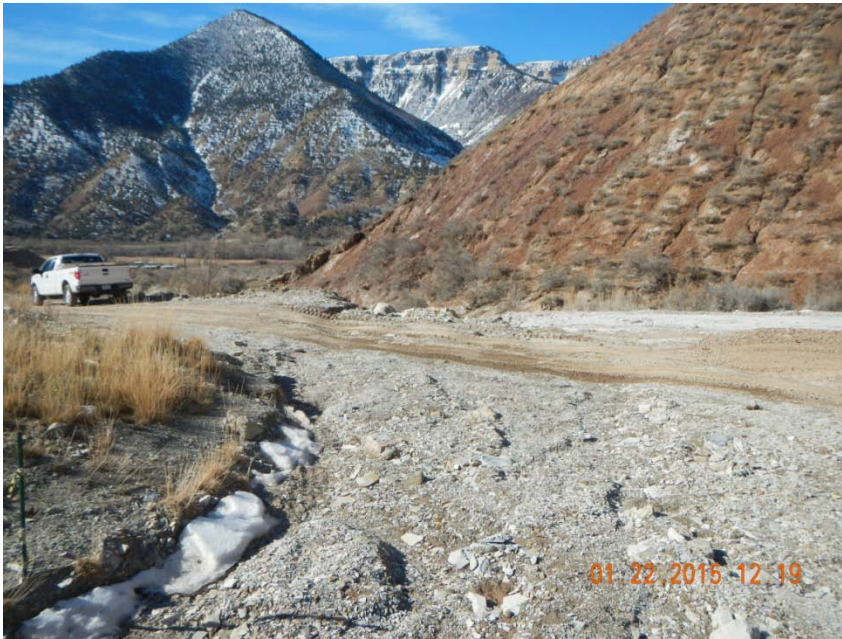
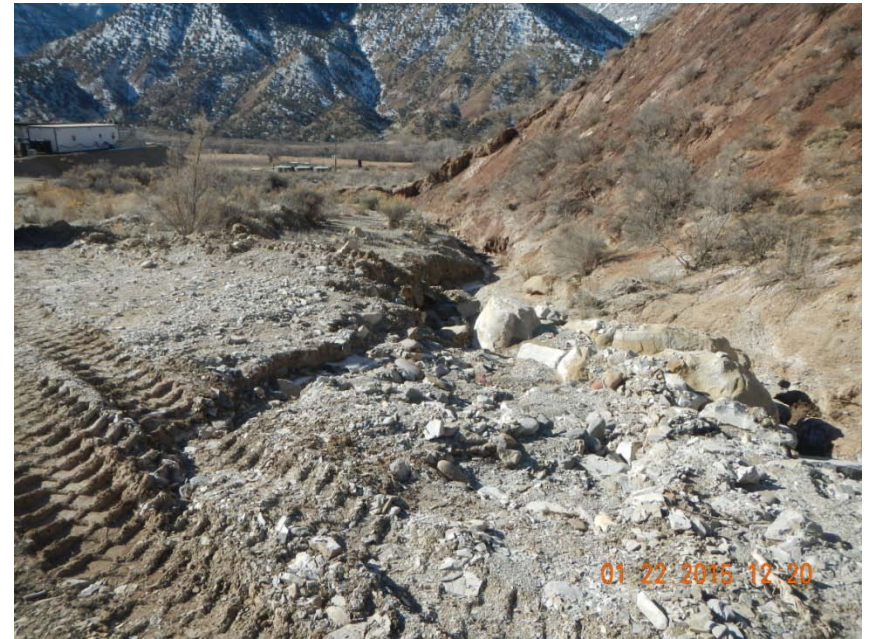
Low water crossing eroding on out let side

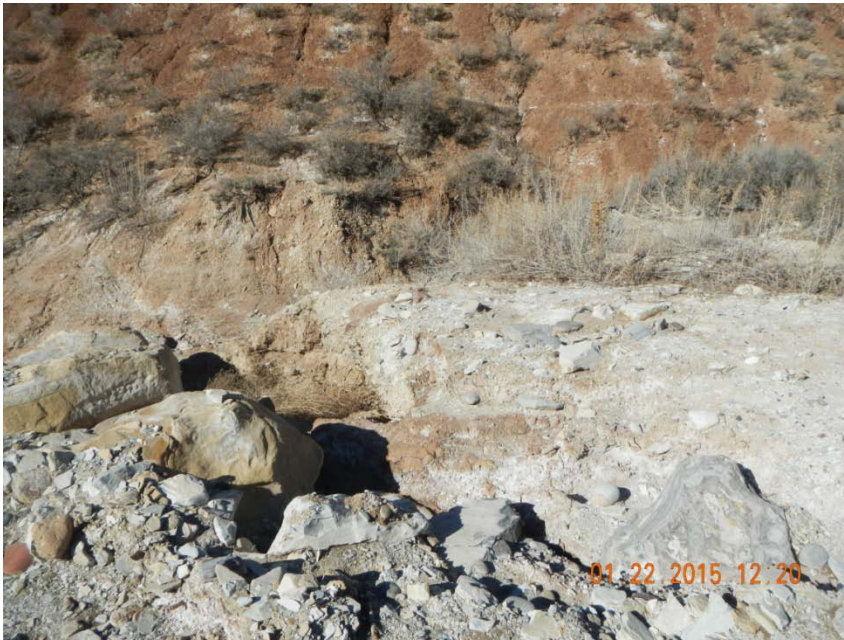
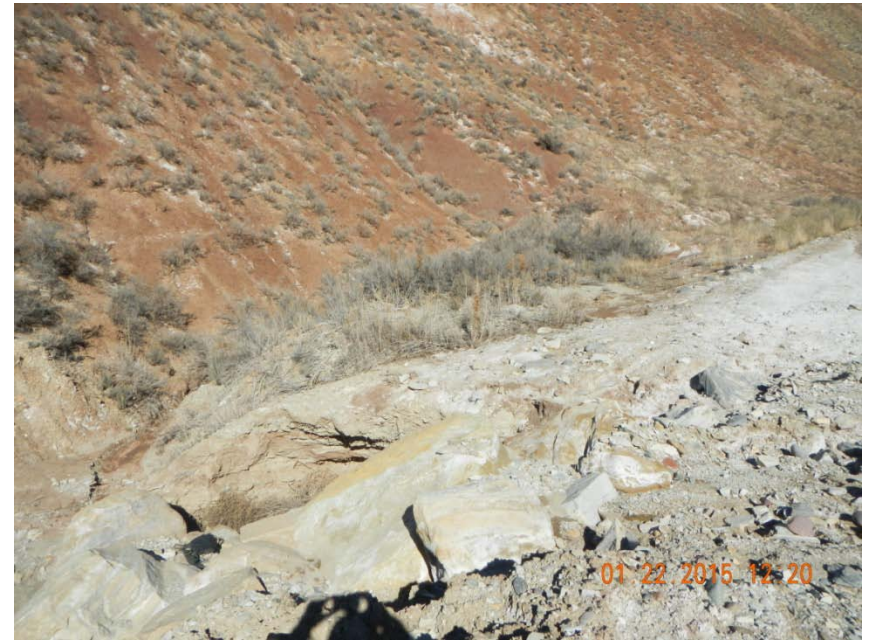
Erosion damage outlet side of low water crossing.

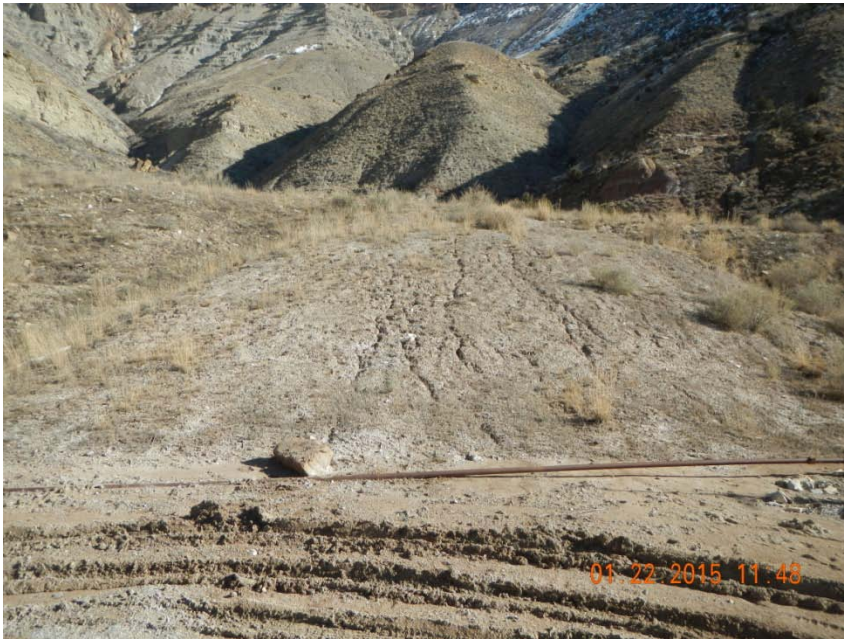
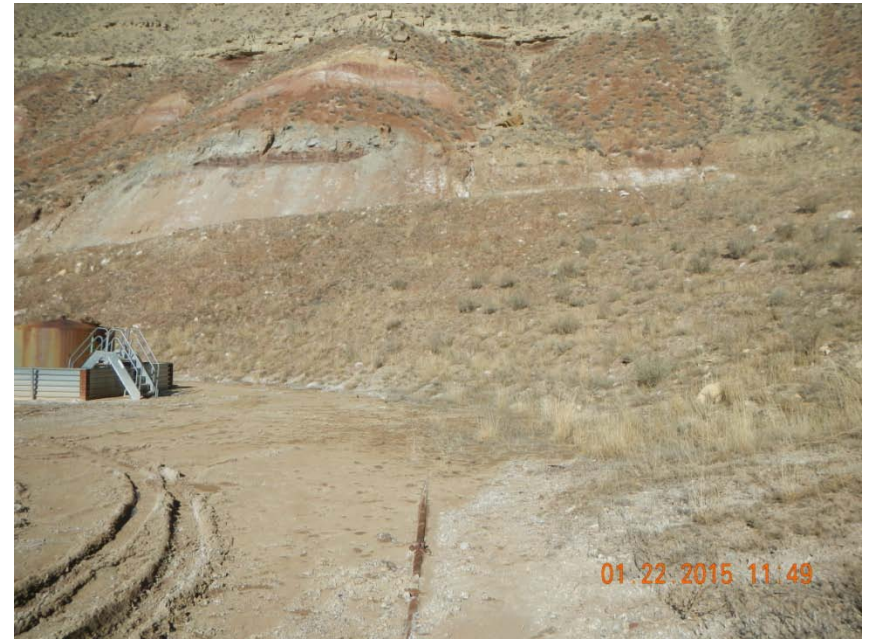
Erosion rills from hillside have buried
tank flow line.
