Site Photos: API# 05-009-06124

Date: January 20, 2015

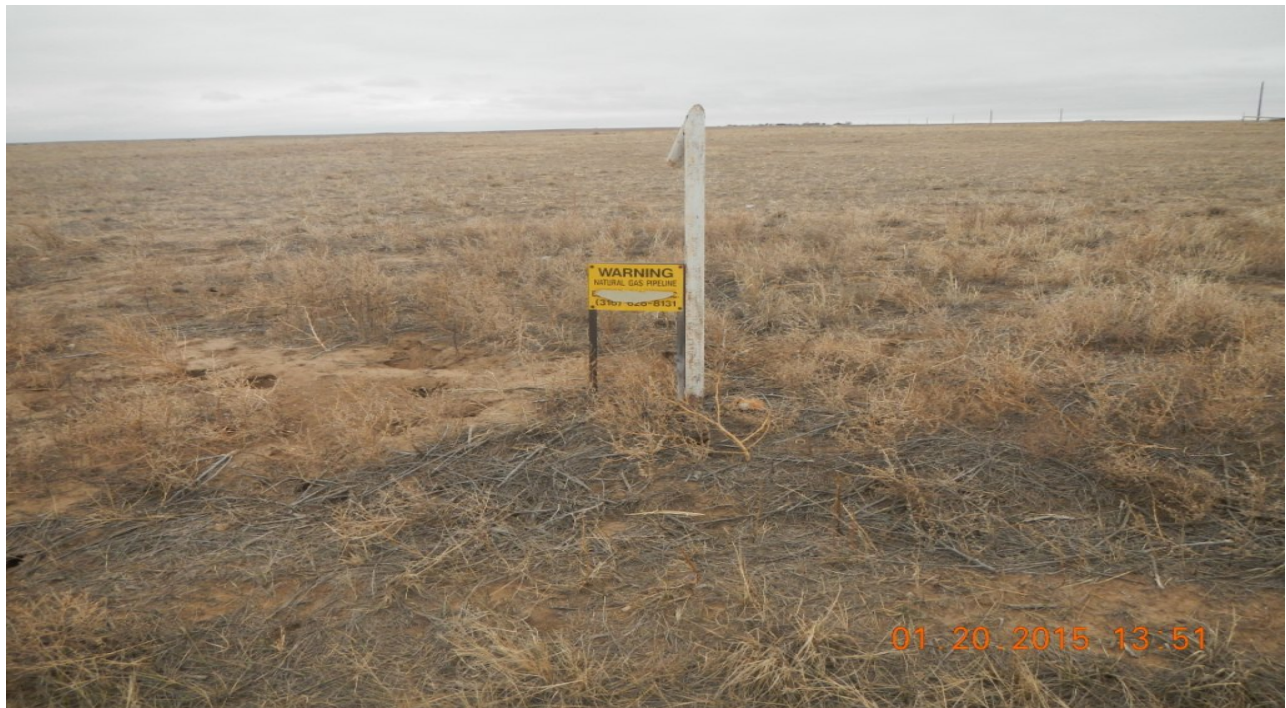
**photo 1:** Pipe riser remains near the east side of the location.

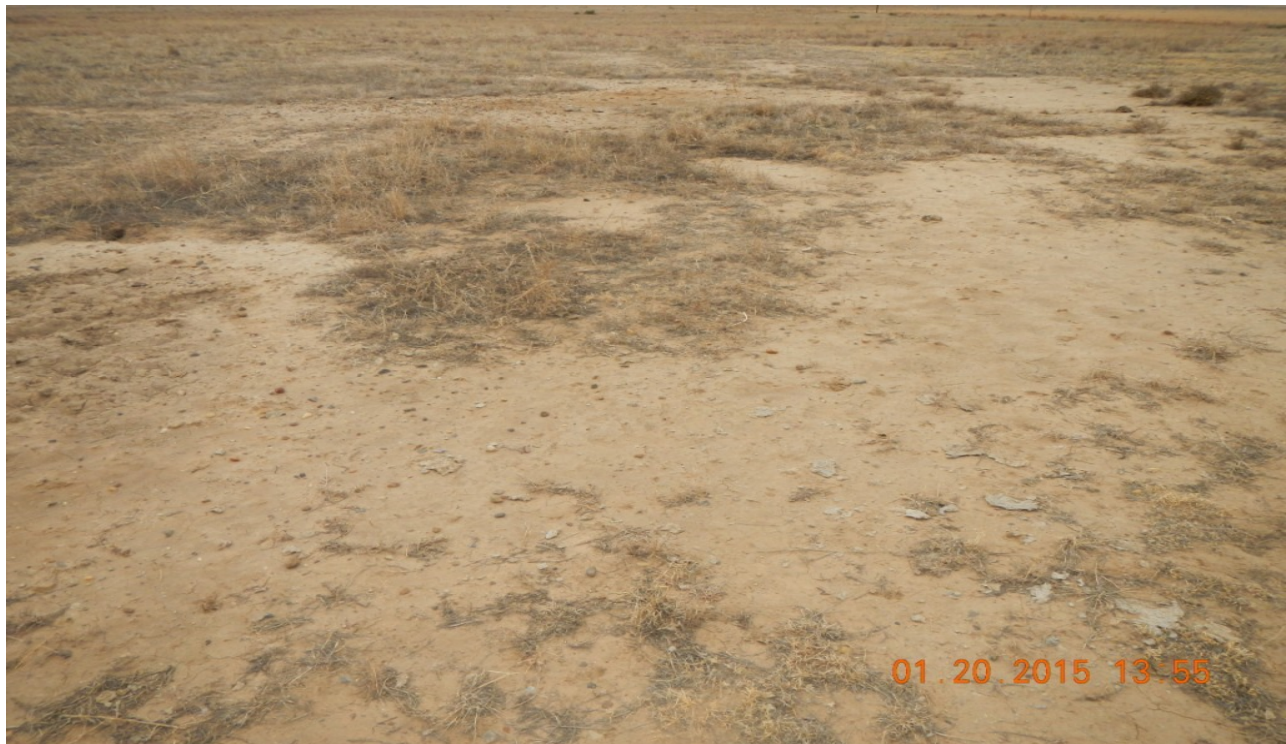
**photo 2:** East side of the location facing west. Bare areas 20'x10' and 15'x10'.

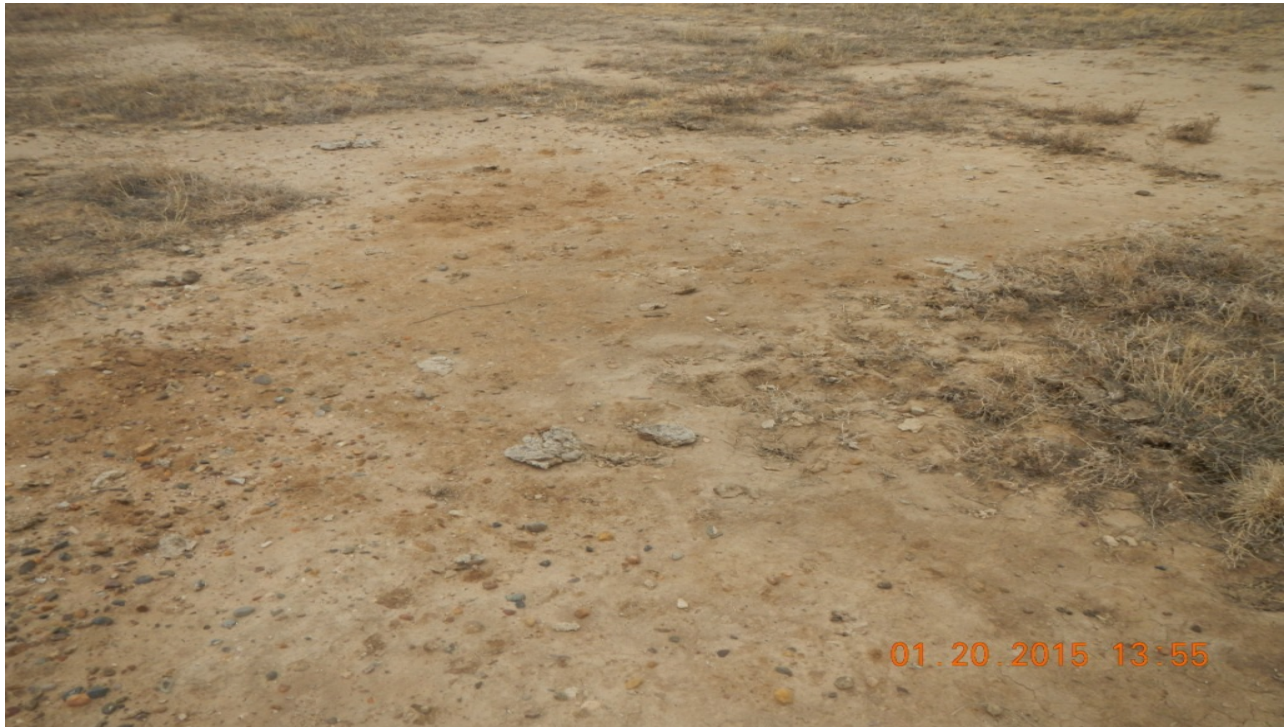
**photo 3:** Oil stained soil approx. 10'x5'. Soil had a strong oil odor.

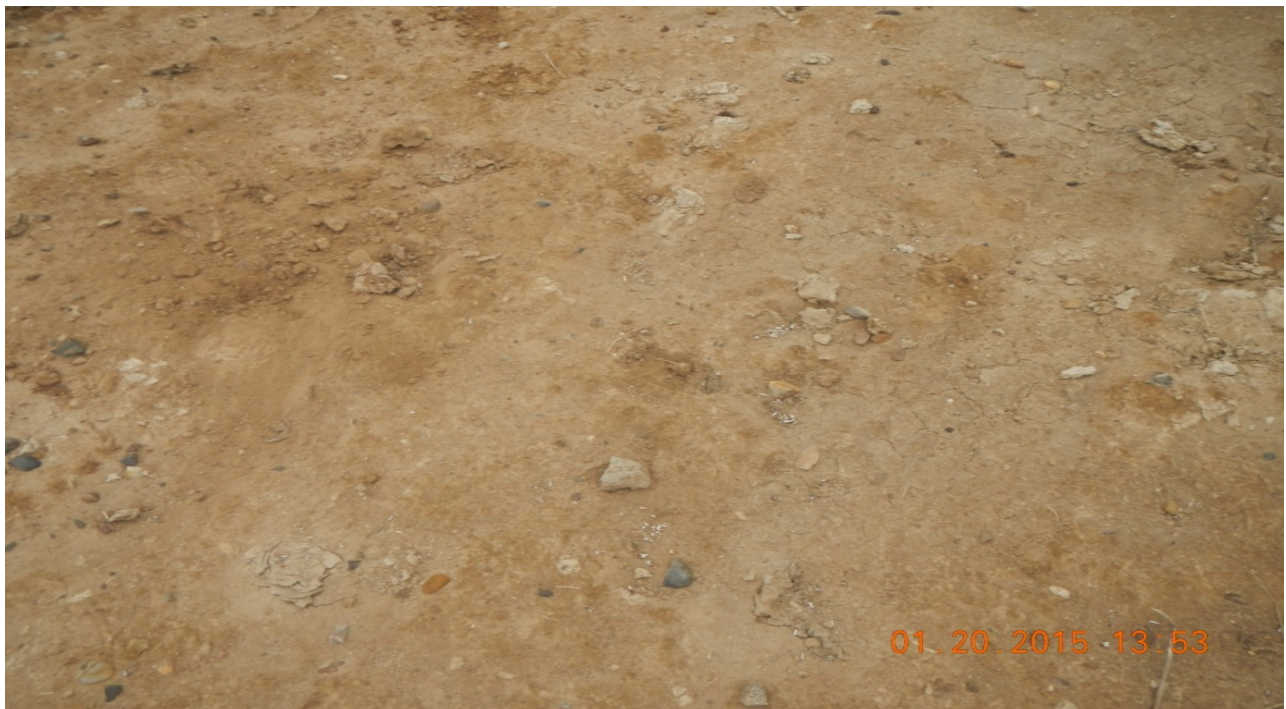
**photo 4:** Oil stained soil approx. 10'x5'. Soil had a strong oil odor.

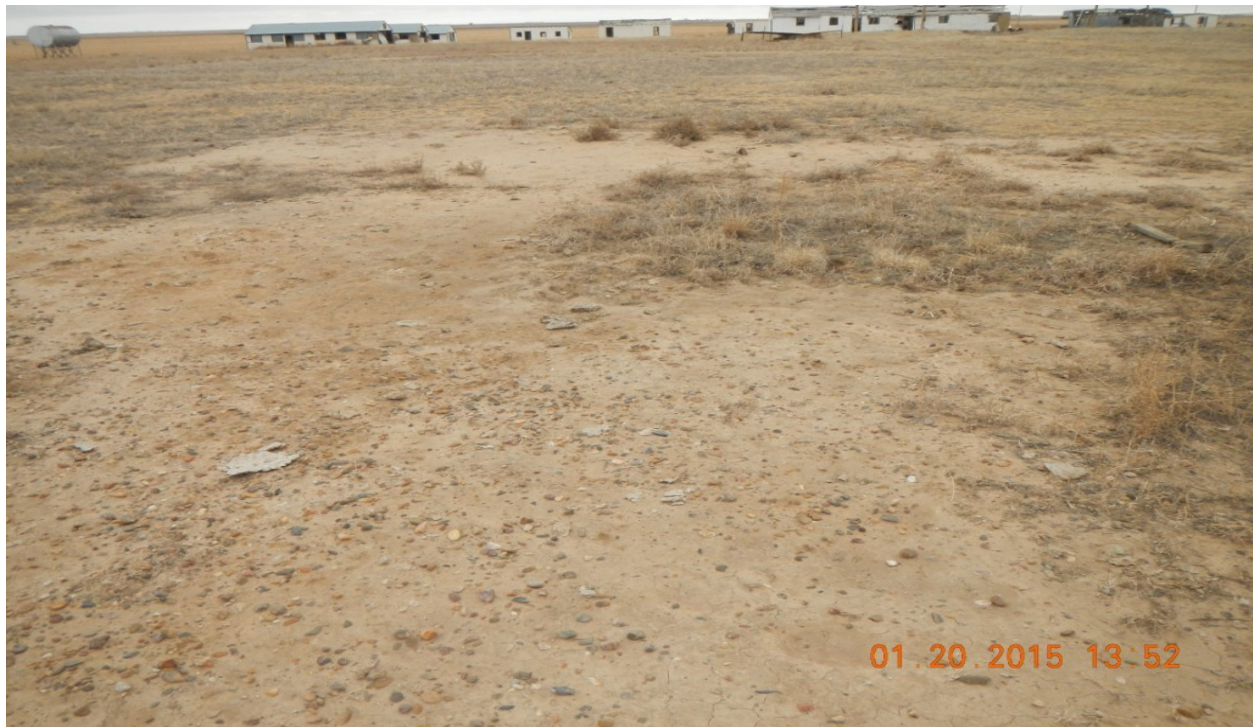
**photo 5:** Center of the location facing north.

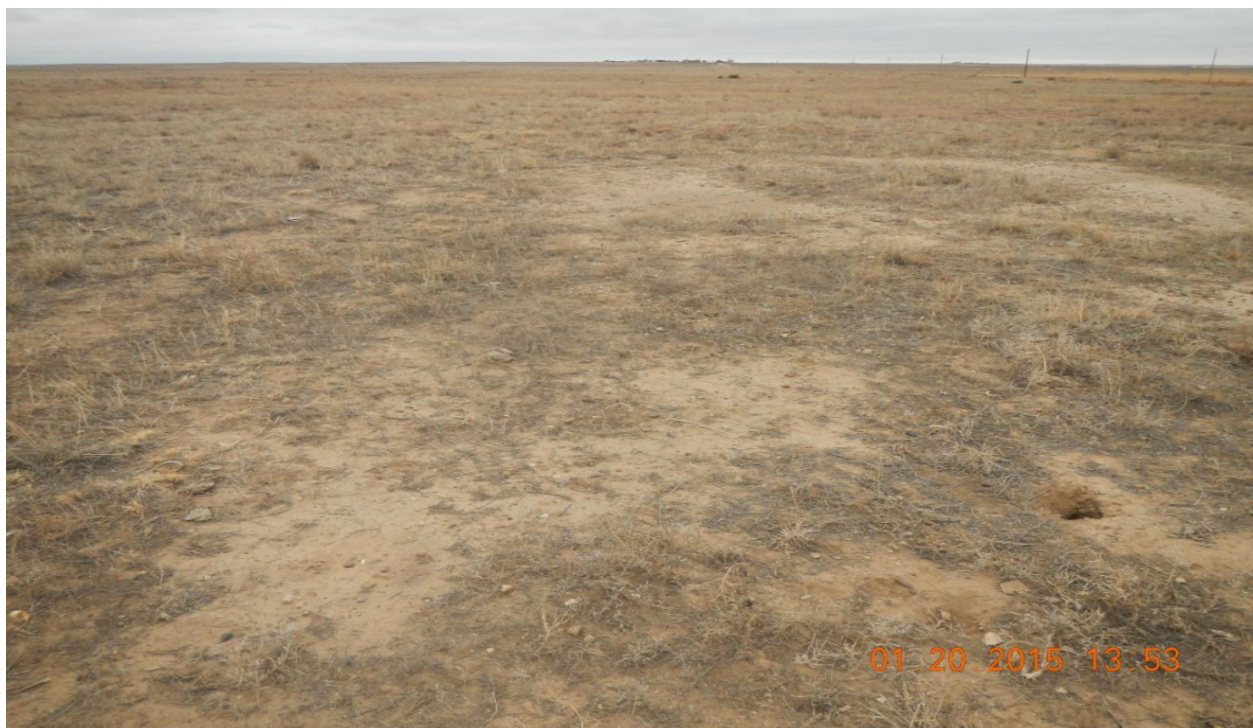
**photo 6:** Center of the location facing west.

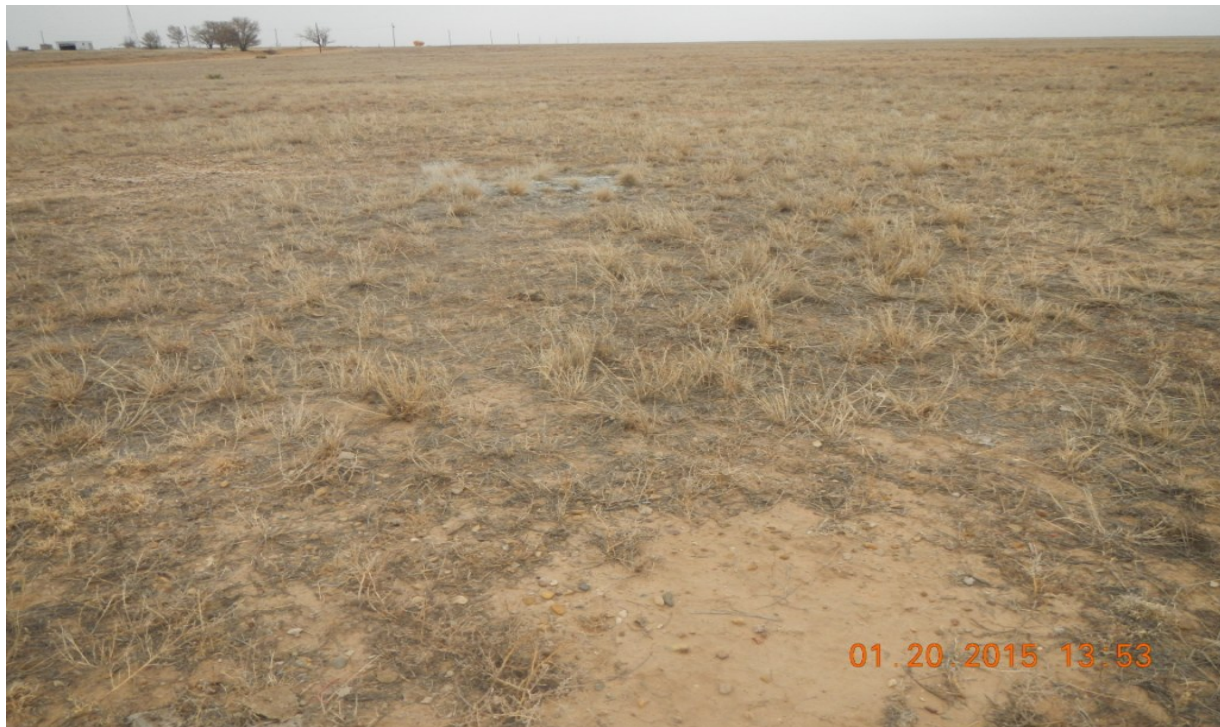
**photo 7:** Center of the location facing south.

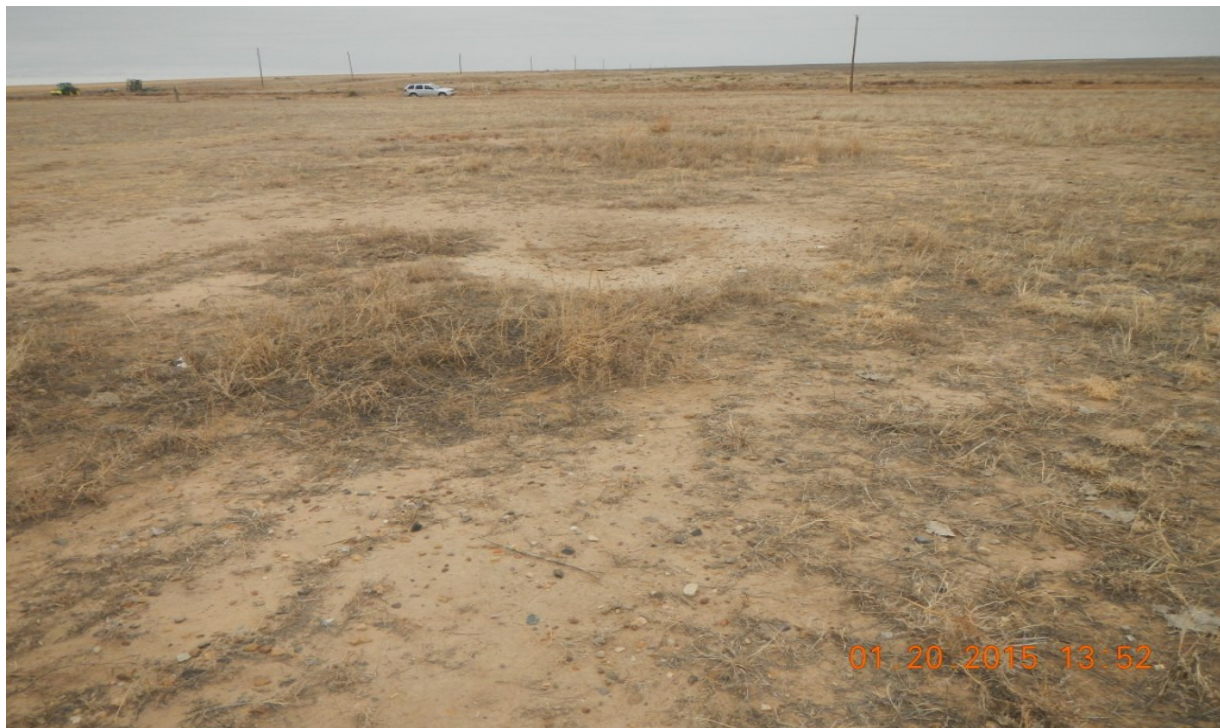
**photo 8:** Center of the location facing east.

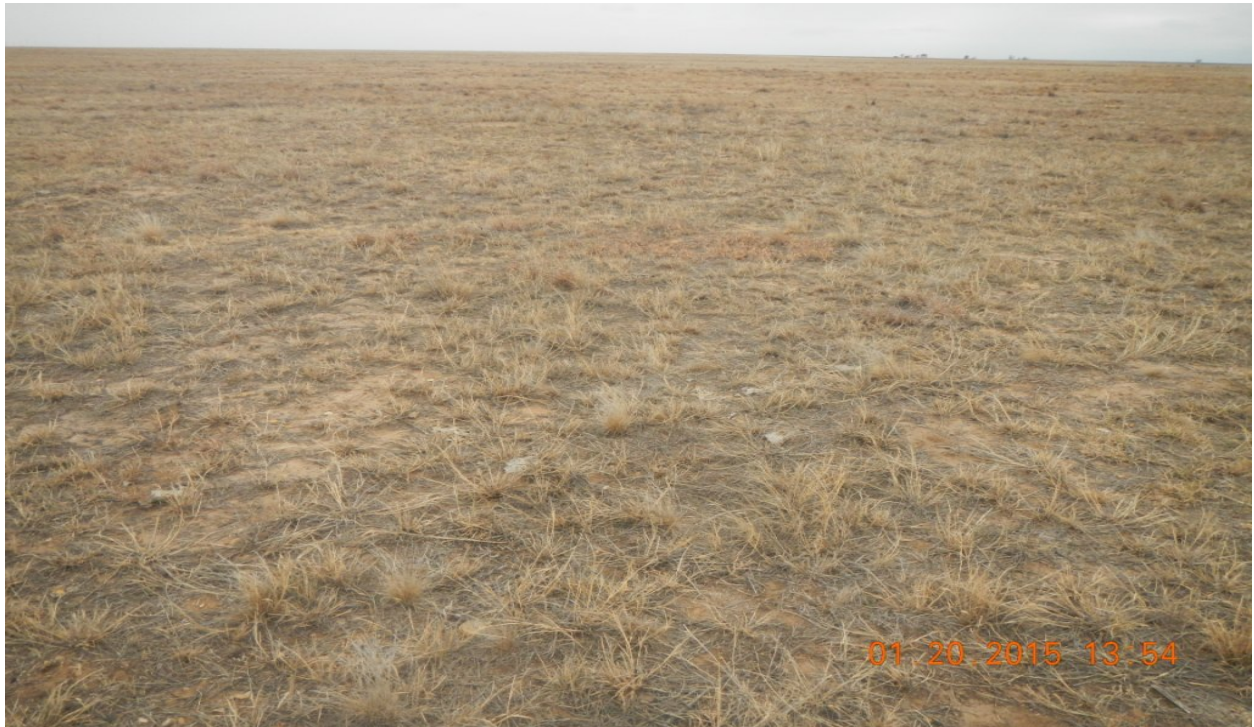
**photo 9:** Facing east, surrounding vegetation around the location.

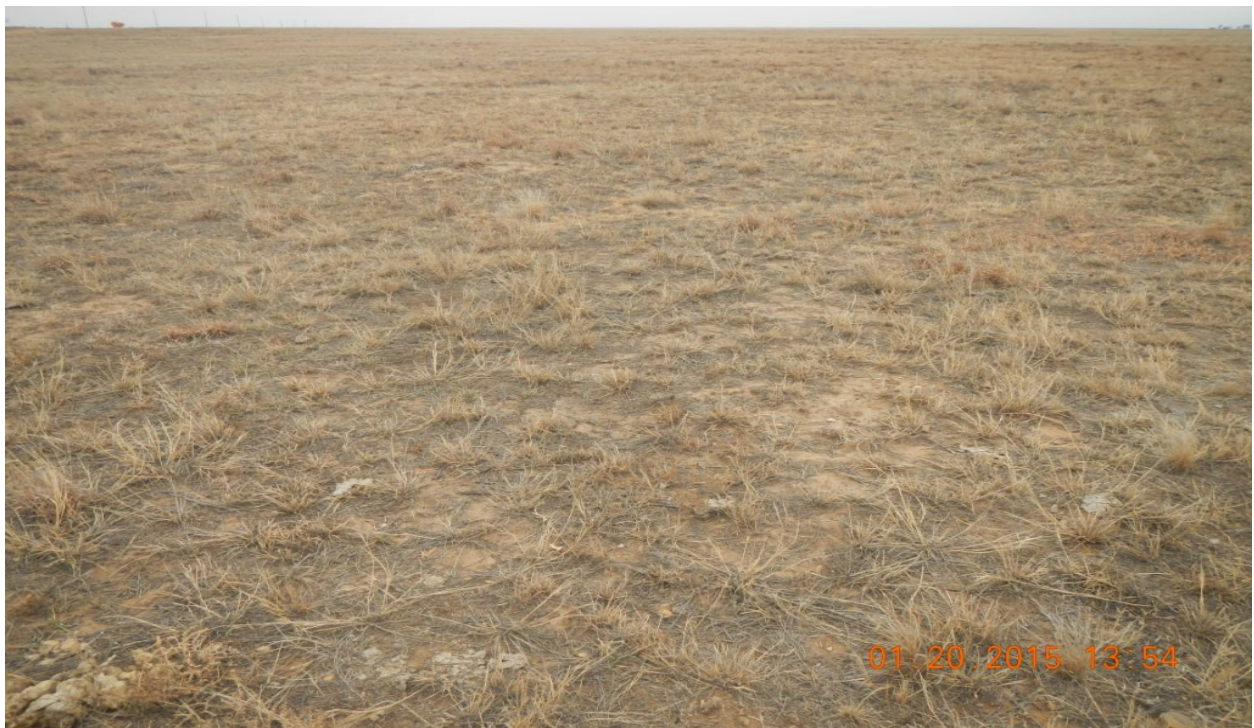
**photo 10:** Facing south, surrounding vegetation around the location.
