WPX Energy

GM 33-1

Location # 324063

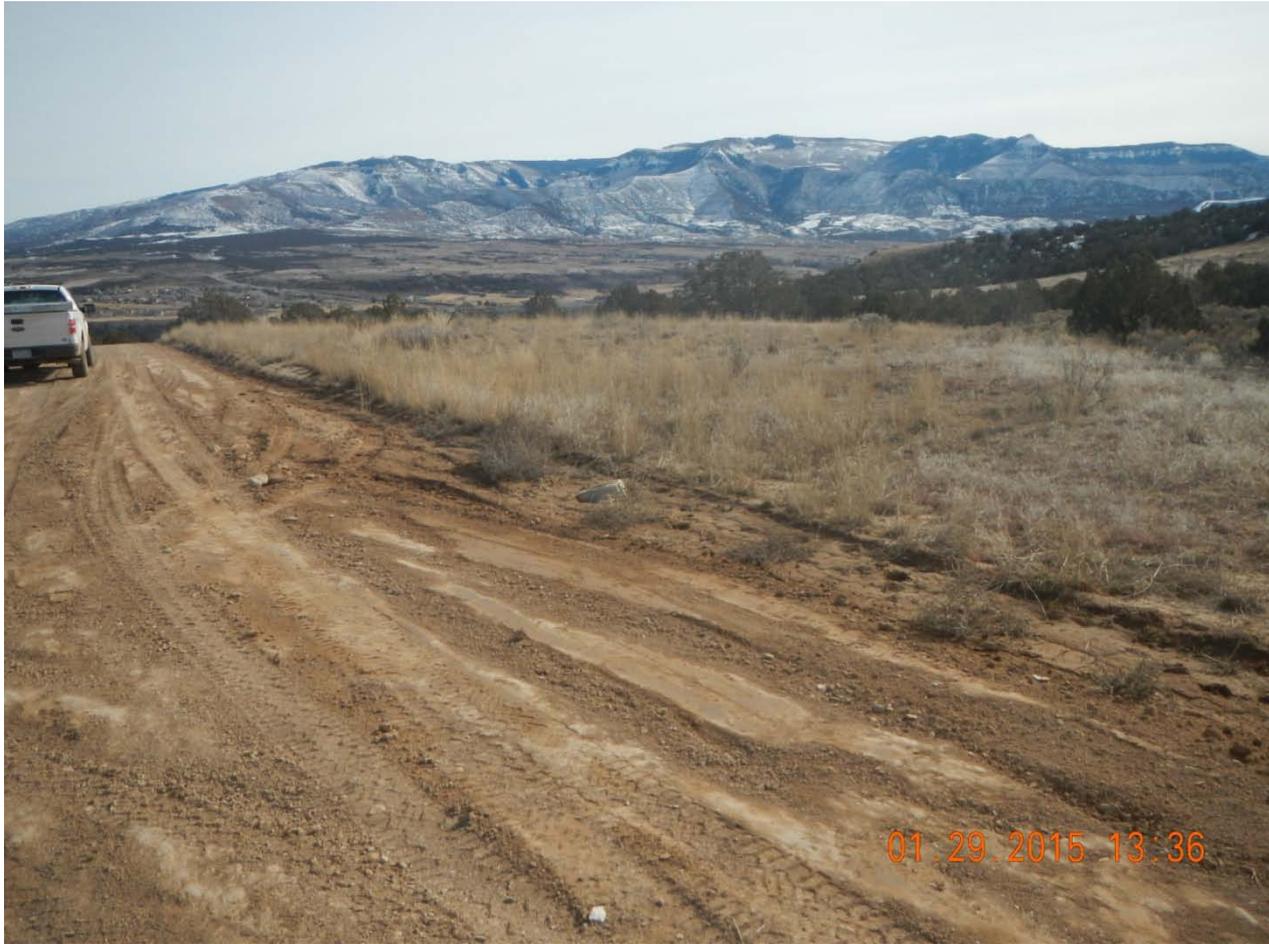
Build up of sediment in ditch at entrance of location

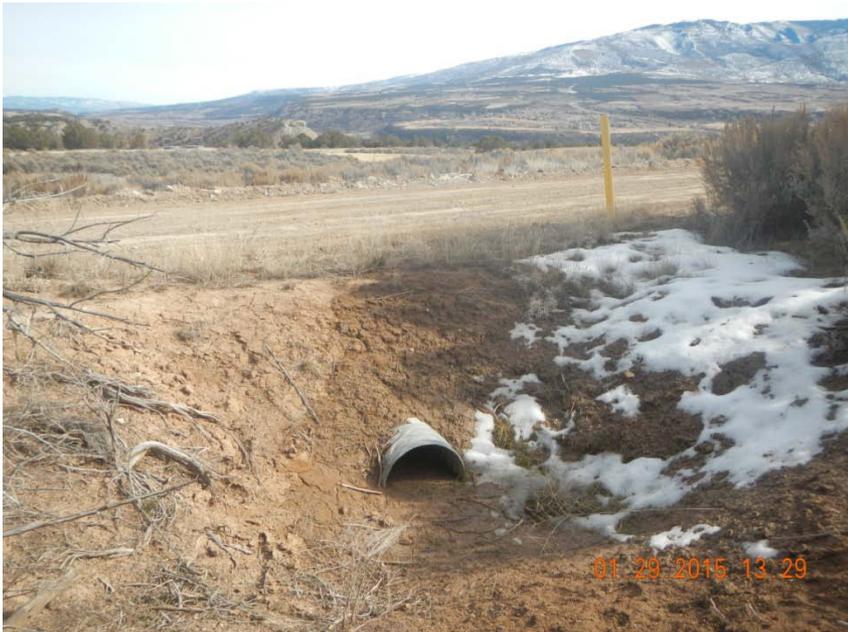
Sediment build up in inlet

Culvert needs maintained

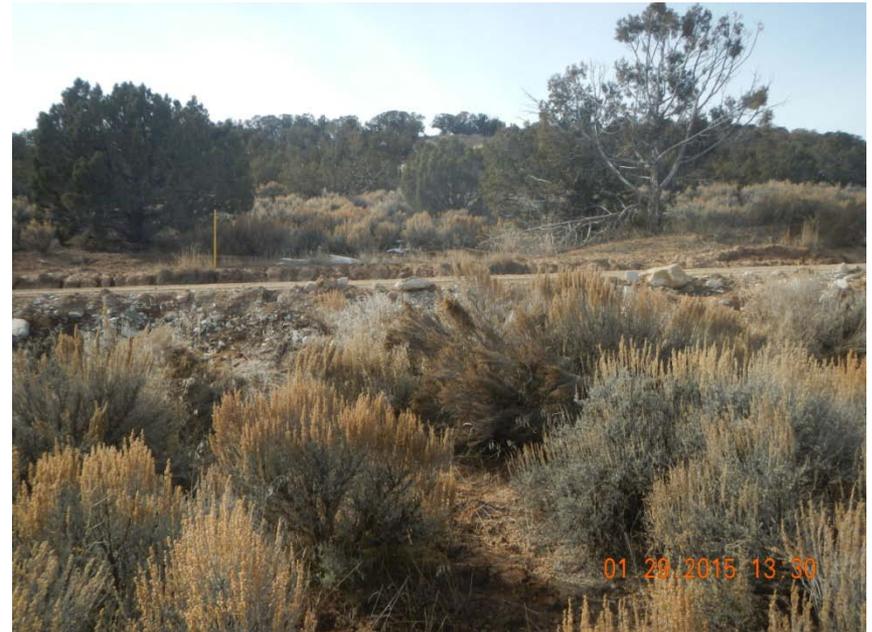
Unable to find outlet
