Site Photos: API# 05-043-06224

Date: February 10, 2015

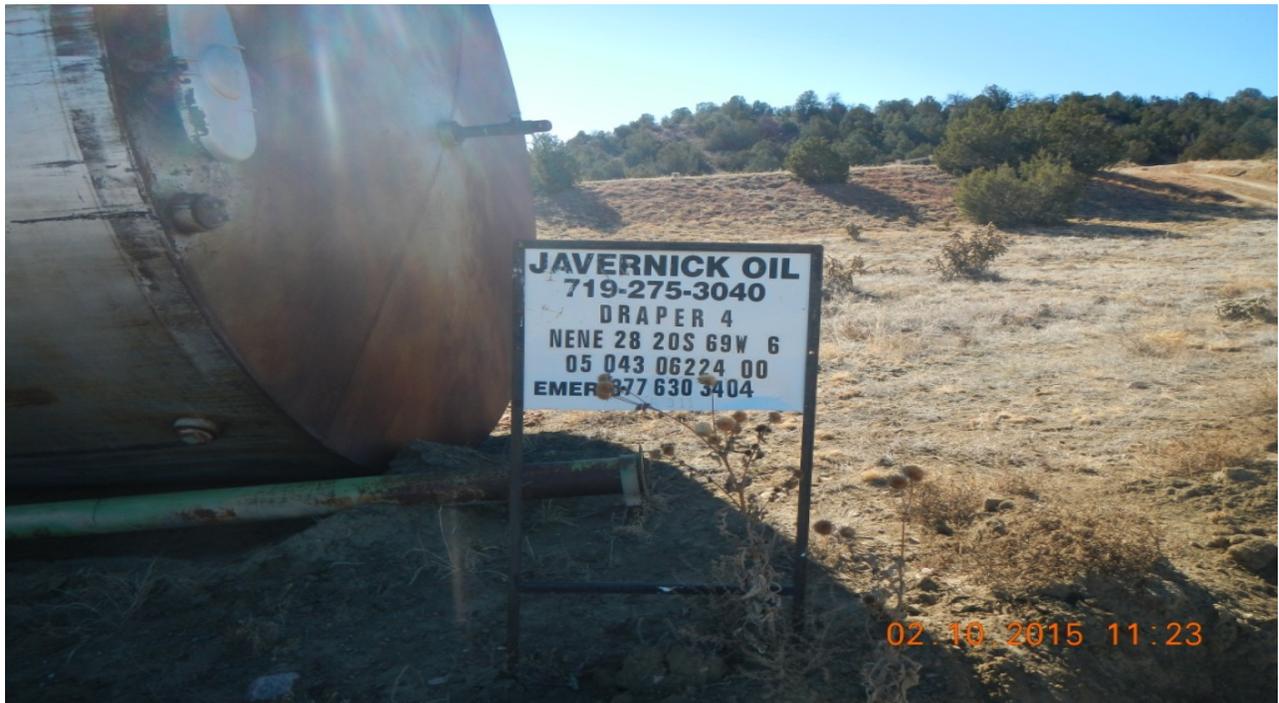
photo 1: Operator/Location sign at the tank battery. Lat/Long: 38.28764/-105.10938

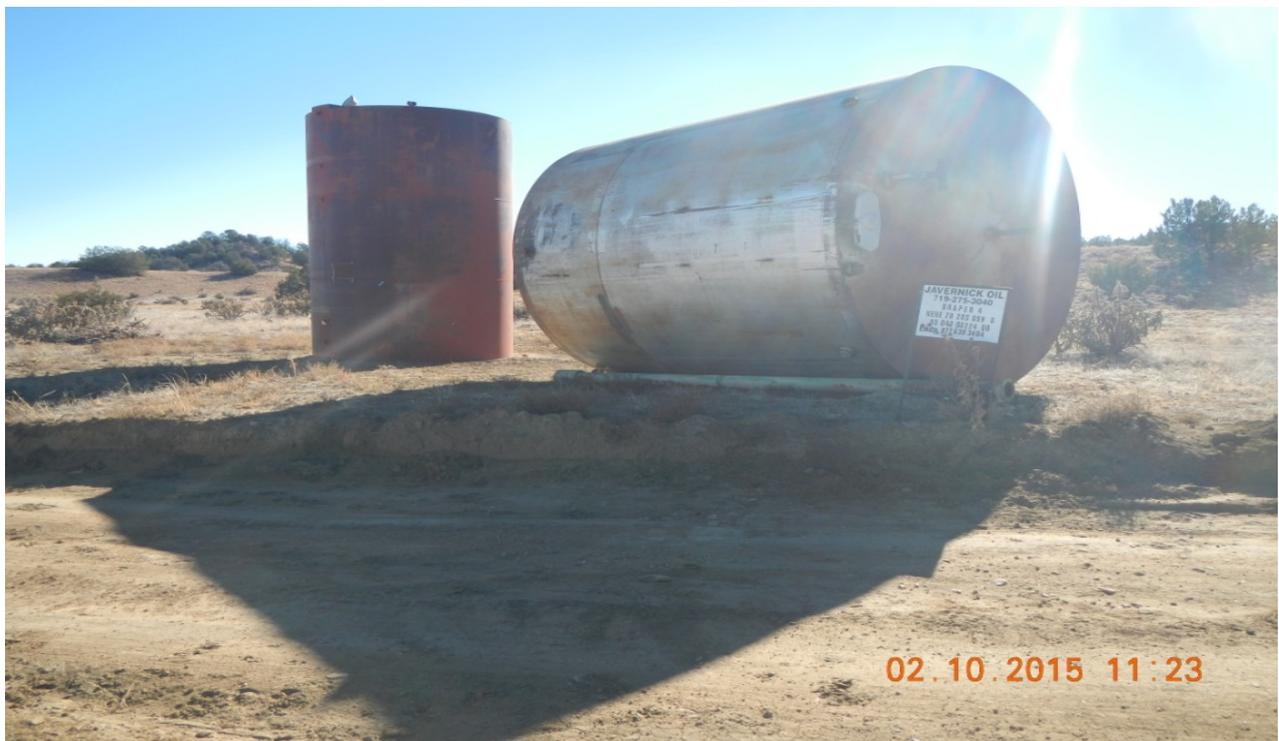
photo 2: Tank battery location, approximately 100yds north of the location.

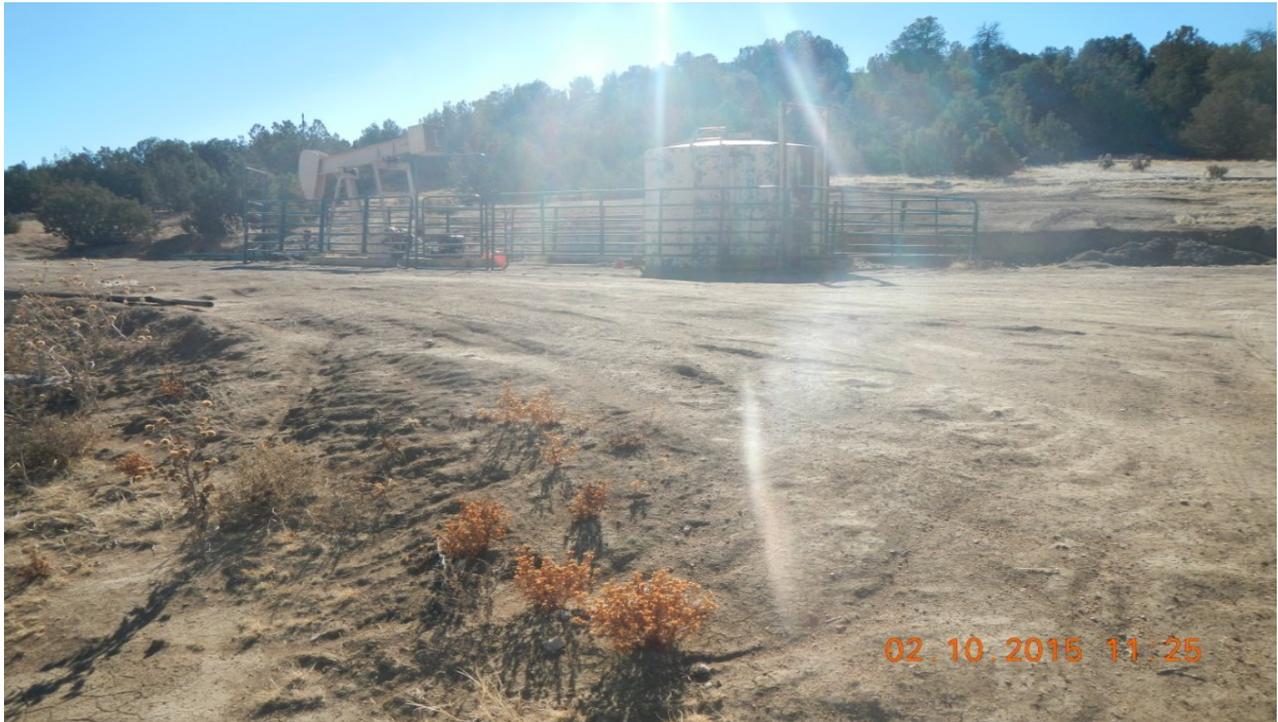
photo 3: Facing south towards the location.

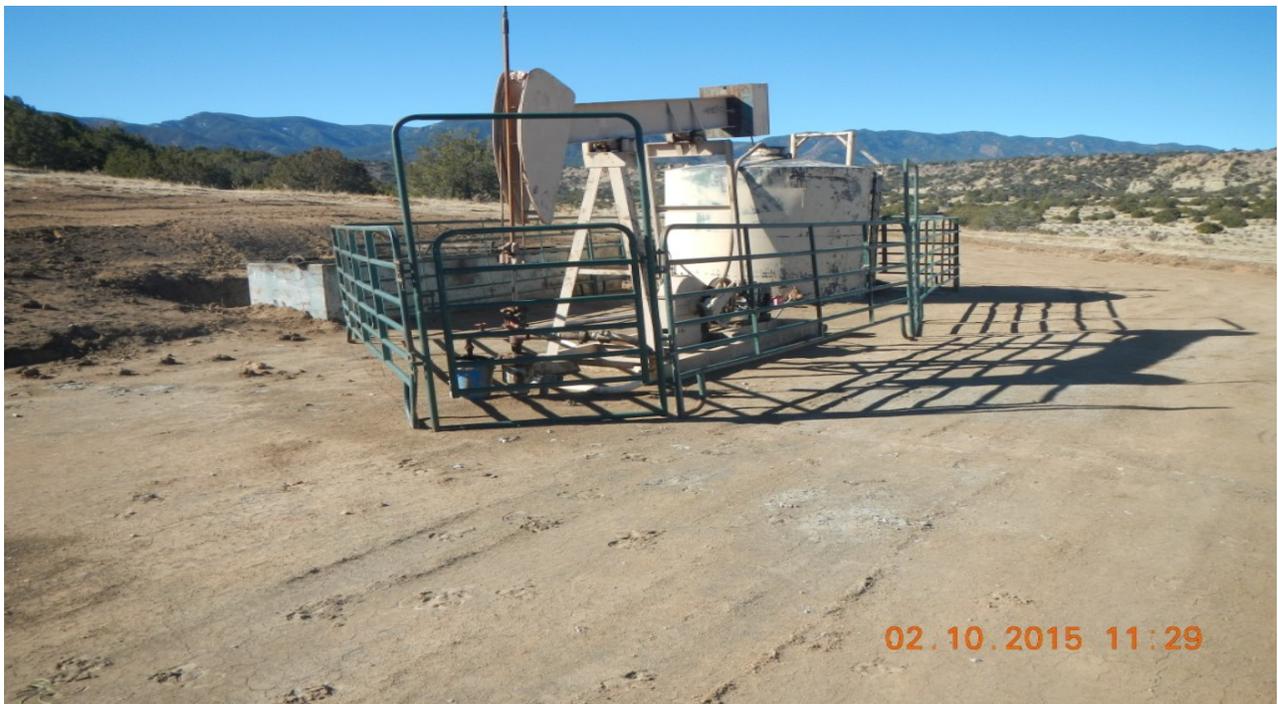
photo 4: Well head and tank battery. No signs or markers were found required by rule 210.

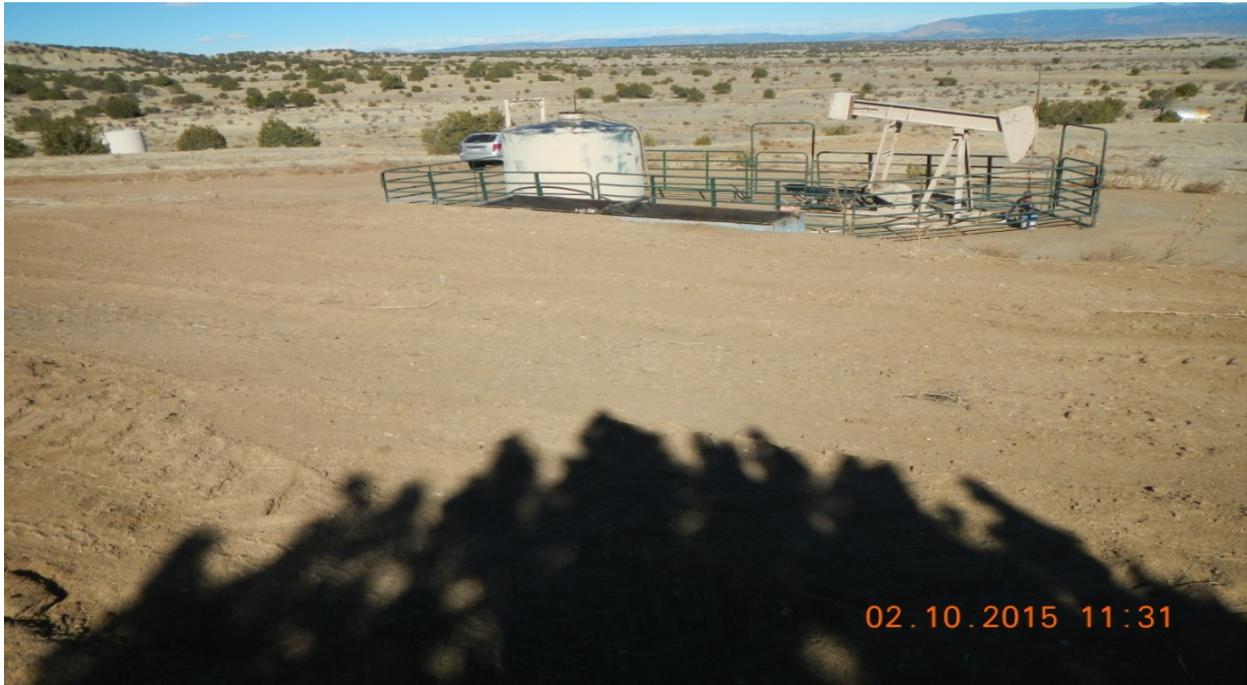
photo 5: Southeast corner of location facing northwest. The location has not been reclaimed.

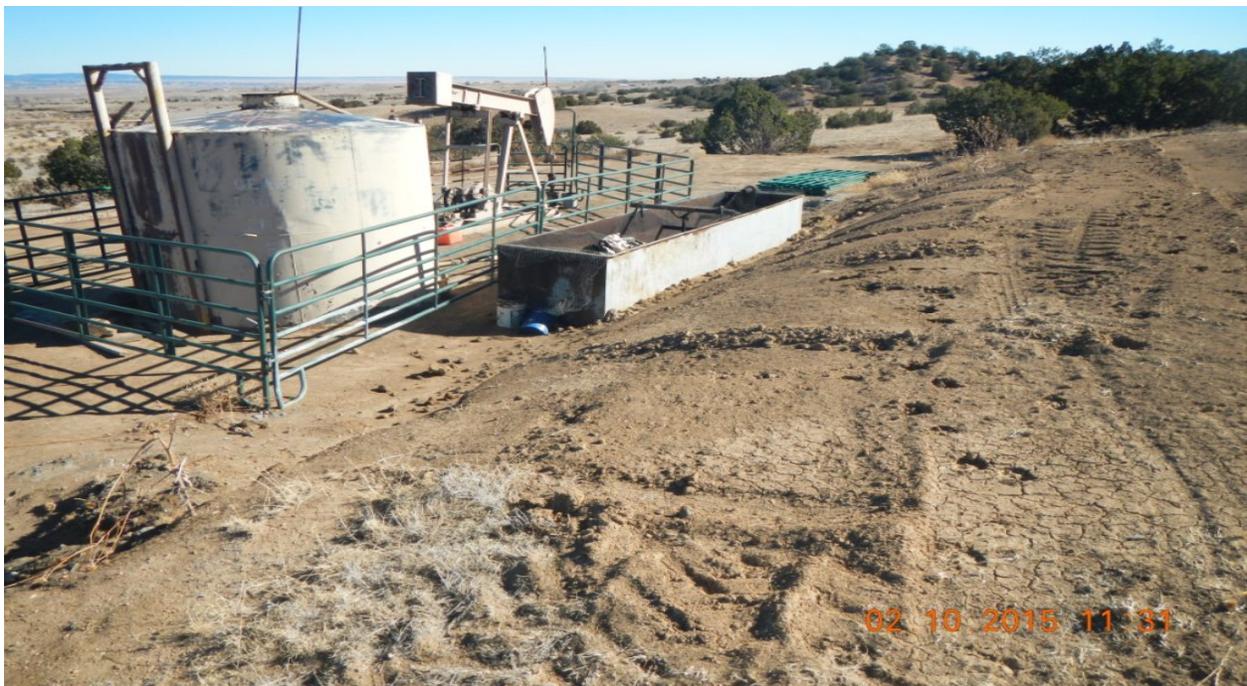
photo 6: Southwest side of the location facing east towards the production equipment.

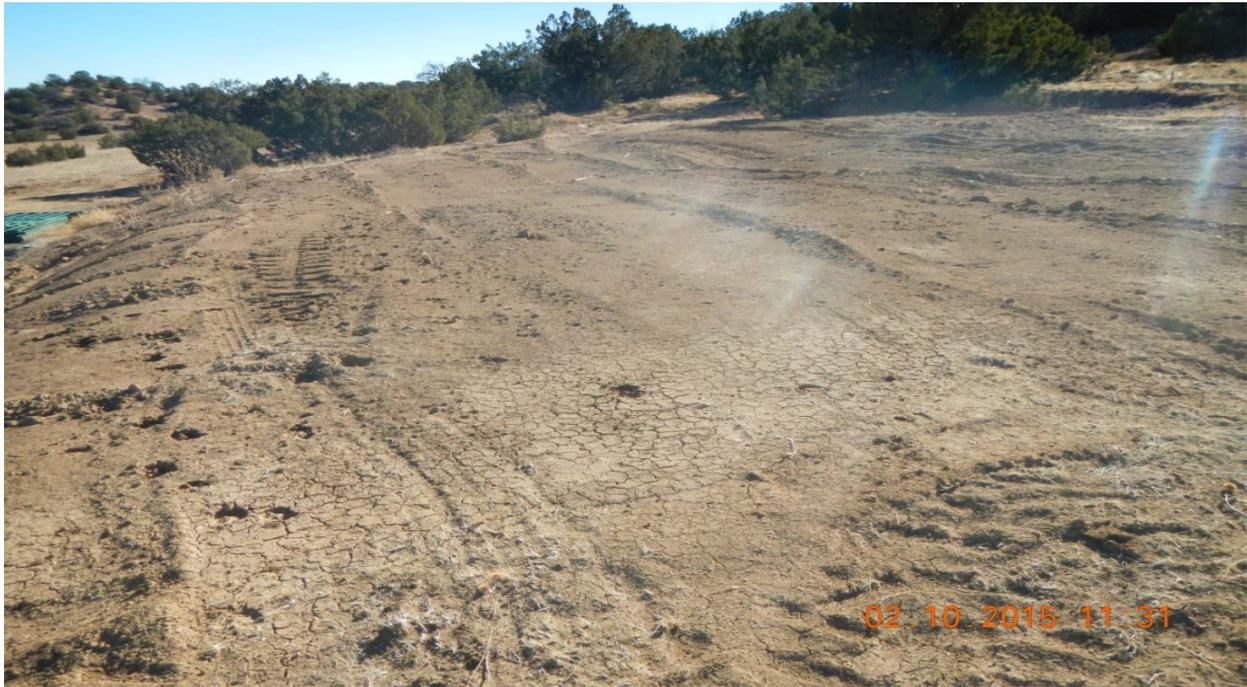
photo 7: The area on the south side of the location has not been reclaimed and is susceptible to erosion.

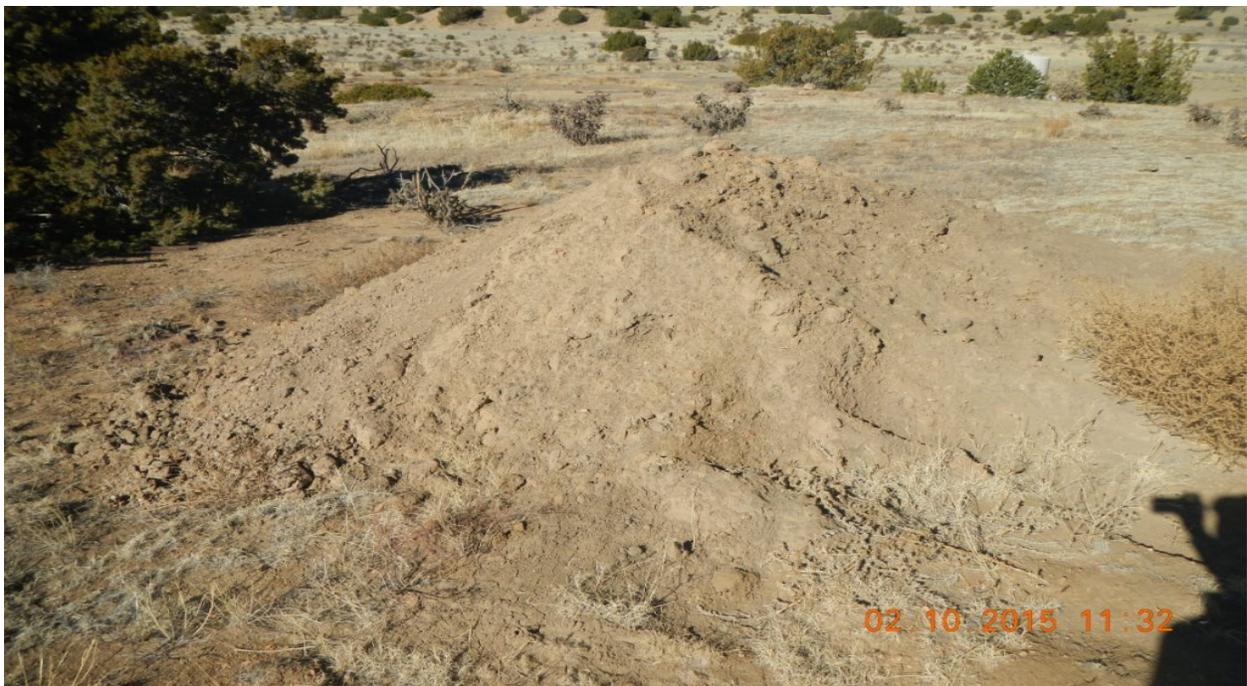
photo 8: Soil stockpile at the southwest corner of the location is not stabilized.

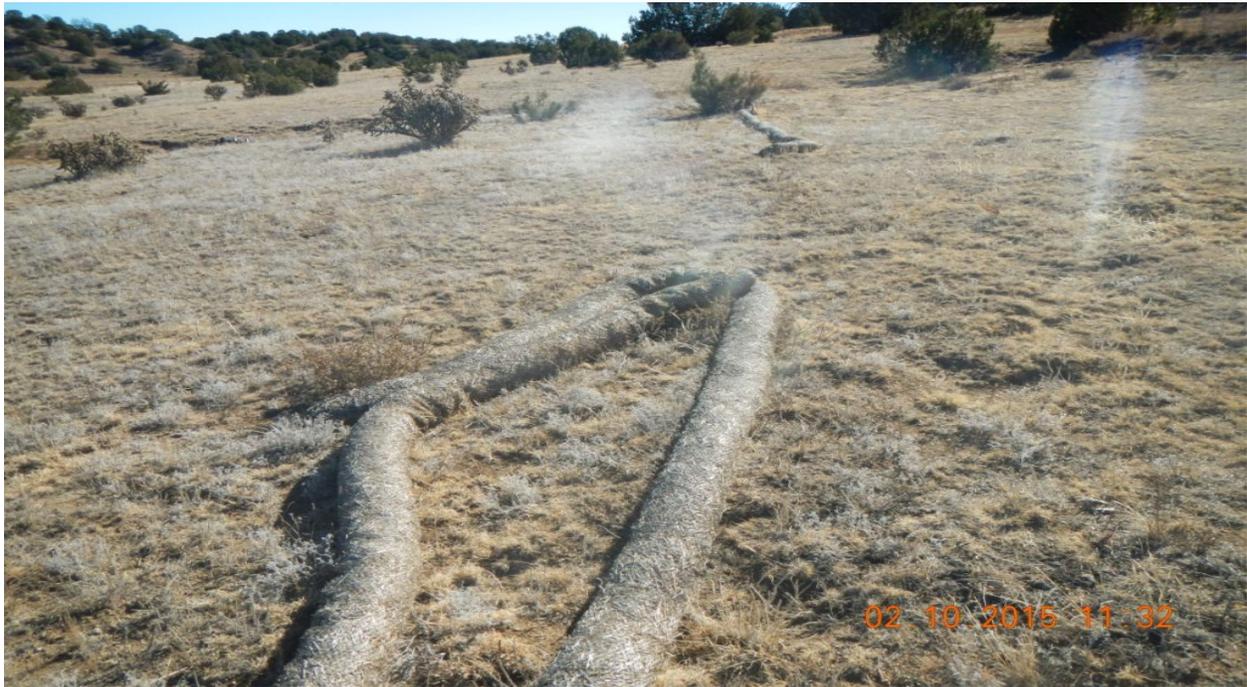
photo 9: Waddles are displaced at the north side of the location.

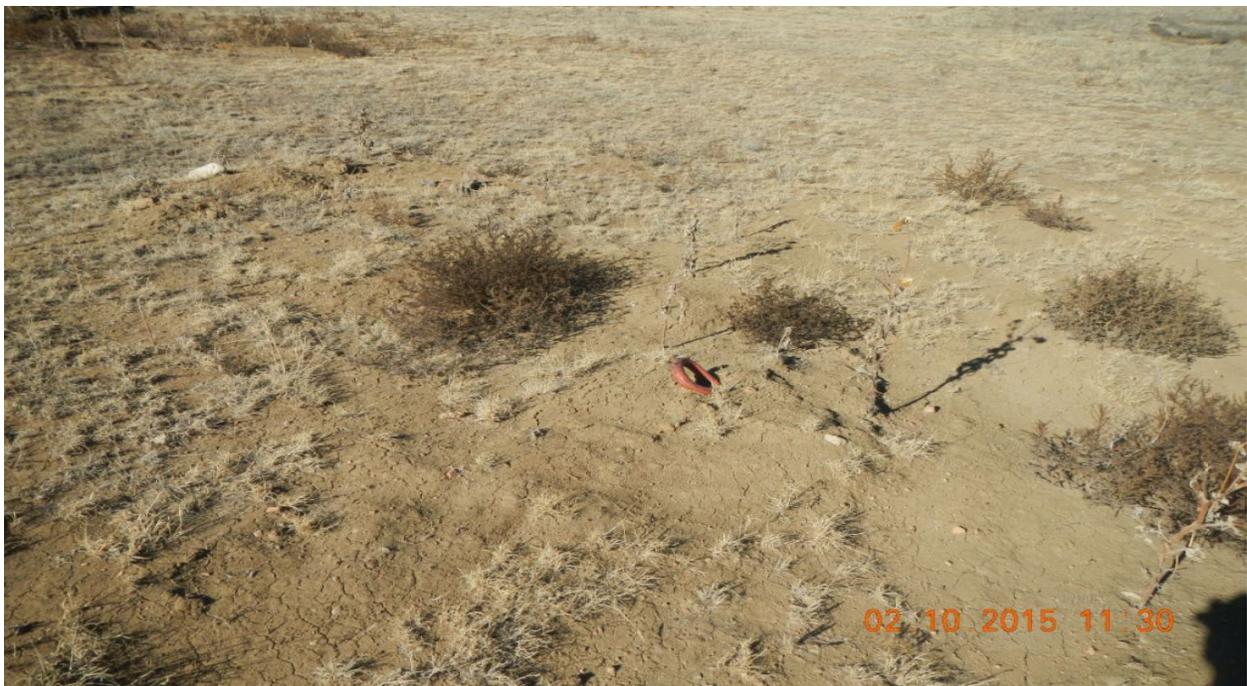
photo 10: Guy line anchors around the location do not have a marker.

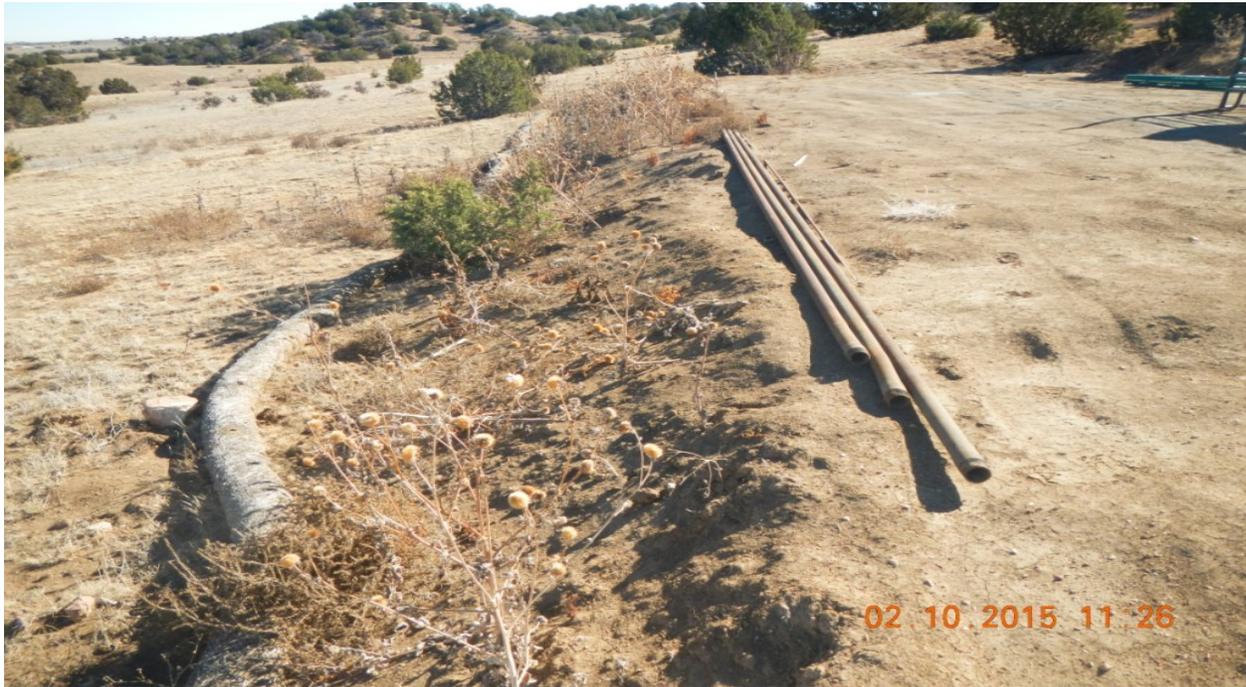
photo 11: Unused equipment/sections of pipe remain at the location.

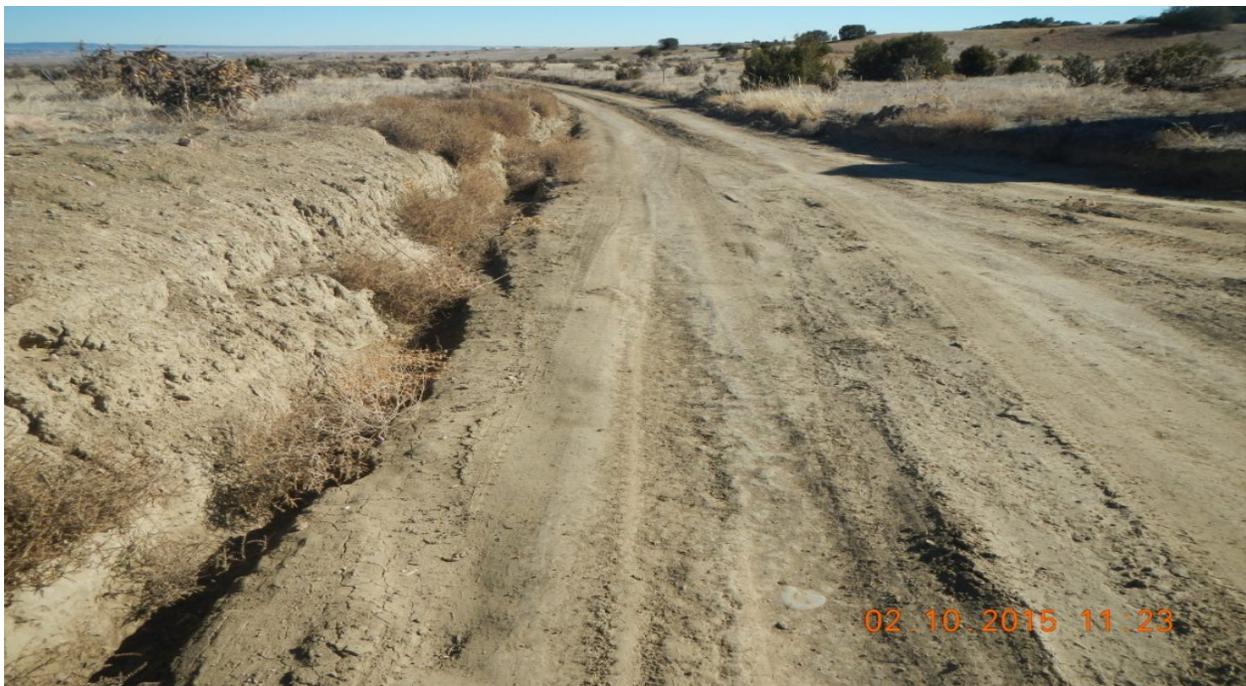
photo 12: Facing east at the access road that goes towards the location.
