Grizzly 3-32H

Inspection# 673401785

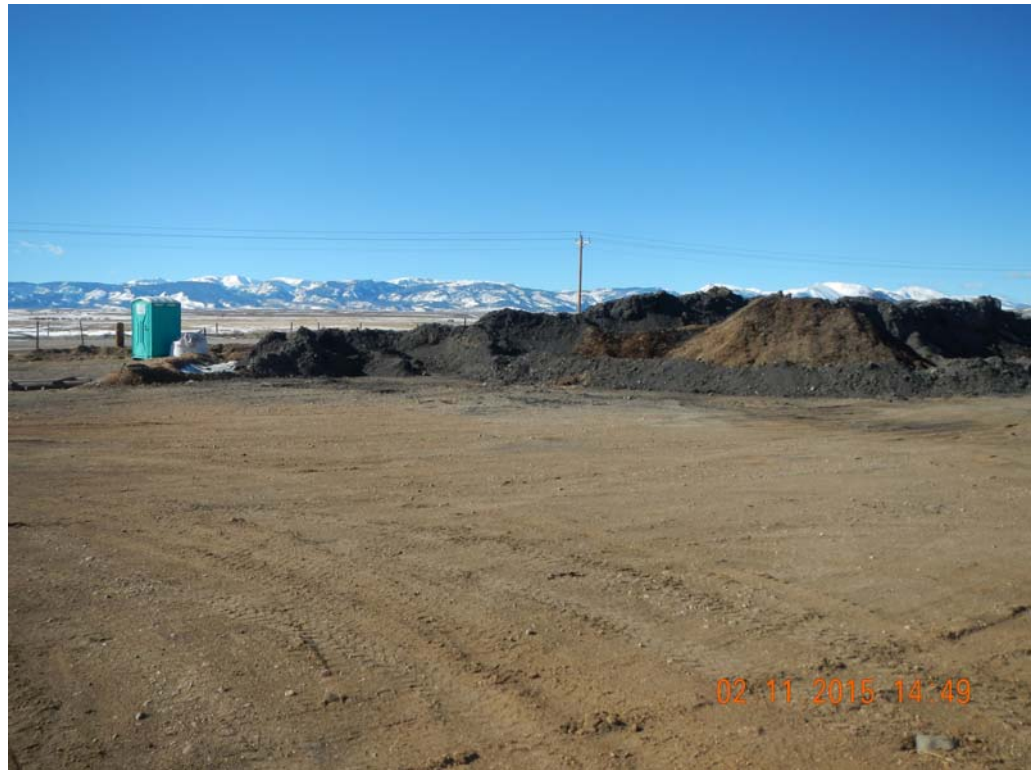
Cuttings berm made out of
what appears to be cuttings.
Not compacted, not
continuous.

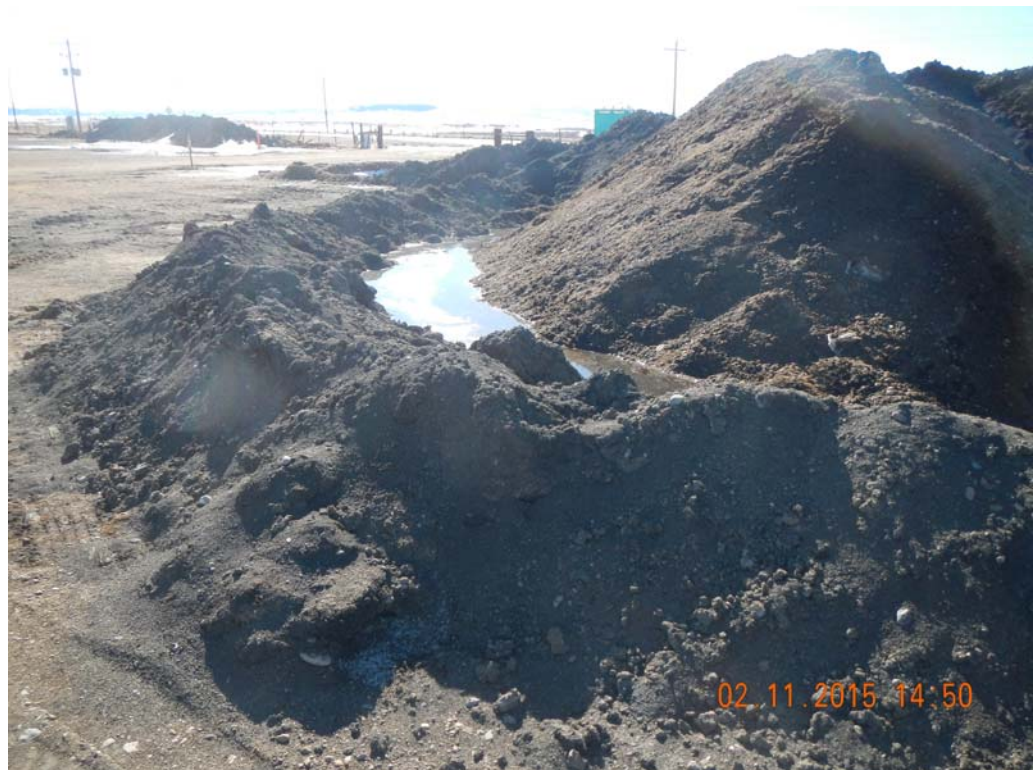
Cuttings berm made out of
what appears to be cuttings.
Not compacted.

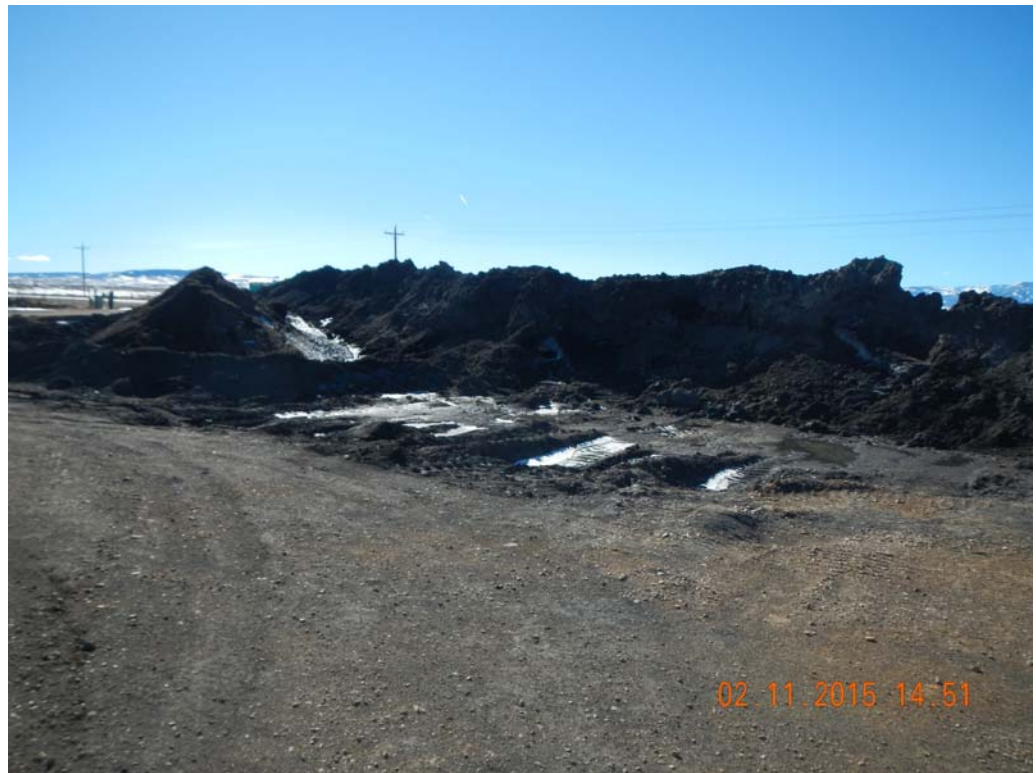
Cuttings with no berm.

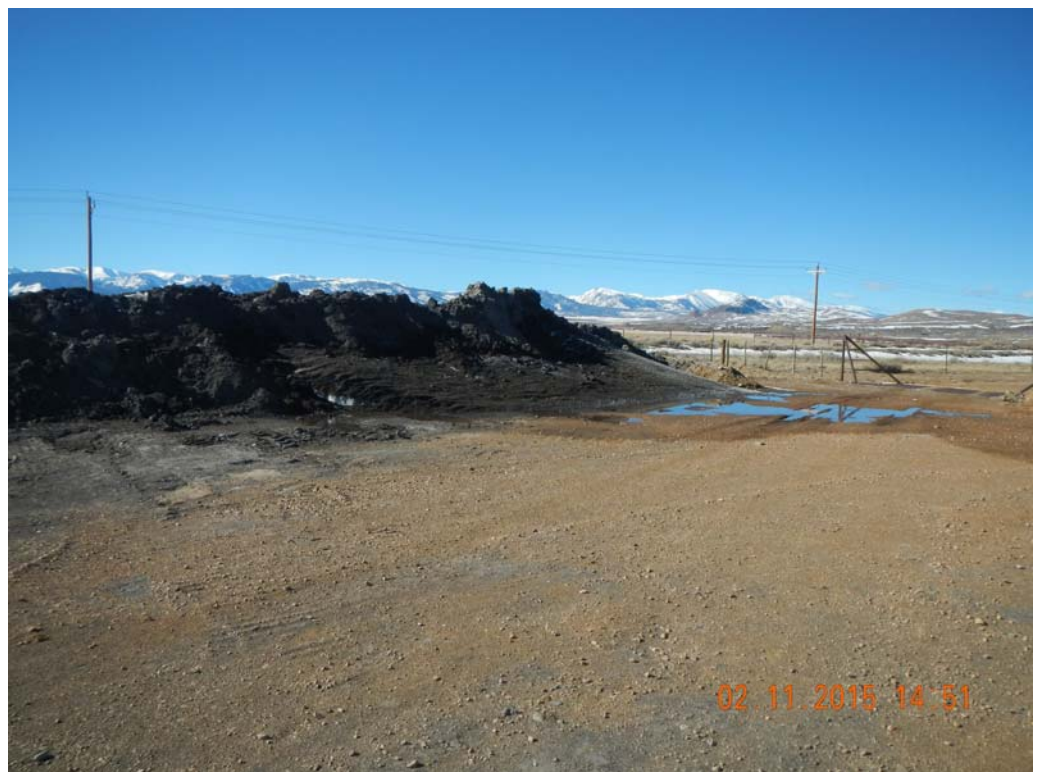
Cuttings with no berm.

Alternate location entrance
and HWY 14 visible on right
side of picture.

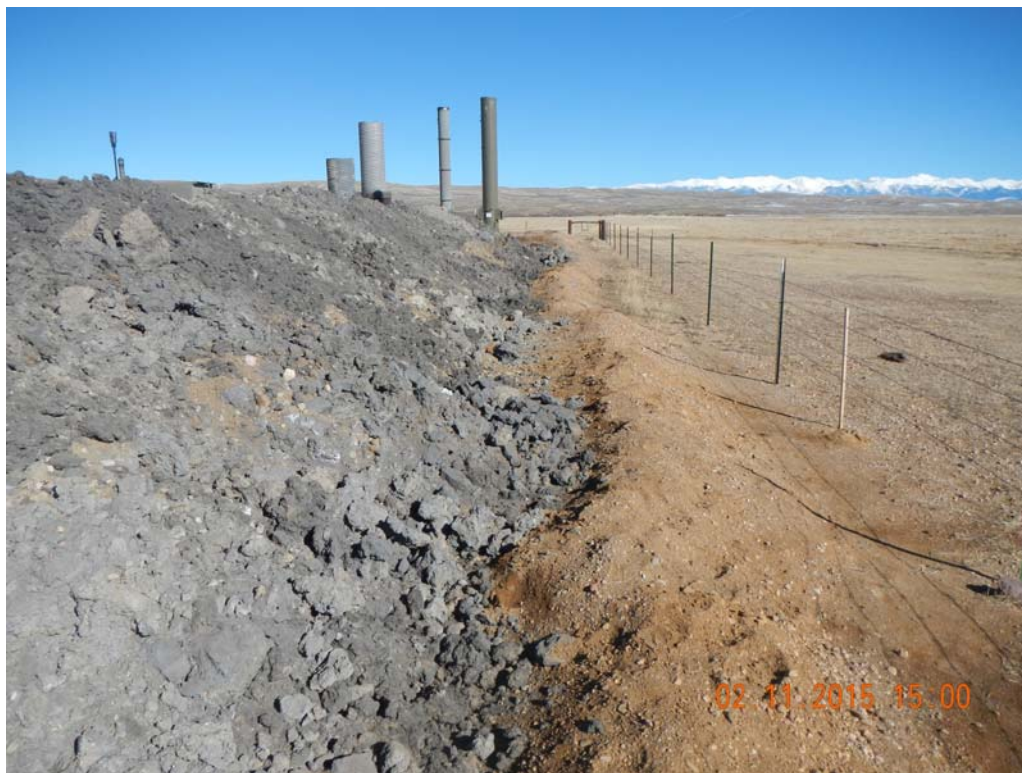
Cuttings berm not
compacted.

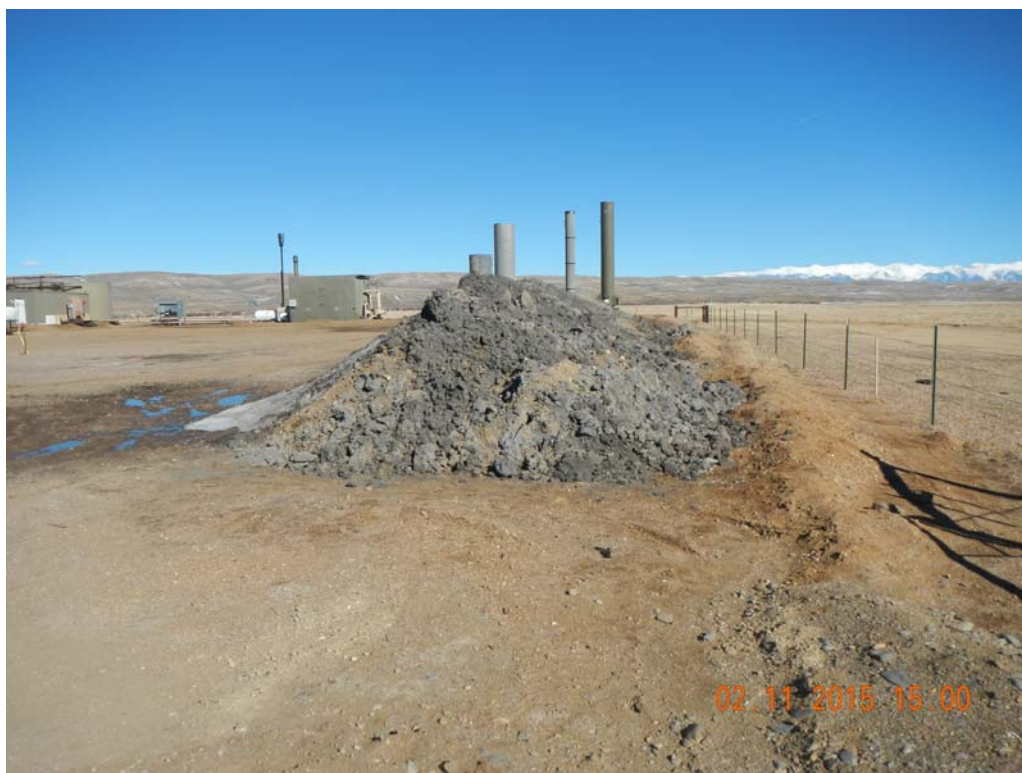
Cuttings berm not
continuous or compacted.

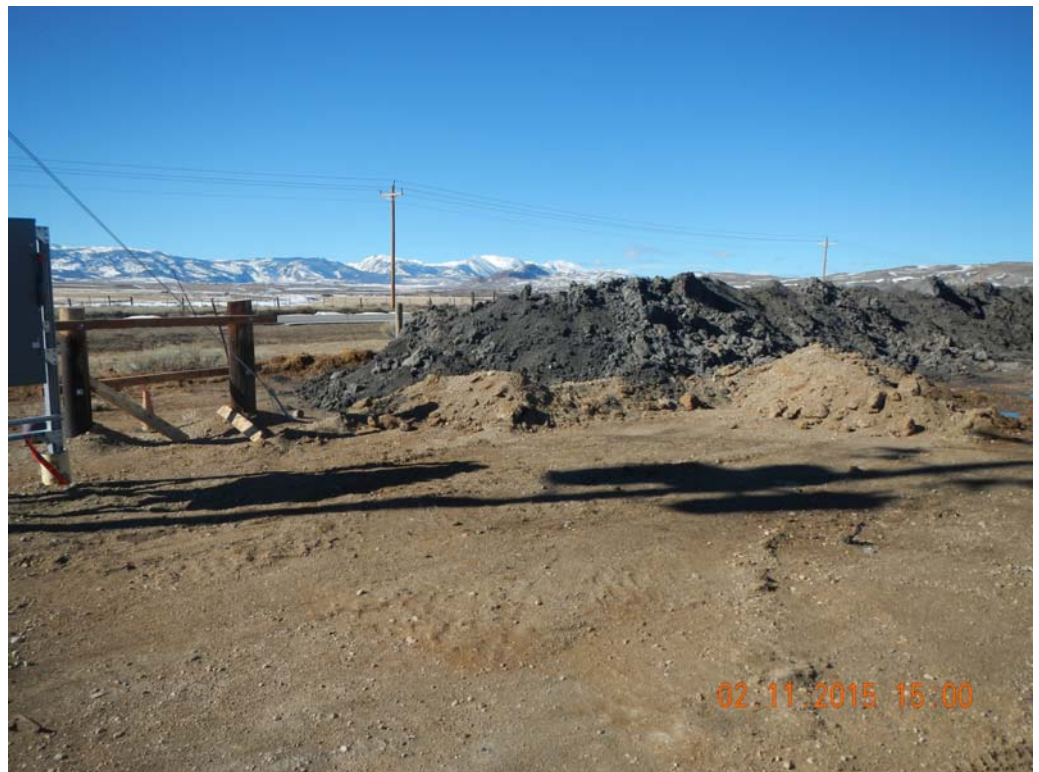
Cuttings berm not
continuous or compacted.

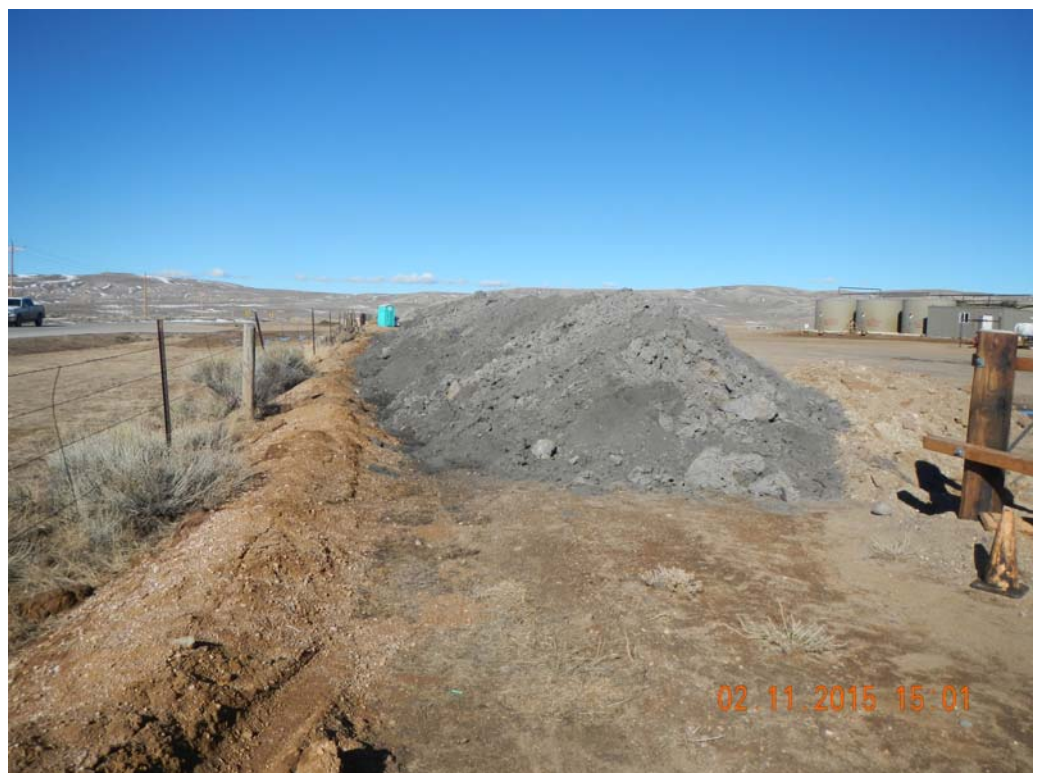
Cuttings berm not
continuous or compacted.

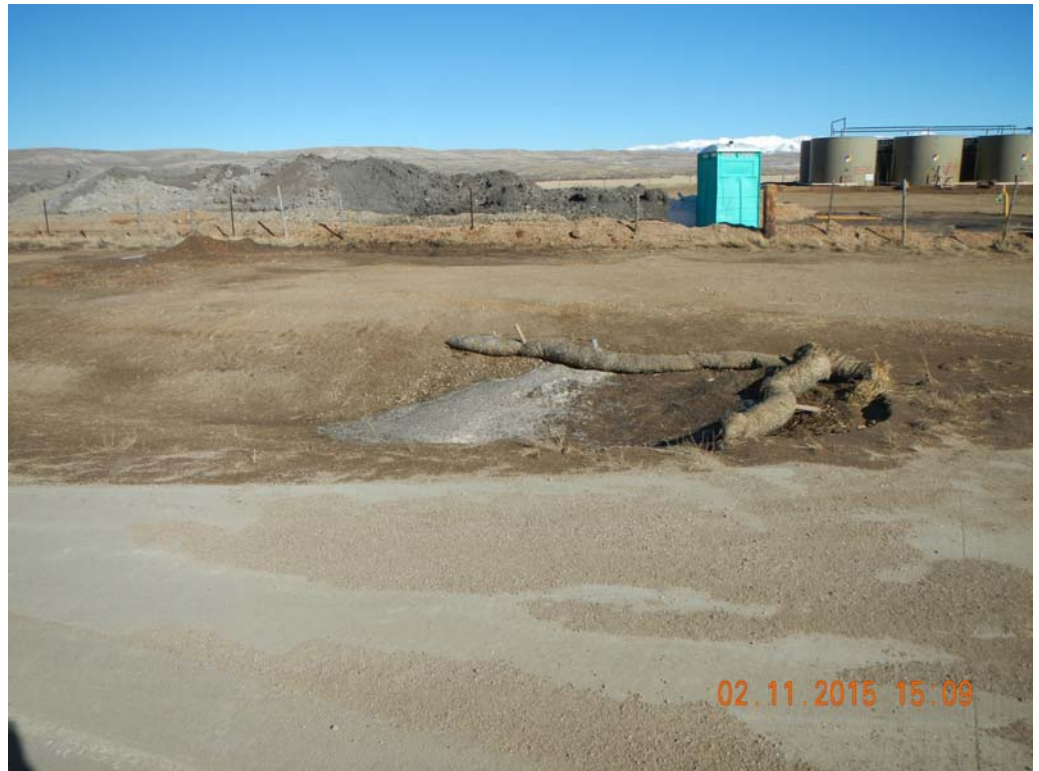
Waddles falling into culvert
at entrance to location.

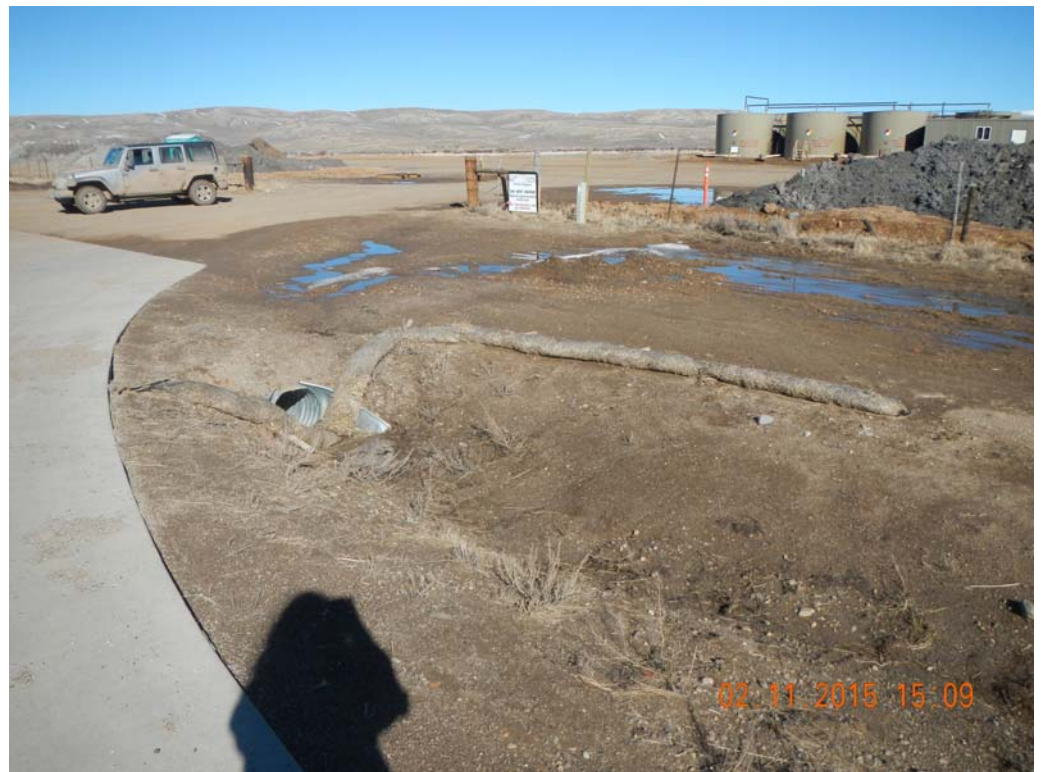
Waddles falling into culvert
at entrance. Cuttings in a
non continuous/compacted
berm visible behind ditch.
Ditch runs along HWY 14.

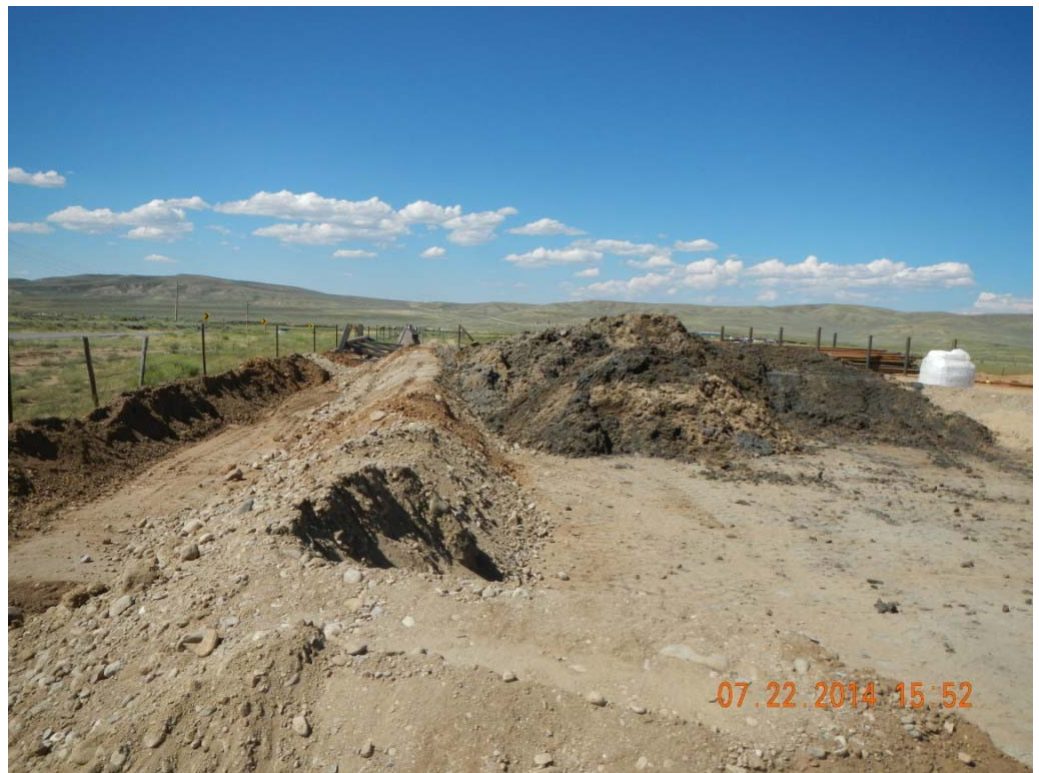
Cuttings berm not
continuous or compacted.

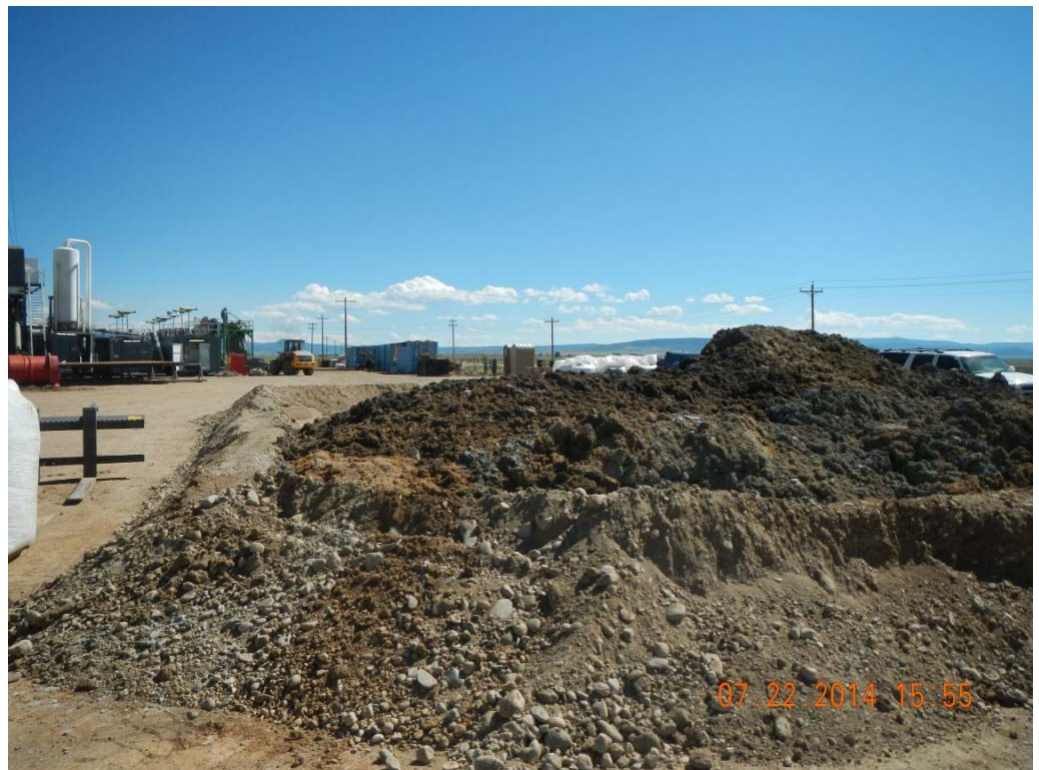
Cuttings berm not
compacted.

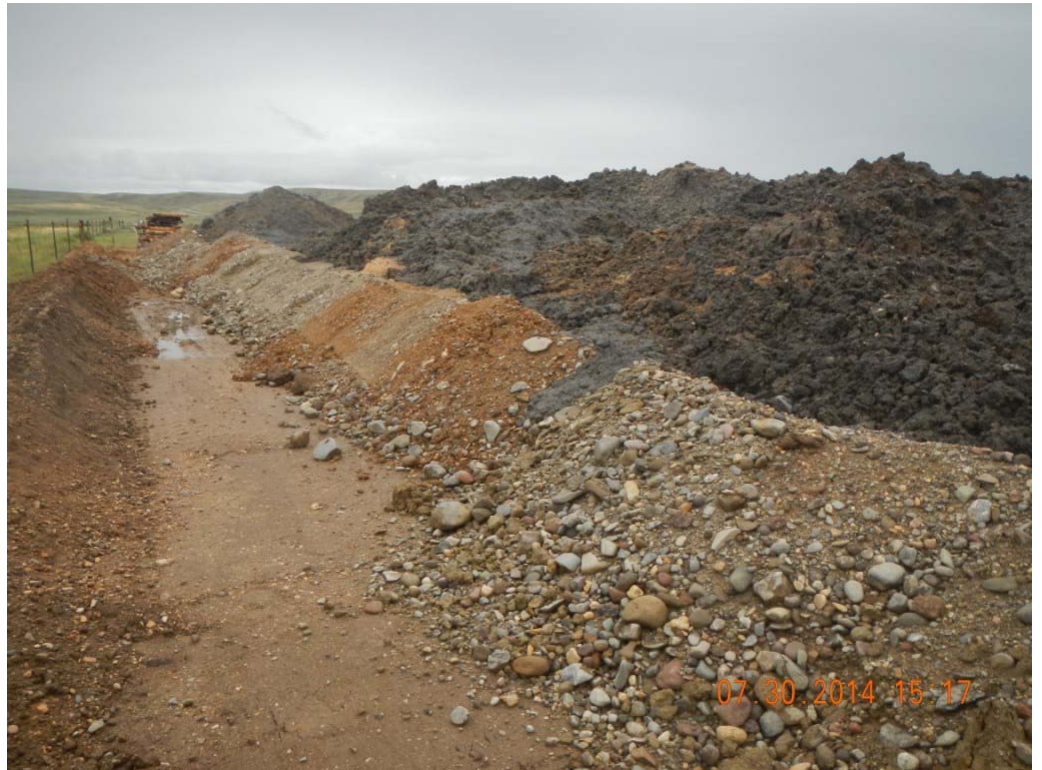
Cuttings berm not
compacted. Cuttings
spilling over berm.

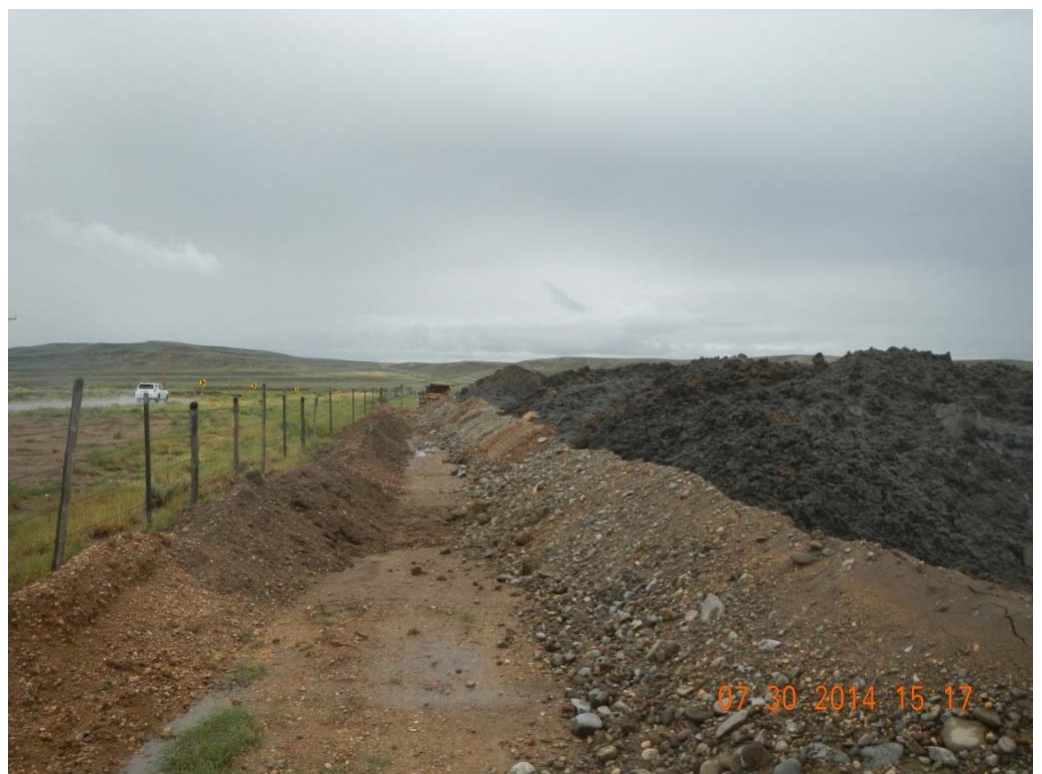
Cuttings berm and
perimeter berm not
compacted.
