## Grizzly 3-32H

Inspection# 673401899

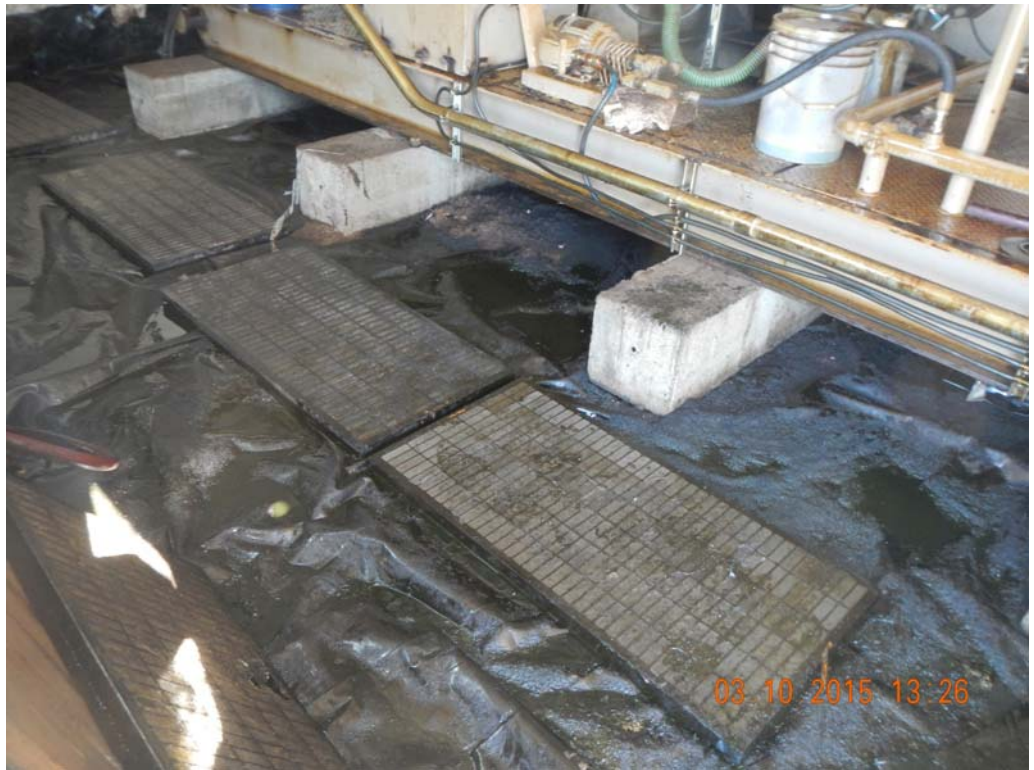
Oily fluid in pump house.

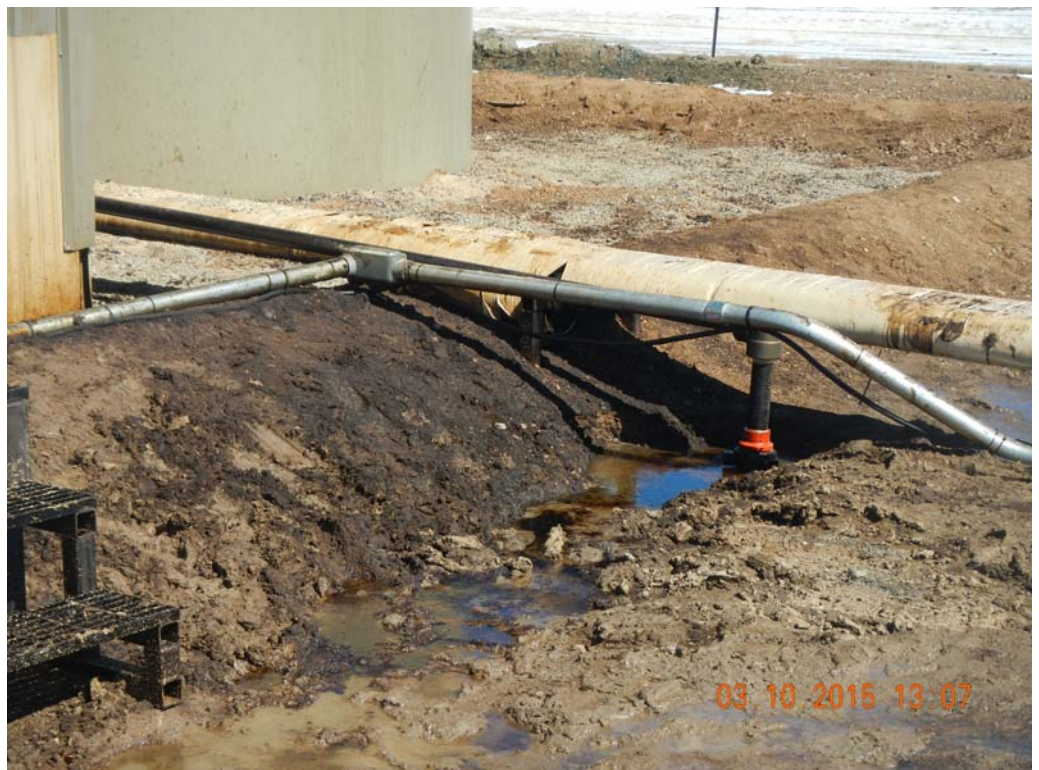
Stained soil, oil in water  
outside of berm.

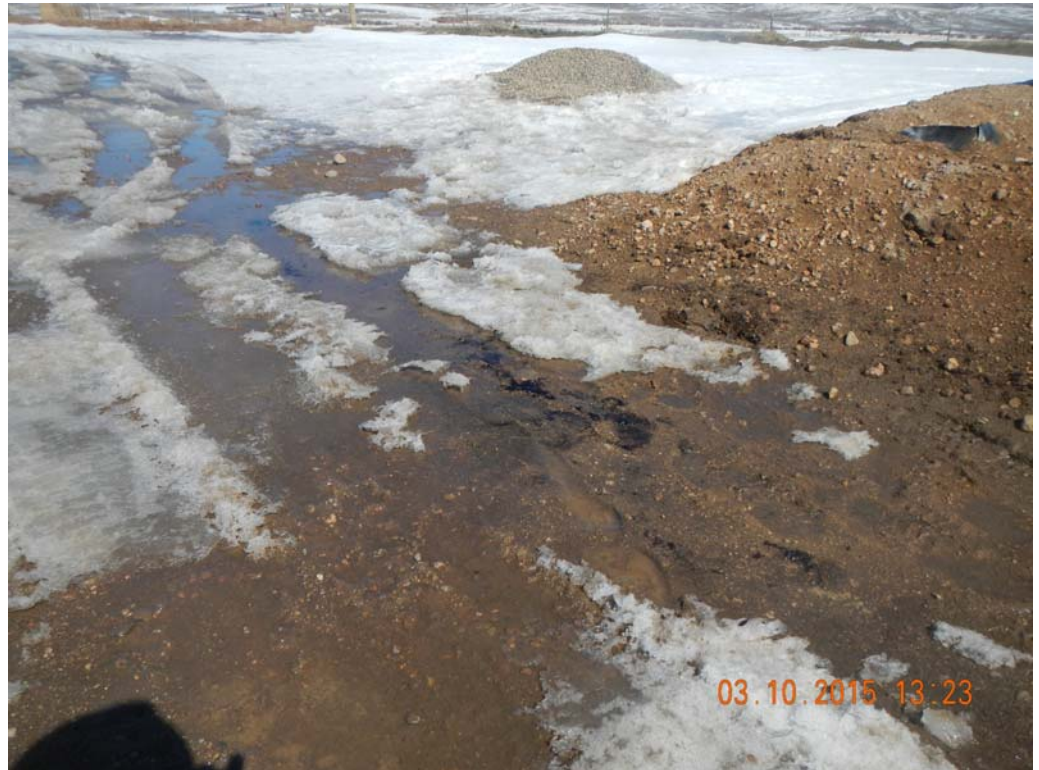
Product outside of berm  
mixing with stormwater.

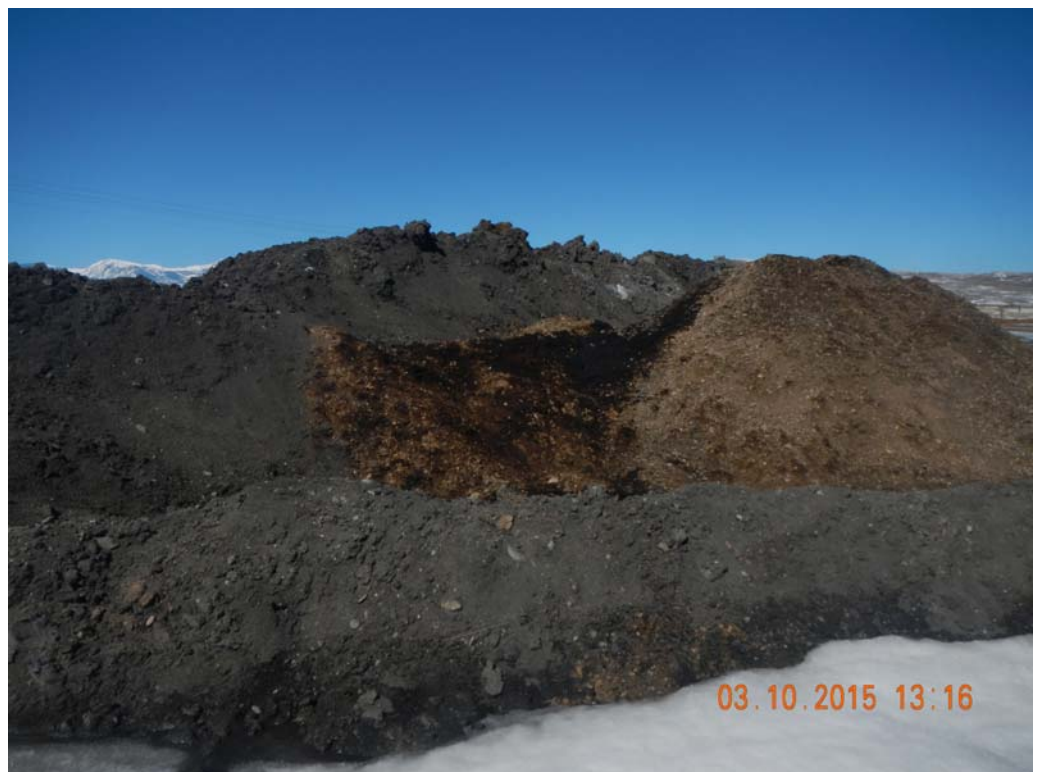
Contaminated soil bermed  
with and by cuttings.

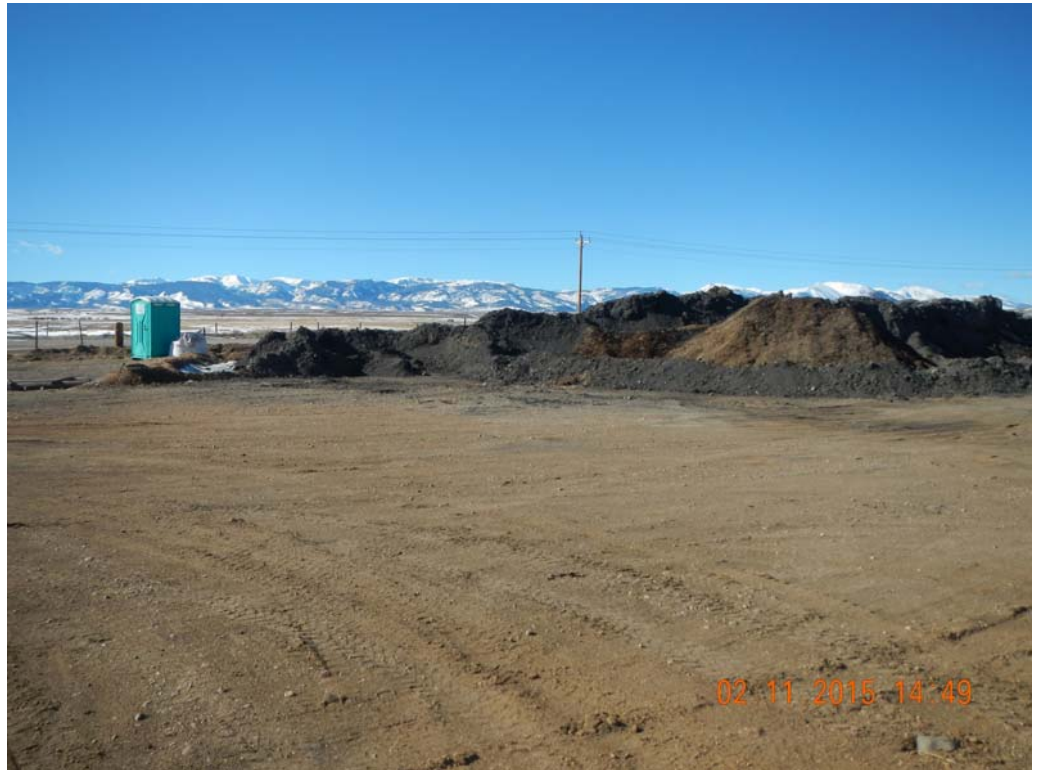
Contaminated soil bermed  
with and by cuttings.

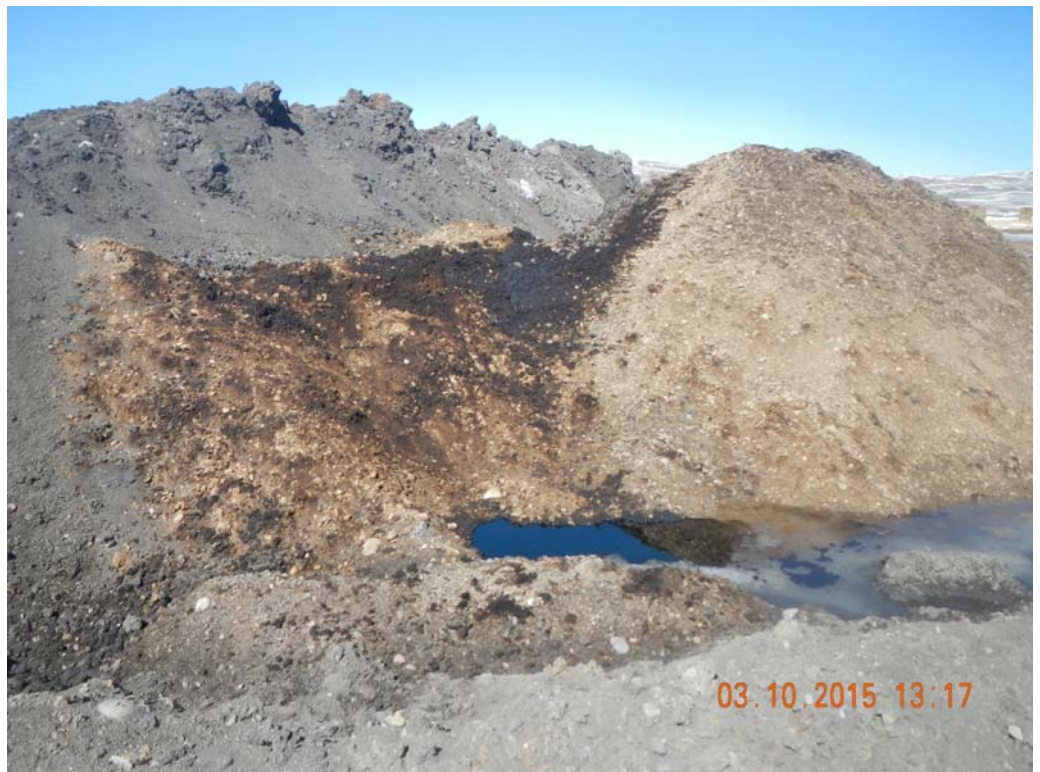
Contaminated soil with  
fluid.

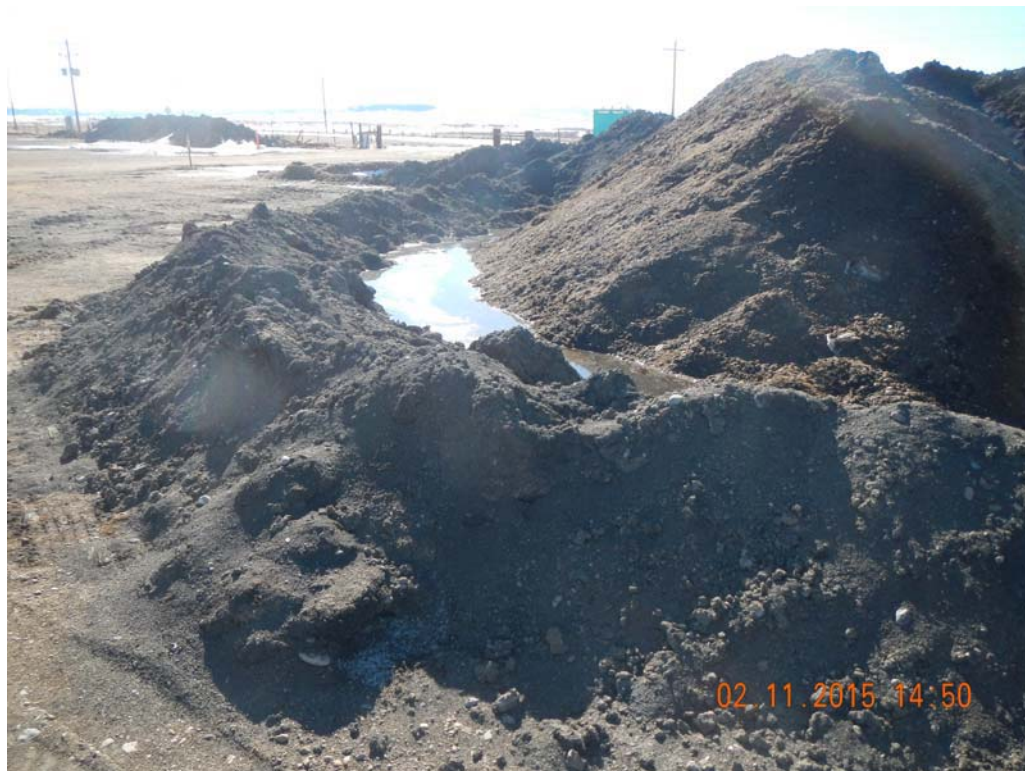
Contaminated soil with  
fluid.

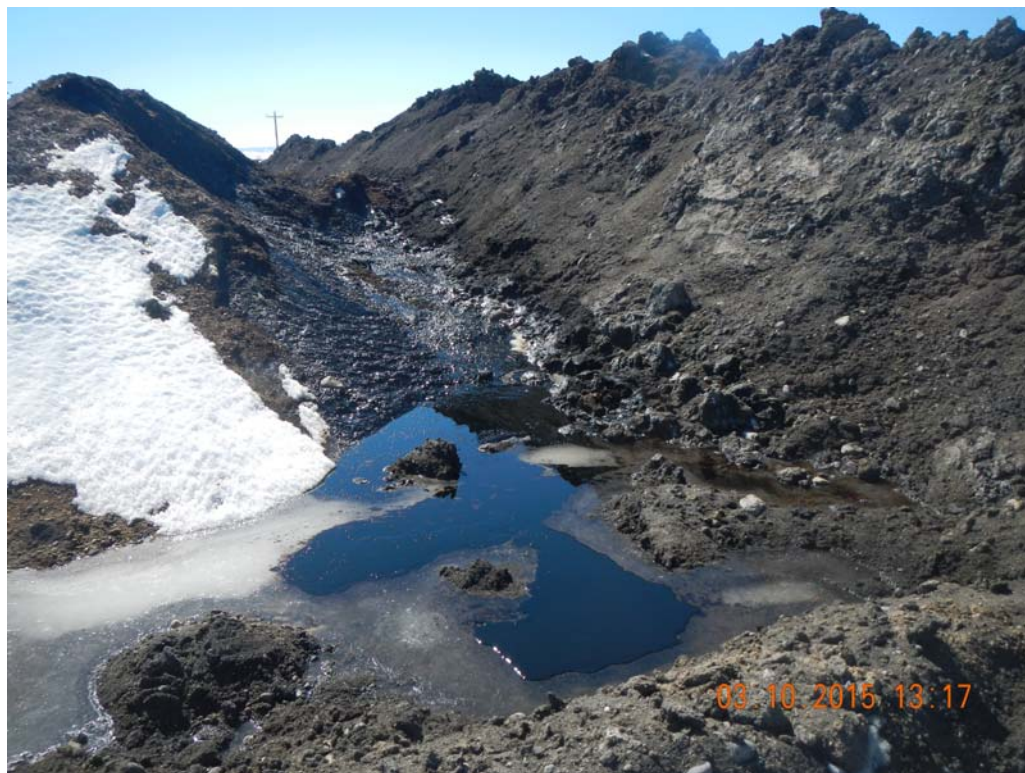
Contaminated soil with  
fluid.

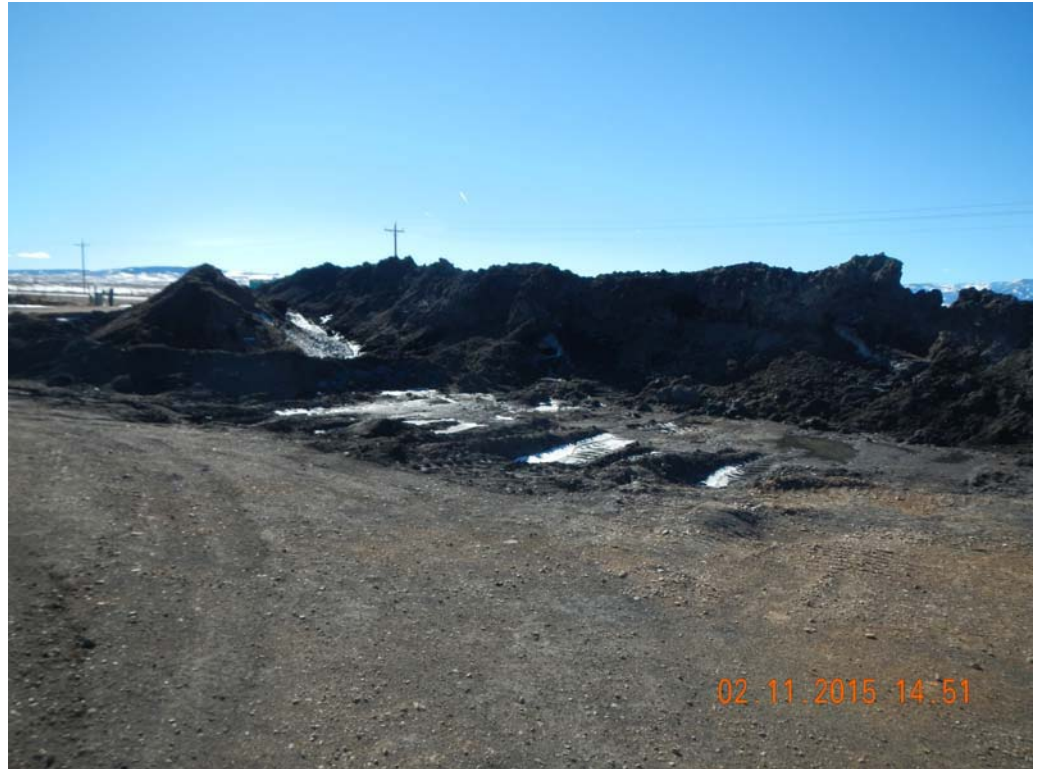
Contaminated soil with sheen.

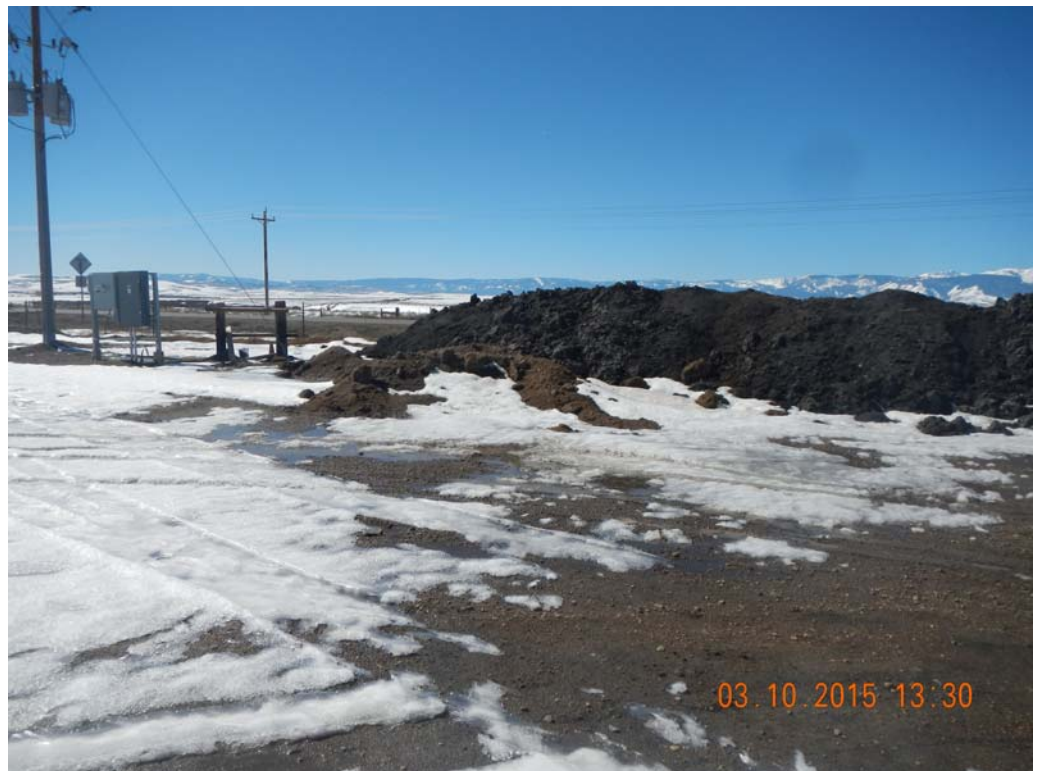
Cuttings with no berm.

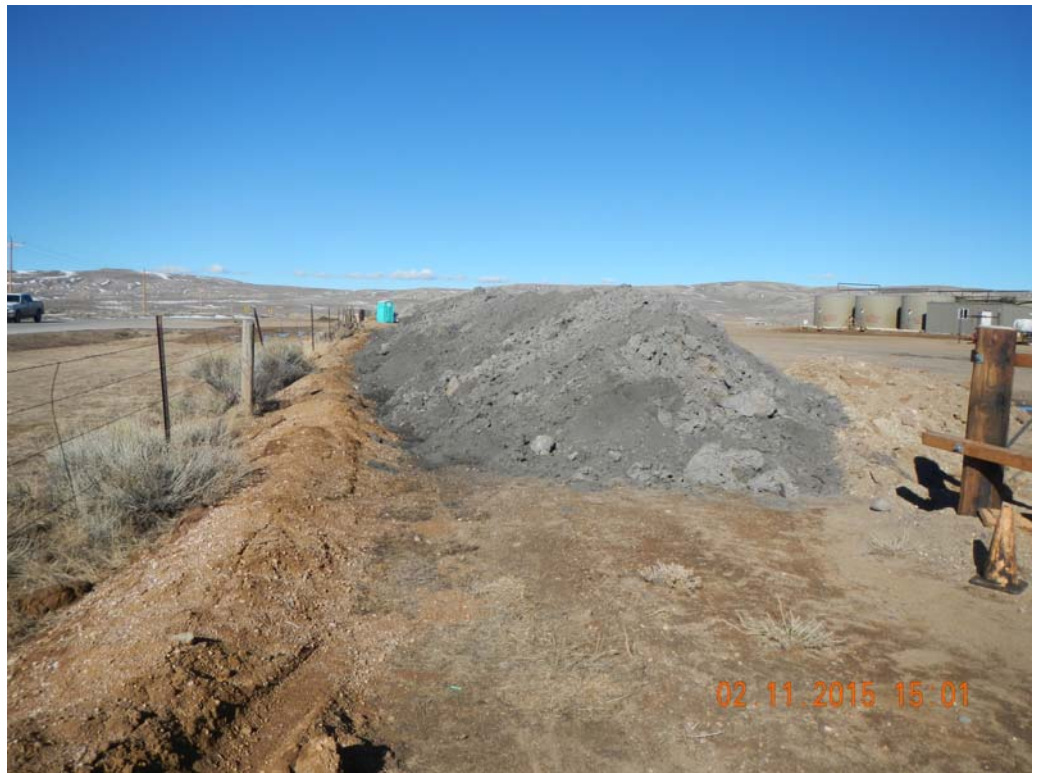
Cuttings with no berm.

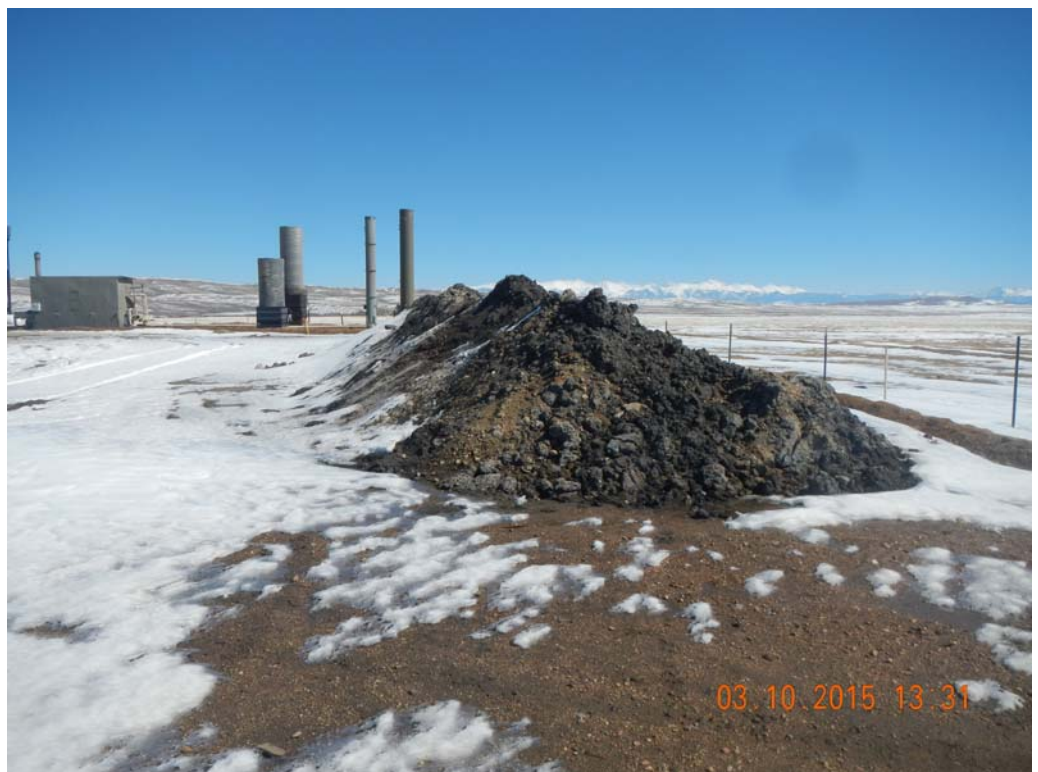
Cuttings with no berm.

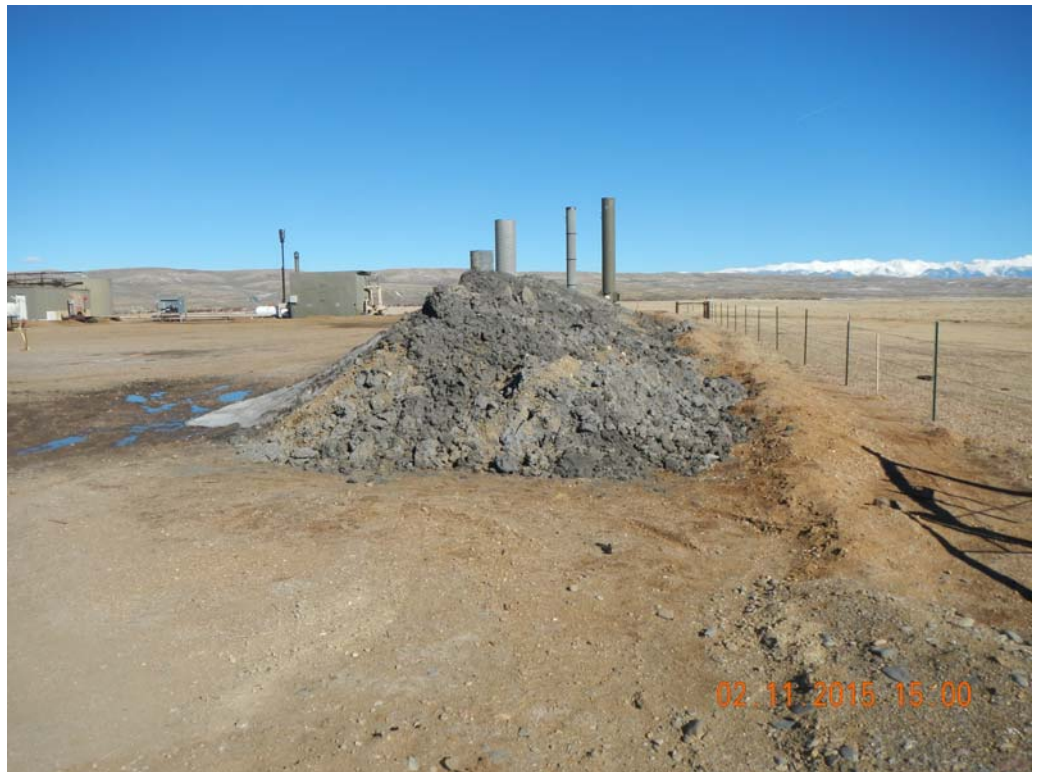
Cuttings with no berm.

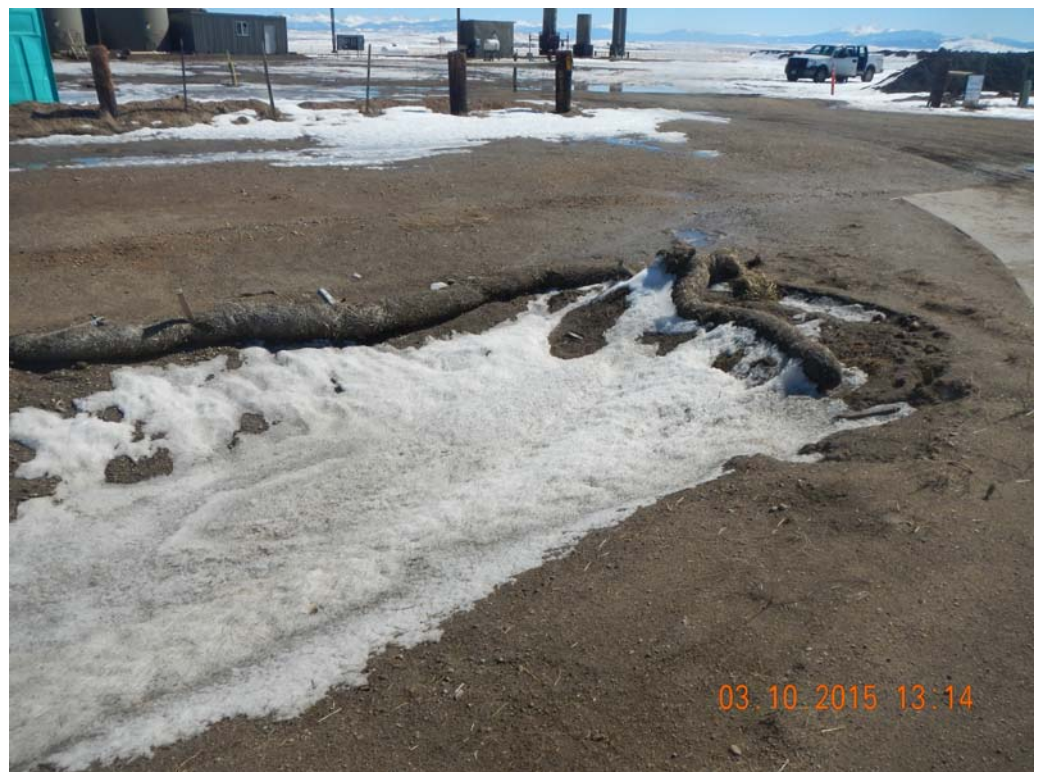
Waddles blocking culvert  
at entrance.

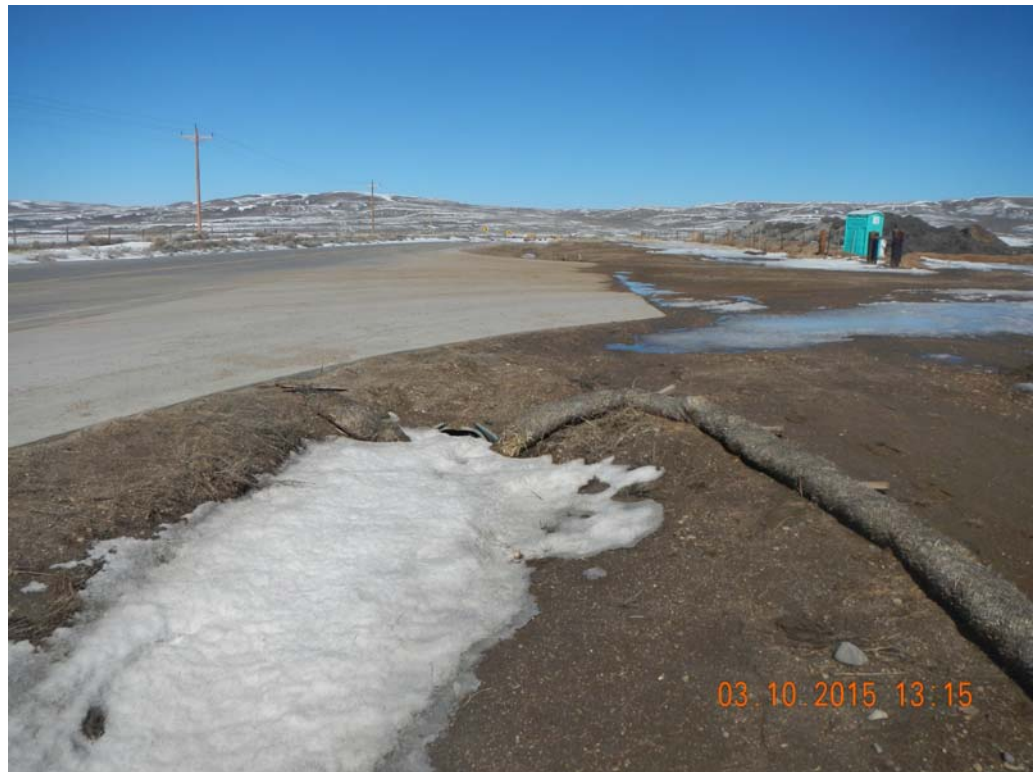
Waddles blocking culvert at  
entrance.

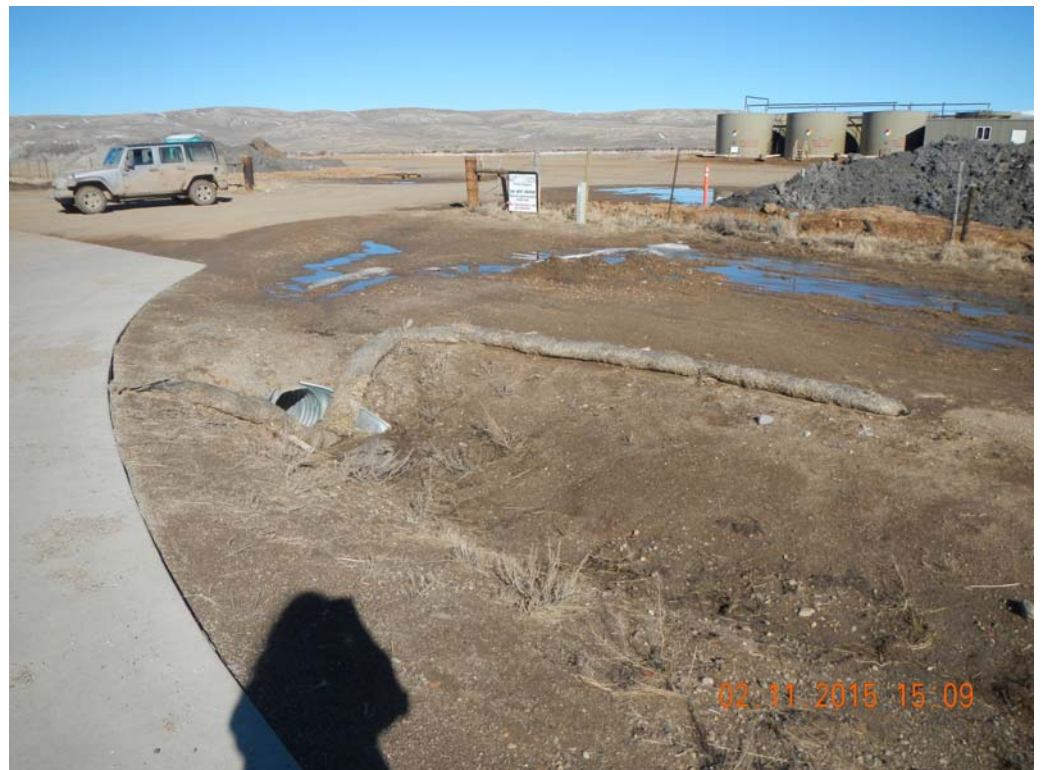
Waddles falling into culvert  
at entrance.

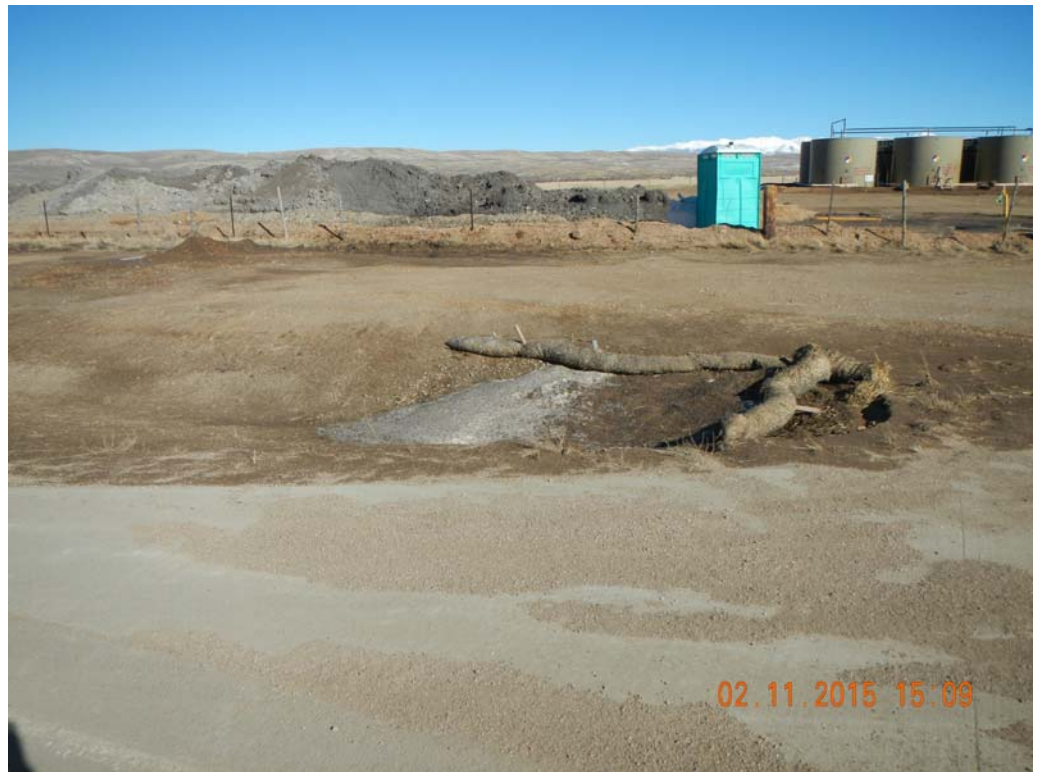
Waddles falling into culvert  
at entrance.

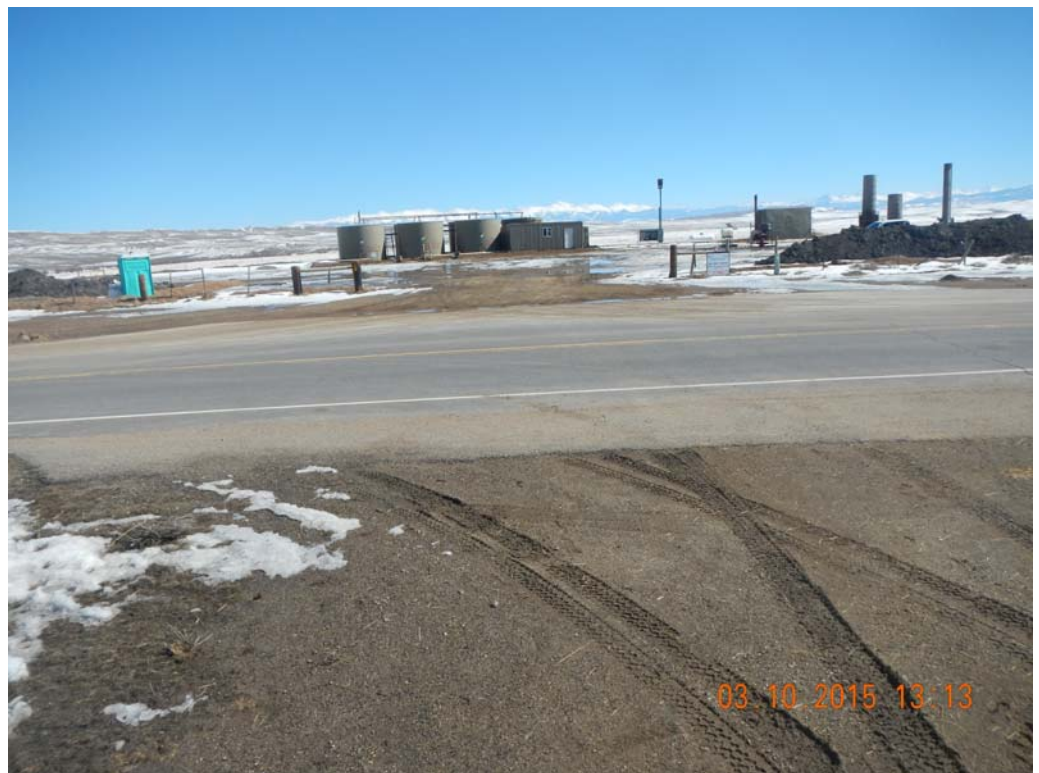
Vehicle tracking off of  
location.
