Antero Lundgren A-1 Location ID# 324342 (Lundgren Frac/Flowback Pit, #149019)

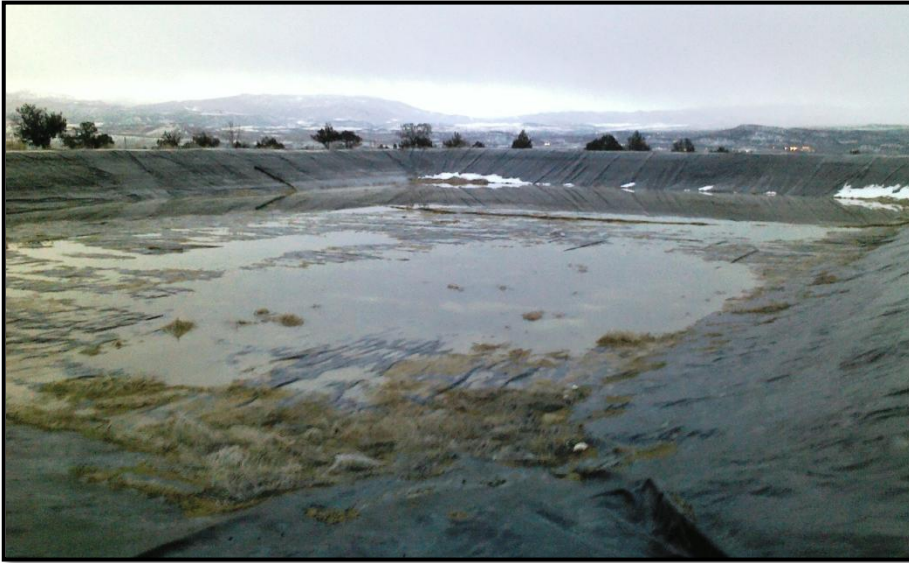
Viewing south: Frac/Flowback pit.

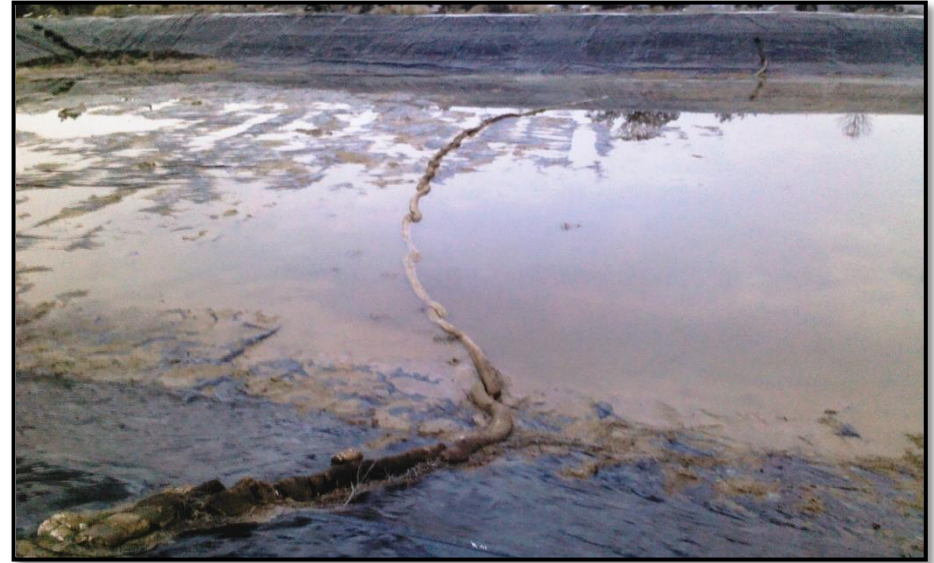
Viewing East: Frac/Flowback pit

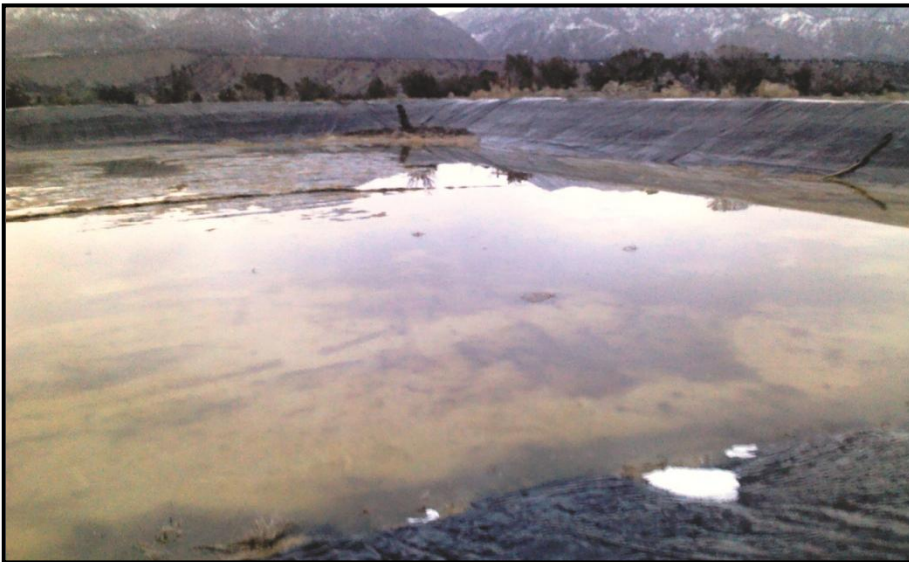
Viewing northeast: Frac/Flowback pit

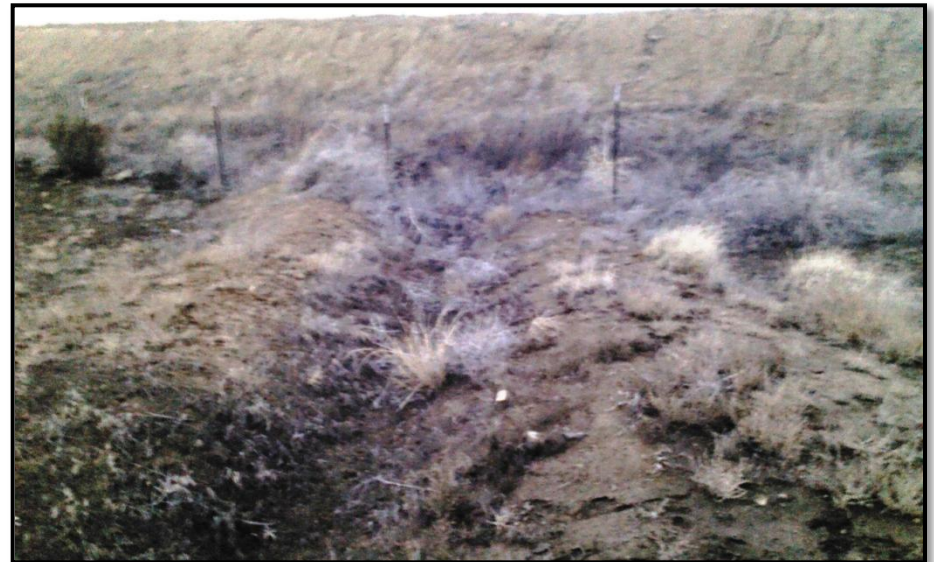
Viewing north & downgradient of Frac/Flowback pit: Pre-existing salvaged irrigation diversion ditch & pit's southern fill slope.

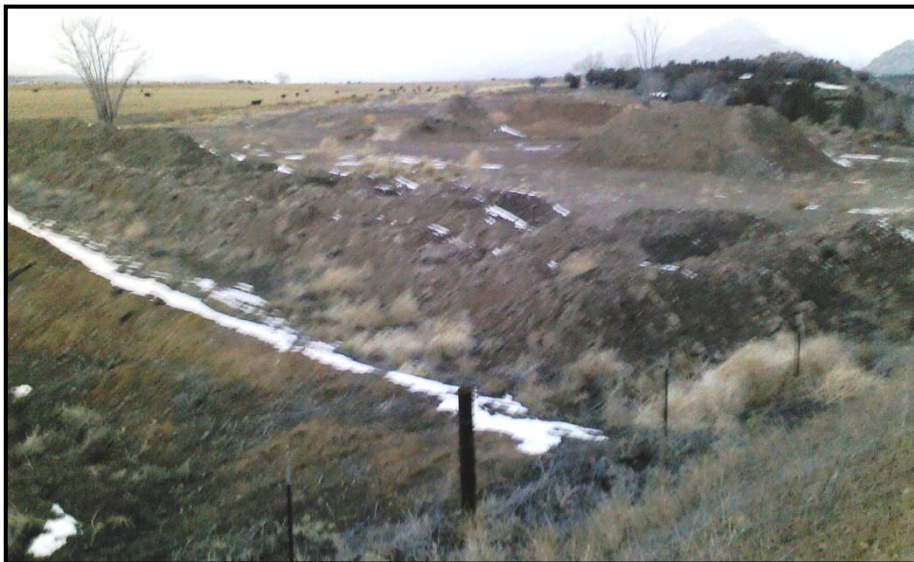
Viewing northwest from pit area: Lundgren Well Pad with stockpiled E&P waste.

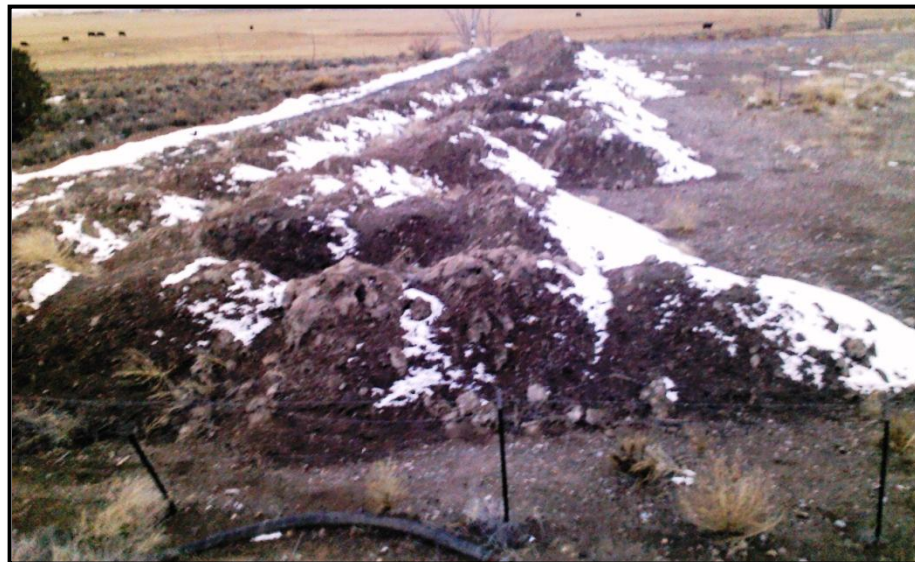
Viewing west: E&P Landfarm strip and adjacent berm & ditch stormwater BMPs.

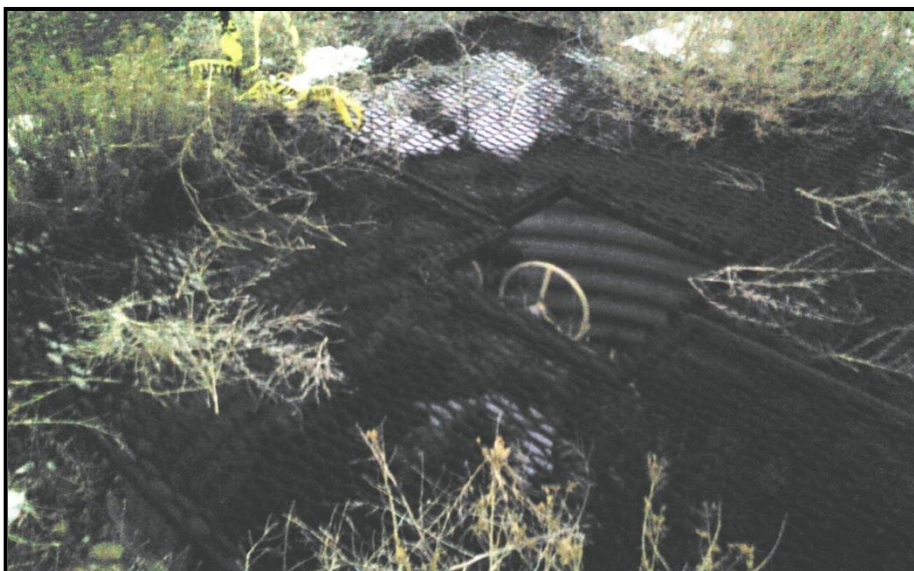
View of cellar-enclosed Shut-in well (Lundgren A-1# 045-11276).

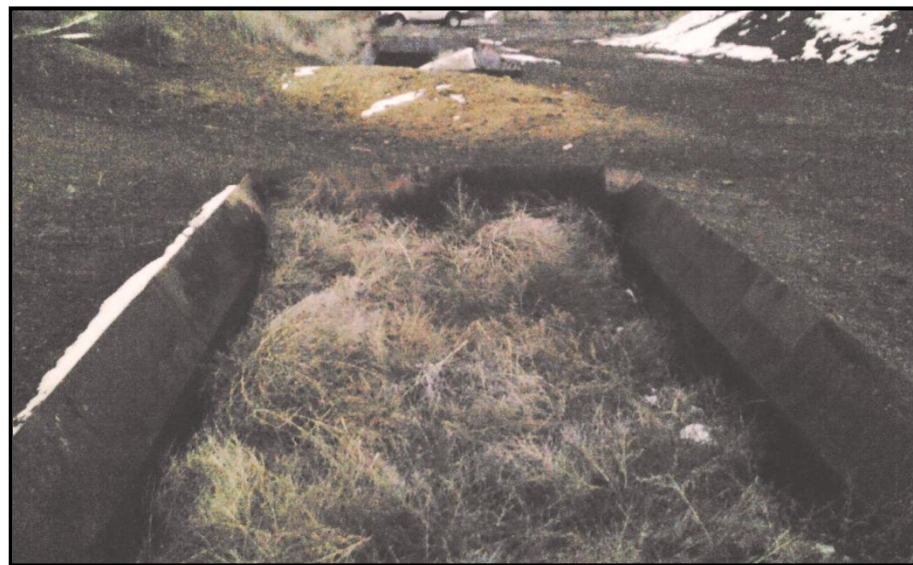
Viewing East : open receptacles containing miscellaneous debris: weeds, dirt, oily debris & stormwater.
