WPX Energy

PA 24-34 Production Facility

Location # 334989

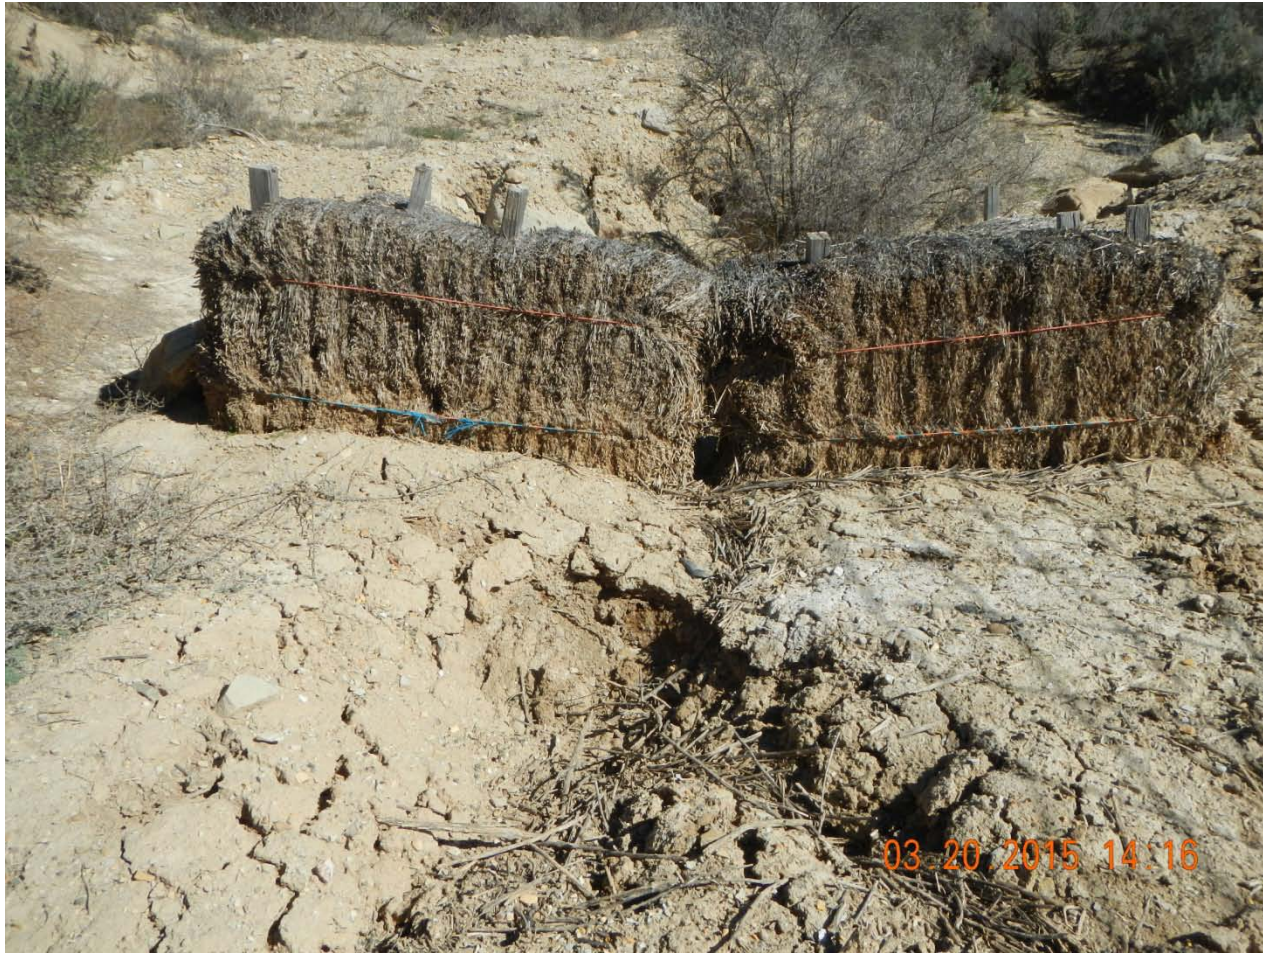
Subsidence of buried culvert

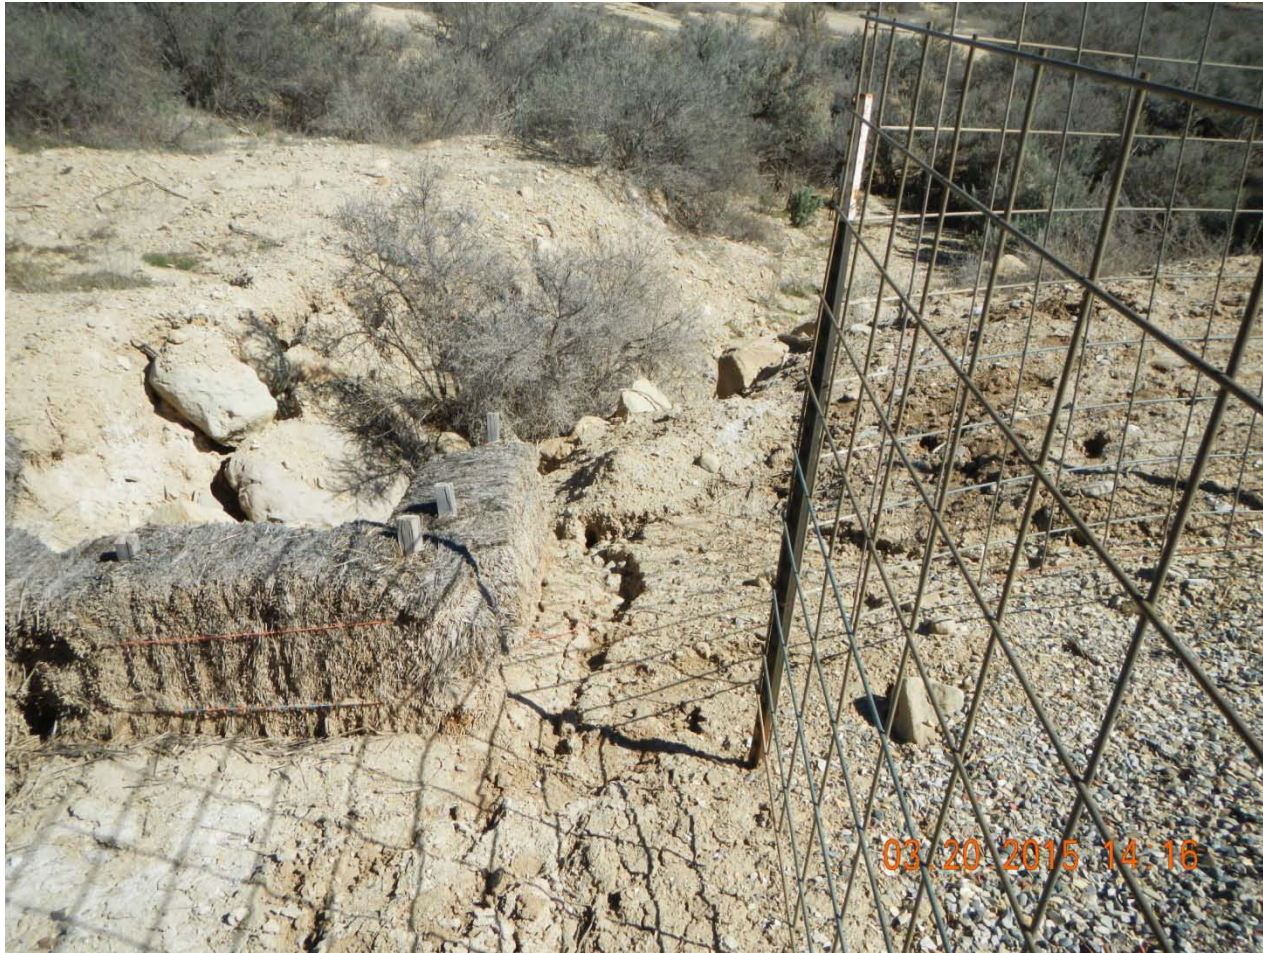
Rill running along bale into ditch

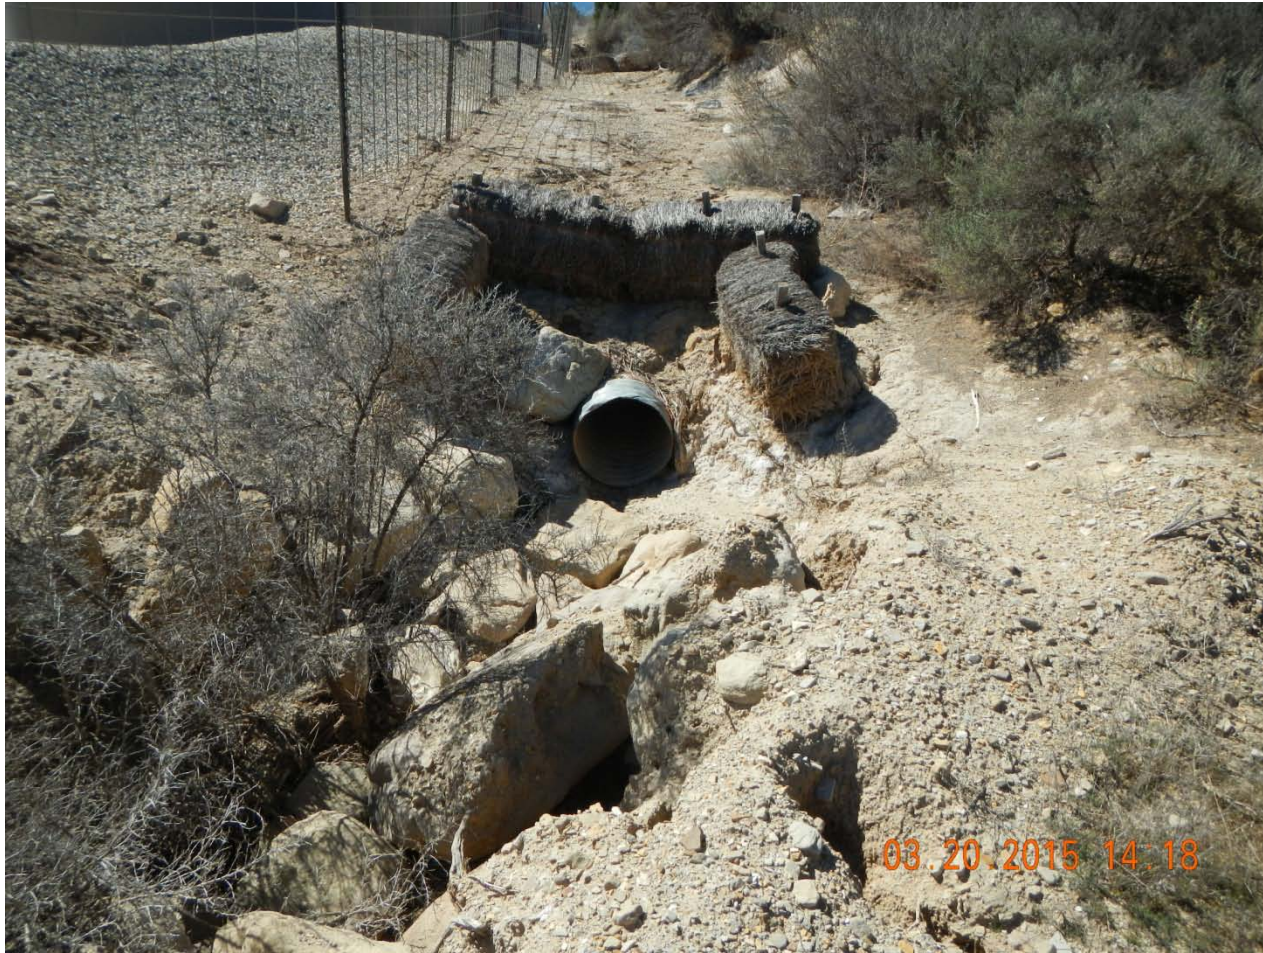
Erosion ditch at culvert outlet

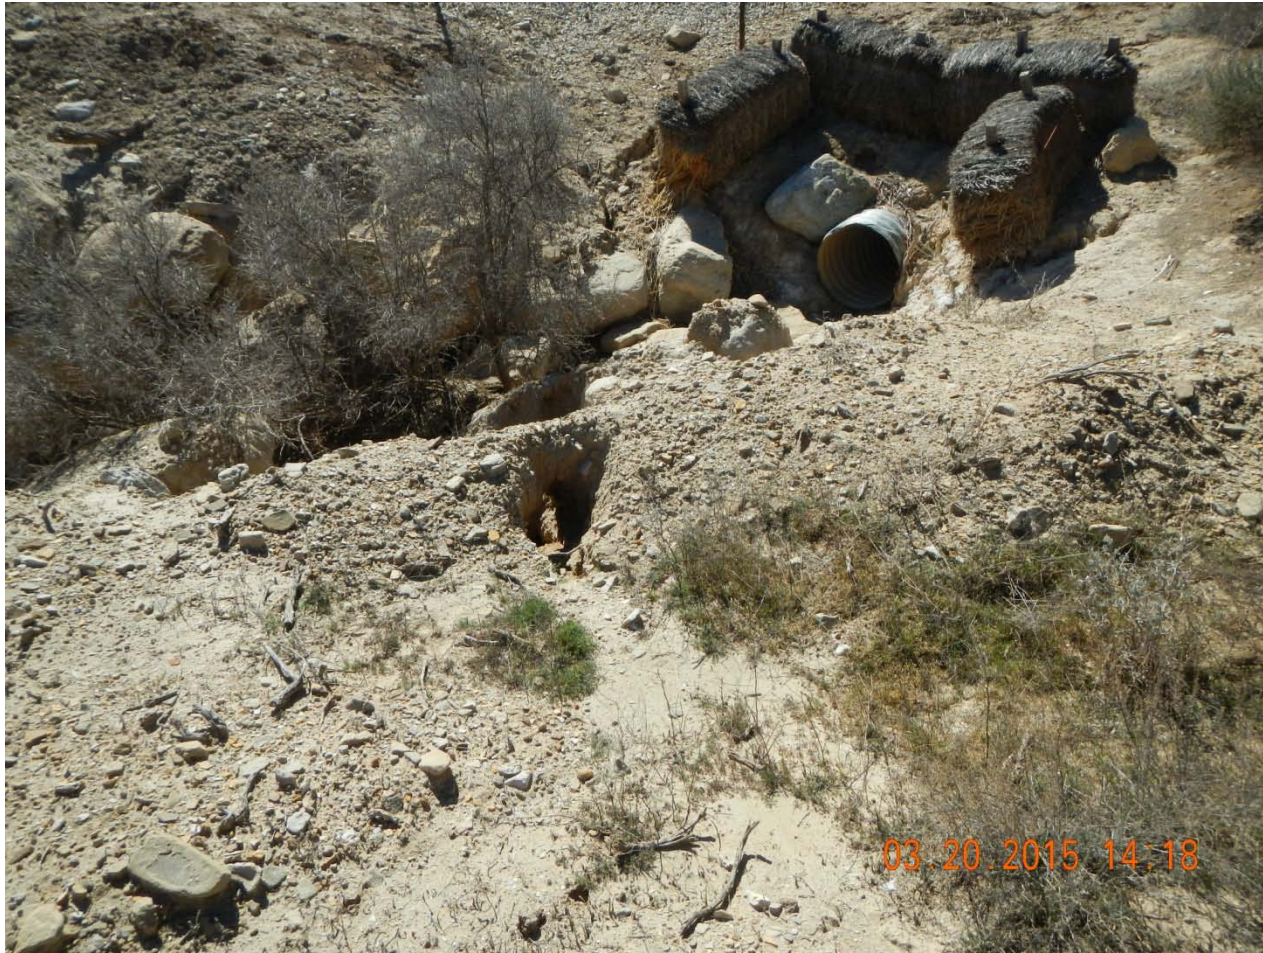
Sink hole on ditch wall
