WPX Energy

ARCO-66S96W 31 SENE

Location # 335222

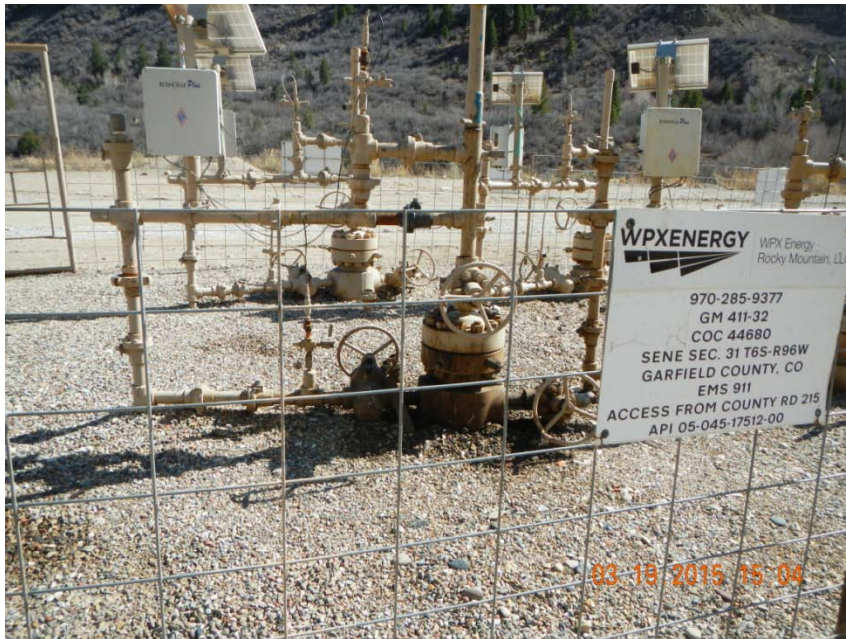
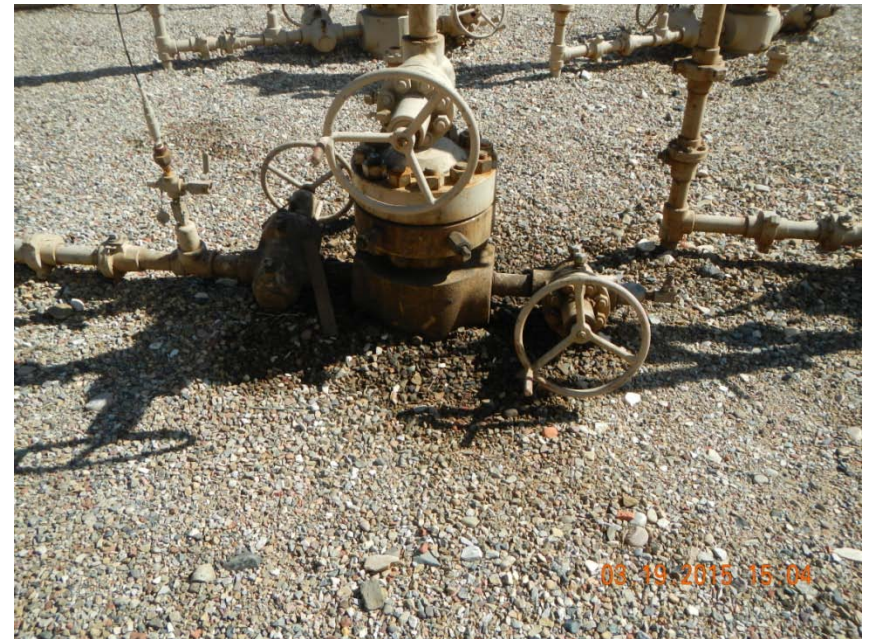
Stain around well.

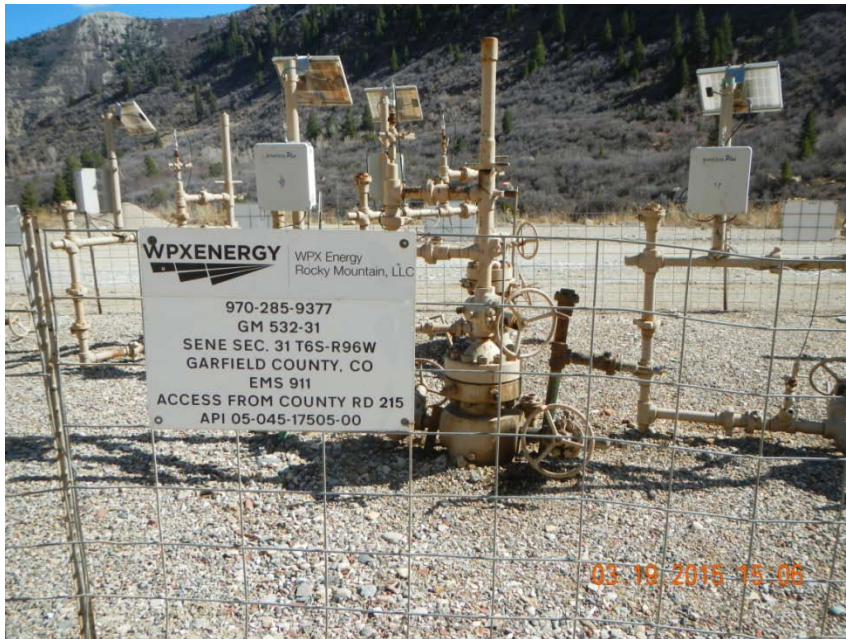
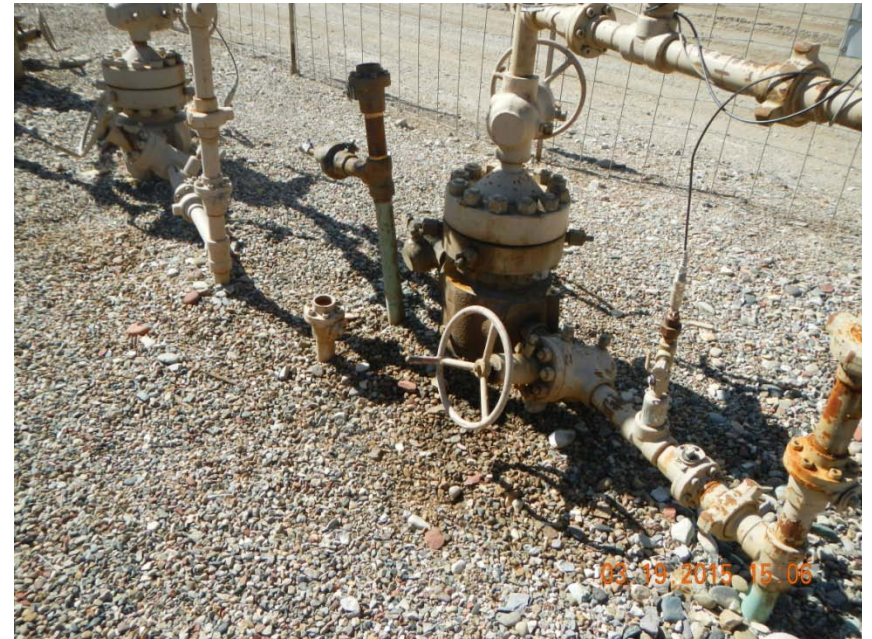
Stain around well.

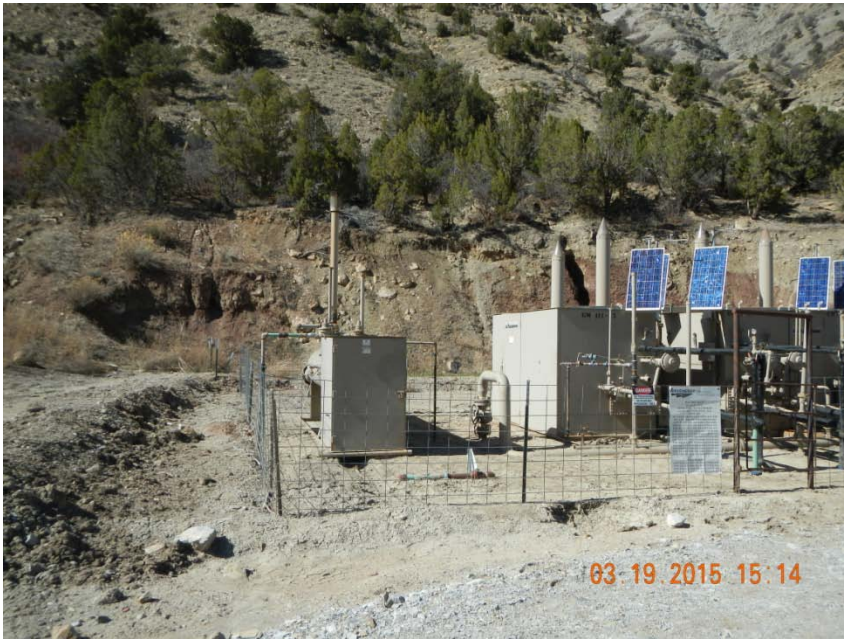
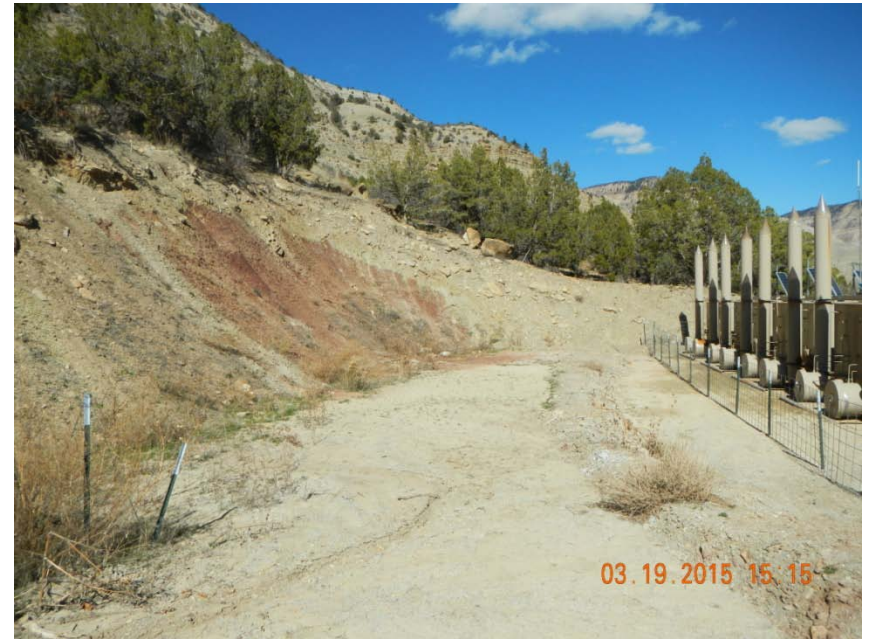
Unstable cut slope behind separators.

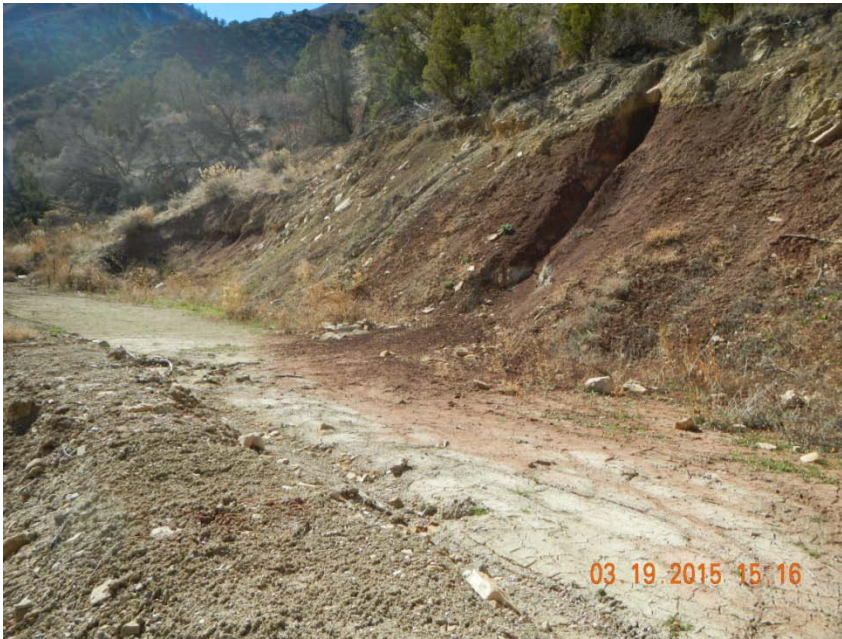
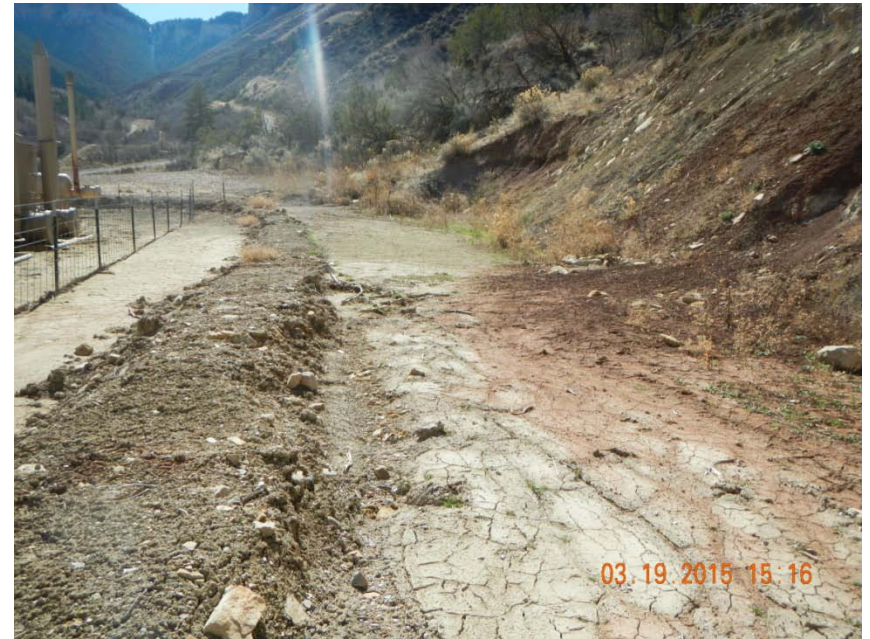
Erosion of cut slope behind separators and sediment build up.

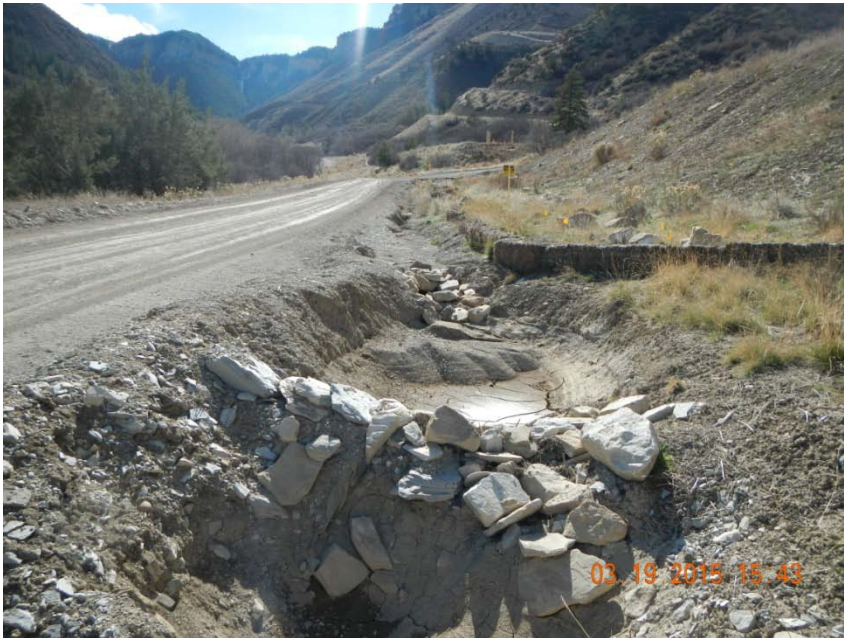
Ditch down the corner of location entrance.

Sediment built up before check dam

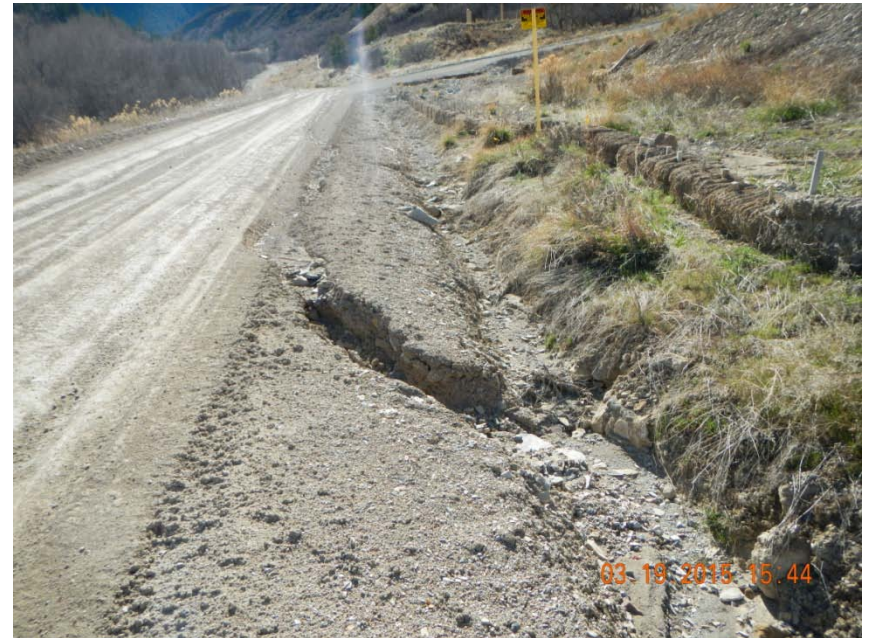
Erosion of road cutting into ditch
