**Horse Shoe Canyon Access Road  
(Cedar Willy Blvd)**

Inspection# 675201281 Complaint# 200426603  
(ID#'s based on 2012 HCSI Status Report)

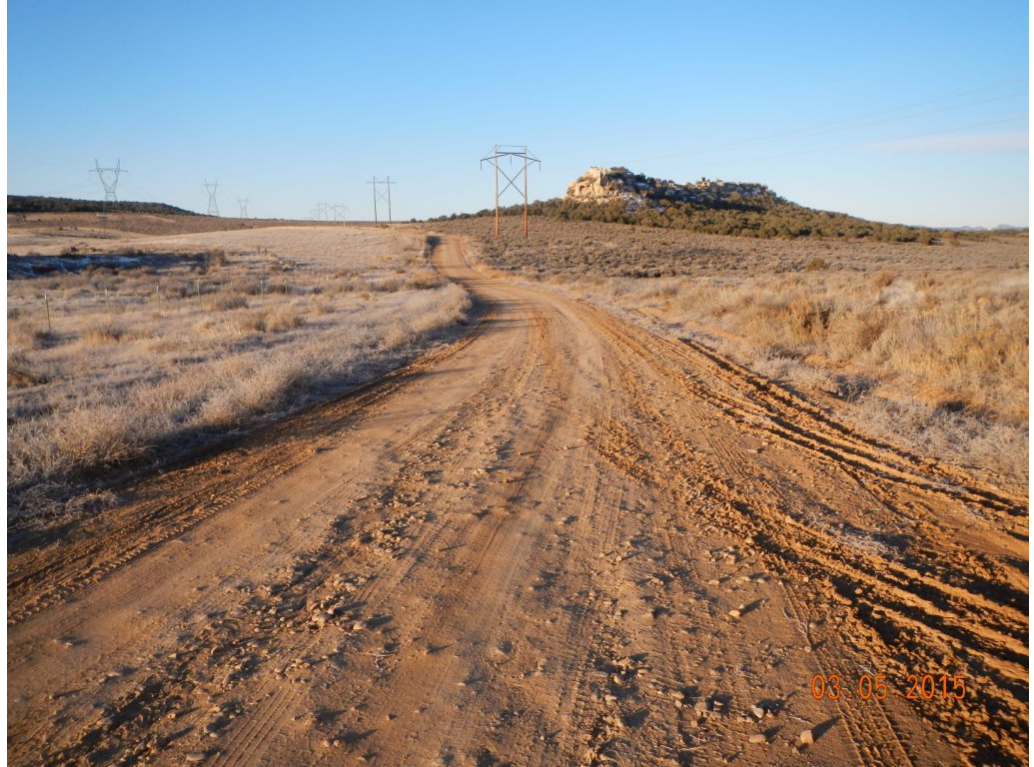
39.22948/ -108.20583

Start of road referenced in  
complaint.

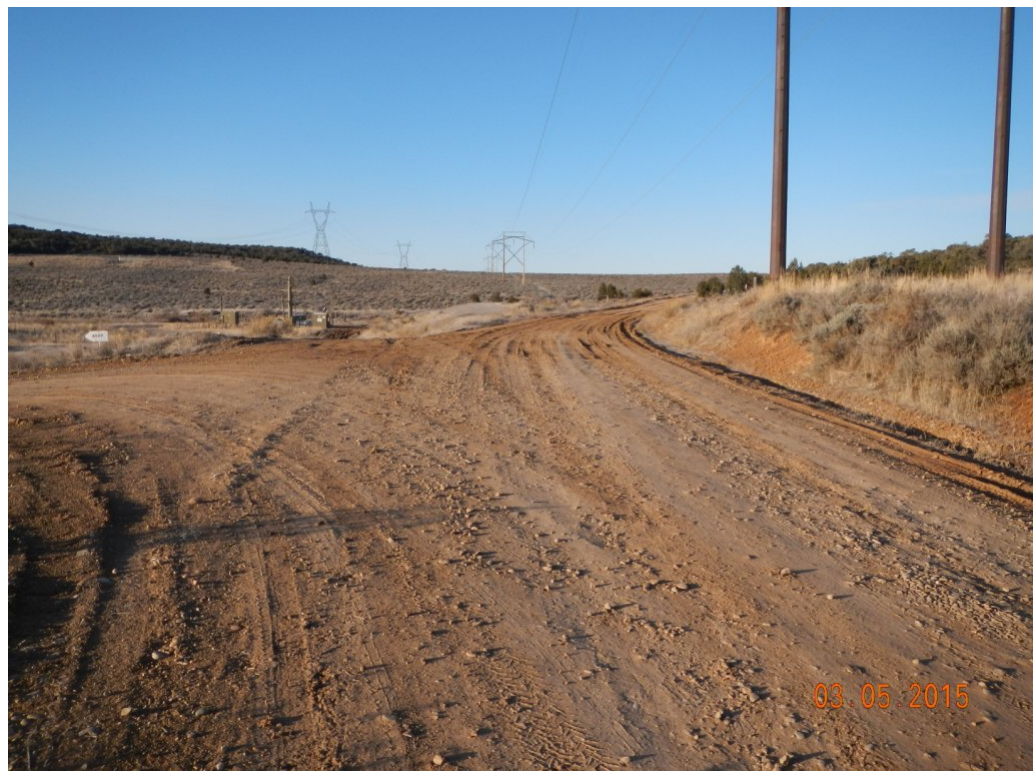
First intersection. Access to  
Encana (API 077-09060) and  
Blackhills (API 077-08336)  
Wells.

No substantial rutting up to  
this point.

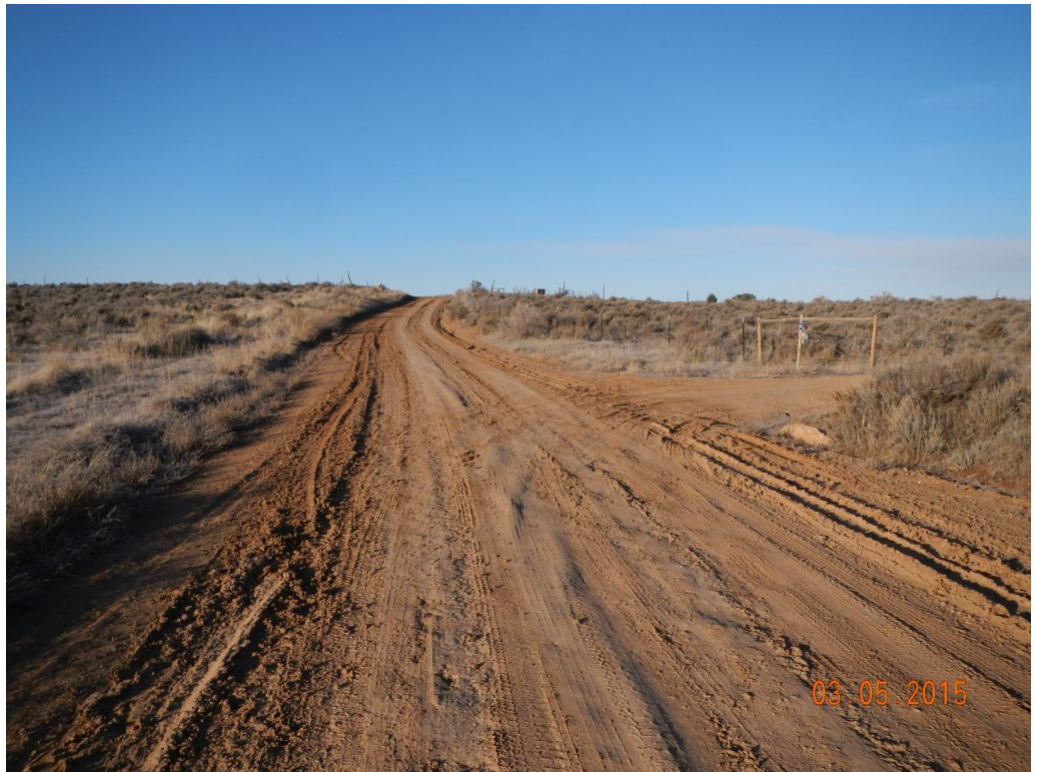
Residential entrance off  
main access road.  
39.22510/ -108.21281

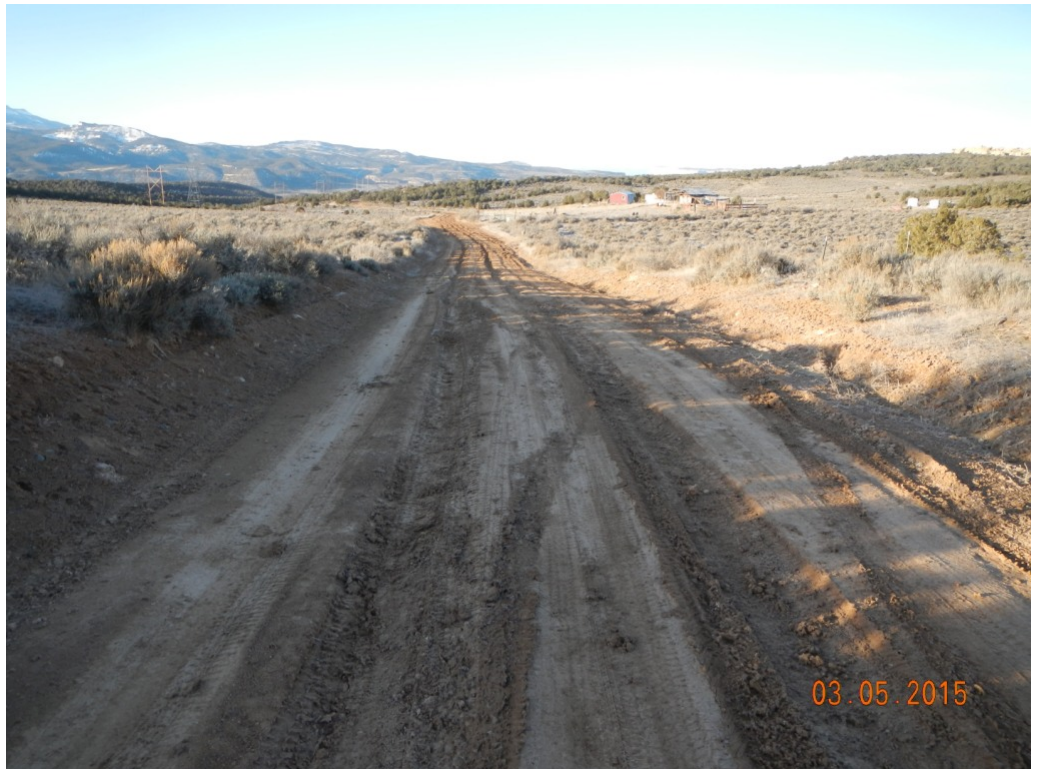
Main access road at  
39.22400/ -108.21485  
Rutting present at time of  
inspection.

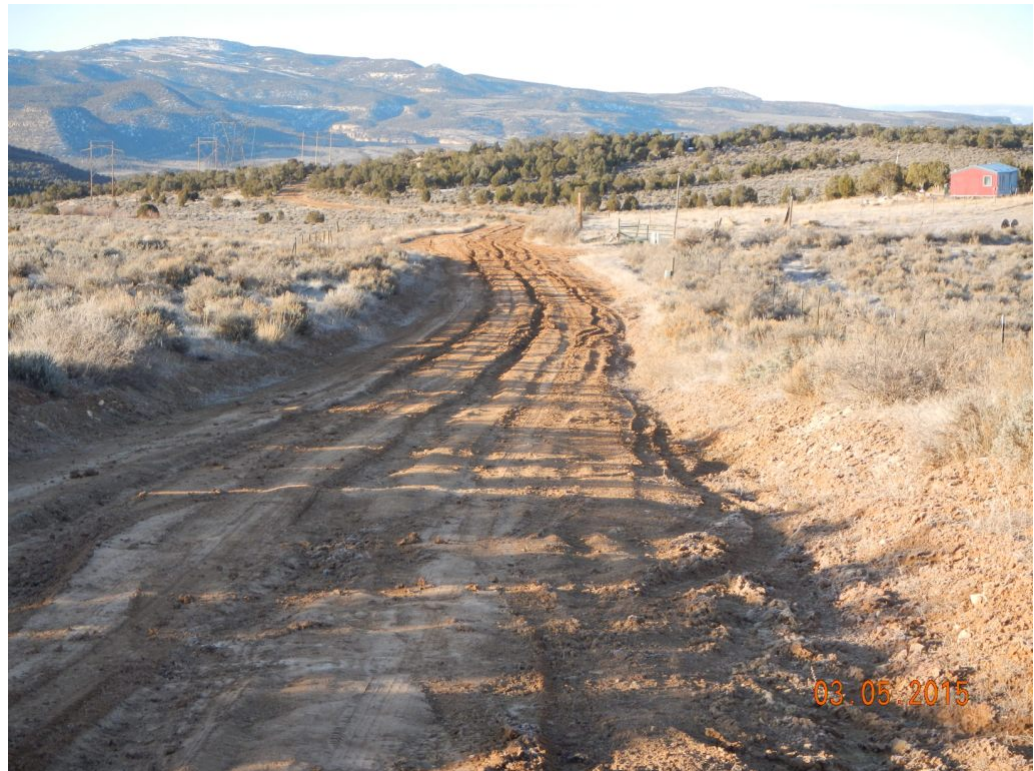
Main access road at  
39.22400/ -108.21485

Rutting present at time of  
inspection.

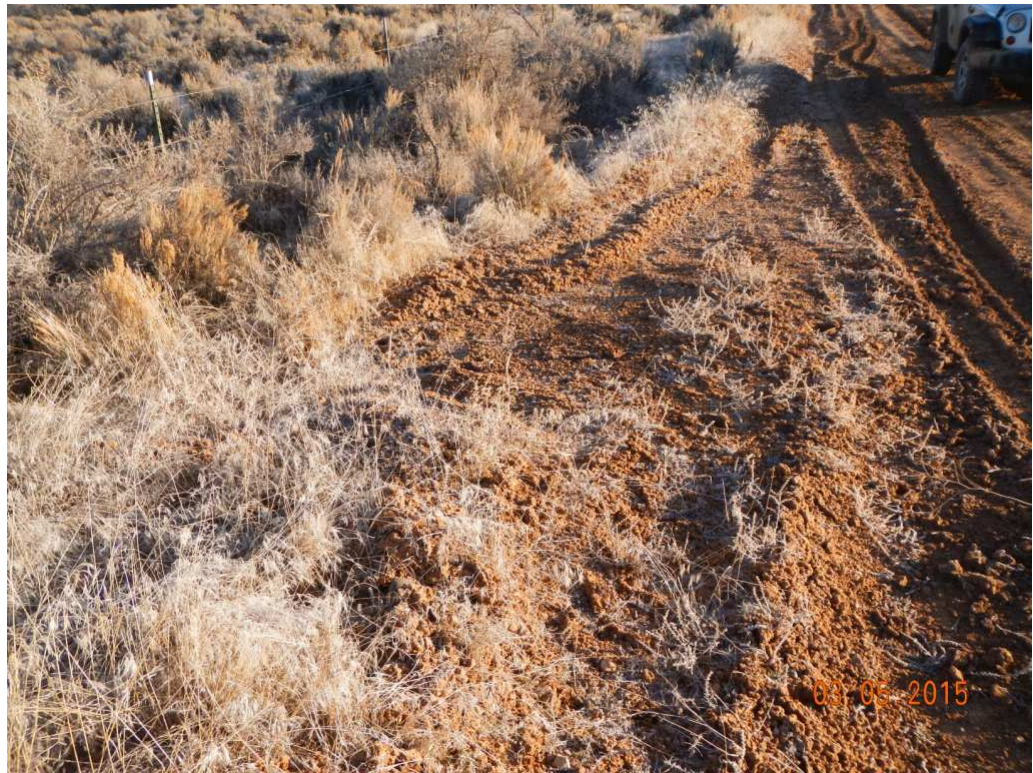
ID # 31

Turnout and Rip Rap

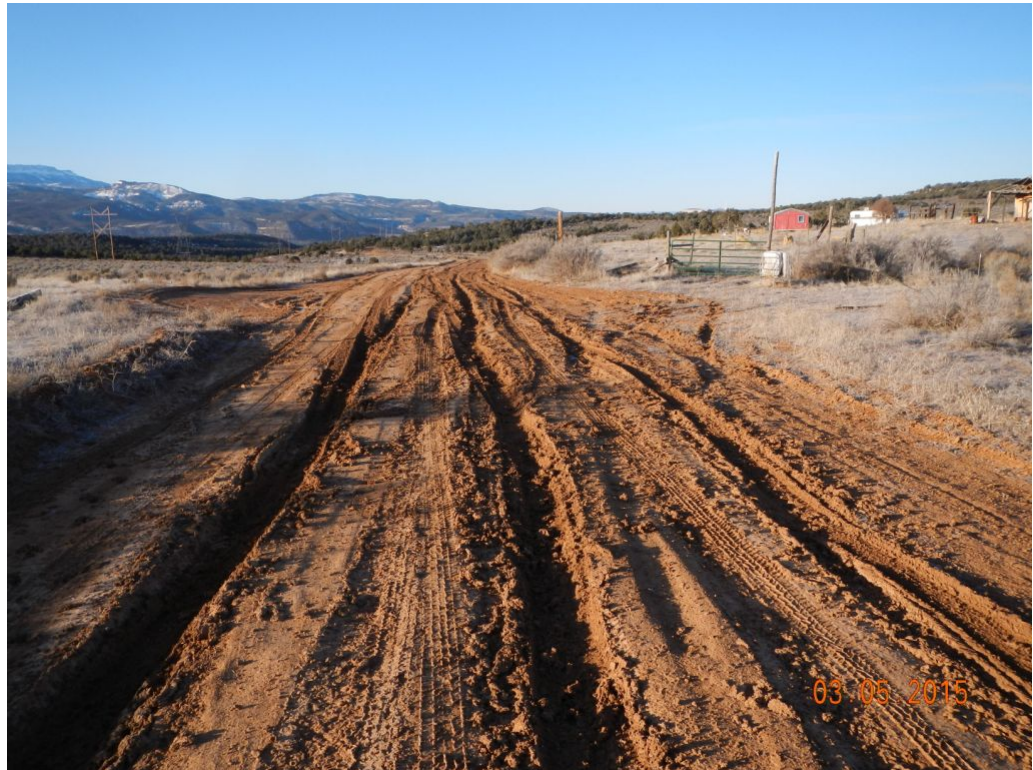
Residential entrance at  
39.22316/ -108.21558

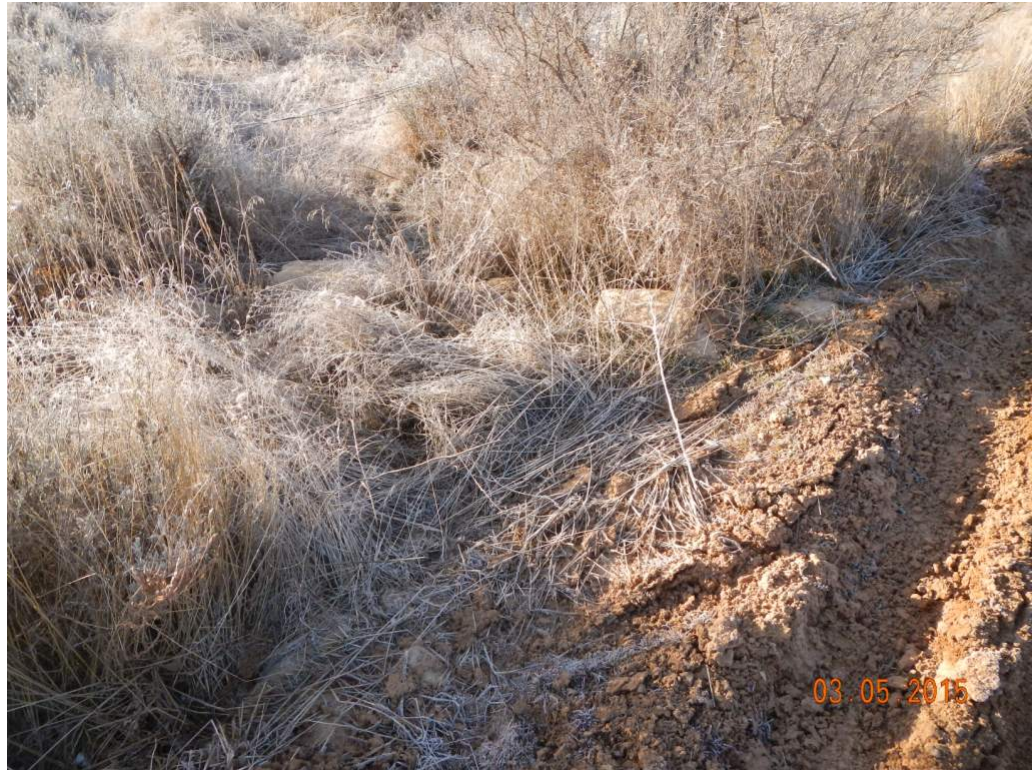
ID# 27

Rip Rap covered in  
vegetation and not  
maintained.

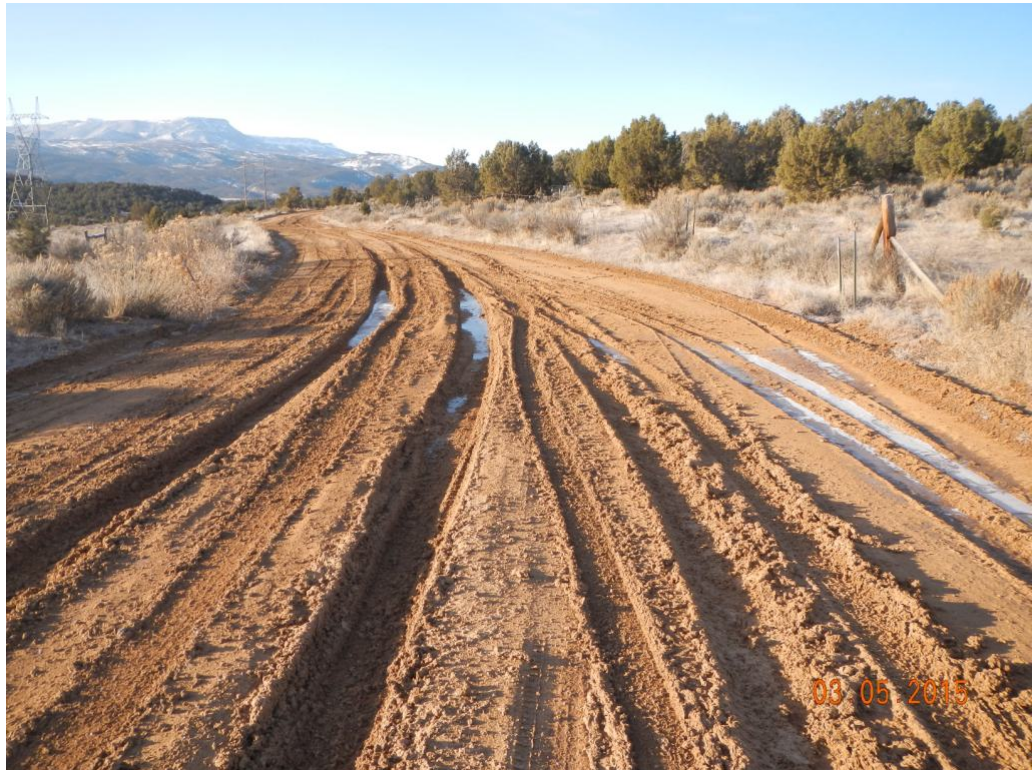
ID# 20-25

Rutting present at time of  
inspection.

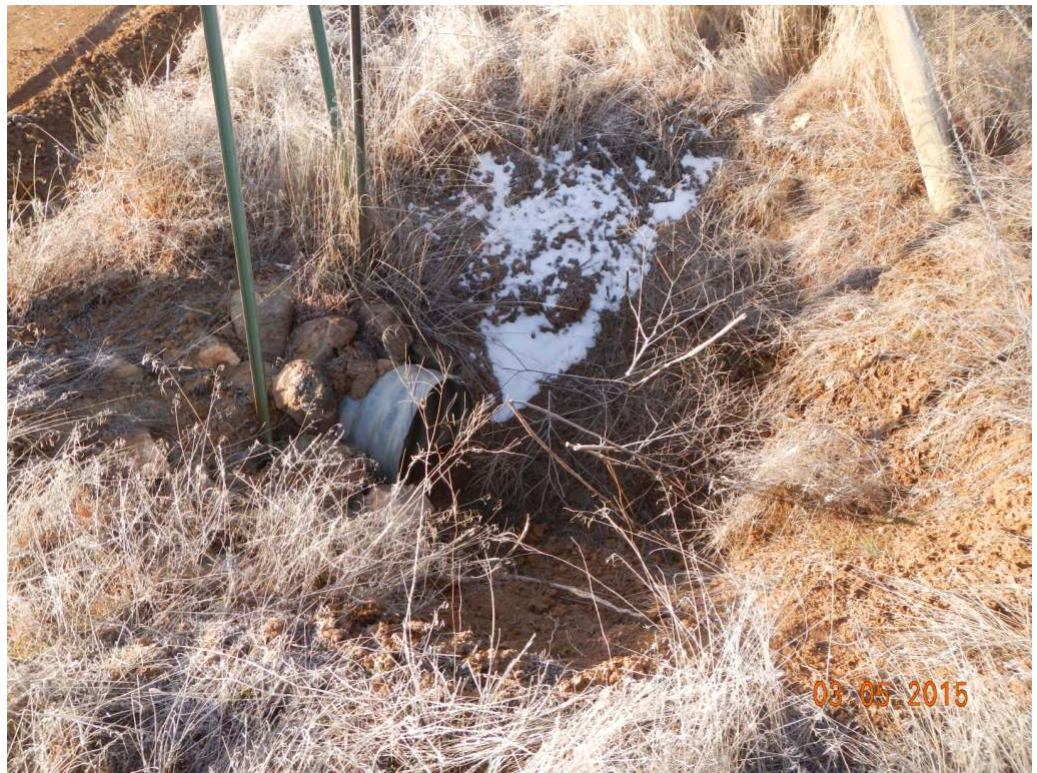
ID# 20-25

Culvert inlet.

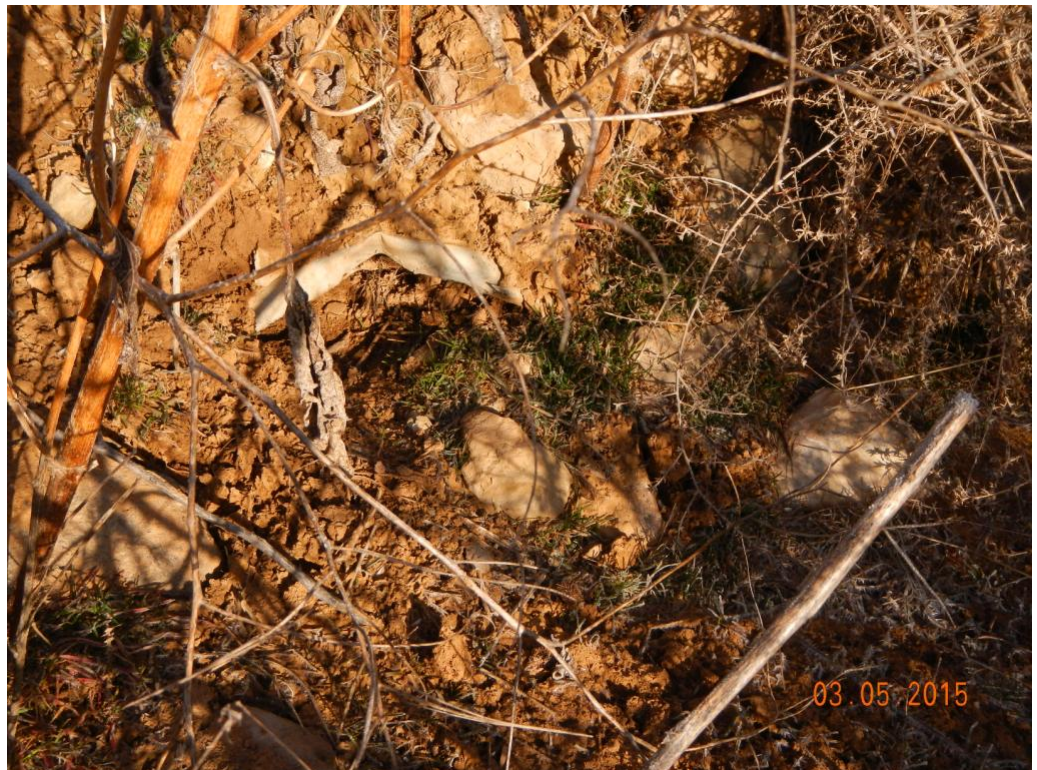
ID# 20-25

Culvert outlet is smashed.

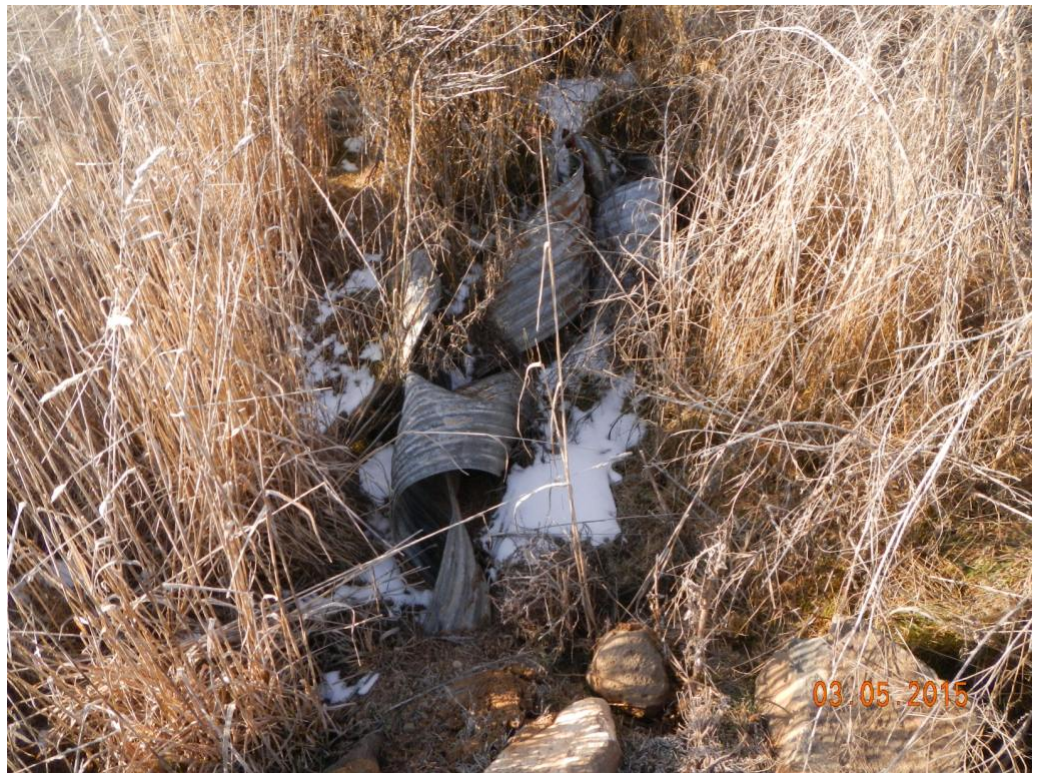
ID# 20-25

Debris/trash near outlet of  
culvert.

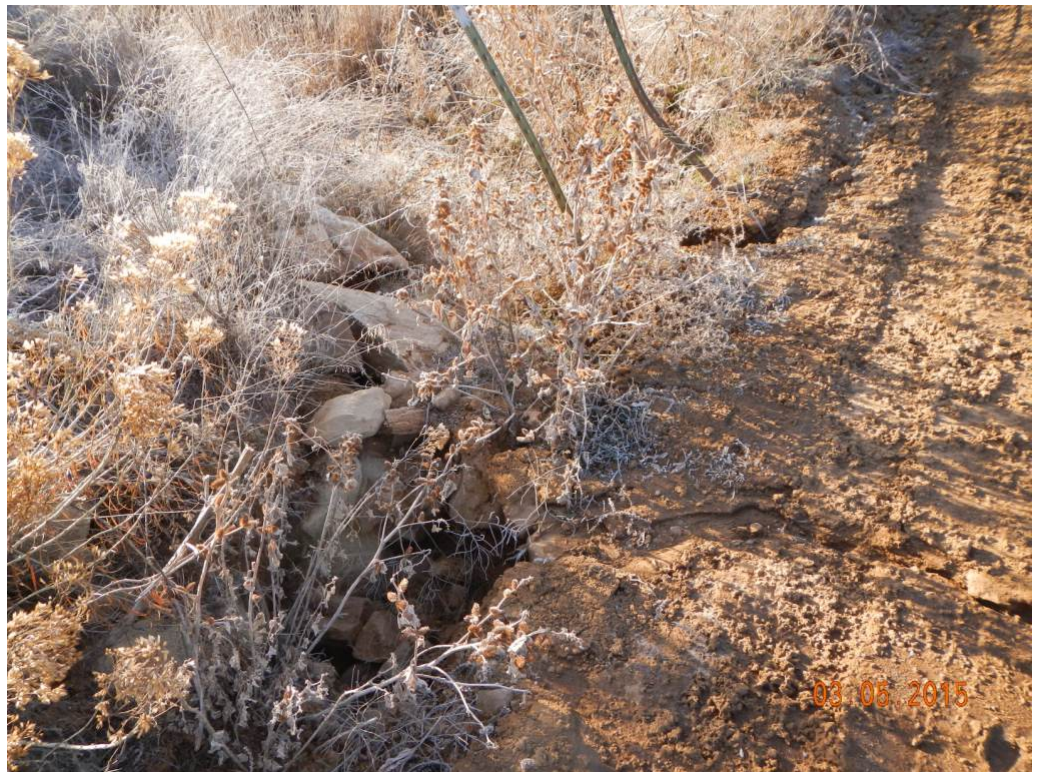
ID# 20-25

Rip rap and erosion near  
culvert outlet.

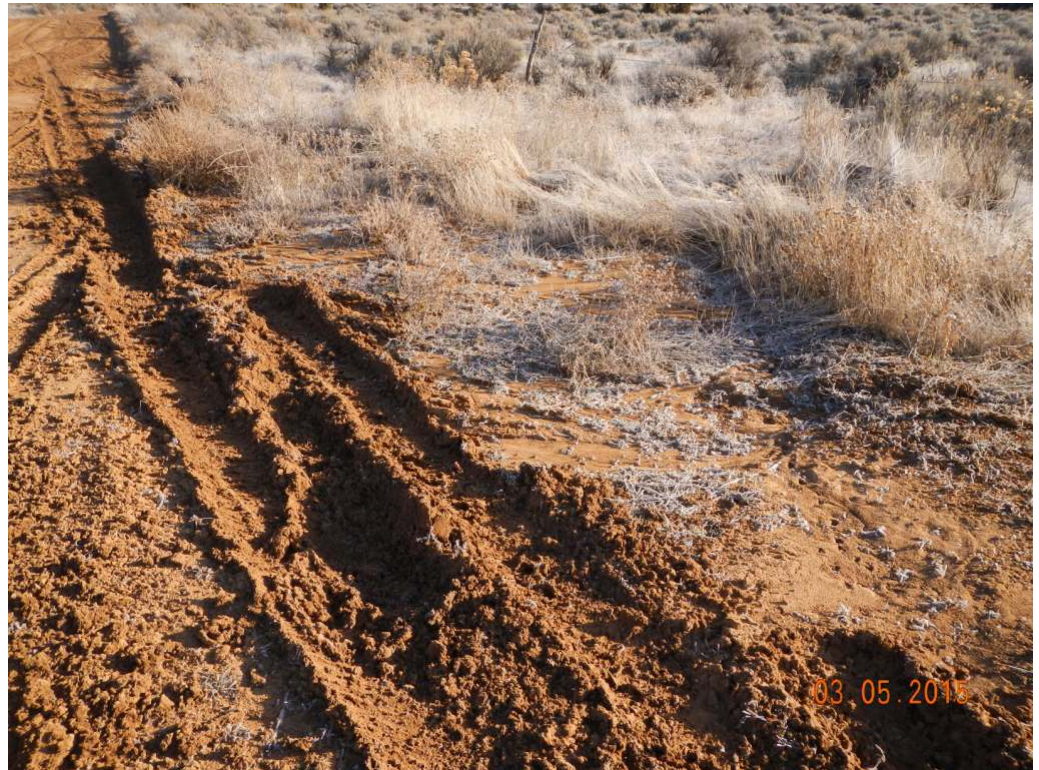
ID# 32-33

Turnout and Rip Rap.

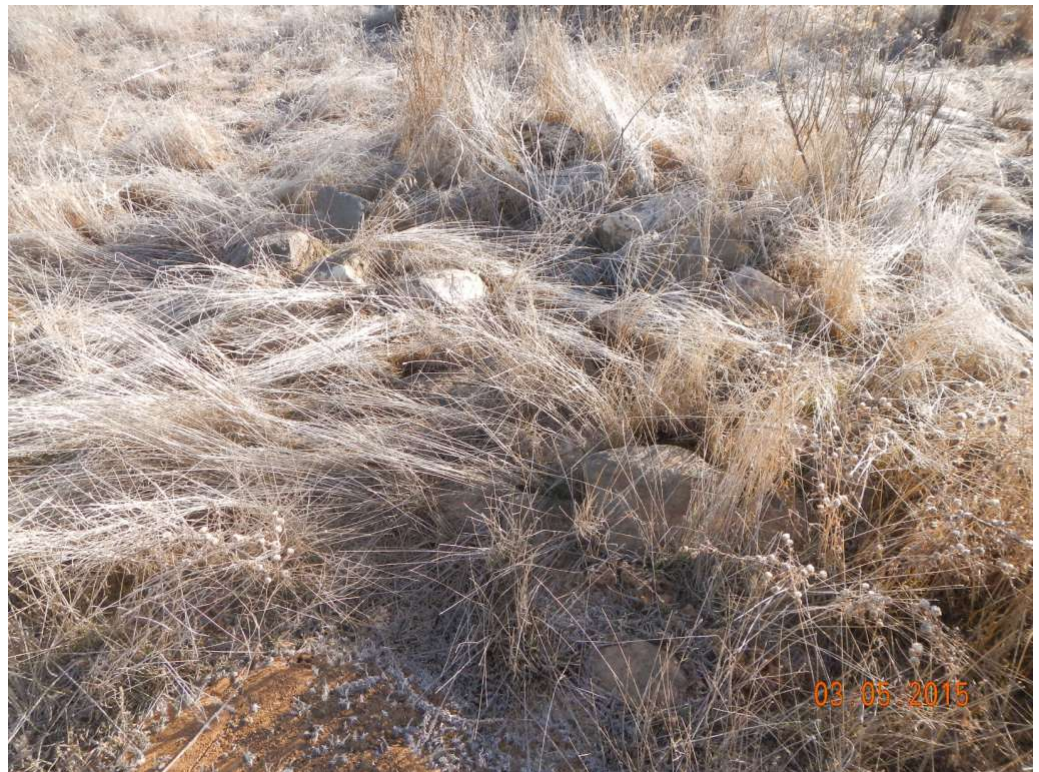
ID# 32-33

Turnout and Rip Rap.

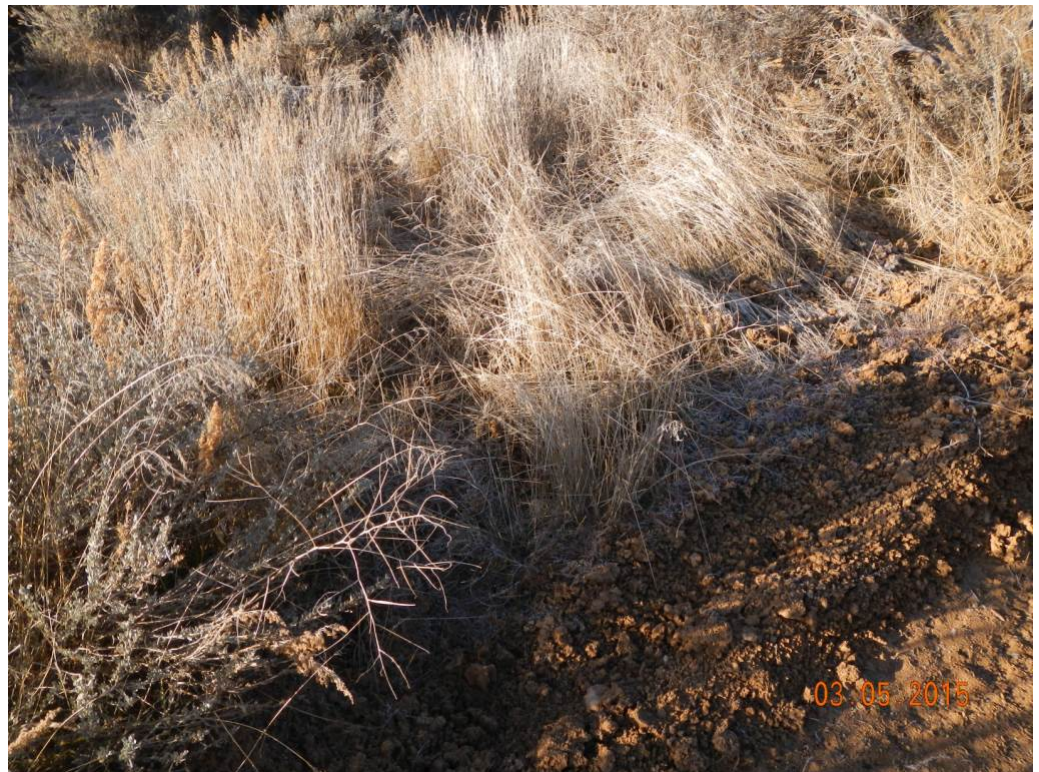
ID# 42

Turnout and Rip Rap.

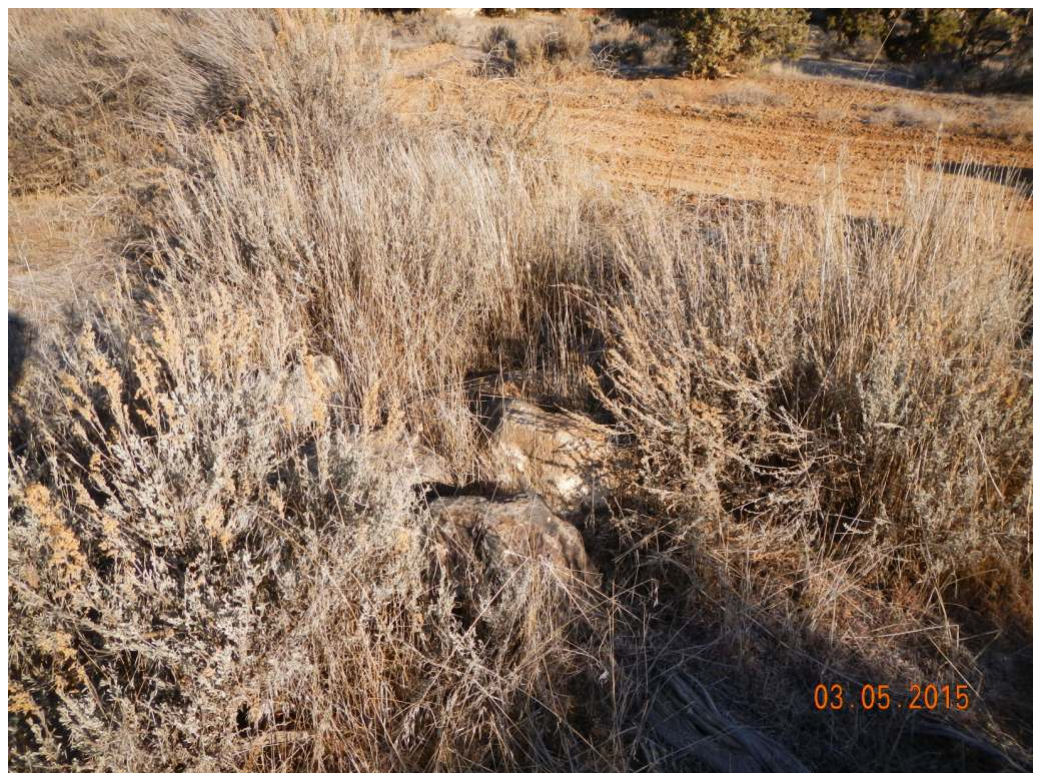
ID#42

Turnout and Rip Rap.

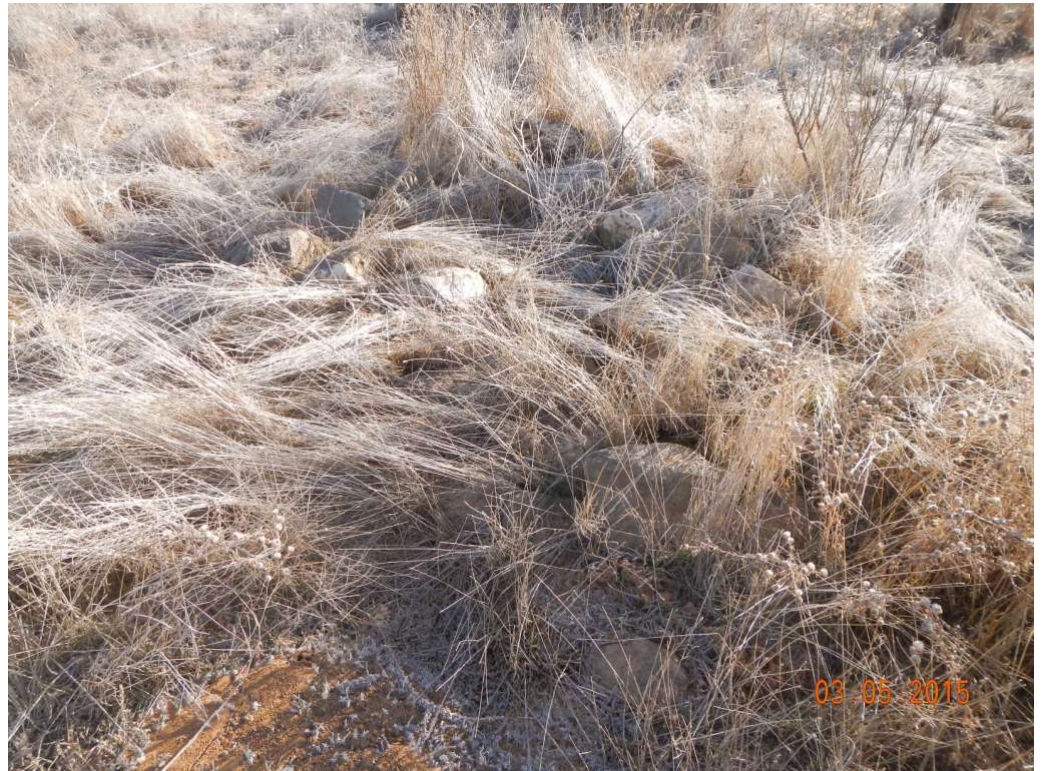
ID# 42

Turnout and Rip Rap.

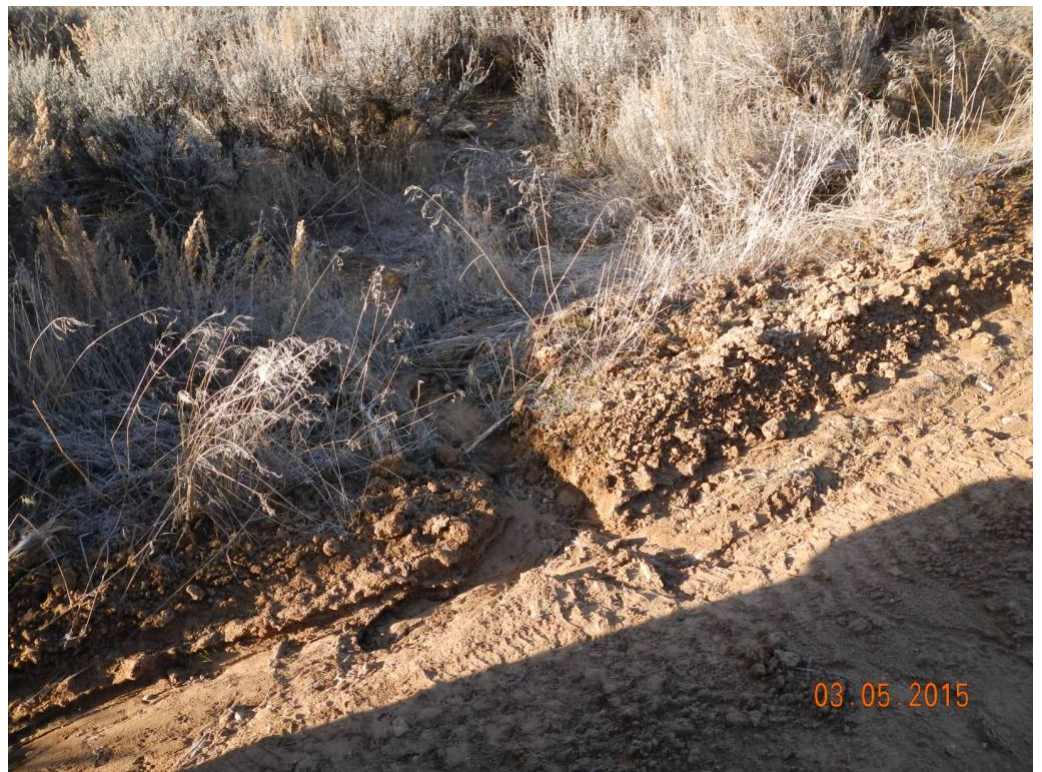
39.21825/-108.21979

Erosion and sediment  
migration.

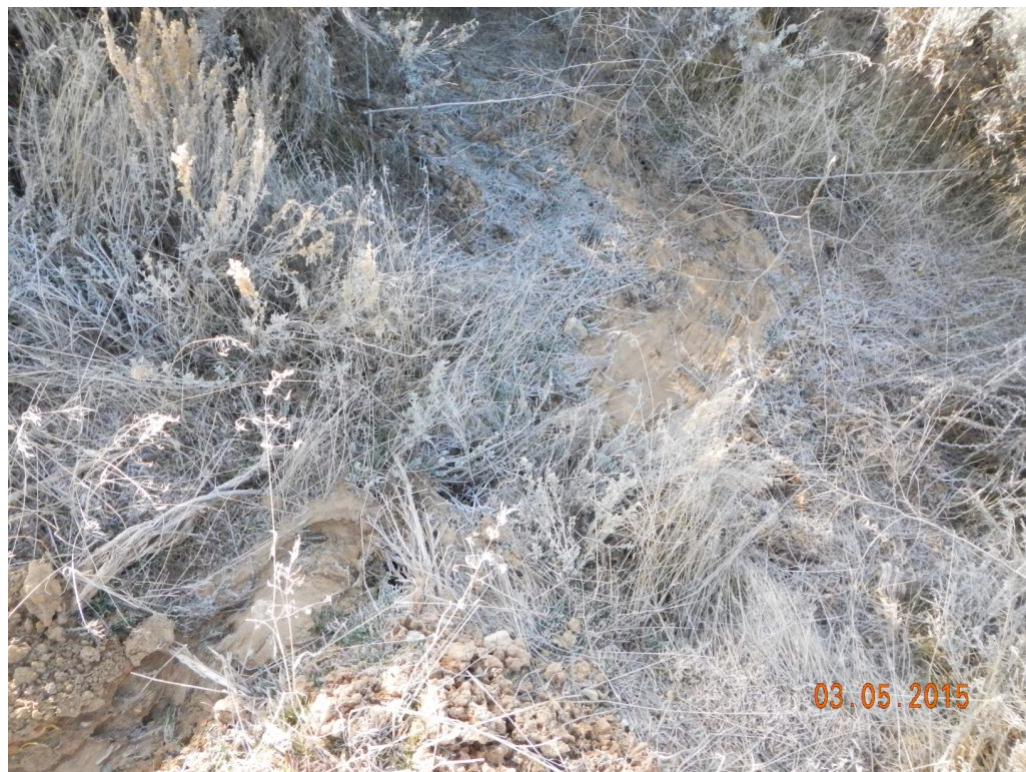
39.21825/-108.21979

Erosion and sediment  
migration.

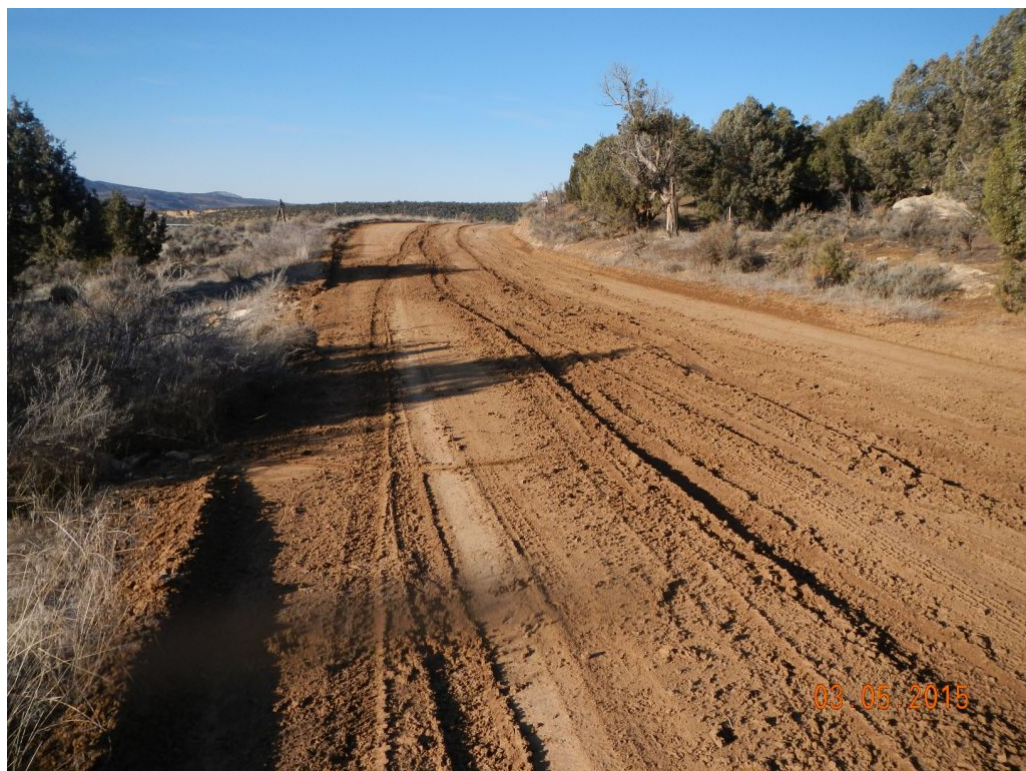
39.21781/-108.22276

Rutted Road

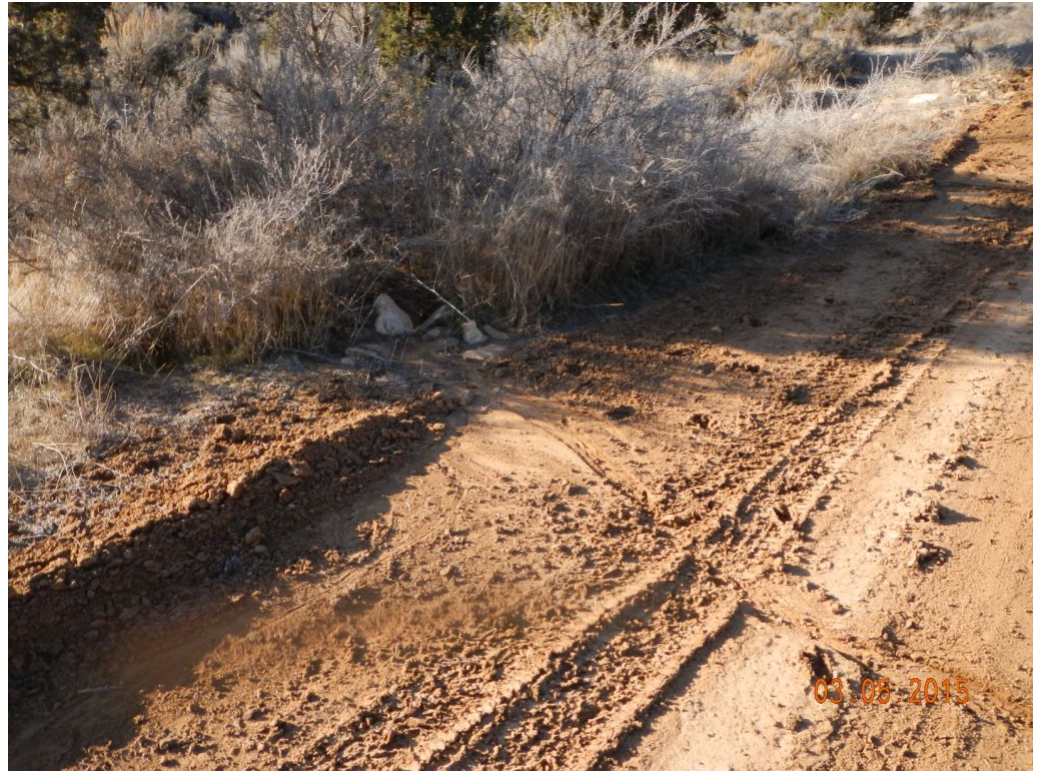
ID# 34-37

Erosion and sediment  
migration.

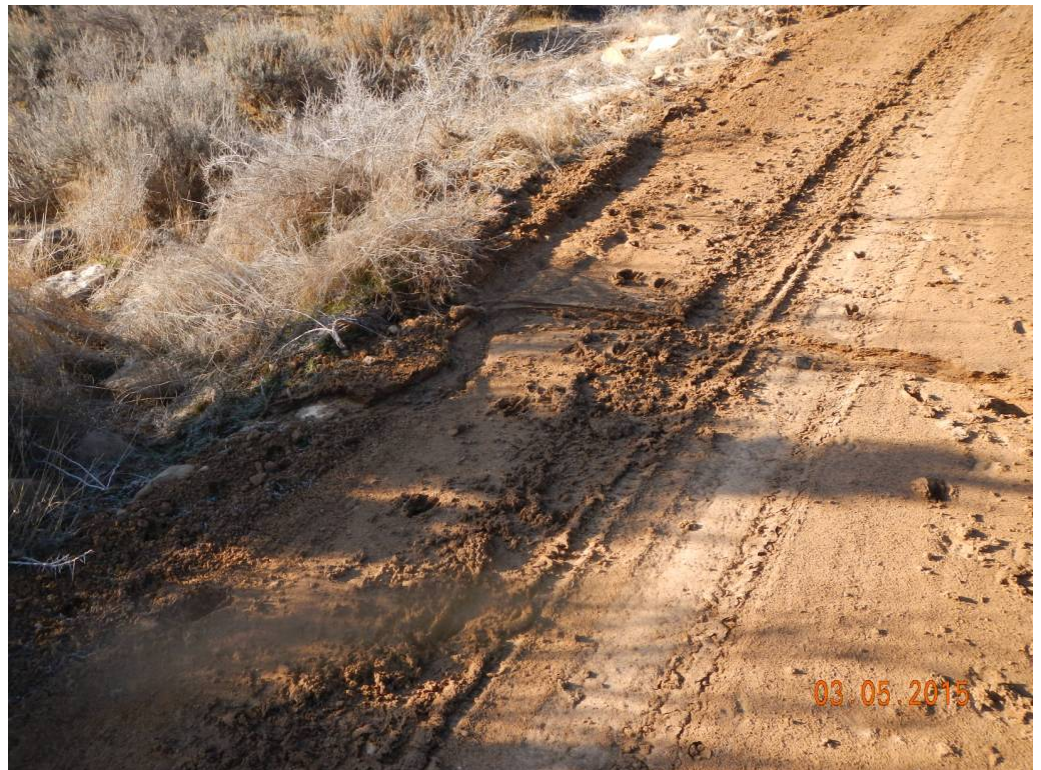
ID# 34-37

Erosion and sediment  
migration.

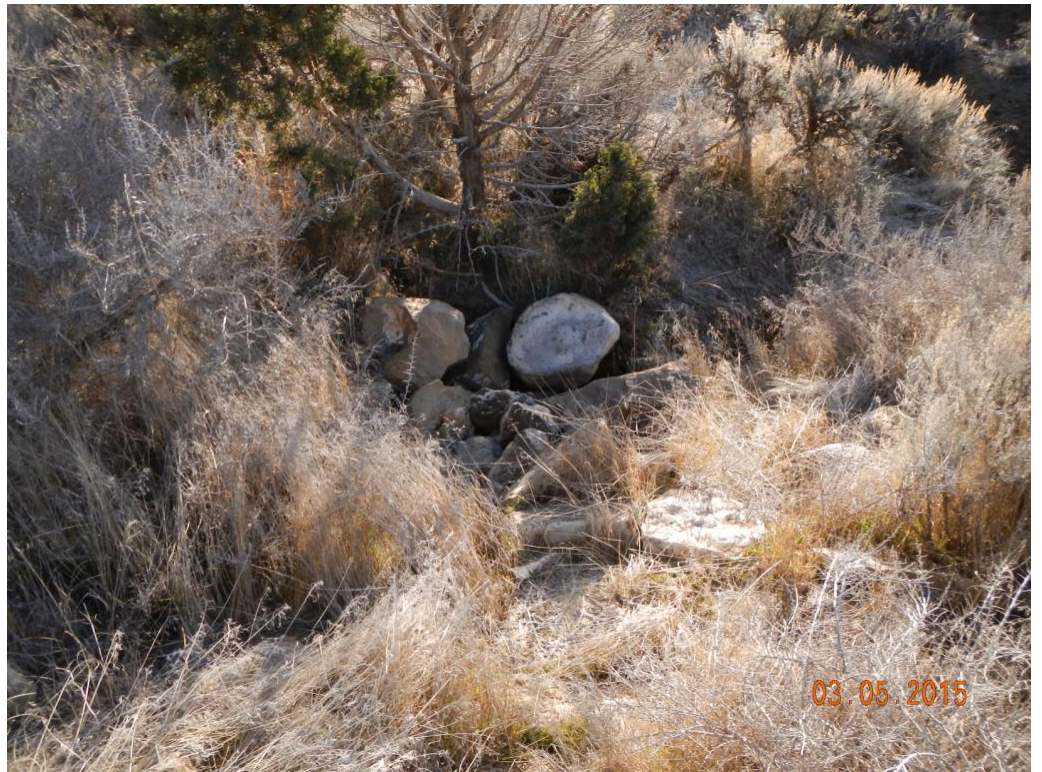
ID# 34-37

Rip Rap

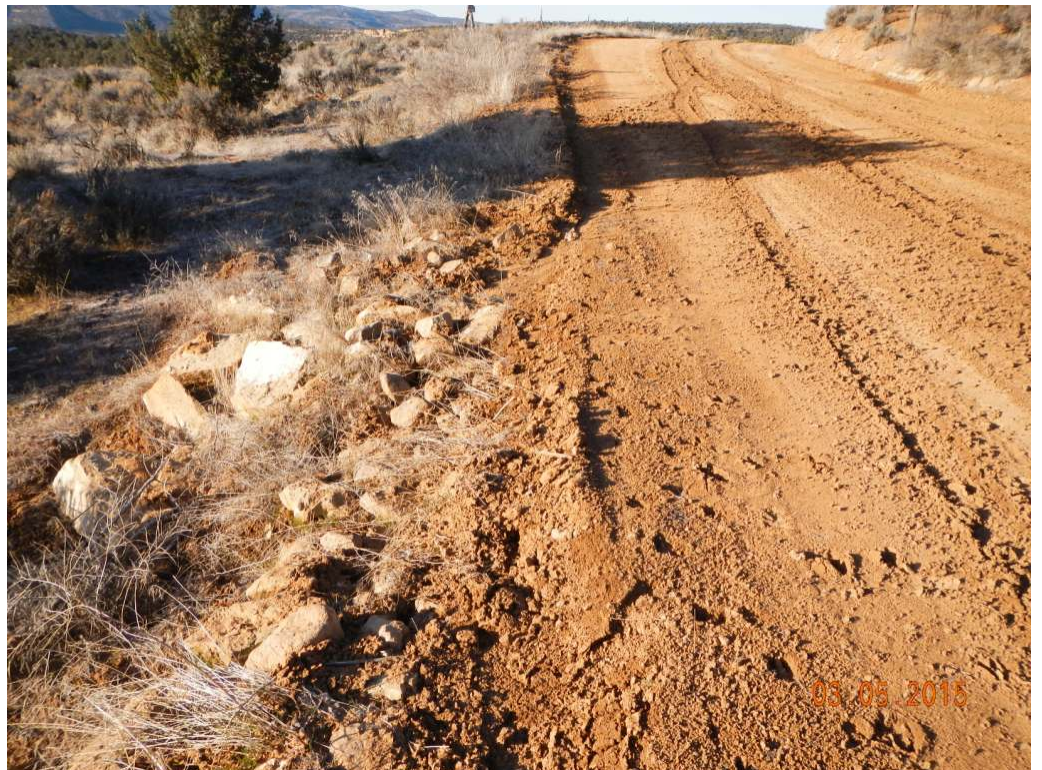
ID# 34-37

Rip Rap

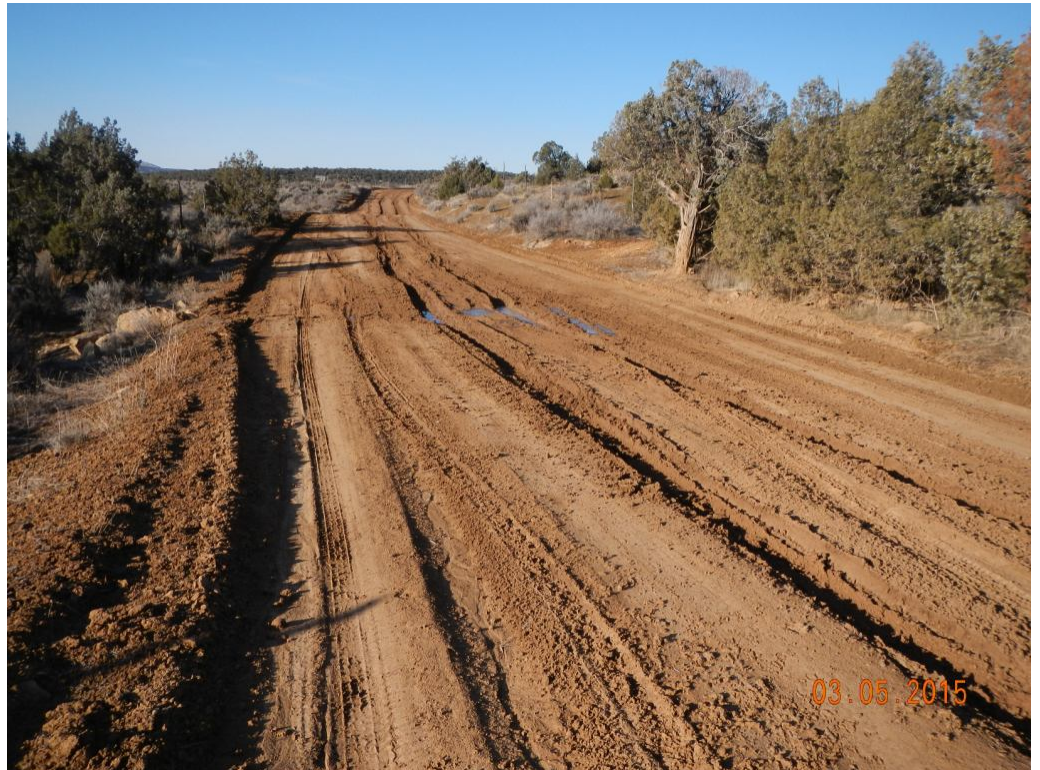
ID# 48

Rutted road

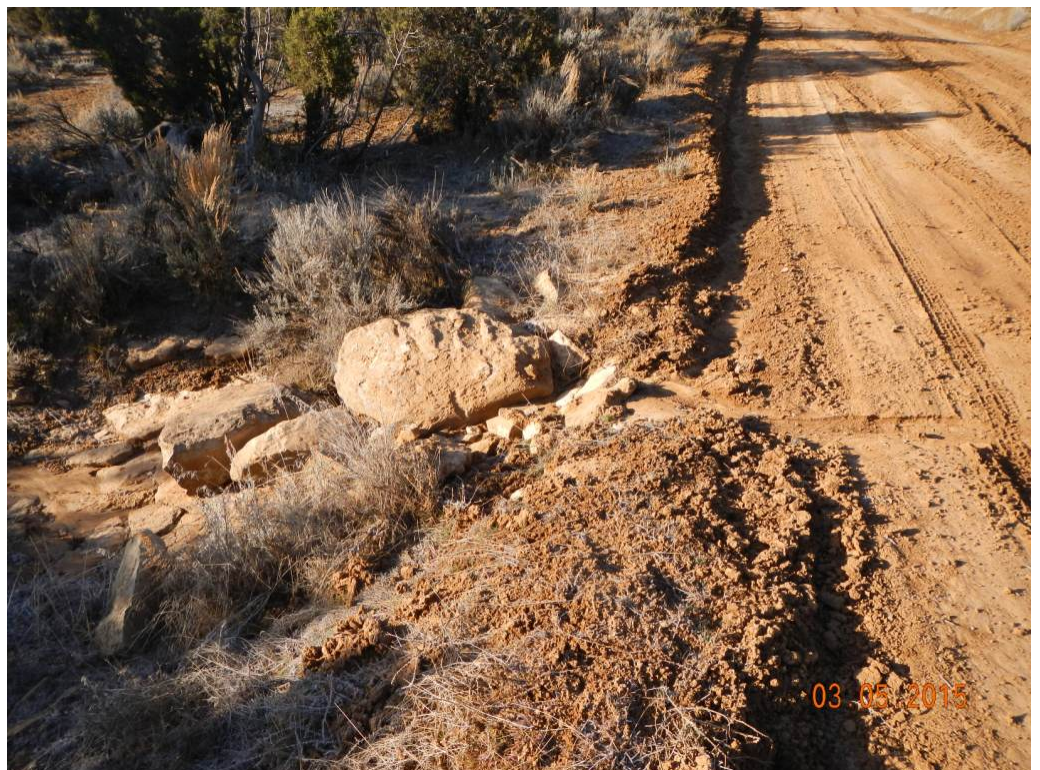
ID#48

Erosion and sediment migration.

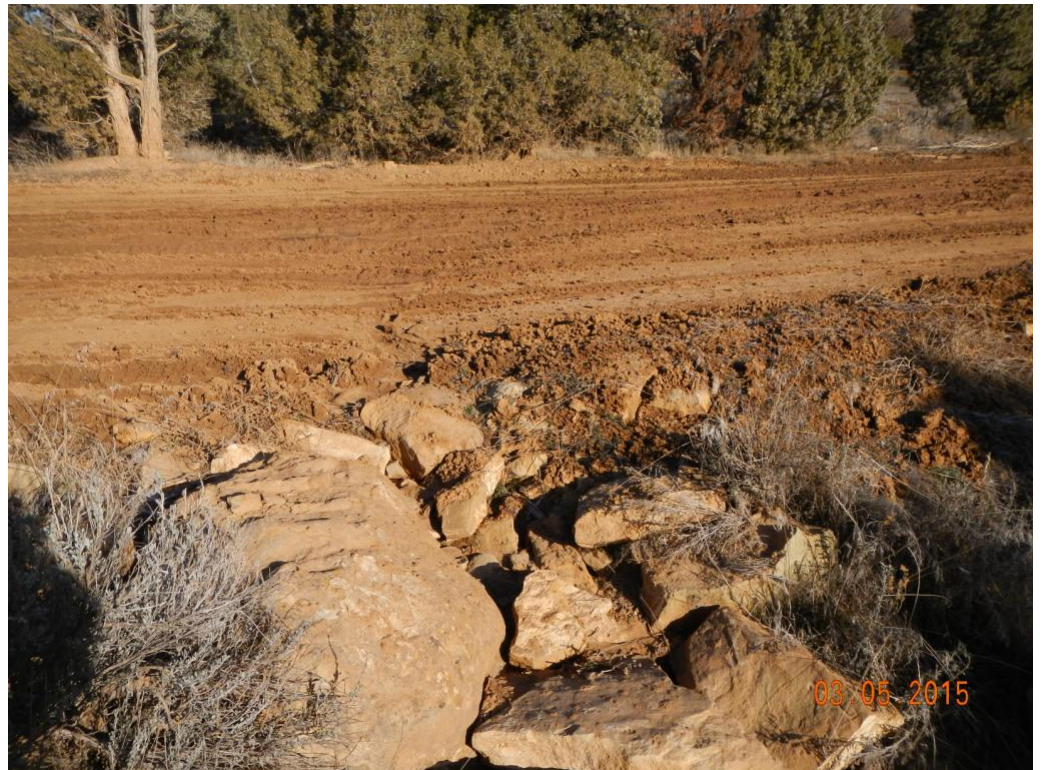
ID# 48

Rip Rap
