**Horse Shoe Canyon Access Road  
(Cedar Willy Blvd)**

Inspection# 675201281 Complaint# 200426603  
(ID#'s based on 2012 HCSI Status Report)

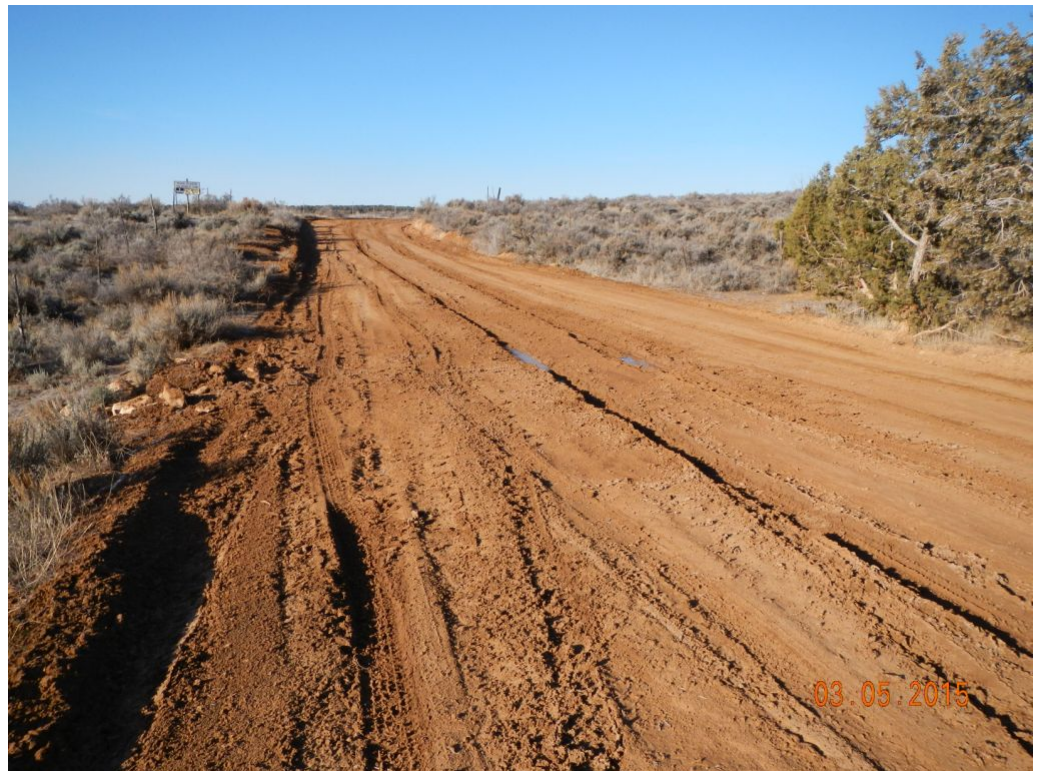
ID # 47

Rutted road.

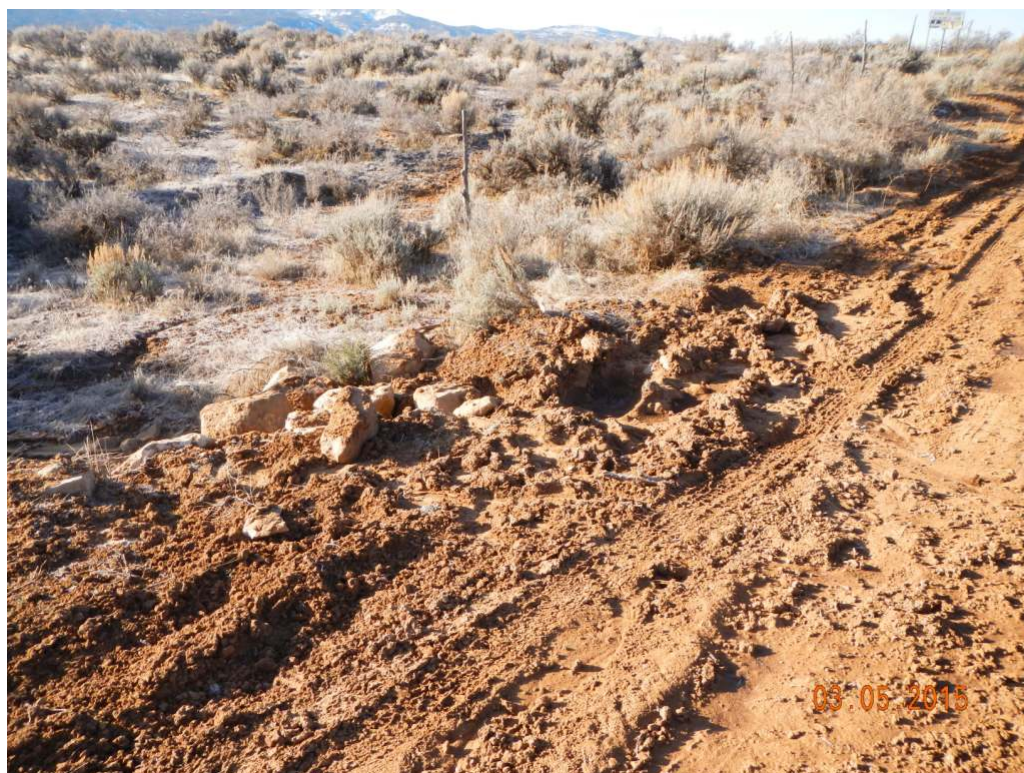
ID# 47

Rip Rap

Erosion and sediment  
migration.

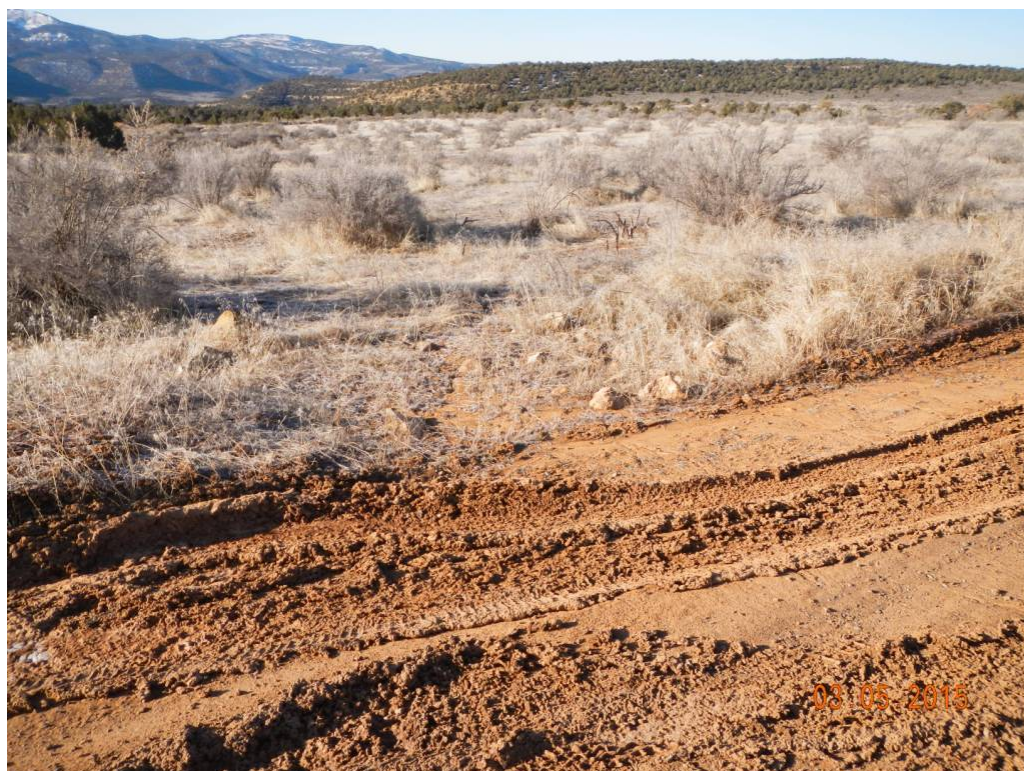
ID# 45

Rutts preventing turnout  
from being functional.

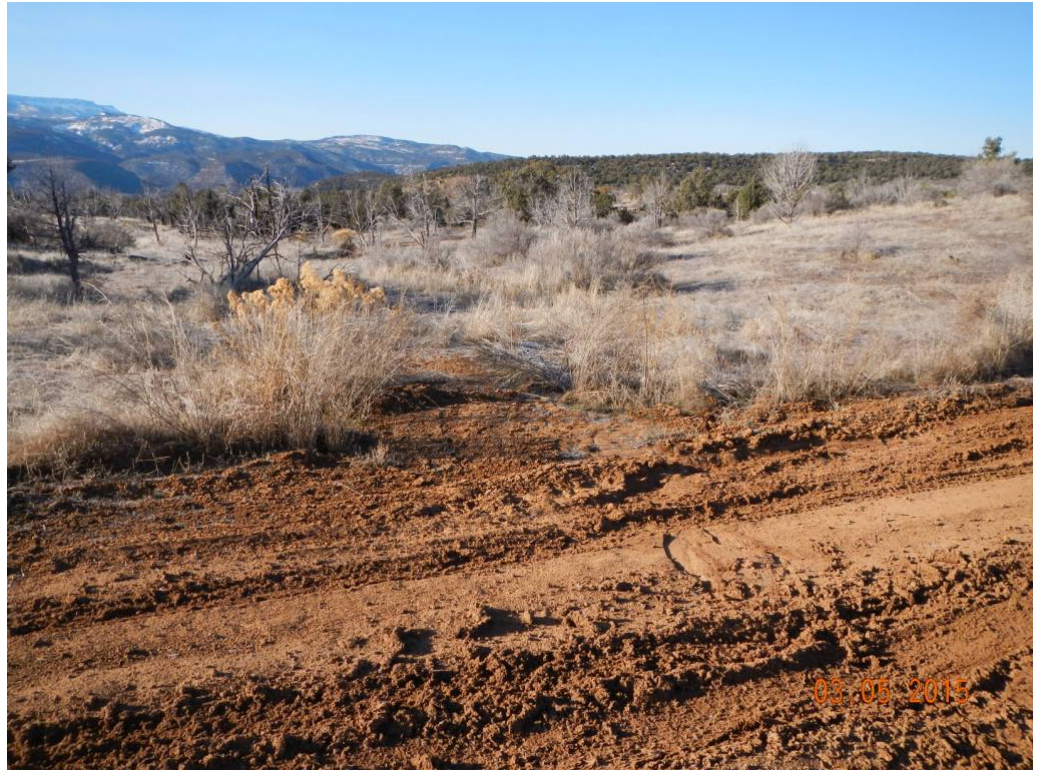
ID# 43

Rip Rap has been removed

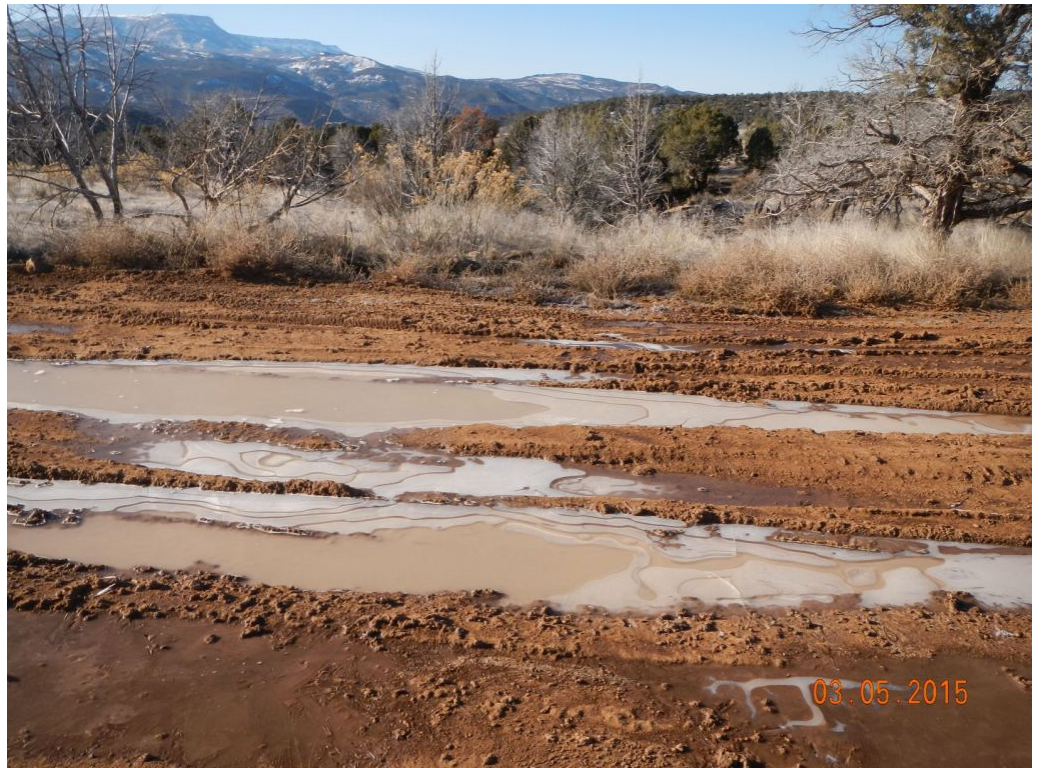
ID# 56-58

Water pooling in road.

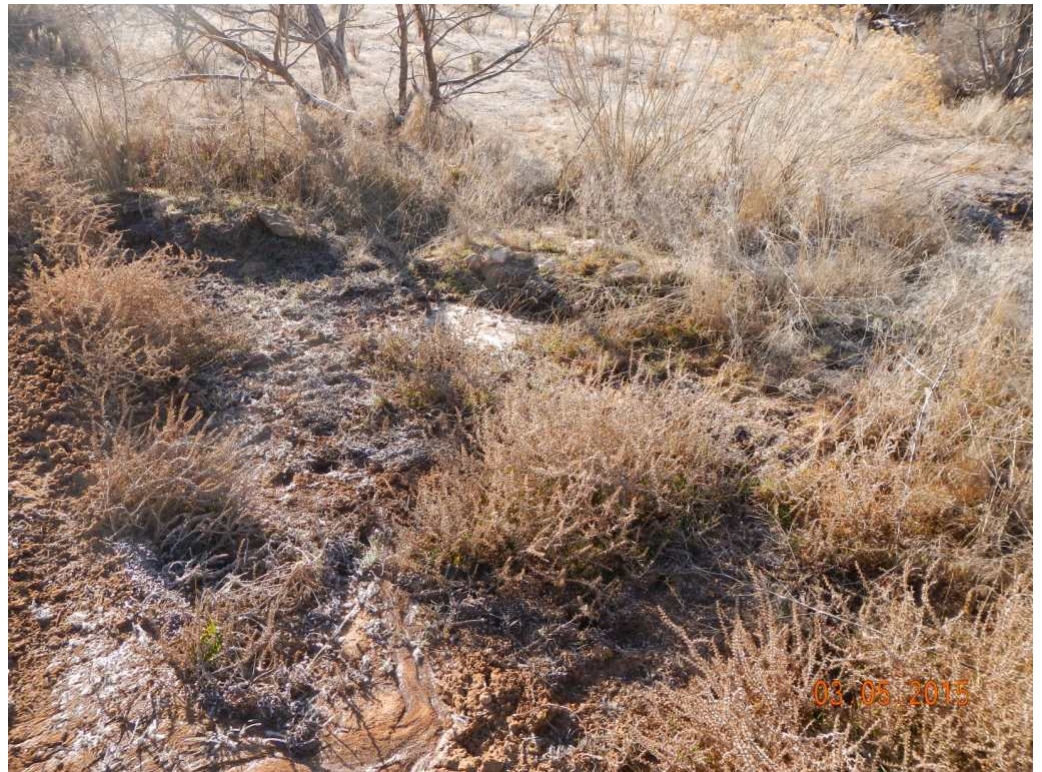
ID# 56-58

Erosion and sediment  
migration.

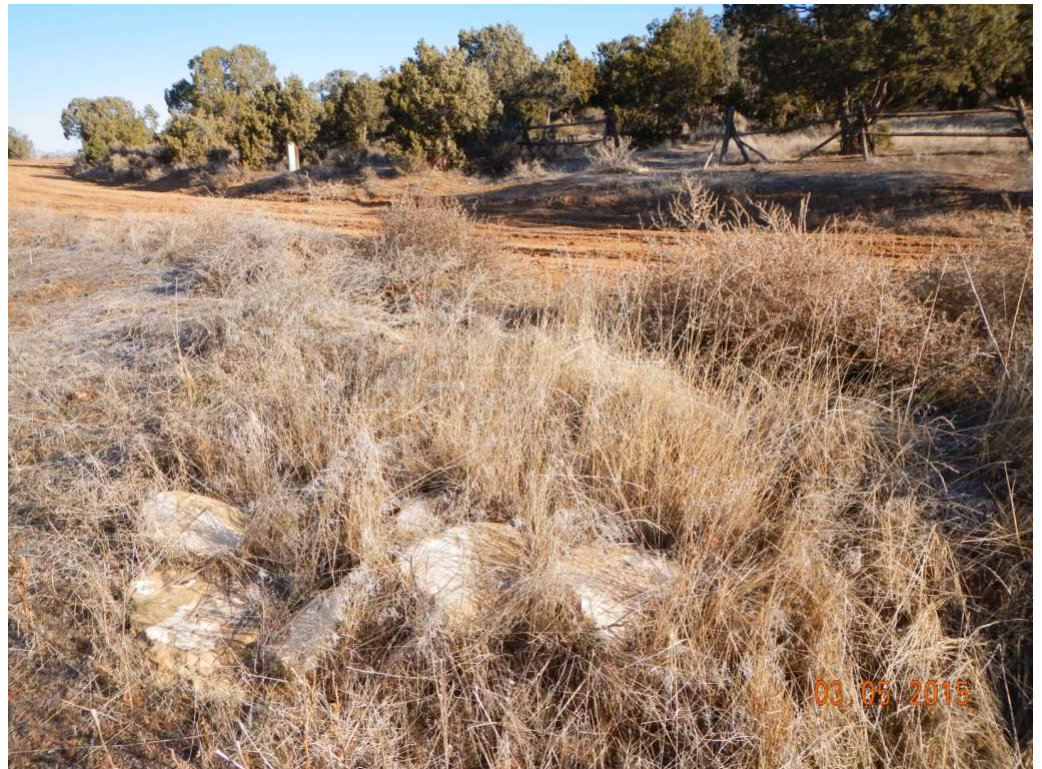
ID# 64

Rip Rap

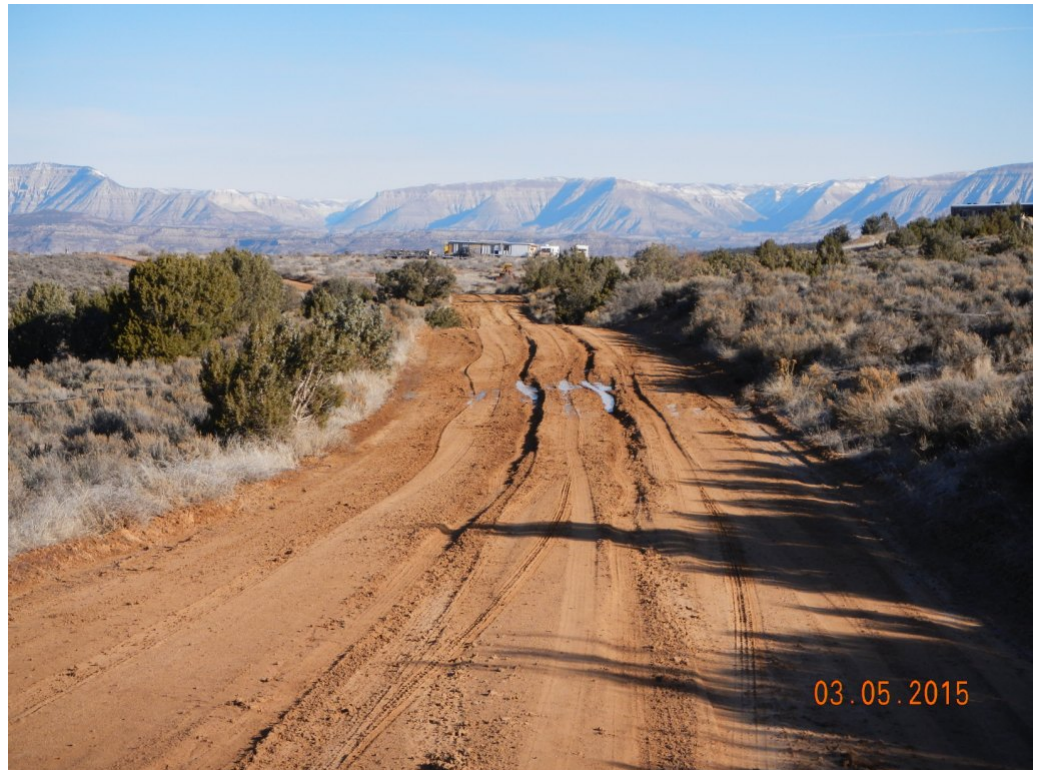
39.21878/-108.23284

Rutted road.

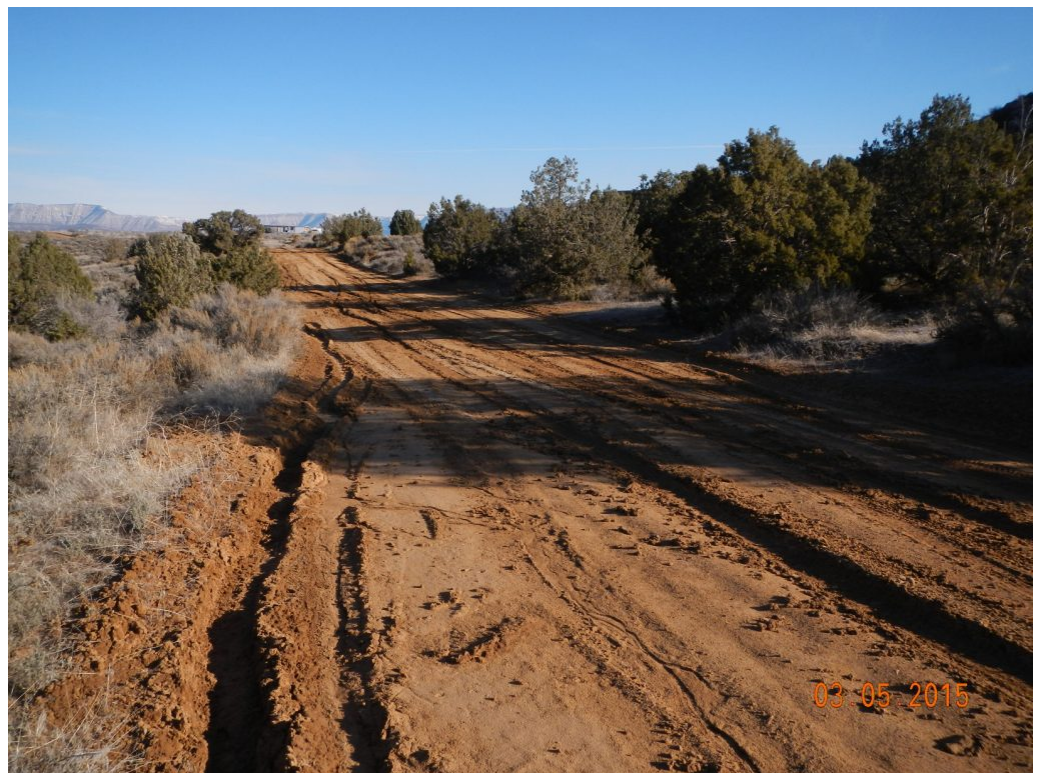
ID# 55-58

Rutted Road

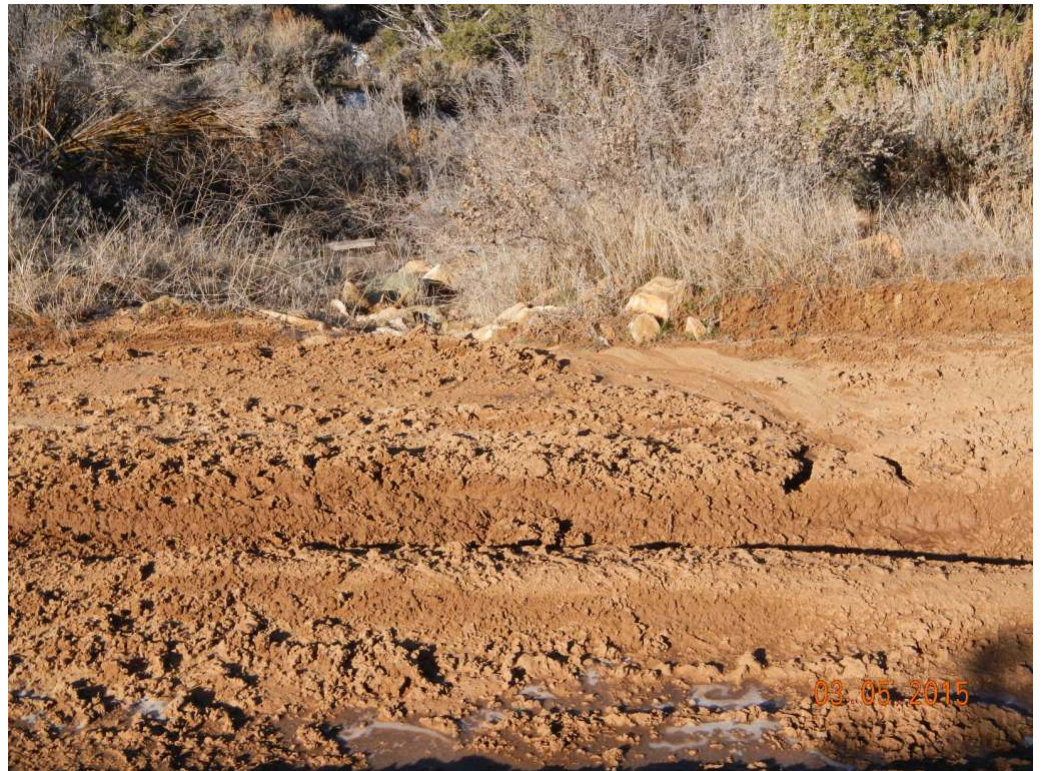
ID# 55-58

Erosion and sediment  
migration.

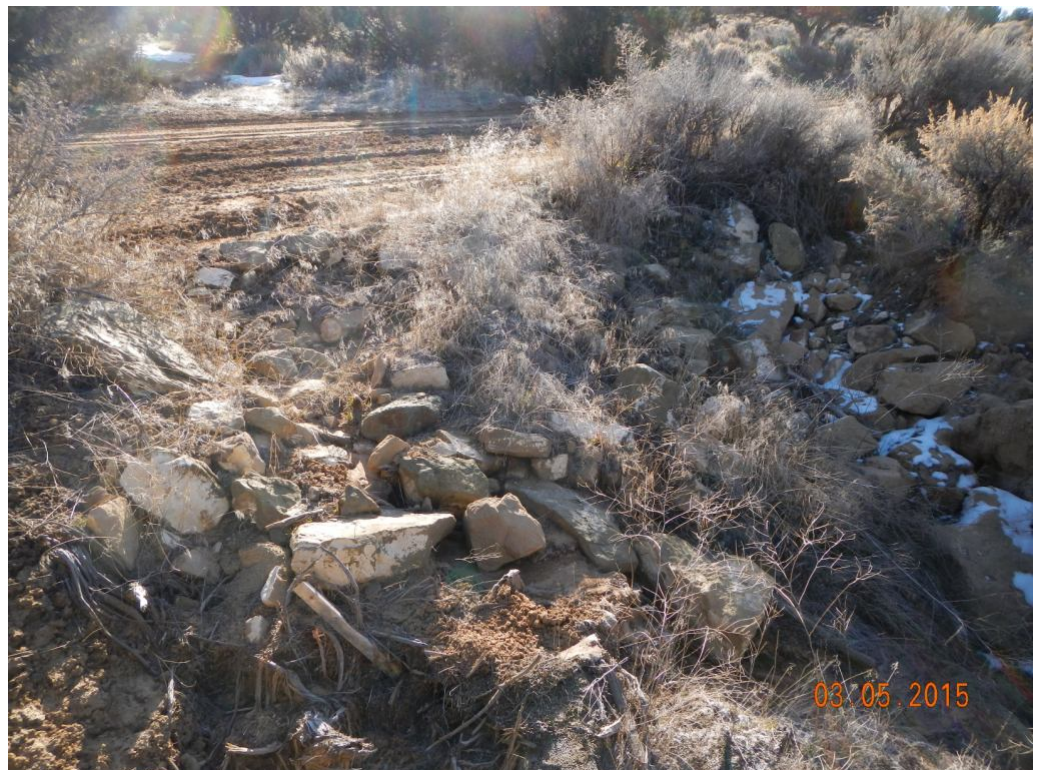
ID# 56-58

Rip Rap

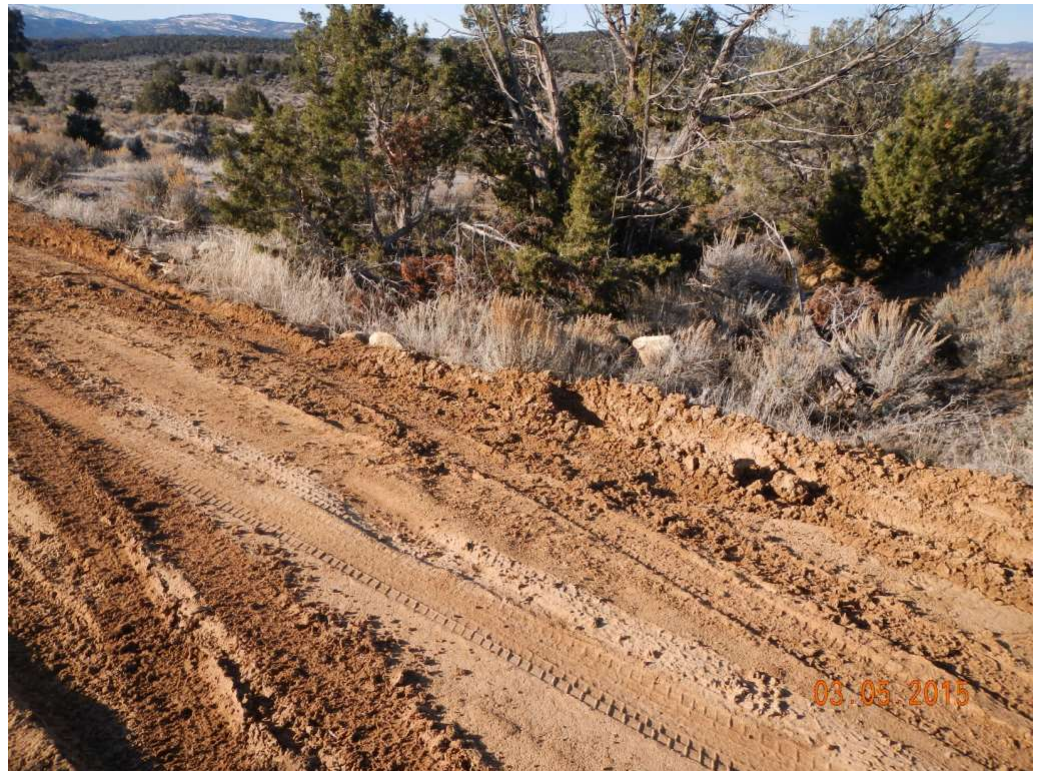
ID# 53

Rutted Road

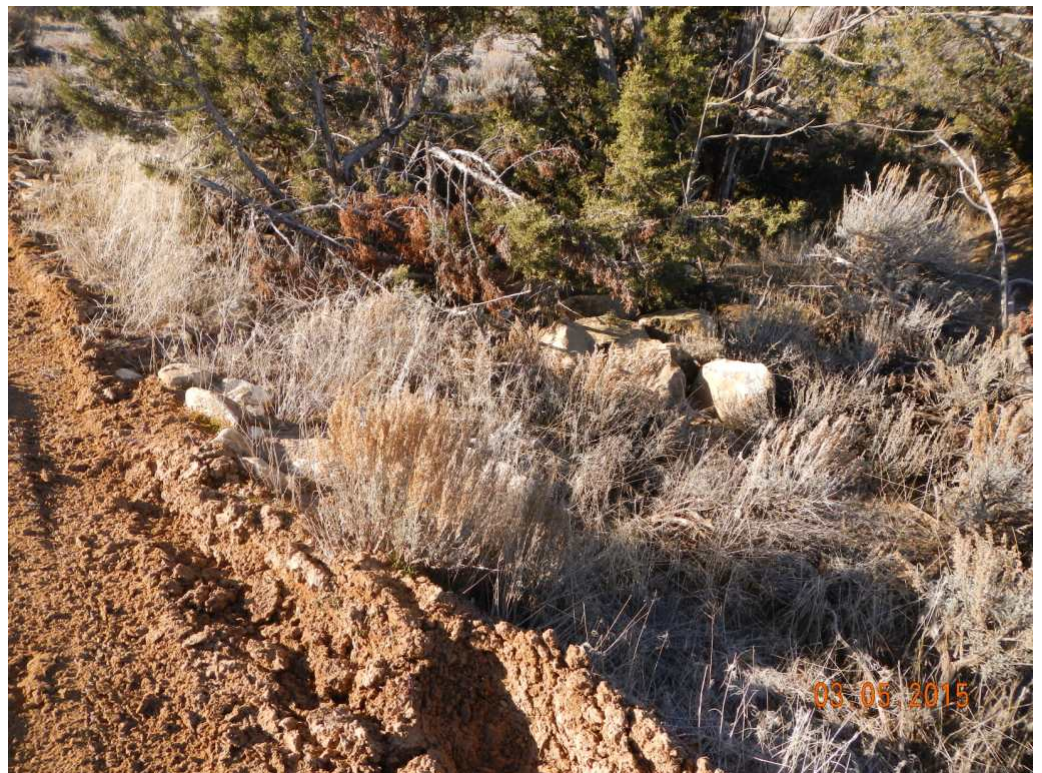
ID# 53

Rip Rap

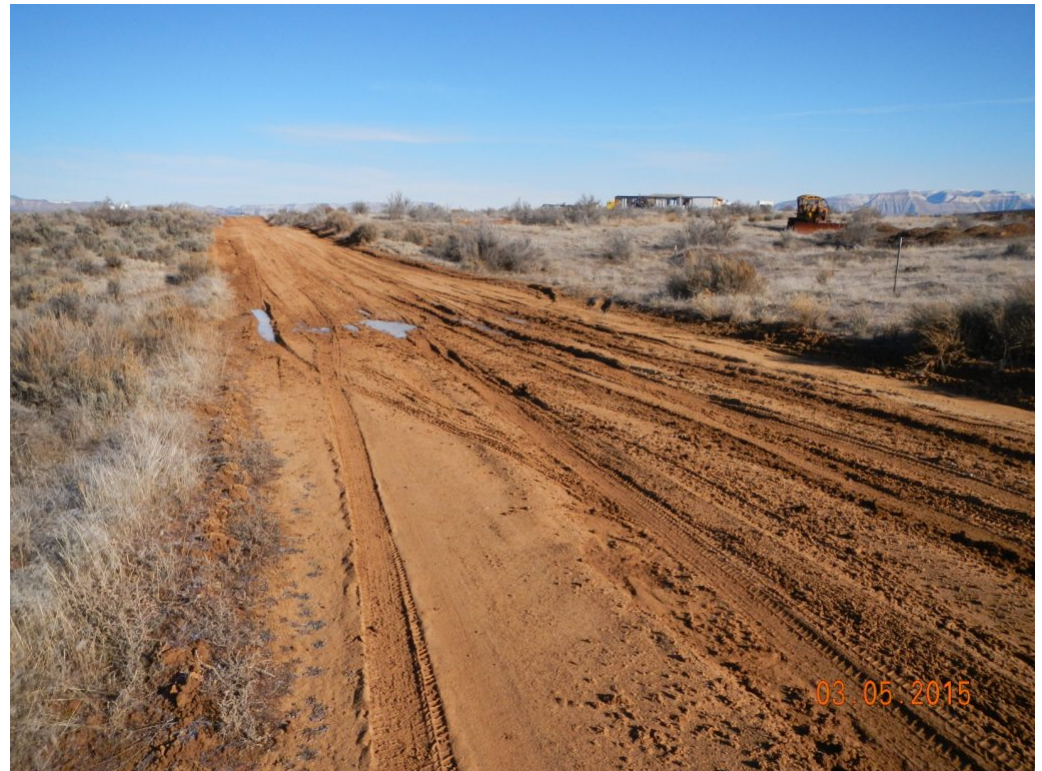
ID# 49

Rutted Road

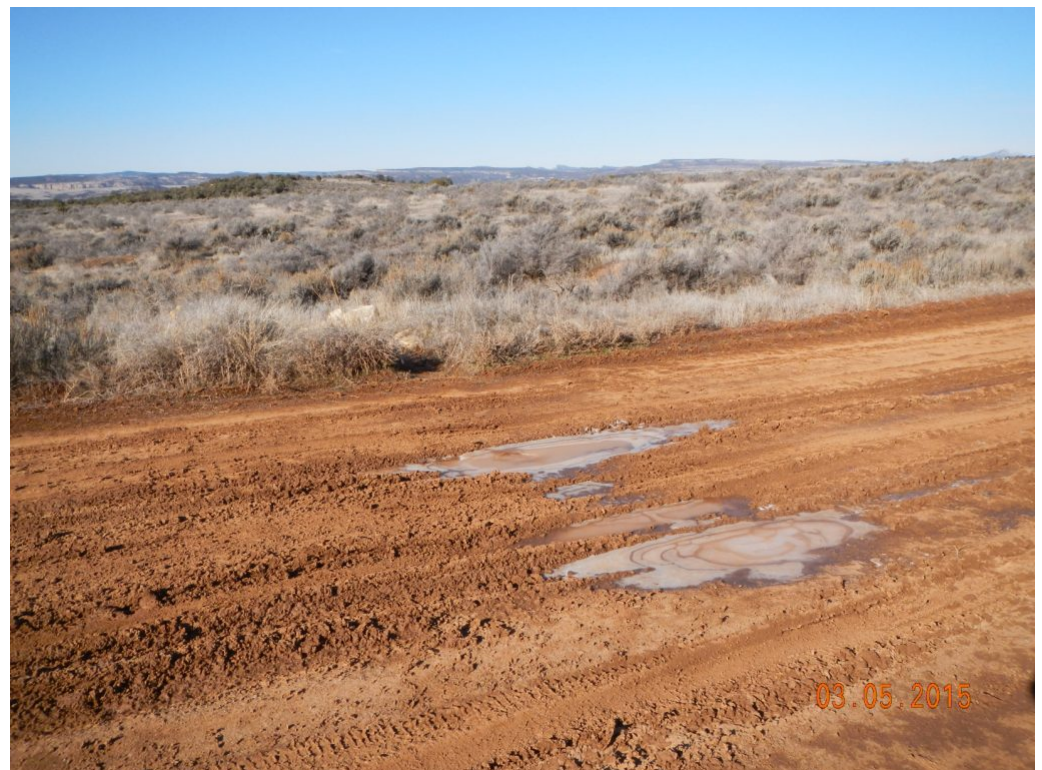
ID#13-17

Moderate pooling on  
road.

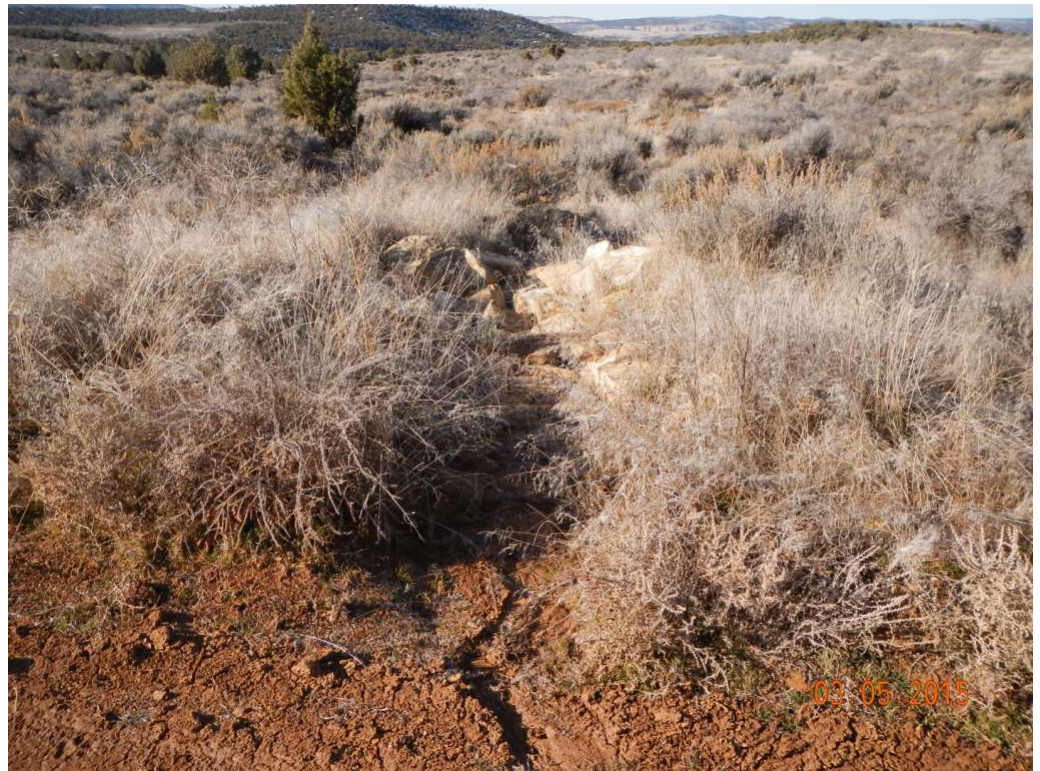
ID# 13-17

Drain and Rip rap

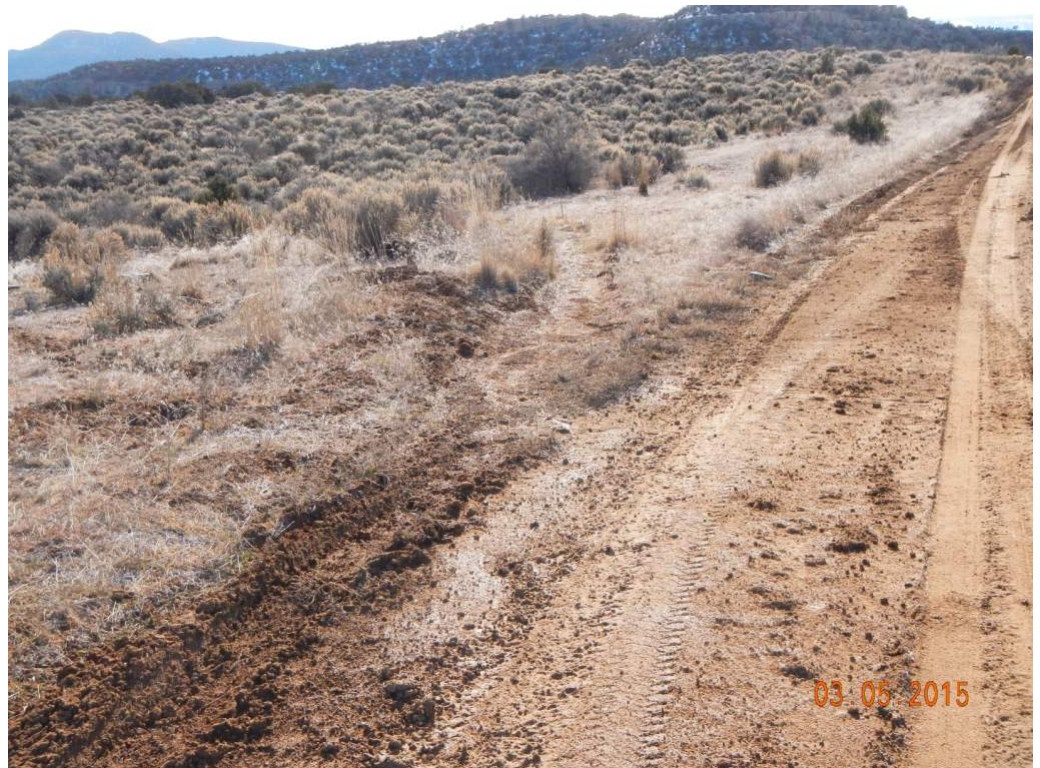
ID# 11

Turnout

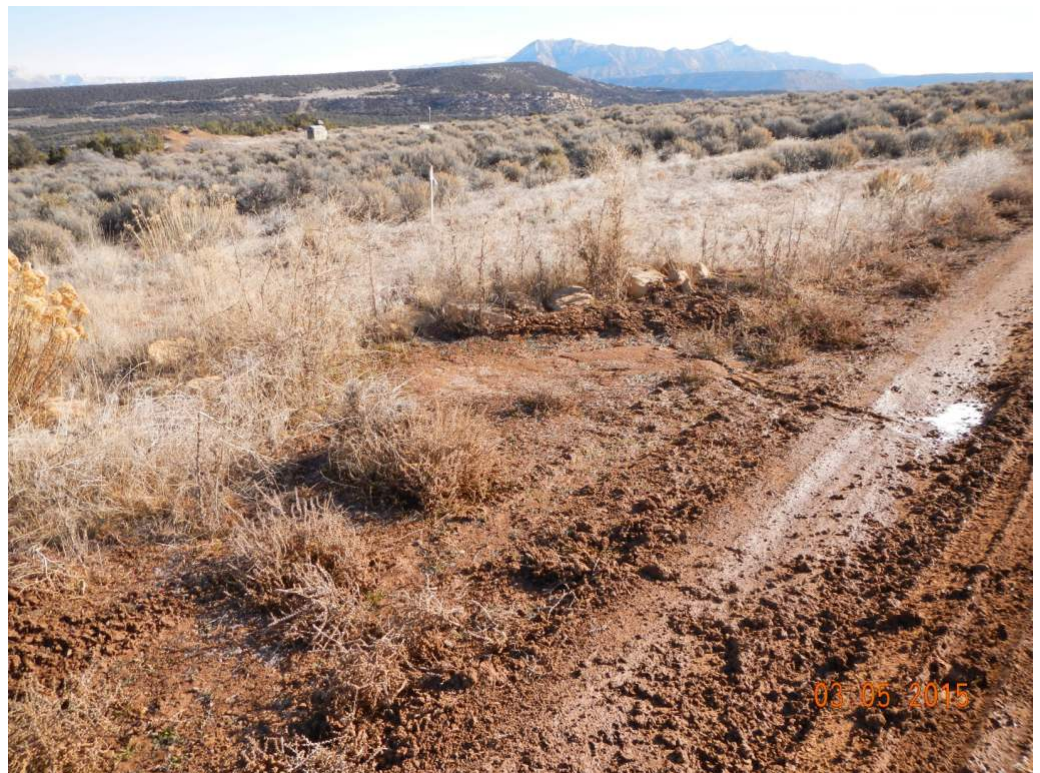
ID# 10

Erosion and sediment  
migration.

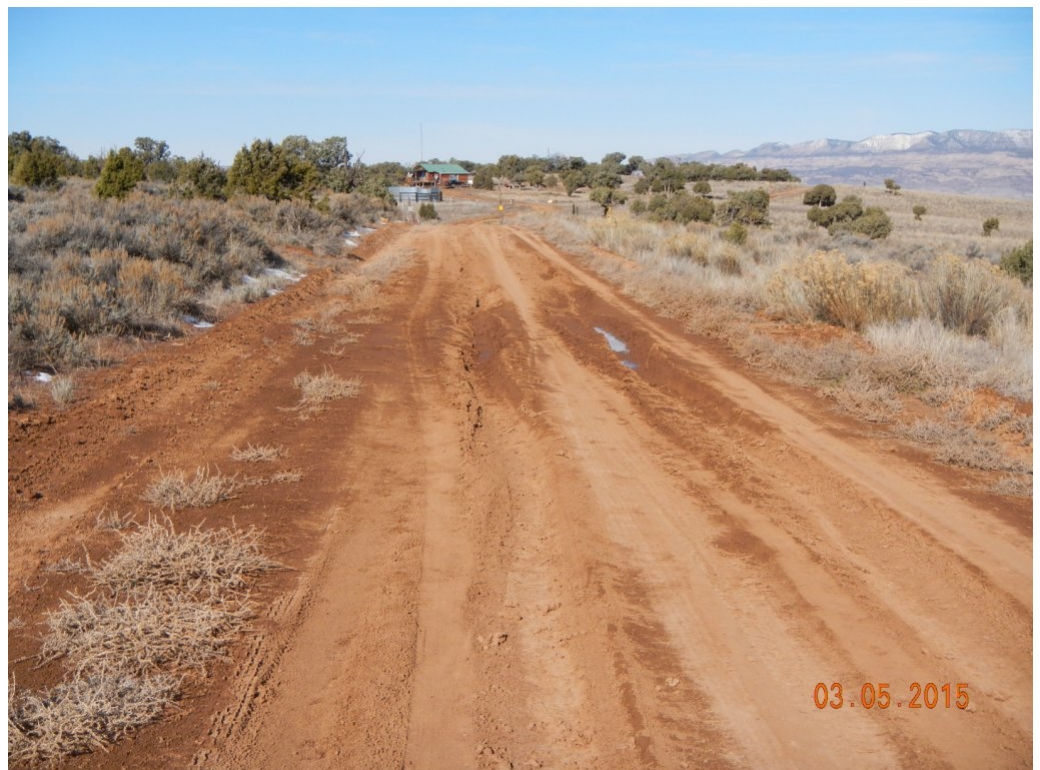
39.22667/-108.24519

Rutted Road

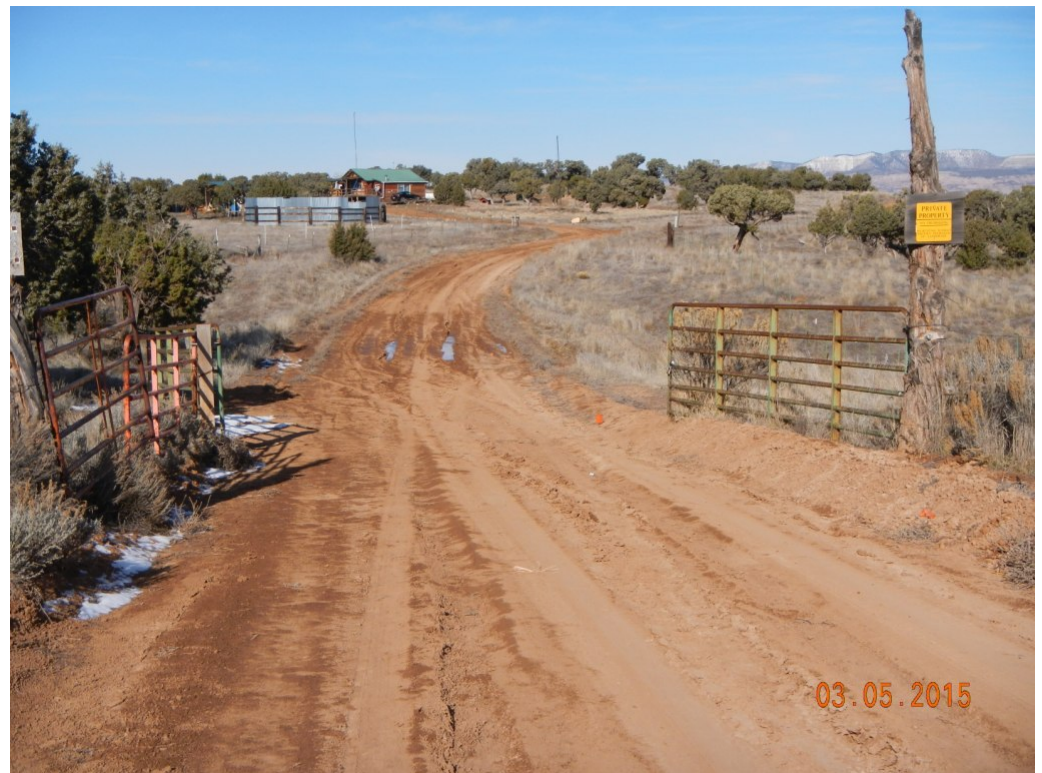
ID #7

Gate at last residence

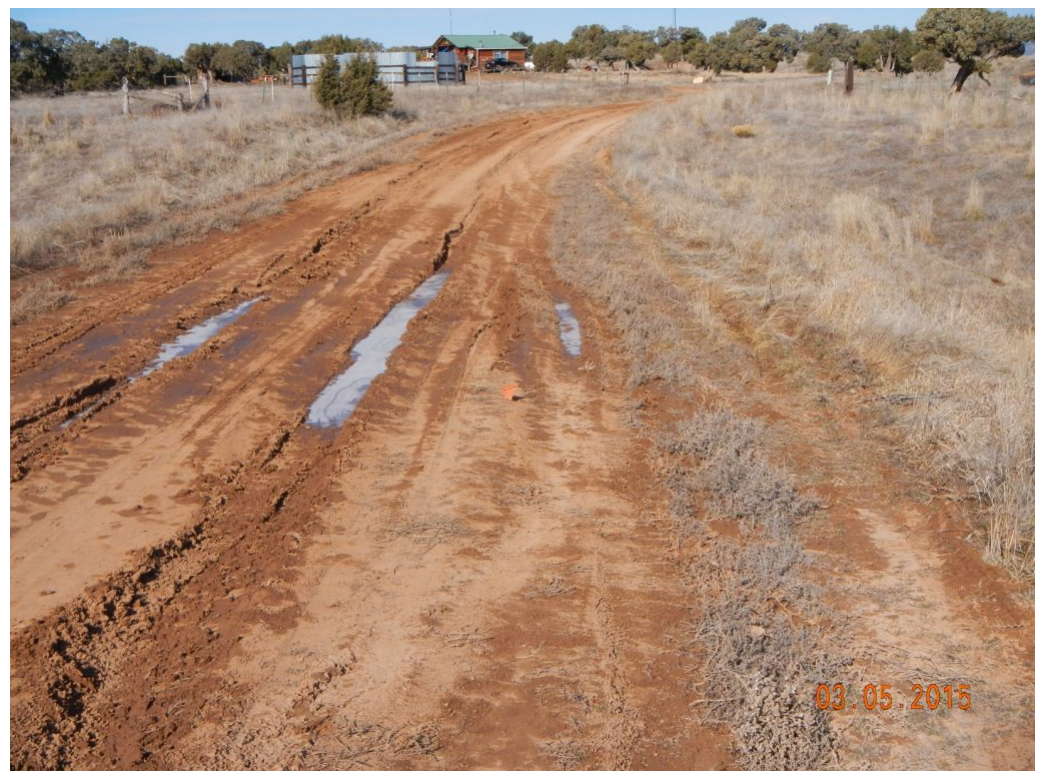
ID# 7

Road is rutted and vehicle tracking in vegetation.

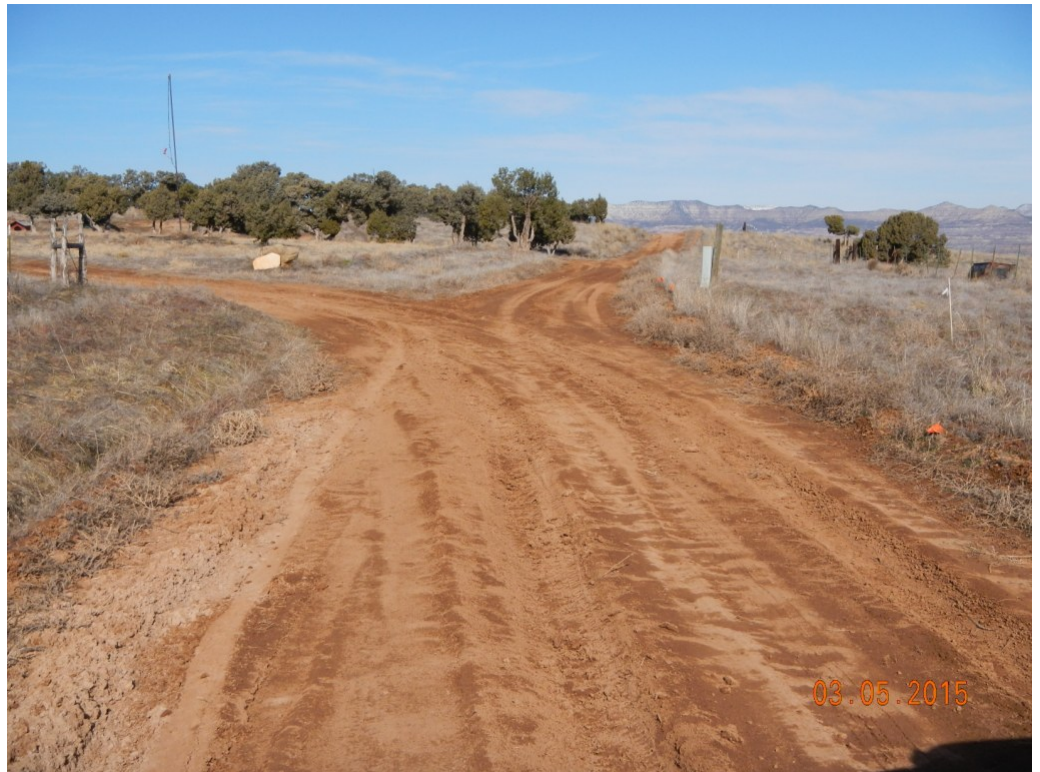
39.22742/-108.24749

No significant rutting or  
stormwater issues beyond  
this point at time of  
inspection.
