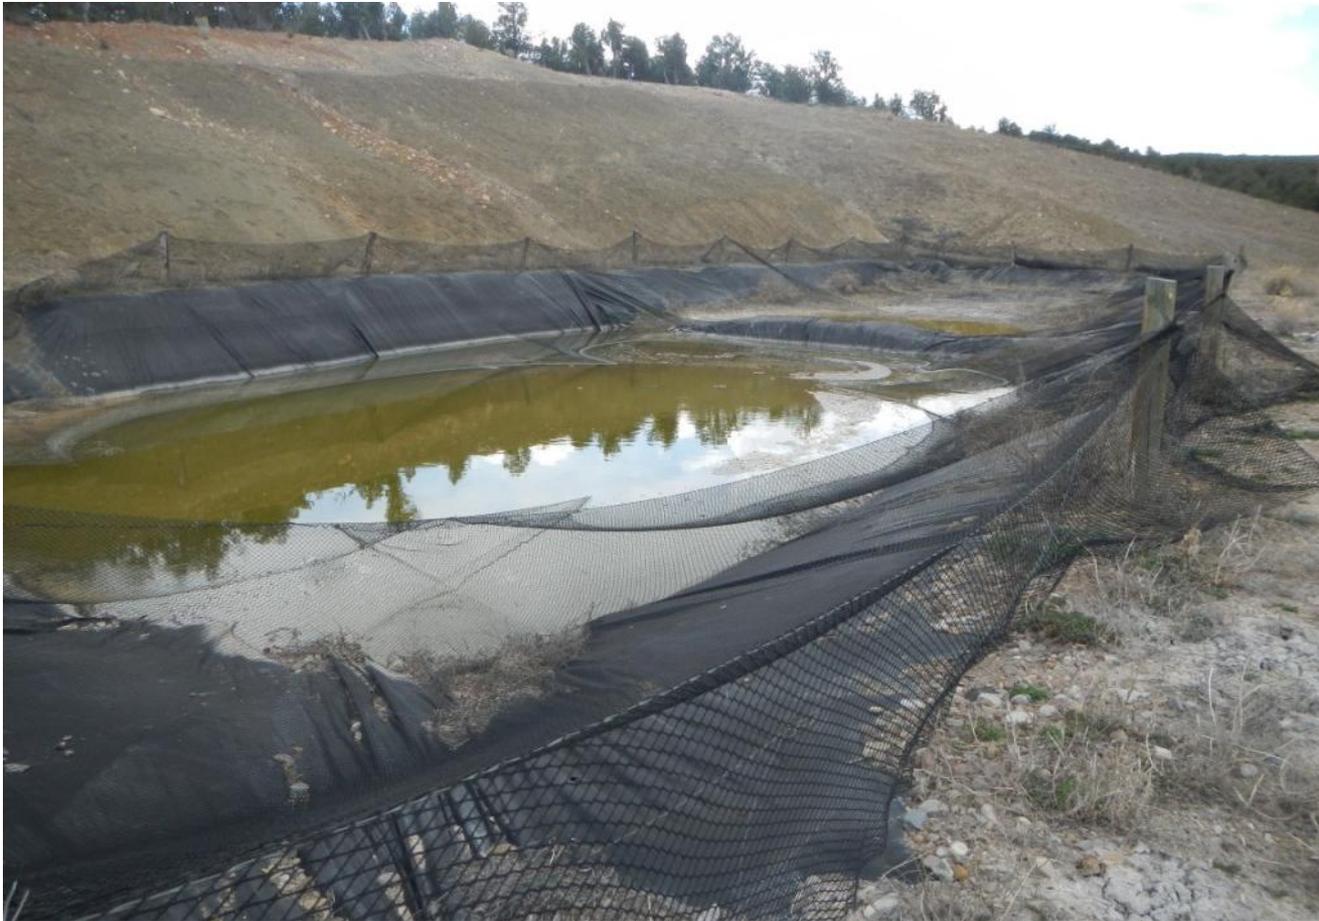
Photo 1. View of pit in northeastern portion of project area.

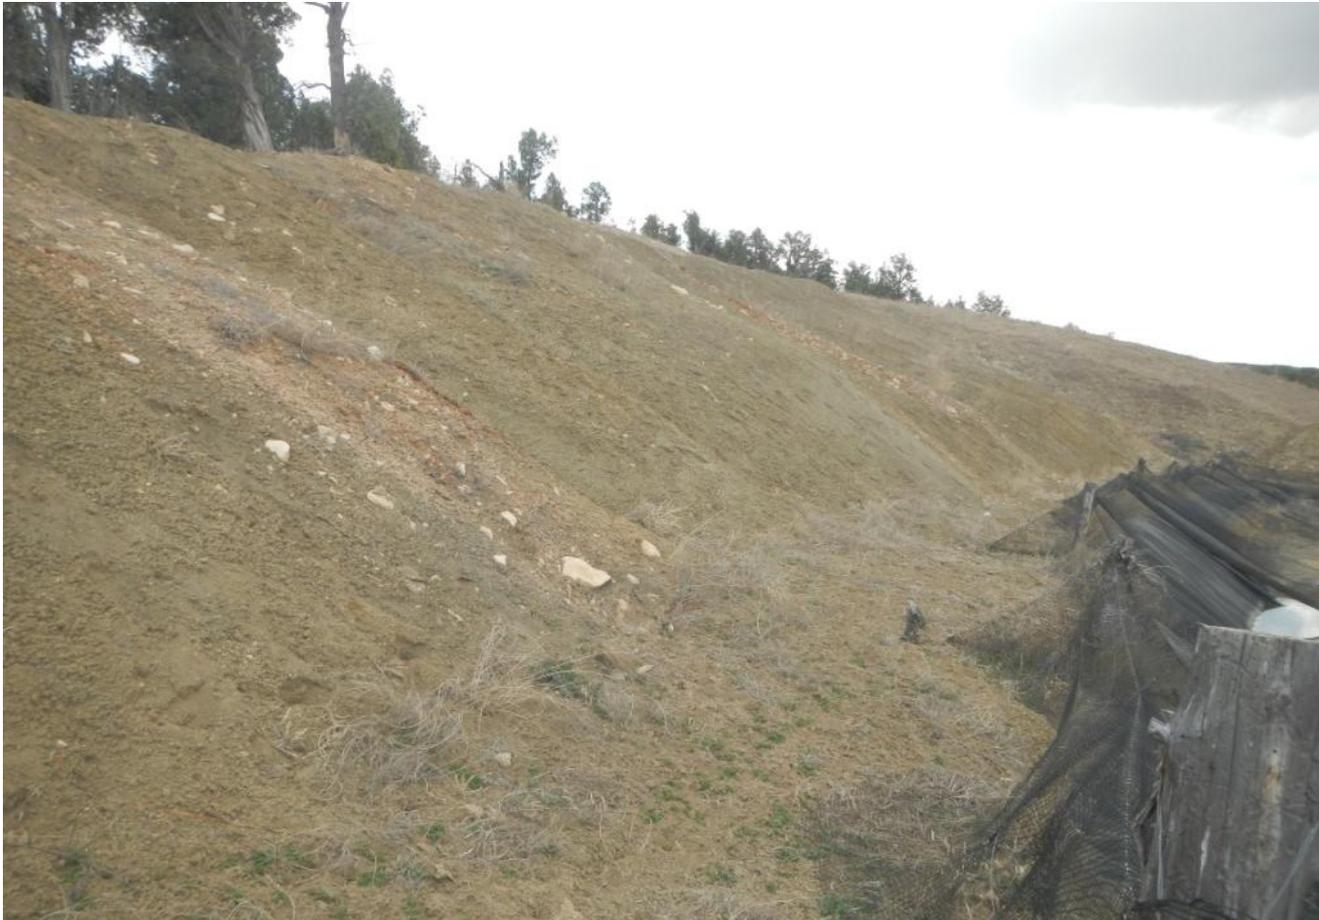
Photo 2. View of eastern portion of project area from northeastern corner of well pad facing southward.

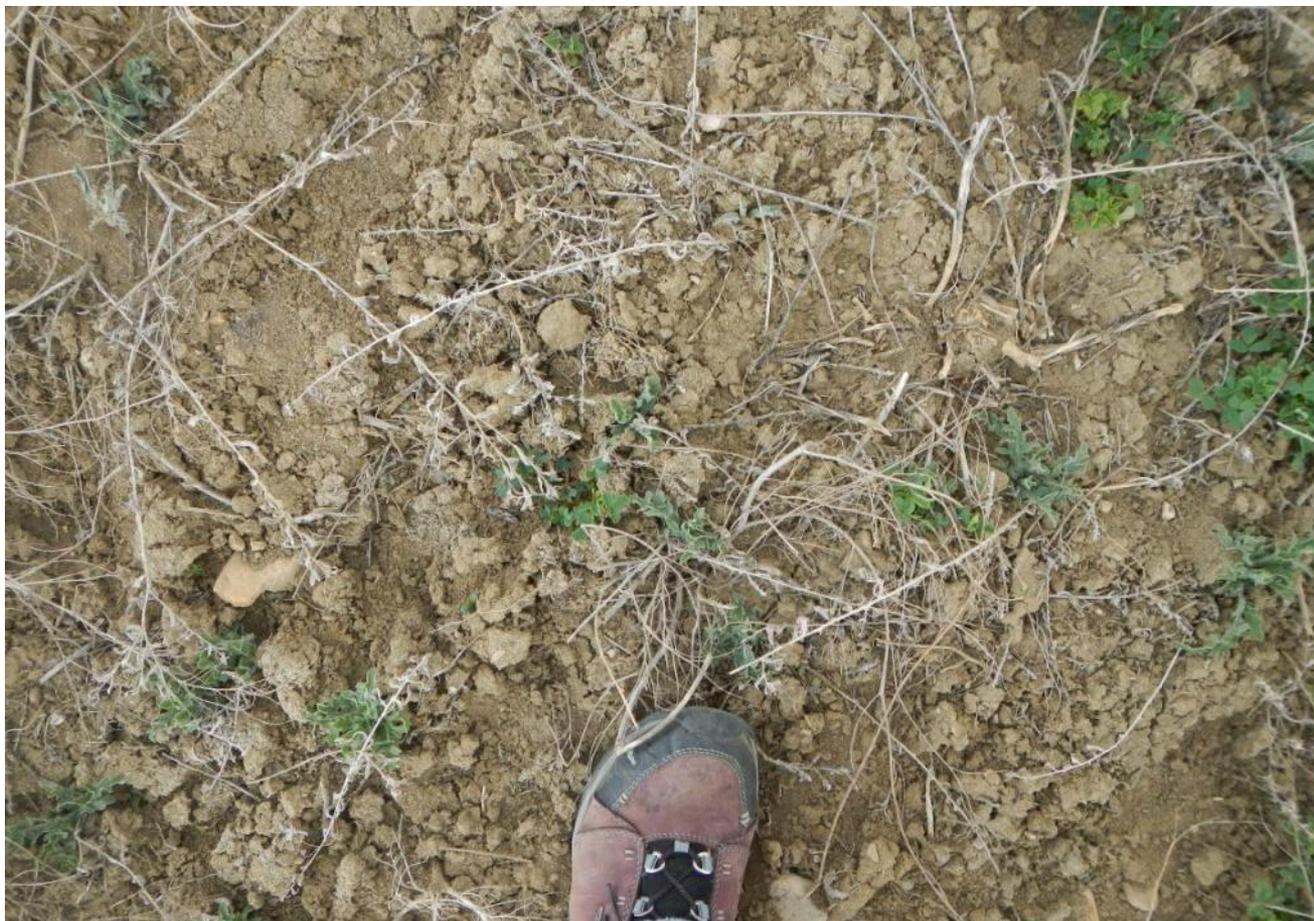
Photo 3. View of Russian knapweed (*Acroptilon repens*) rosettes (light green) within the project area. Russian knapweed is a State and County-listed noxious weed.

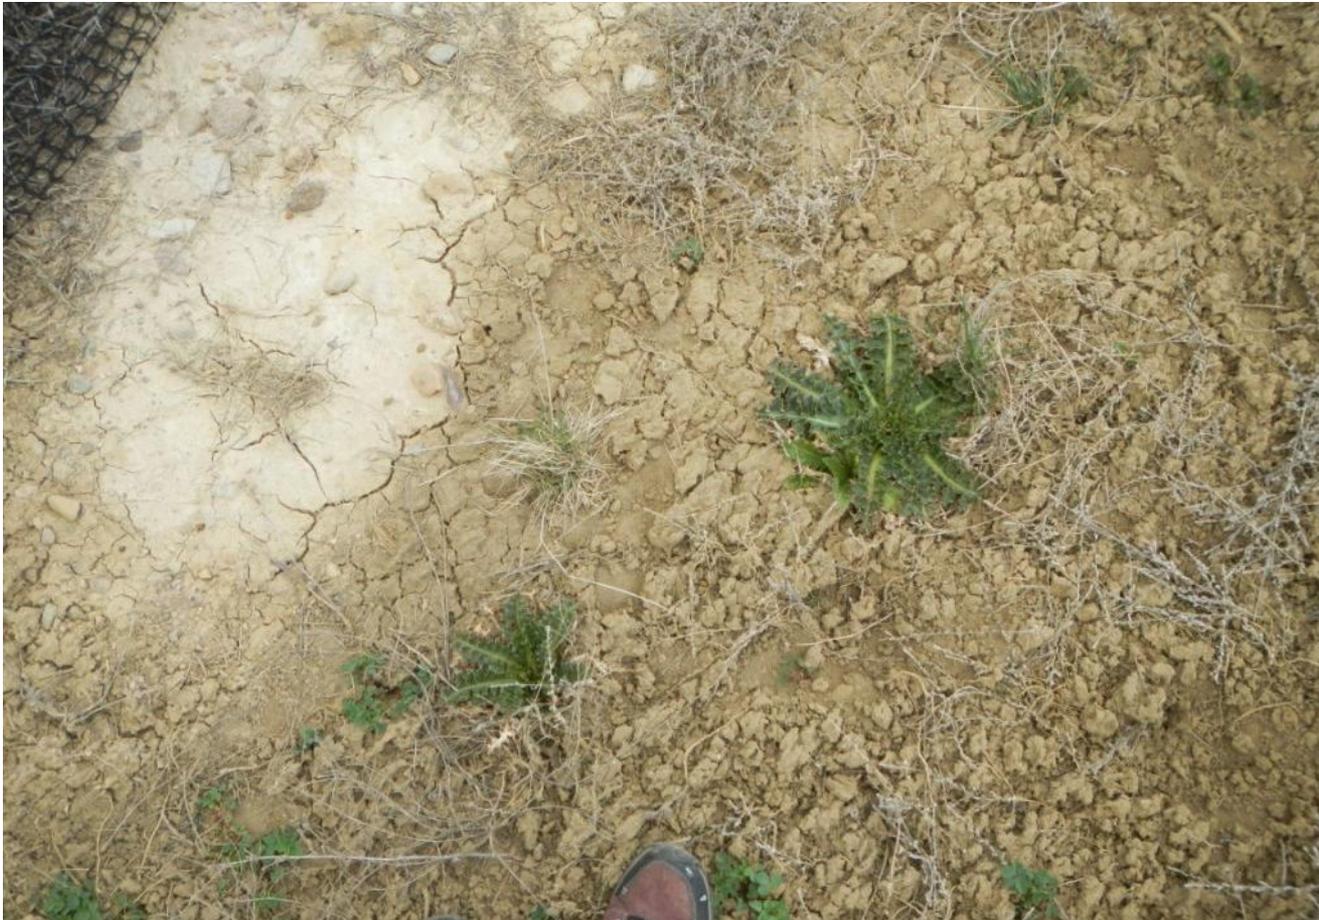
Photo 4. View of musk thistle (*Carduus nutans*) rosettes within the project area. Musk thistle is a State-listed noxious weed.

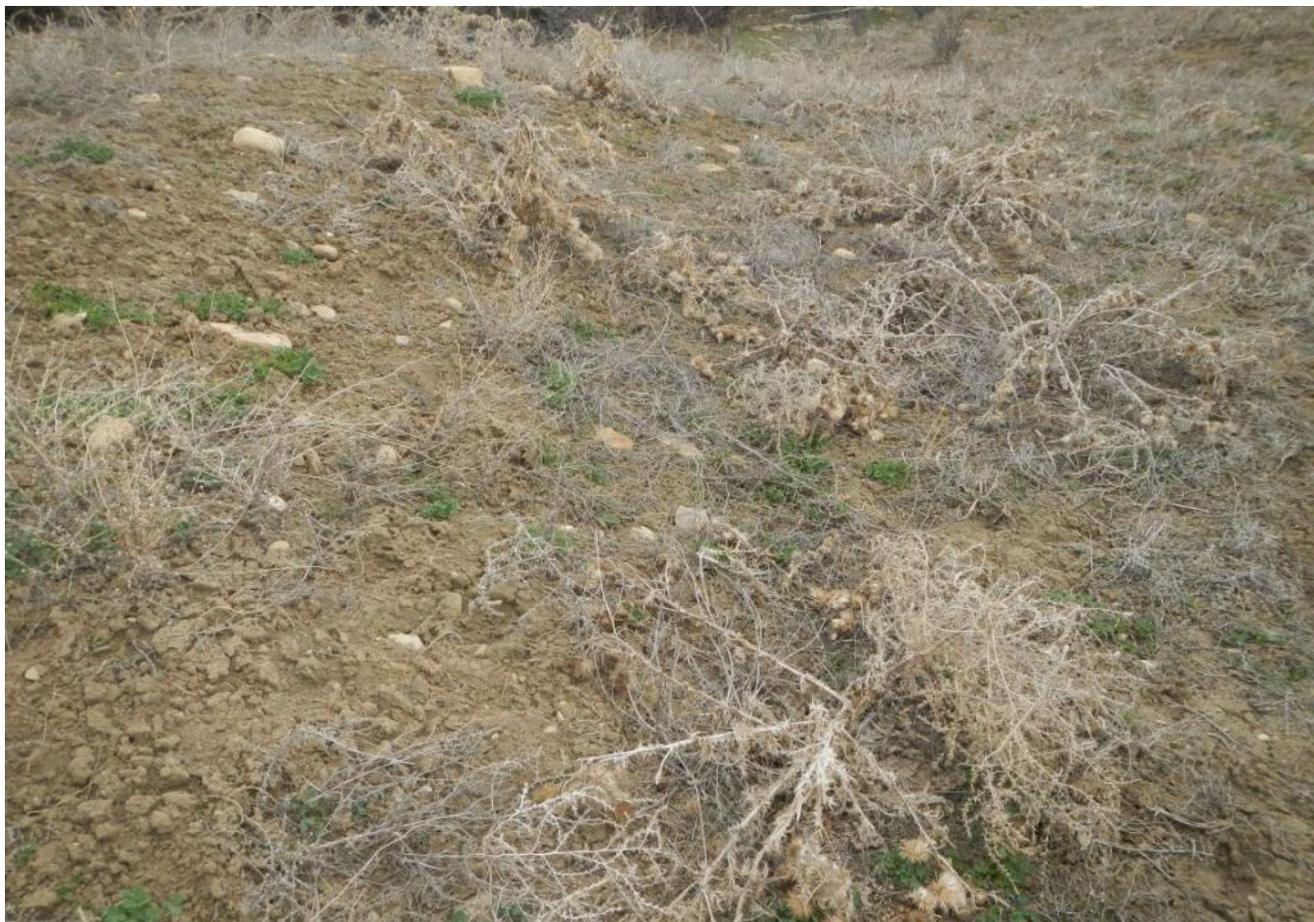
Photo 5. View of residual plant material from the previous growing season of musk thistle, kochia (*Kochia scoparia*), and Russian thistle (*Salsola tragus*).

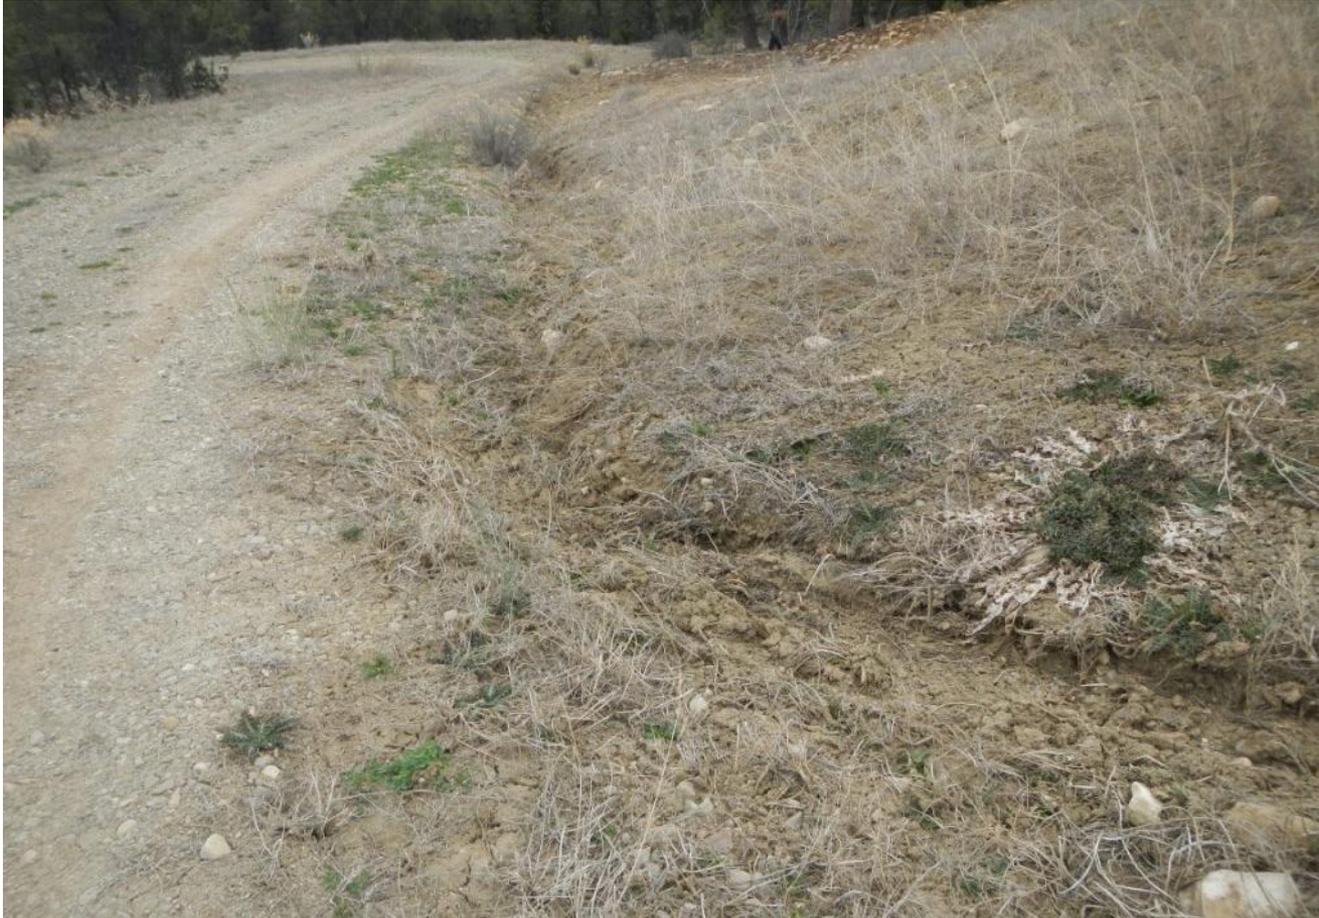
Photo 6. View of access road from well pad facing northward. Erosional channel is forming on the eastern edge of the access road from the well pad.

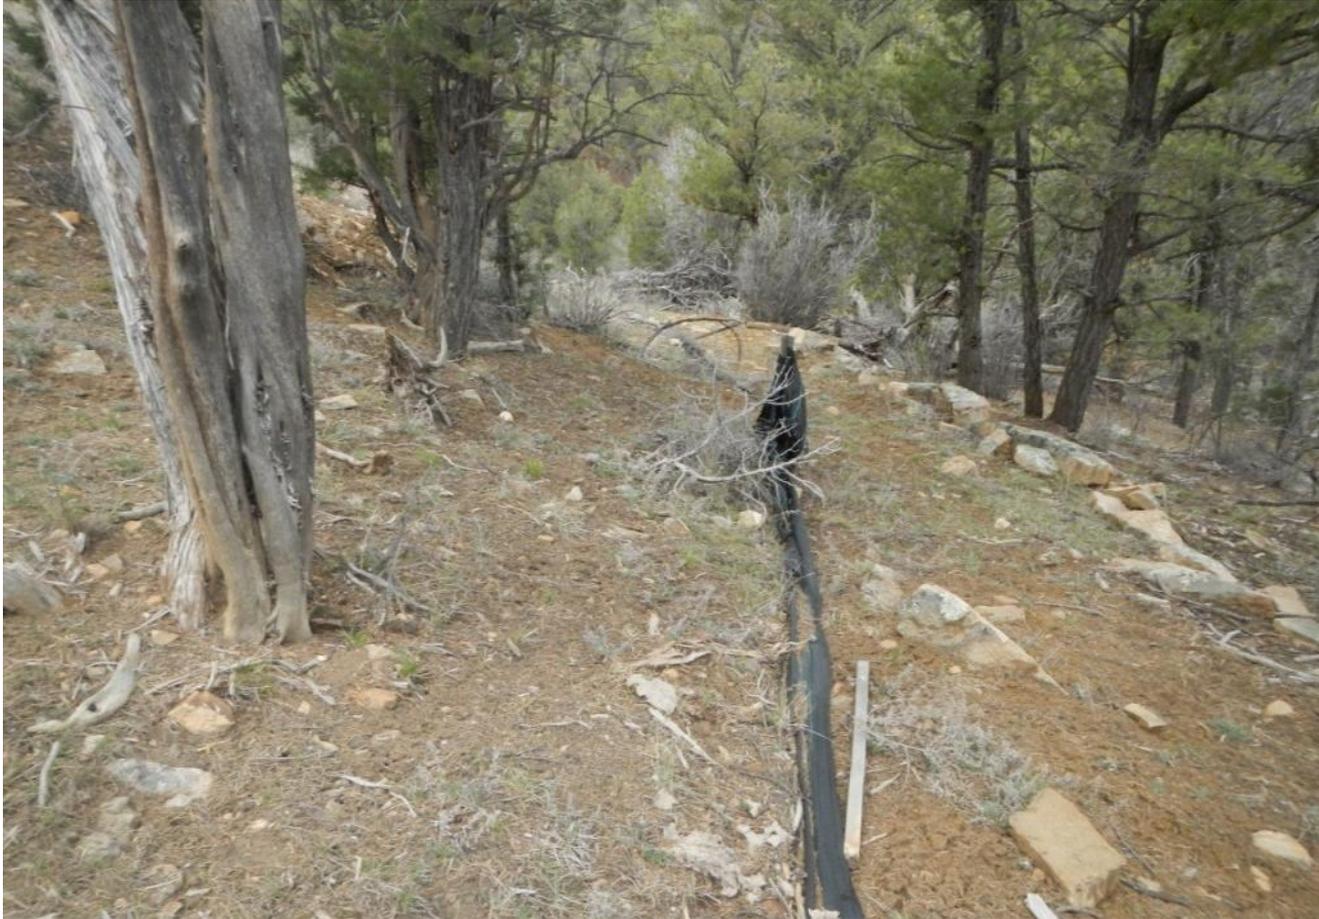
Photo 7. View of dilapidated silt fence that is installed around the perimeter of the project area.

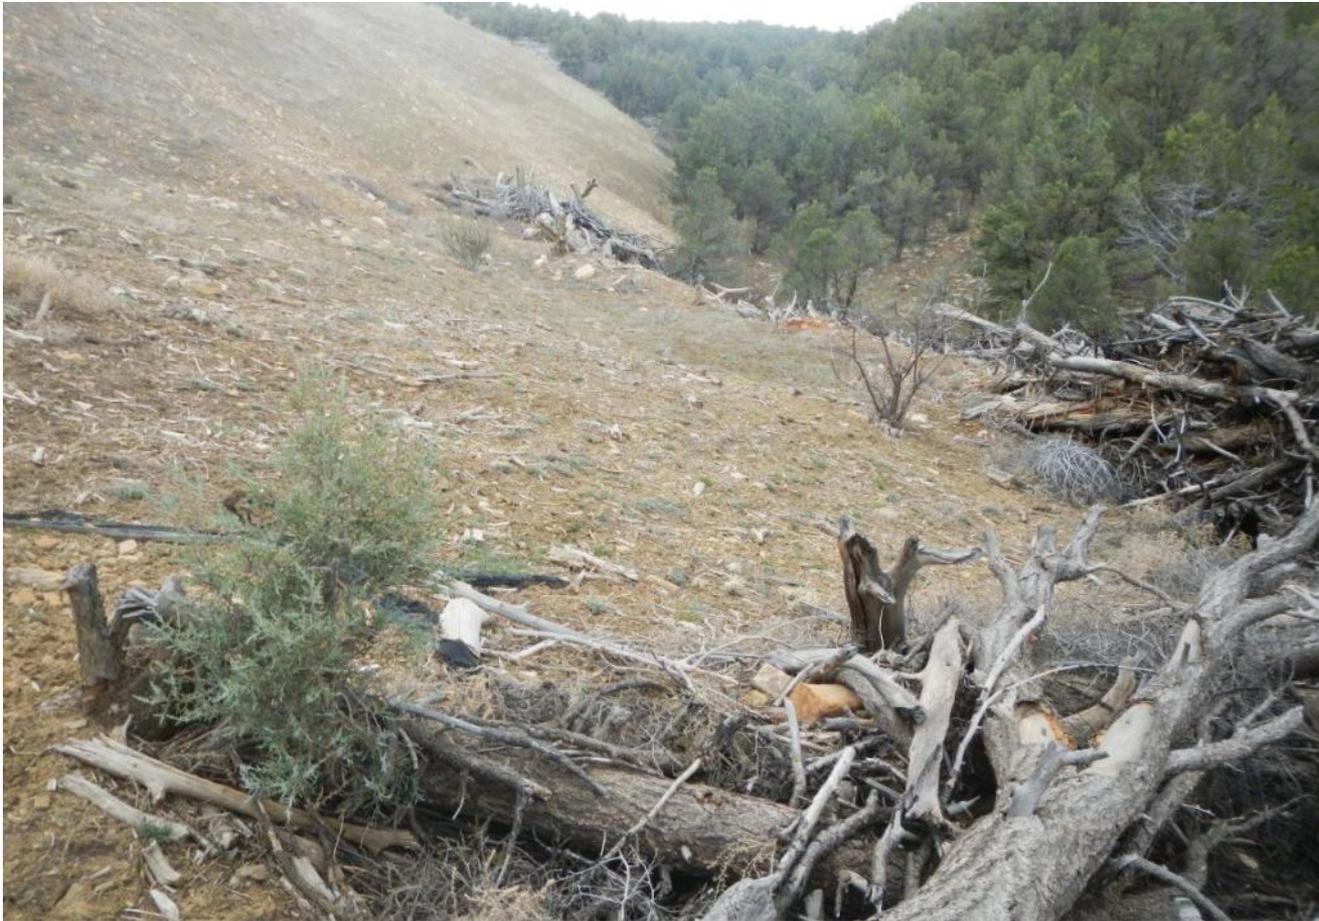
Photo 8. View of western portion of project area from northwestern corner facing southward. Woody debris stockpiled in northwestern corner and large fill slope can be seen above ephemeral drainage that flows along western edge of the project area (on right).

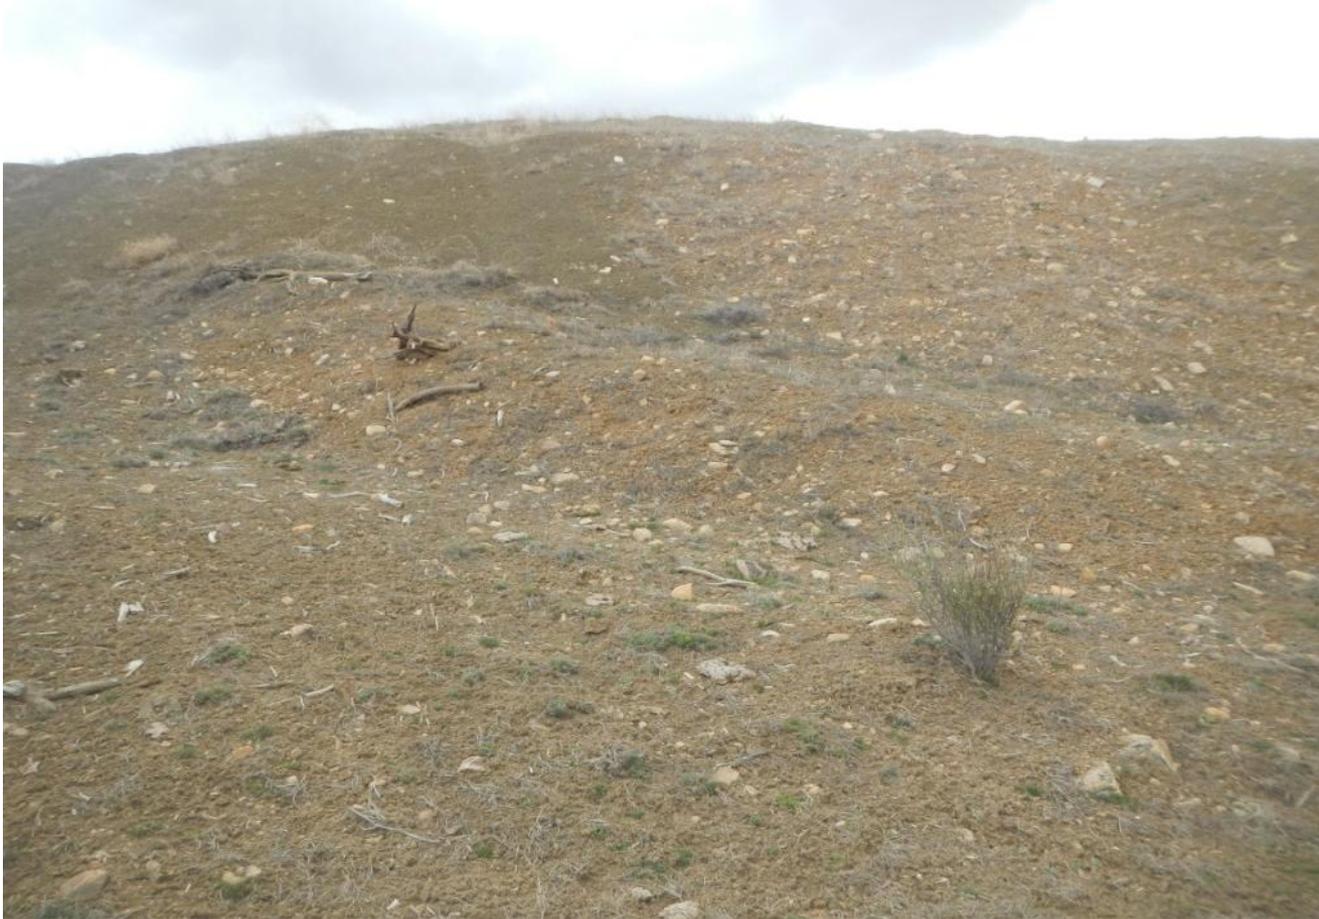
Photo 9. View of fill slope from western edge facing eastward.

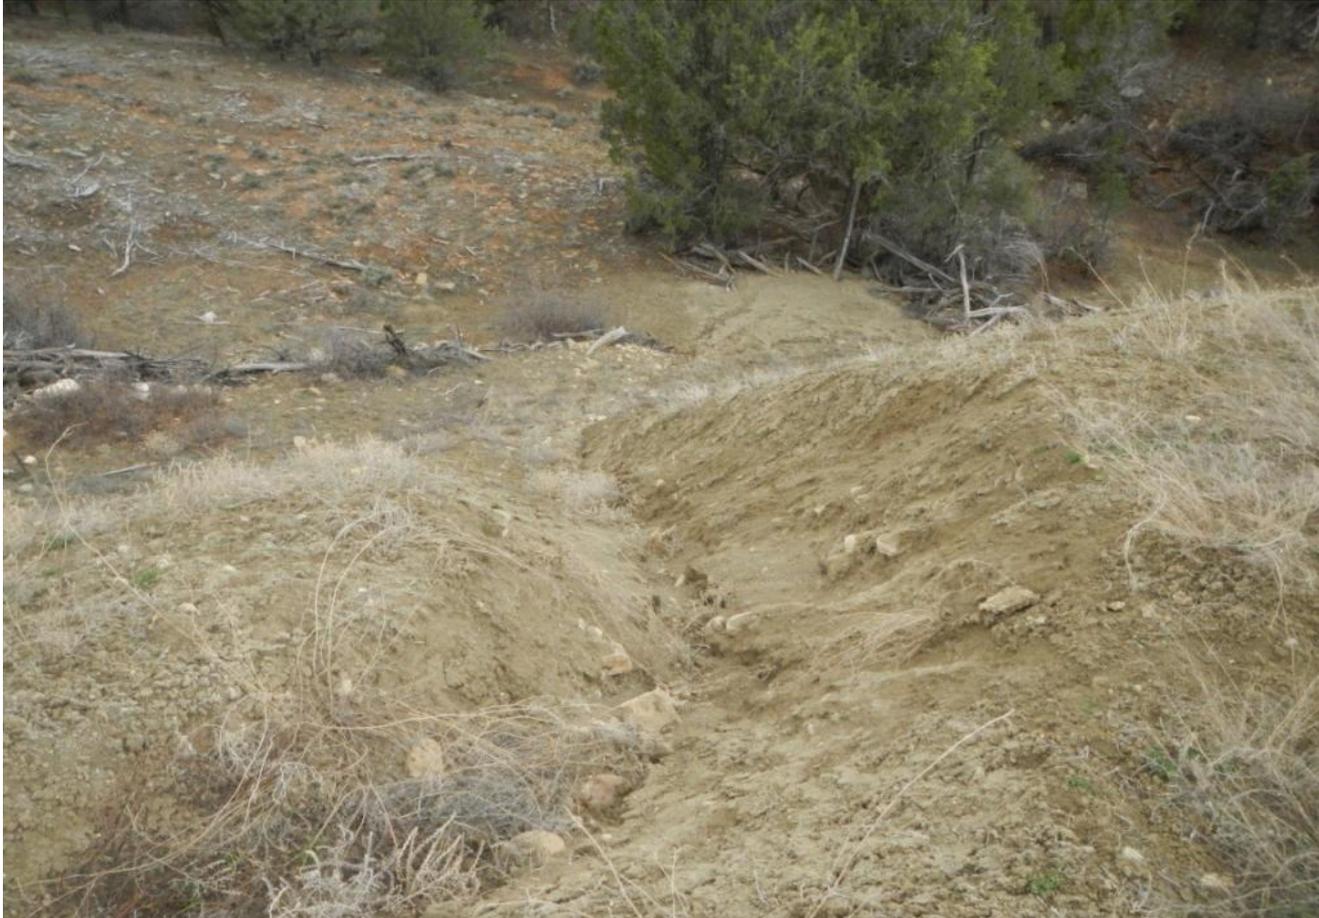
Photo 10. View of erosional channel and sediment deposition at the bottom of the slope, in southern portion of project area.

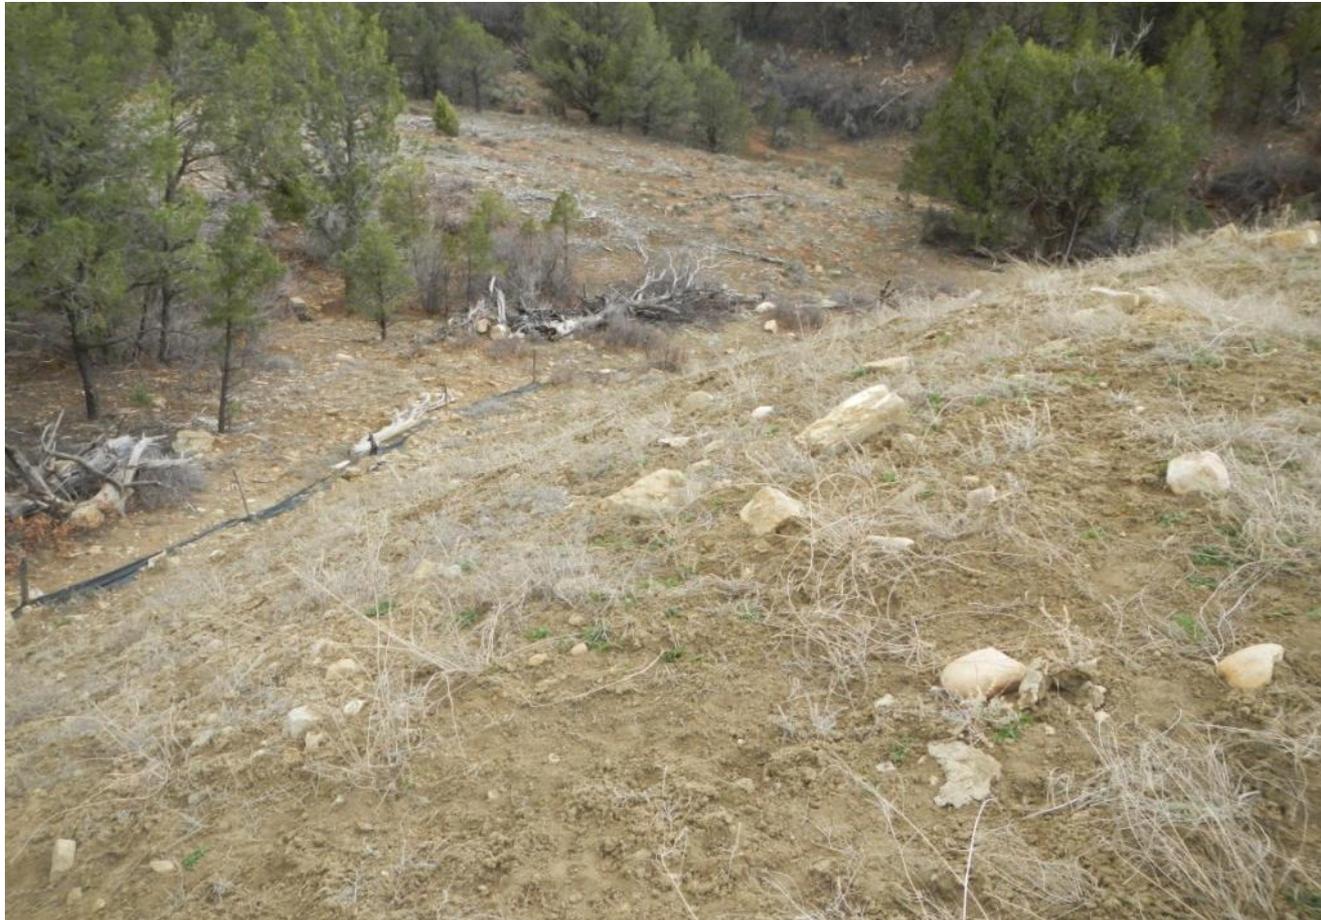
Photo 11. View of southern fill slope facing southward.

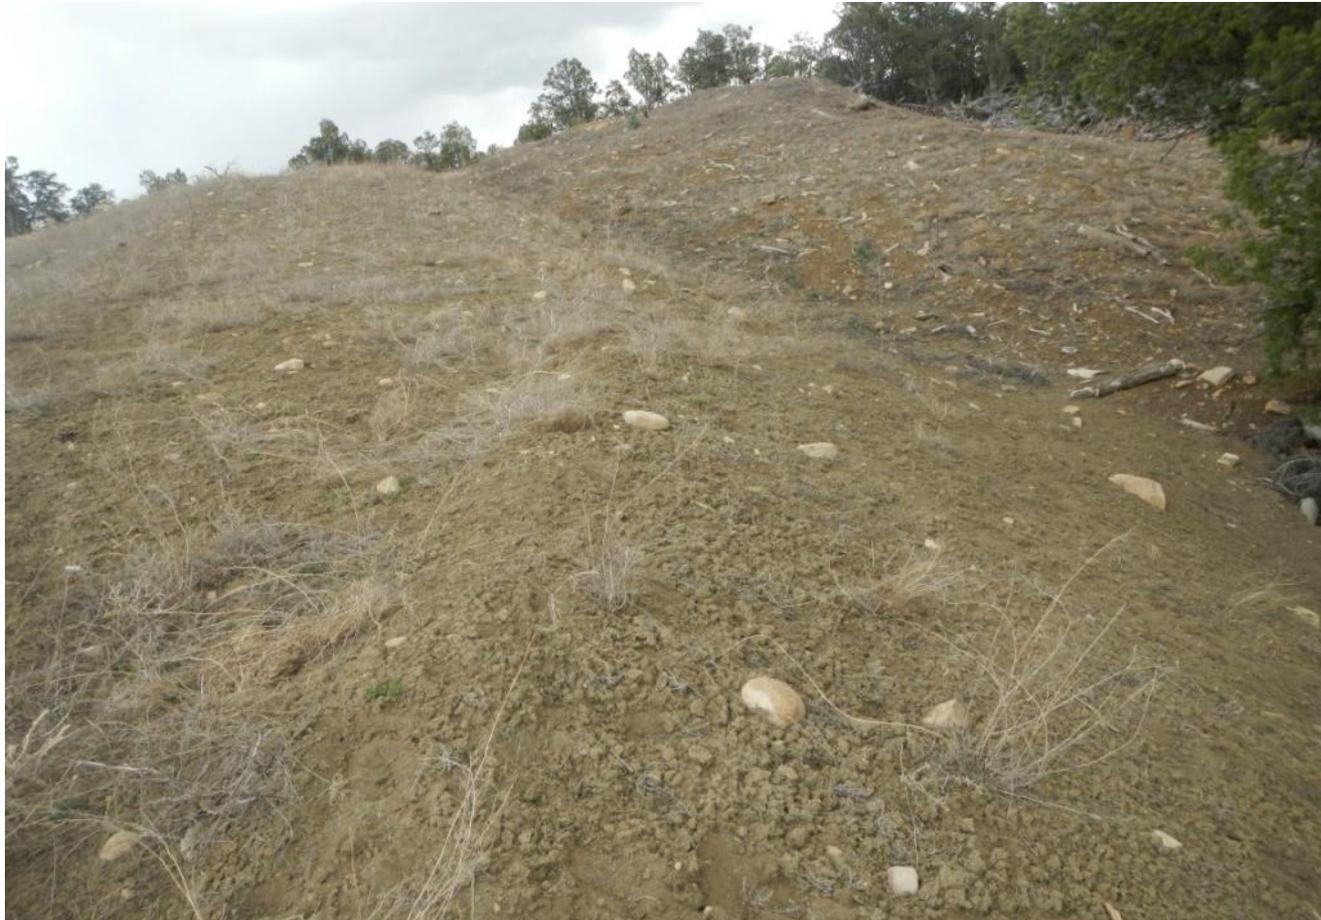
Photo 12. View of steep cut slope in southeastern corner of project area from southern edge facing eastward.

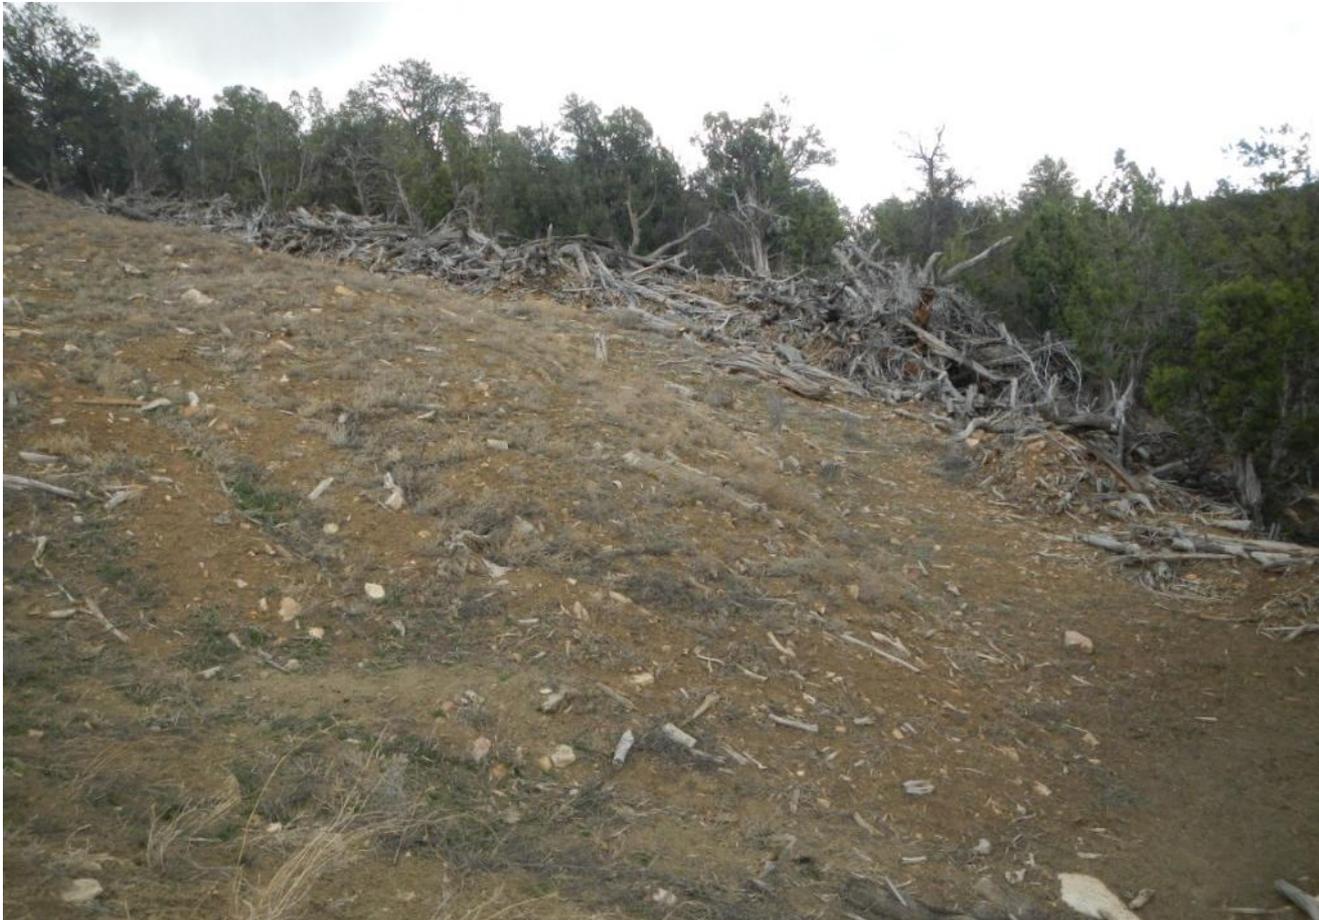
Photo 13. View of woody debris stockpiled within southeastern portion of project area.

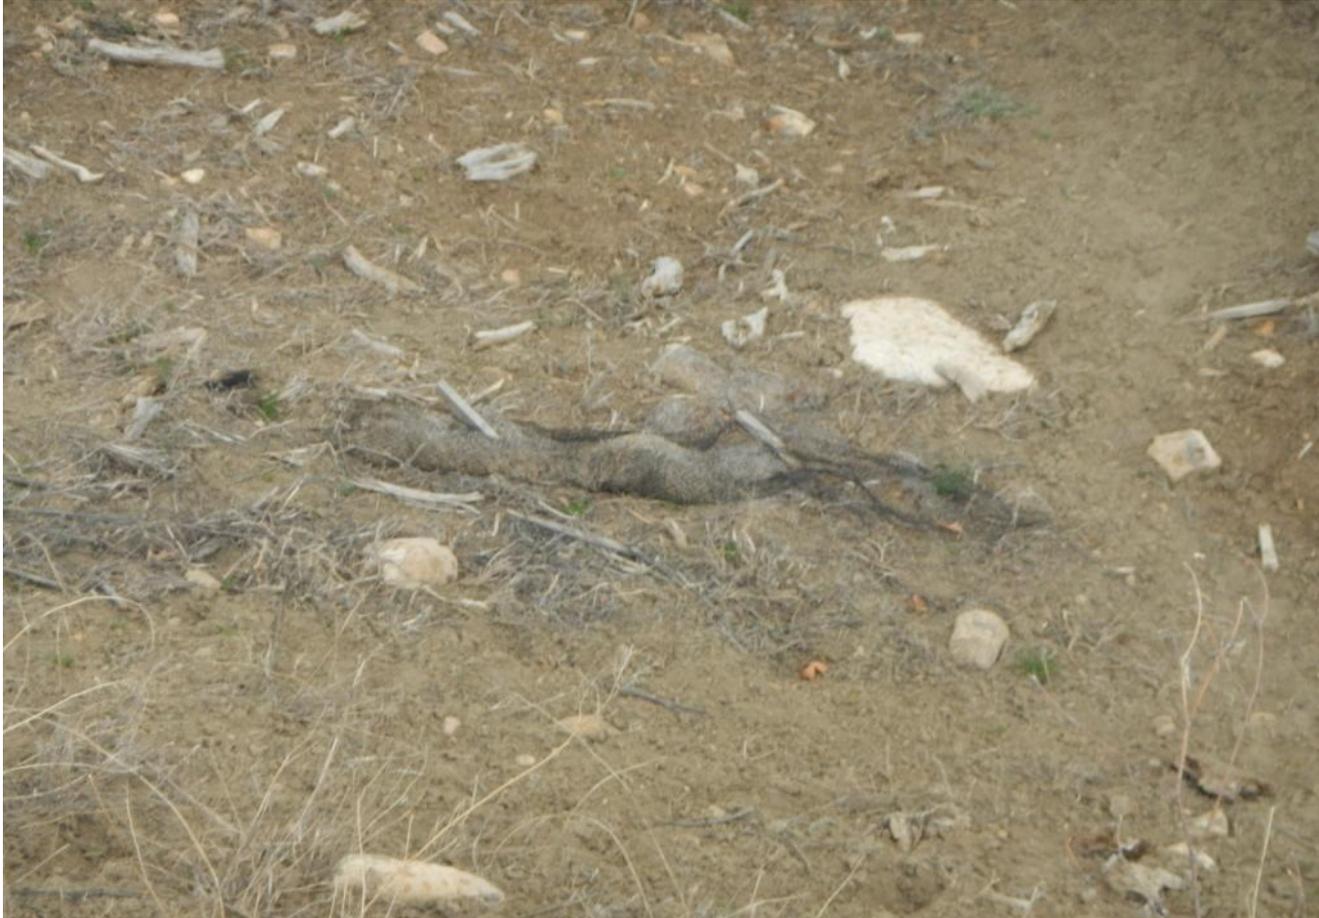
Photo 14. View of degraded straw wattle in southeastern portion of project area.

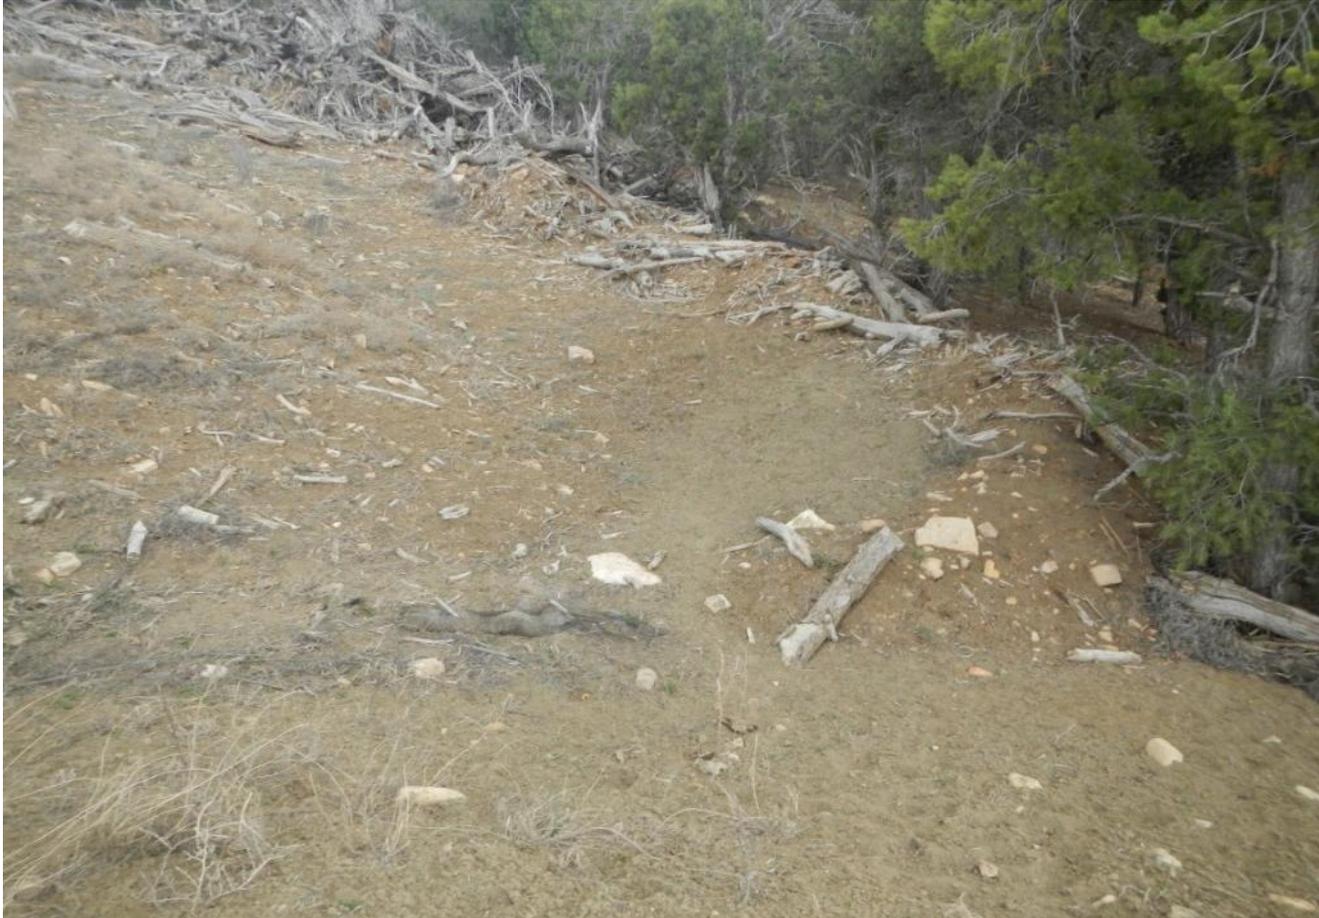
Photo 15. View of stormwater diversion in southeastern portion of project area that appears to be full of sediment.

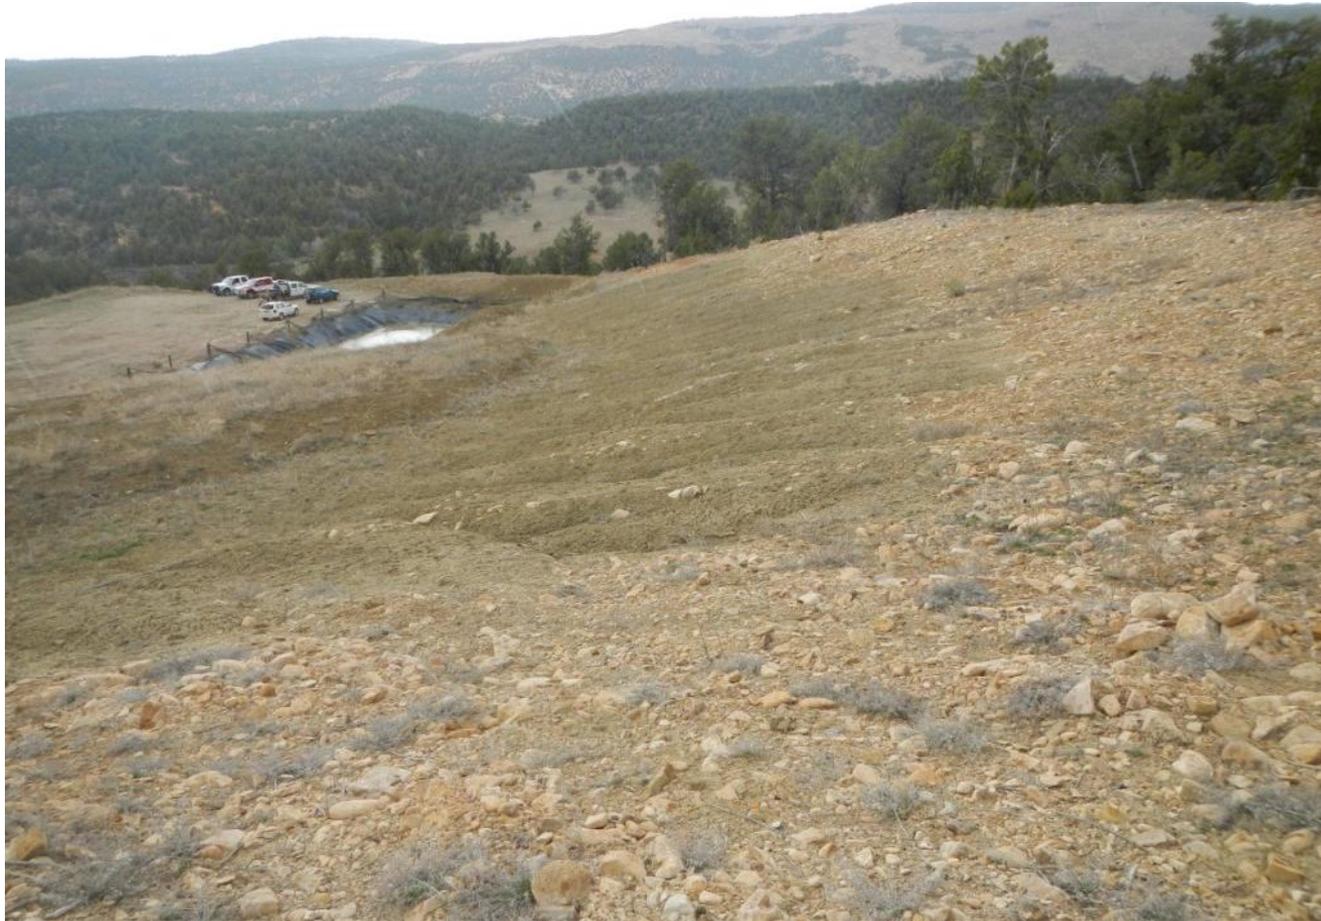
Photo 16. View of project area from southeastern corner facing northward.

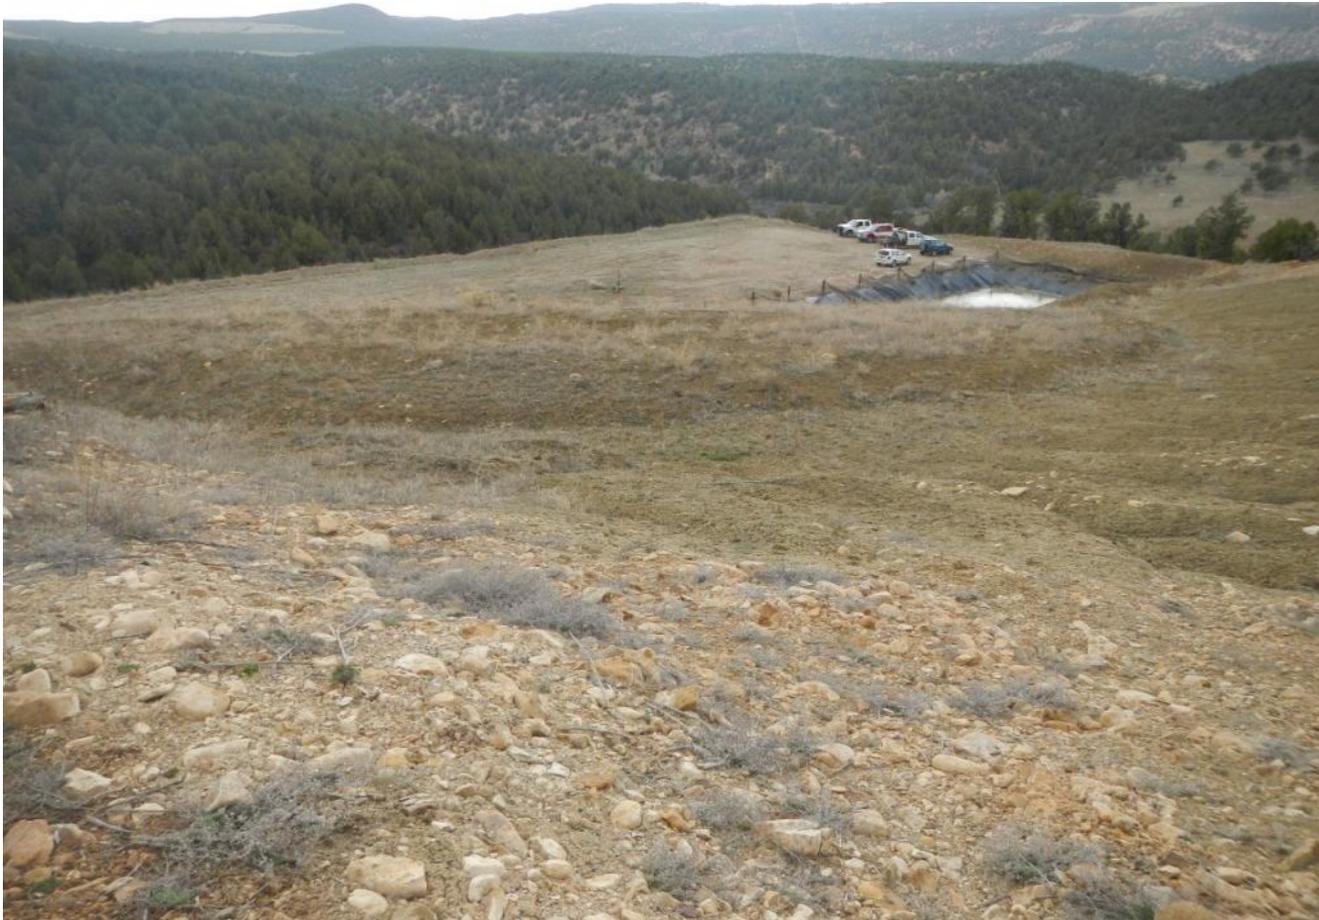
Photo 17. View of project area from southeastern corner facing center.

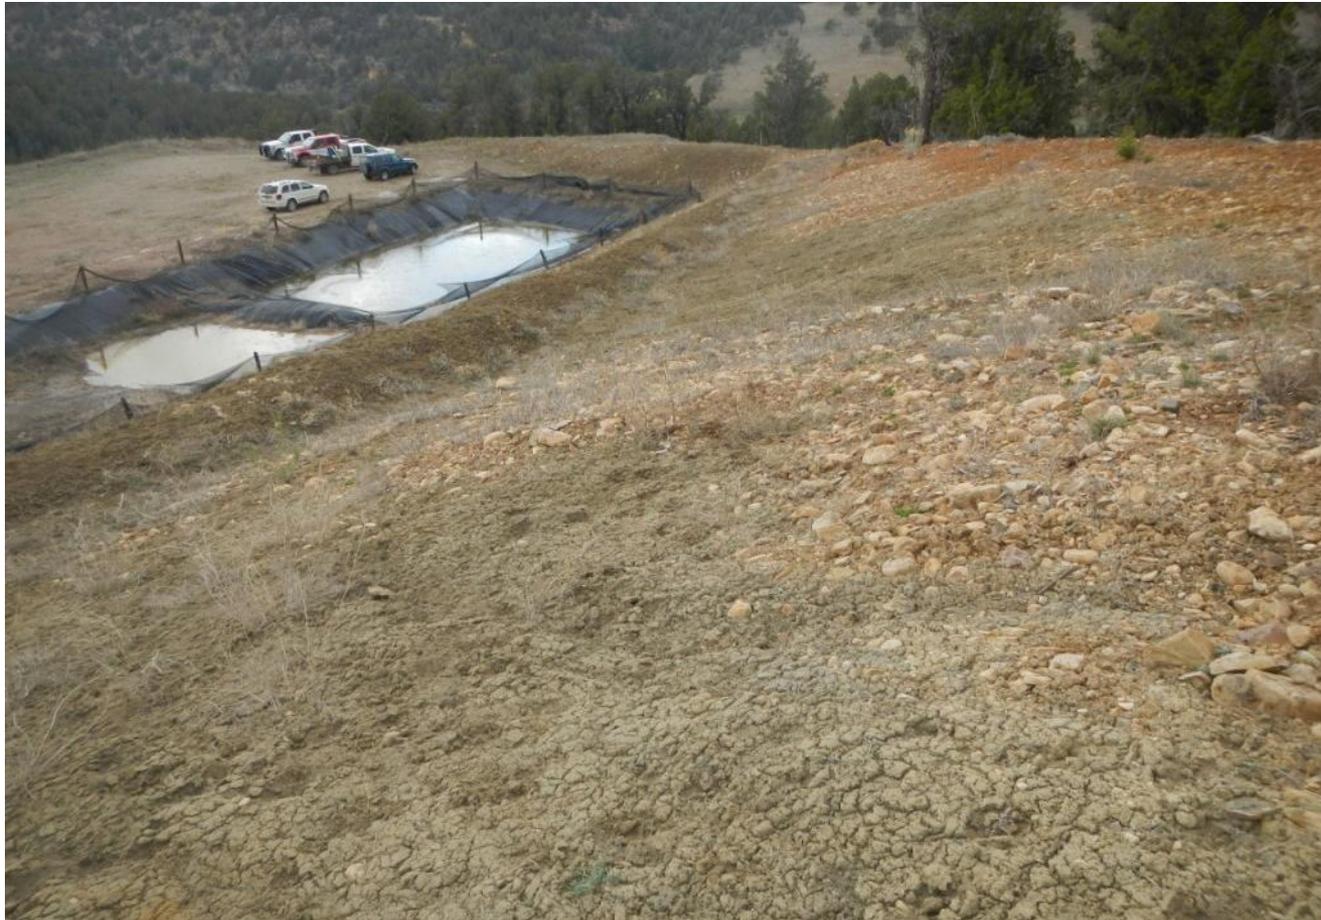
Photo 18. View of pit from eastern edge of project area.
