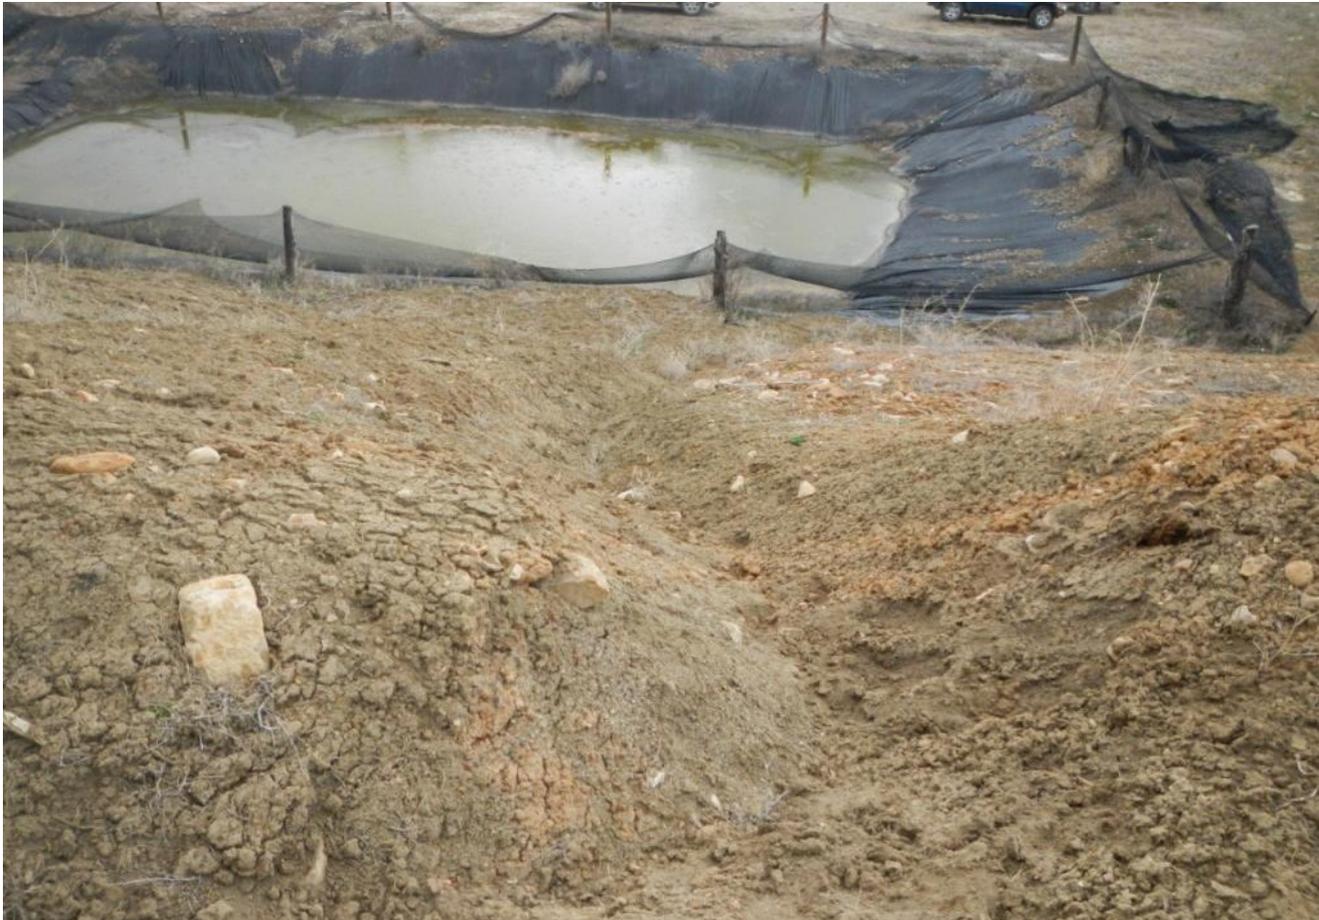
Photo 19. View of stormwater erosion toward pit from cut slope on eastern portion of well pad.
