Supplemental Incident Report to COGCC Form 19

Lightning Strike and Fire

NGL C4 Water Treatment Facility

Incident Date: 17 April 2015

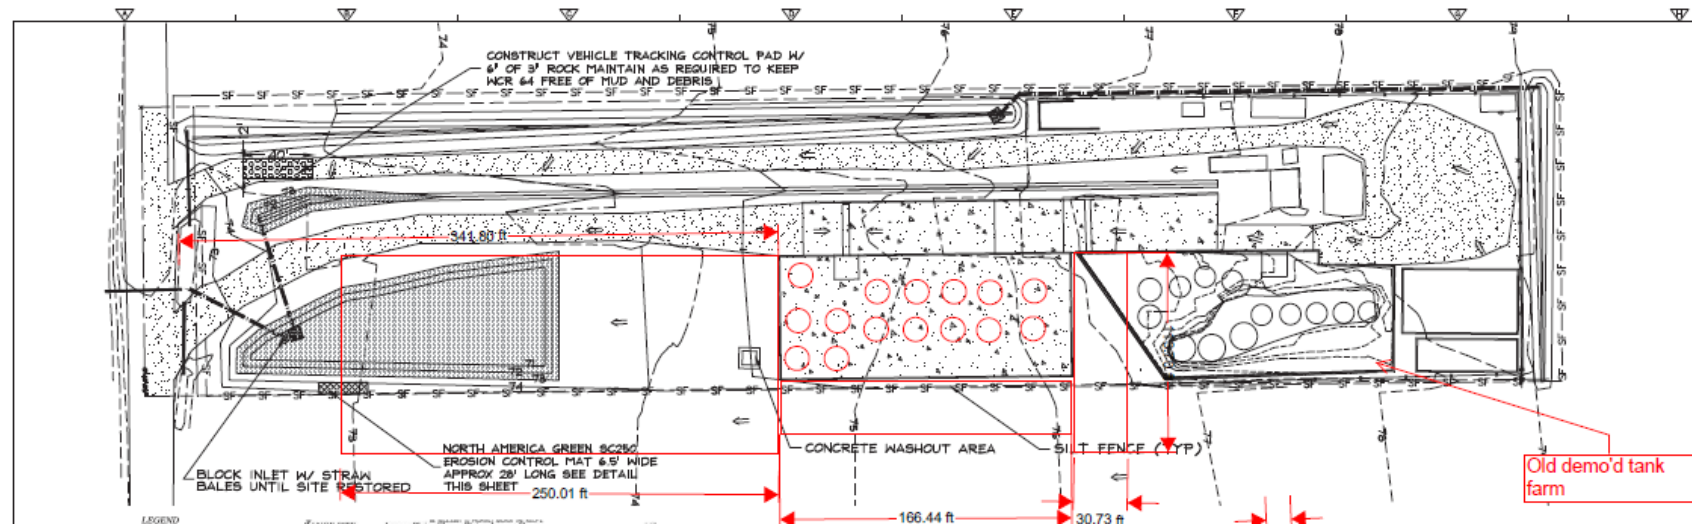
Appendix A – Impacted Soil Areas on C4 facility site.

Virtually all fluids, including rain water, firefighting water, product and oil were contained either by the secondary containment system, the storm water retention pond, and the pad. A strip of soil 30' wide east of the facility received some fluid contamination.

Soil at the facility was also scraped and removed where contaminated by the mixture of produced water, oil splash, sludge and firefighting water. Volumes and disposition are recorded in the table below.

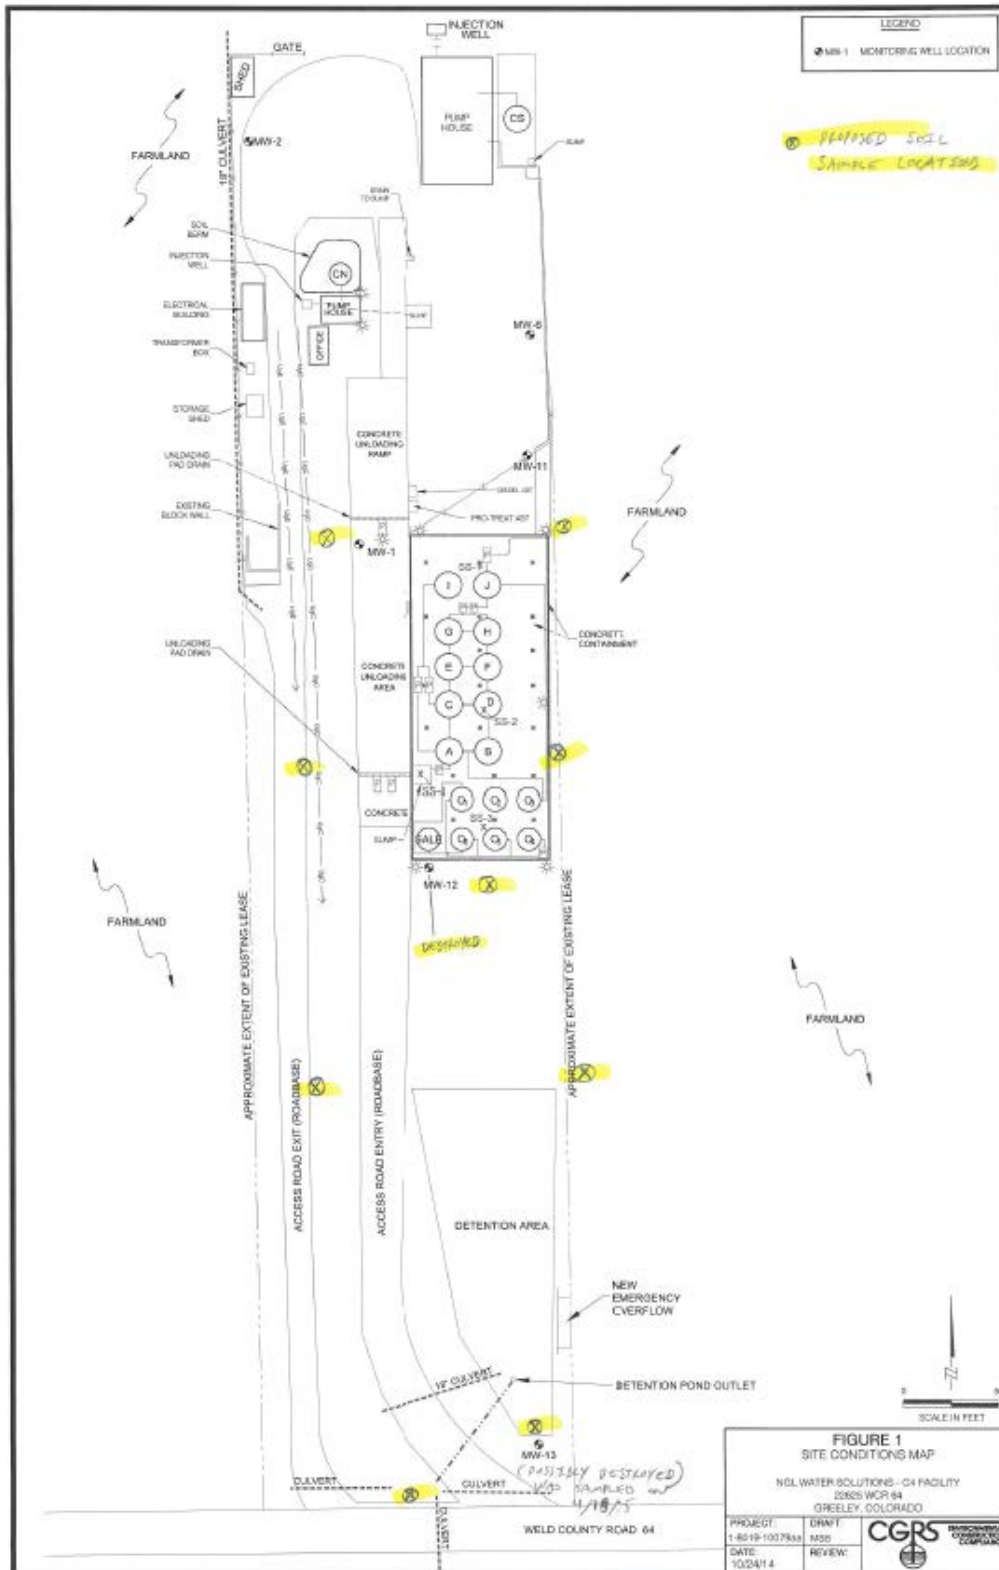
Appendix B – Soil Sample and Monitoring Well Locations

A comprehensive sampling plan was implemented and results are pending. A follow up report will be submitted.

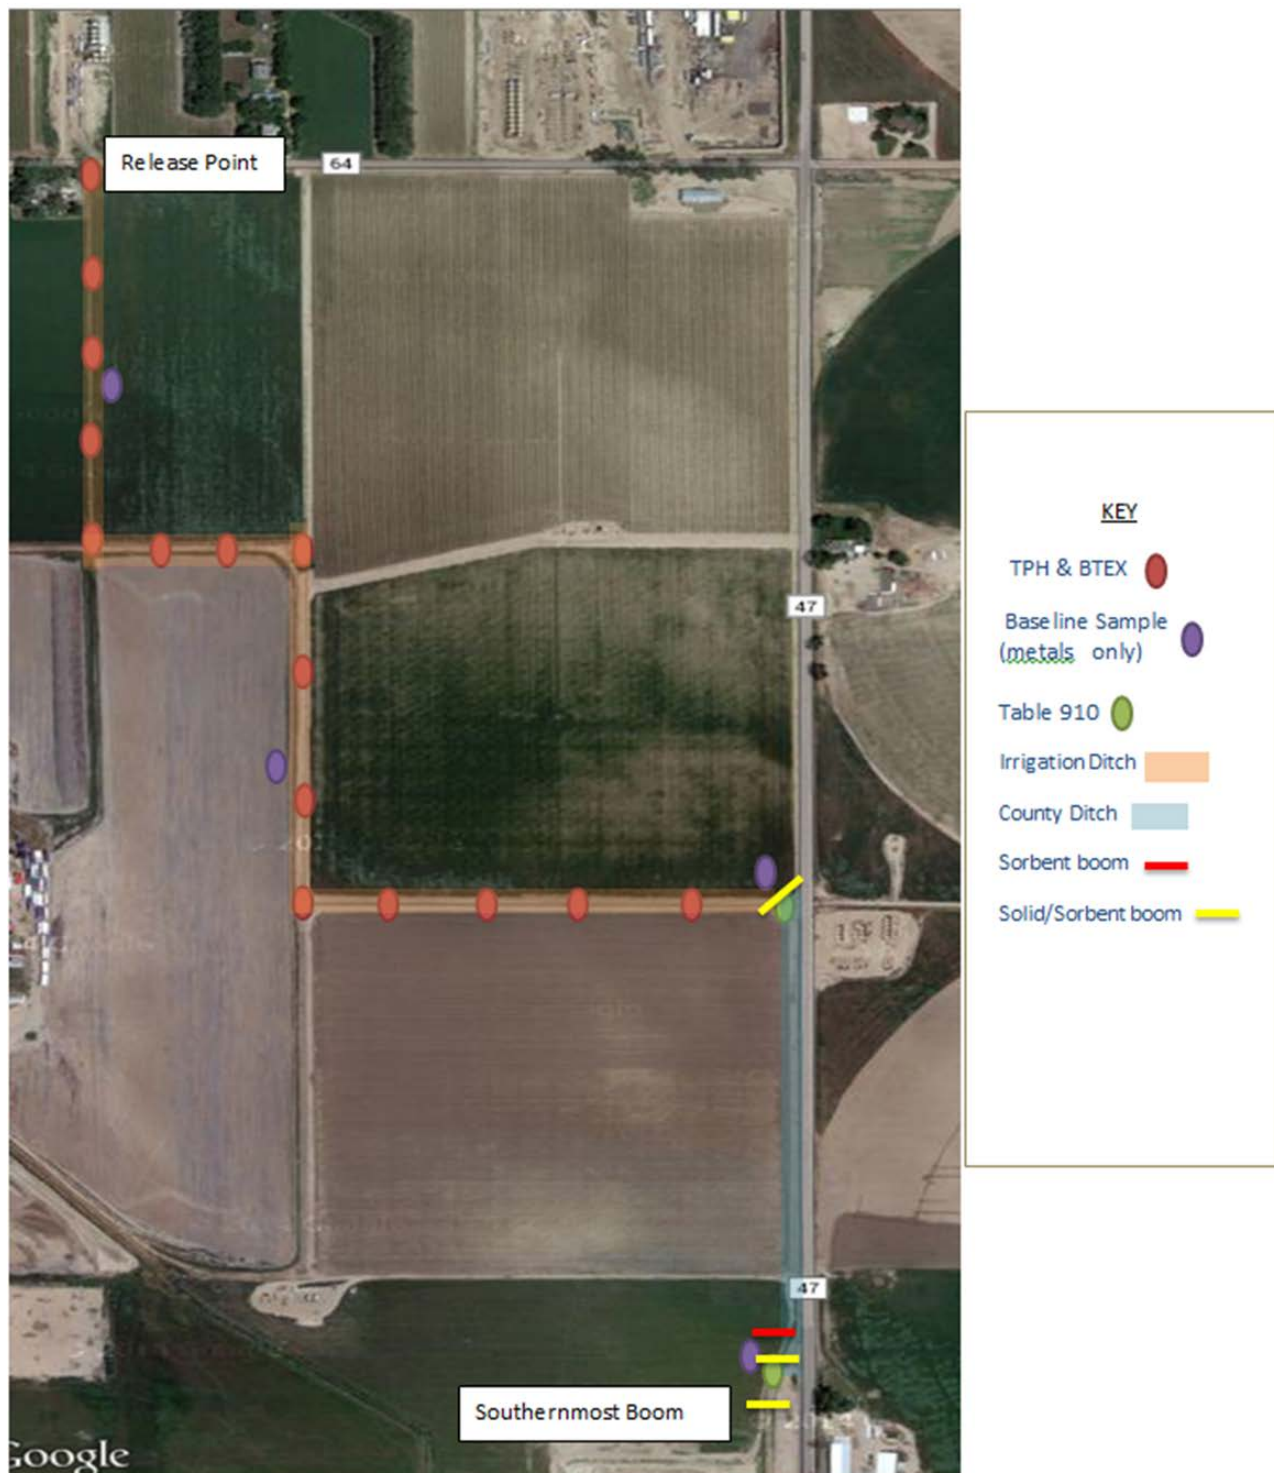
Appendix C – Sample Locations in Irrigation Ditch and Boom Placement During Response

2nd, from the balance of fluids it is estimated that 198 barrels of fluid left the secondary containment system. This fluid was largely contained on the industrial site and in the storm water collection pond. A small amount of fluid, estimated to be 5-10 barrels by the COGCC inspector on site, appears to have entered an irrigation ditch where vac-trucks were dispatched to mitigate consequences. Some fluid also entered a drainage ditch and was subsequently recovered.

All fluid escaping into the irrigation ditch and drainage ditch was recovered by vac-trucks and manually using booms and adsorbent pads before they could overflow and escape.
