Reference Area Photographs

Inspection Conducted on April 21, 2015

**Vanguard Operating
MDP #6 Multi-well Pit
Location Facility # 416979
Pit Facility ID #430352
API 045 19420**

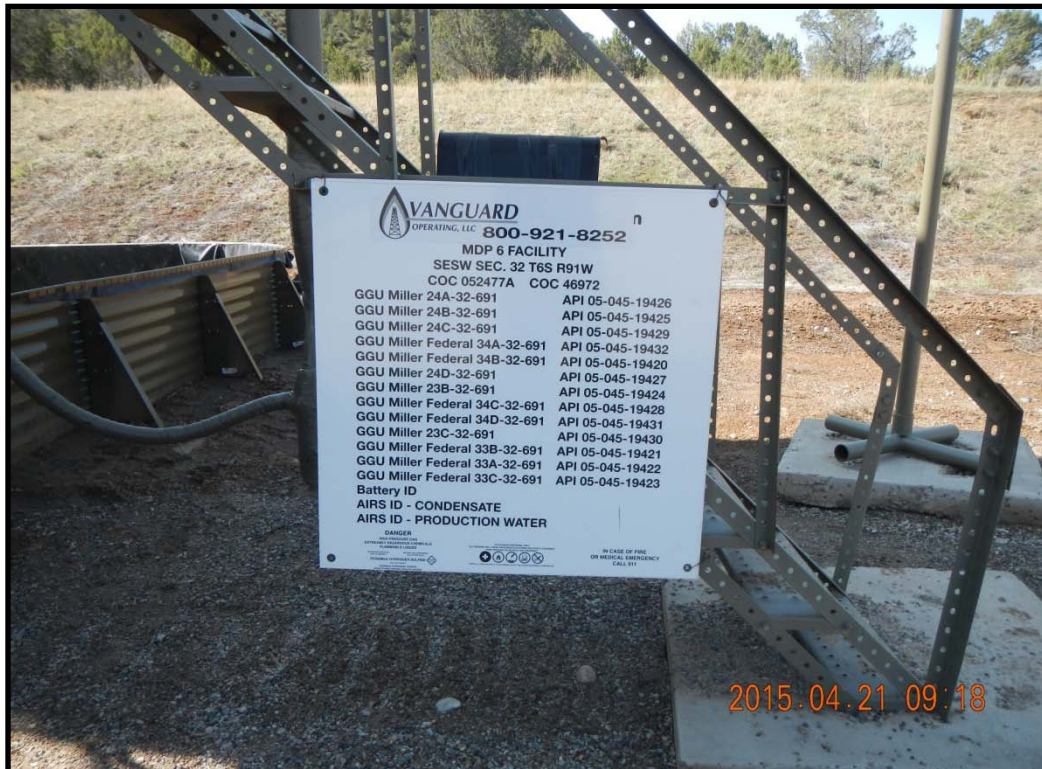
Sign by the tanks with list of wells and operator's information.

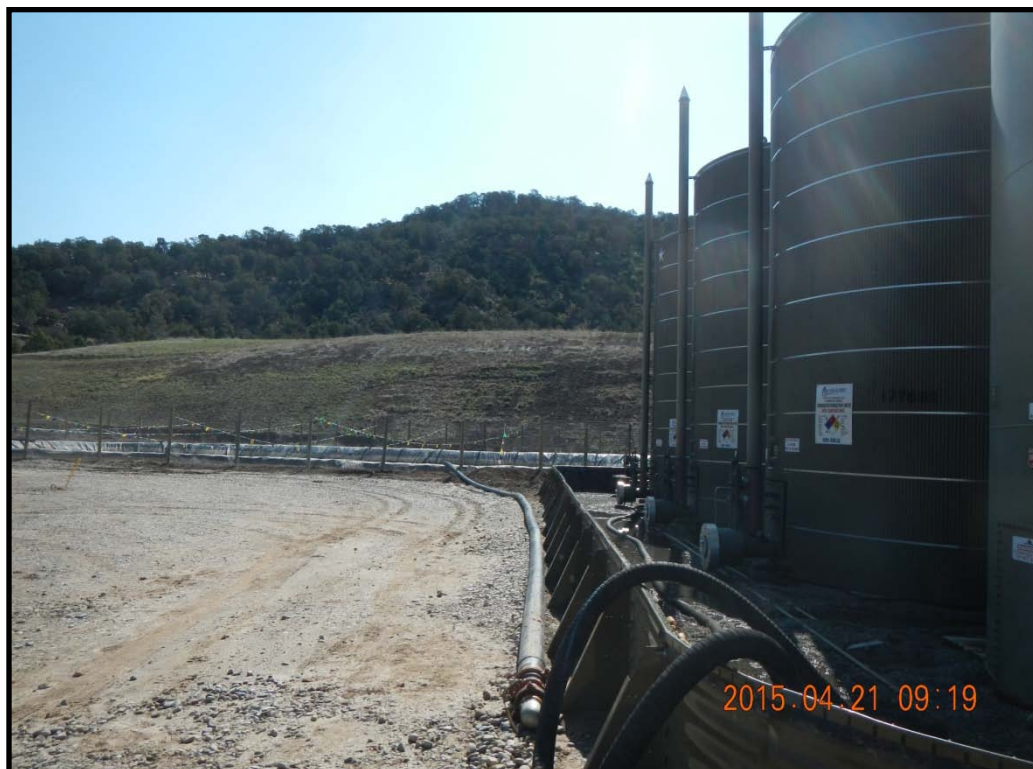
Dedicated inlet water line is currently disconnected. Water from other go to the tanks, and from there to the multi-well pit (through the dedicated line).

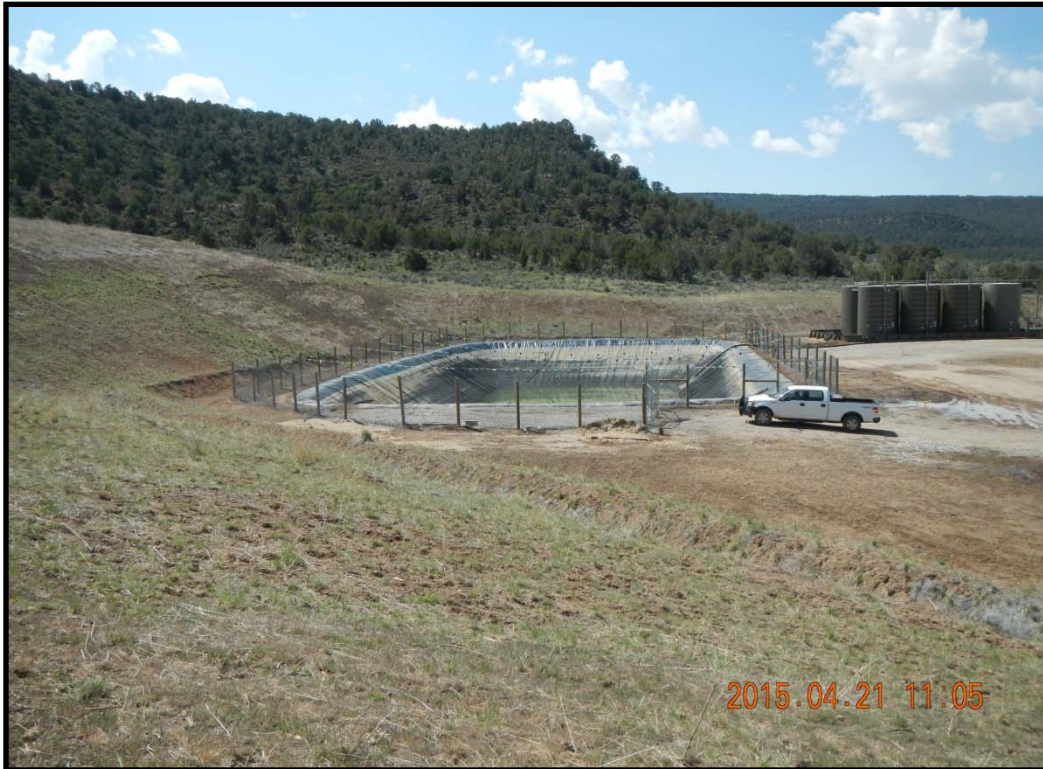
View of the multi-well pit. Looking west-southwest. Pit is fenced and colored flags are in place for bird protection.

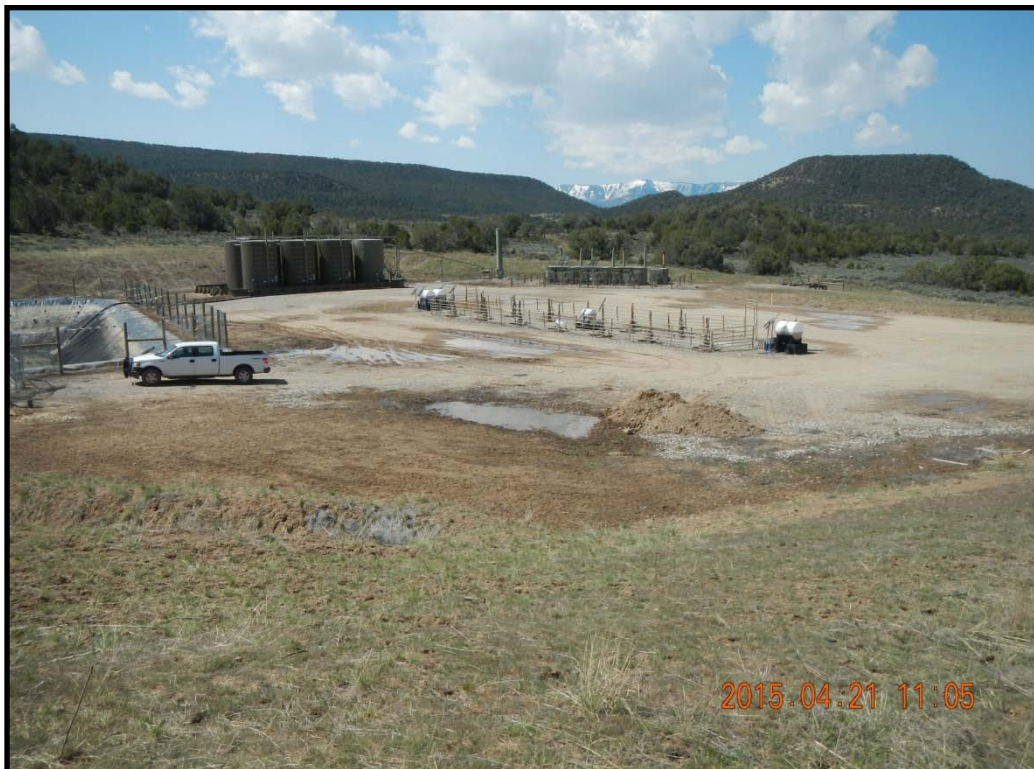
View of the facility from the hill, looking west. No weeds or junk were observed on premises. No staining observed.

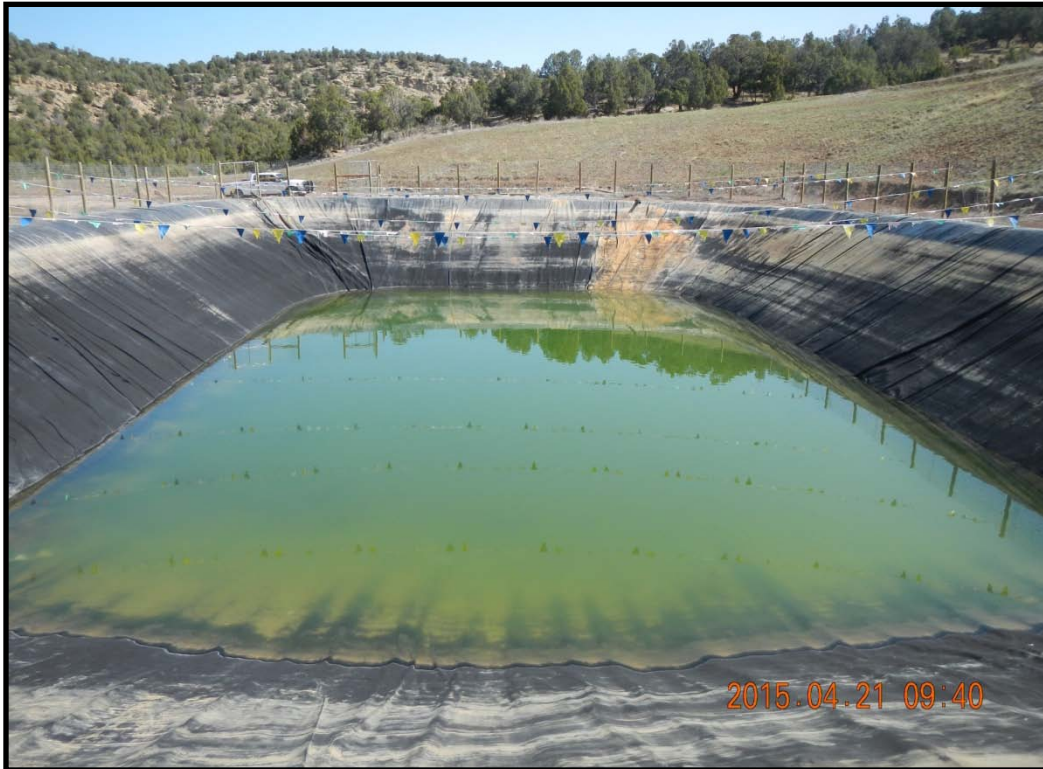
View of the pit. Water from snowmelt and recent rainfall. No oil residue was observed. The pit is currently inactive.

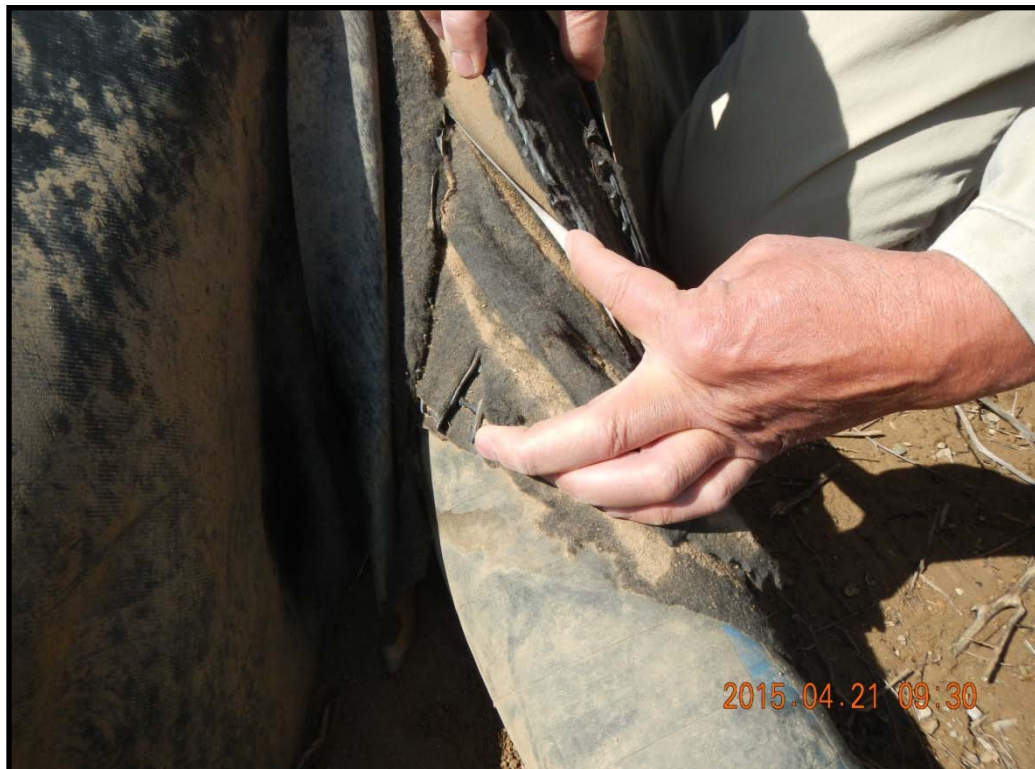
Liner system consists of two layers of geocomposite made of felt and geogrid, below and between the two liners. Secondary liner is 30 mil thick. The primary liner is a XR5 8130 reinforced 30 mil thick liner.

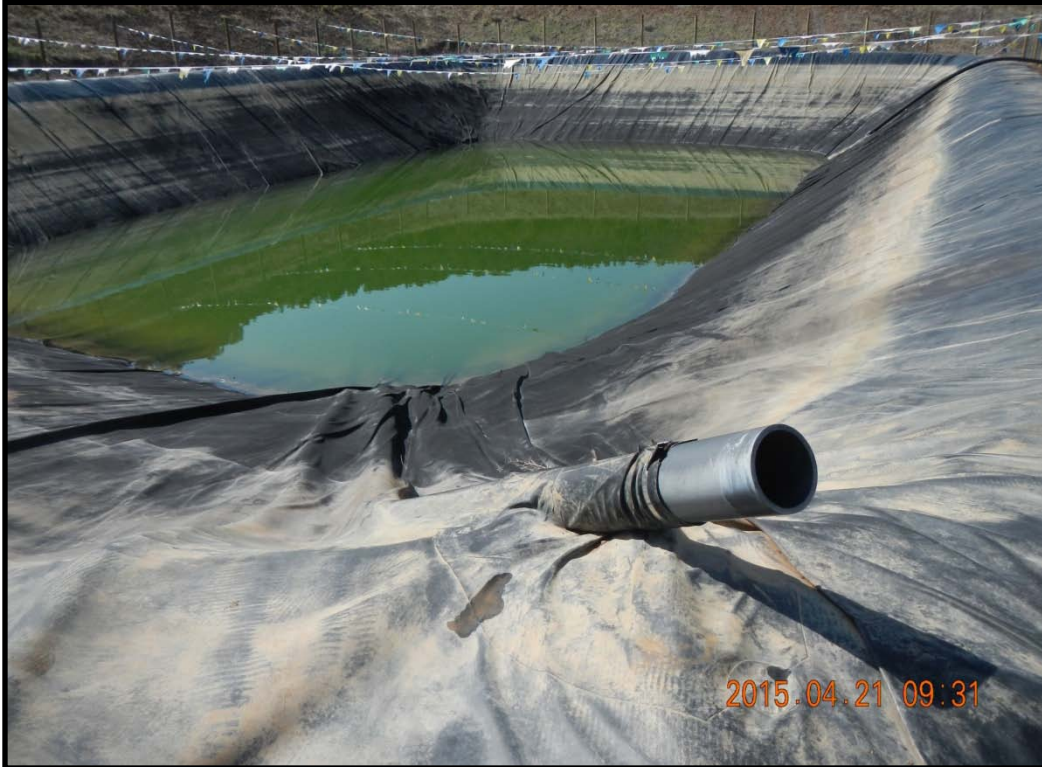
Leak Detection system consists of two pipes connected to two sumps, respectively. One sump is hydraulically connected to the space between liners (geocomposite) and the other one is connected to the geocomposite below the secondary liner.
