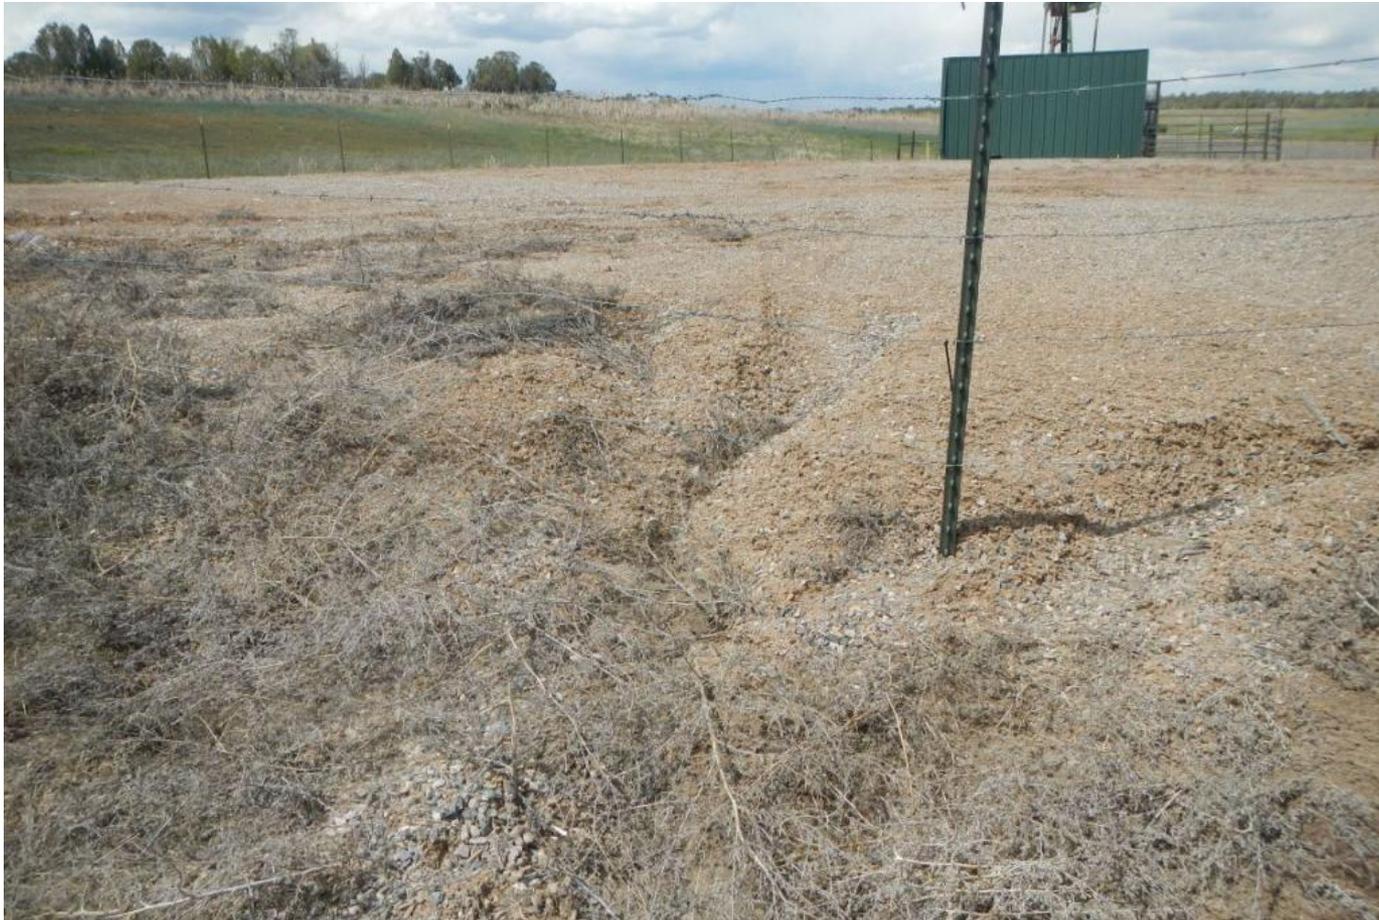
Photo 1. View of rill erosion from what appears to be stormwater flows exiting the southern edge of the working area of the well pad.

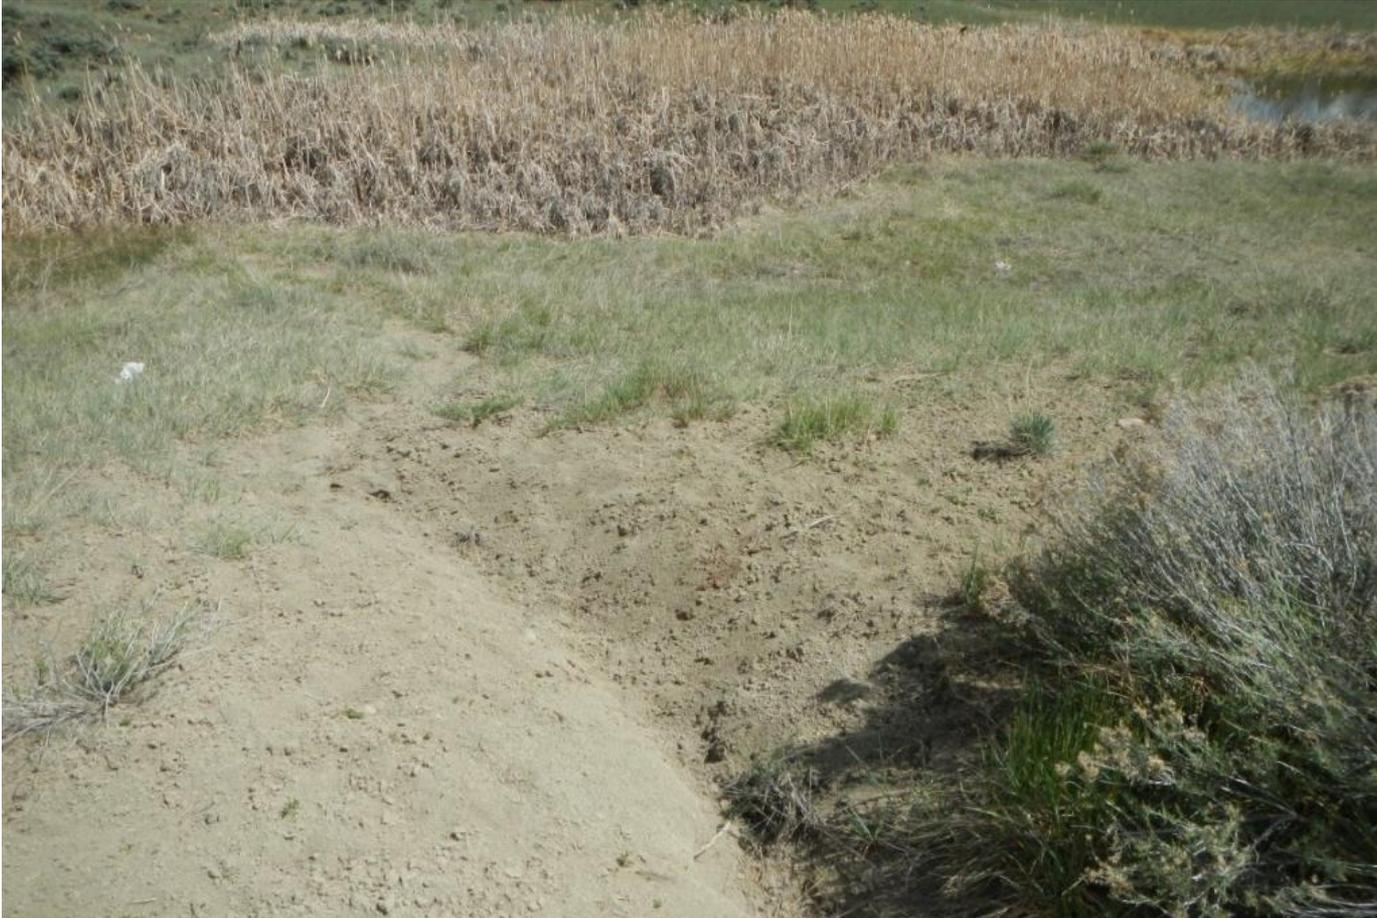
Photo 2. View of erosional channel from well pad (approximately two feet wide and two feet deep that is flowing toward pond and wetland southeast of project area.

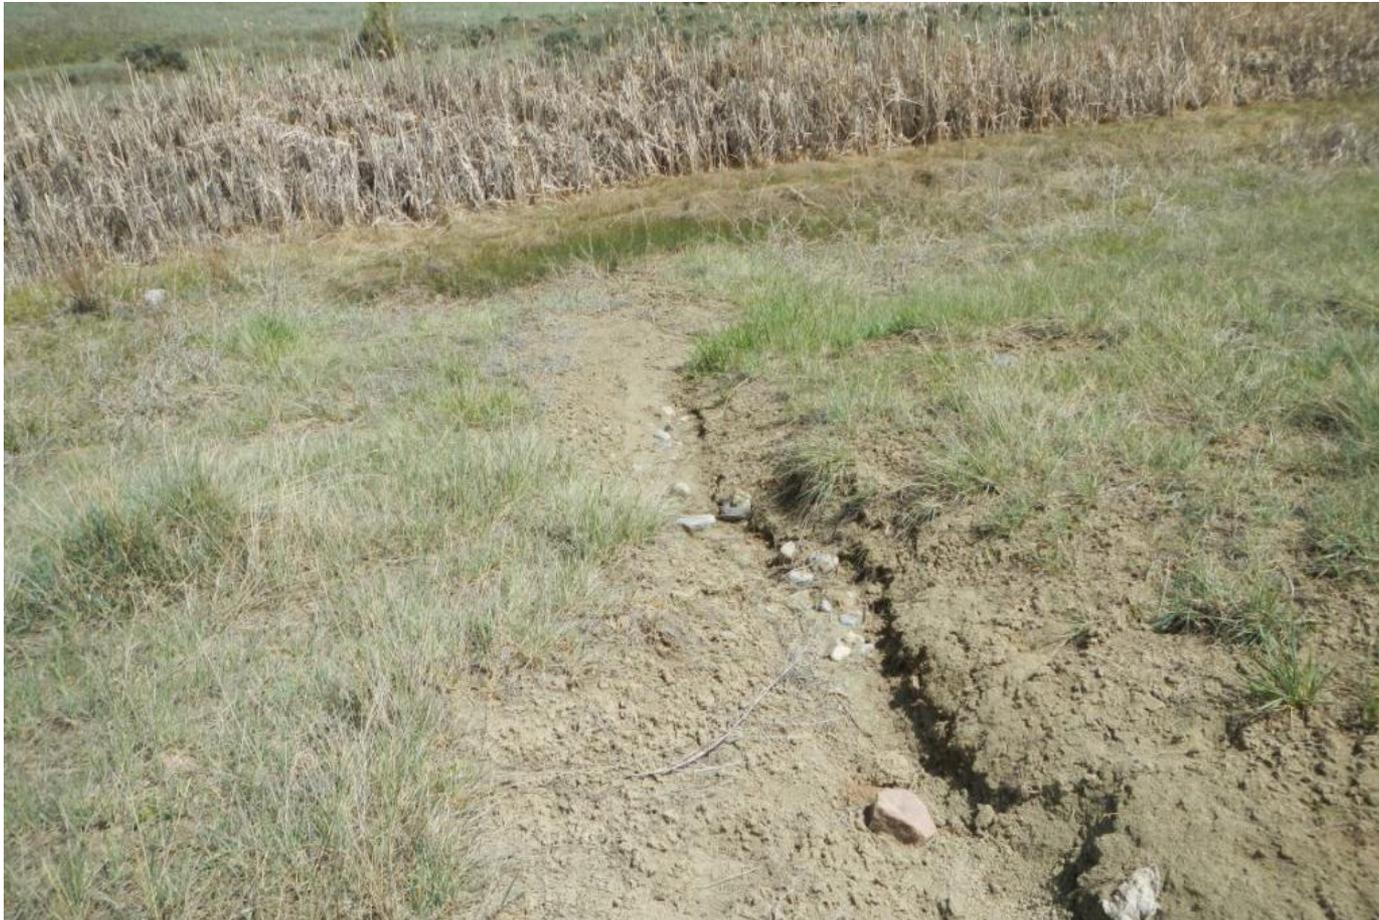
Photo 3. View of erosional channel (approximately 1 to 2 feet wide and 1 foot deep) from well pad flowing toward wetland complex east of well pad.

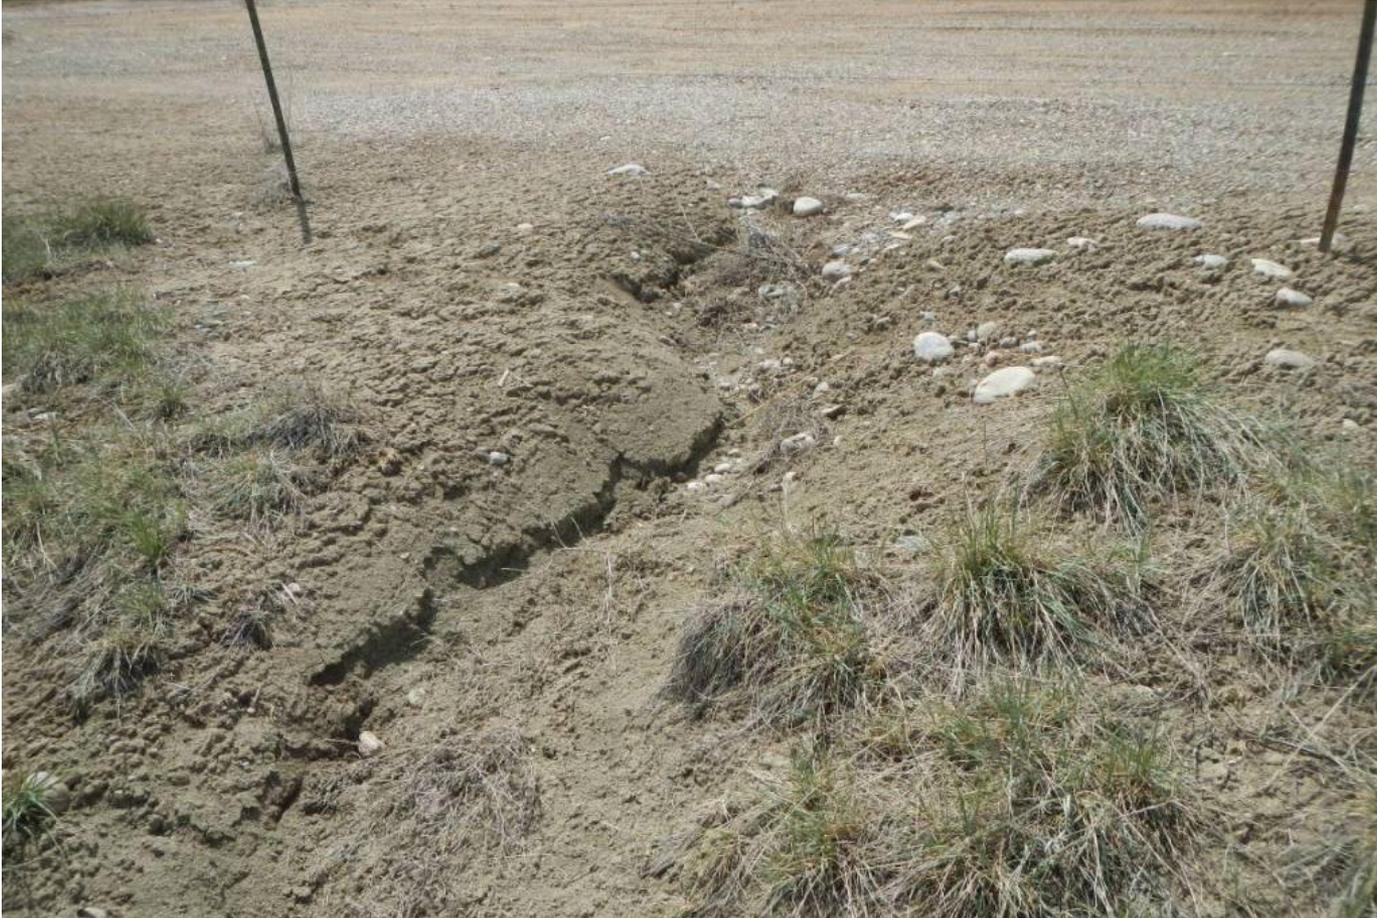
Photo 4. View of erosional channel on eastern edge of project area.
