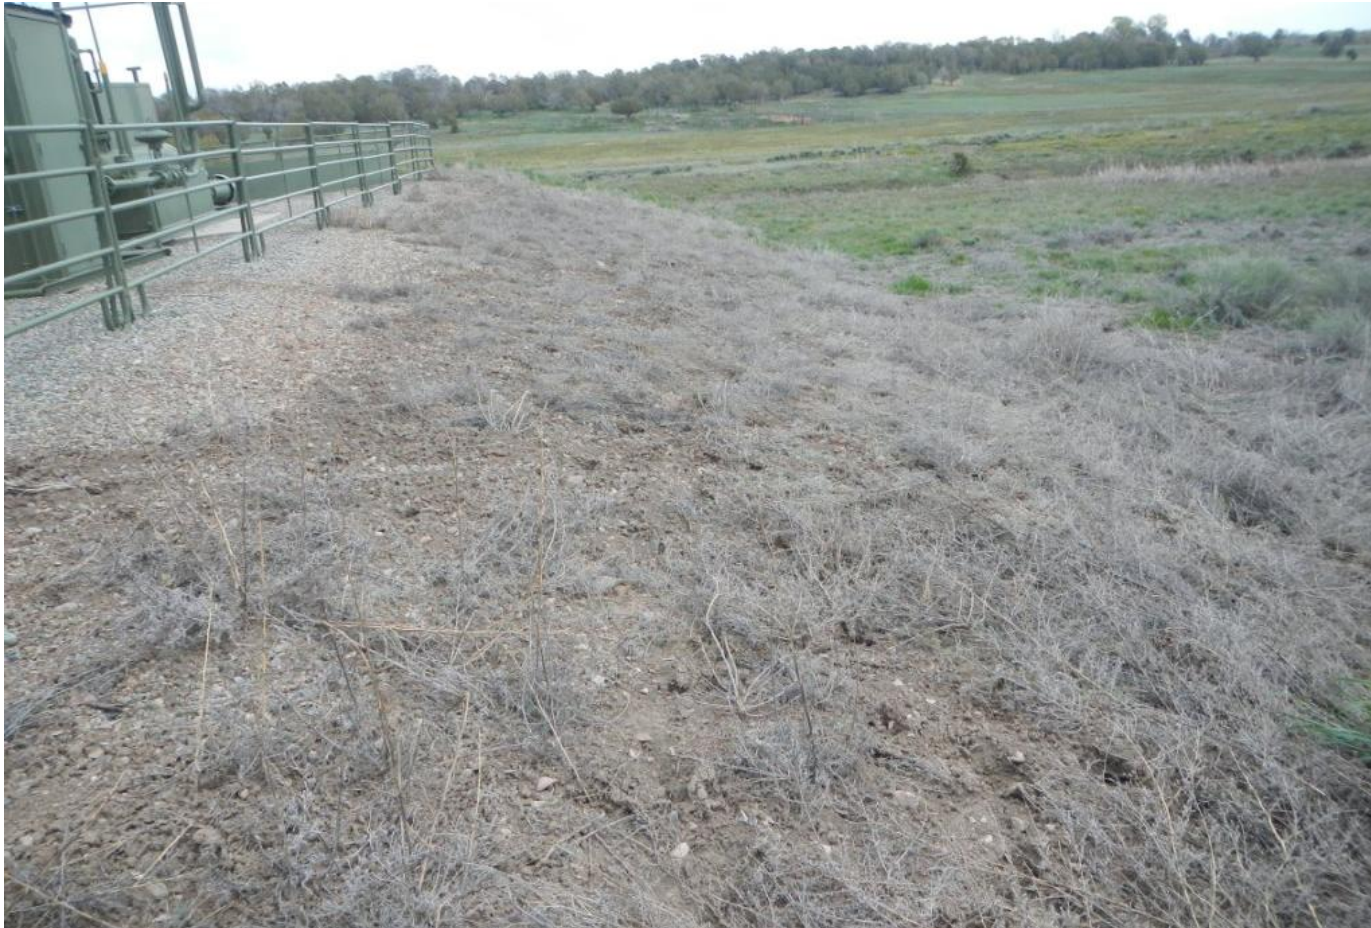
Photo 1. Area in southern portion of project area that is approximately 15 feet wide by 50 feet long needing revegetation.

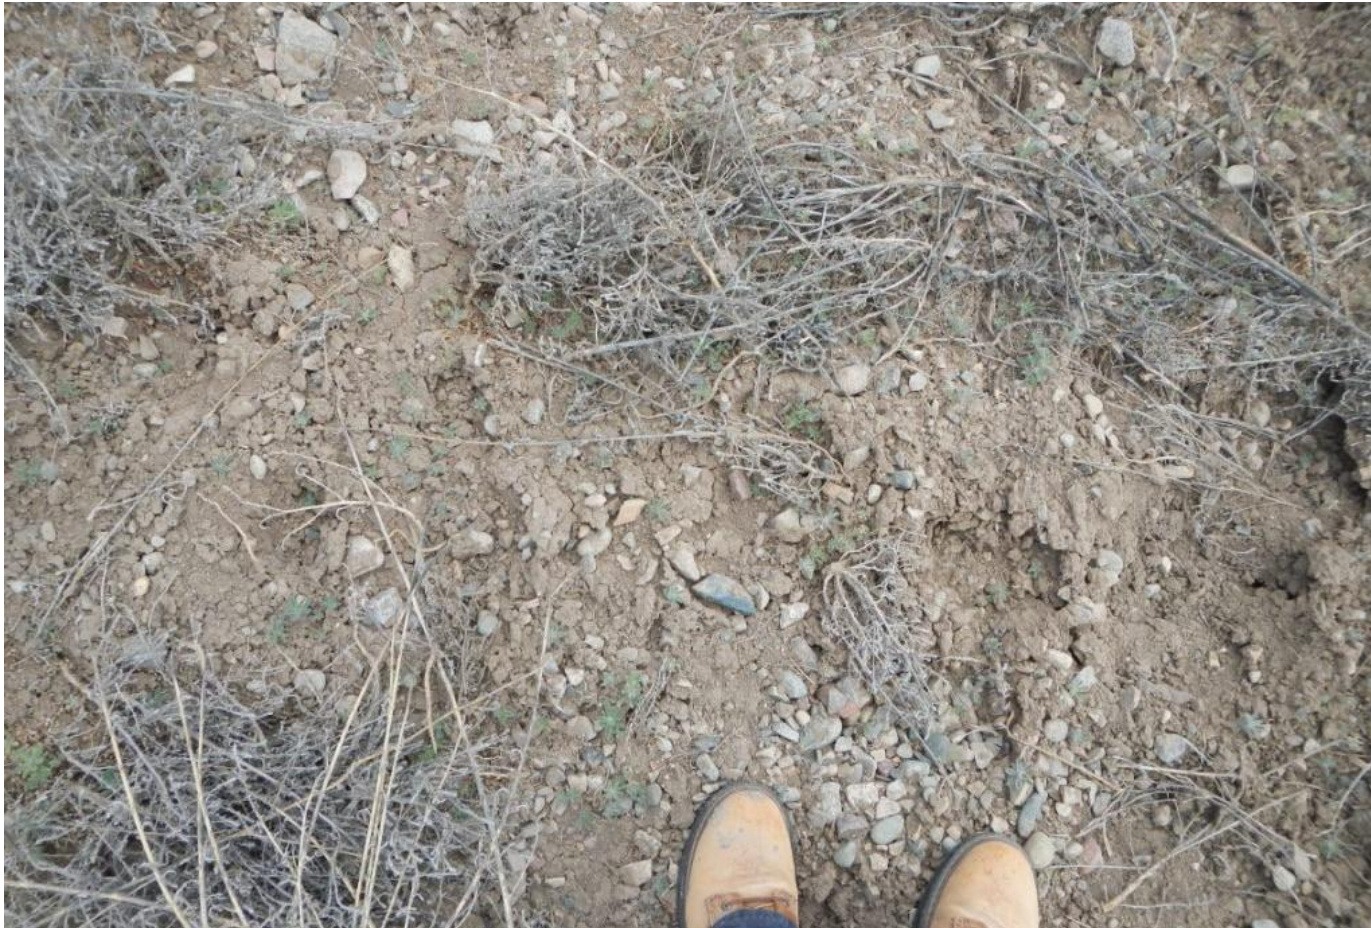
Photo 2. View of kochia seedlings and kochia debris in area needing revegetation within the southern portion of project area.

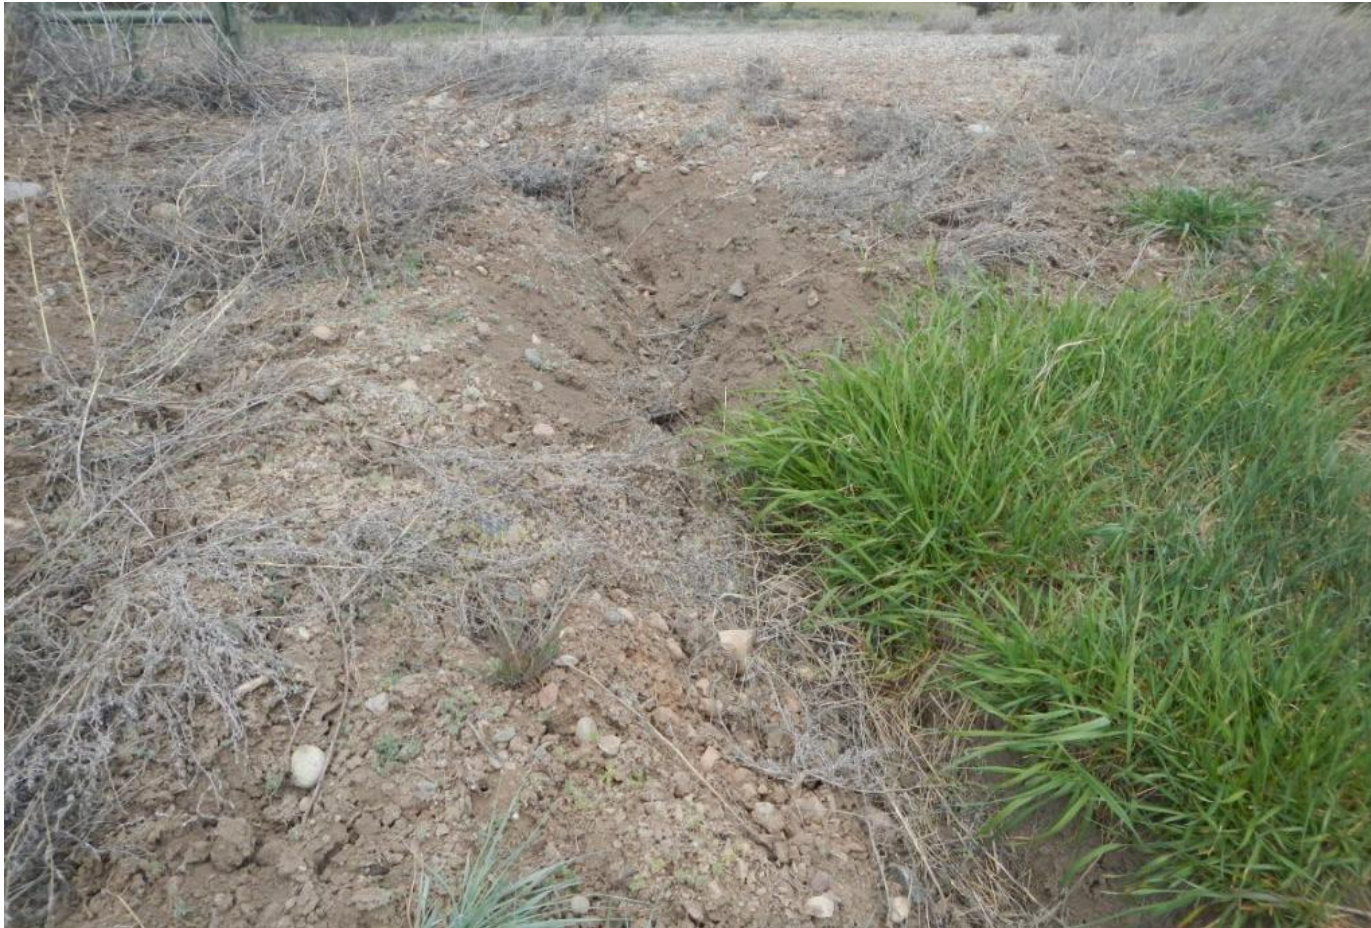
Photo 4. View of rill erosion from stormwater flows exiting the southern edge of the working area.

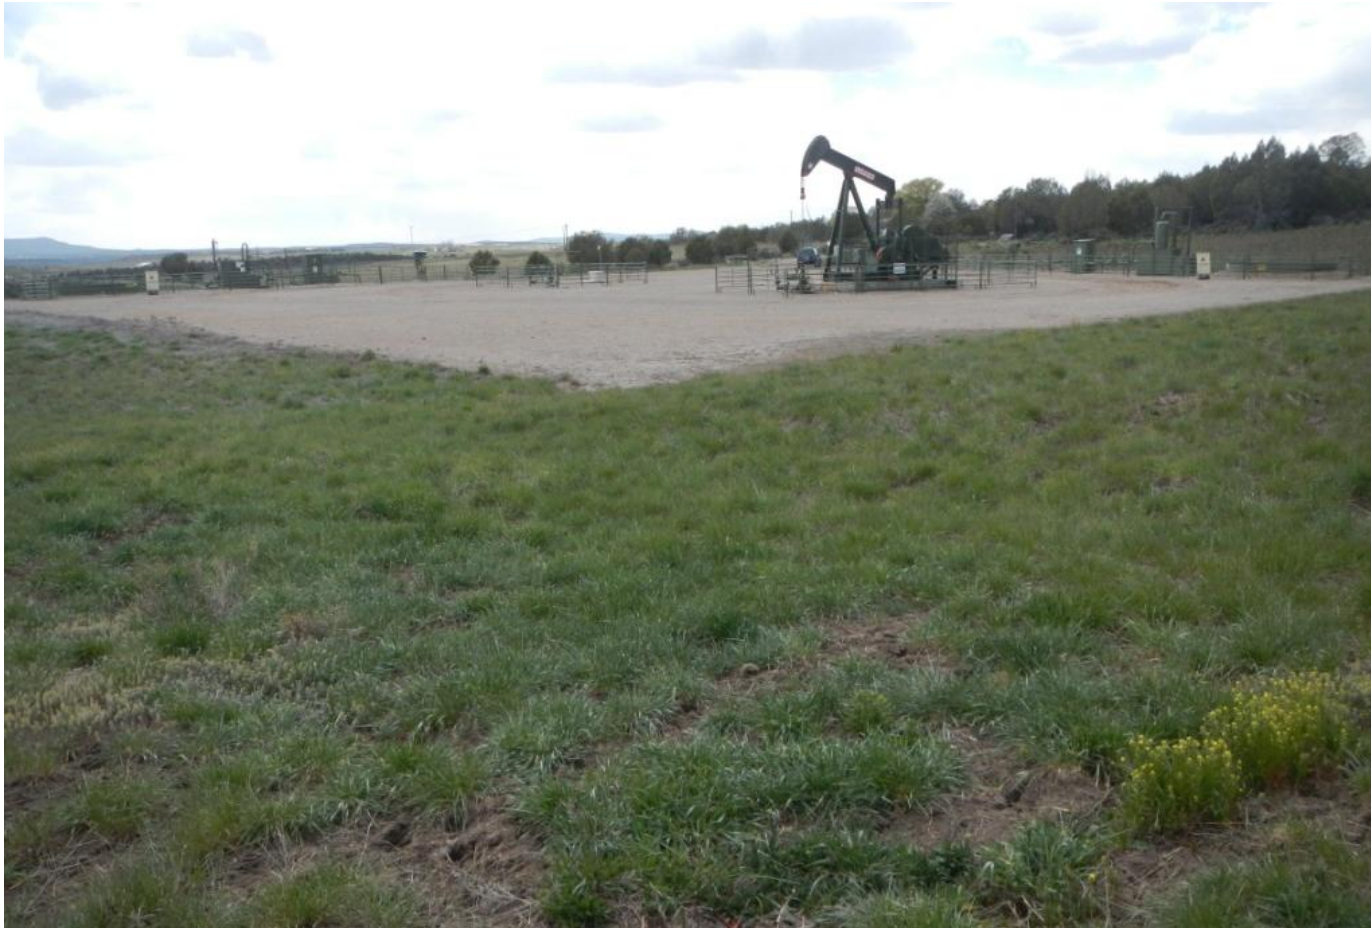
Photo 5. View of project area from northeastern corner facing center. Good revegetation throughout much of the project area.
