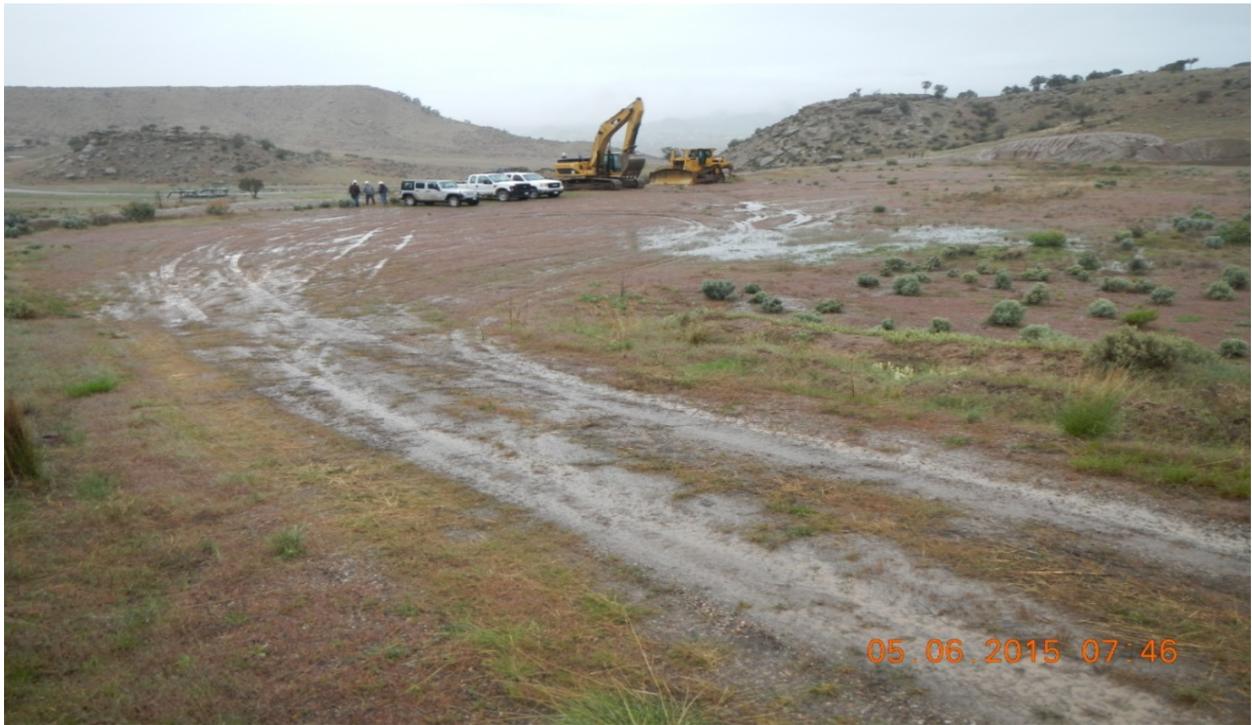
photo 1: Facing northwest towards the location. Equipment is on-site to begin the project.

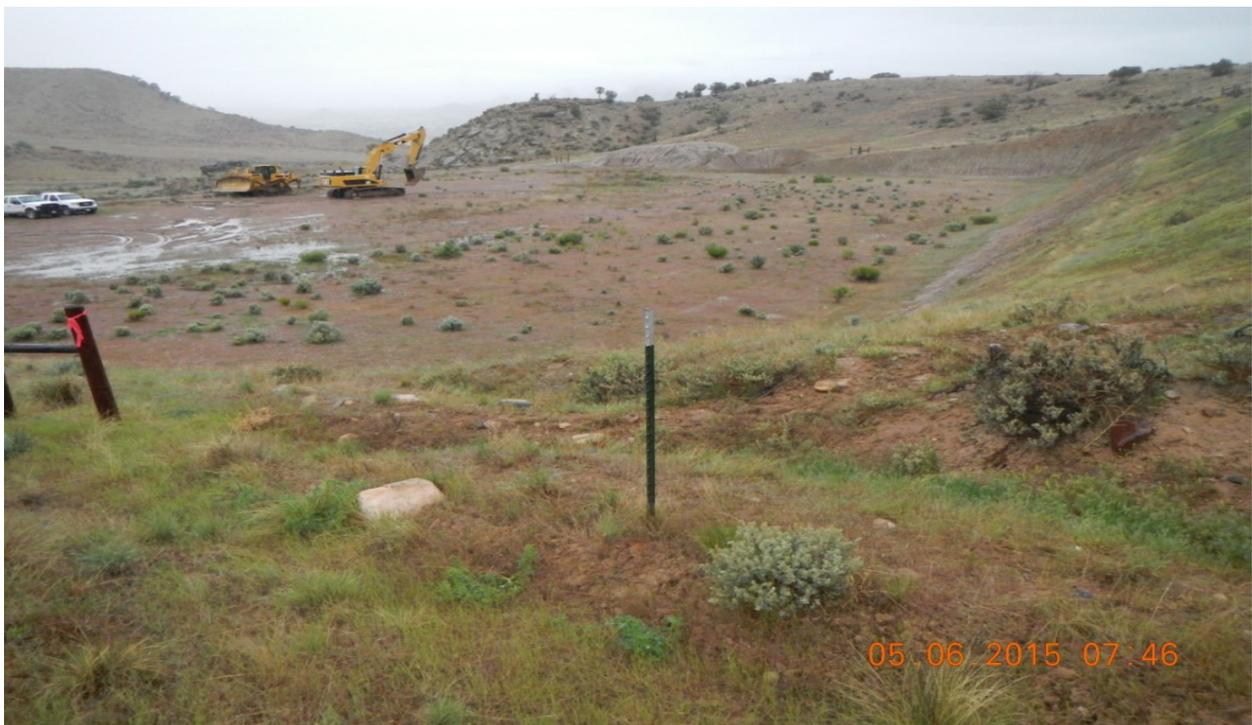
photo 2: Facing north towards the location. Equipment beginning to mobilize to start the project.

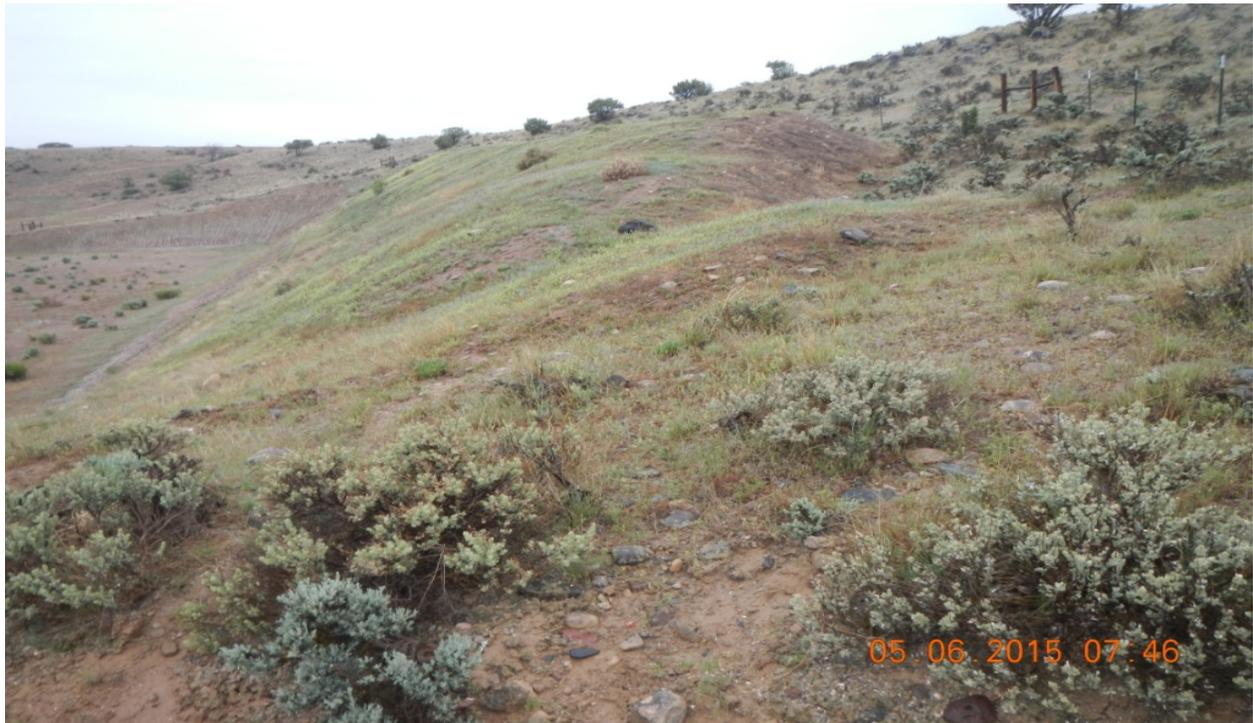
photo 3: Top soil pile located at the east side of the location

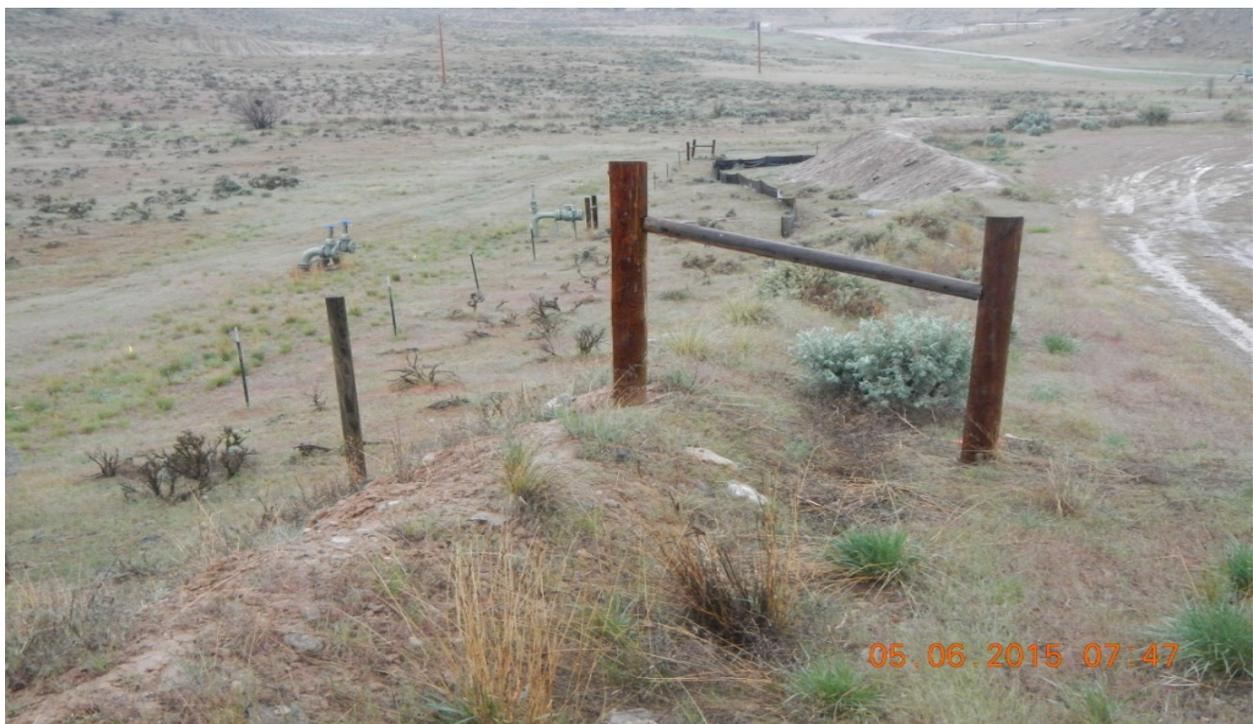
photo 4: Facing west towards the south side of the location. Perimeter of the location is fenced.

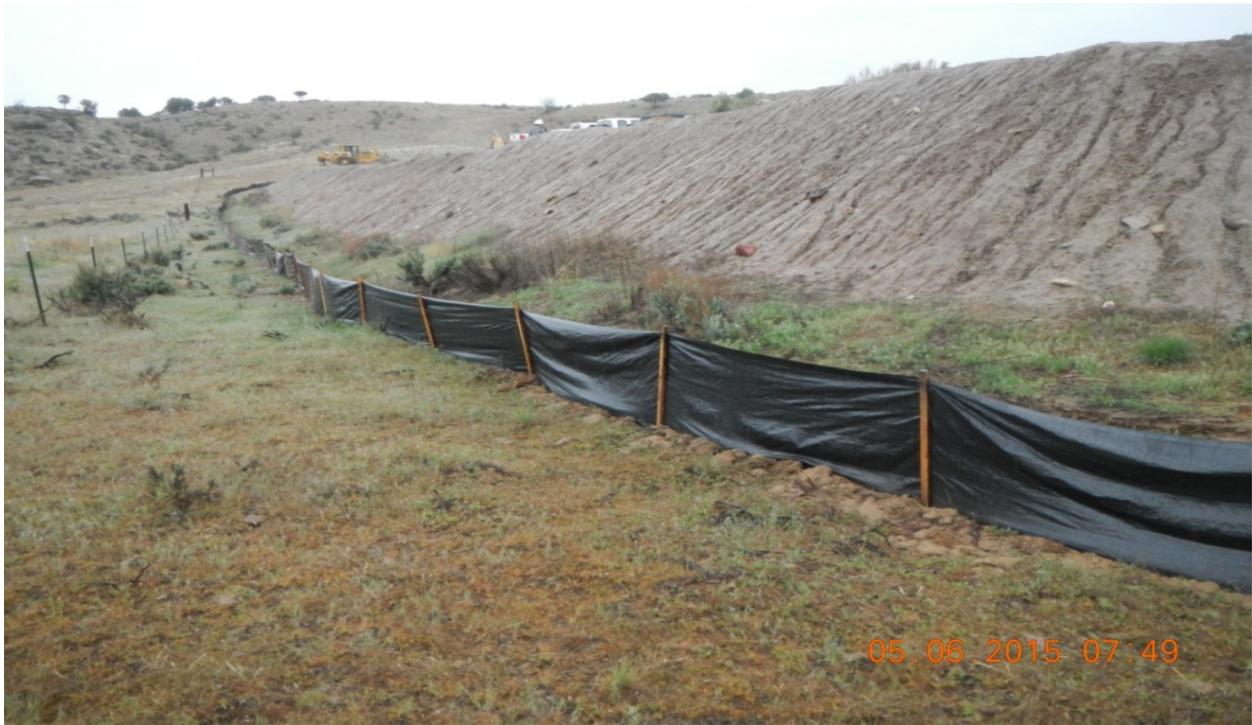
photo 5: Silt fence installed around the west side of the location.

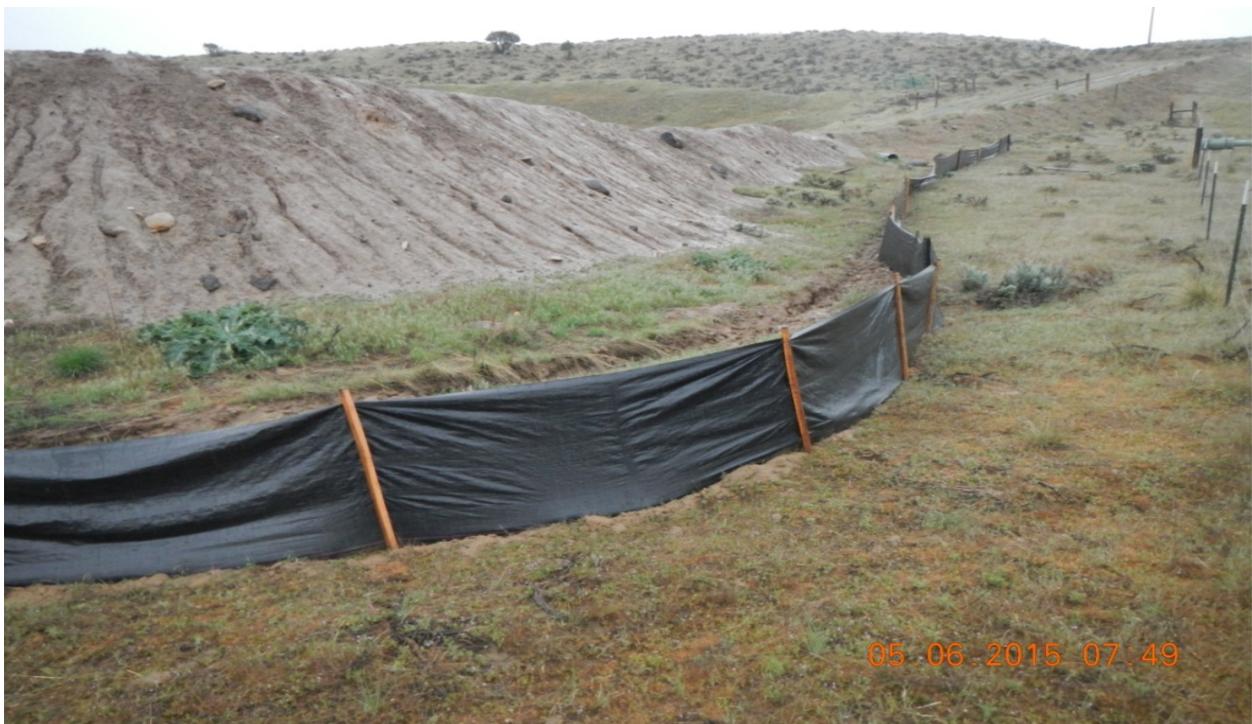
photo 6: Facing east, silt fence has been installed prior to excavation operations.

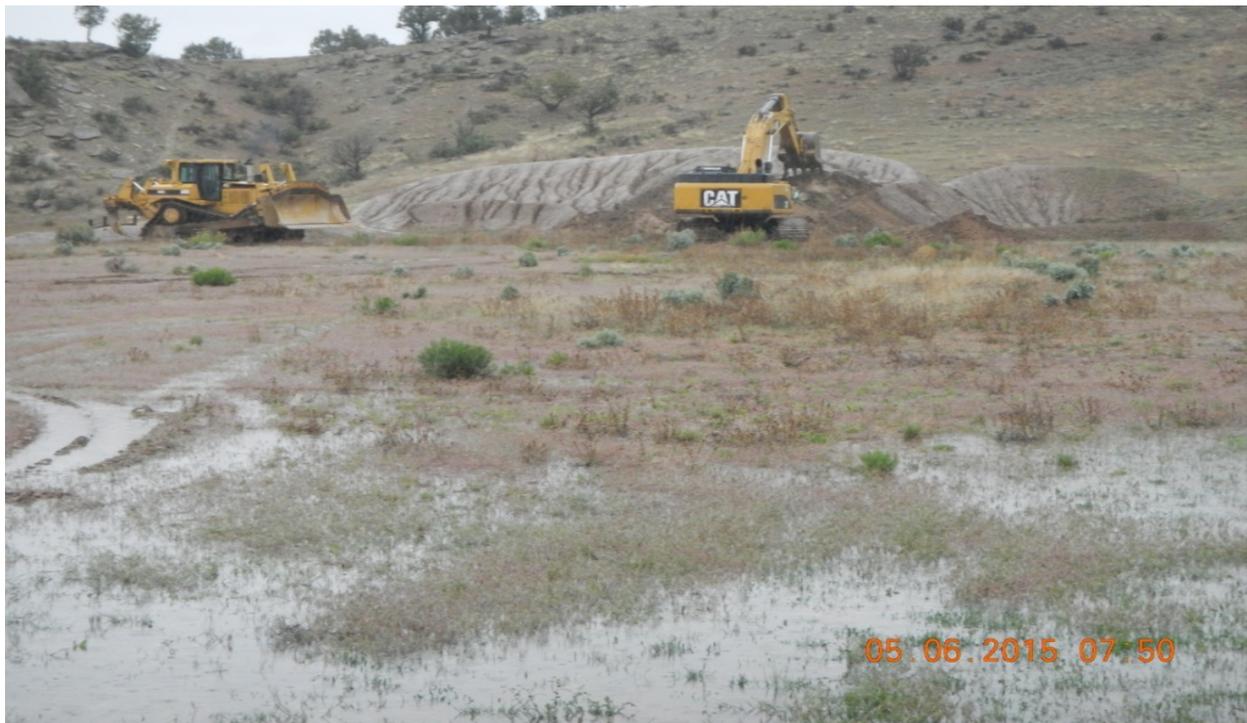
photo 7: Beginning of the excavation operation to re-contour the location.

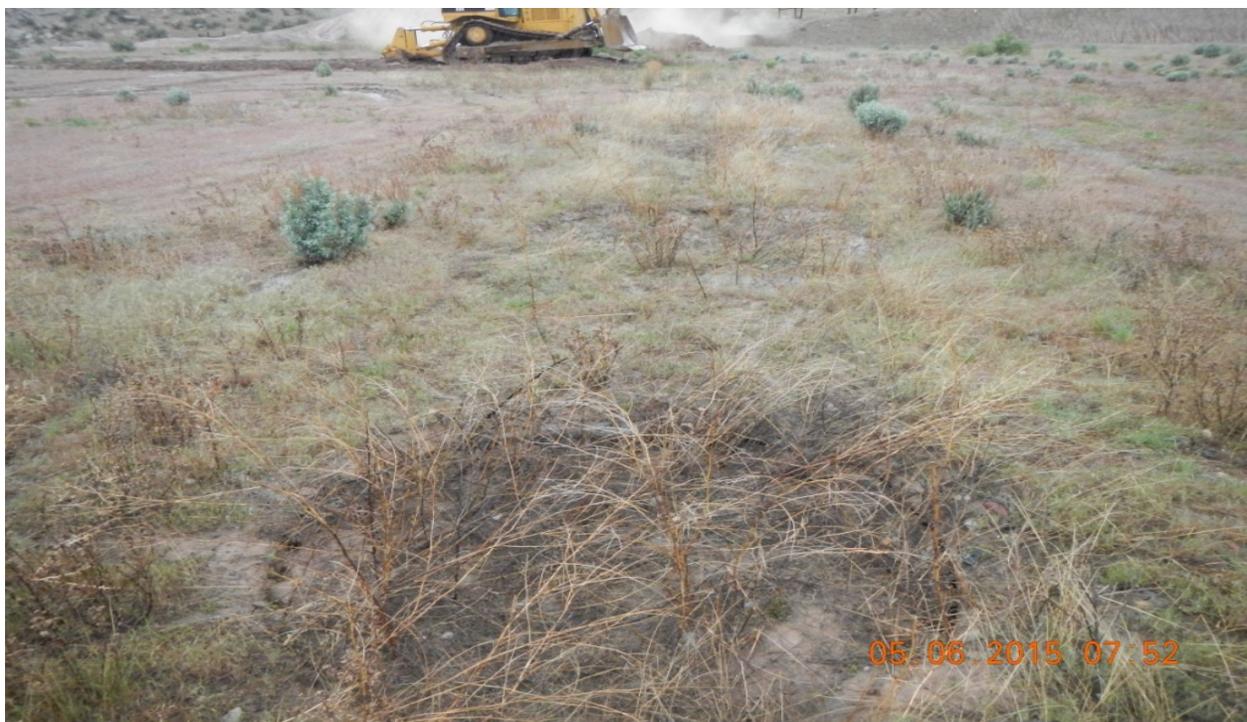
photo 8: Bottom, center of the photo where cellar rings existed.

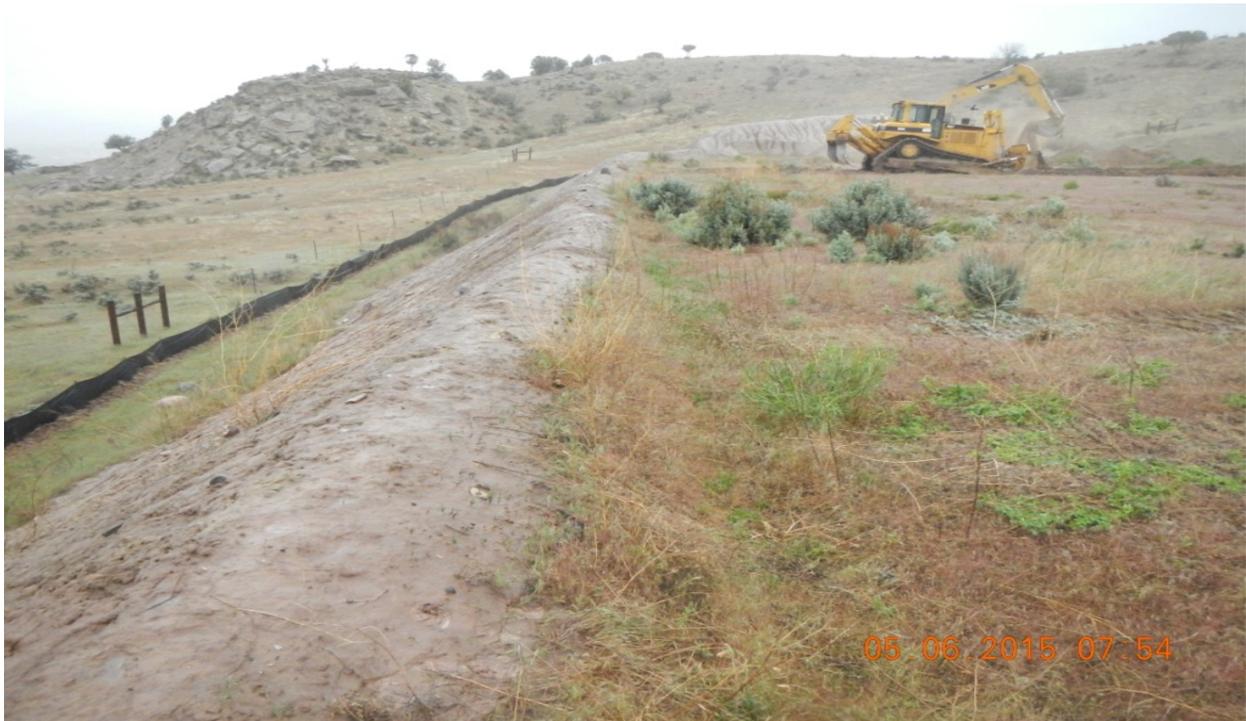
photo 9: Facing north, beginning of the excavation operation to re-contour the location.

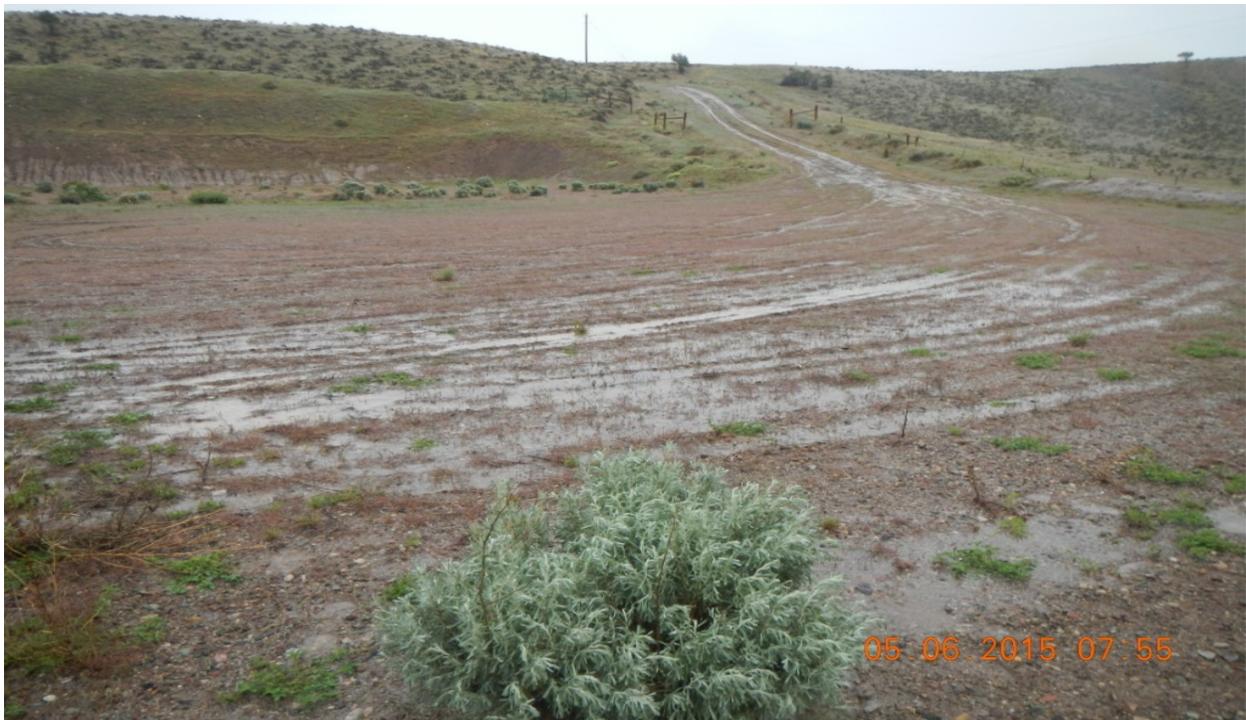
photo 10: Facing southeast on the location towards the access road.

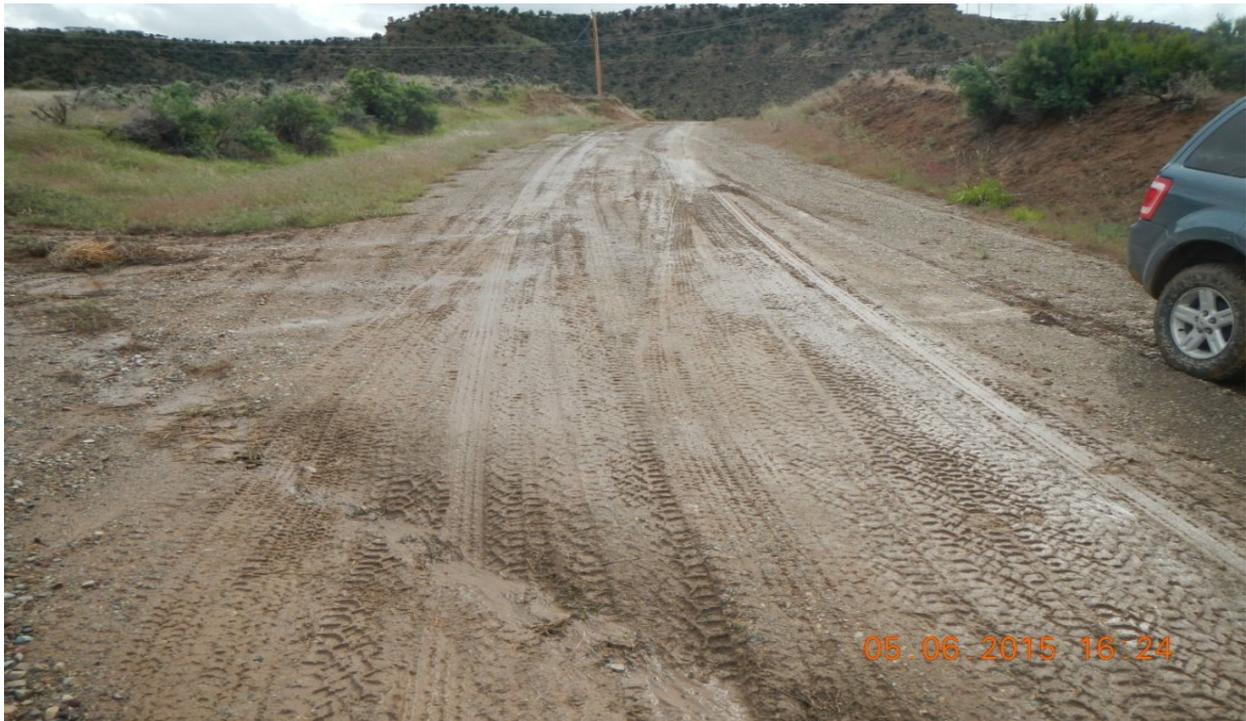
photo 11: Beginning of the access road facing southwest.

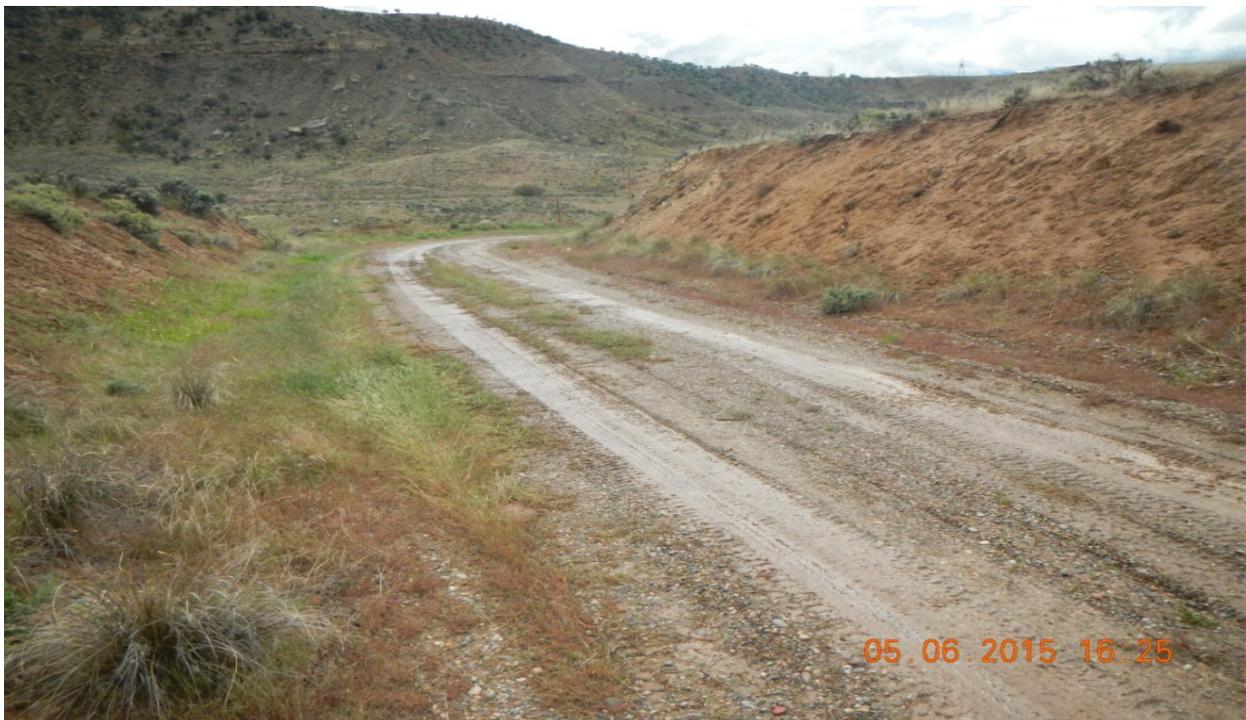
photo 12: Access road west towards the location which will be re-contoured.

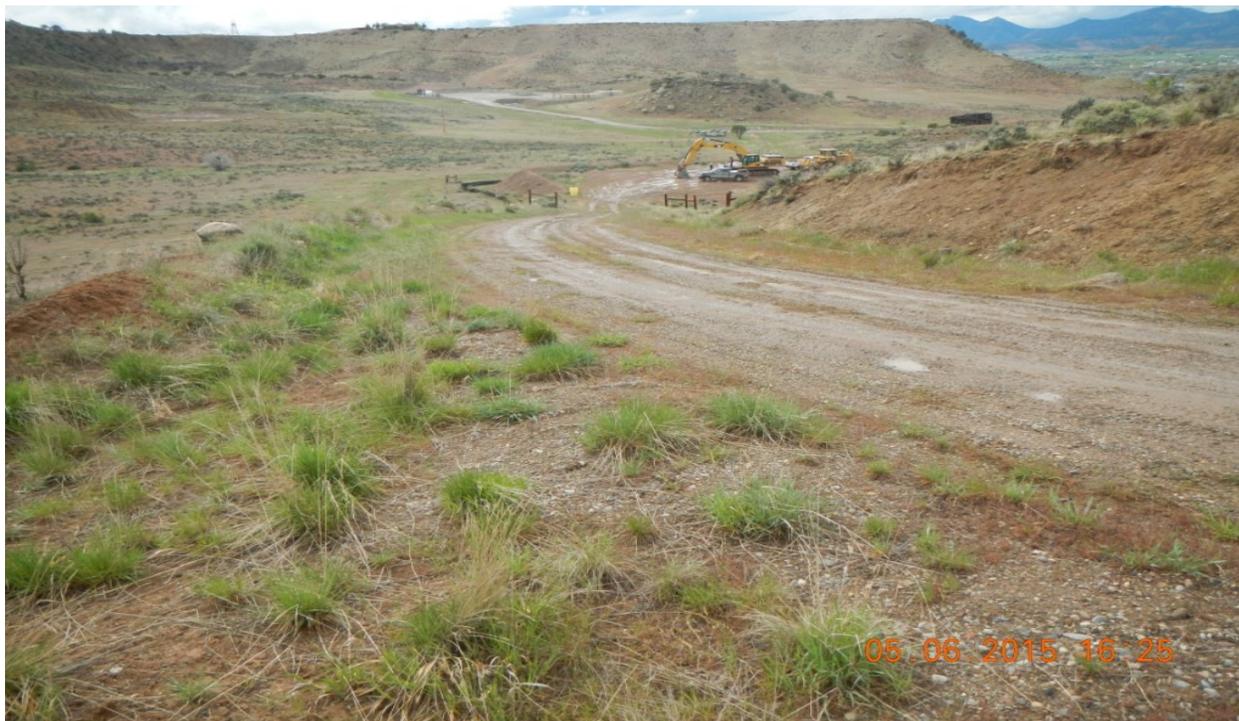
photo 13: Facing northwest towards the location.

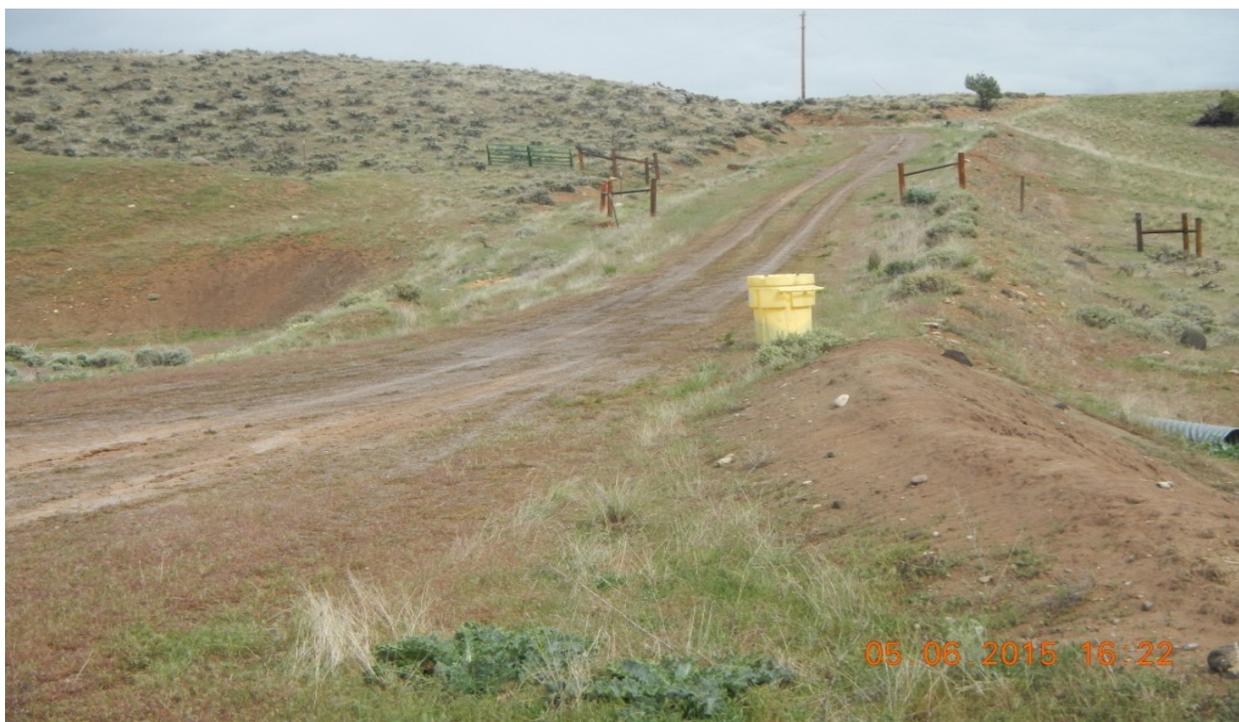
photo 14: Spill kit (yellow barrel) at the bottom of the access road.

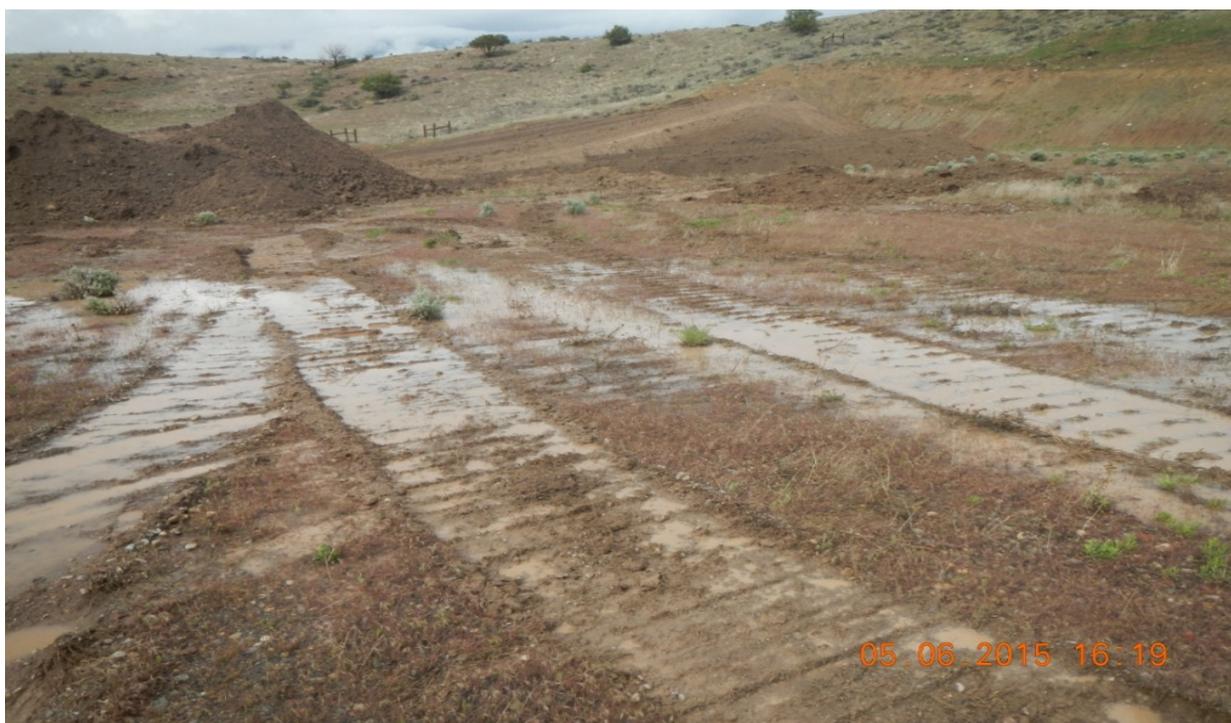
photo 15: Facing north at the material that has been pushed up for recontouring.

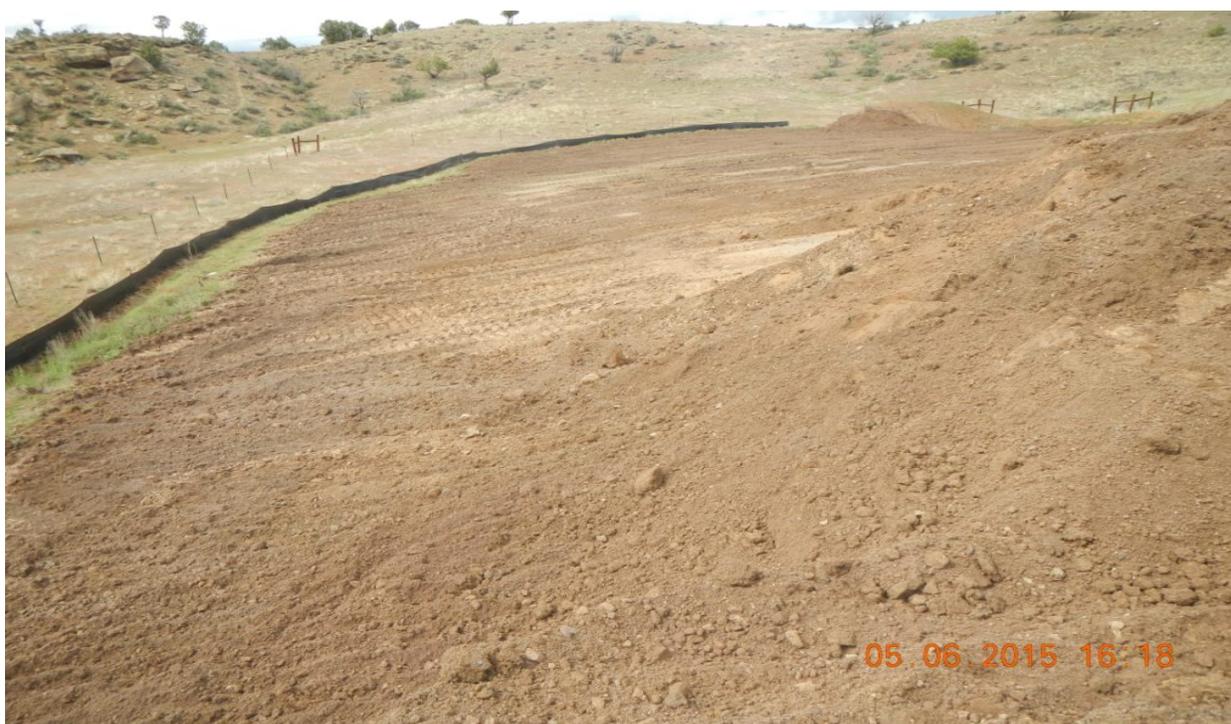
photo 16: Facing north towards the north side of the location.

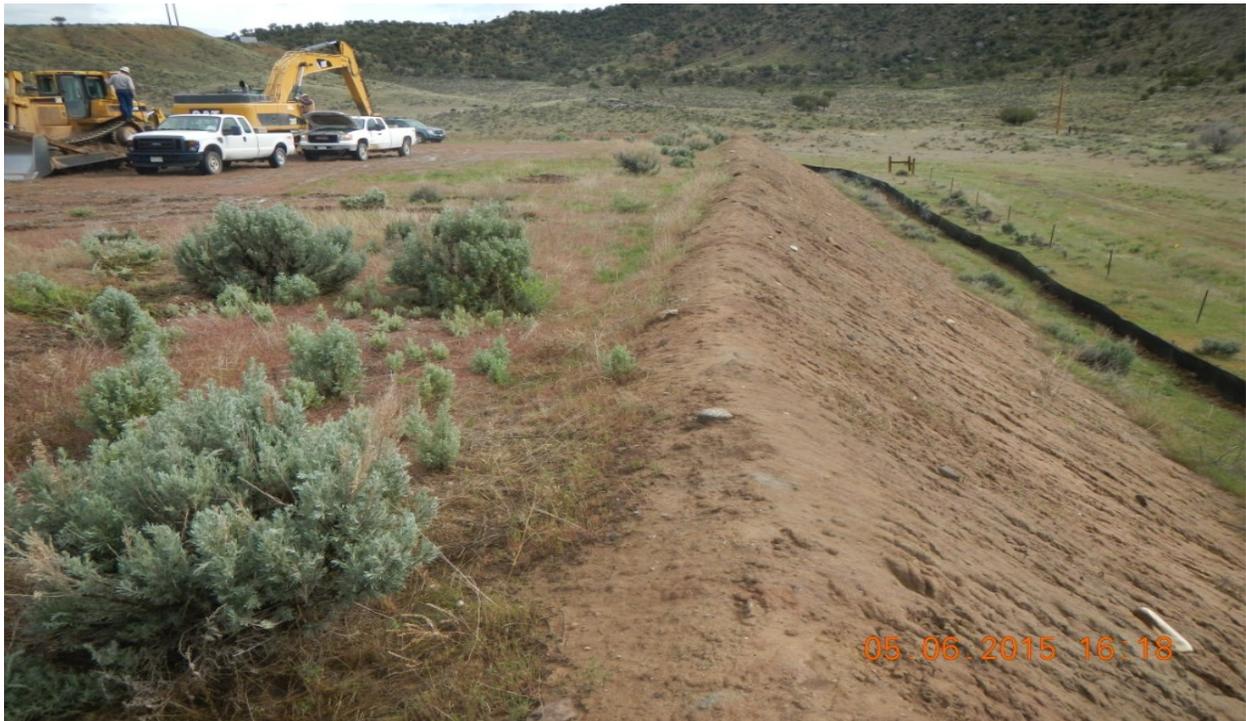
photo 17: Facing south along thwe west side of the location.

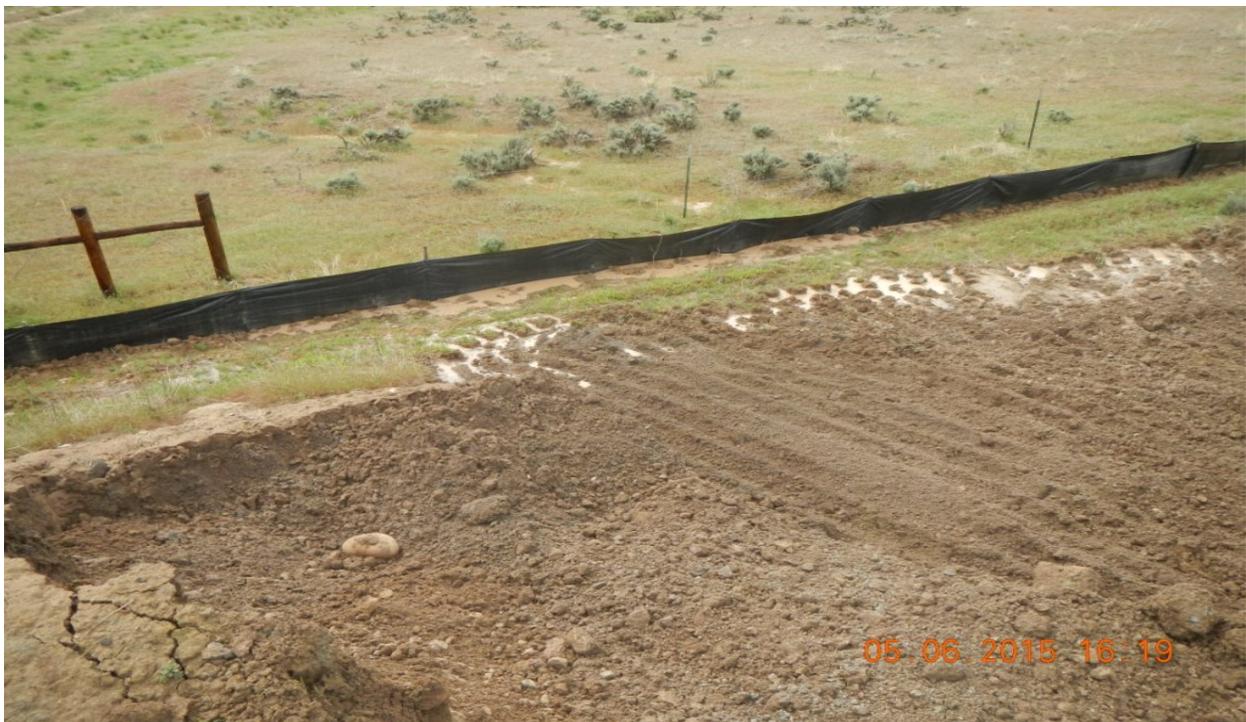
photo 18: West side of the location where silt fence is preventing sediment from running off site.

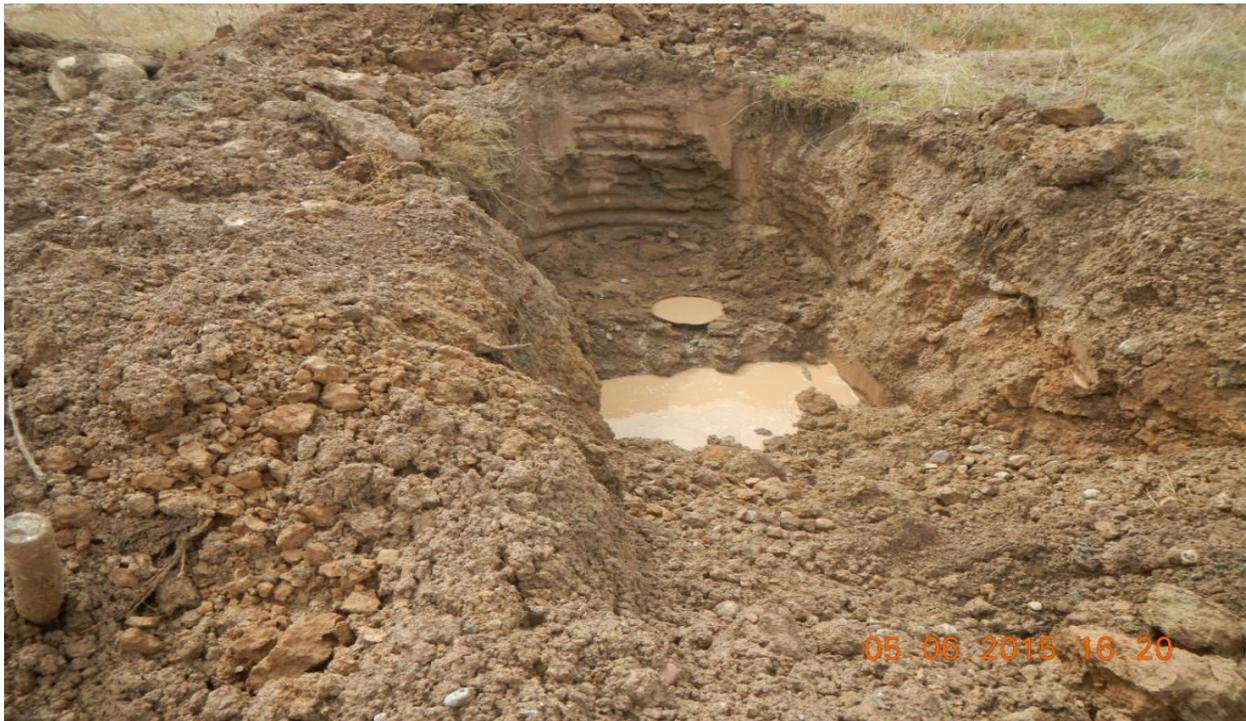
photo 19: Cellar ring has been removed. Conductor pipe found about 5ft. below the surface.

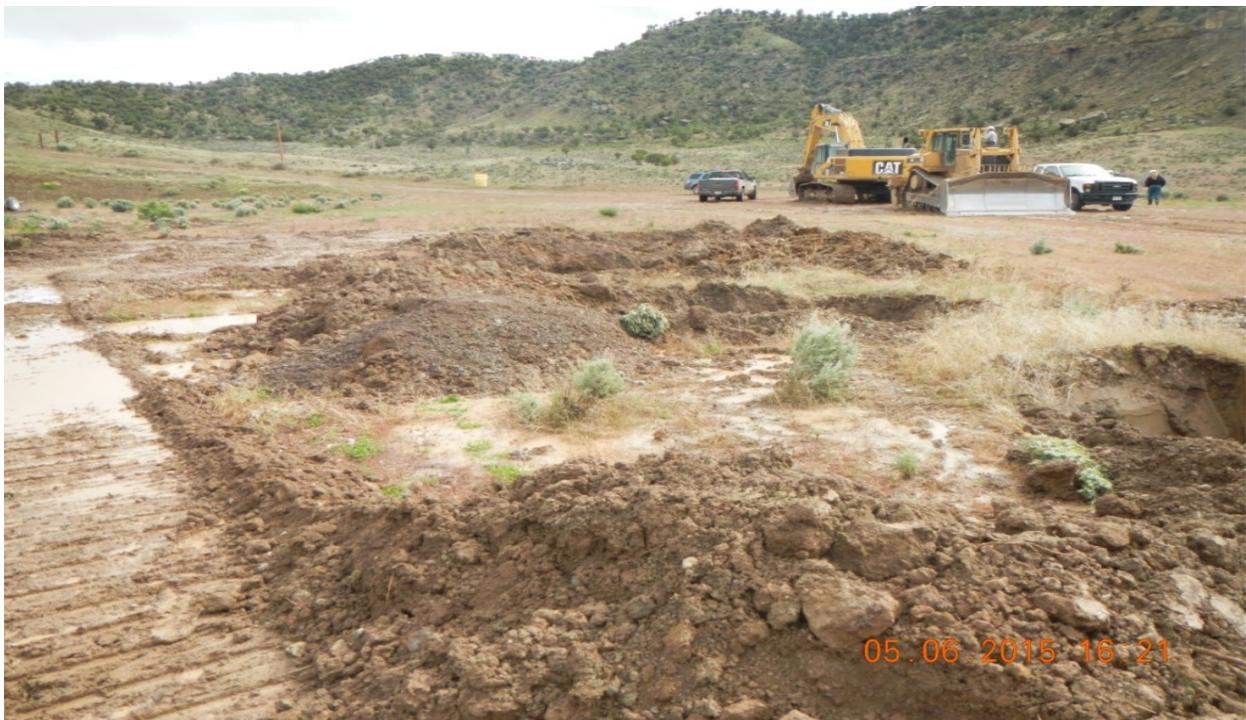
photo 20: Center of the location where 4 cellar rings have been removed.
