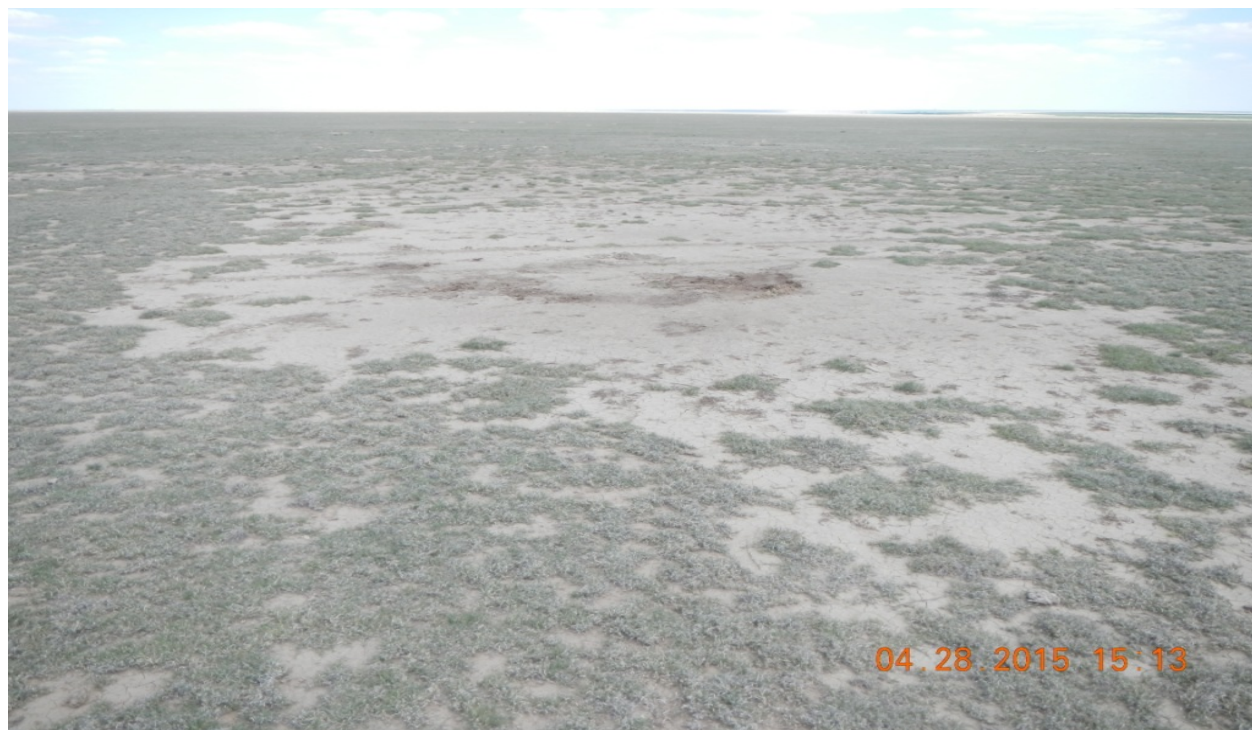
**photo 1:** Facing east towards the location which has no vegetation growth where soils are compacted.

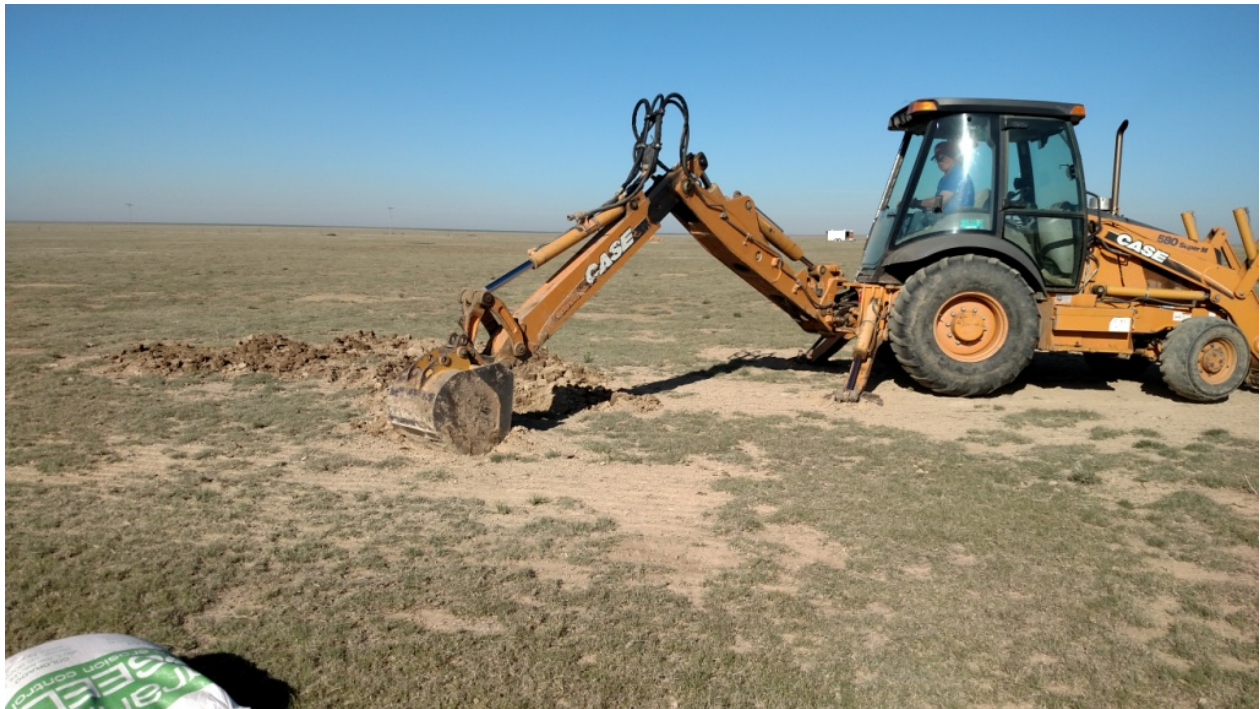
**photo 5:** Soil de-compaction in areas where vegetation will not grow.

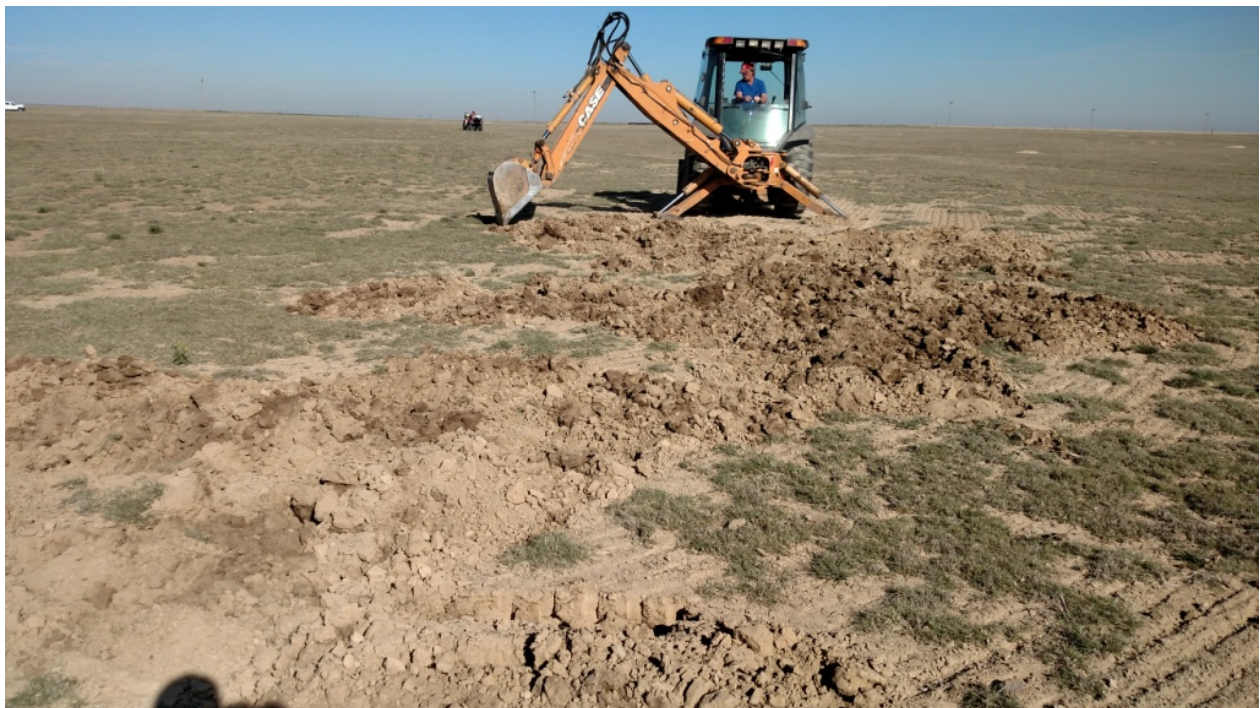
**photo 6:** Compacted soils being excavated with a backhoe to break up the compacted soils.

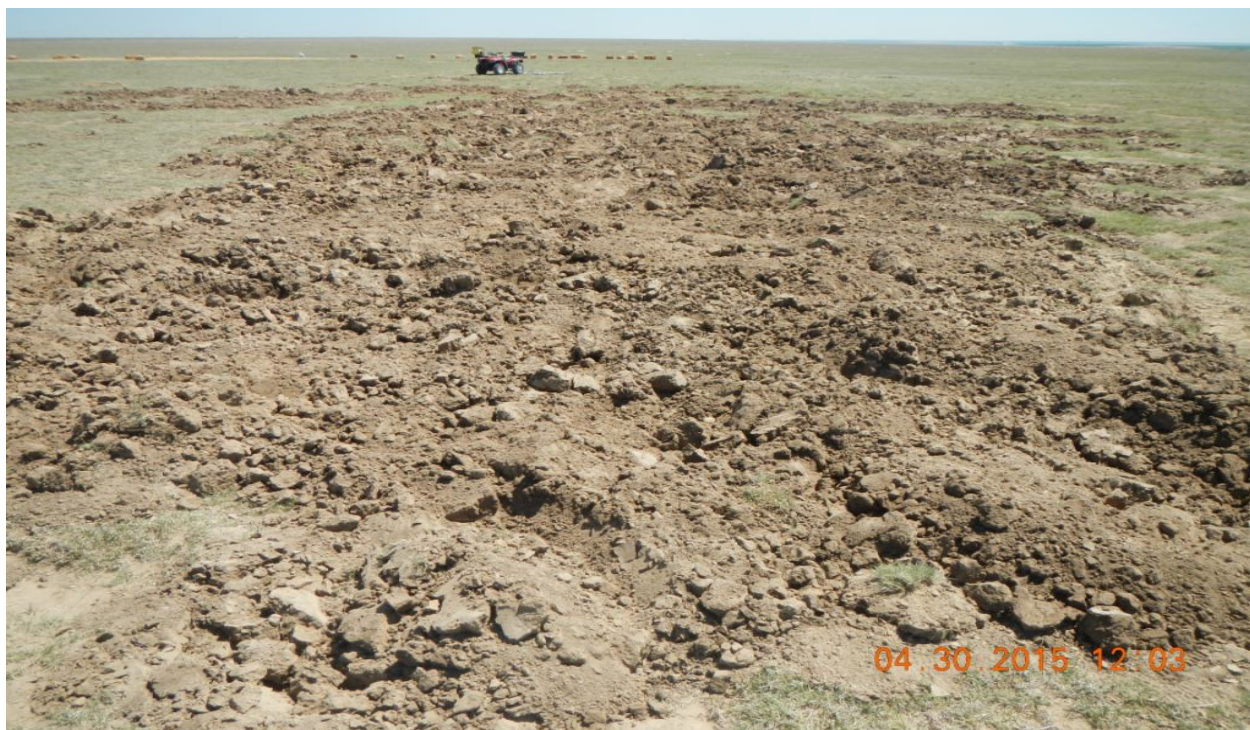
**photo 7:** Facing east towards areas which were decompacted with the backhoe.

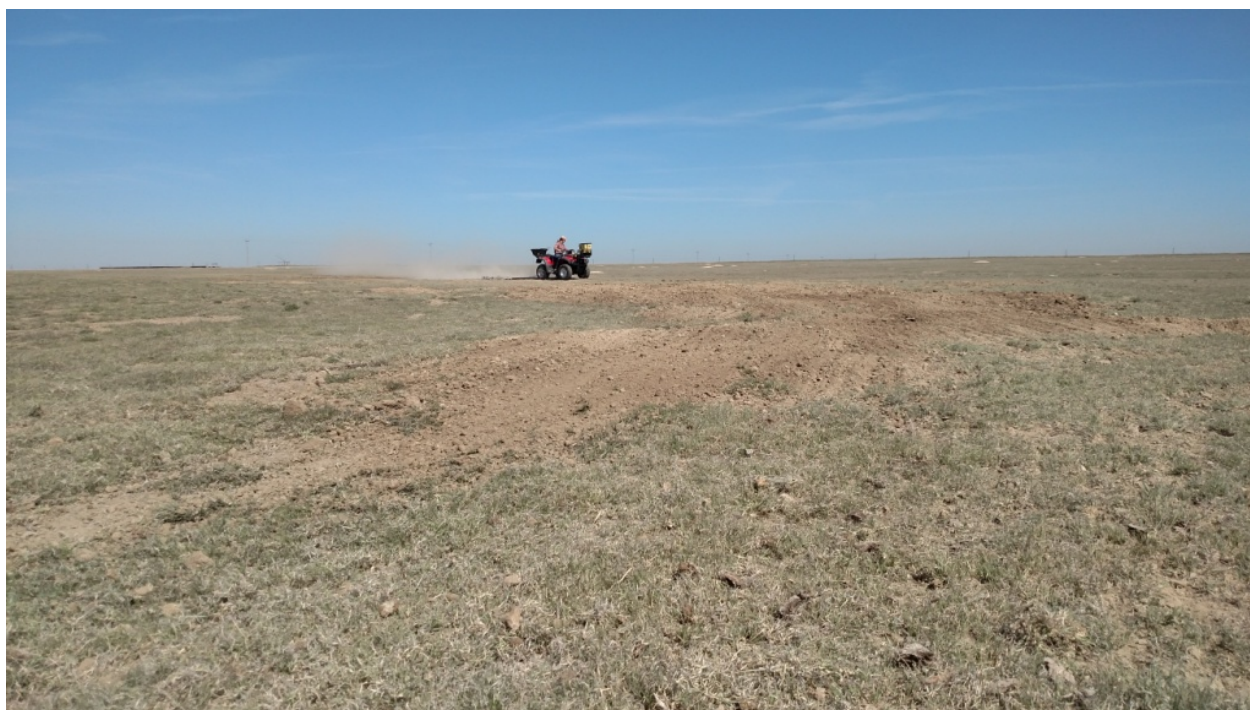
**photo 8:** Harrowing the decompacted areas with the atv.

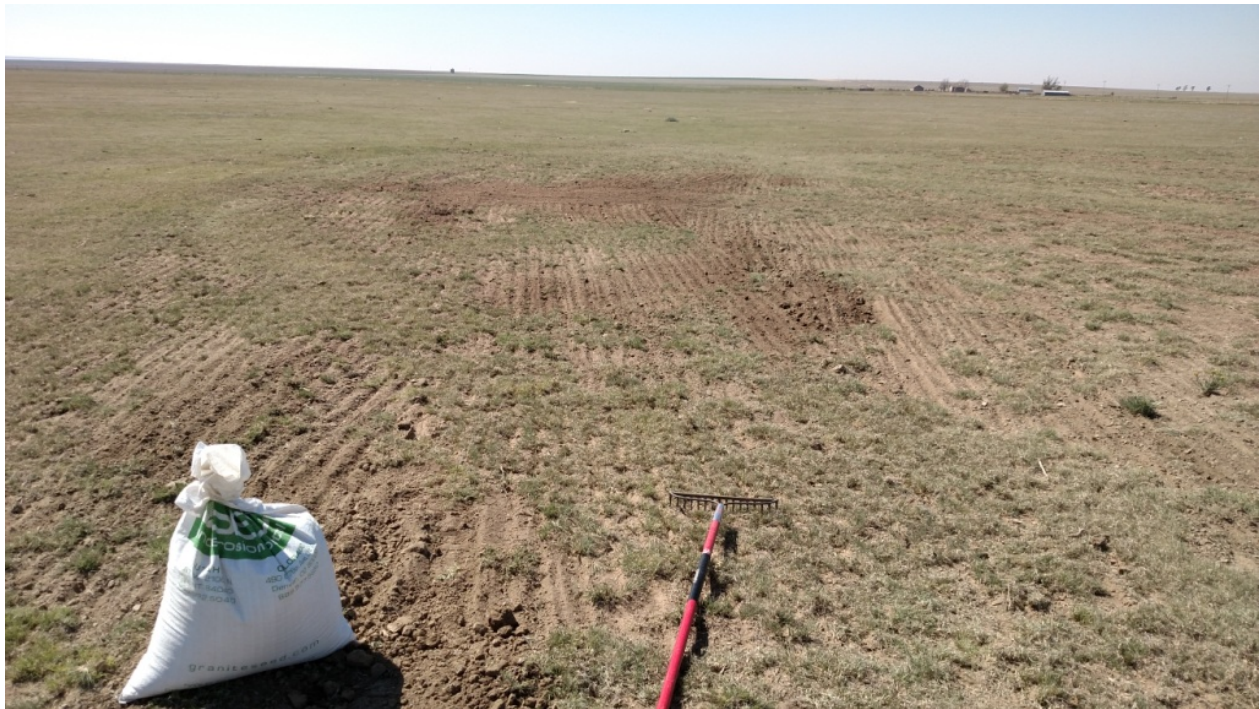
**photo 9:** Bare areas were decompacted, fertilized, and seeded.

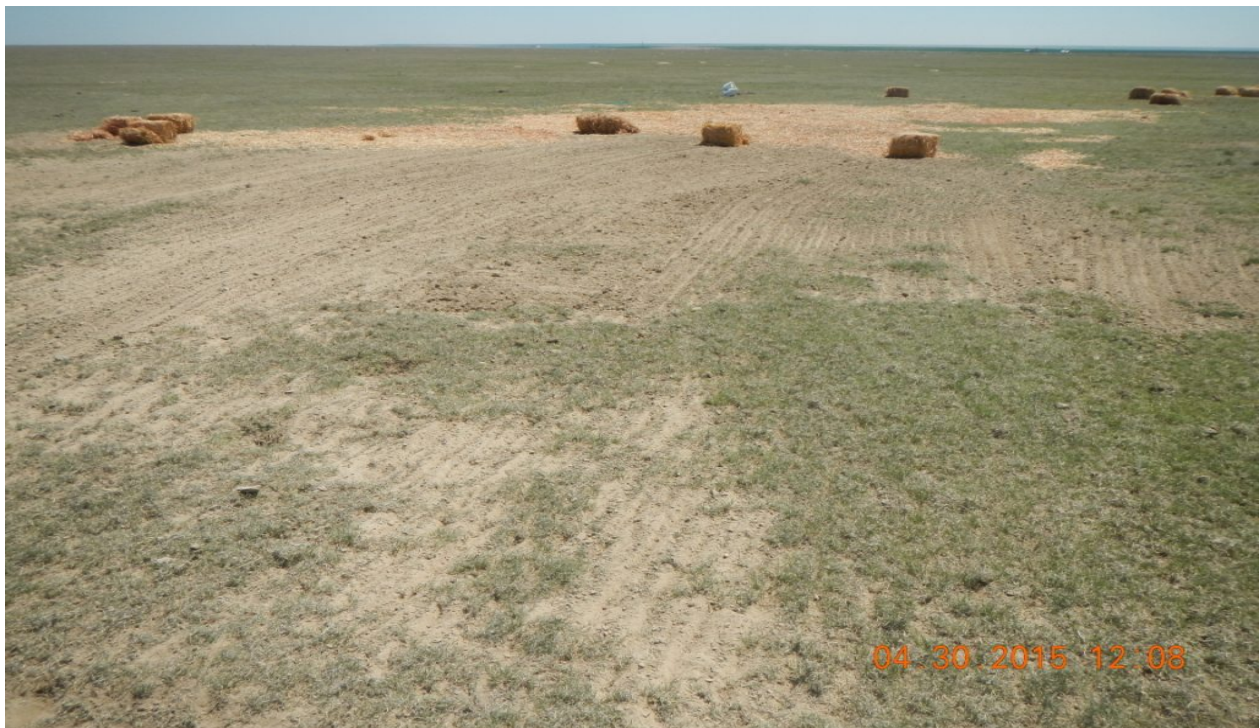
**photo 10:** Bare areas were spread with wood mulch.

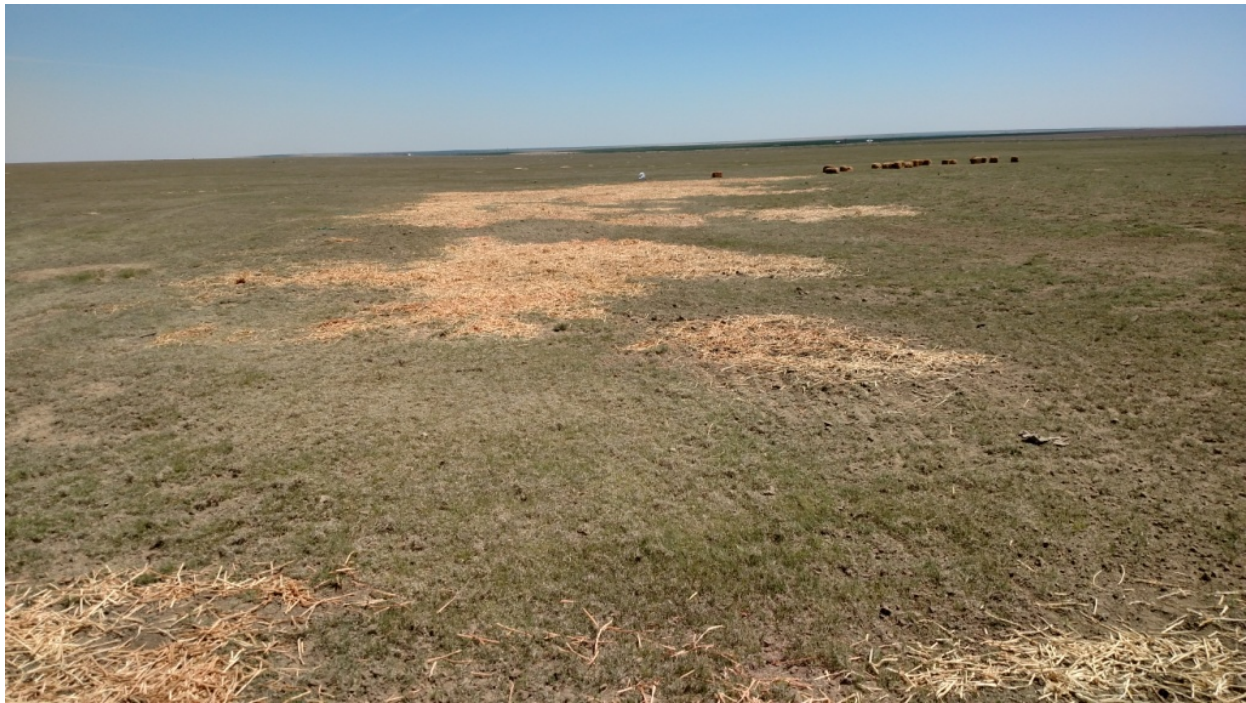
**photo 11:** Areas bare of vegetation covered with wood straw mulch approx 50% coverage.

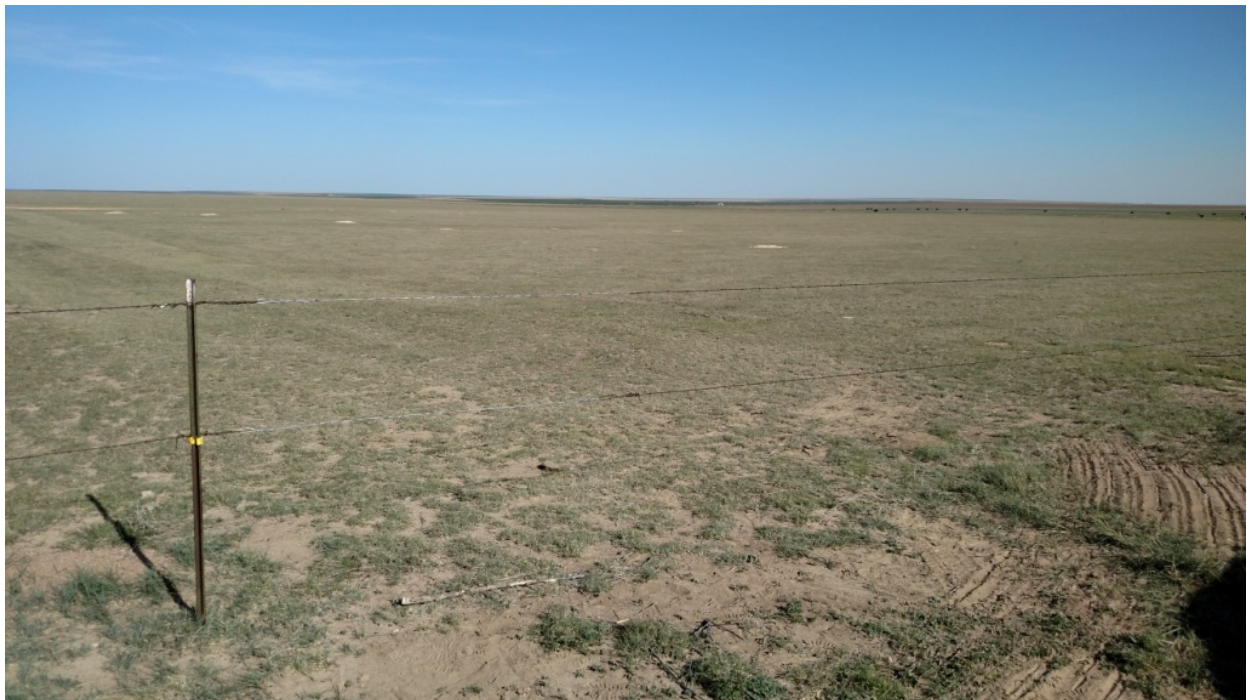
**photo 14:** Upon completion the fence where the site was accessed was properly fixed.
