Bosely SG 24-22 (5/11/15)

Inspection# 675201539

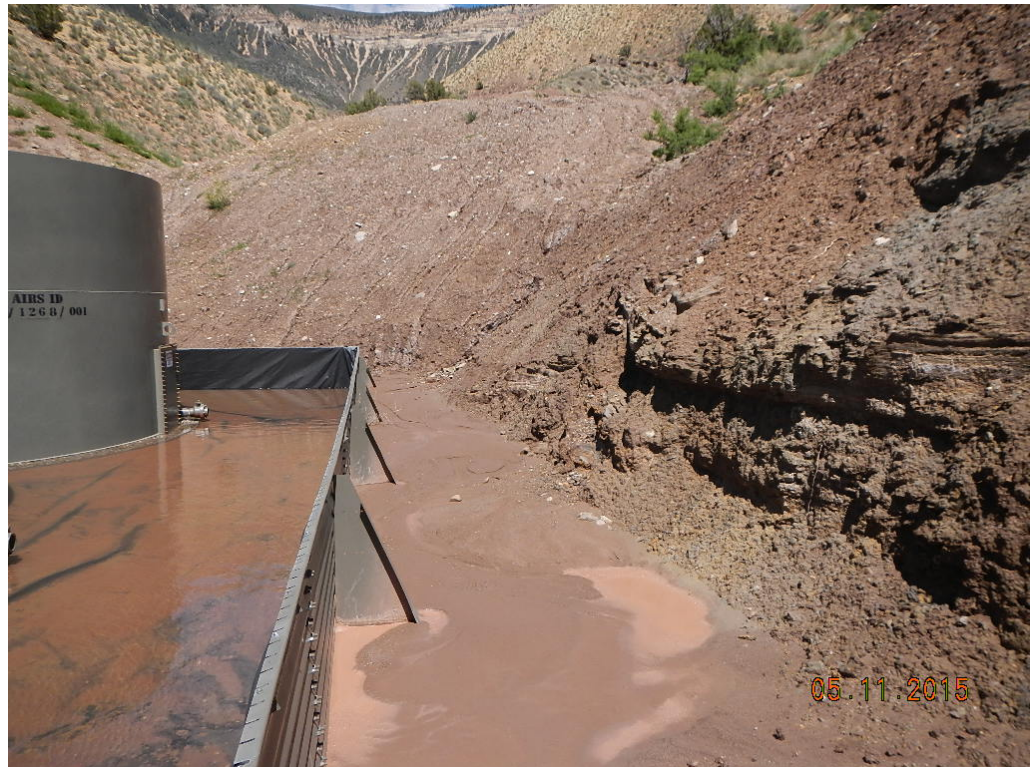
Sediment run on in NE
corner of location.

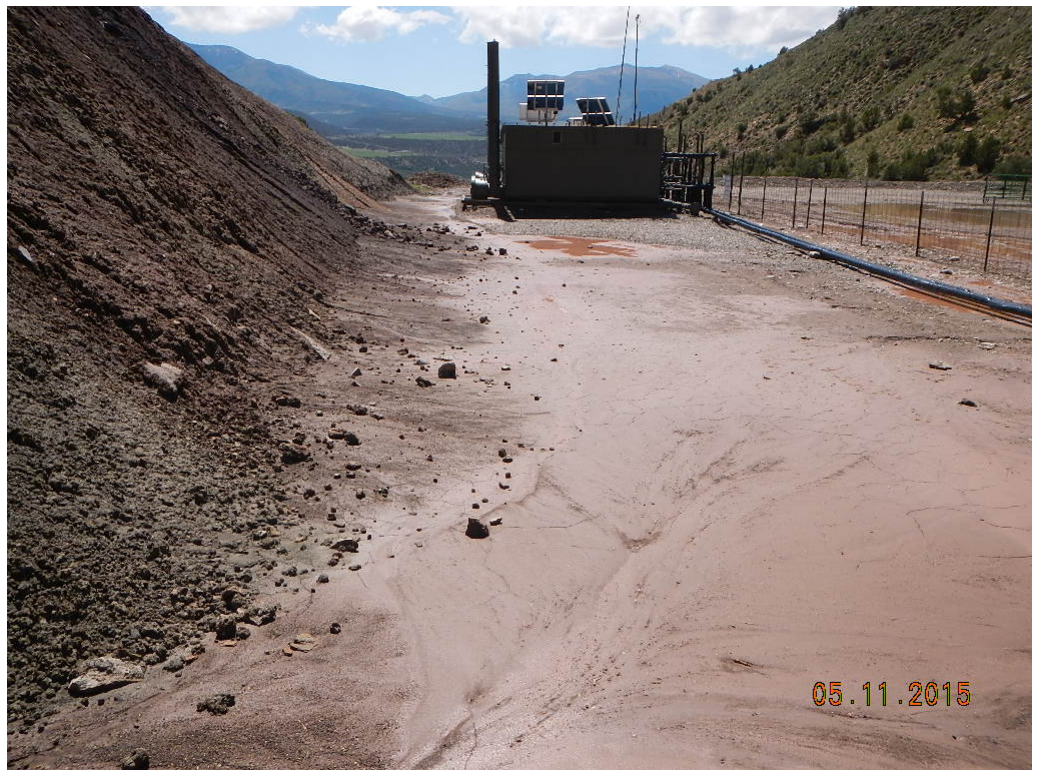
Sediment run on from NE
corner of location.

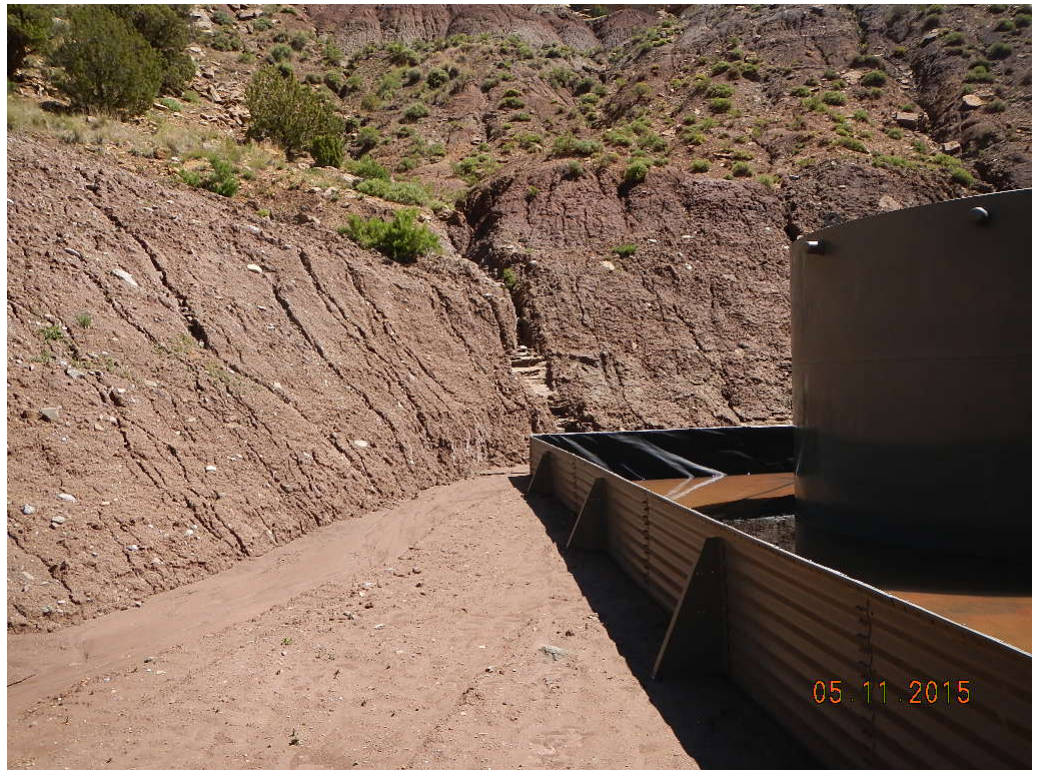
Sediment run on in NE corner of location and erosion channel.

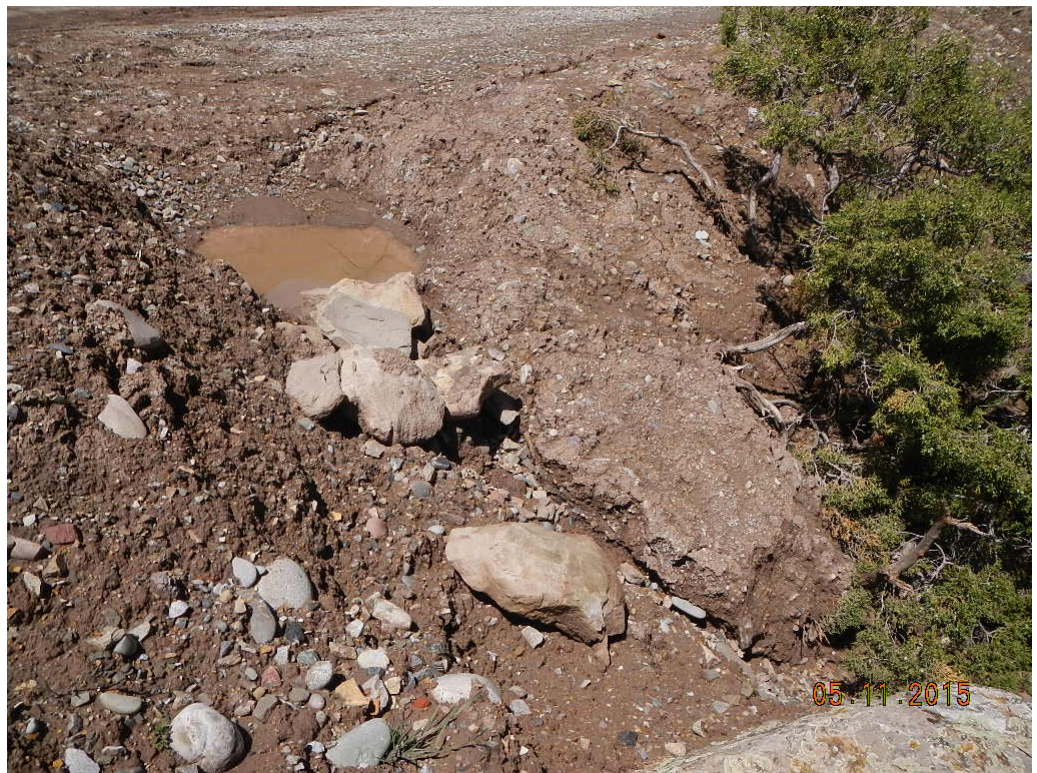
Erosion under rip rap outlet of retention pond.

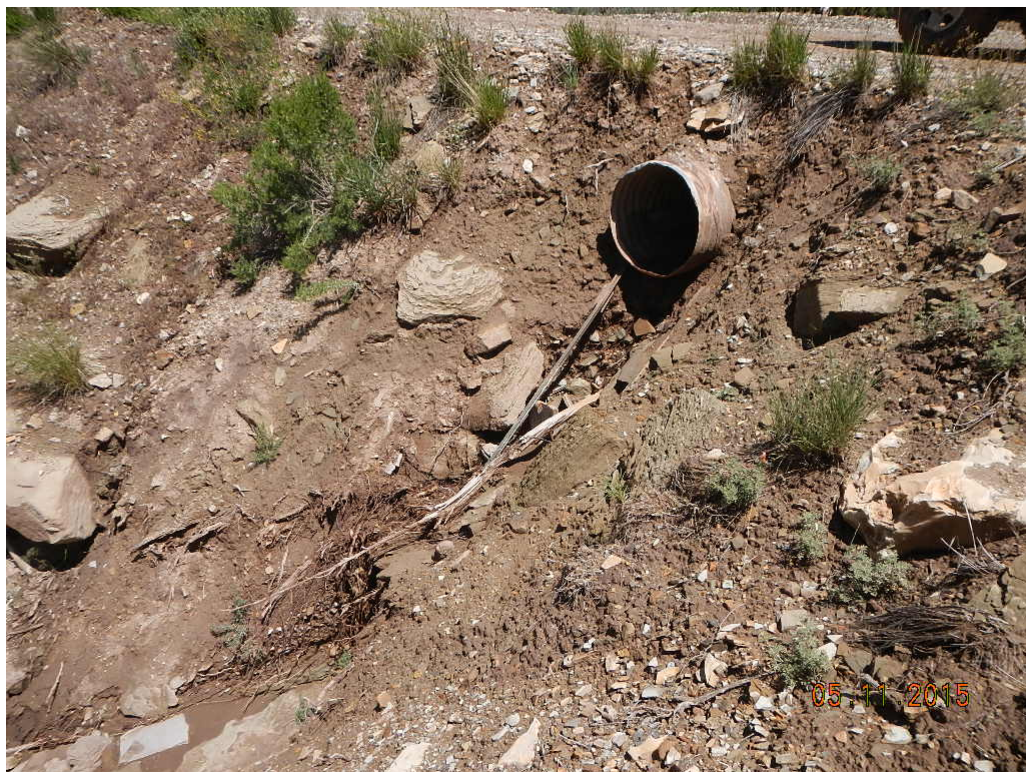
39.41736/-108.09930

Erosion at culvert outlet.

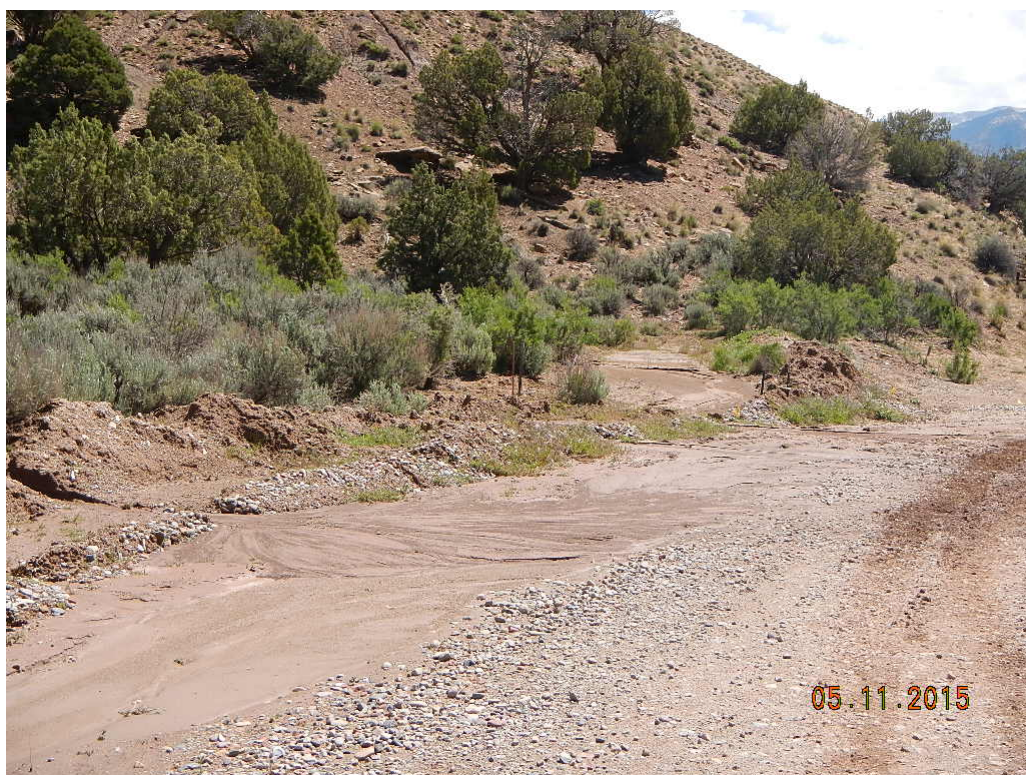
39.41645/-108.09816

Sediment run on to road.

Noted on previous
inspection.

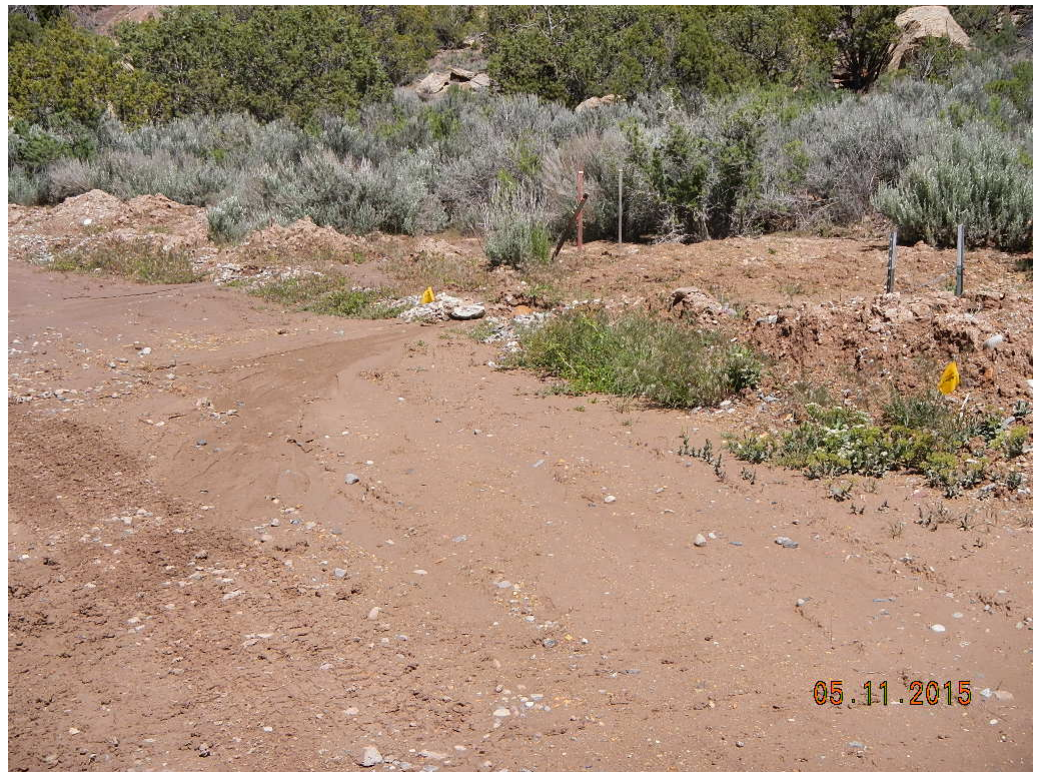
39.41645/-108.09816

Sediment run on to road.
Noted on previous
inspection.

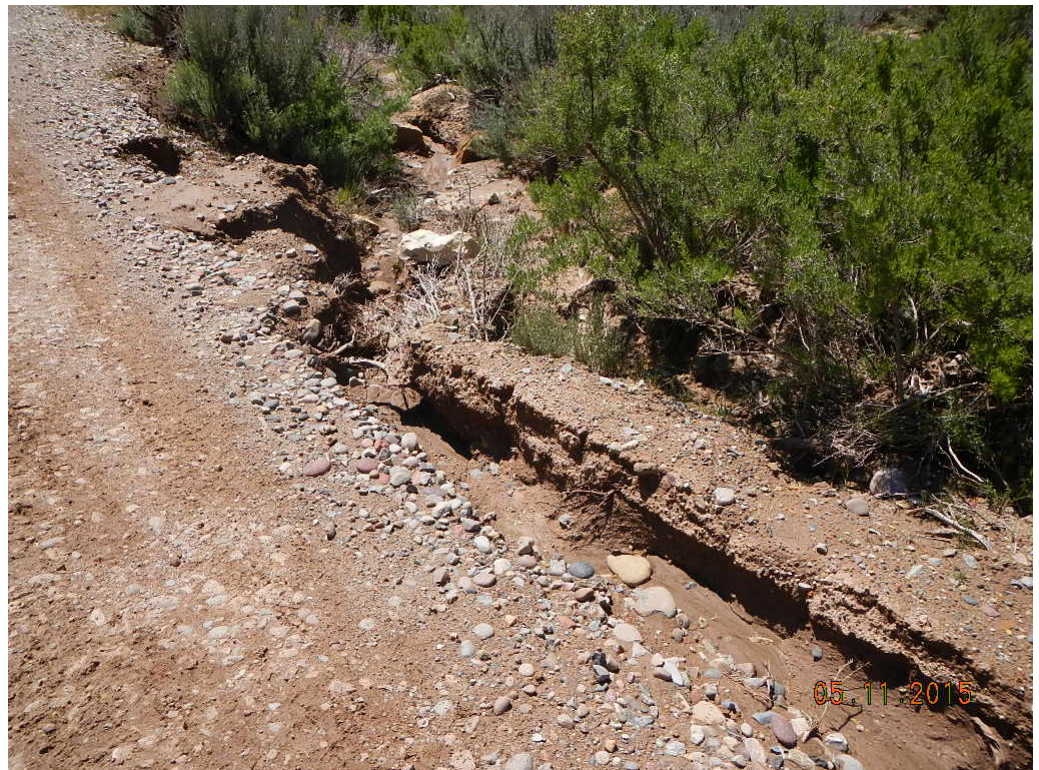
Erosion of road across from
sediment run on. Noted on
previous inspection.

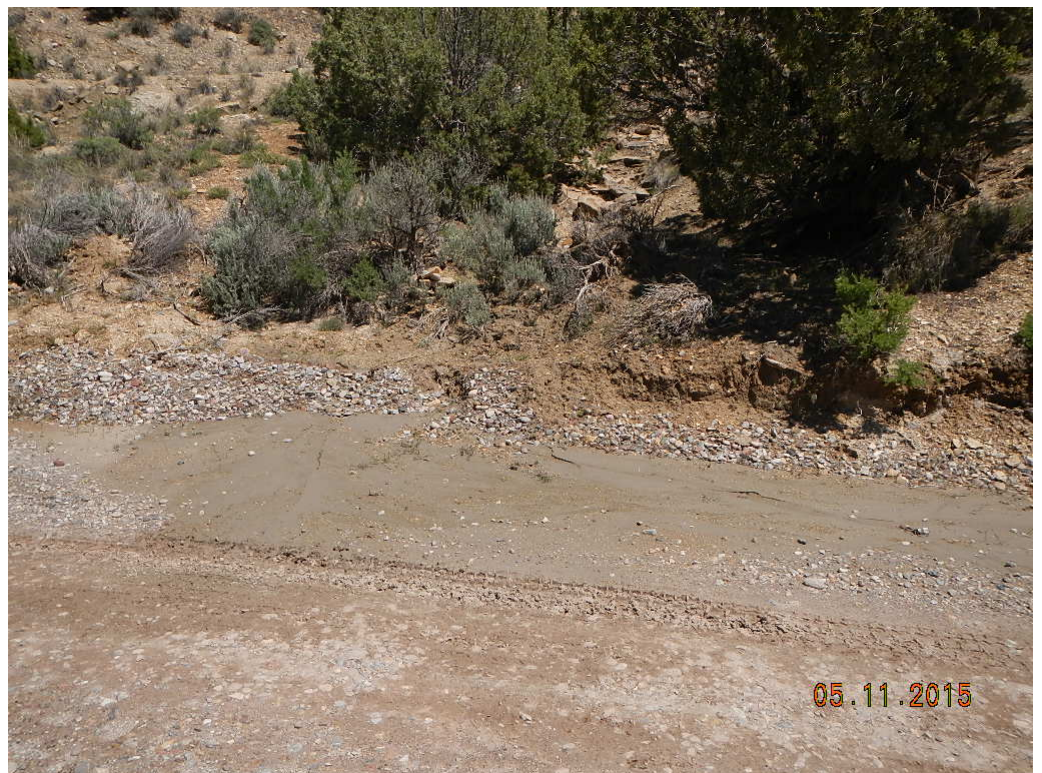
Sediment run on along
access road. Noted on
previous inspection.
