Bosely SG 21-27 (5/11/15)

Inspection# 675201541

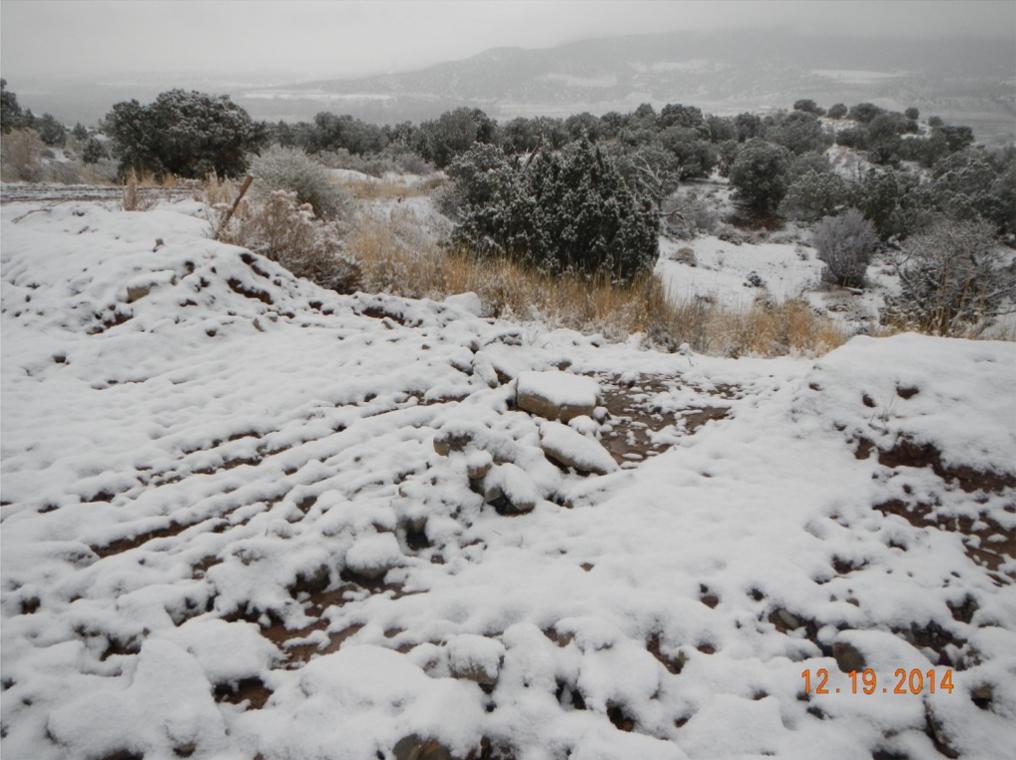
Breached berm at initial inspection. 12/19/14

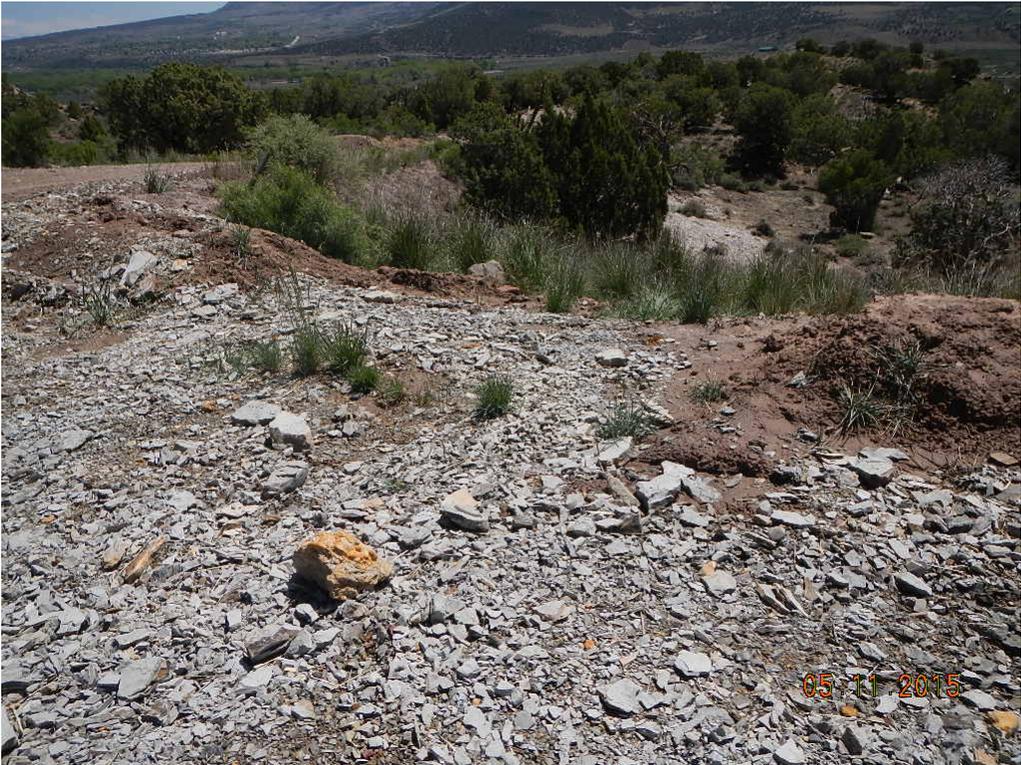
Breached berm at follow up inspection. 5/11/15

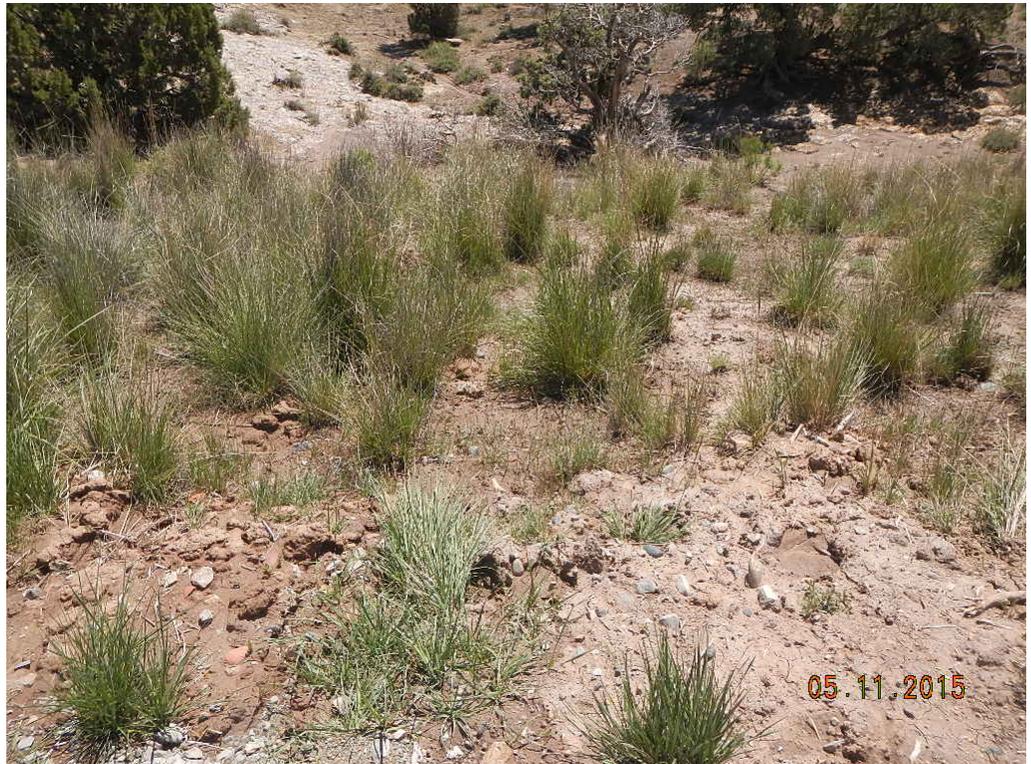
There is sediment movement down gradient from breached berm into vegetation at the follow up inspection. Not visible at initial inspection because of snow cover.
