photo 1: Well sign, Crum 33-5V

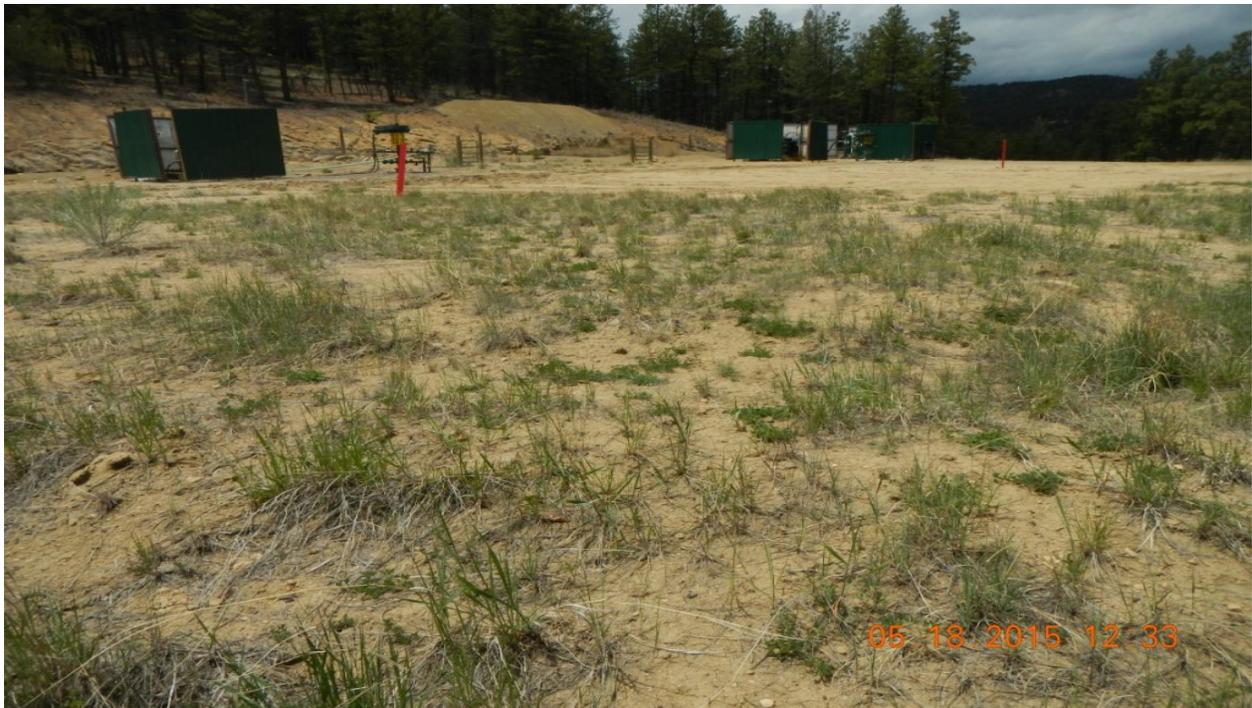
photo 2: Southeast corner of the location facing northwest.

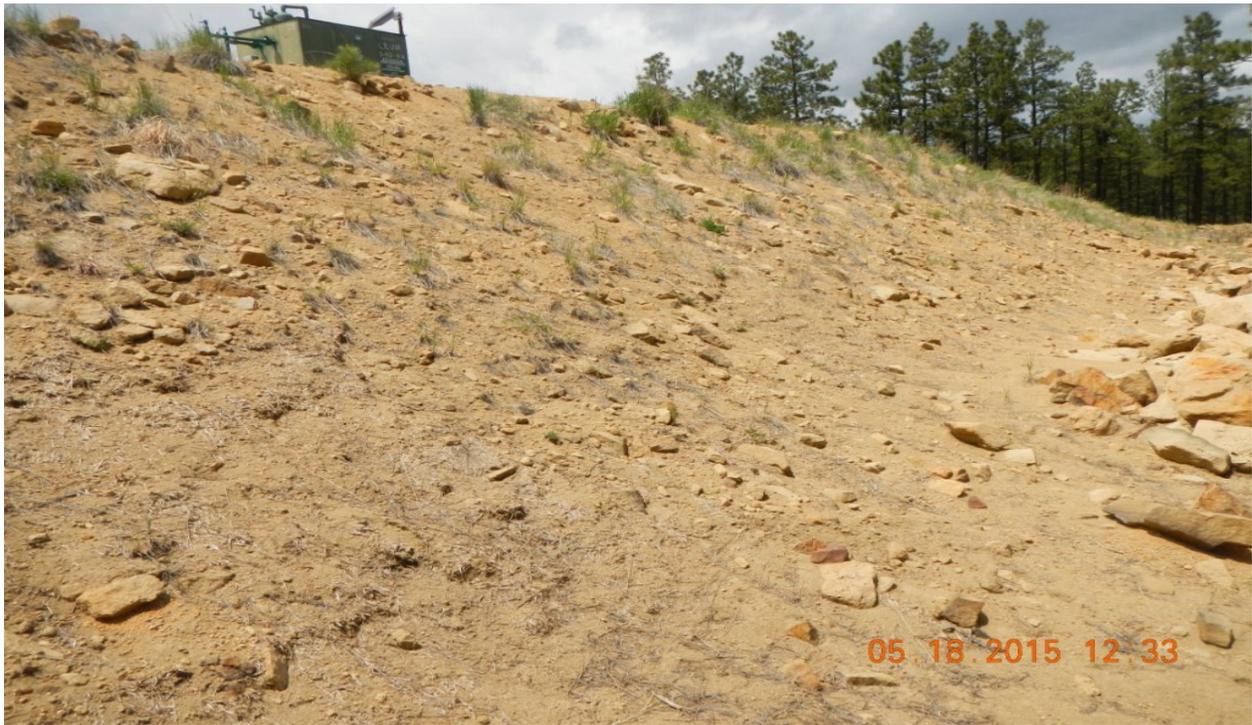
photo 3: Base of the pad at the east side of the location.

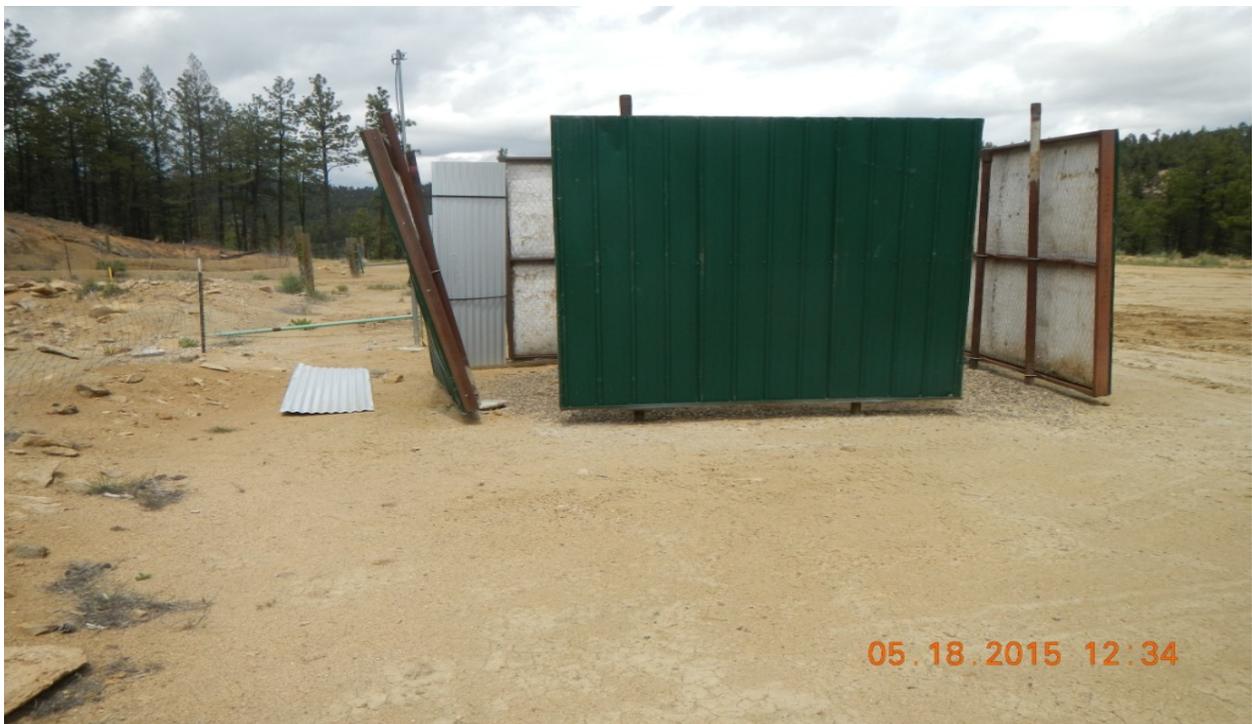
photo 4: Metal tin debris near the pit. Shed panels appear to be leaning.

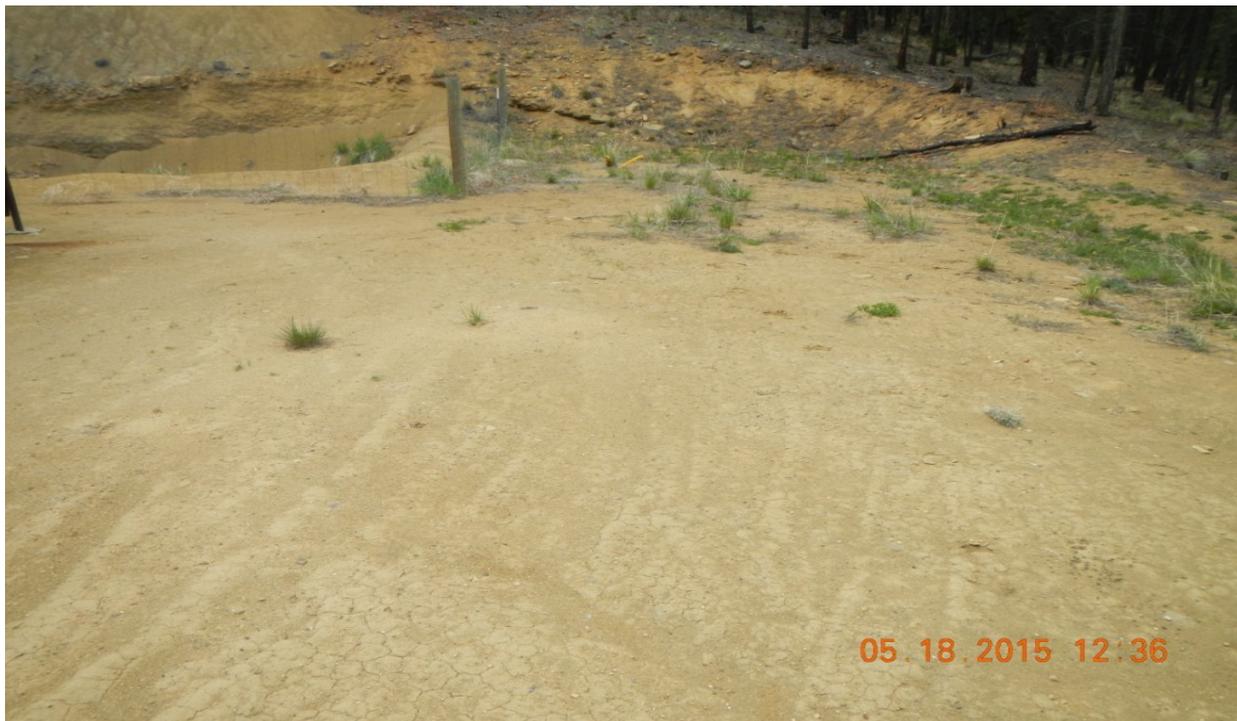
photo 5: North side of the location area in photo has little to no vegetation growth.

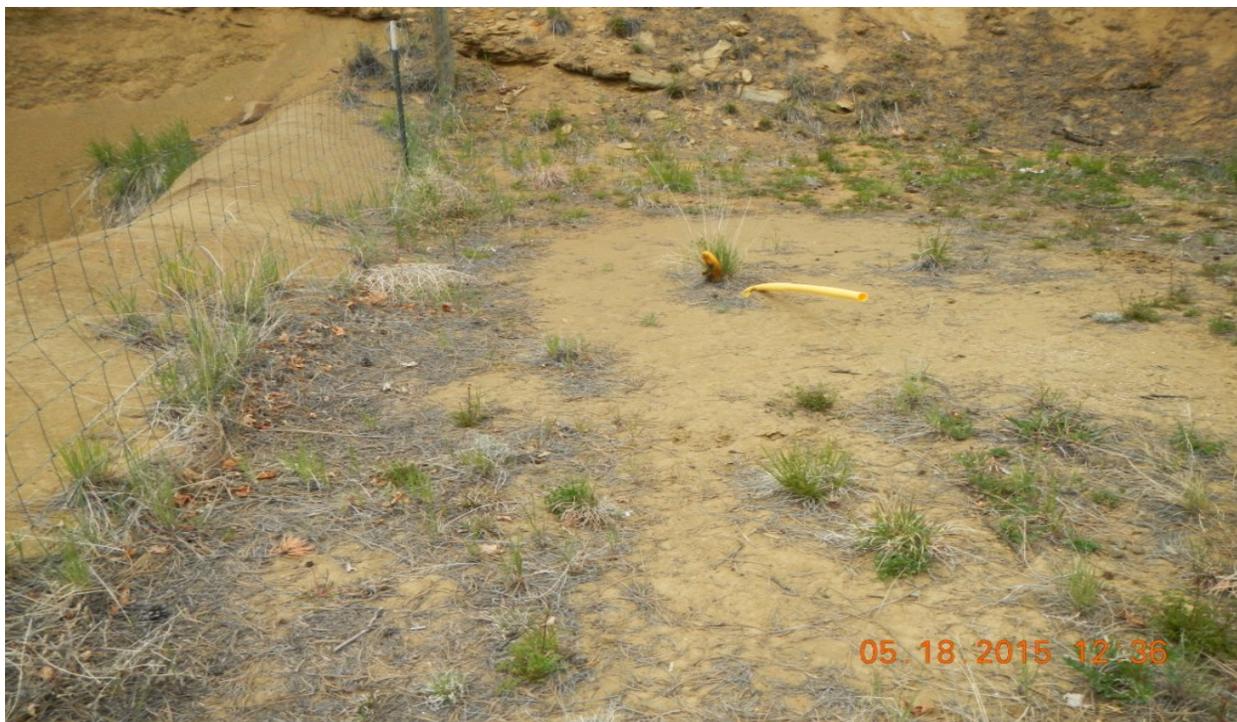
photo 6: The northwest Guyline anchor is not properly marked.
