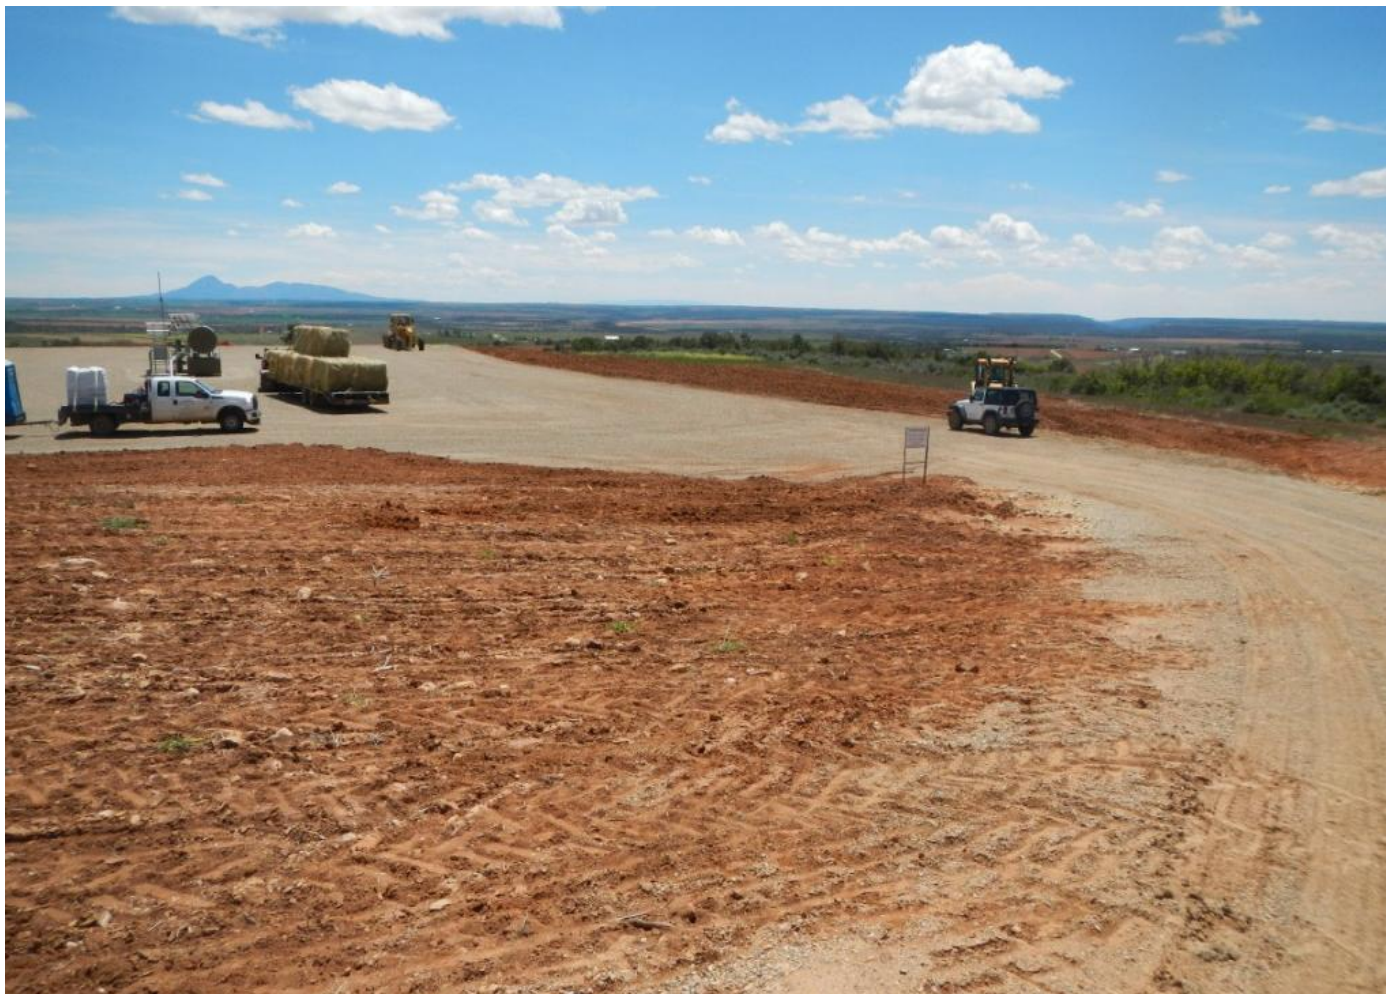
Photo 1. View of northeastern portion of project area from northern edge of interim reclamation area facing southwestward.

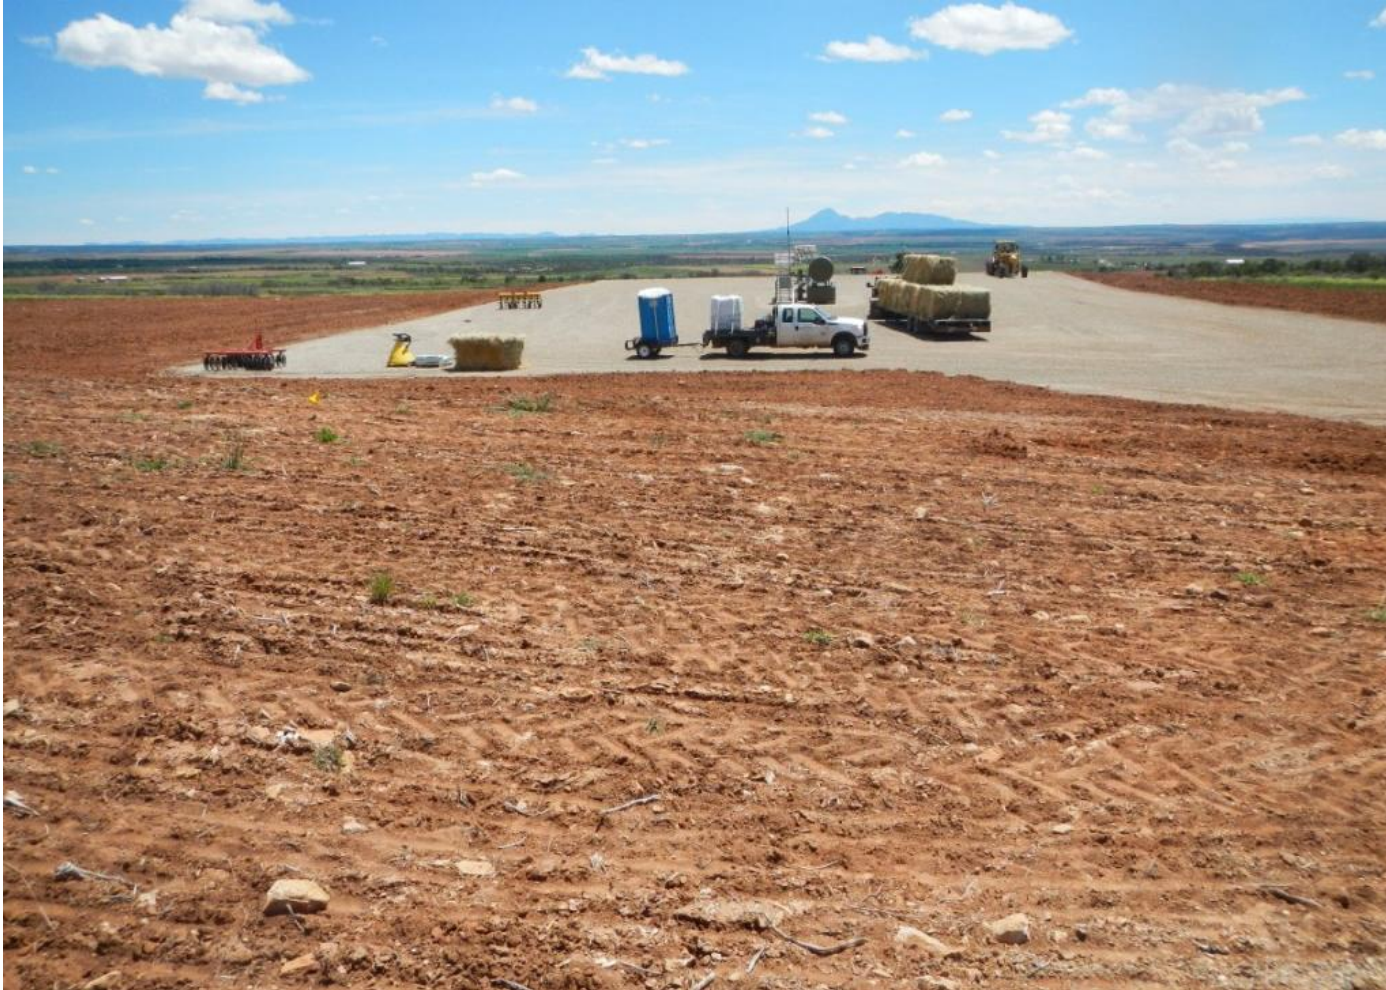
Photo 2. View of interim reclamation area and well pad from northern edge of project area facing southward.

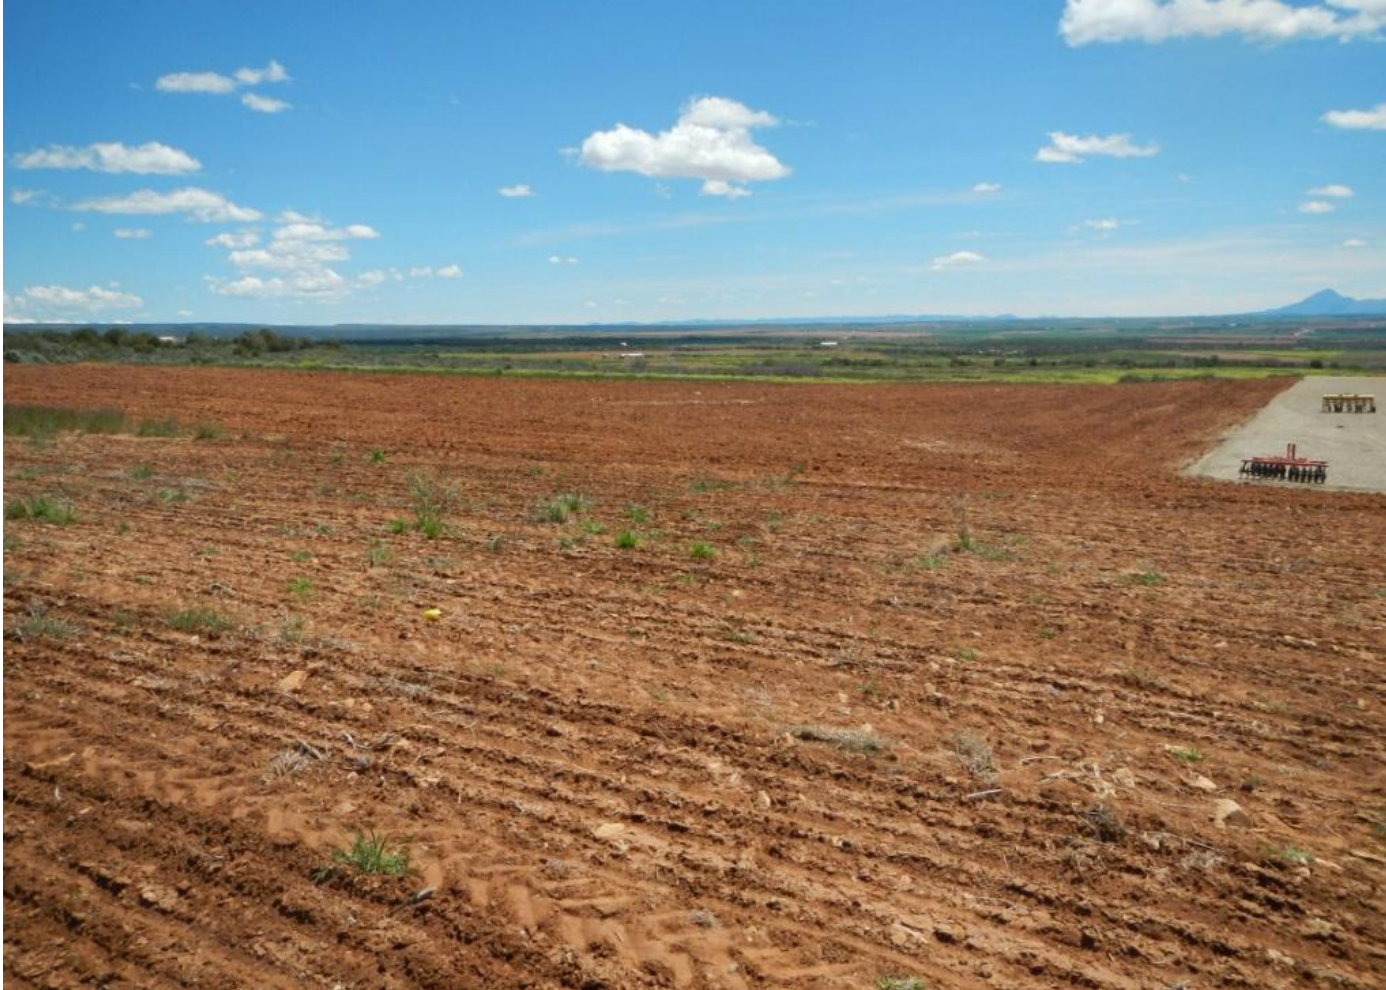
Photo 3. View of northeastern and eastern portion of interim reclamation area from northern edge facing southeastward.

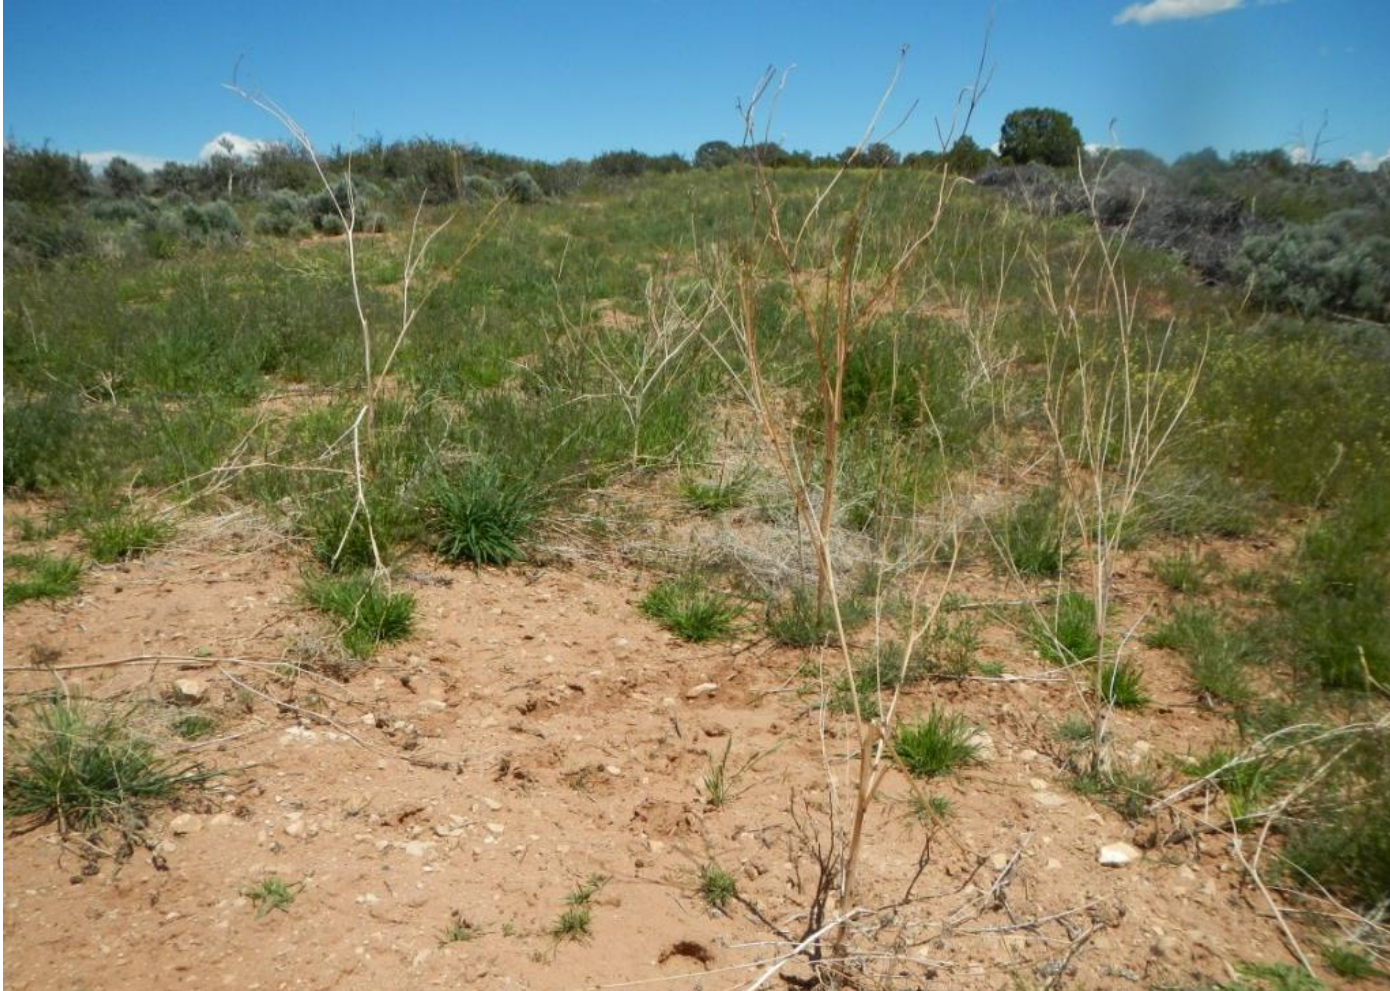
Photo 4. View of flowline from the access road facing east-northeastward. Grass species are not in identifiable condition.

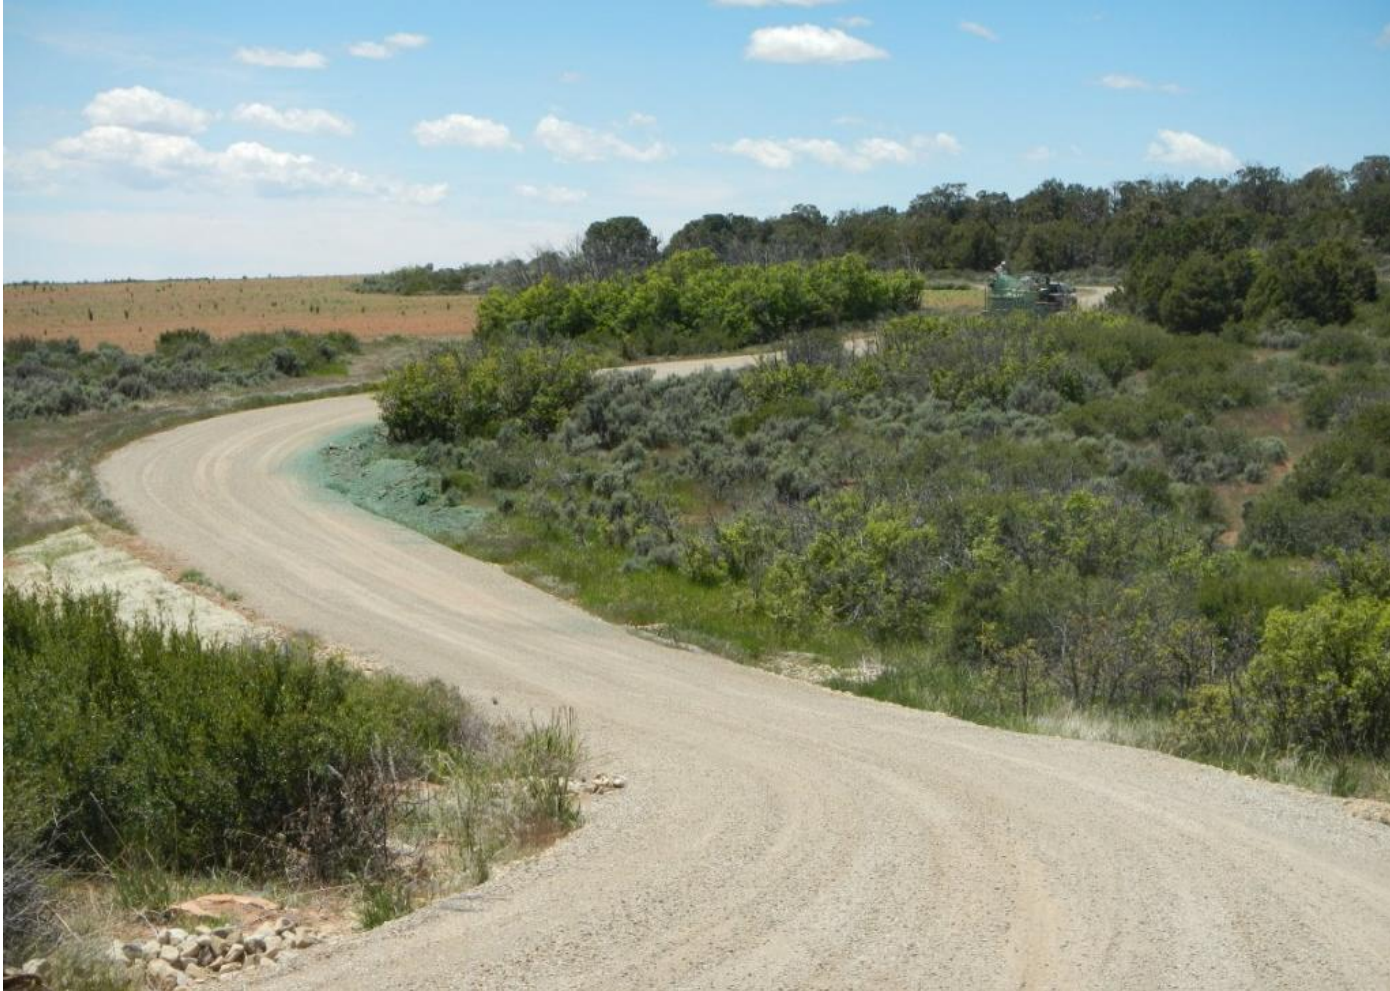
Photo 5. View of hydromulch being applied to the northern edge of the access road.
