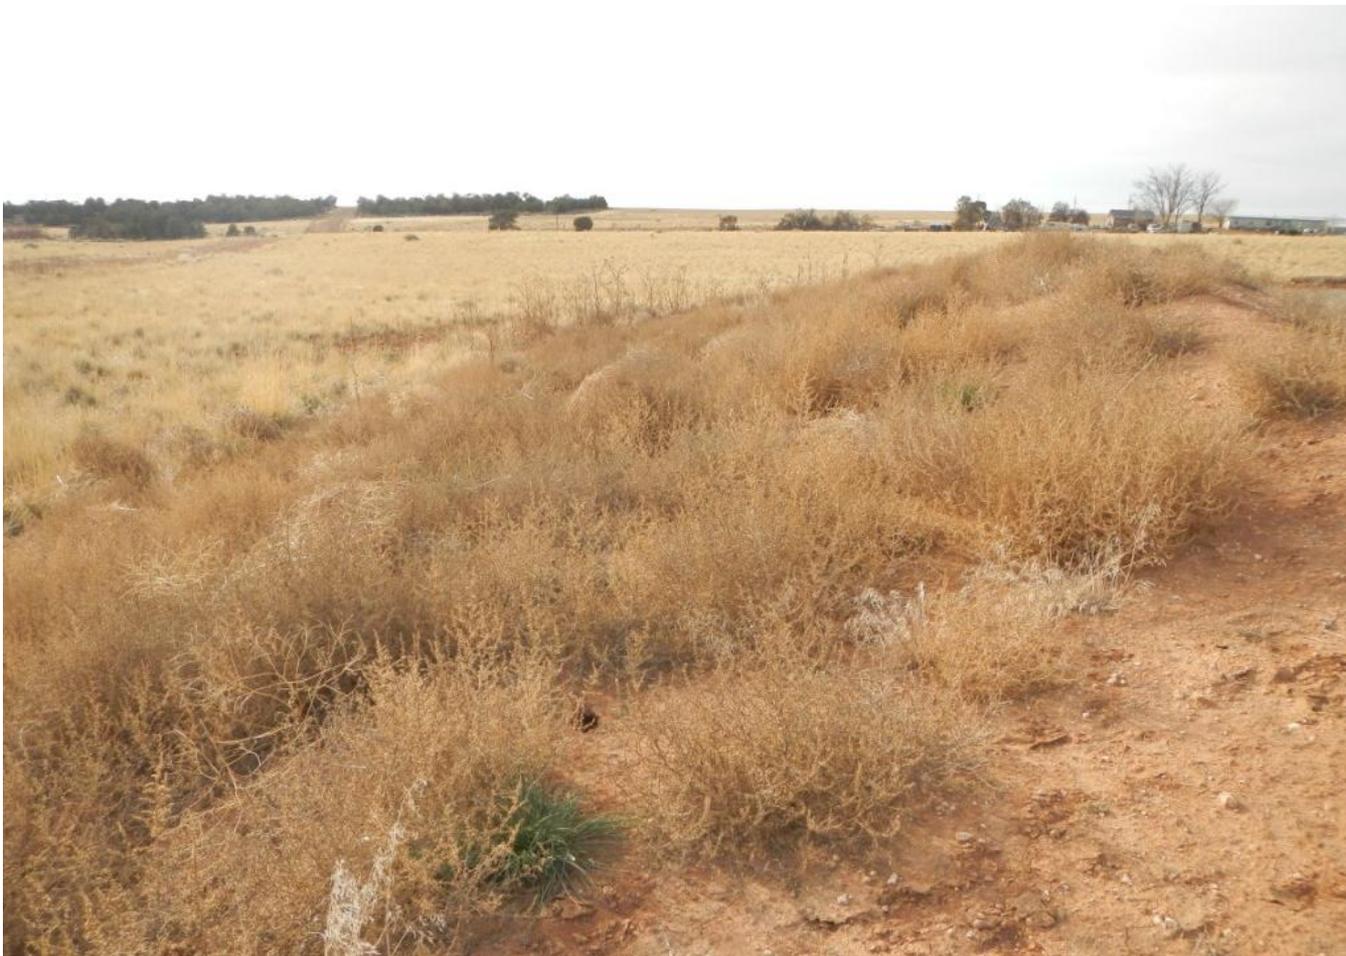
Photo 1. Southern portion of project area from southern edge of working area facing westward.

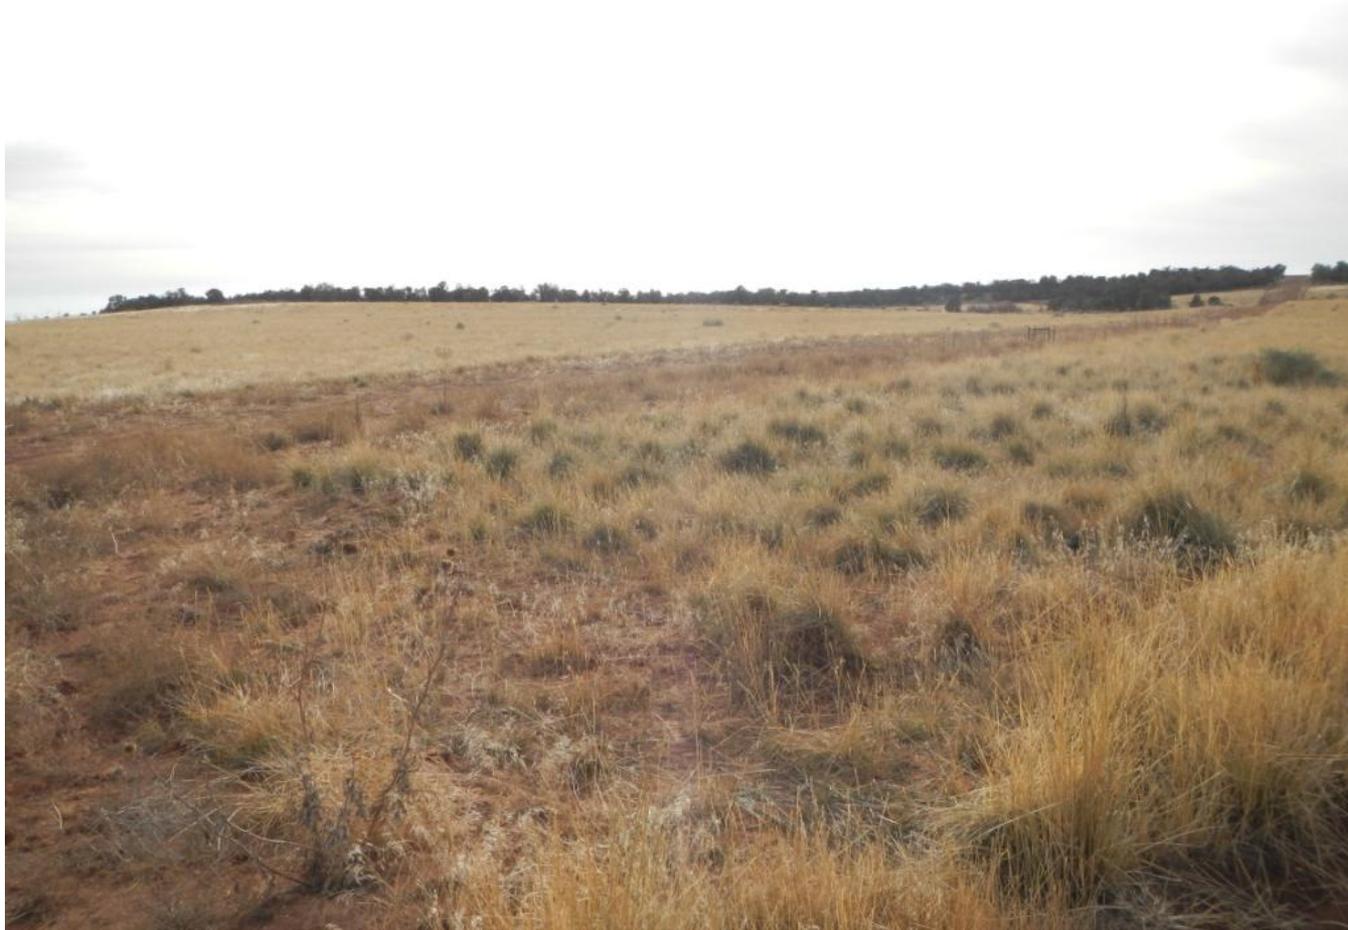
Photo 2. View of flowline disturbance from southwestern corner of well pad that is vegetated with weeds.

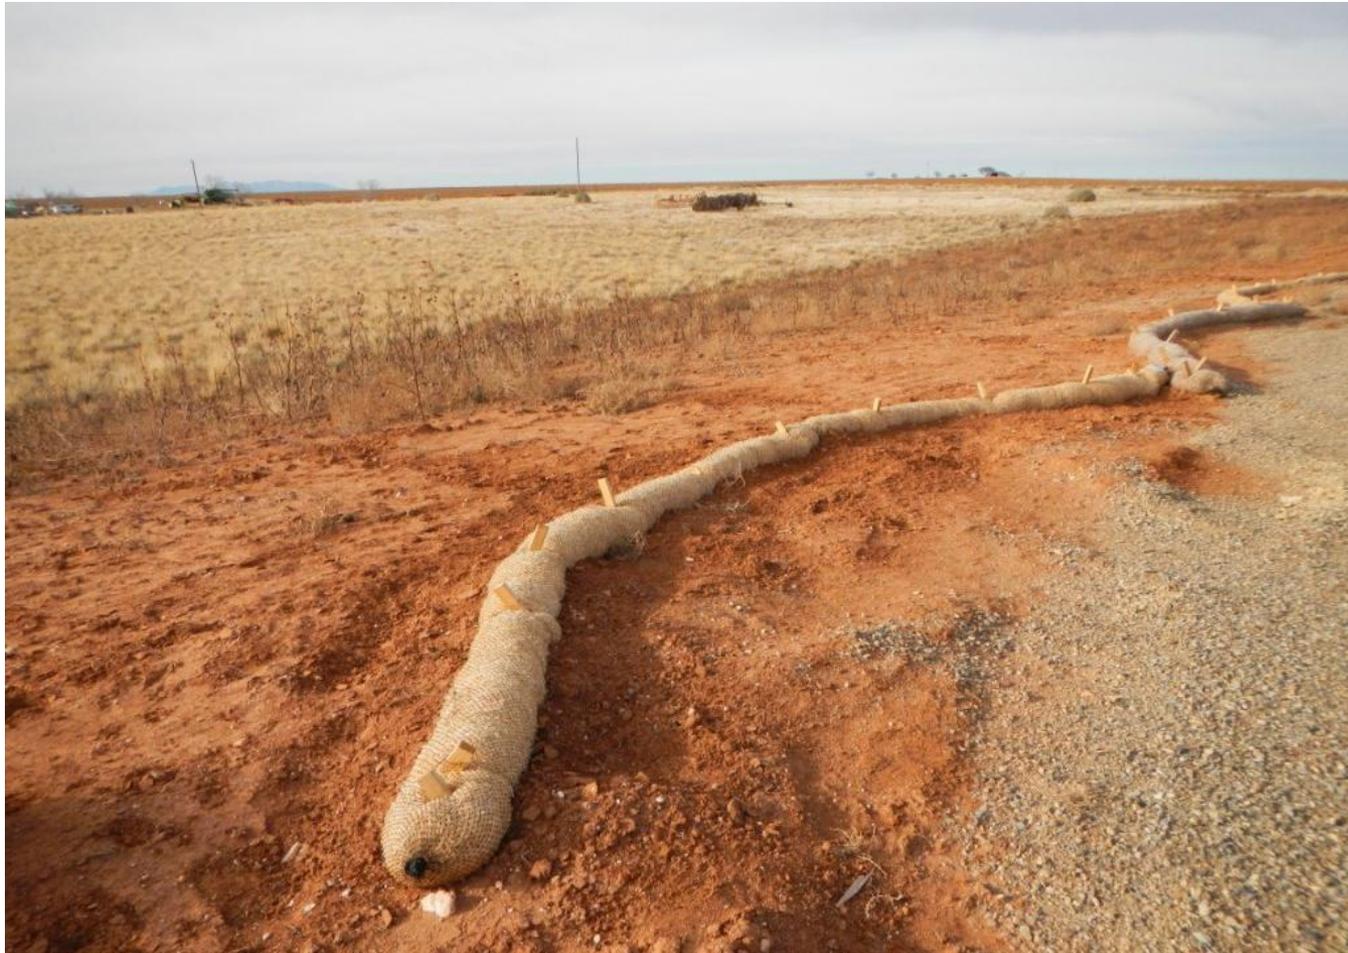
Photo 3. View of straw wattles in western portion of project area.

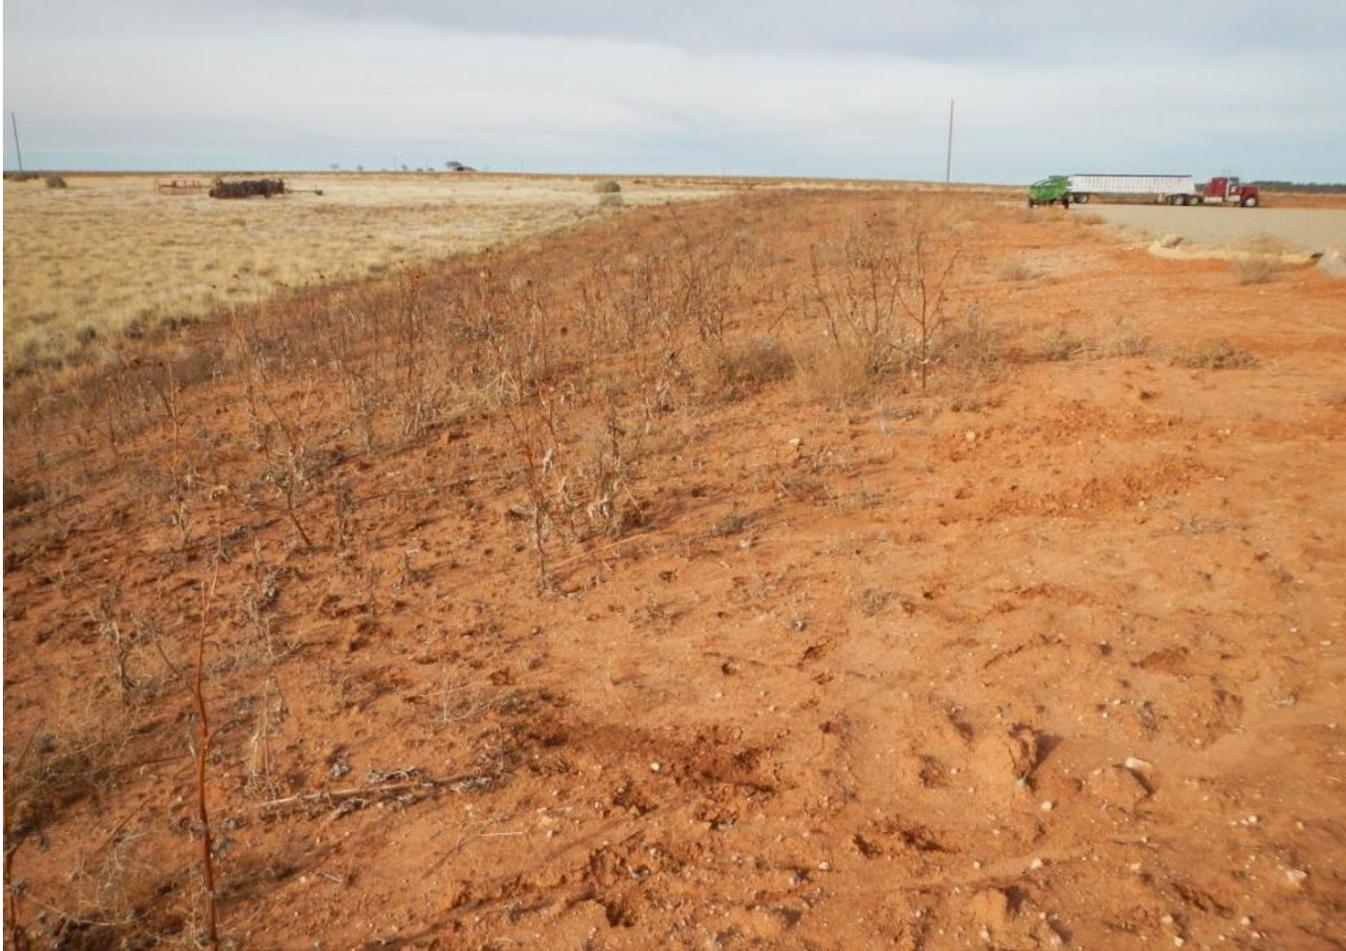
Photo 4. View of western portion of project area from southwestern corner facing northward.

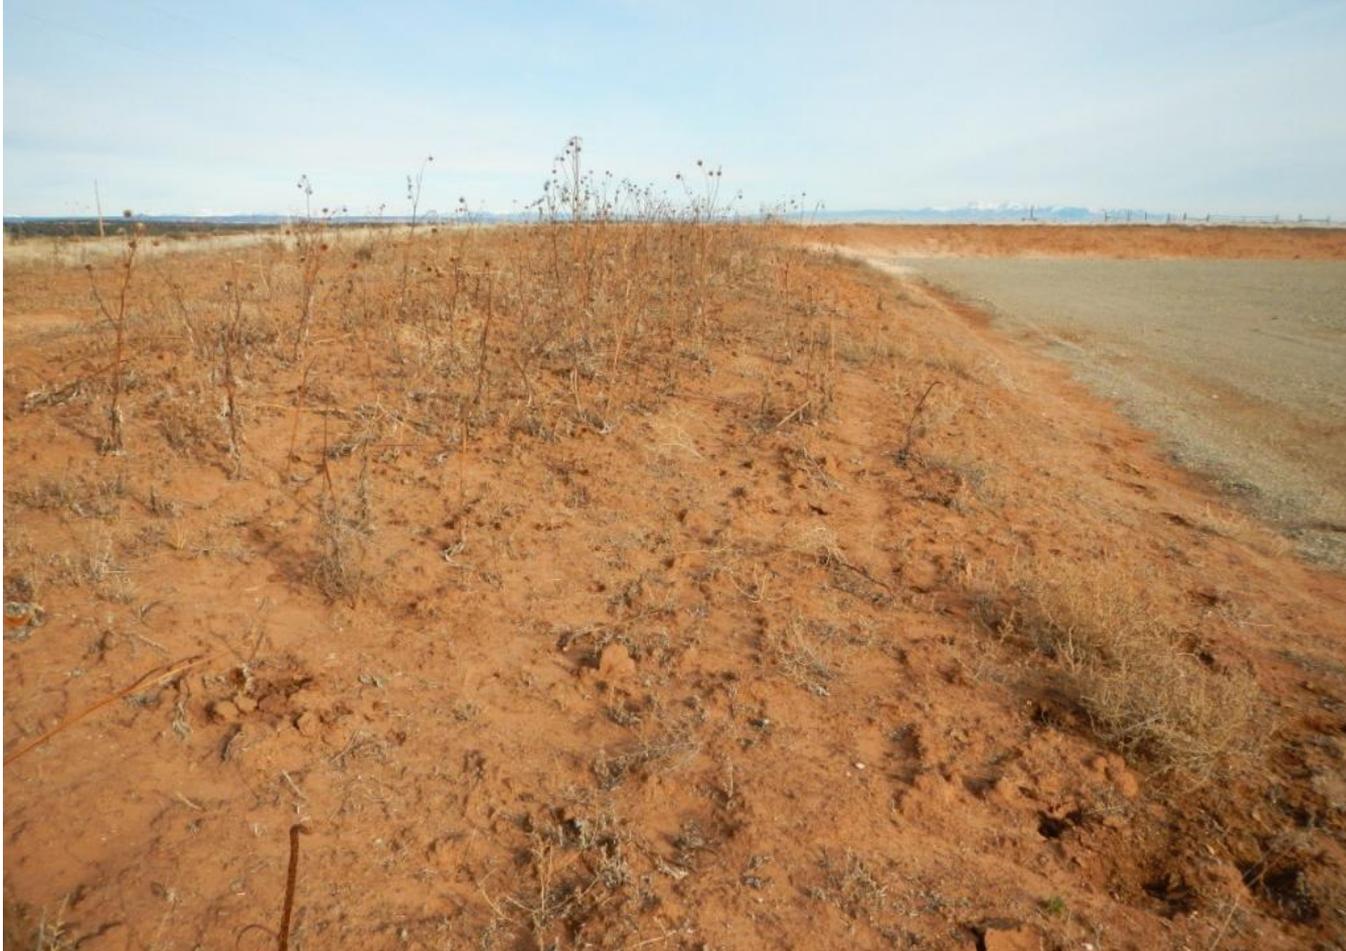
Photo 5. View of northern portion of project area from northwestern corner facing eastward.

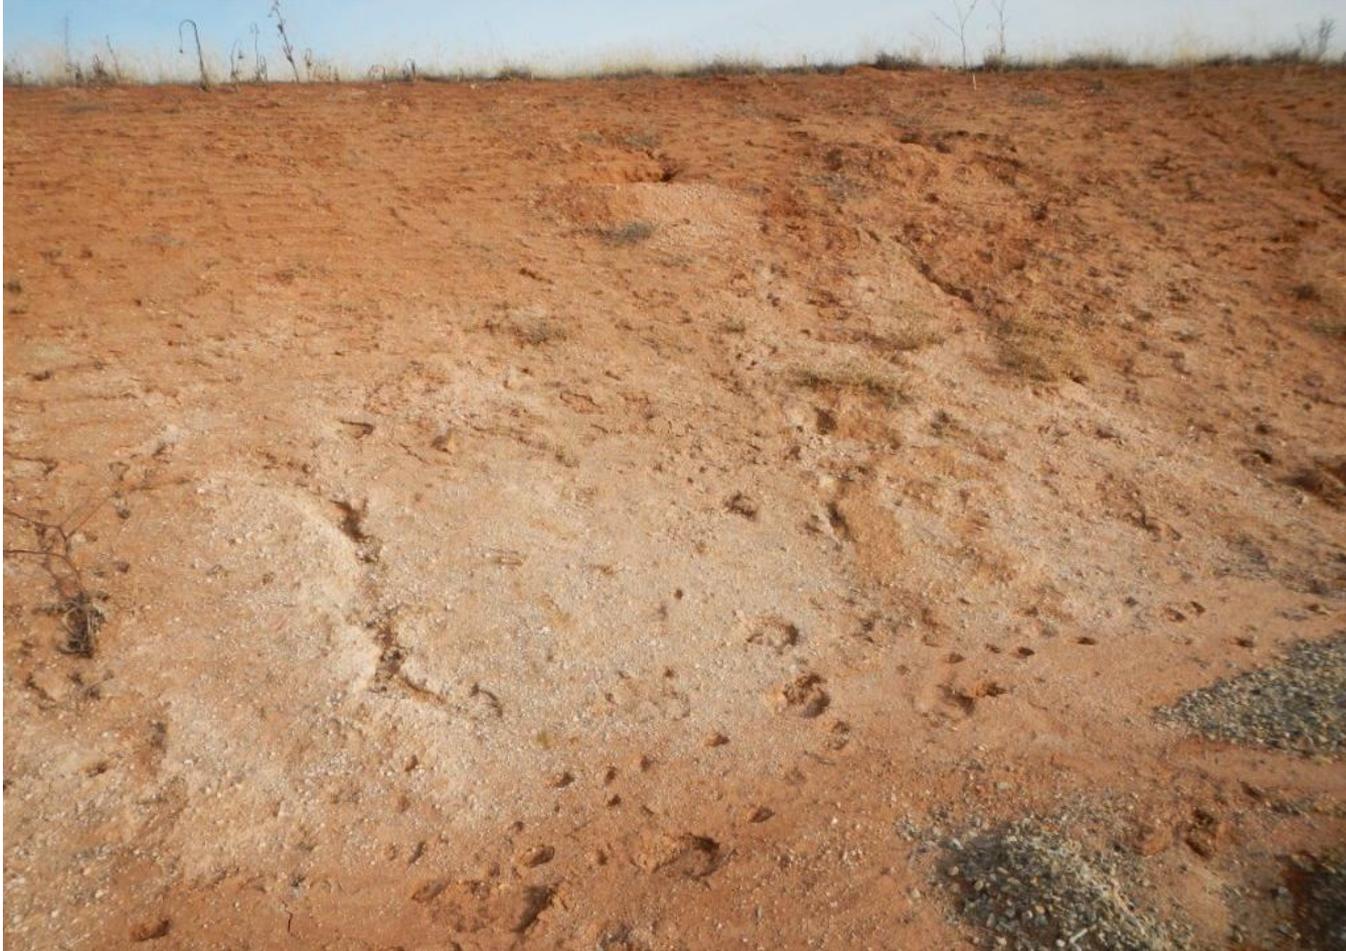
Photo 6. View of cut-slope in eastern portion of project area with no stormwater controls.
