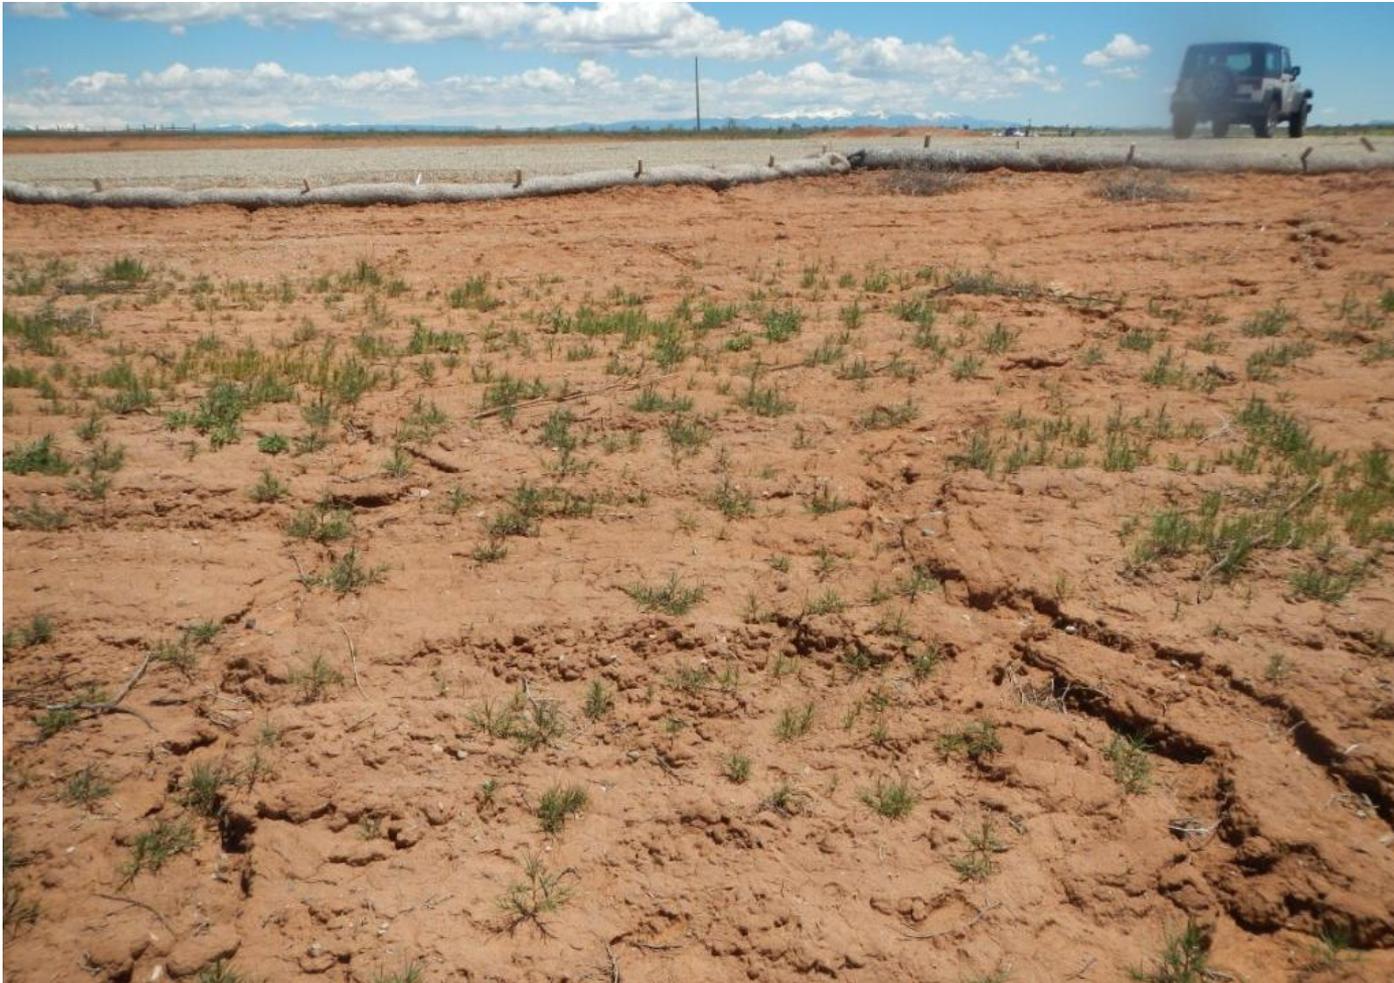
Photo 1. View of rill erosion in western portion of project area, downslope of straw wattles. Vegetation in foreground is largely Russian thistle (*Salsola tragus*).

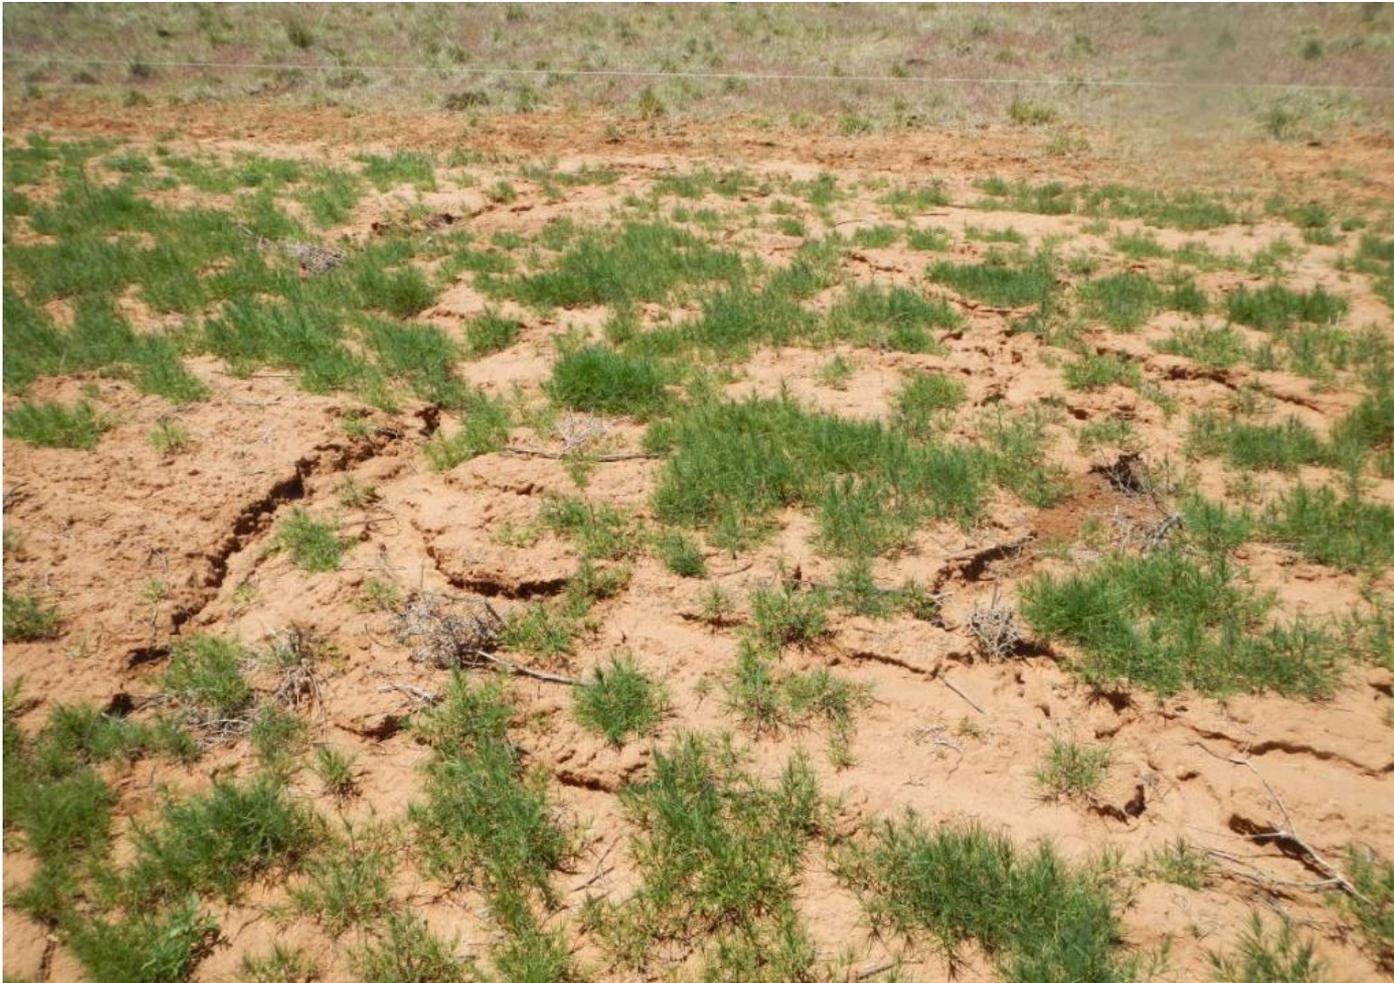
Photo 2. View of more rills in western portion of project area, facing downslope. Green vegetation is Russian thistle seedlings.

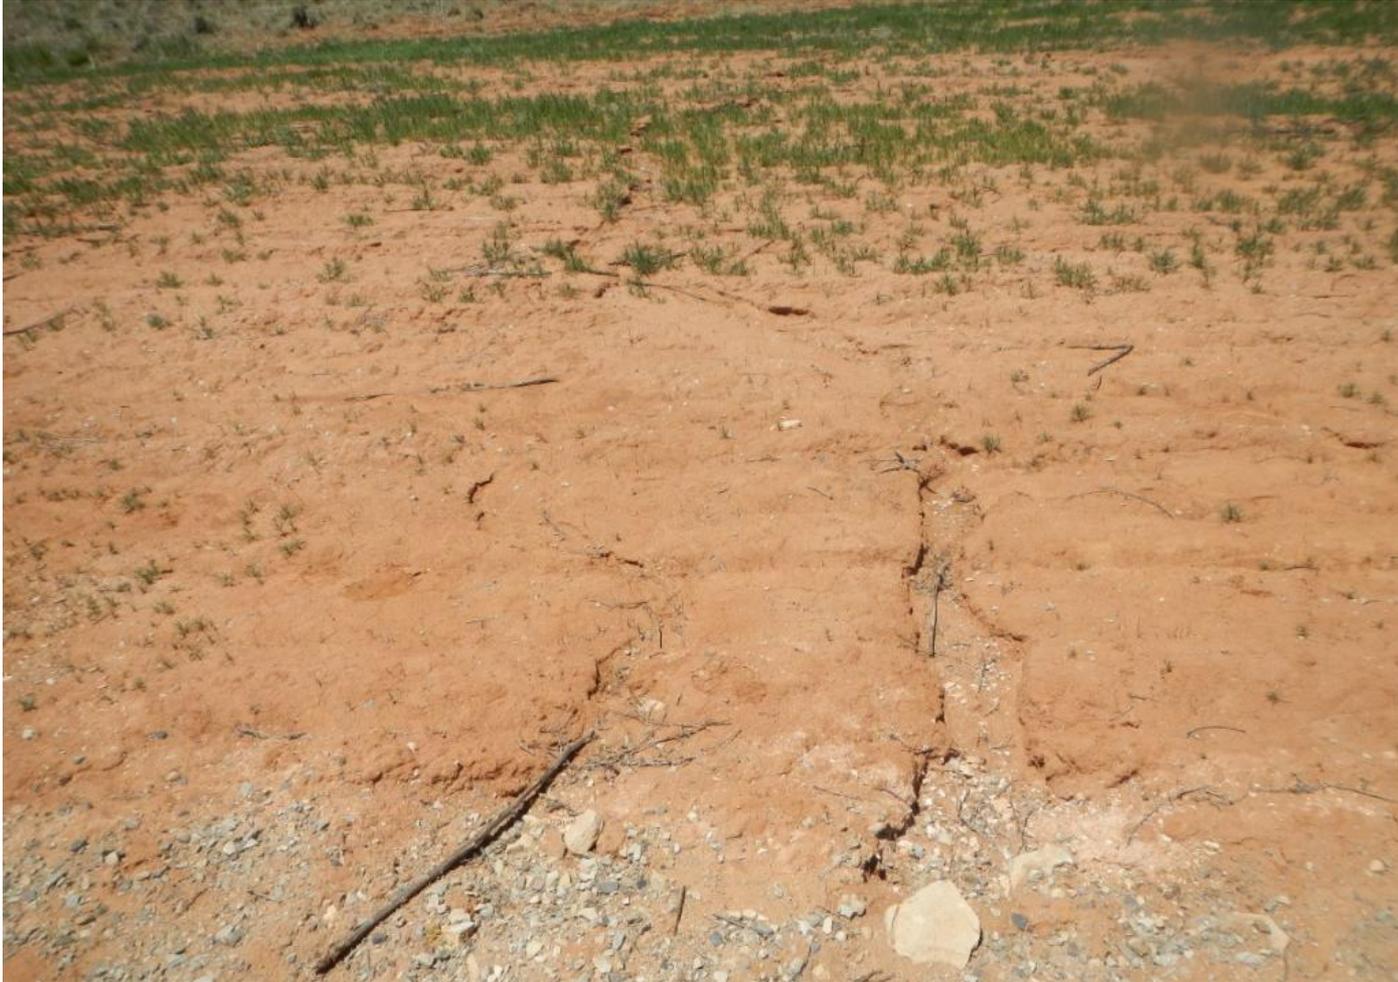
Photo 3. View of more rills coming off of western edge of project area facing downslope.

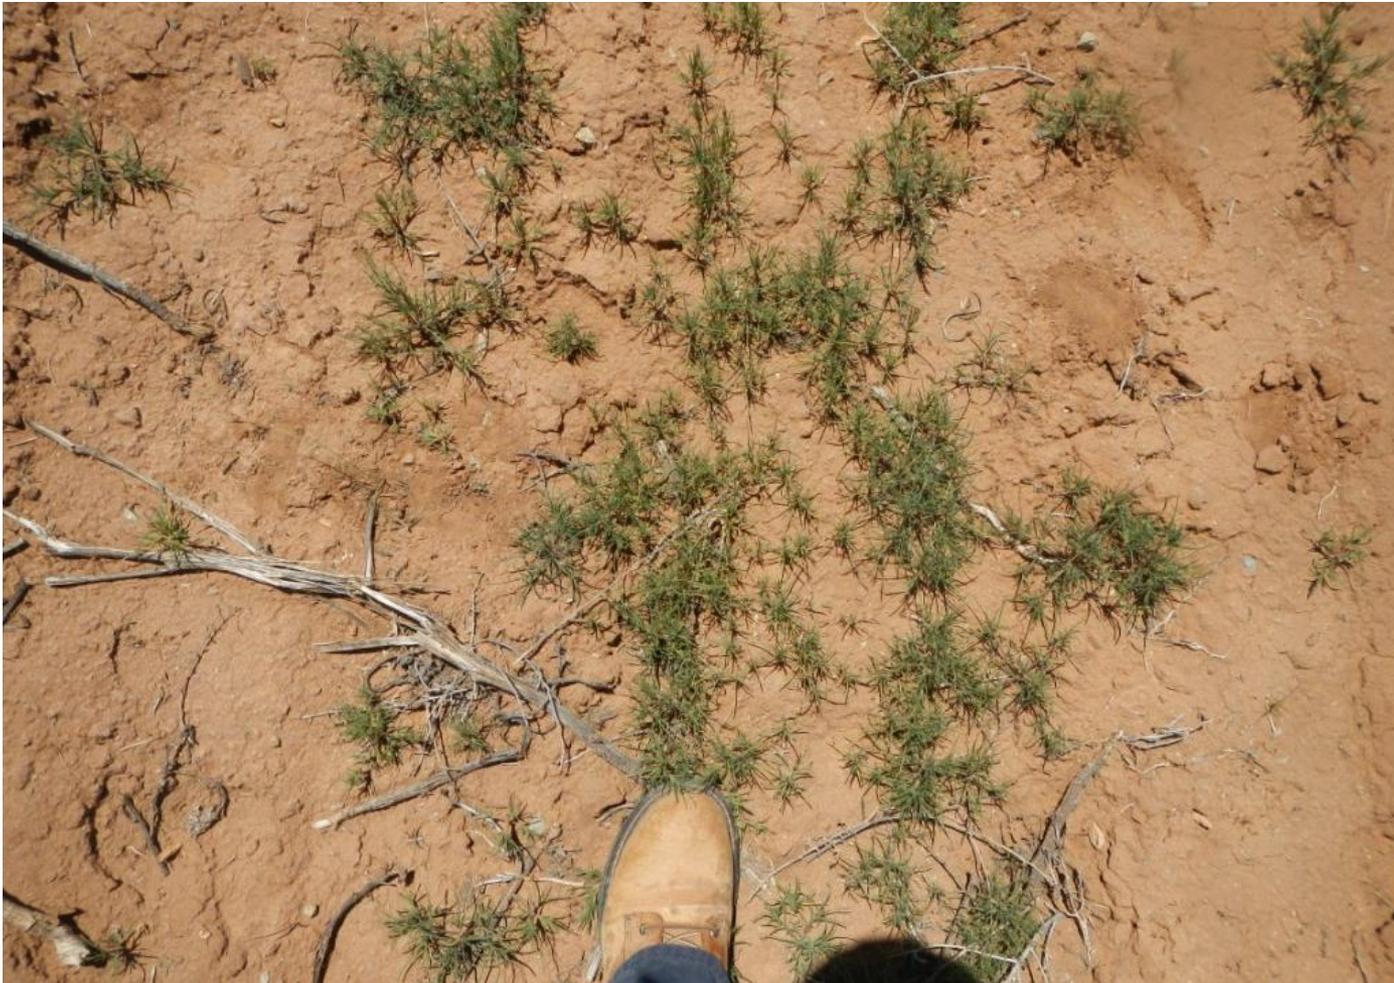
Photo 4. Birdseye view of vegetation within western portion of reclaimed area. Vegetation is largely Russian thistle.

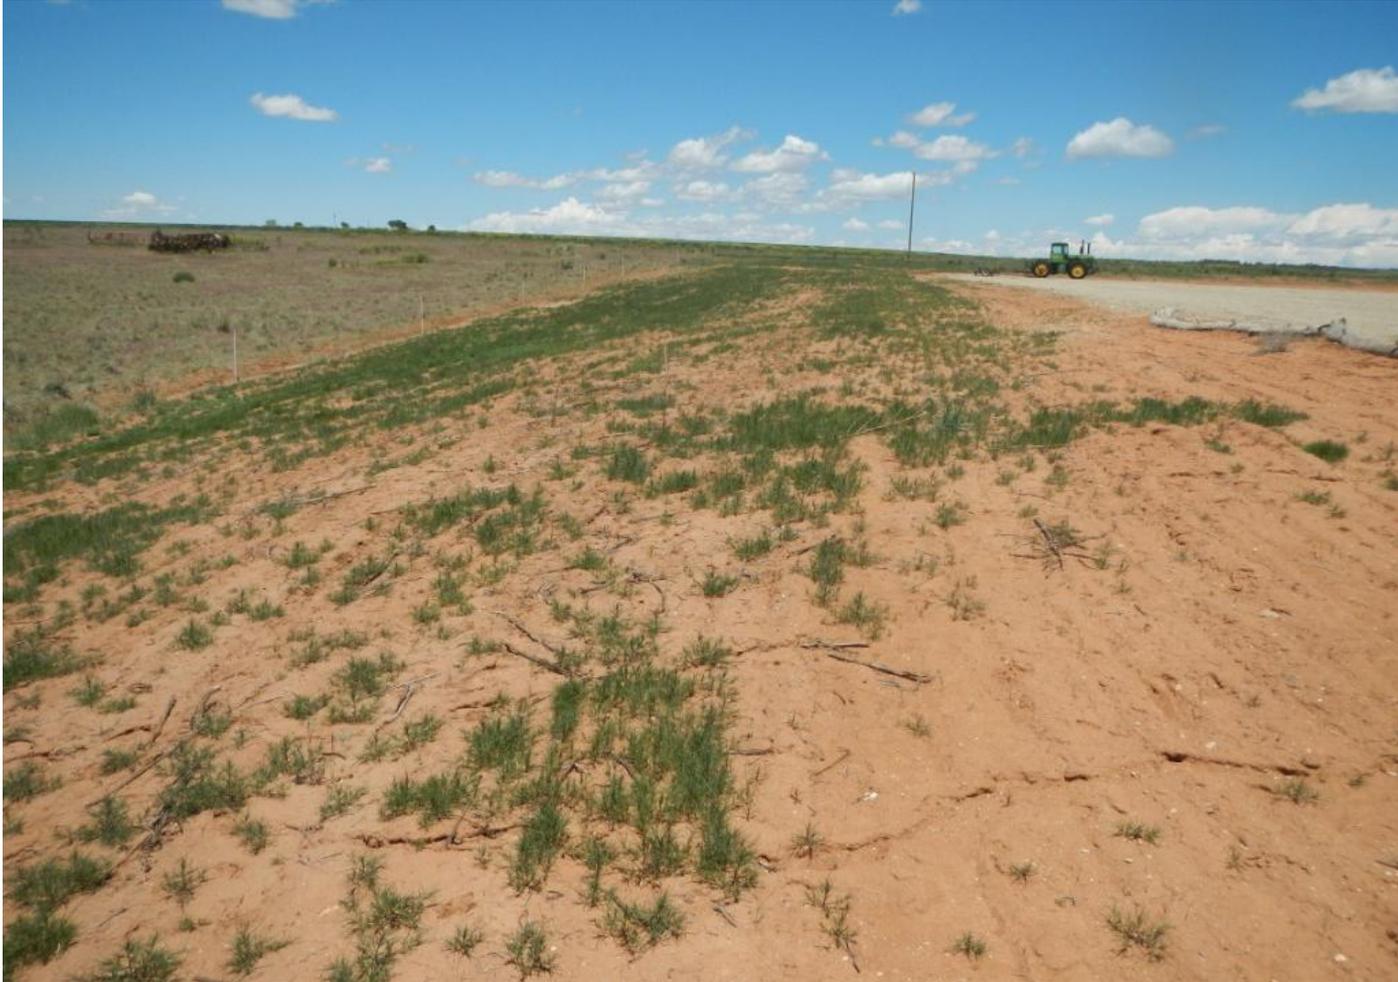
Photo 5. View of western portion of project area from southwestern corner facing northward. Vegetation is largely Russian thistle with scattered grass seedlings and other ruderal vegetation.

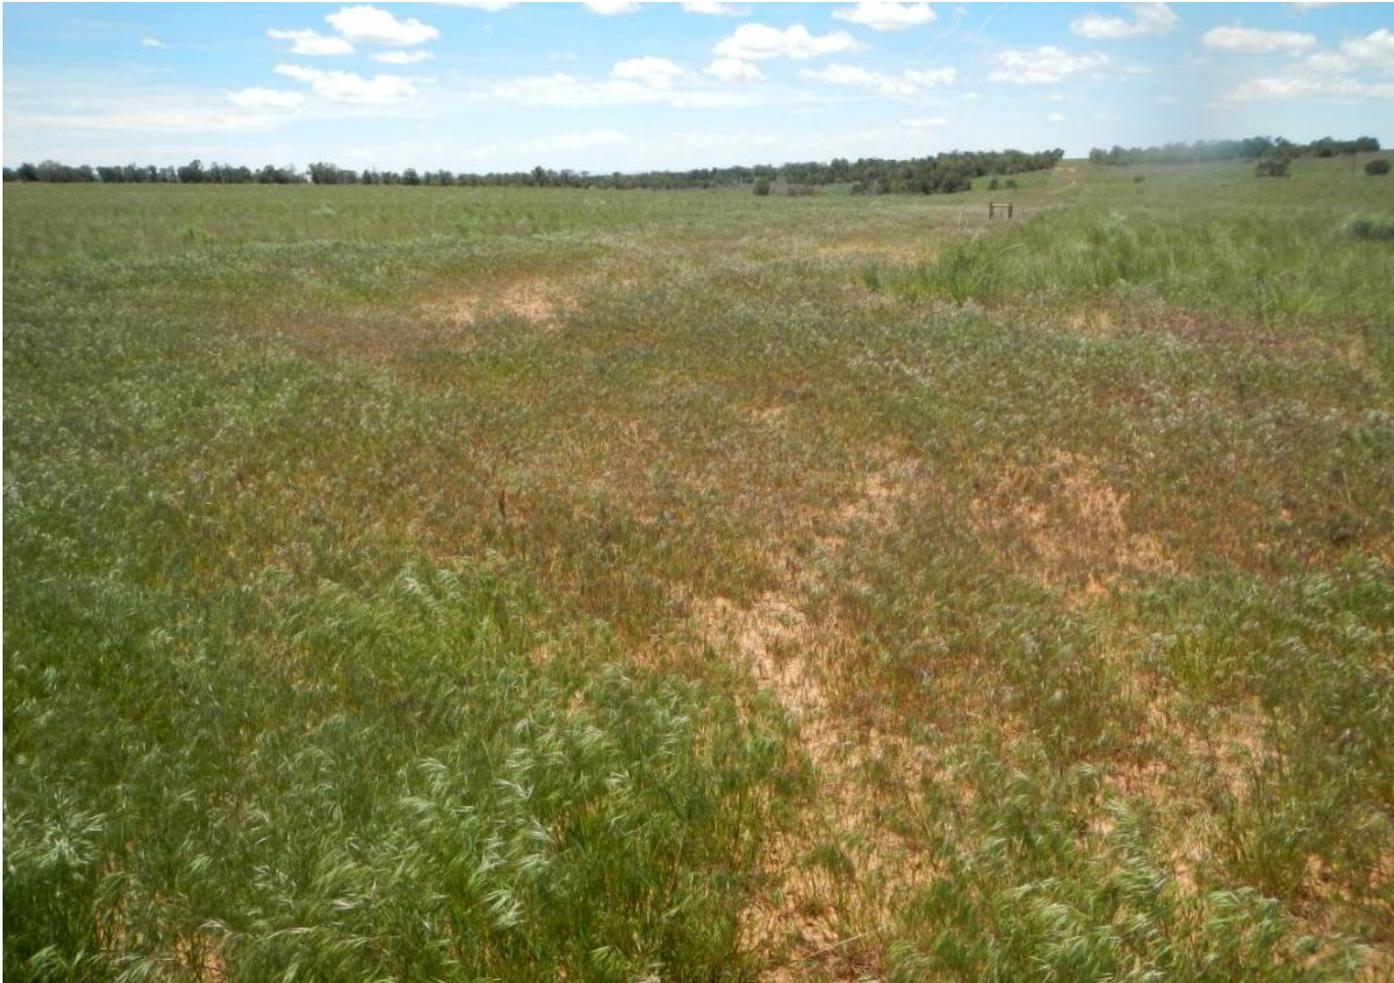
Photo 9. View of unvegetated flowline. Vegetation in flowline is nearly 100 percent cheatgrass (*Bromus tectorum*). Cropland vegetation can be seen on both sides of flowline.
