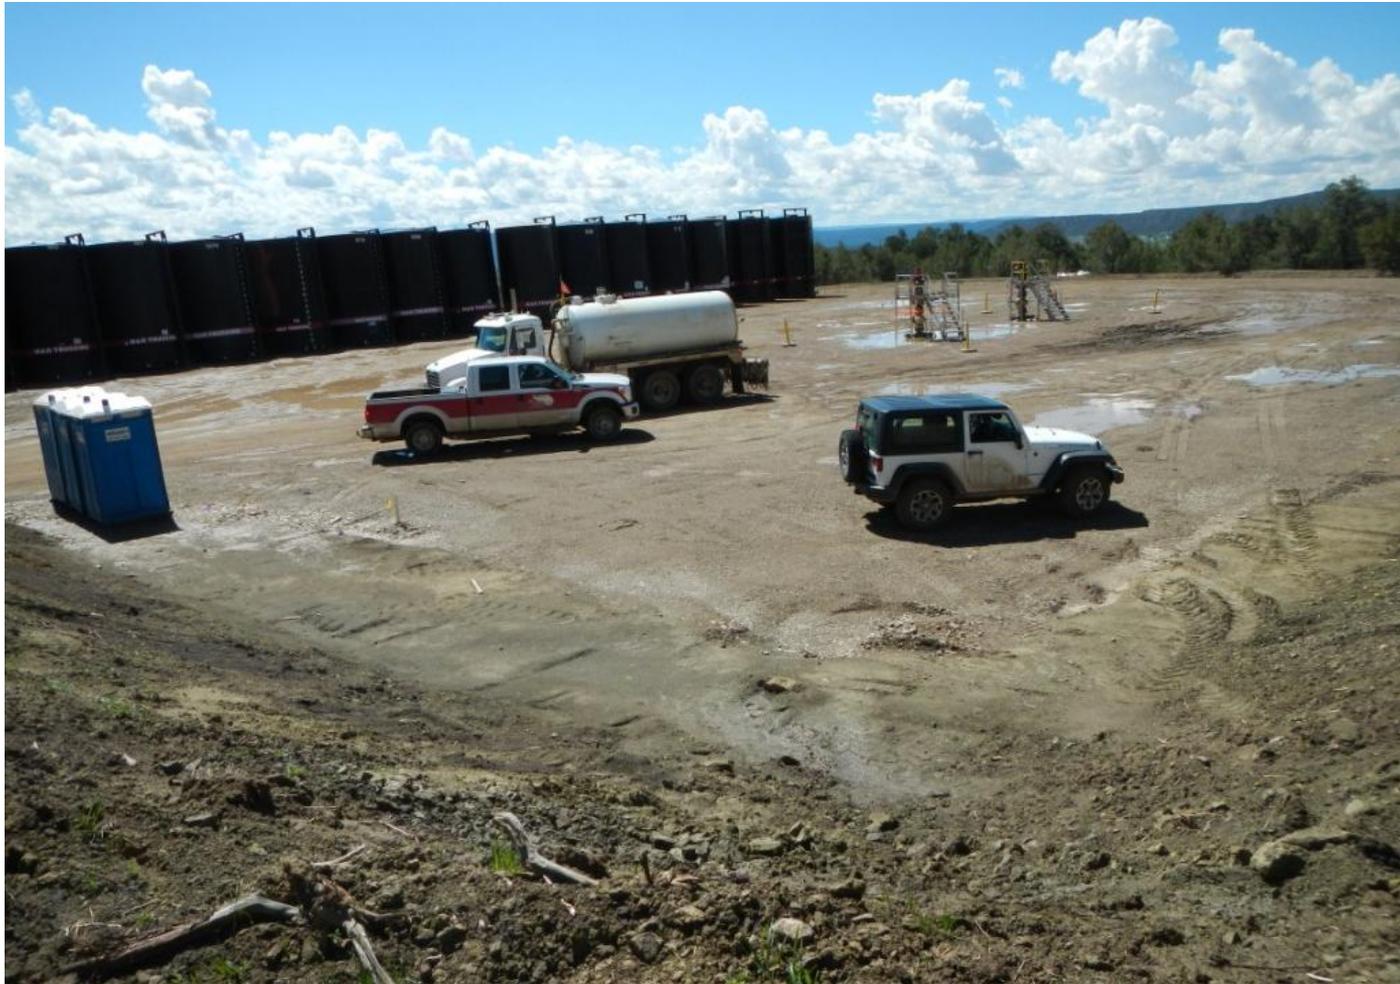
Photo 1. View of project area from northwestern corner facing center.

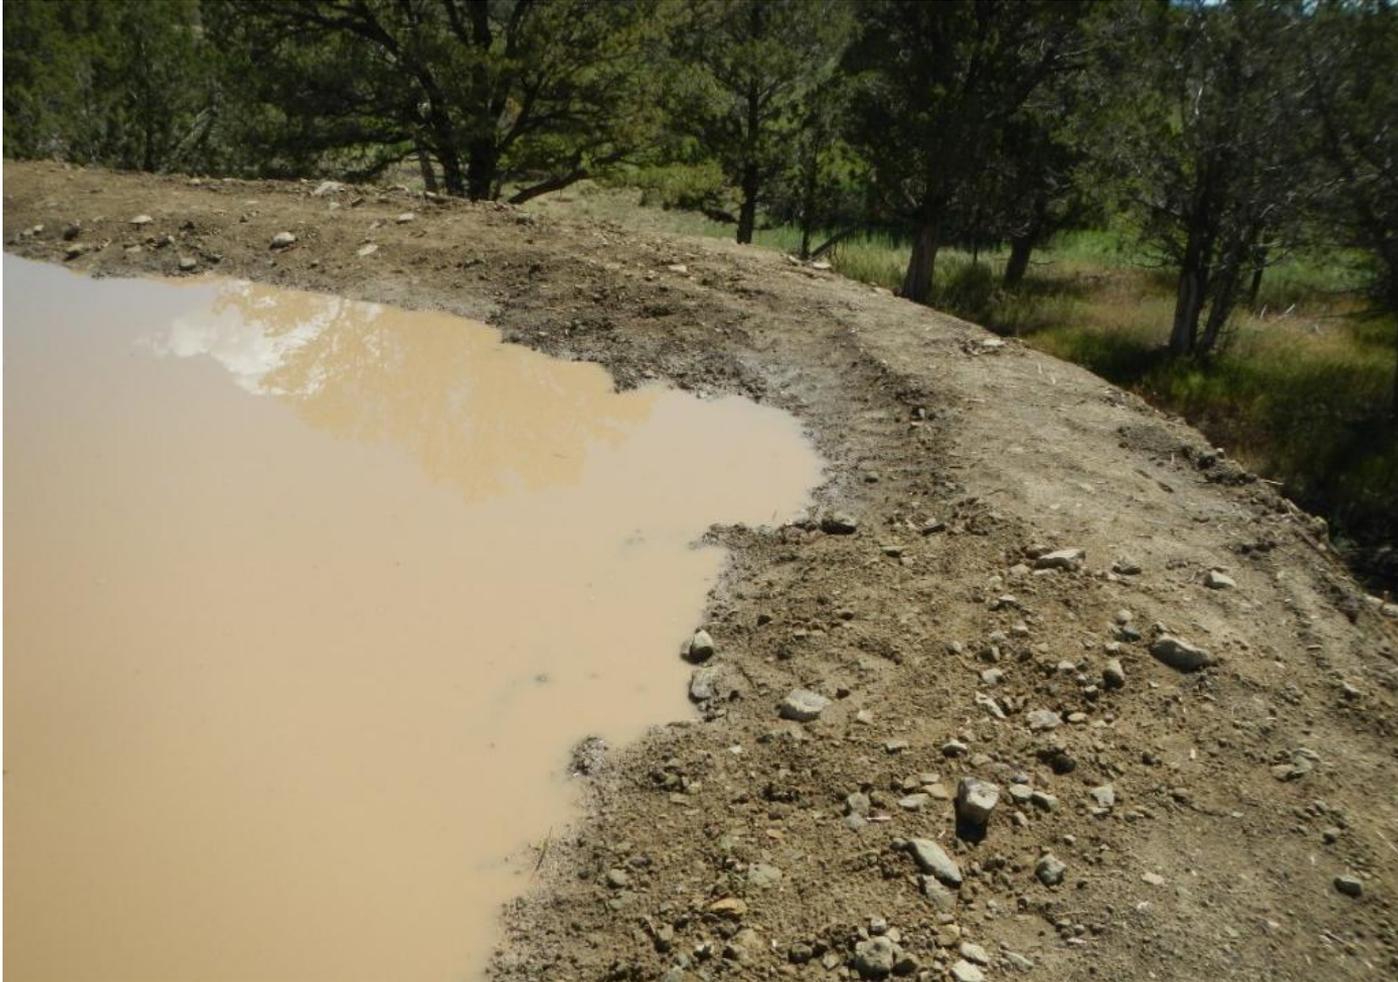
Photo 2. View of stormwater containment in southeastern corner of well pad. This needs to be monitored carefully and deepened and/or reinforced if stormwater continues to accumulate here.

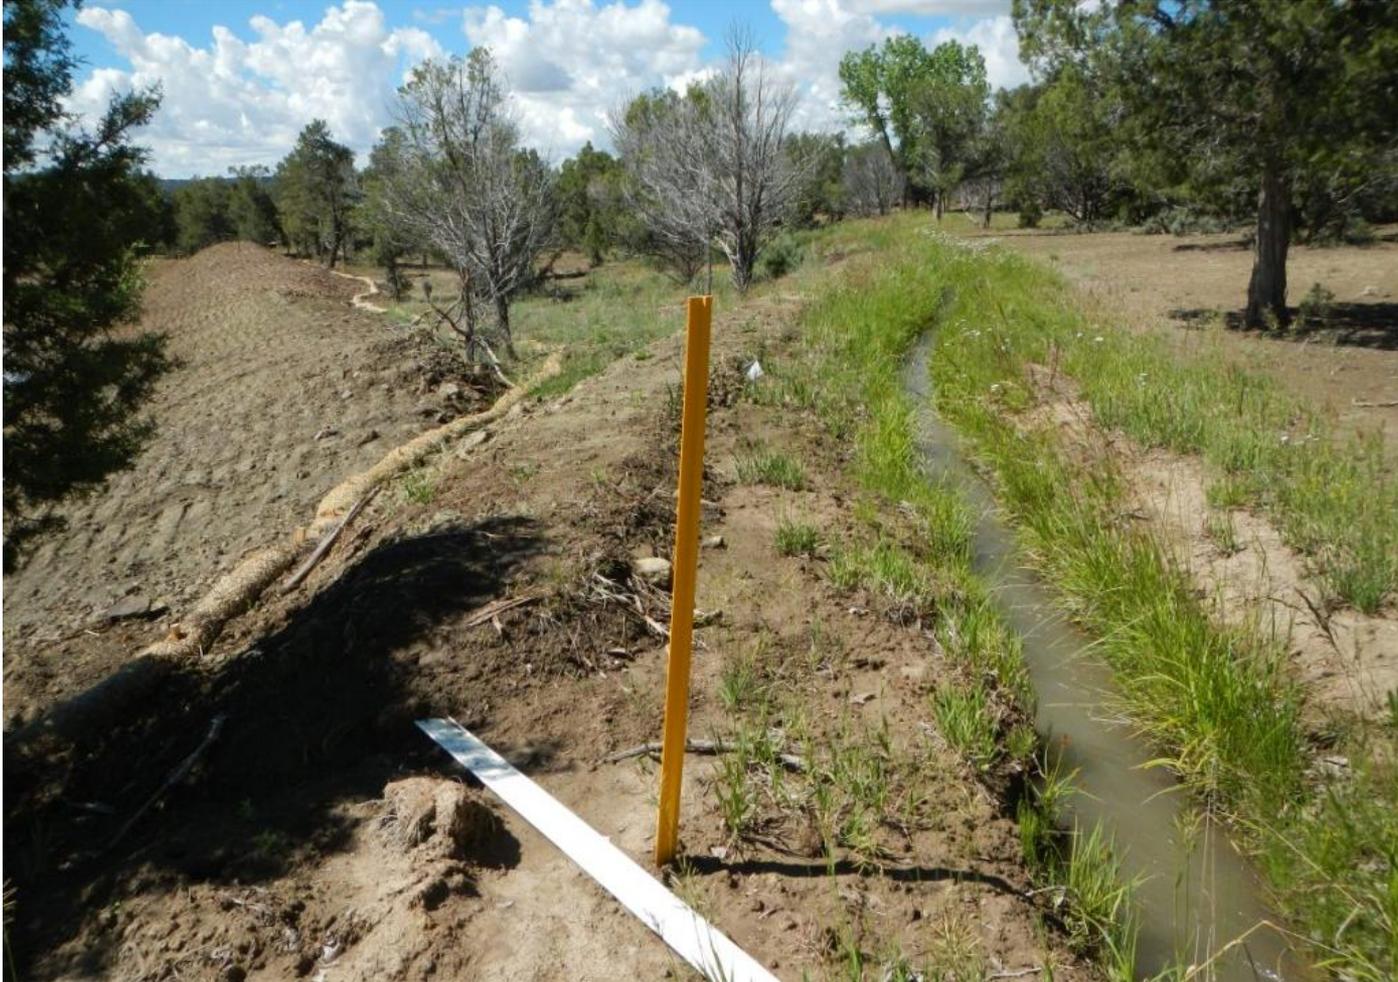
Photo 3. View of irrigation ditch in northwestern corner of project area facing southward.

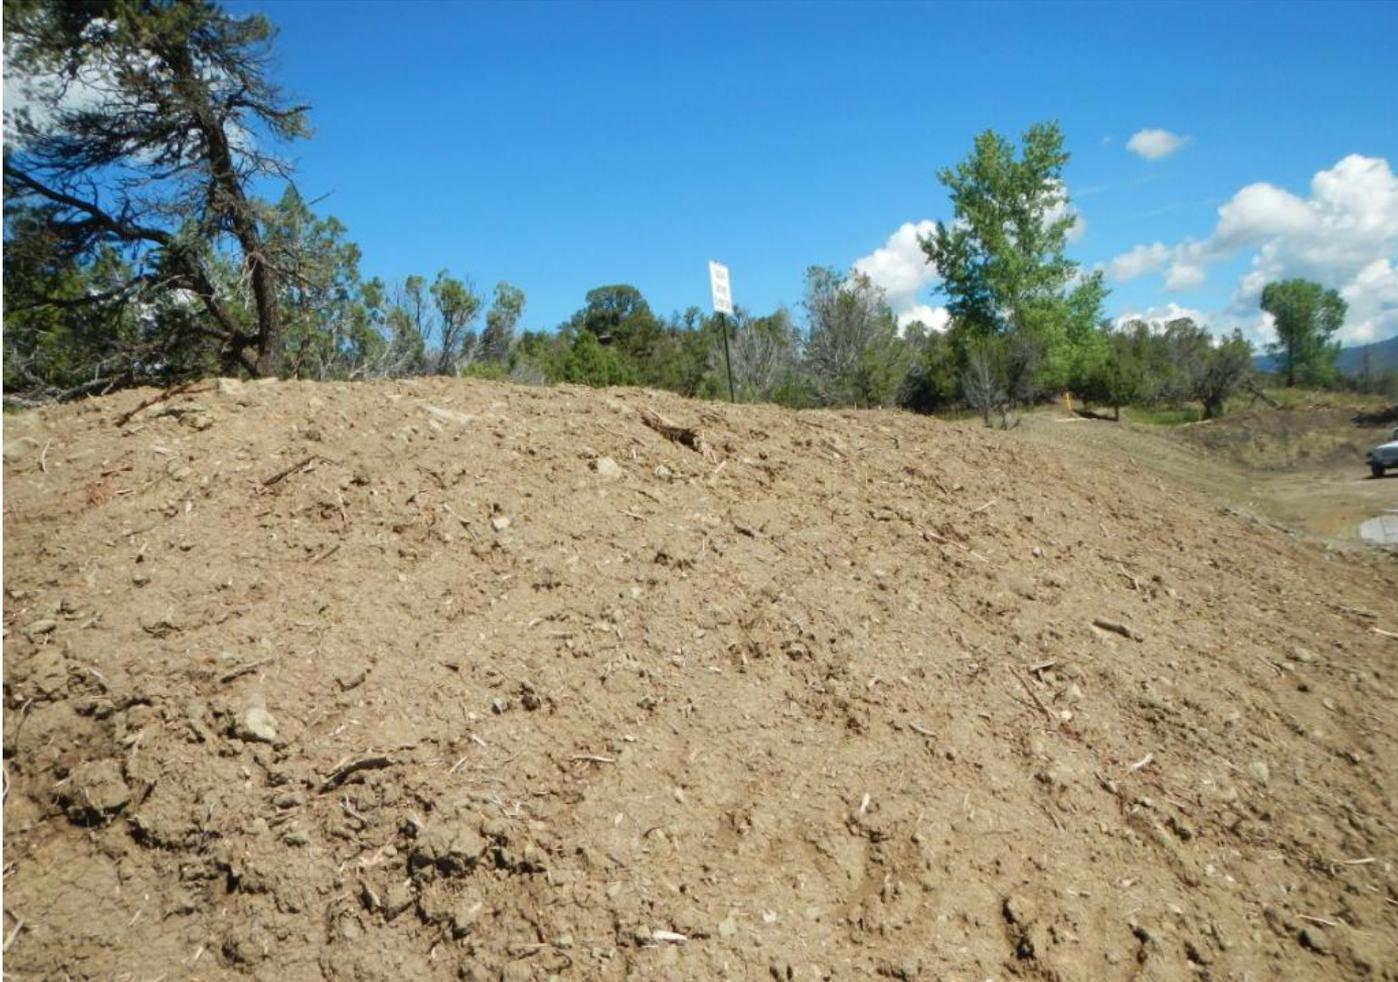
Photo 4. View of topsoil stockpile within western portion of project area facing northward.

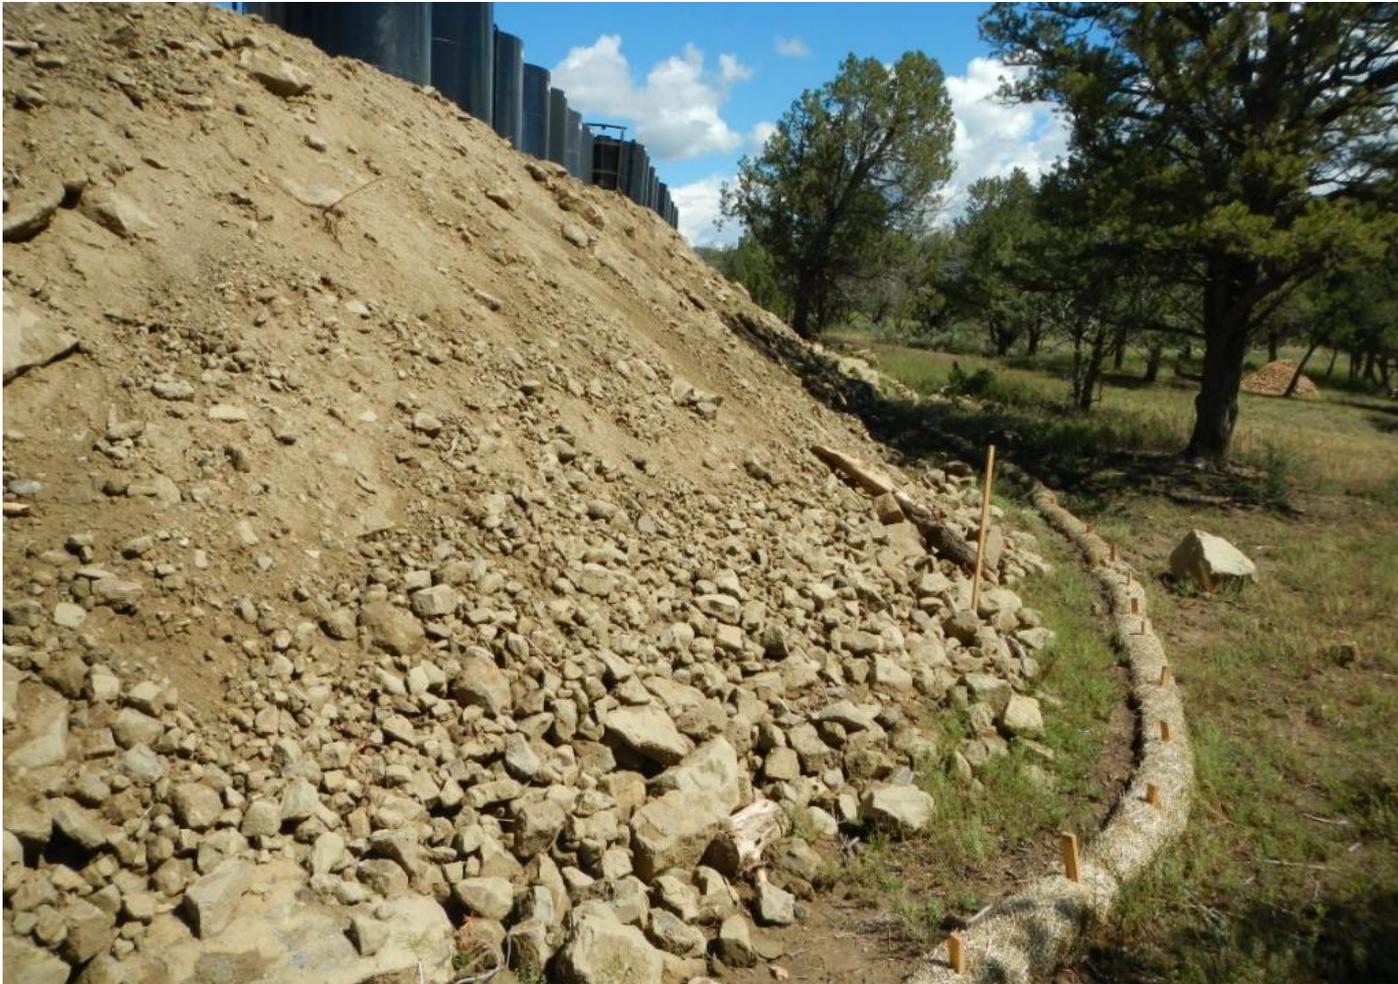
Photo 5. View of eastern edge of project area from southeastern corner facing northward. Perimeter straw wattles appear to be effectively filtering stormwater flows at this time.

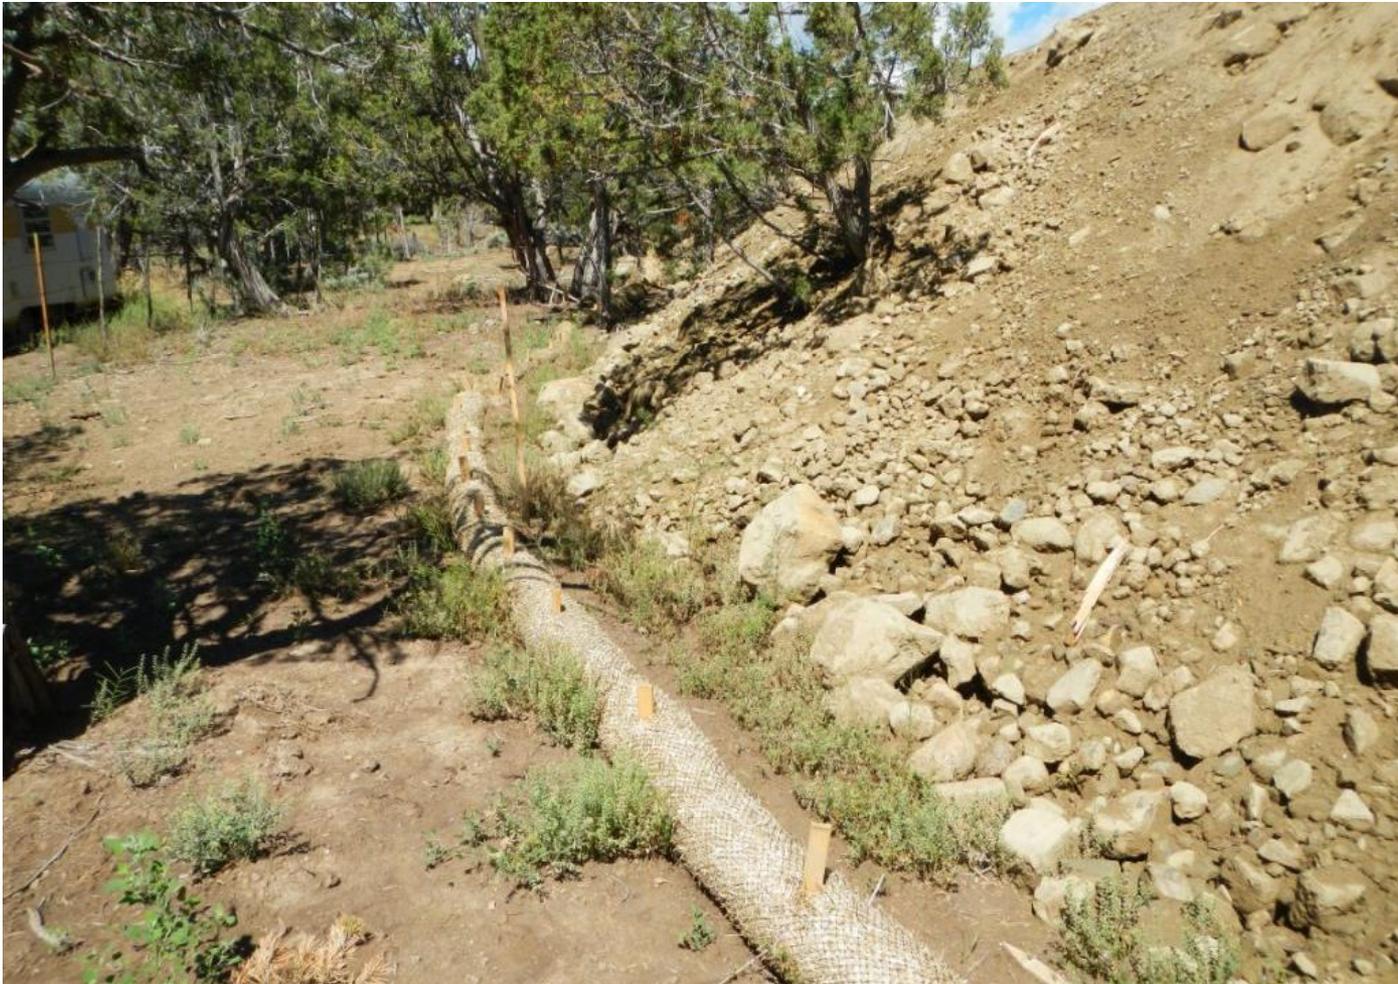
Photo 6. View of southern edge of project area from southeastern corner facing westward. Perimeter straw wattles appear to be effectively filtering stormwater flows at this time.

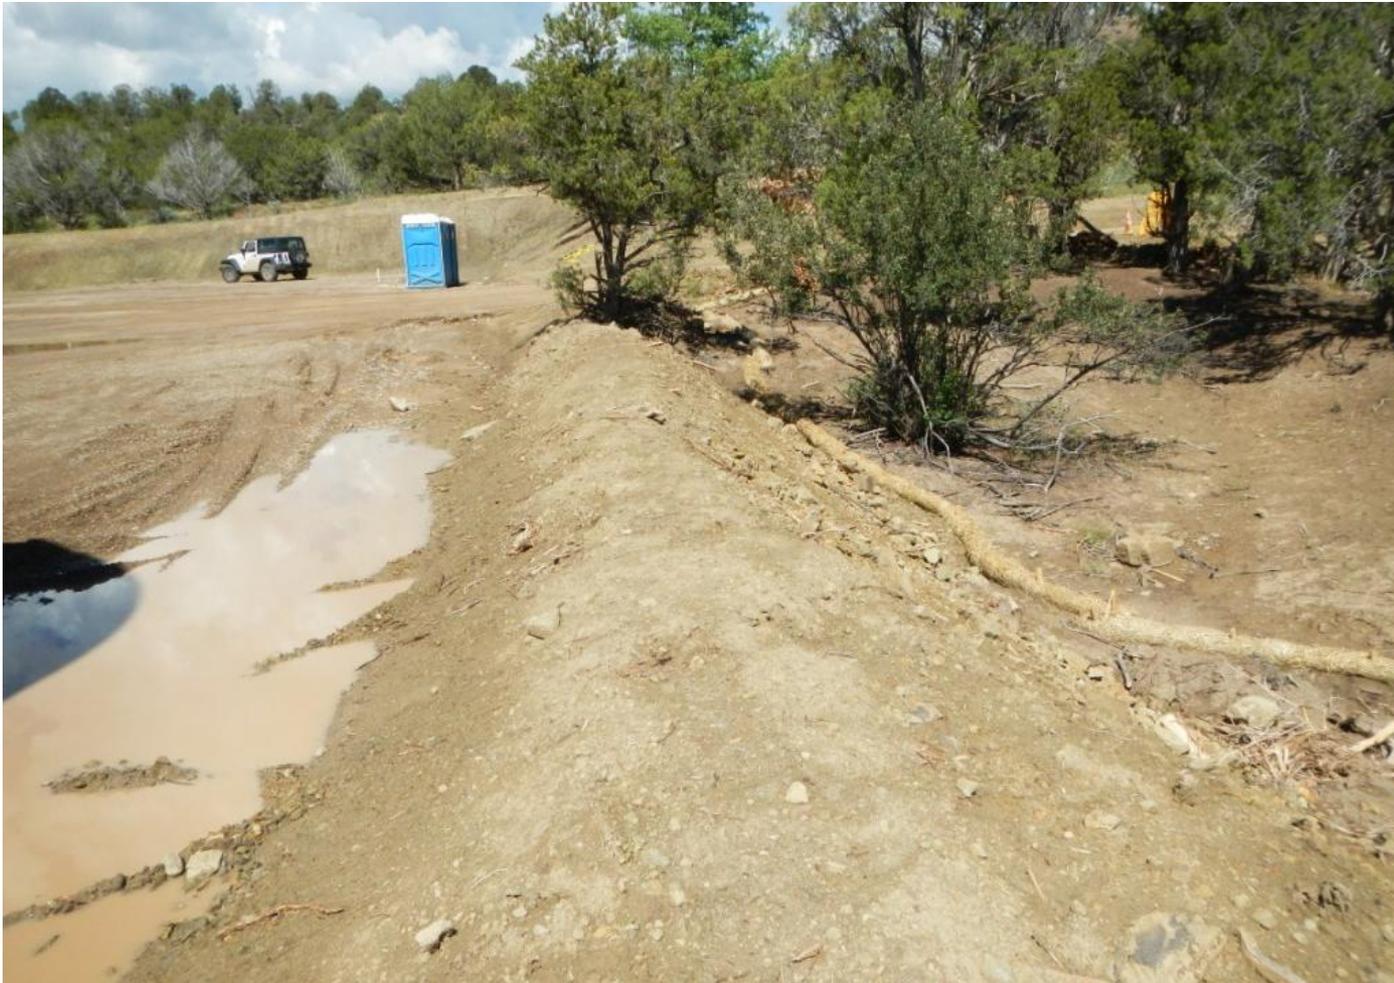
Photo 7. View of northern edge of project area from northeastern corner facing westward.

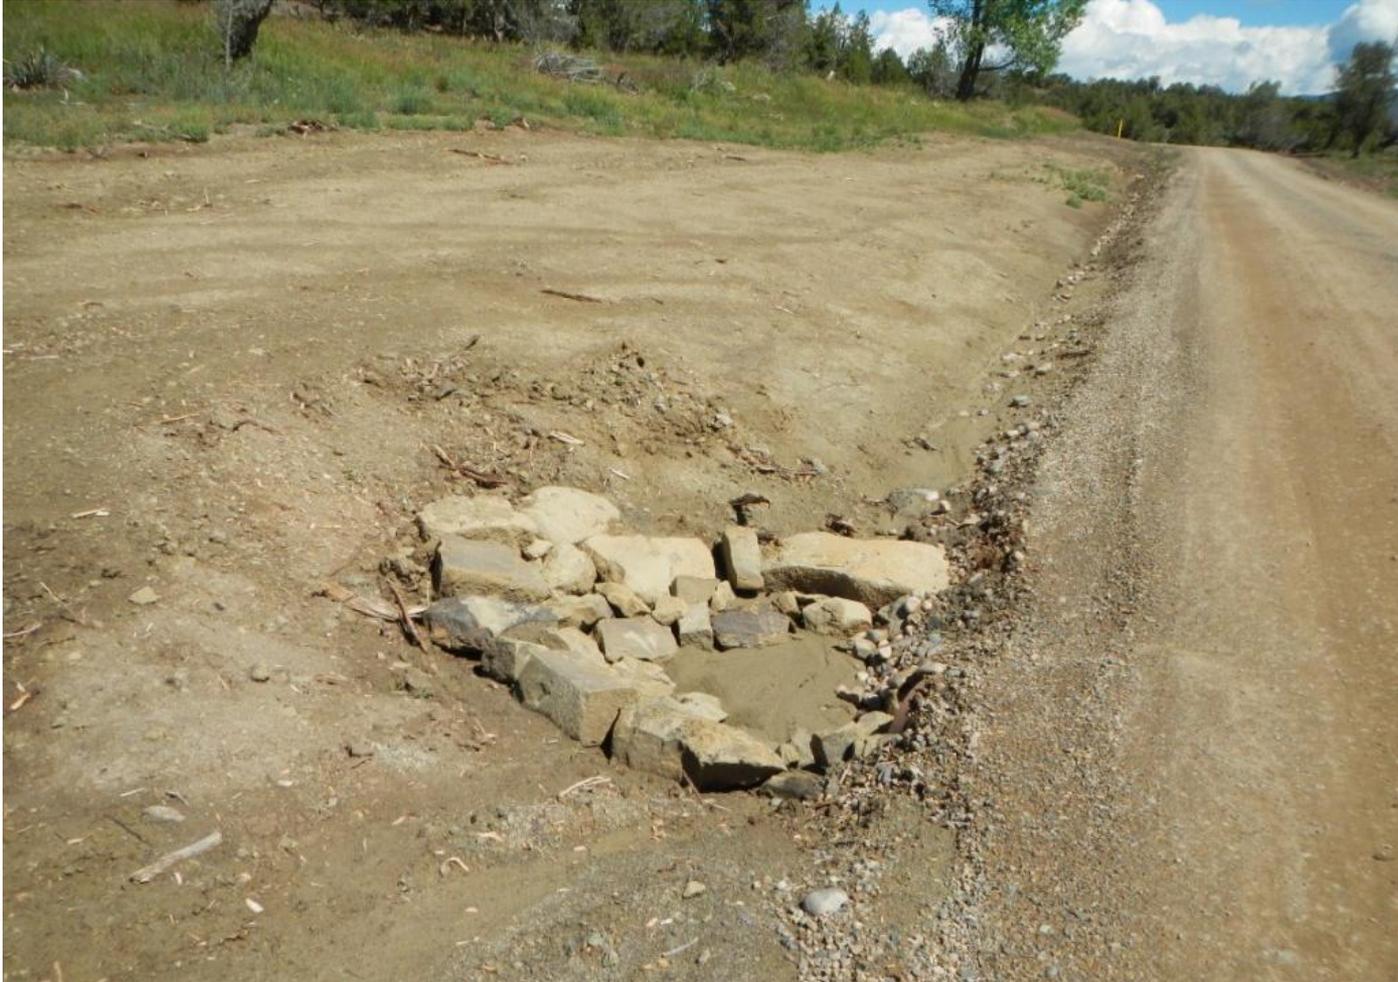
Photo 8. View of culvert inlet along access road. Sediment is accumulating in the inlet basin and will soon need maintenance.
