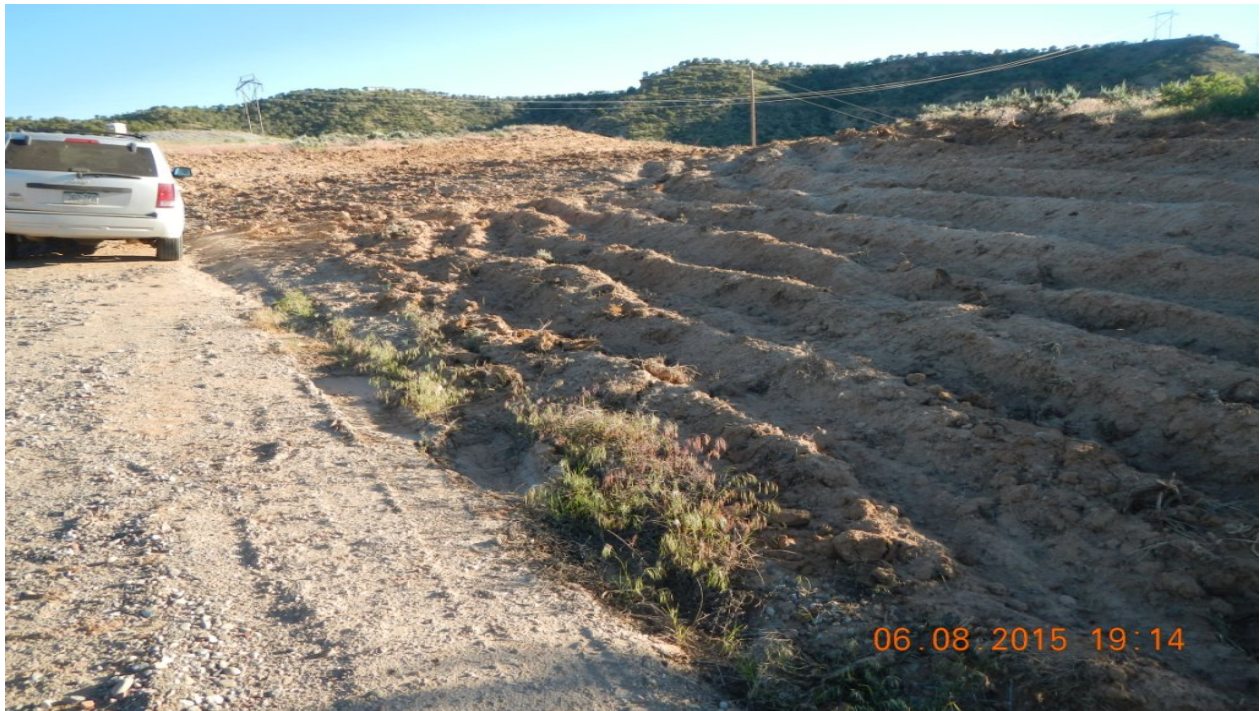
**photo 1:** Prior to reclamation activities facing southwest off of the main access road.

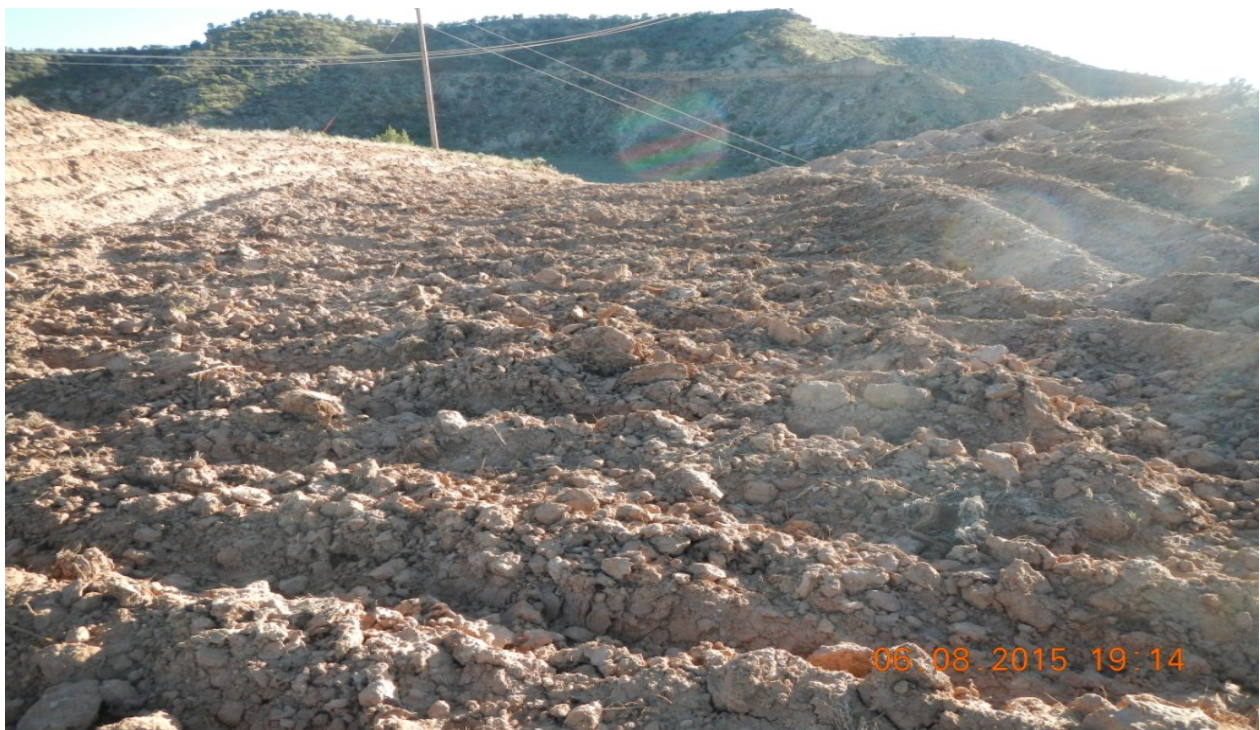
**photo 2:** Facing west along the the recontoured access road to the Arroyo 9-16.

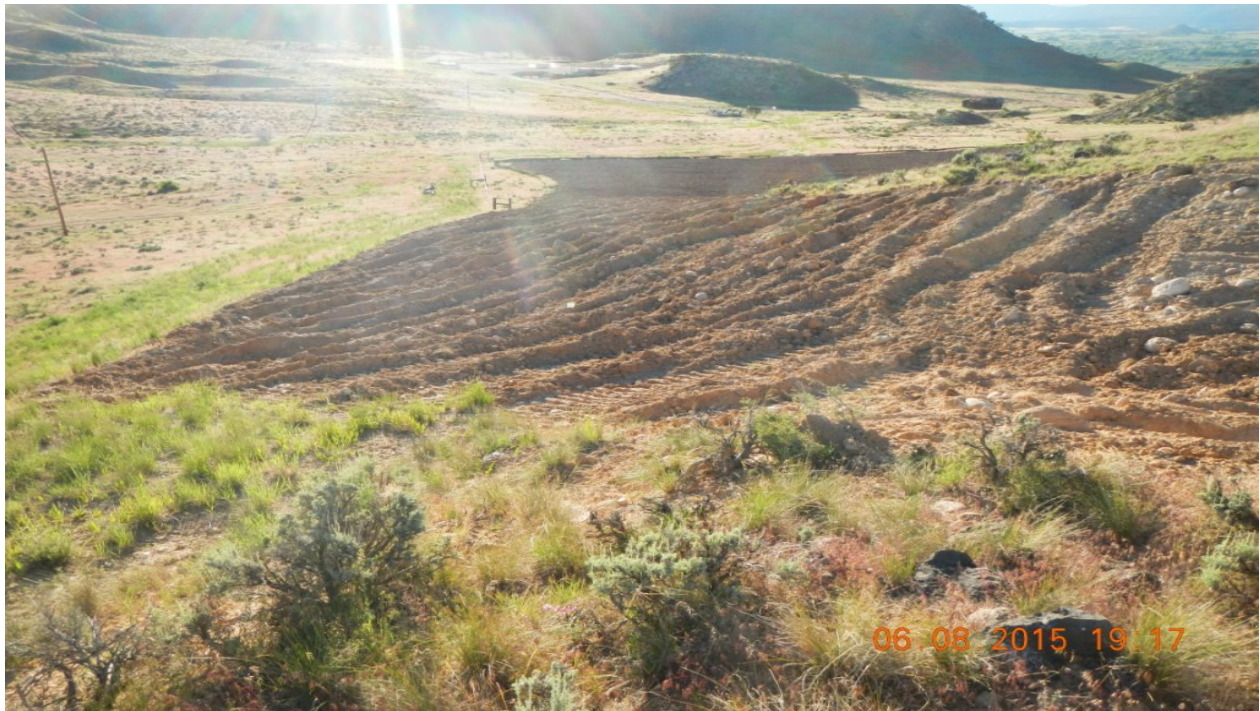
**photo 3:** Facing northwest towards the location prior to reclamation activities.

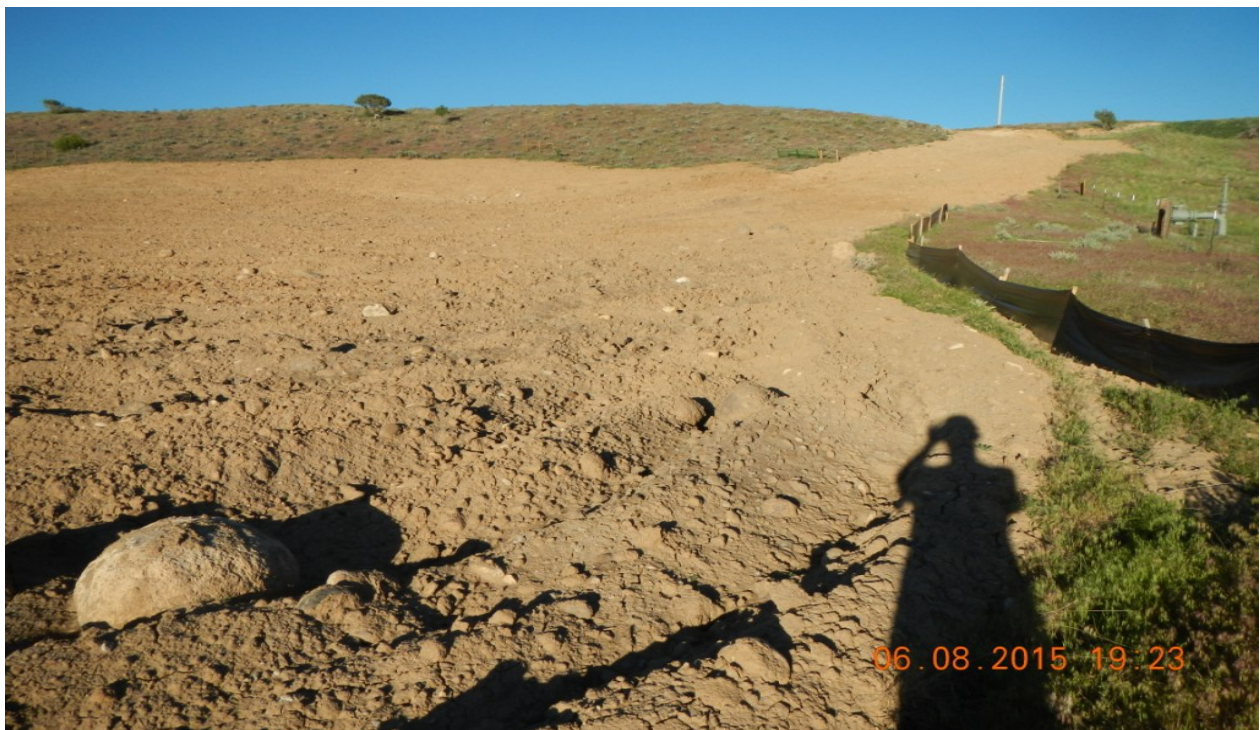
**photo 4:** Facing east from the southwest corner of the location.

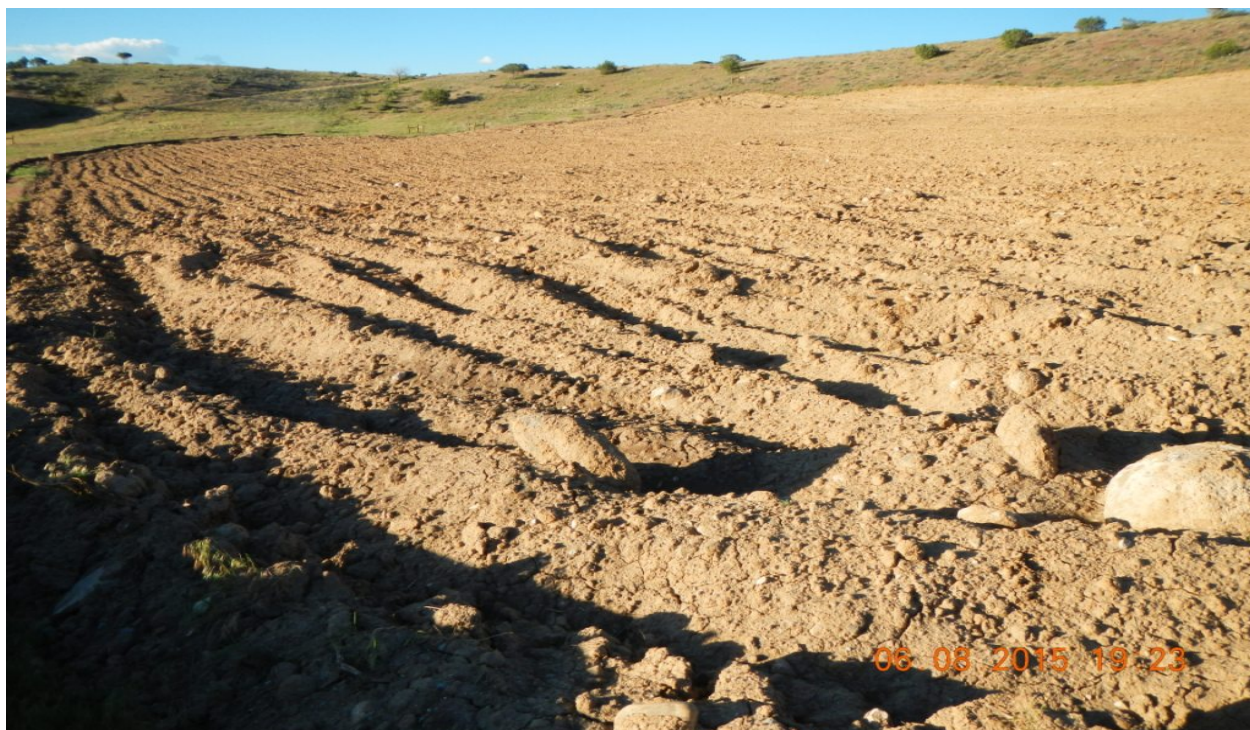
**photo 5:** Facing northeast from the southwest corner of the location.

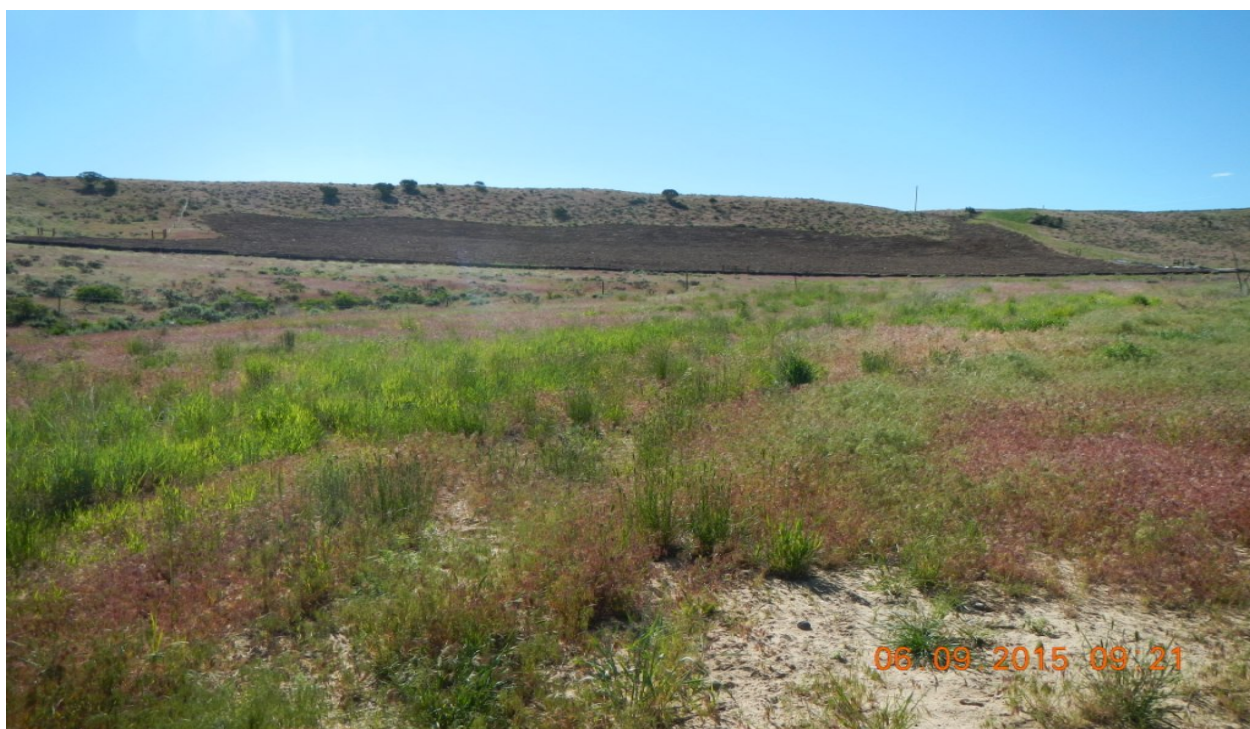
**photo 6:** Facing east towards the location.

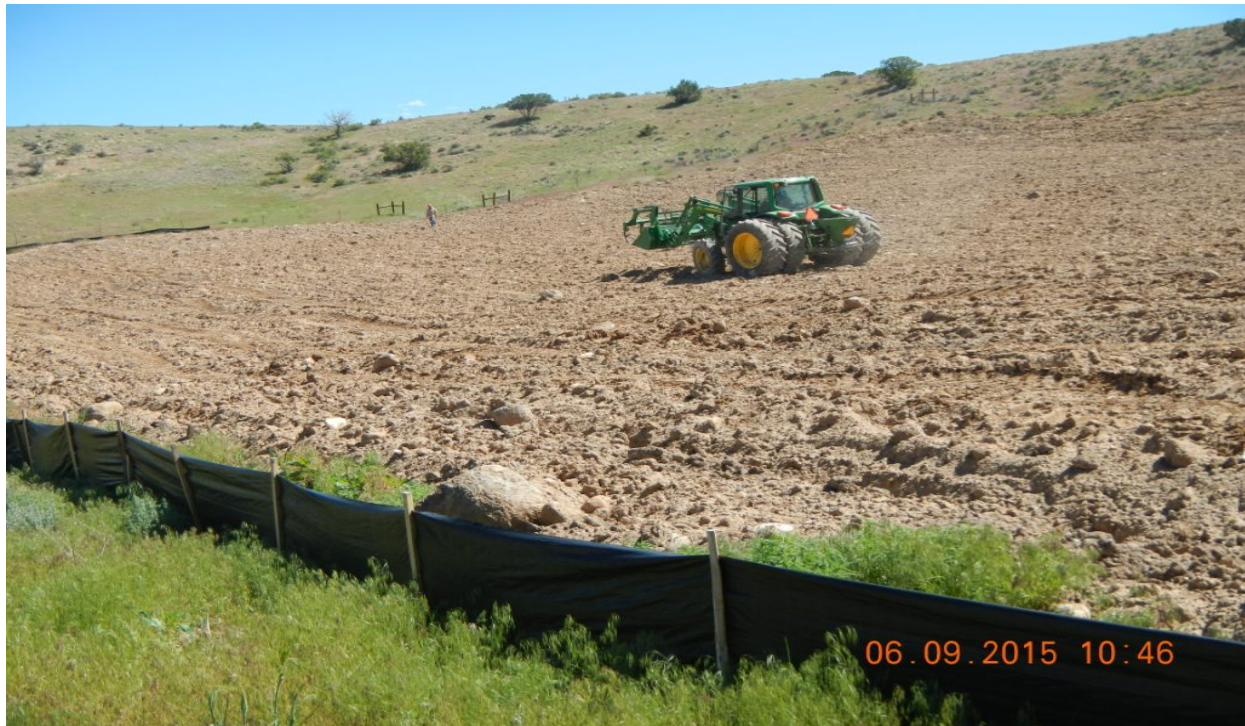
**photo 7:** Reclamation activities beginning with fertilizer application.

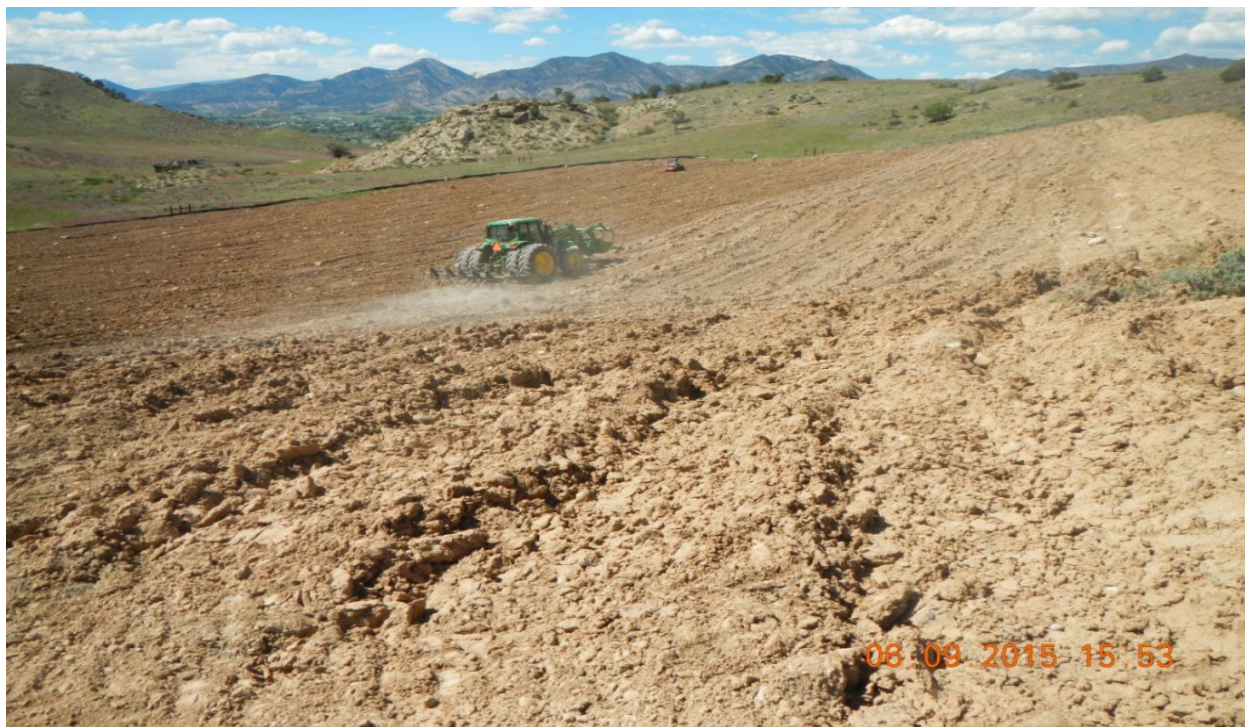
**photo 8:** The location was then disced to incorporate the fertilizer and prepare the soil for seeding.

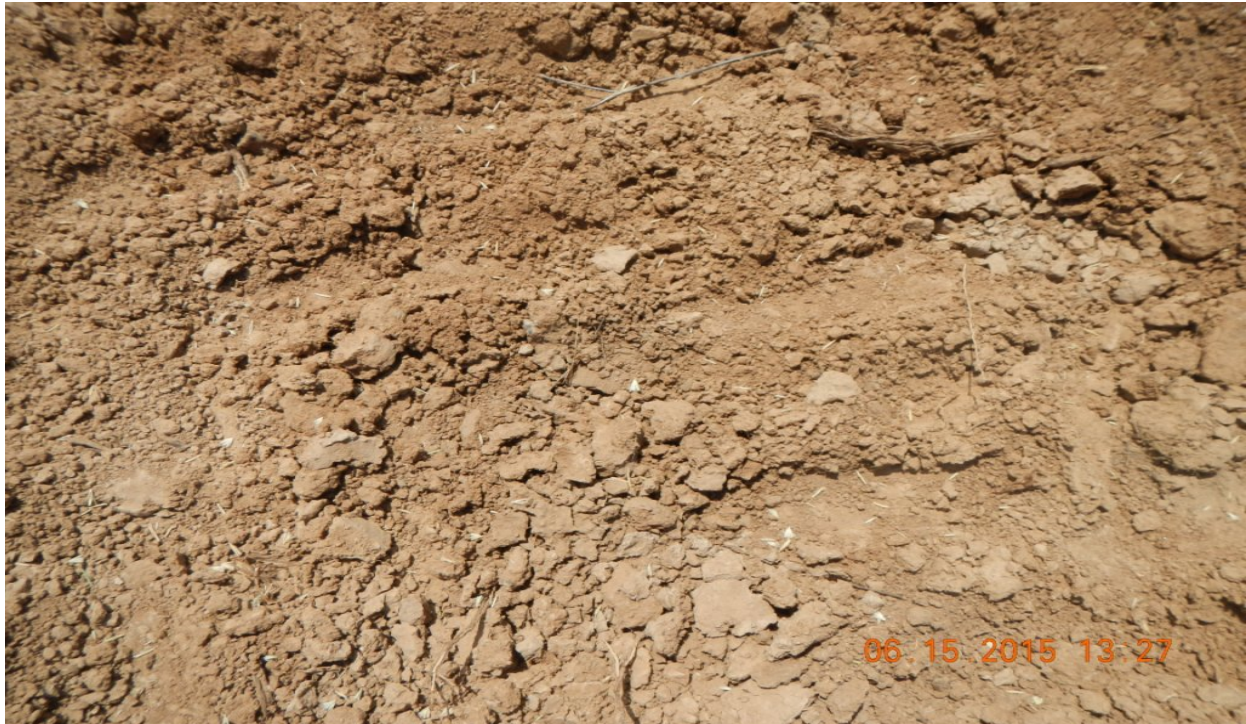
**photo 9:** Broadcast seeding was then performed throughout the location.

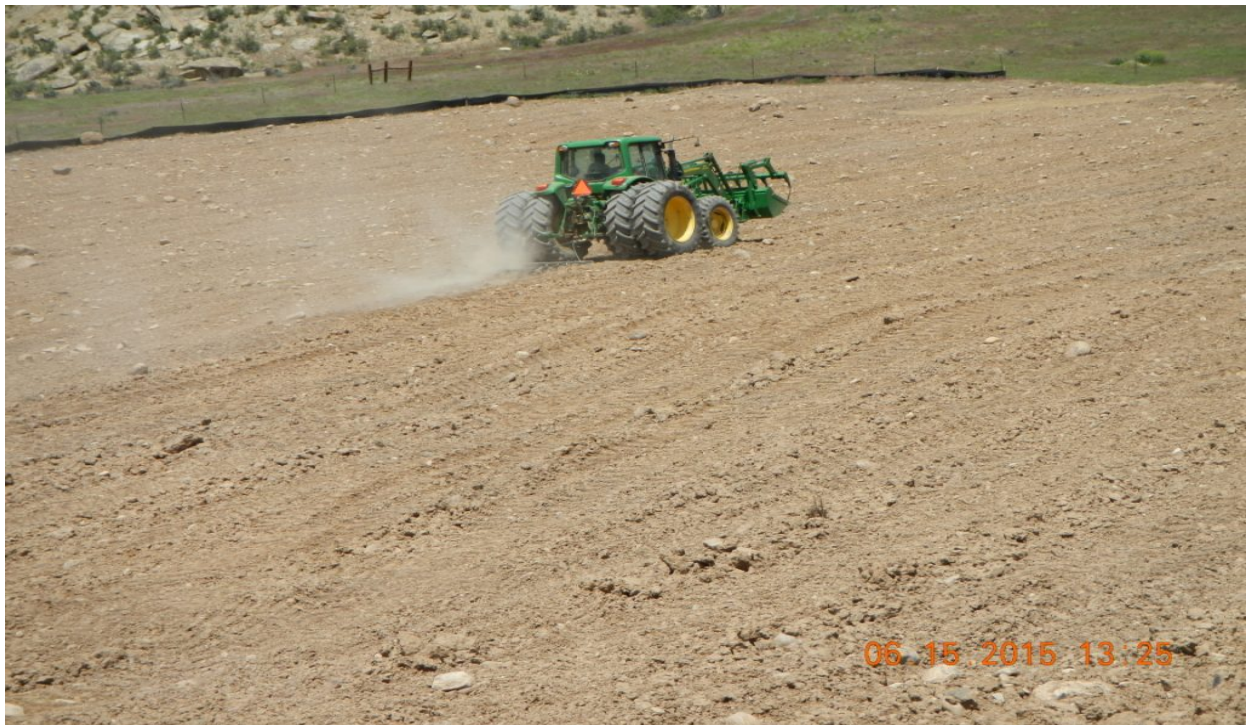
**photo 10:** Following seeding, a harrow was used to ensure proper seed soil contact.

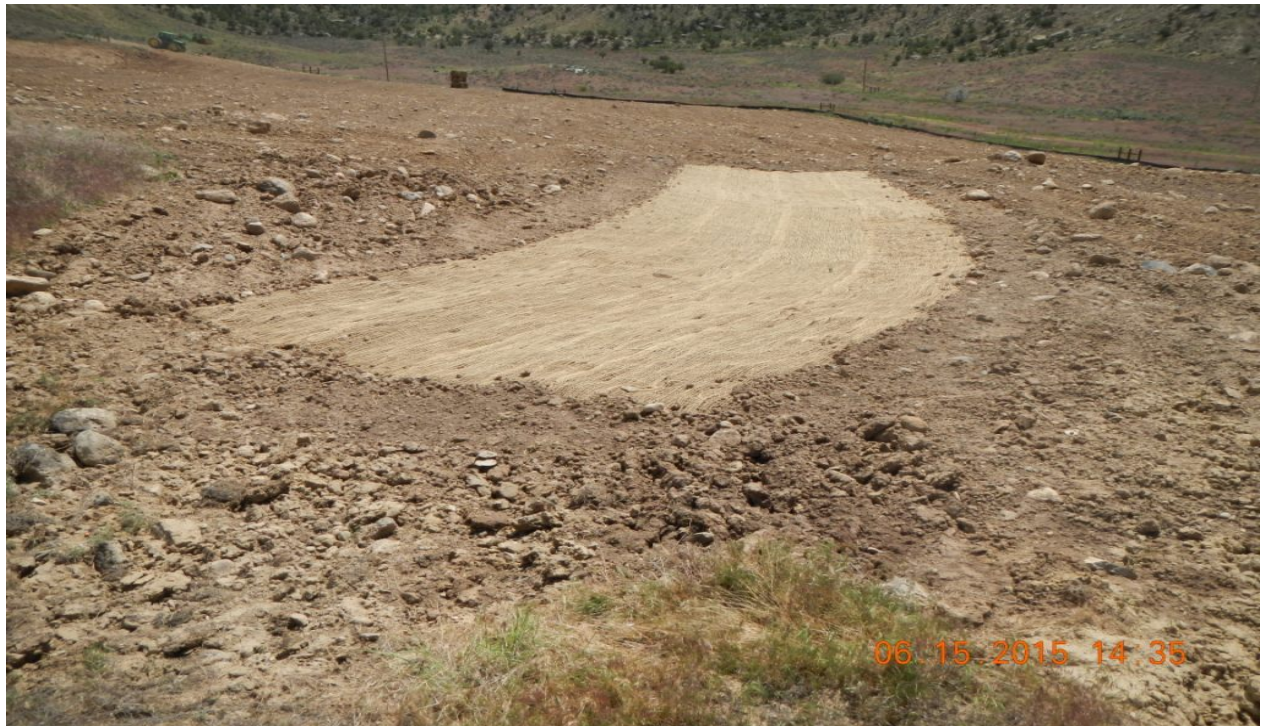
**photo 11:** A jute blanket was installed at the north side of the location.

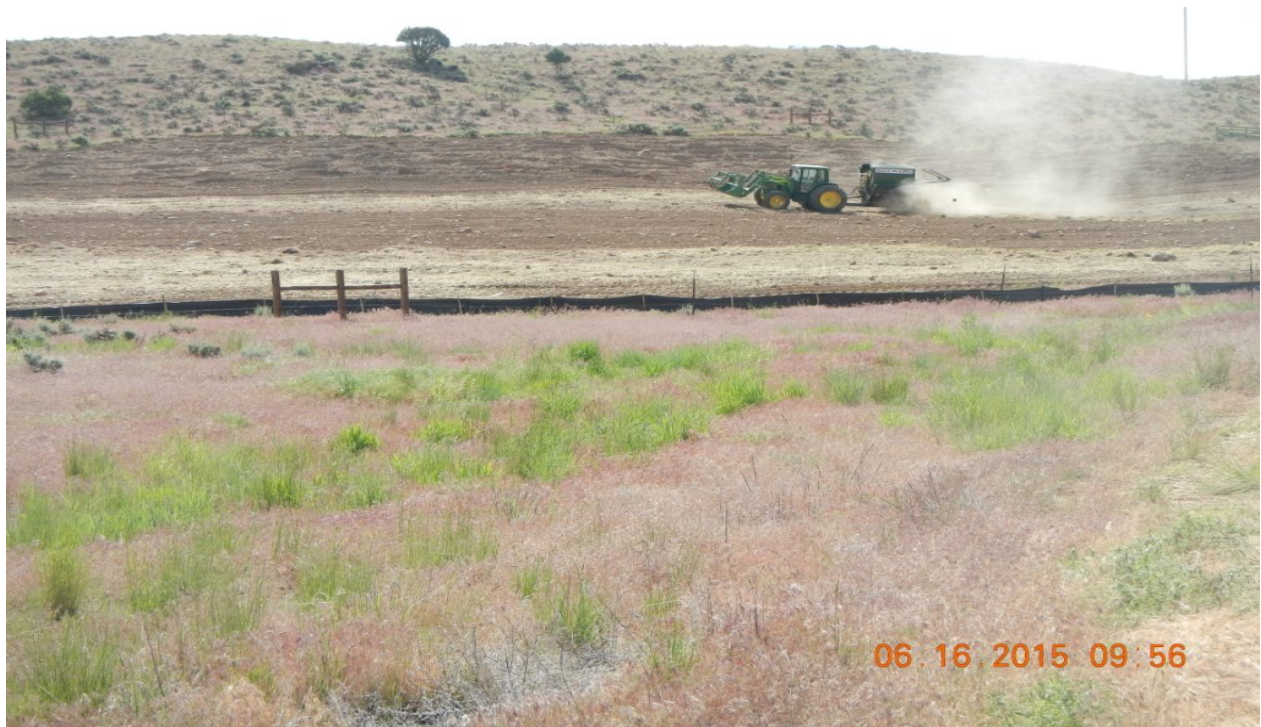
**photo 12:** All disturbed areas of the location were then mulched with certified hay.

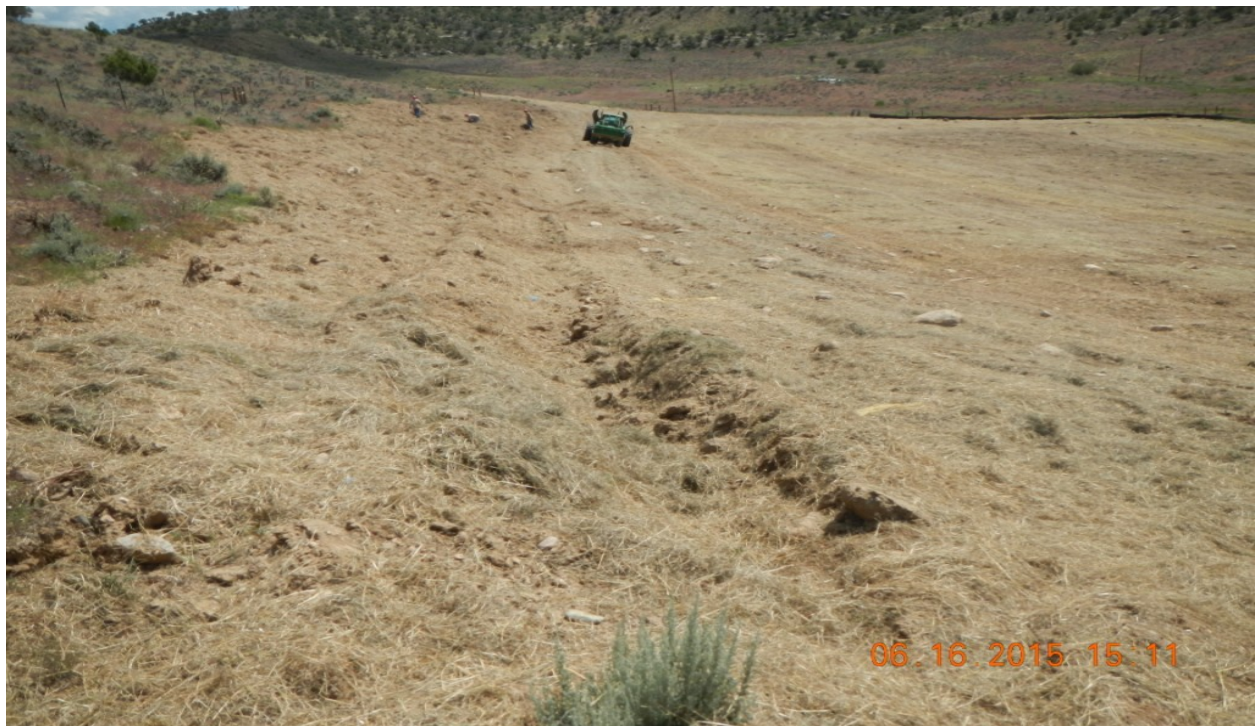
**photo 13:** Northeast corner of the location facing south.

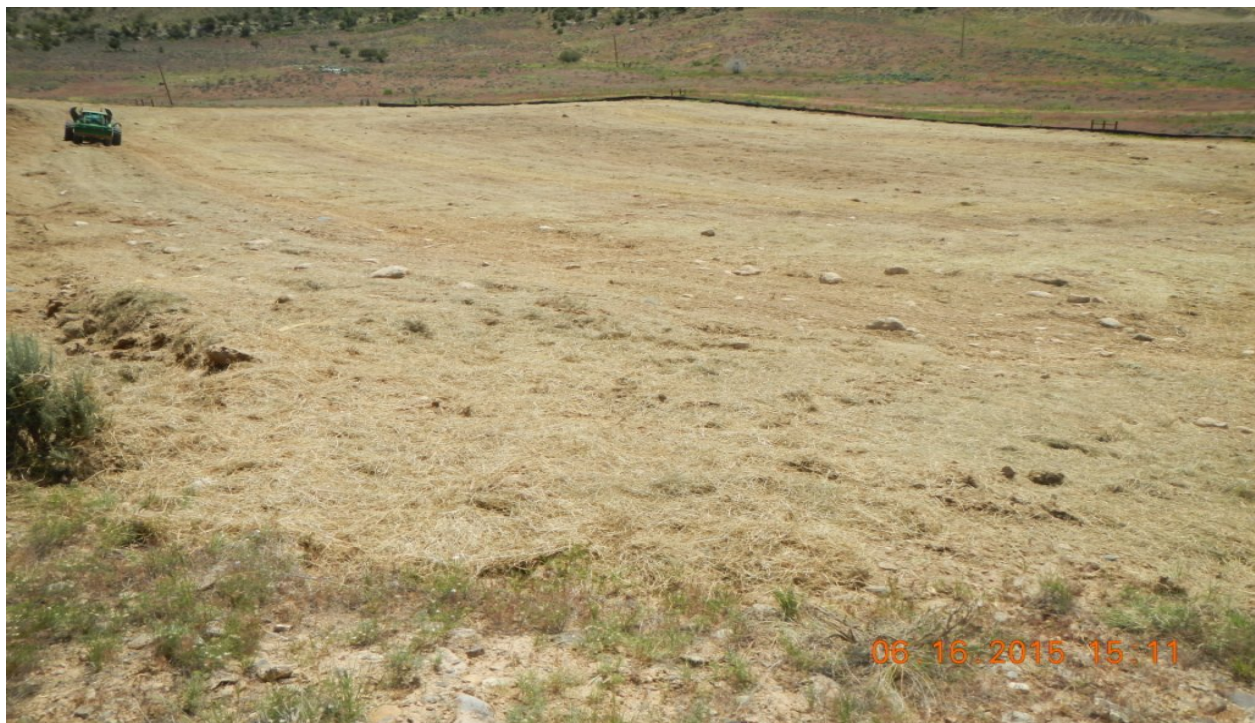
**photo 14:** Northeast corner of the location facing southwest.

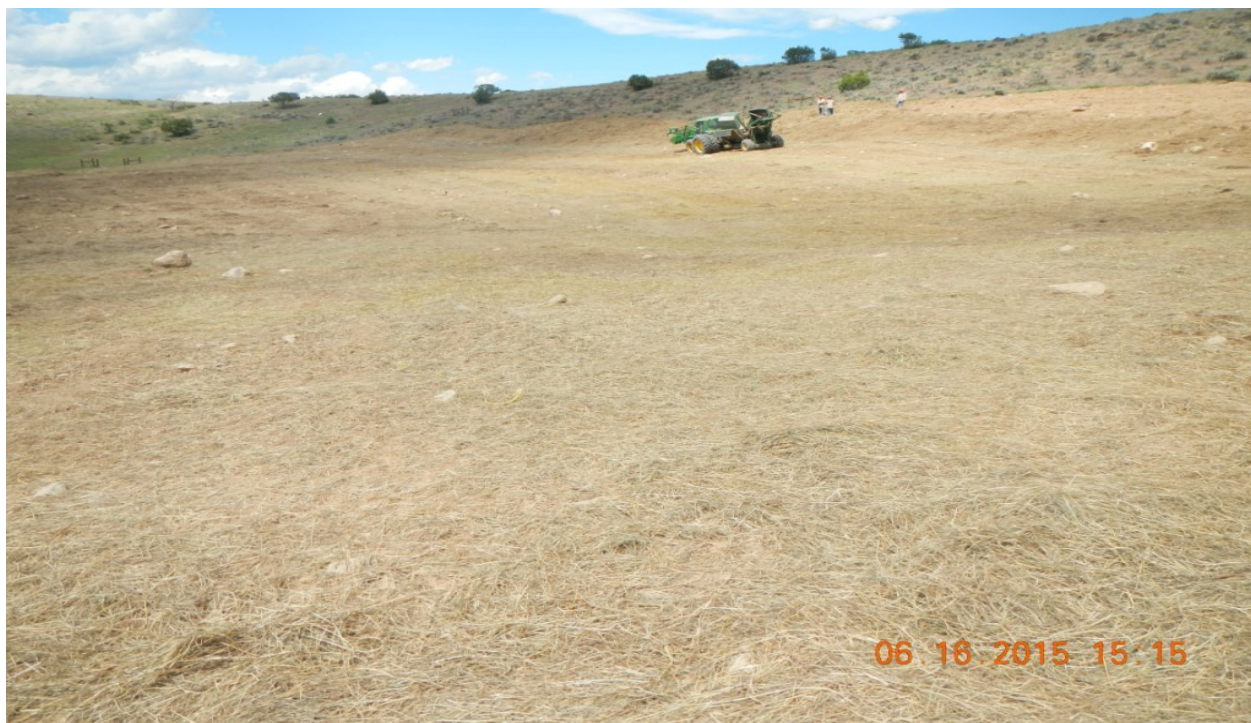
**photo 15:** Southwest side of the location facing northeast.

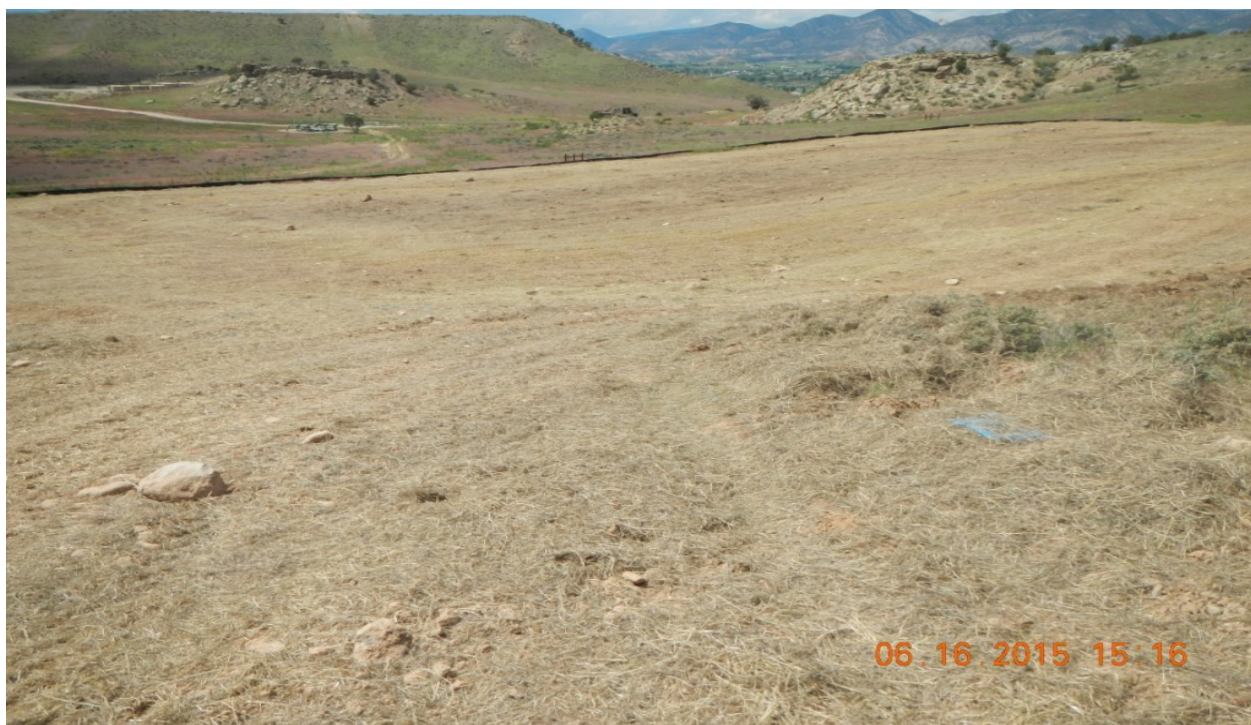
**photo 16:** Southeast corner of the location facing northwest.
