## A.P. Urie 1

Inspection# 673402259

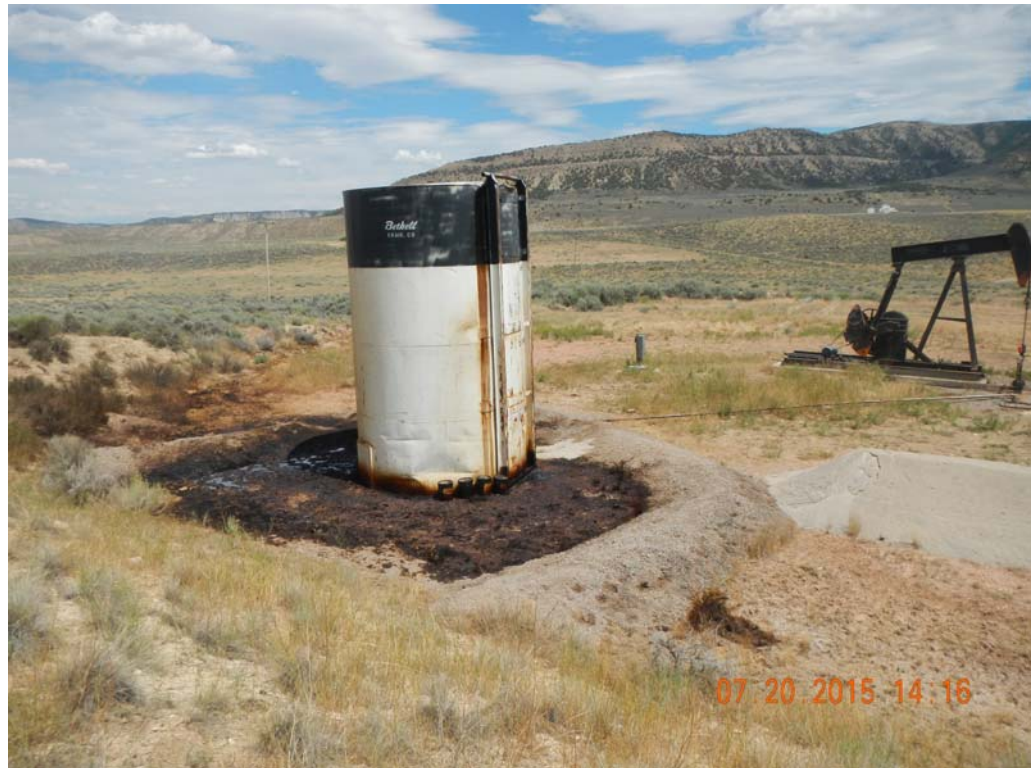
Overview of spill area looking east. Breach of berm at base visible in right foreground. Breach of berm with overflow and resultant spill path visible in left background.

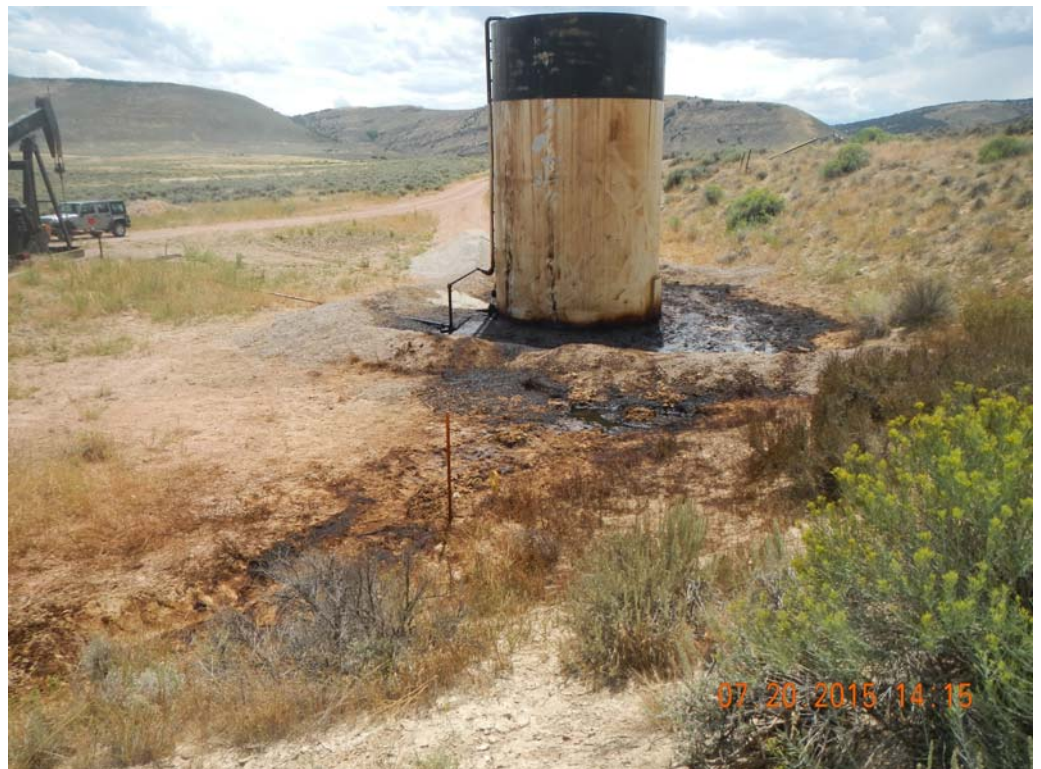
Overview of spill looking south. Berm overflow and spill path visible in foreground.

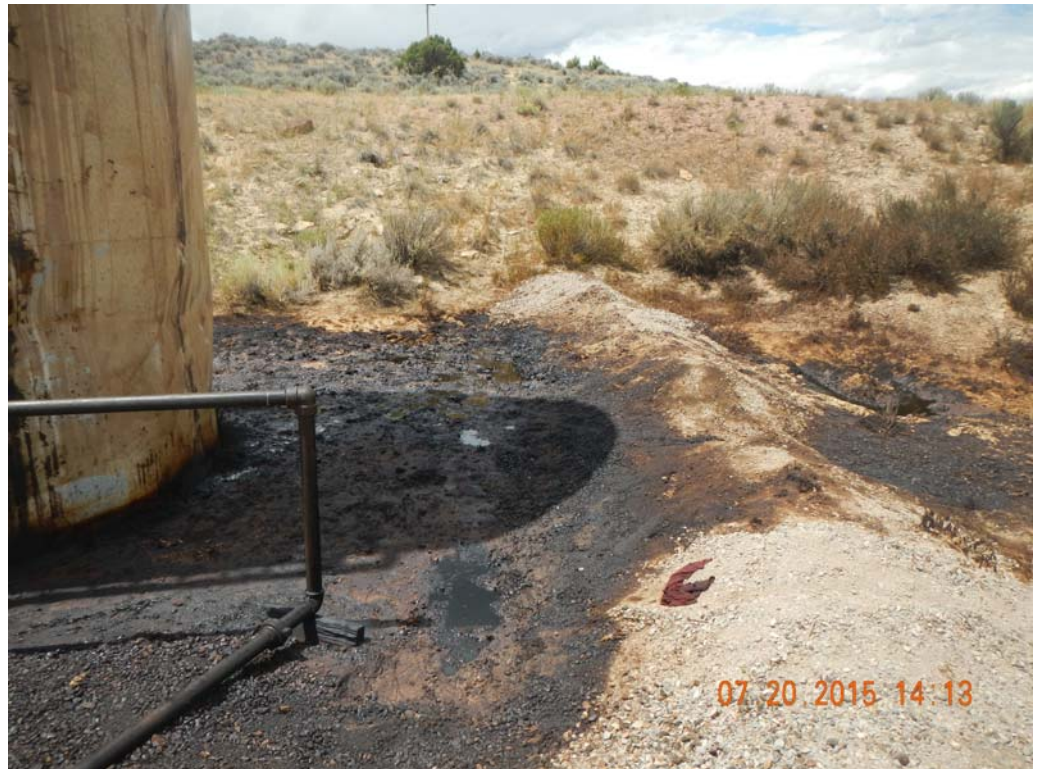
Close-up of berm overflow area on north side of tank/location. Liquid visible is oil.

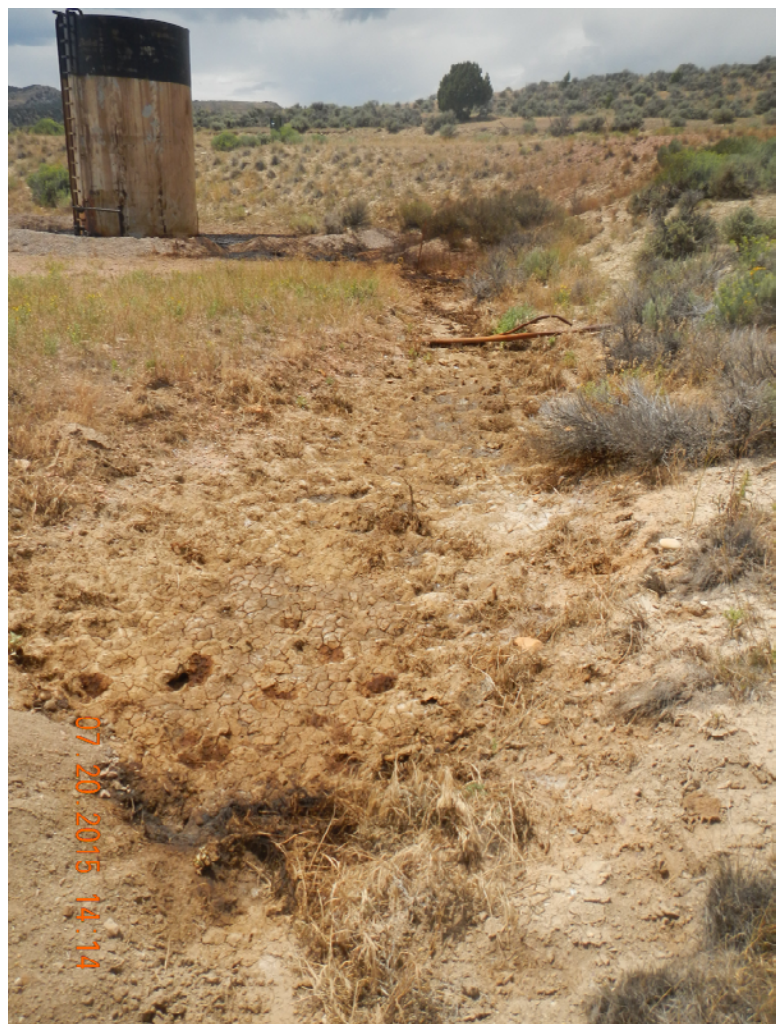
View from terminus of spill pathway approximately 50 feet from edge of berm looking west. Greatest concentration of material appears to be immediately outside of berm.

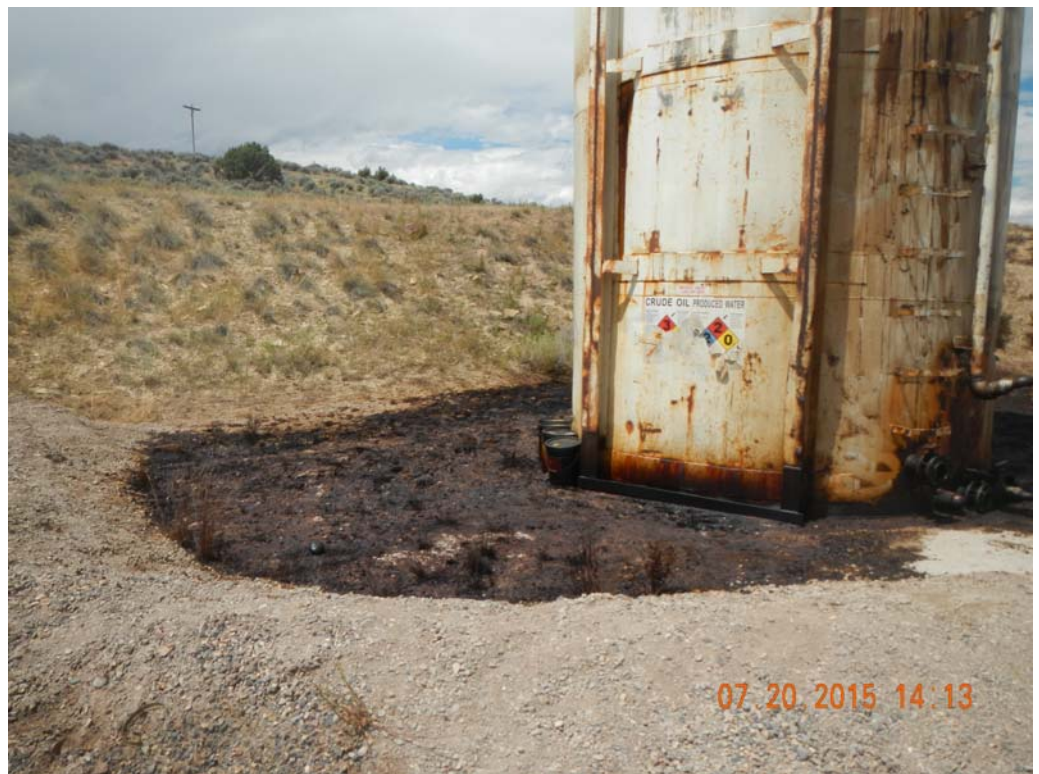
Stained soil inside berm on  
south side of tank/location.  
Incomplete tank labels.

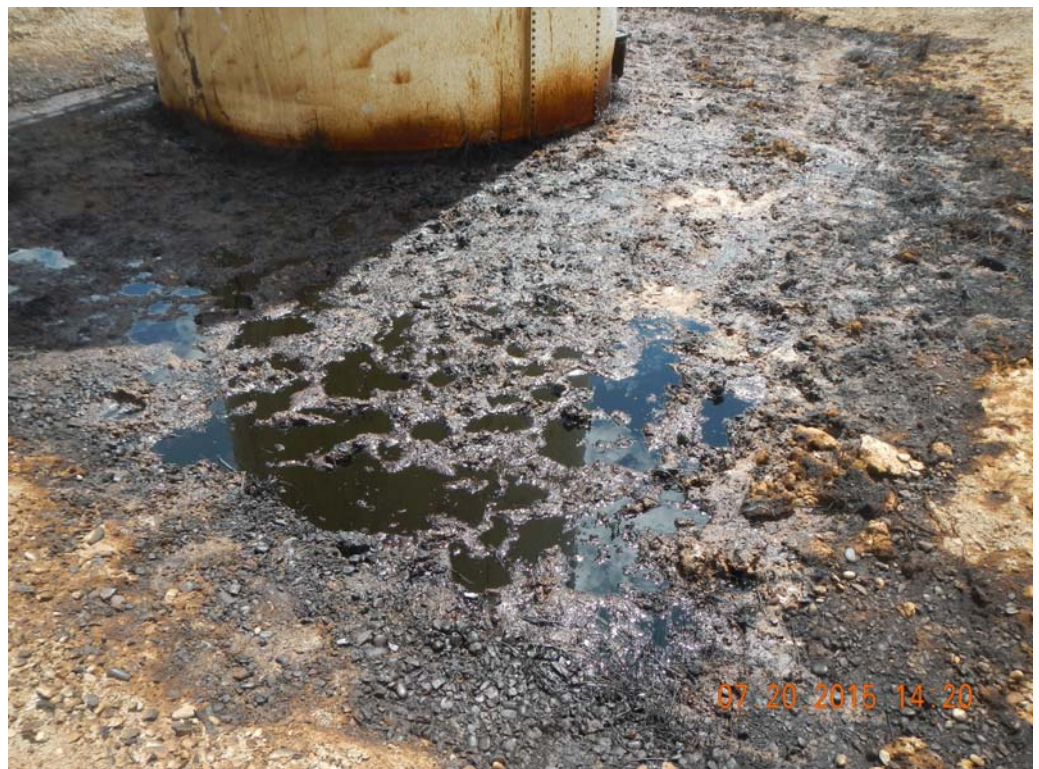
Close-up of pooled  
hydrocarbons inside berm  
on north side of  
tank/location.

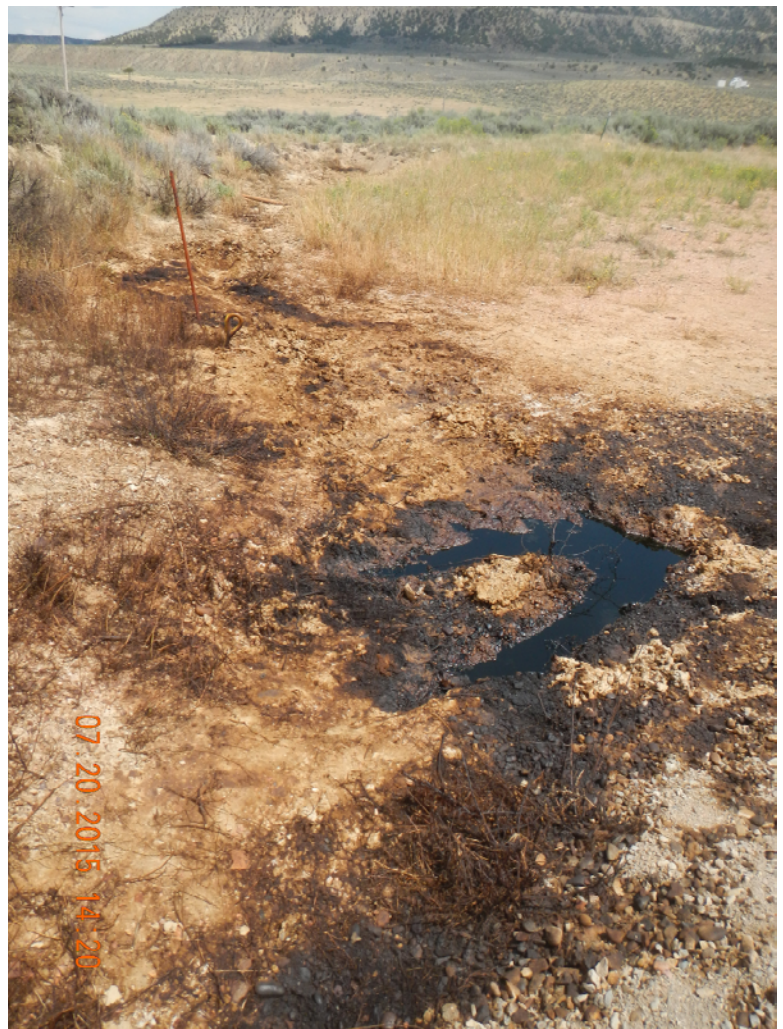
Pooled hydrocarbons outside of berm at beginning of spill pathway on north side of tank/location.

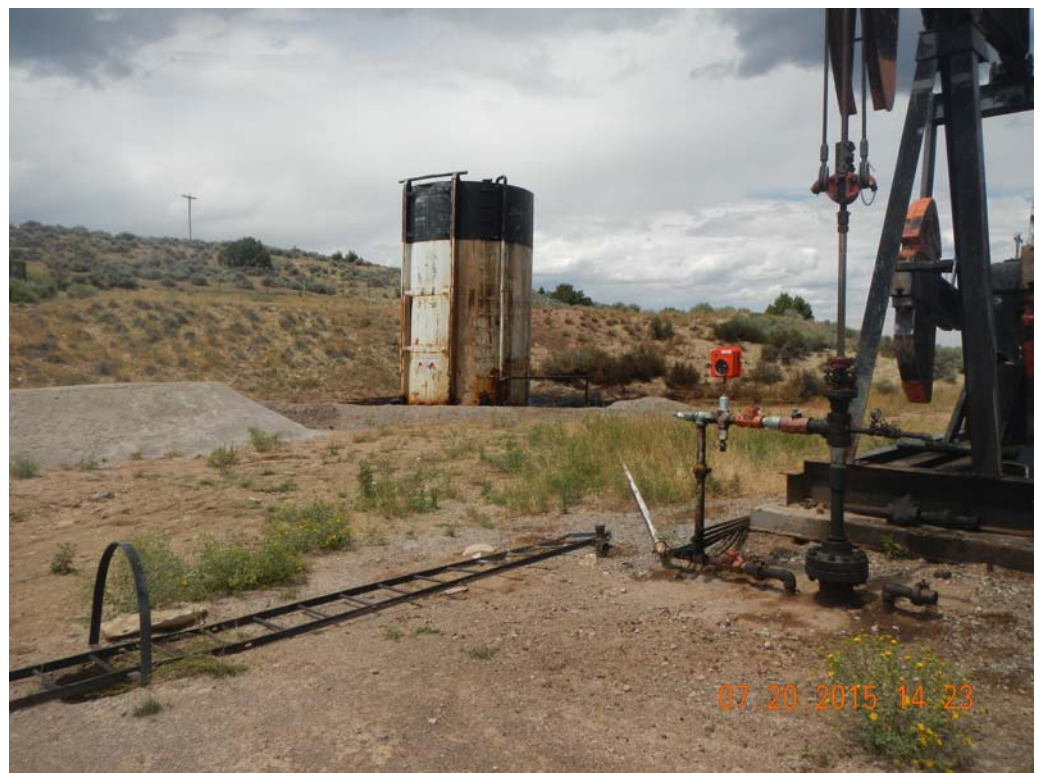
Stained soil at wellhead.  
Unclosed rathole in foreground on left.

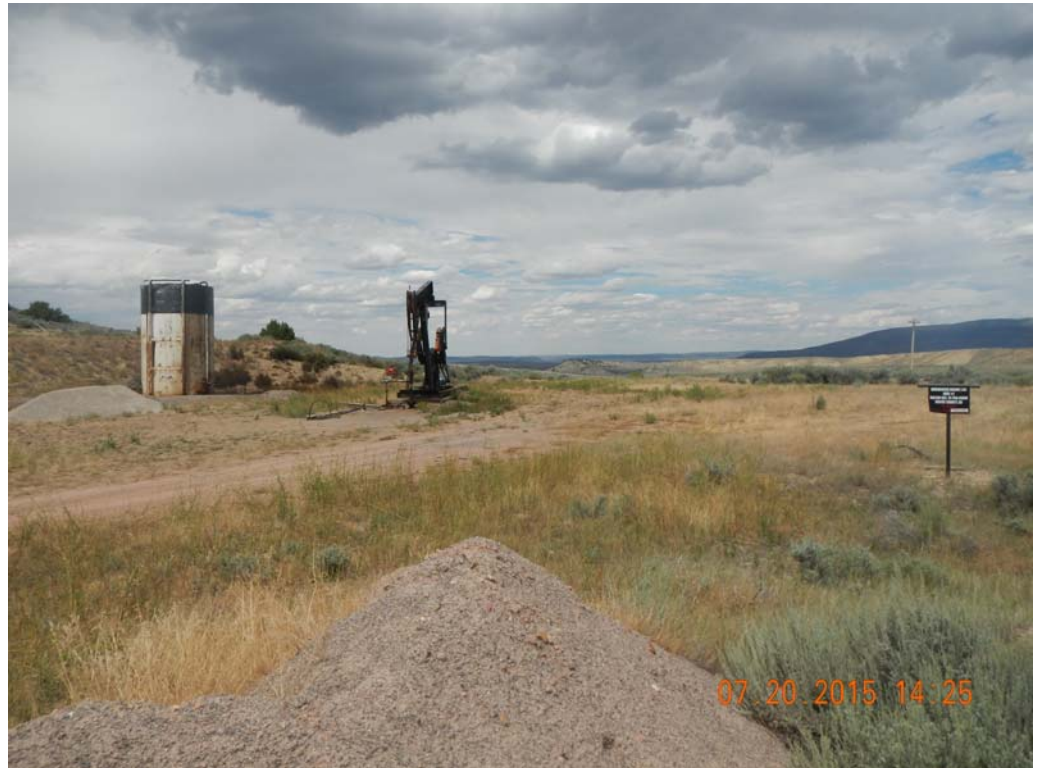
Location overview.  
Incomplete battery sign, no  
wellhead sign, unclosed  
rathole, gravel piles with  
no containment, debris,  
weeds and spill.
