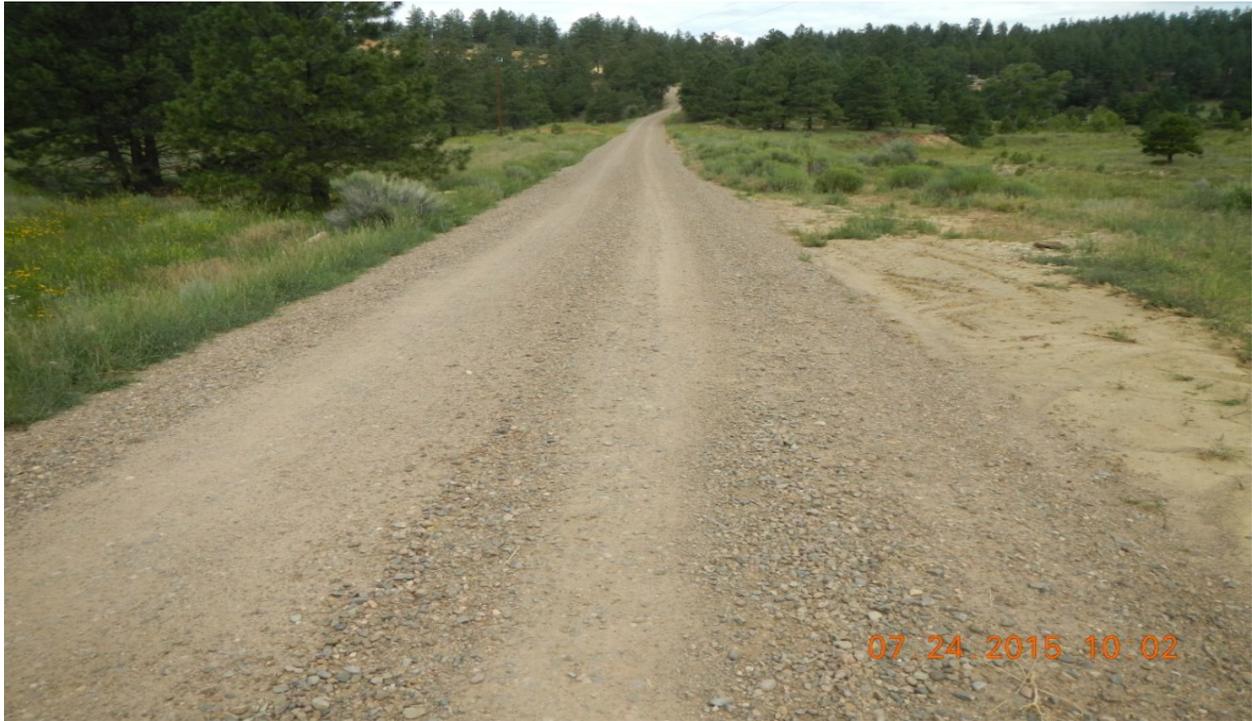
photo 1: Traveling northwest along the main access road.

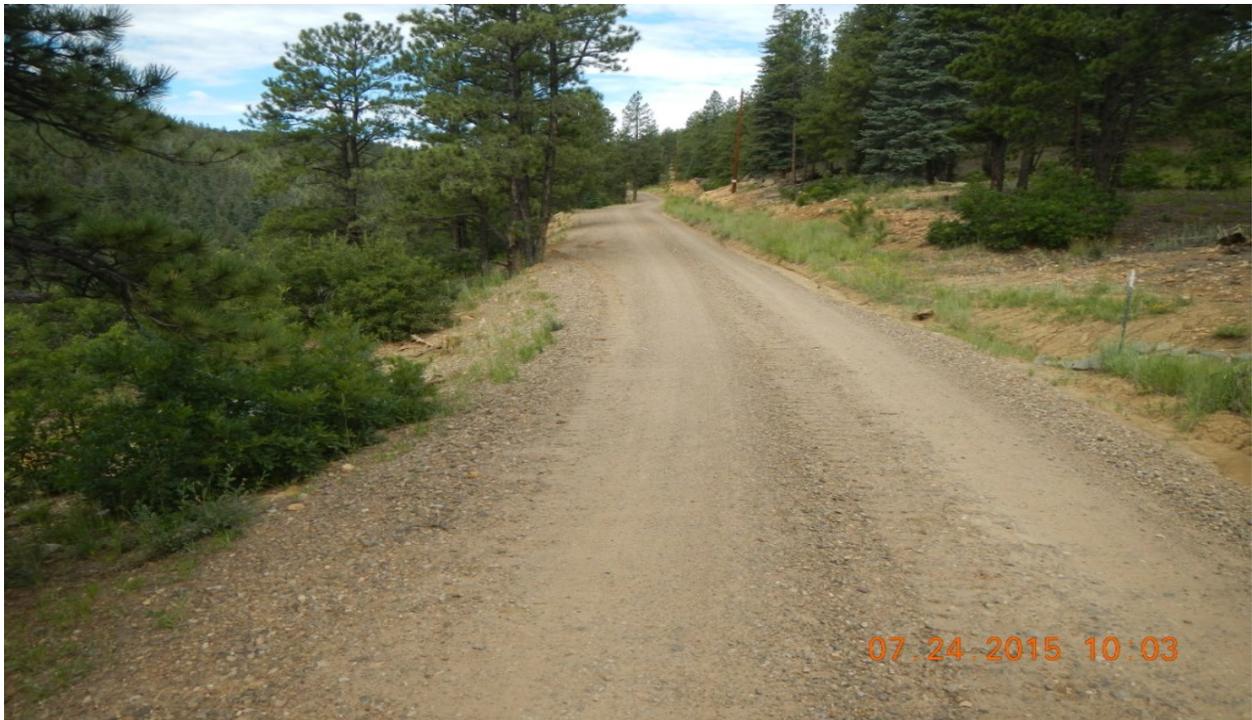
photo 2: Traveling west along the main access road.

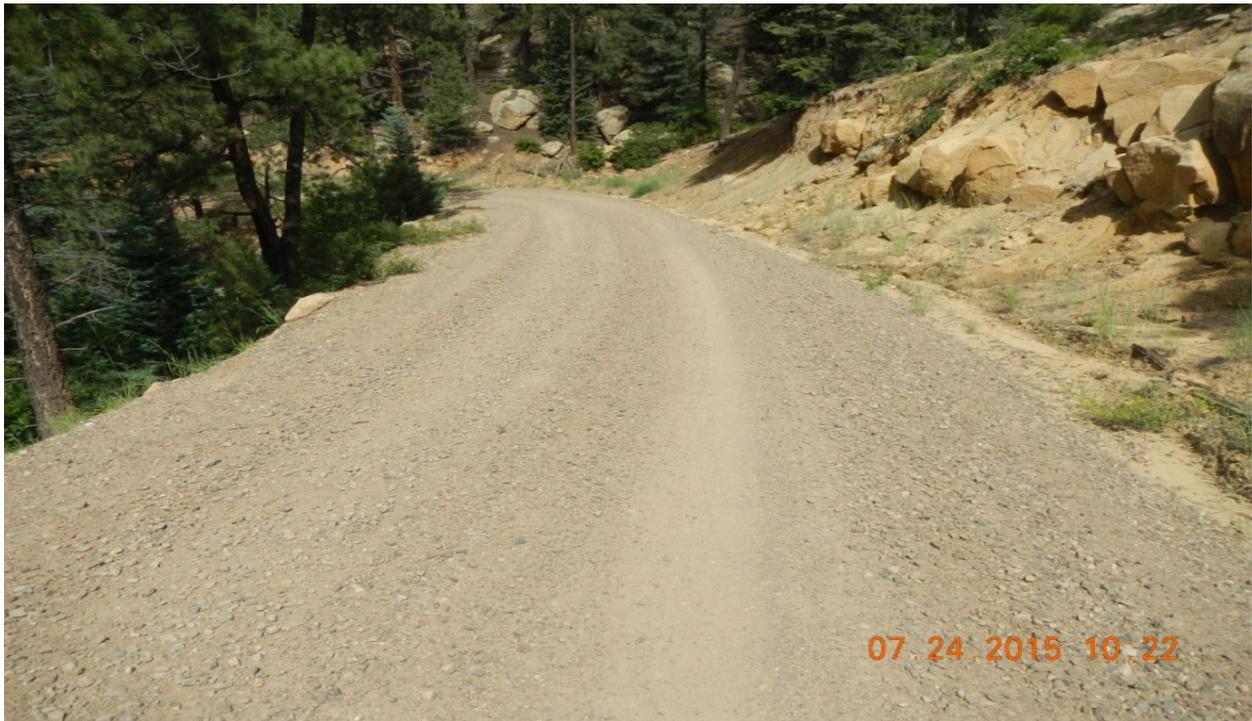
photo 3: Traveling west along the main access road.

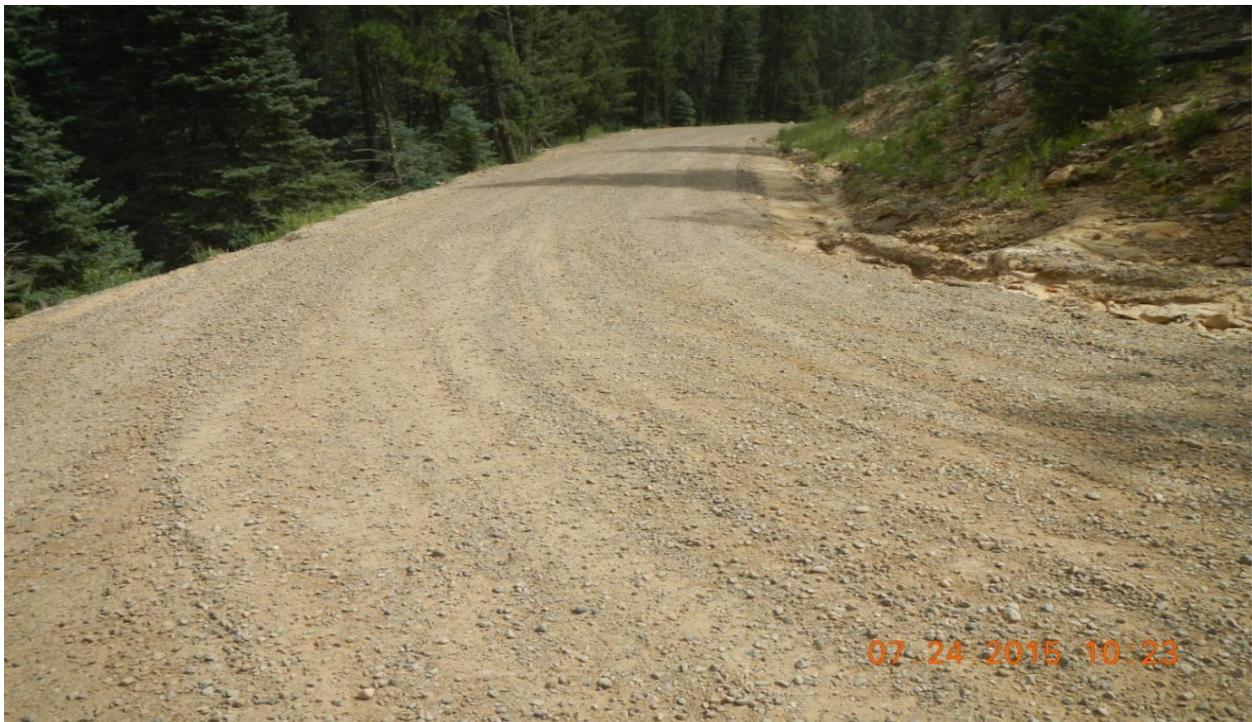
photo 4: Facing back northeast along the main access road.

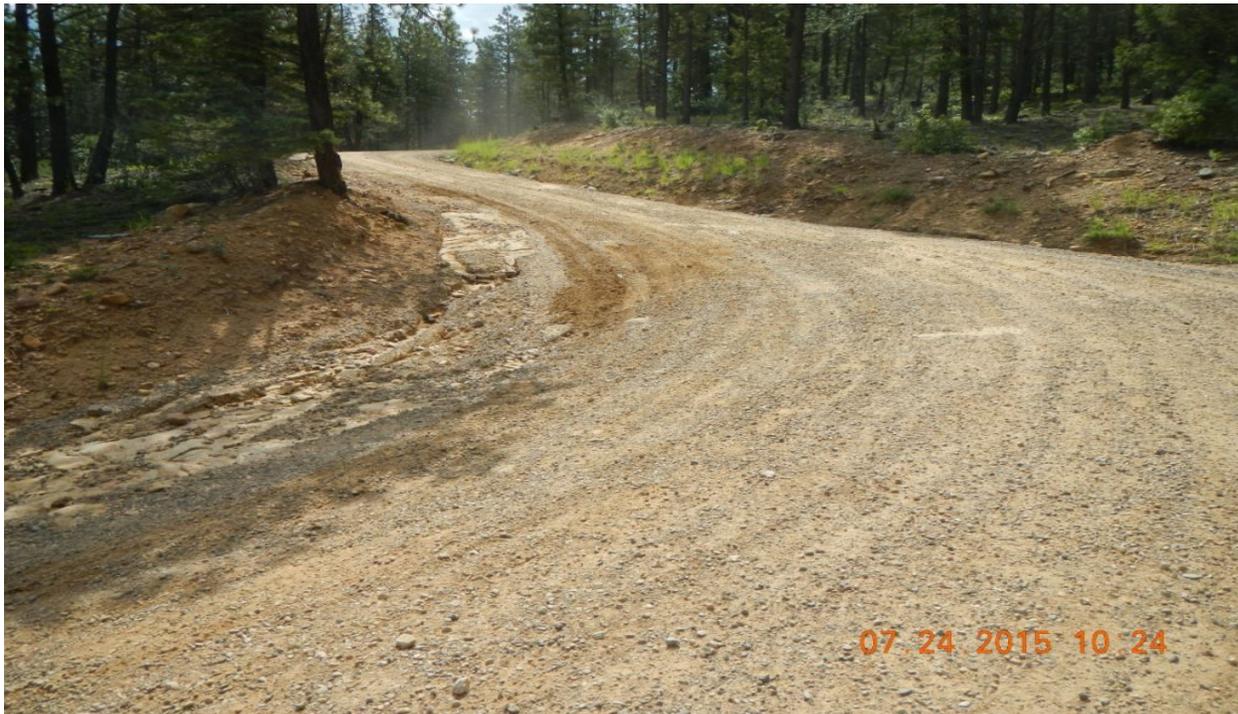
photo 5: Traveling southeast along the main access road. Area of concern of the complainant.

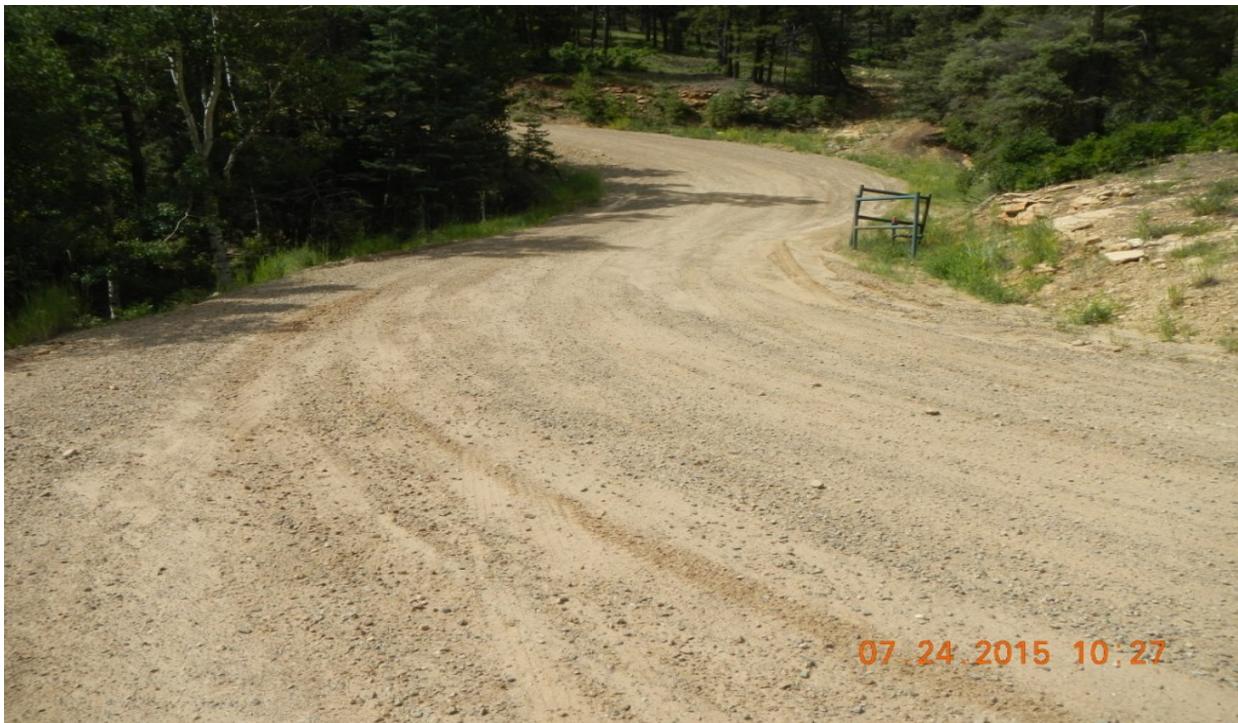
photo 6: Facing south along the main access road. Area of concern of complainant due to potential water pooling.

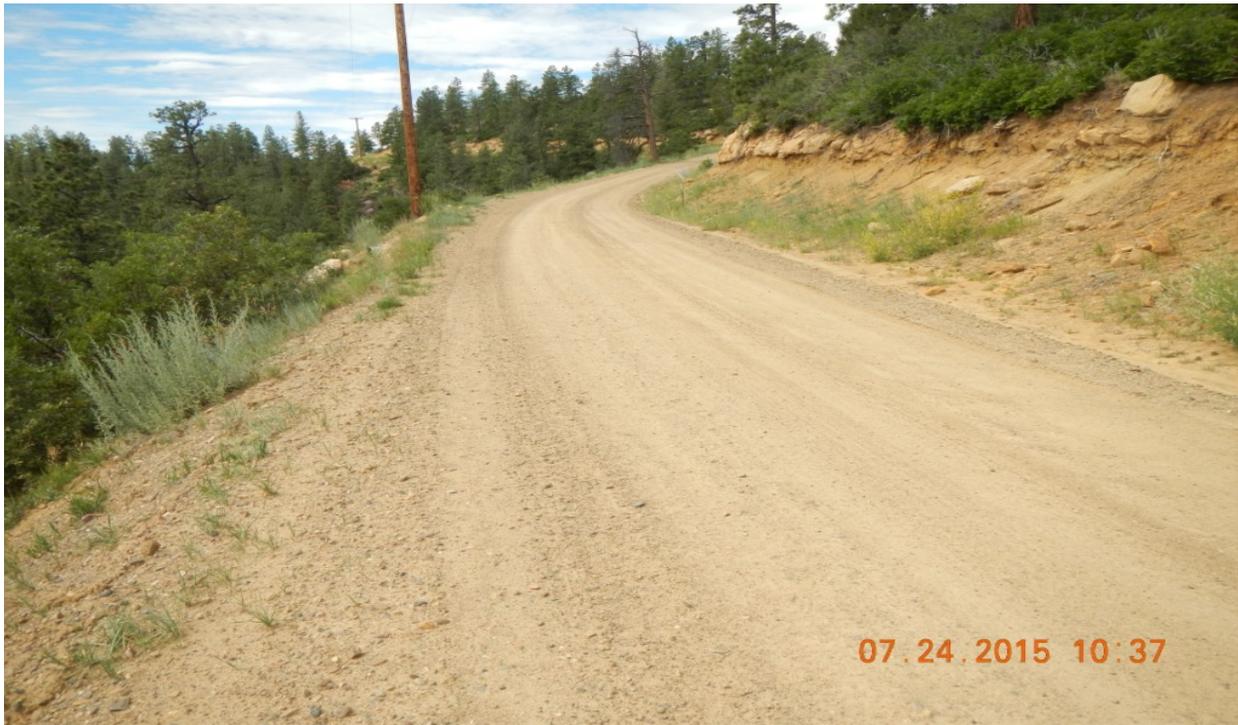
photo 7: Facing south along the main access road. Area of concern of complainant due to potential lack of gravel.

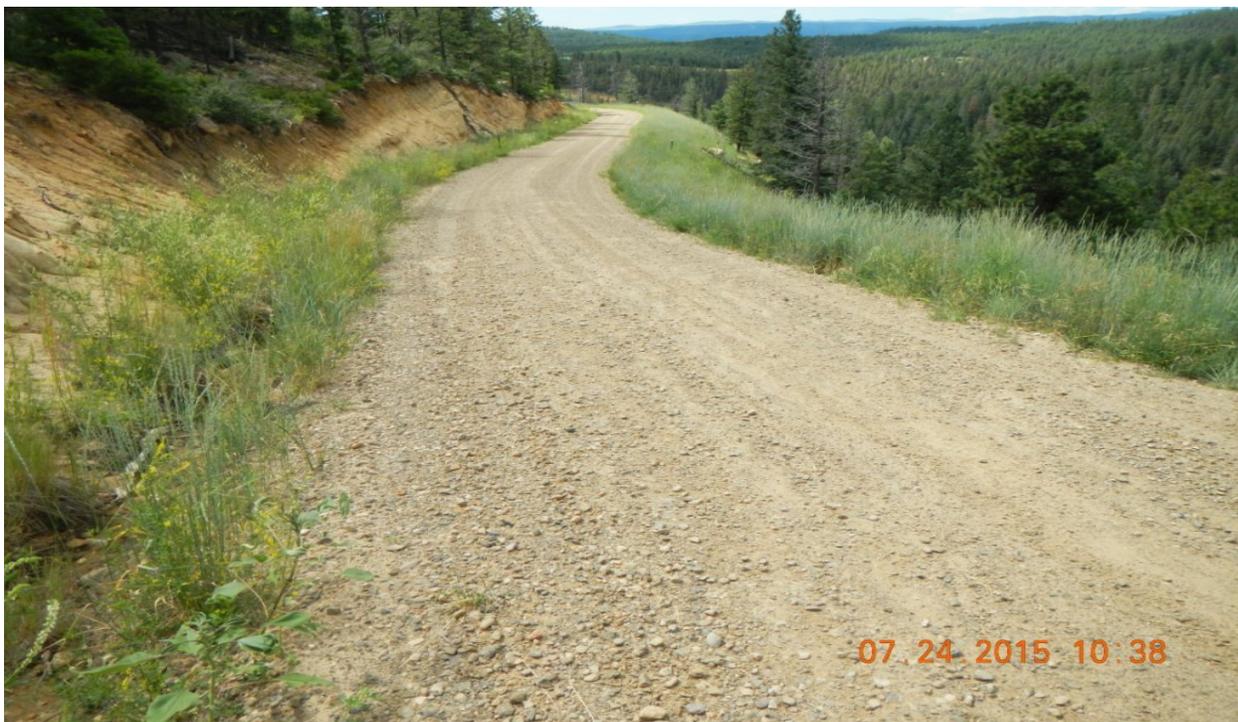
photo 8: : Facing south along the main access road.

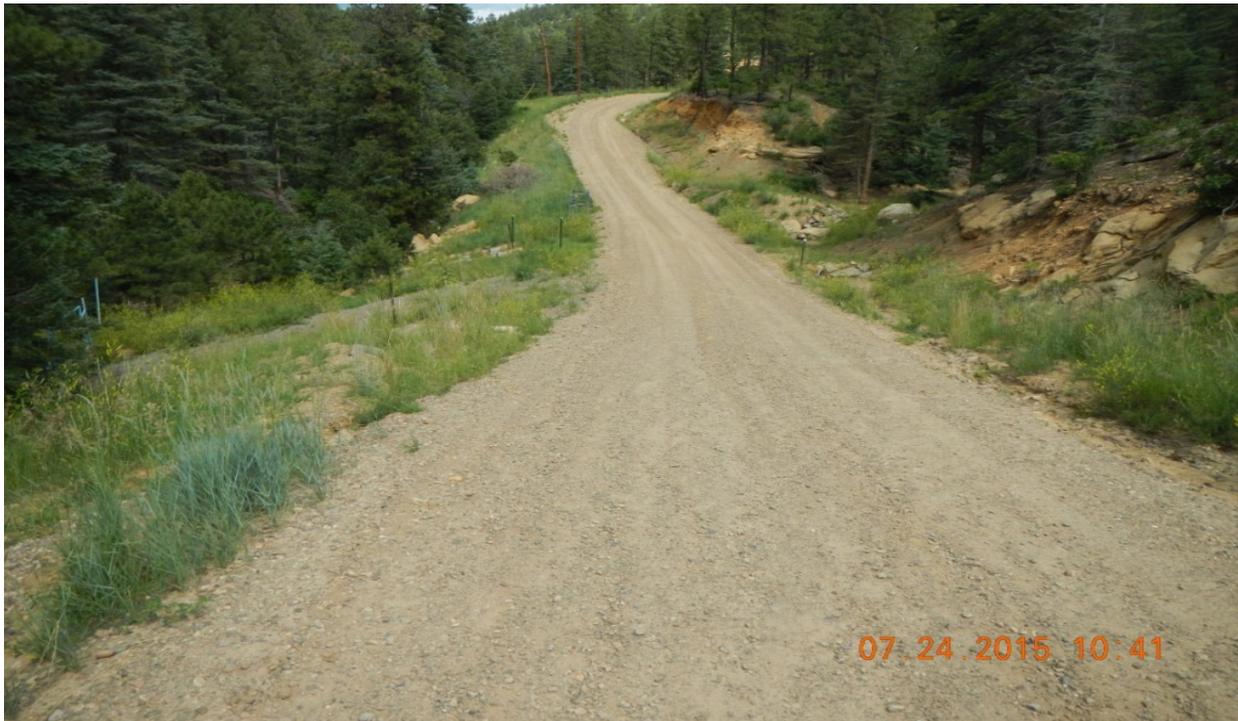
photo 9: Facing west along the main access road. Area of concern of the complainant.

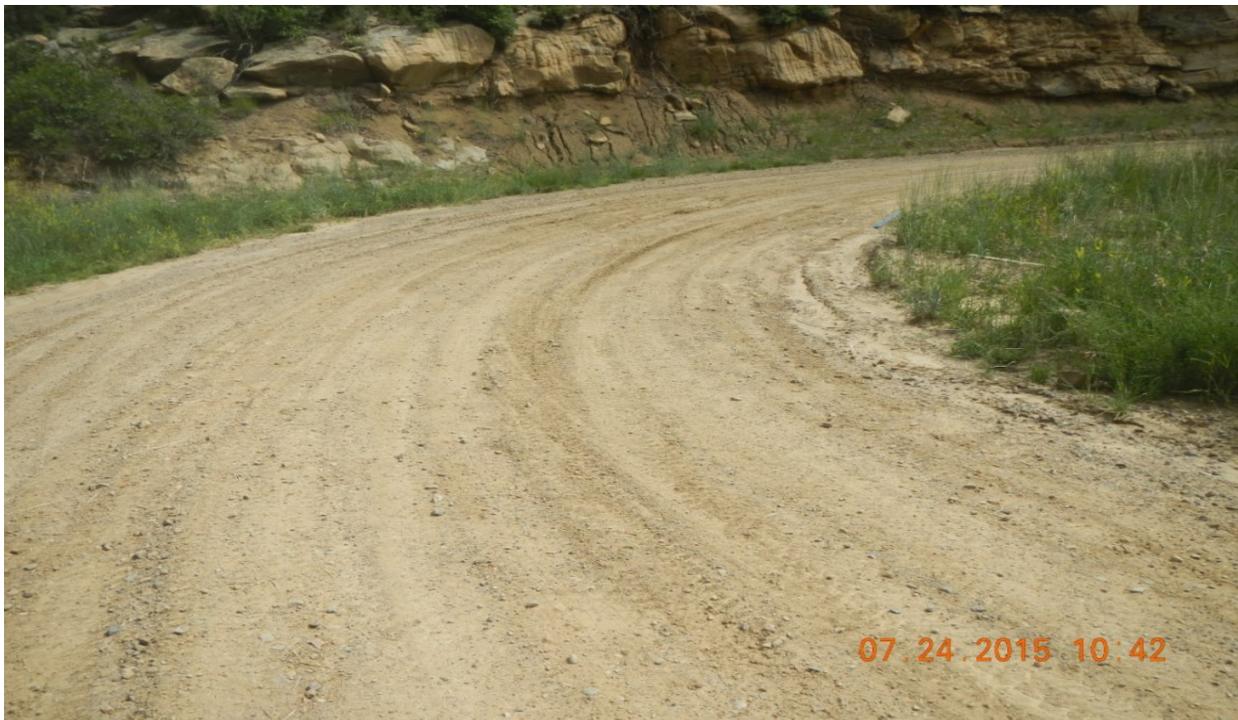
photo 10: Along the main access road. Area of concern of complainant due to potential water pooling.

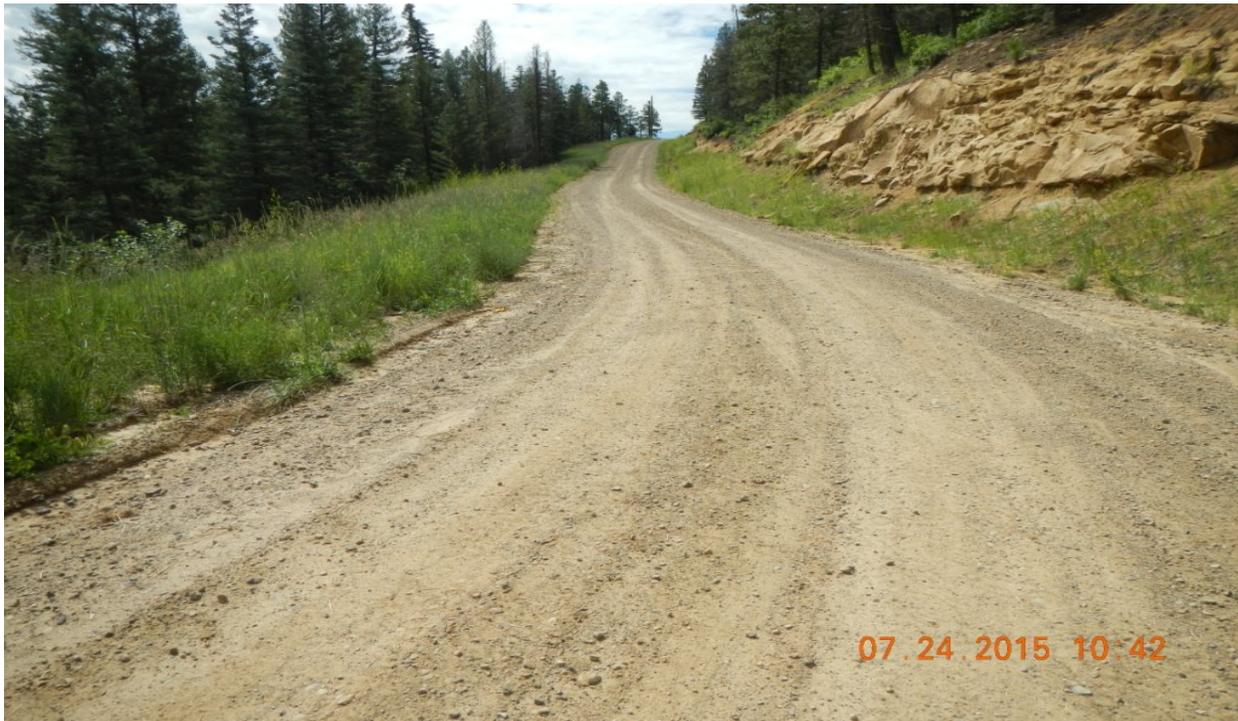
photo 11: Facing southeast along the main access road.

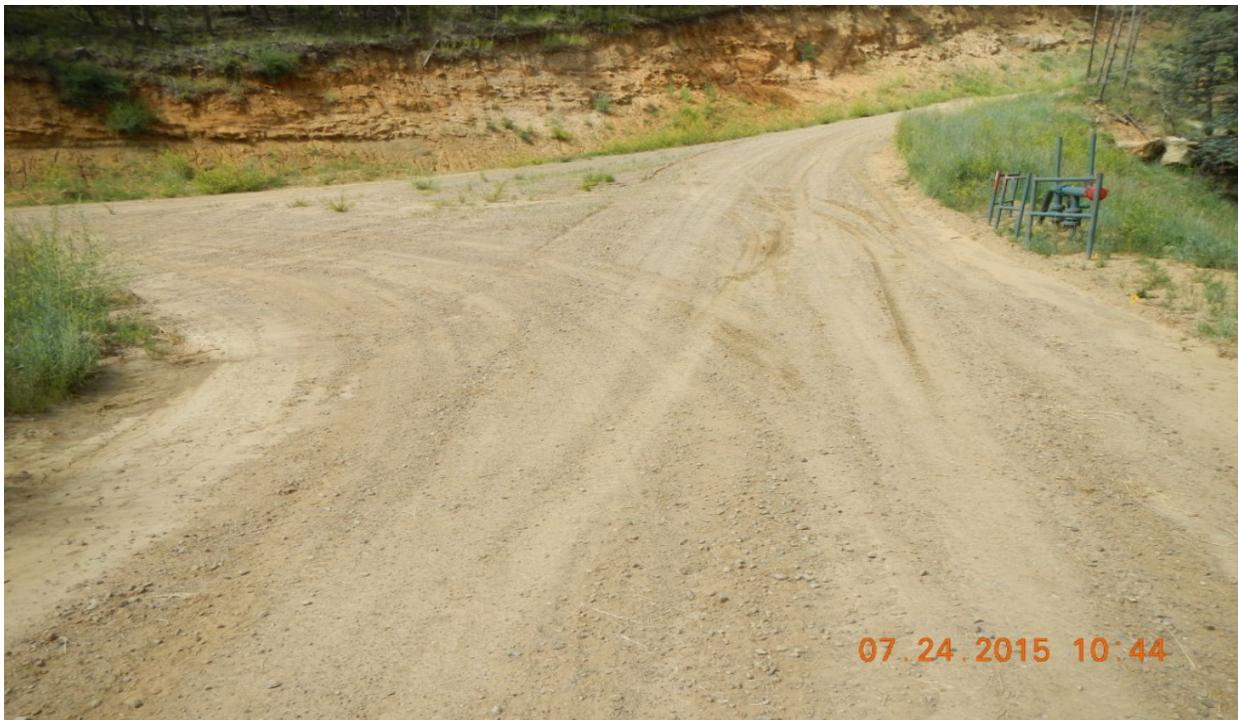
photo 12: Along the main access road. Area of concern of complainant due to potential water pooling.

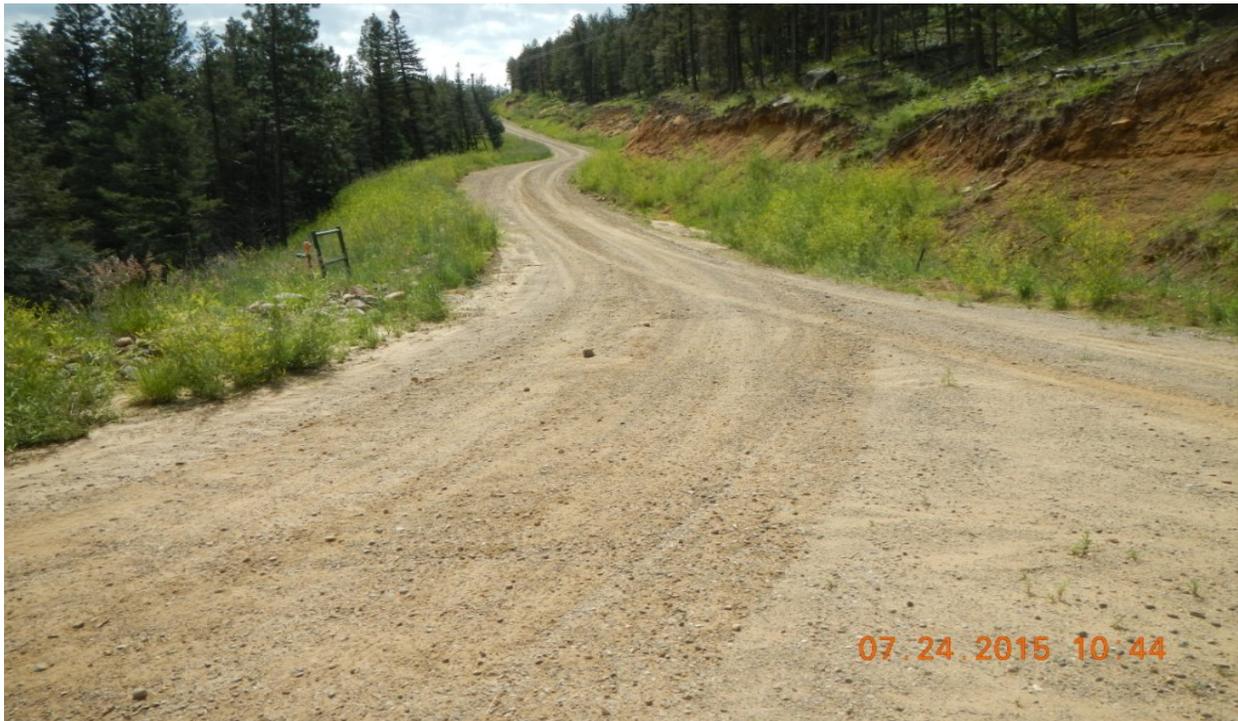
photo 13: Facing southeast along the main access road.

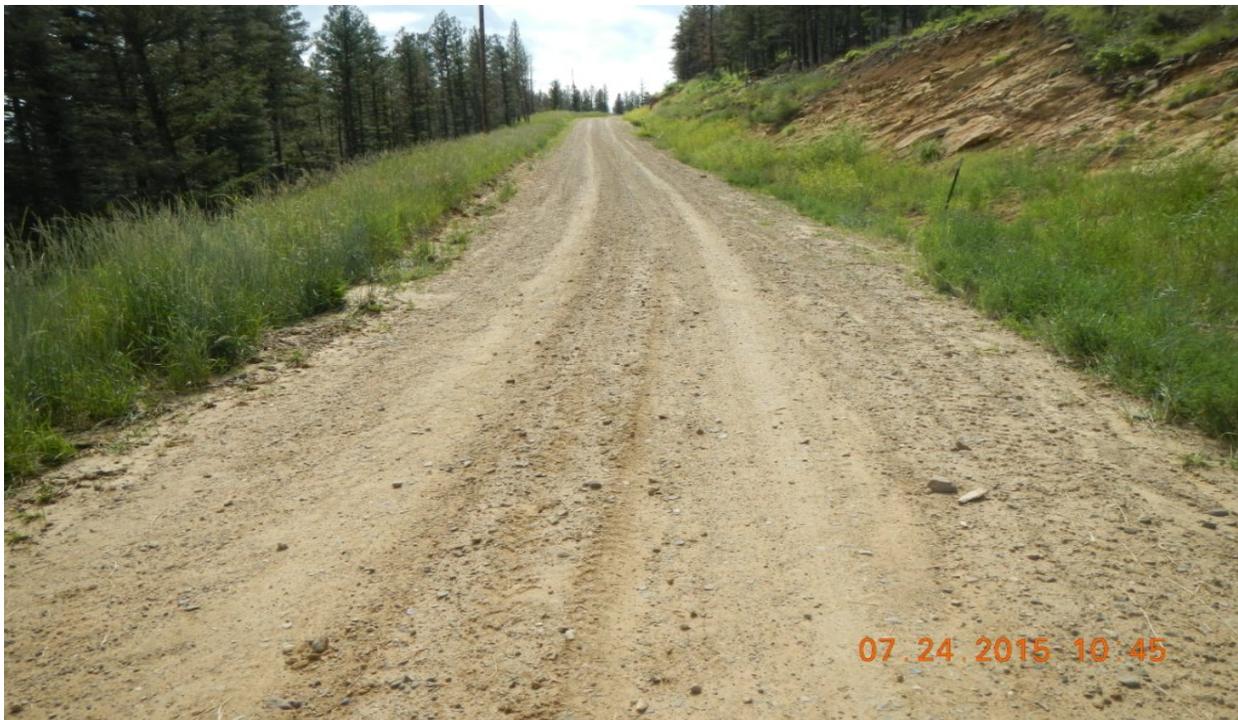
photo 14: Facing southeast along the main access road.

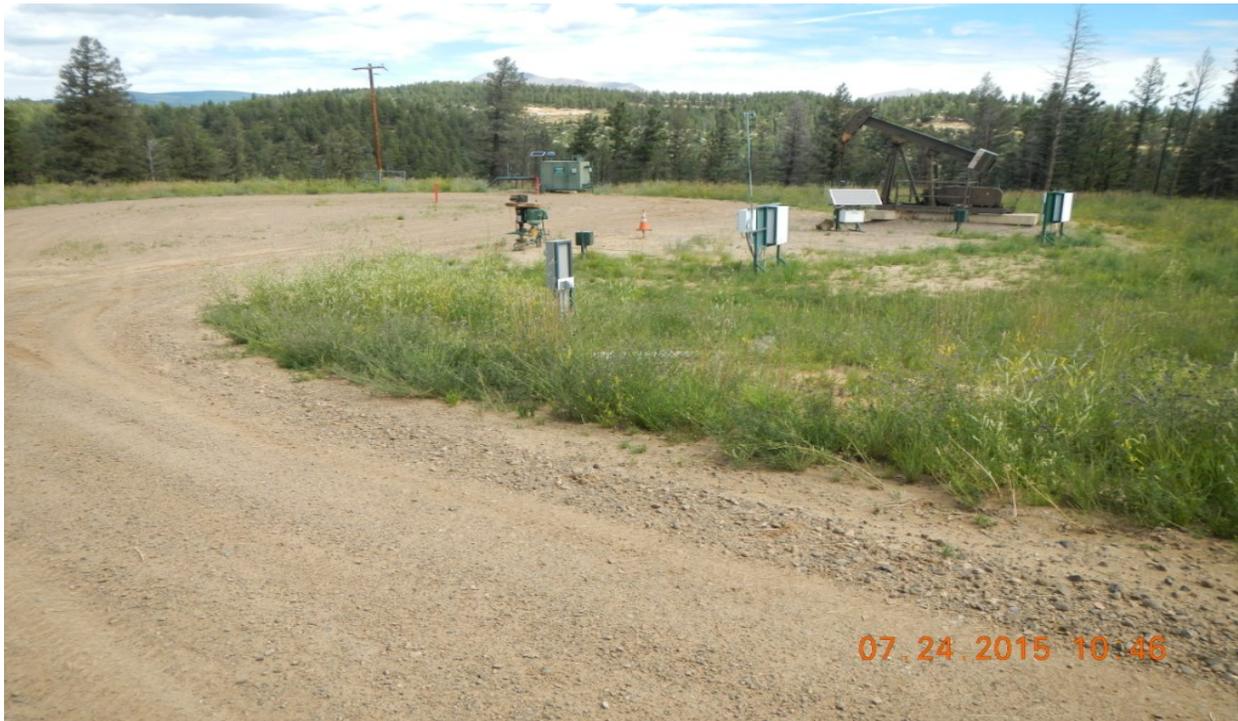
photo 15: Facing north towards the well location.

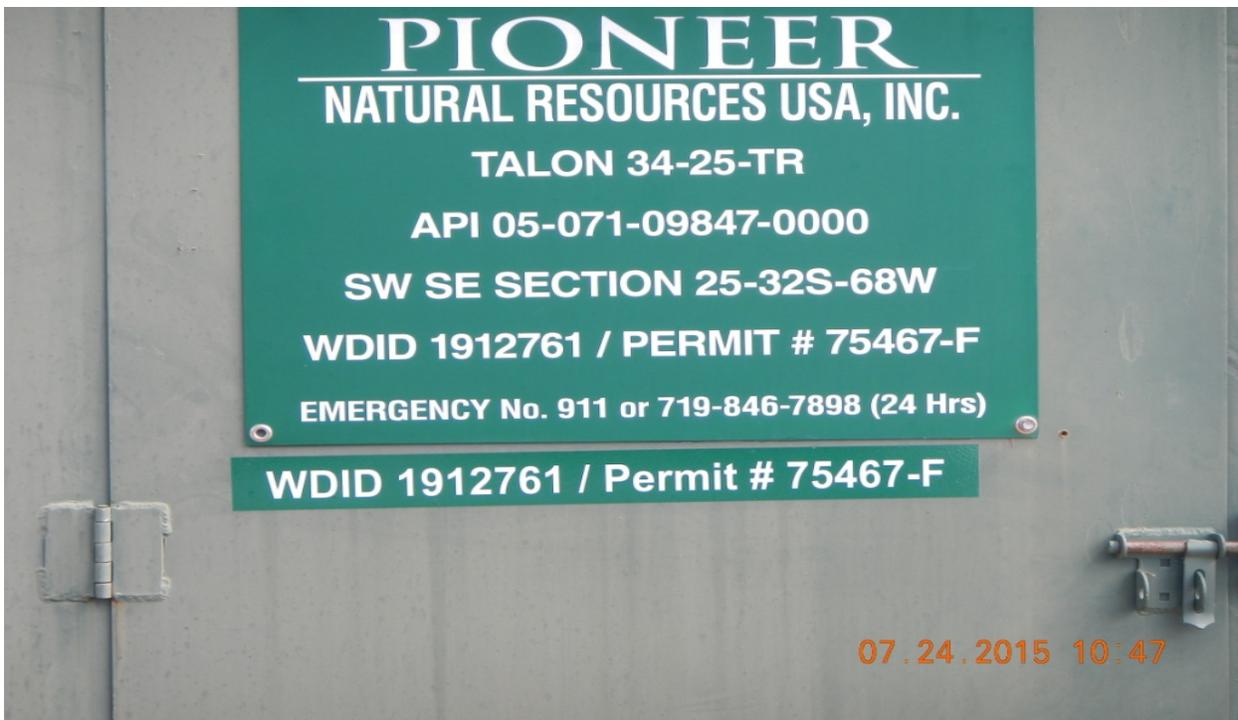
photo 16: Well sign. Talon 34-25
