July 23,2015

Inspection Photos API# 045-13420 loc#  
334747

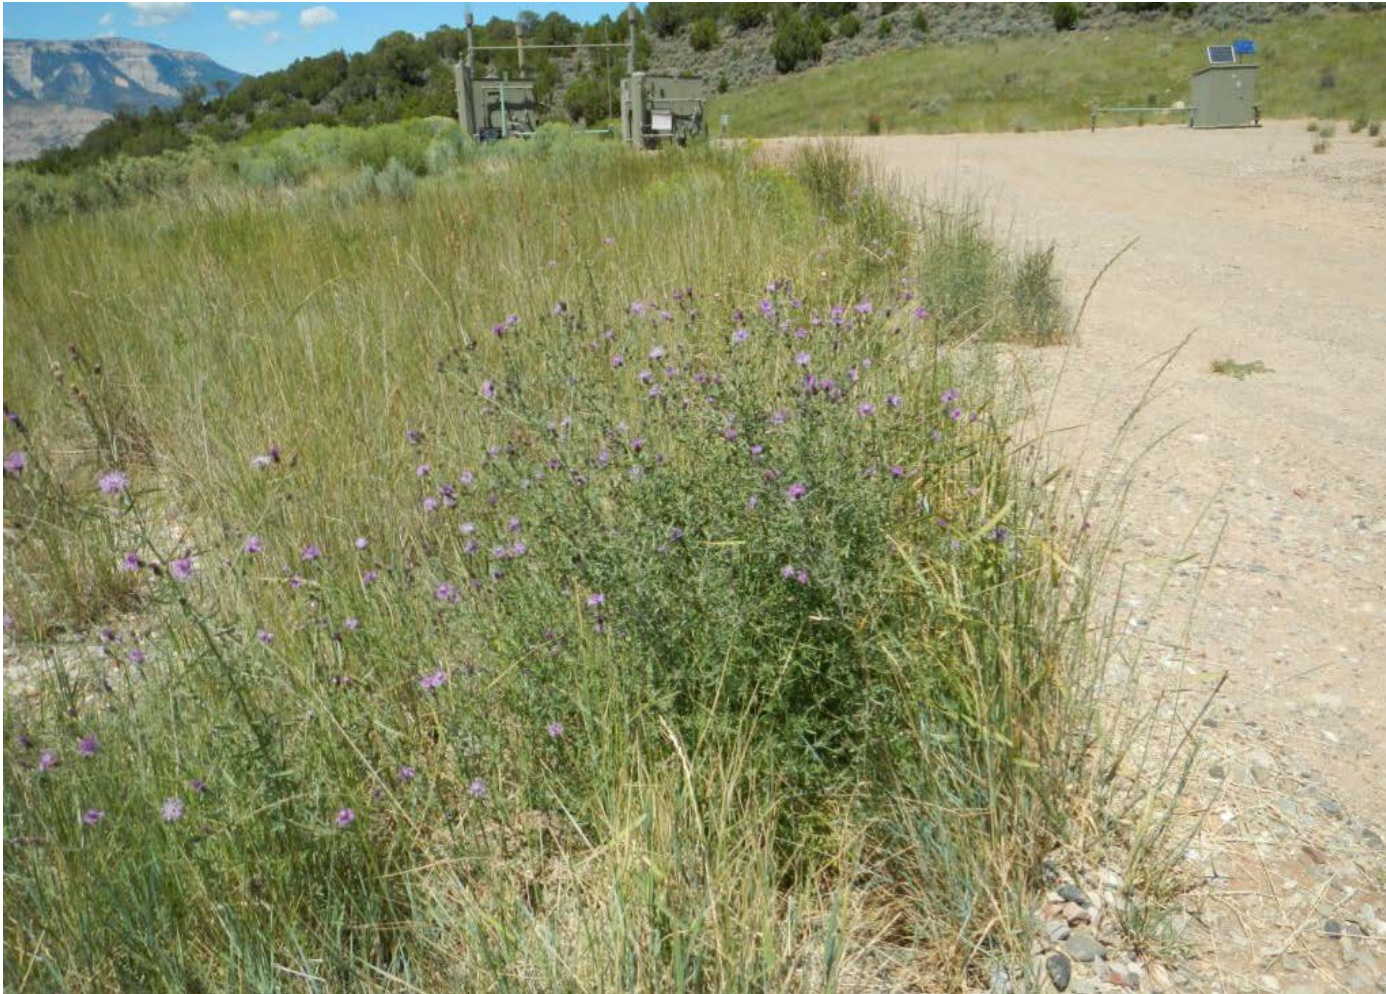
Photo 1. View of location from SW corner looking North , showing Spotted Knapweed.

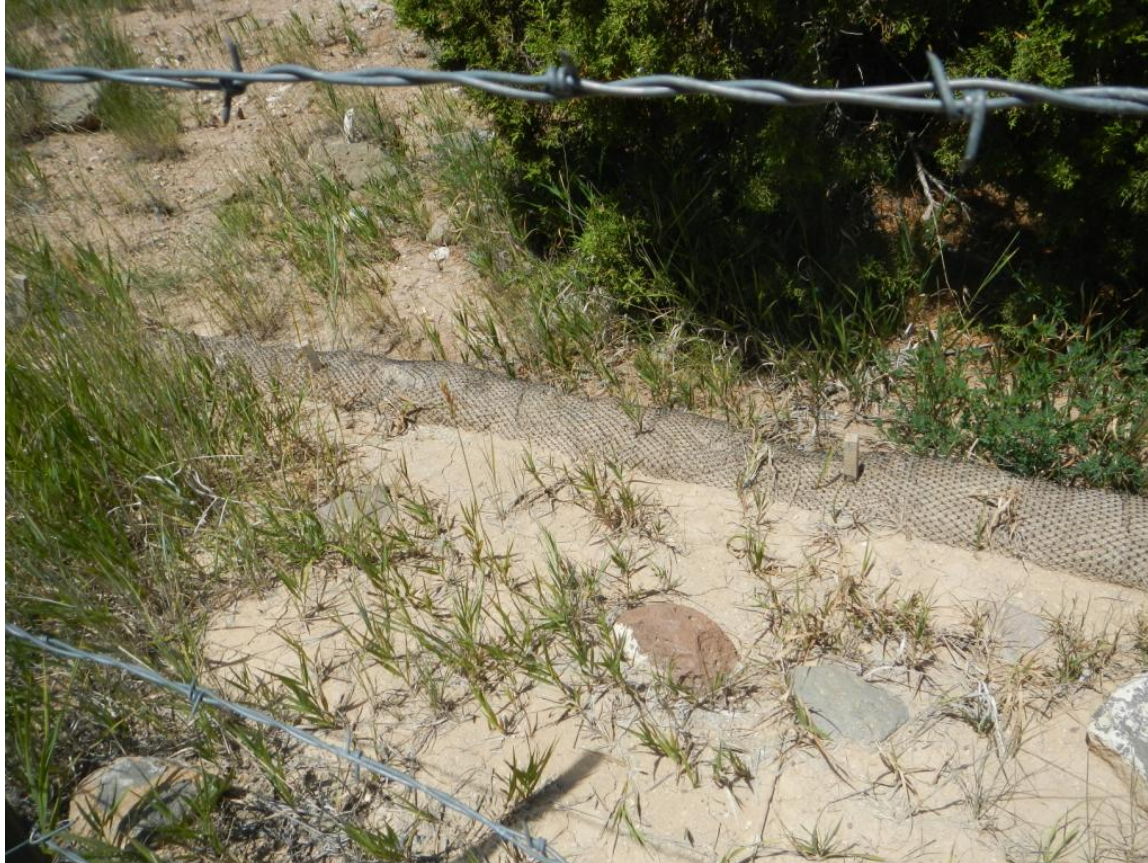
Photo 2. View from NW corner of pad looking down at wattles needing maintenance.

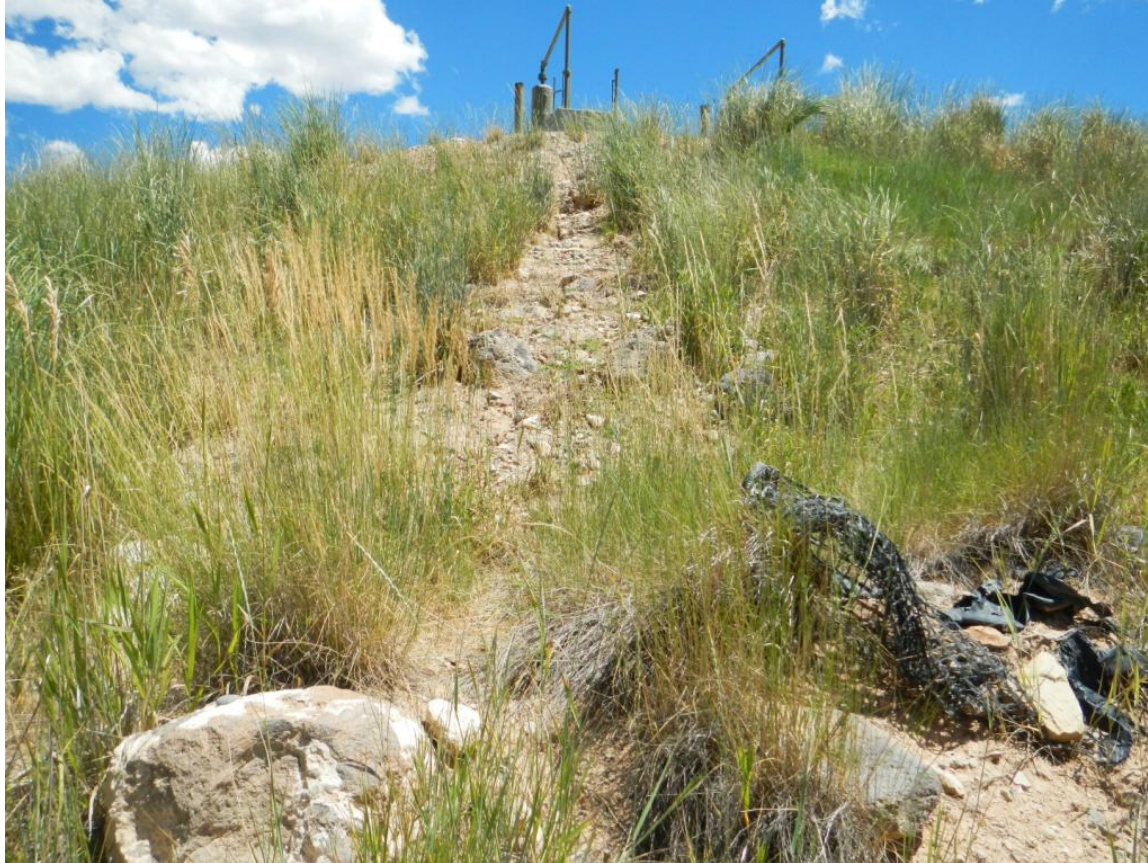
Photo 3. View of location from NW corner below berm, looking up at erosion from stormwater run off from pad.

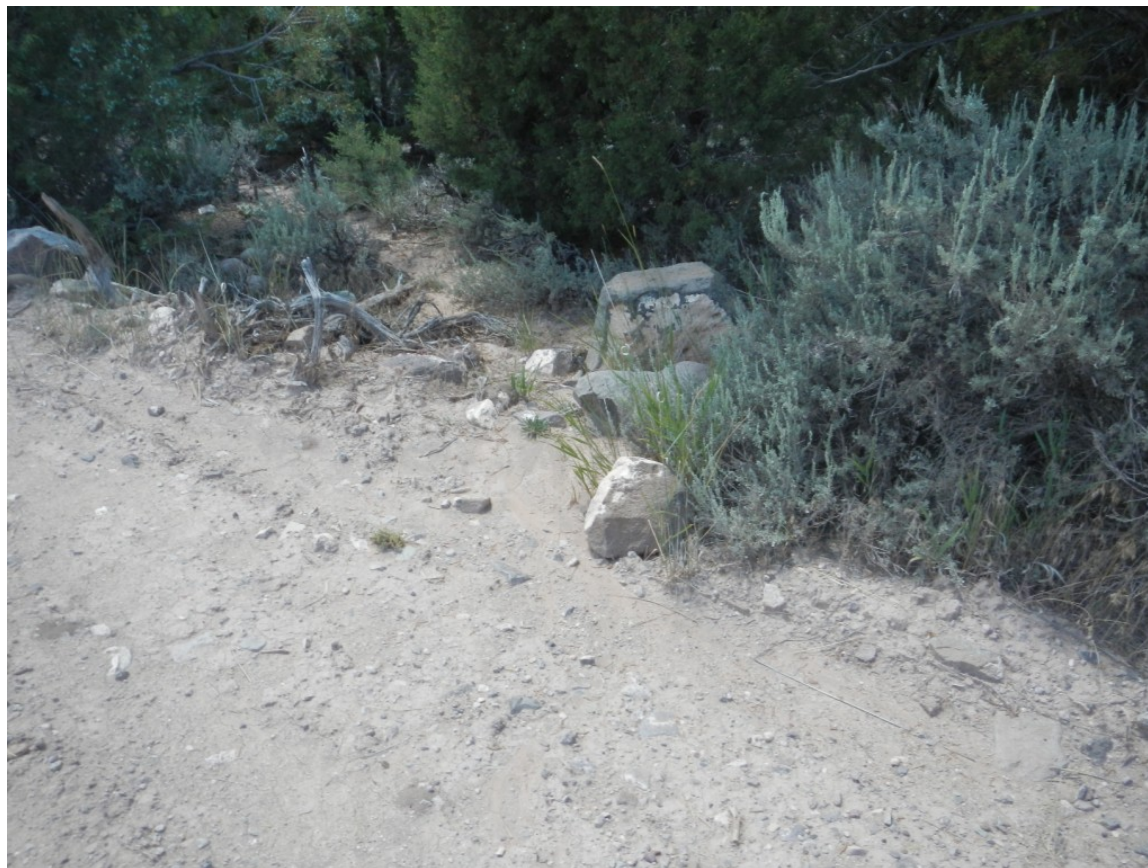
Photo 4. View of access road from SW corner of Location looking at sediment run off .
