Inspection Photos API# 045-07245 Loc #  
334572

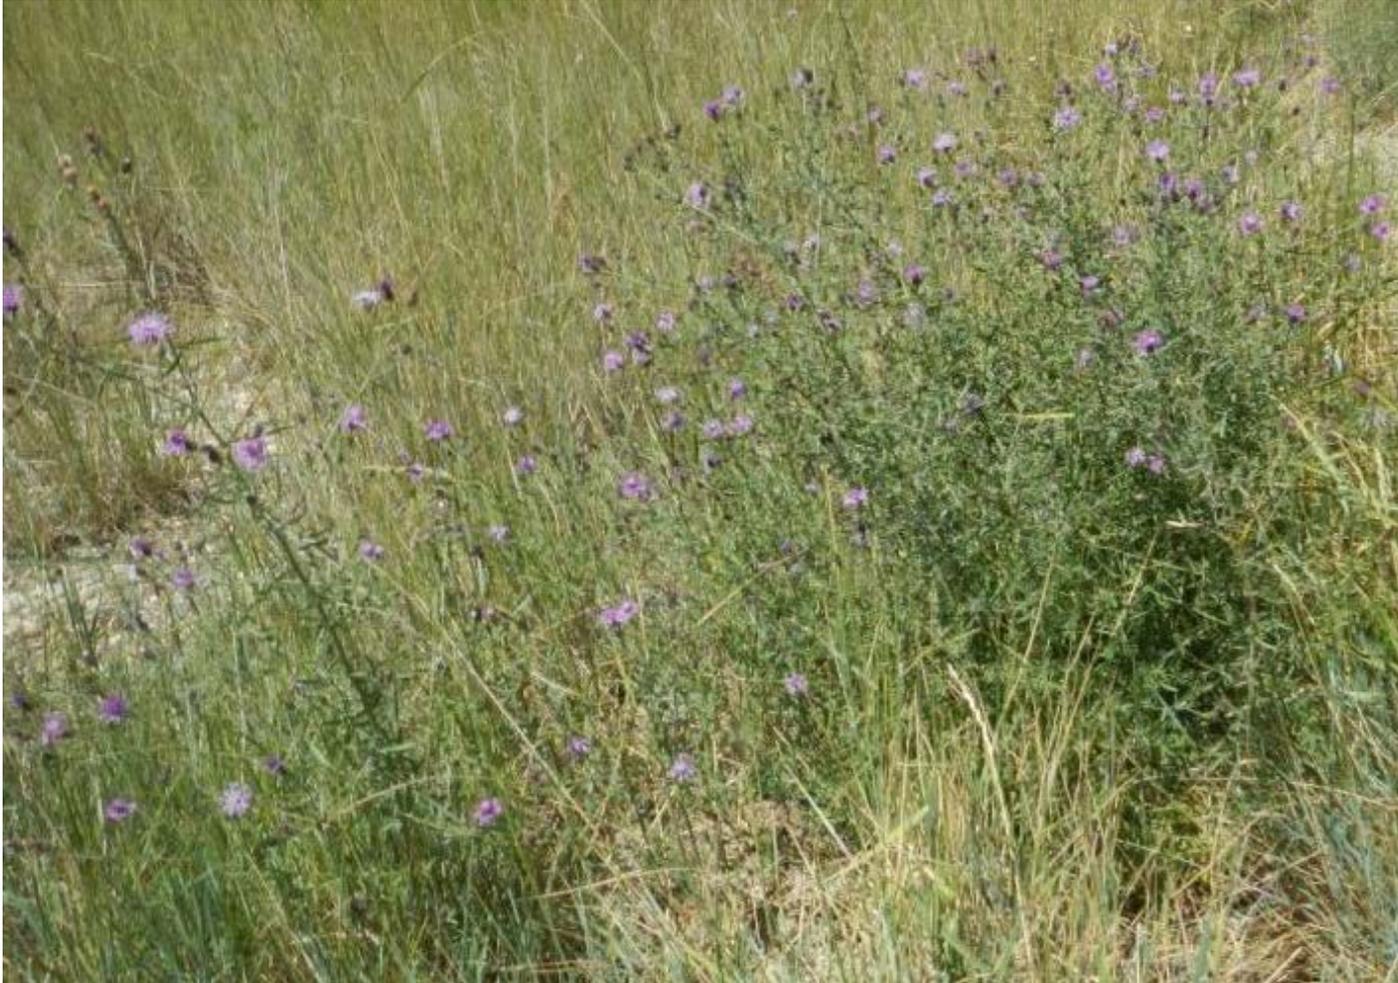
Spotted Knapweed infesting Interim reclamation areas of location.

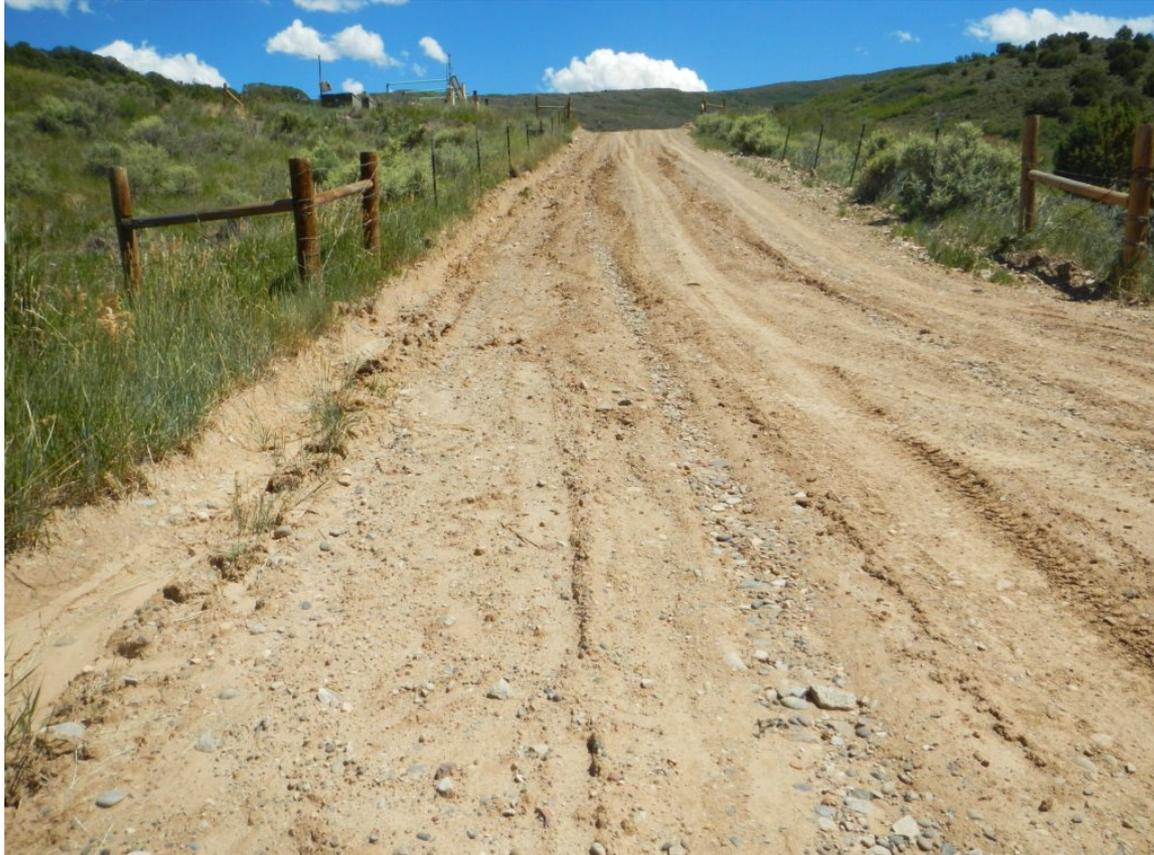
Looking East at access road immediate to Location entrance, in need of maintenance.
