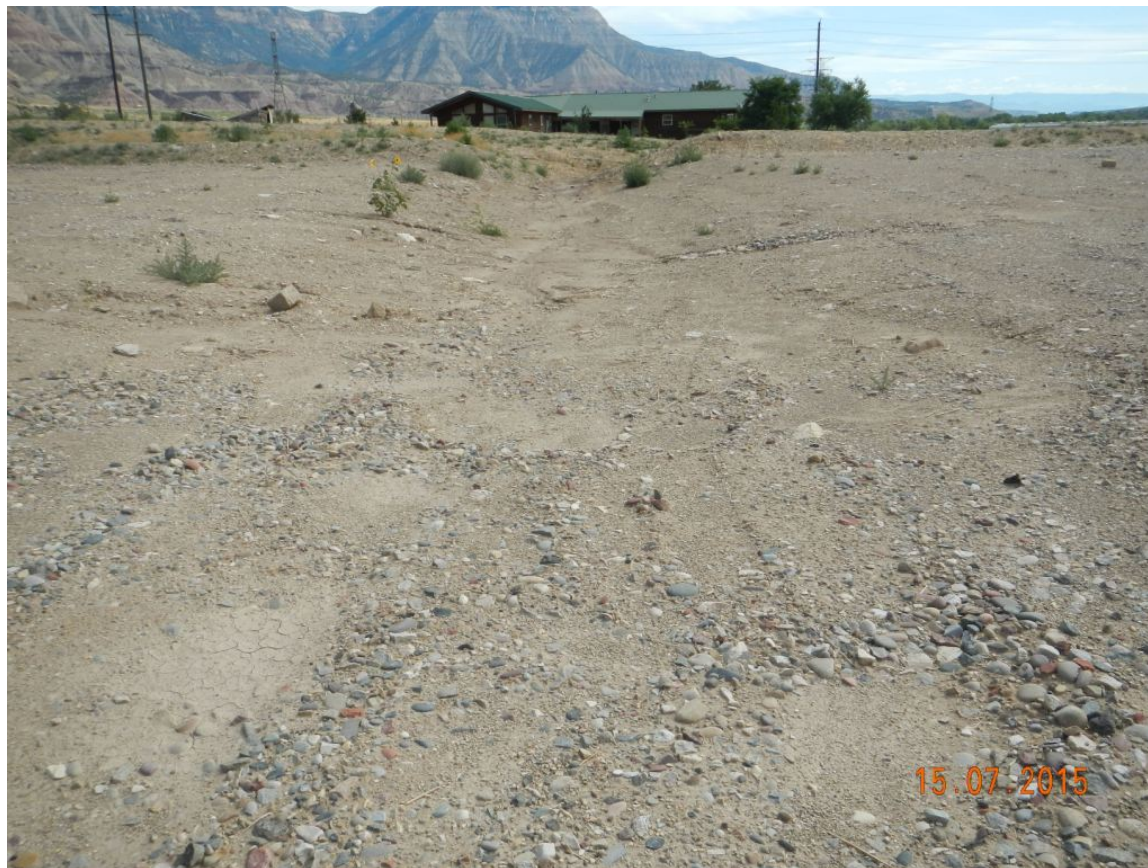
Photo # 1: Center of Pad, which is graded to direct stormwater into ditch at North end of Pad.

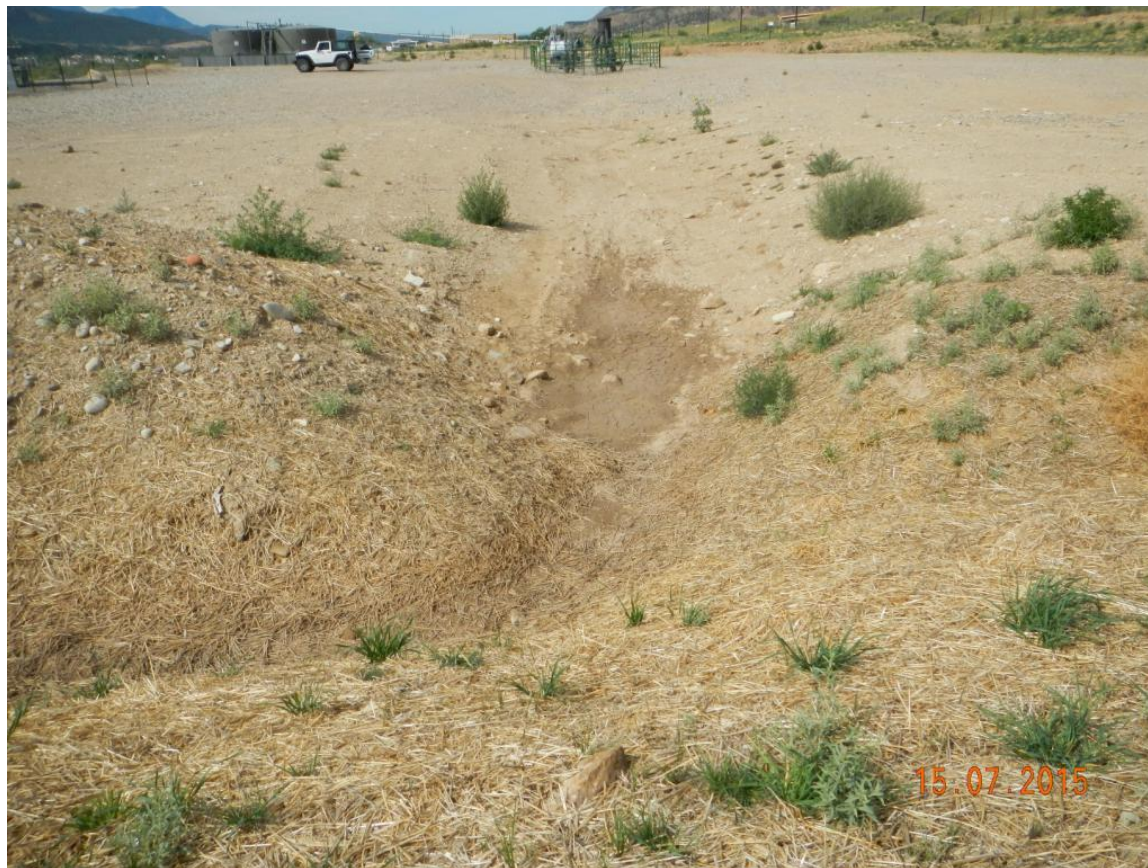
Photo # 2: North end of pad. Here stormwater flows into reclaim area ditch with no evident BMPs.

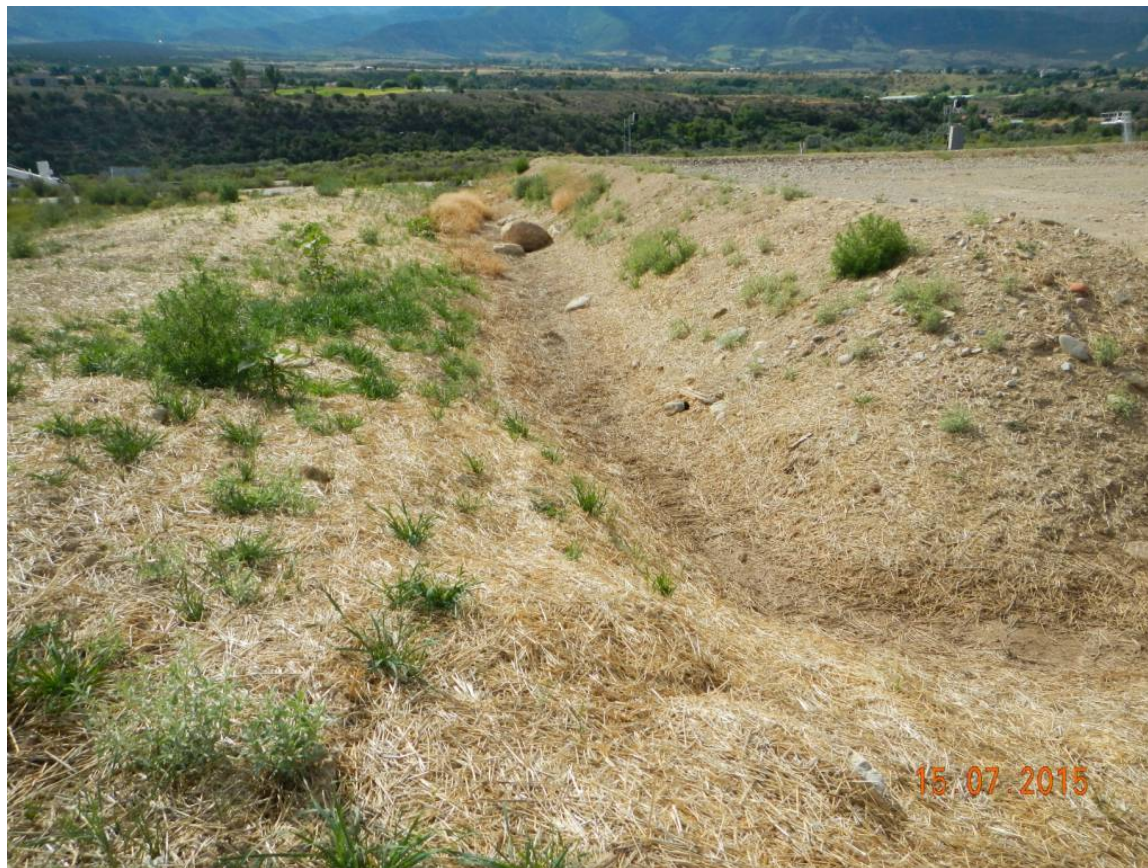
Photo # 3: Following from Photo #2 stormwater flows East. No effective BMPs in place.

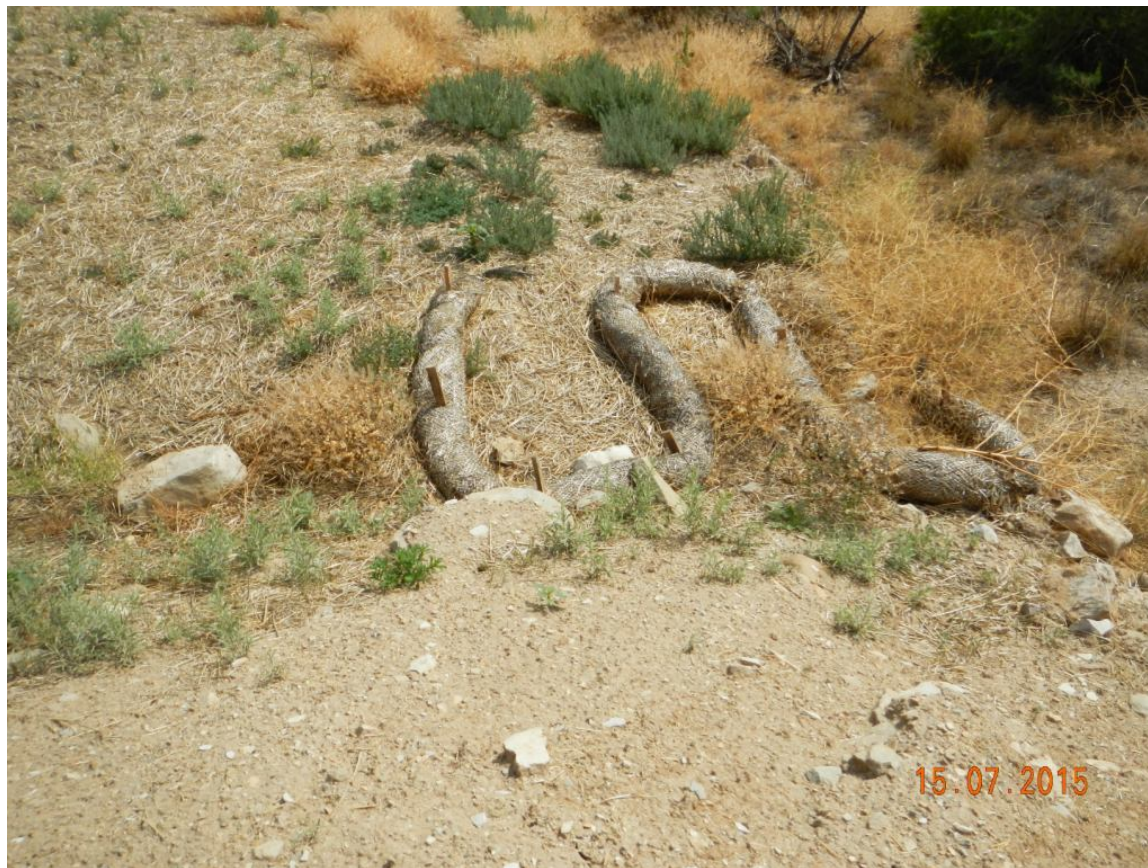
Photo # 4: Termination of ditch in Photo #3. Wattle is not likely sufficient in itself or installed effectively to control, filter and dissipate energy from such a large surface area.

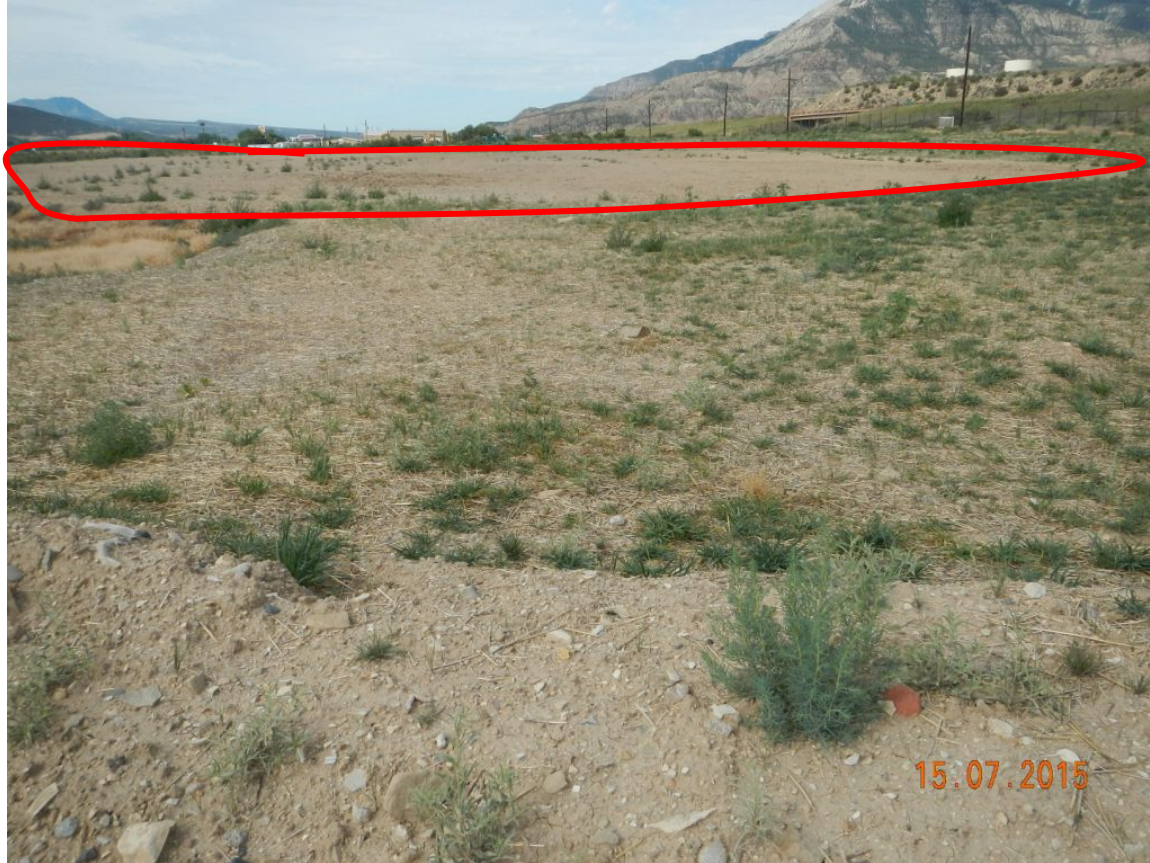
Photo # 5: Area of Location that has not had Interim Reclamation initiated.
