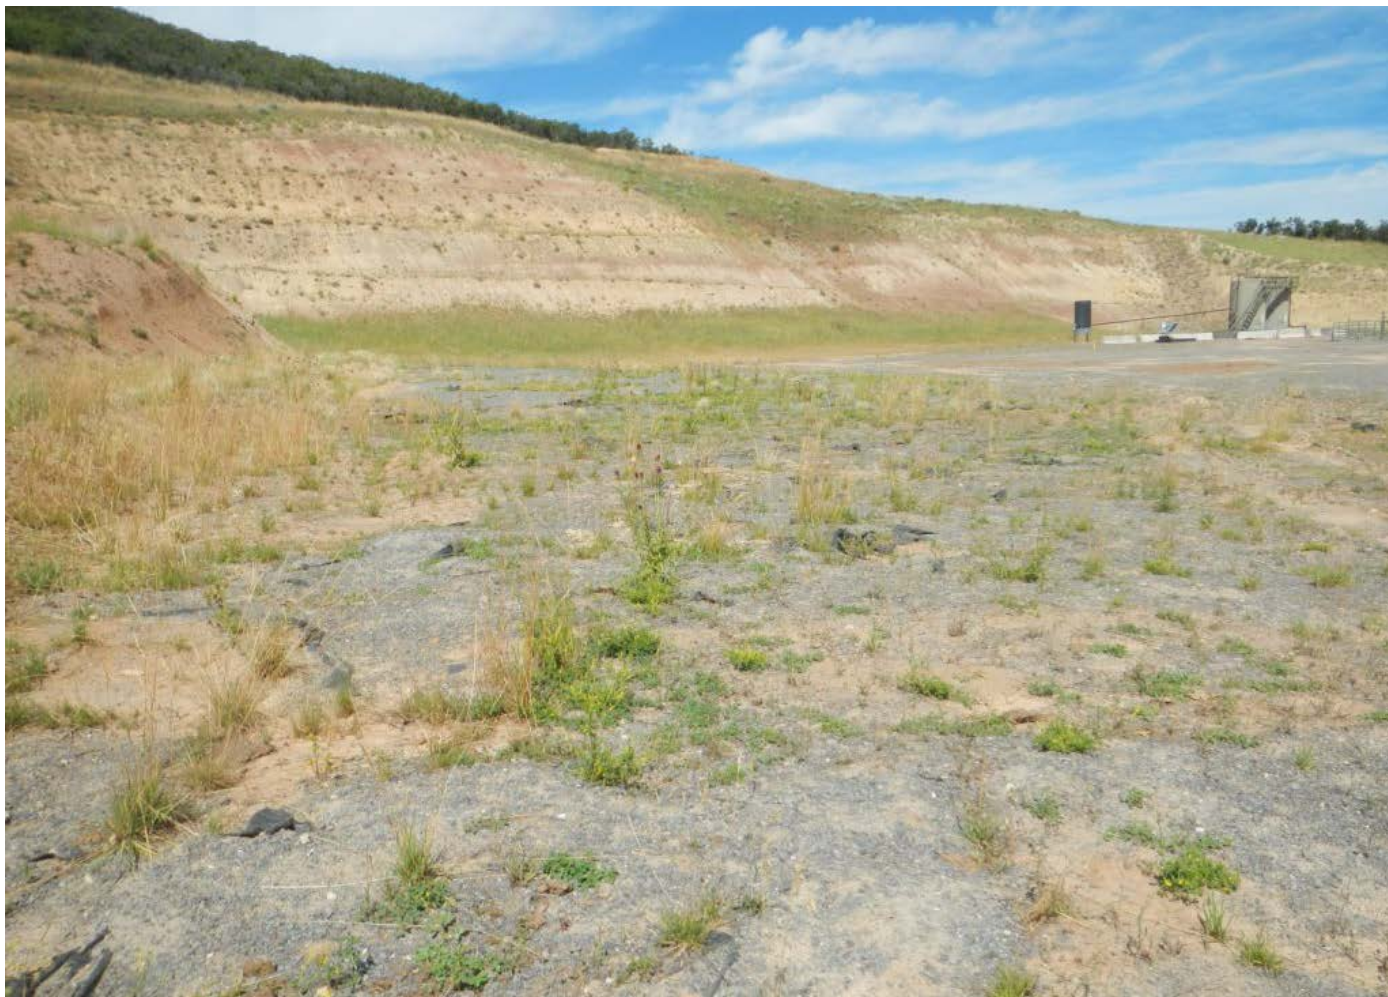
Photo #1: View from SW corner. Large areas of Location no longer needed for production.

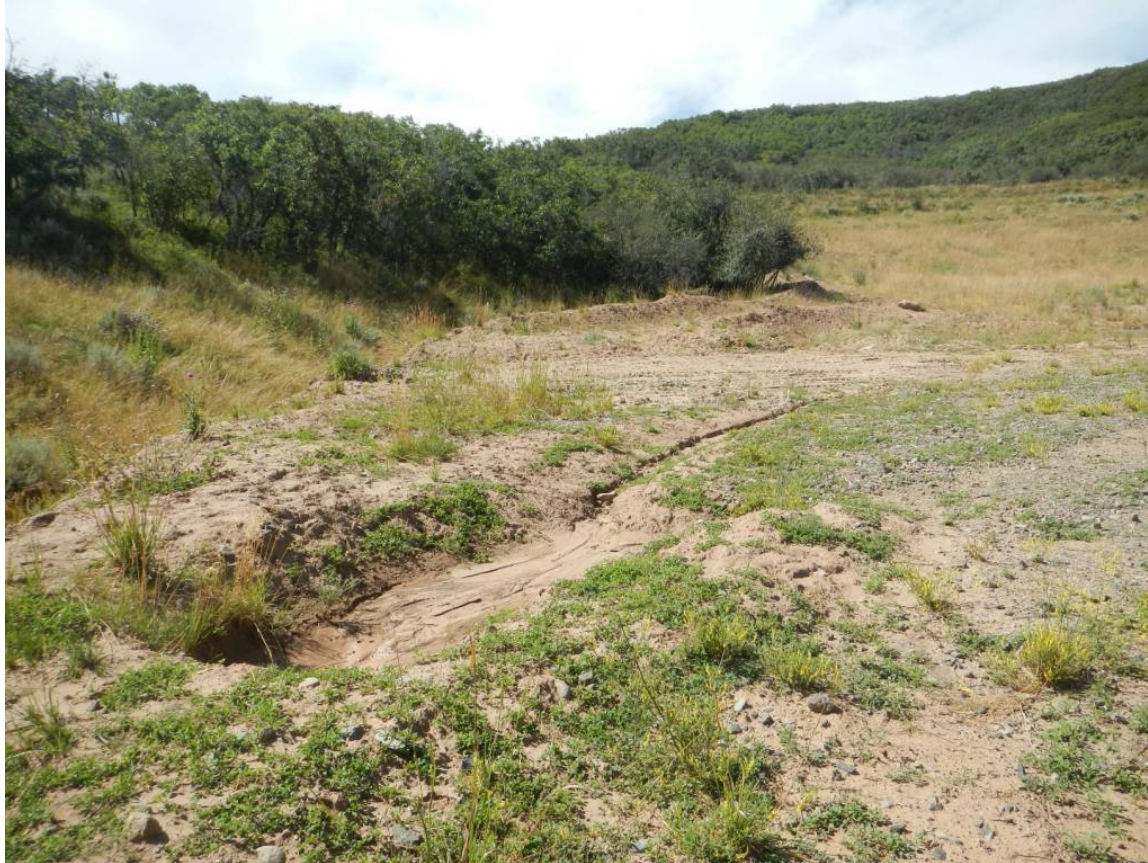
Photo #2: View from SE corner. South end of pad needing stabilizing, reclamation and stormwater maintenance.

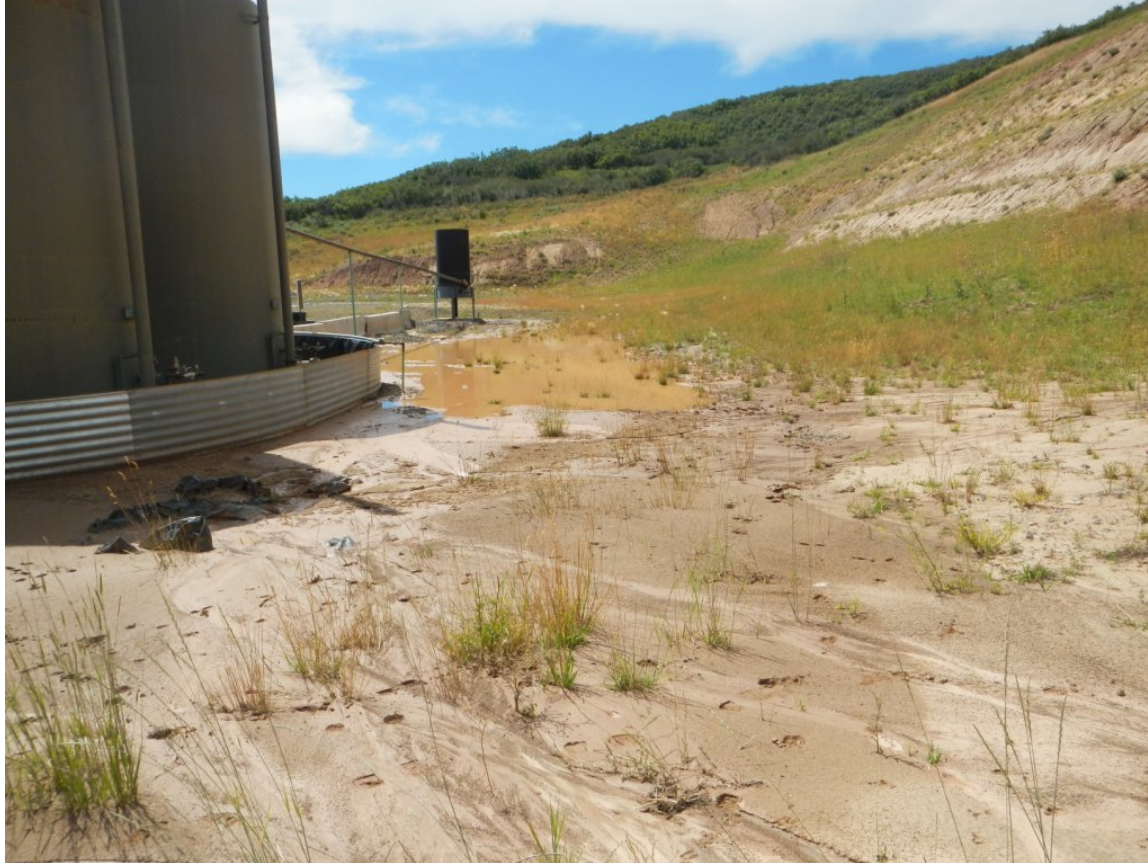
Photo #3: View from NW corner. Run-on from Cut slope NW of tank battery

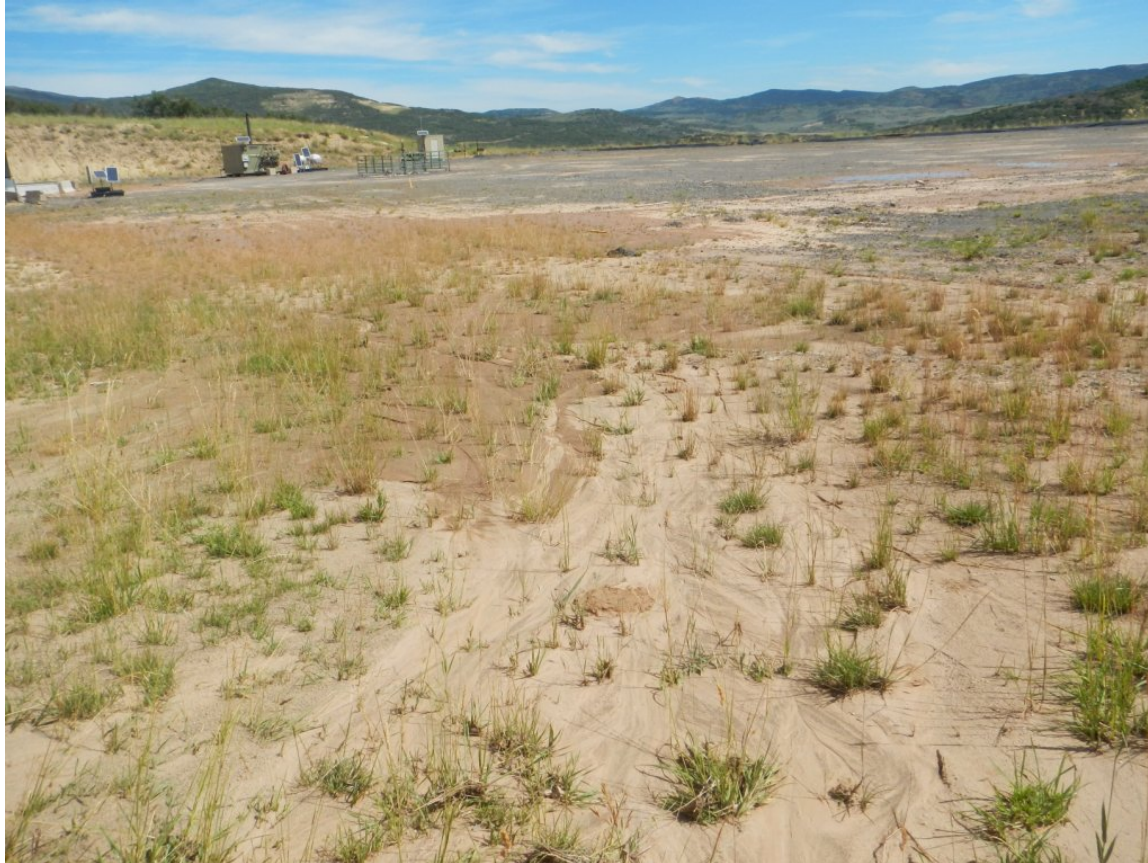
Photo #4 : View from SW corner. Sediment migration from Southern boundary.

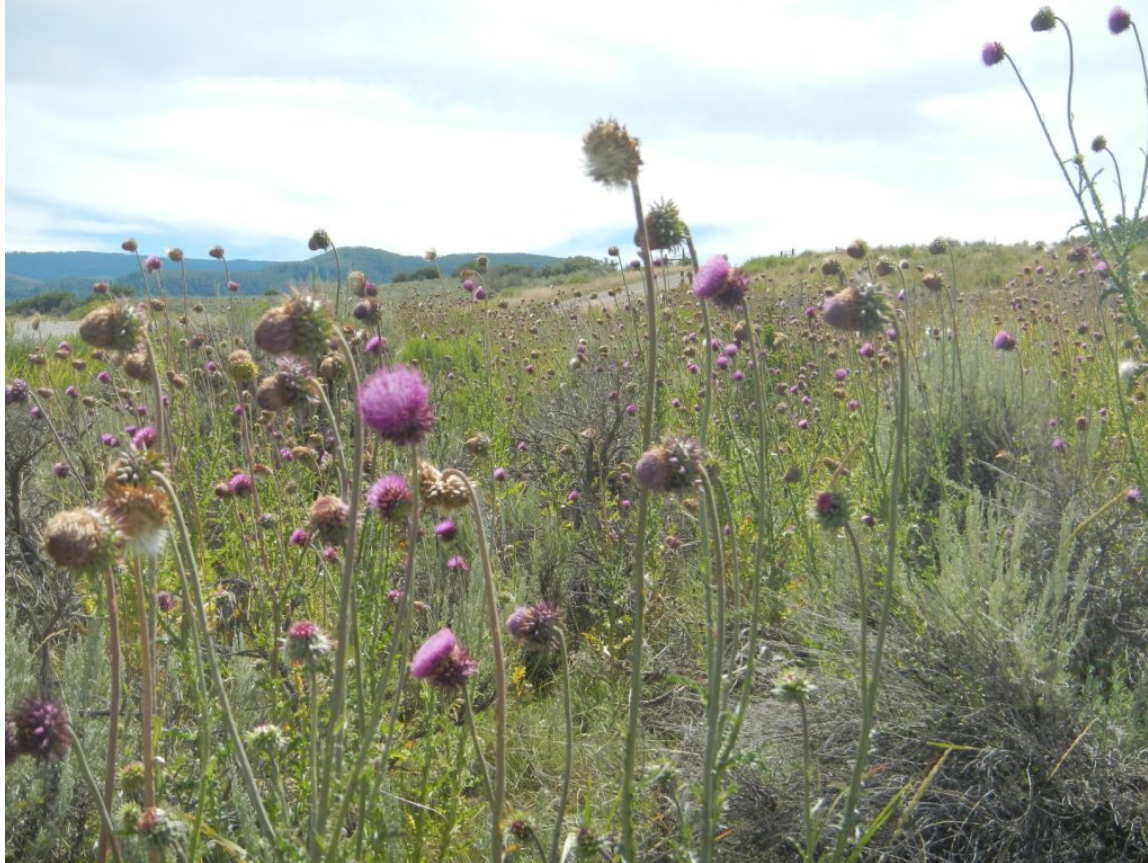
Photo #5: Thistle, B list Noxious weed along access road.
