Fwd: Red Mesa J C K #1, API # 05-067-05765

**FORM
INSP**Rev
05/11**State of Colorado
Oil and Gas Conservation Commission**1120 Lincoln Street, Suite 801, Denver, Colorado 80203
Phone: (303) 894-2100 Fax: (303) 894-2109

08/12/2015

674602196

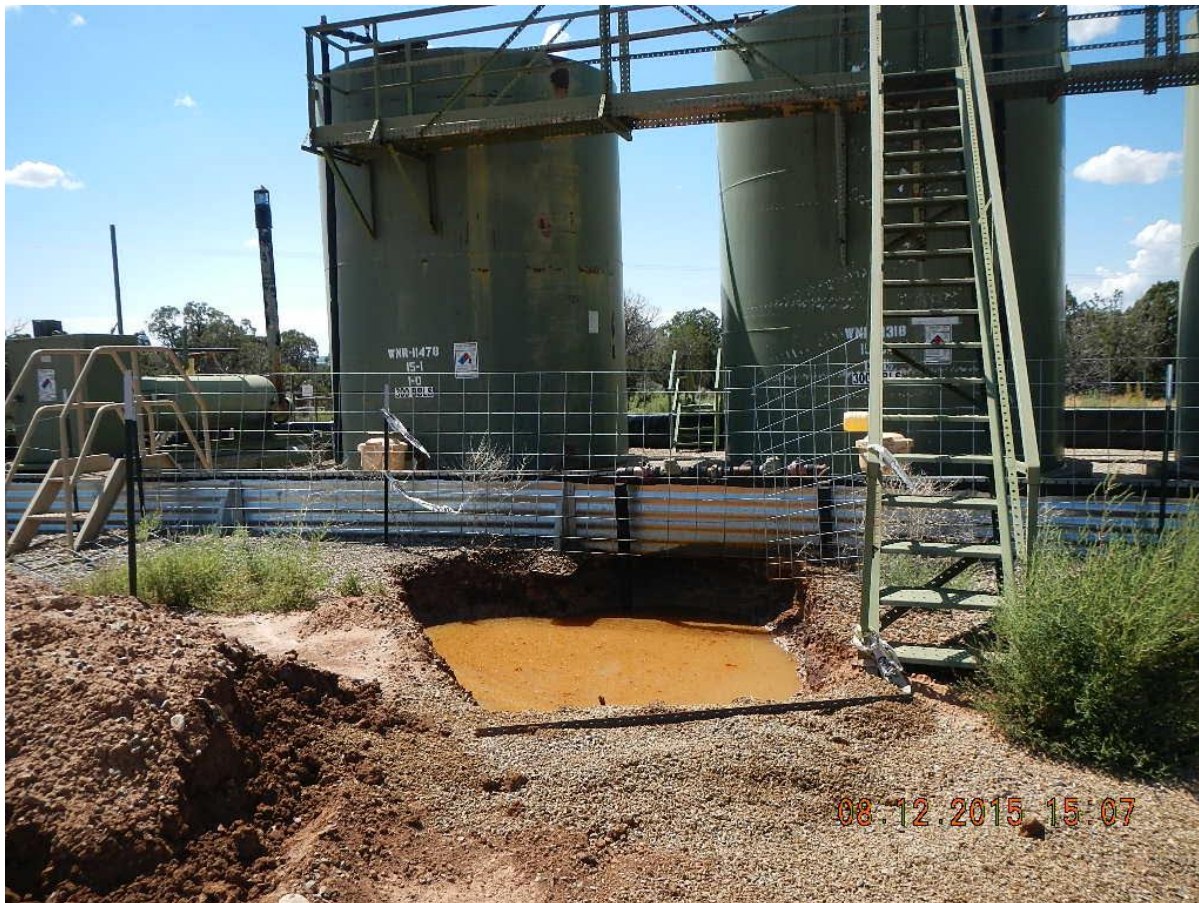
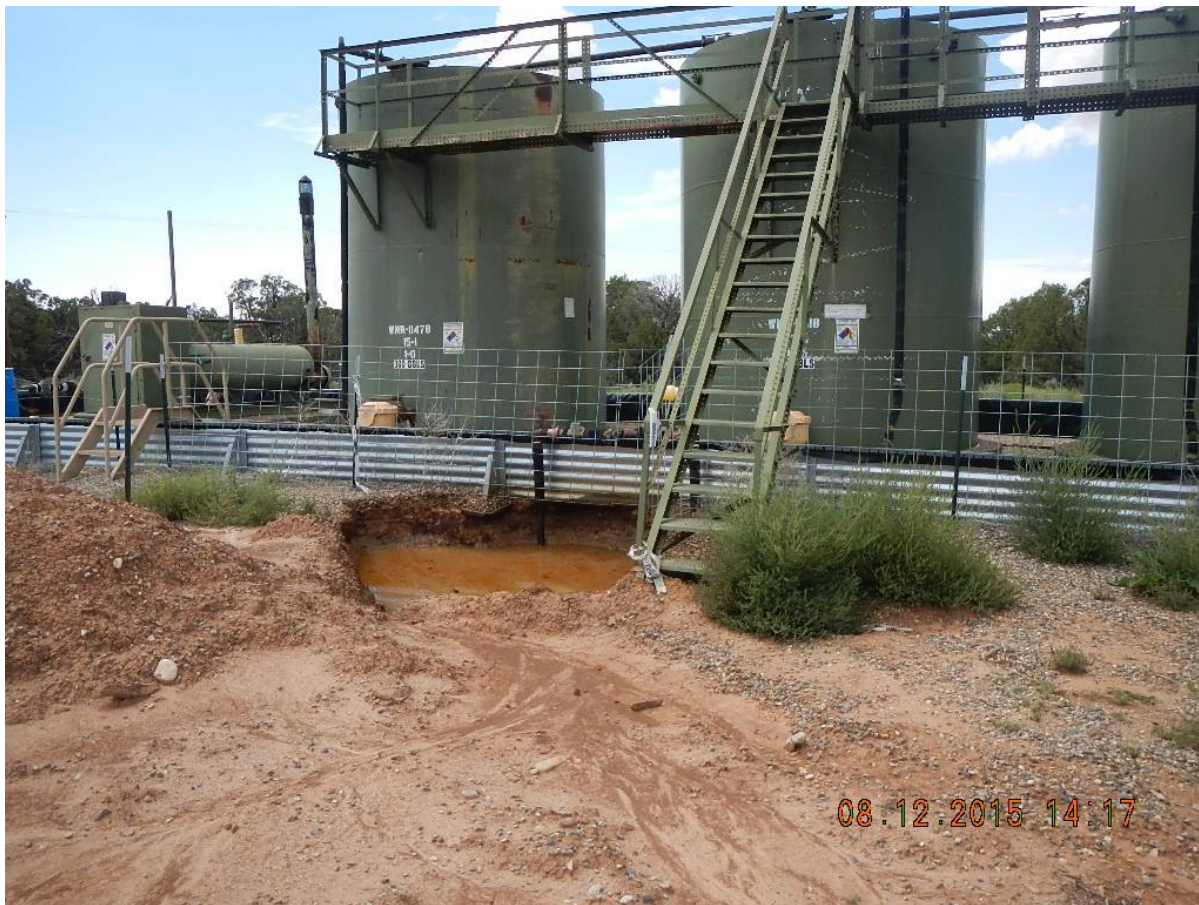
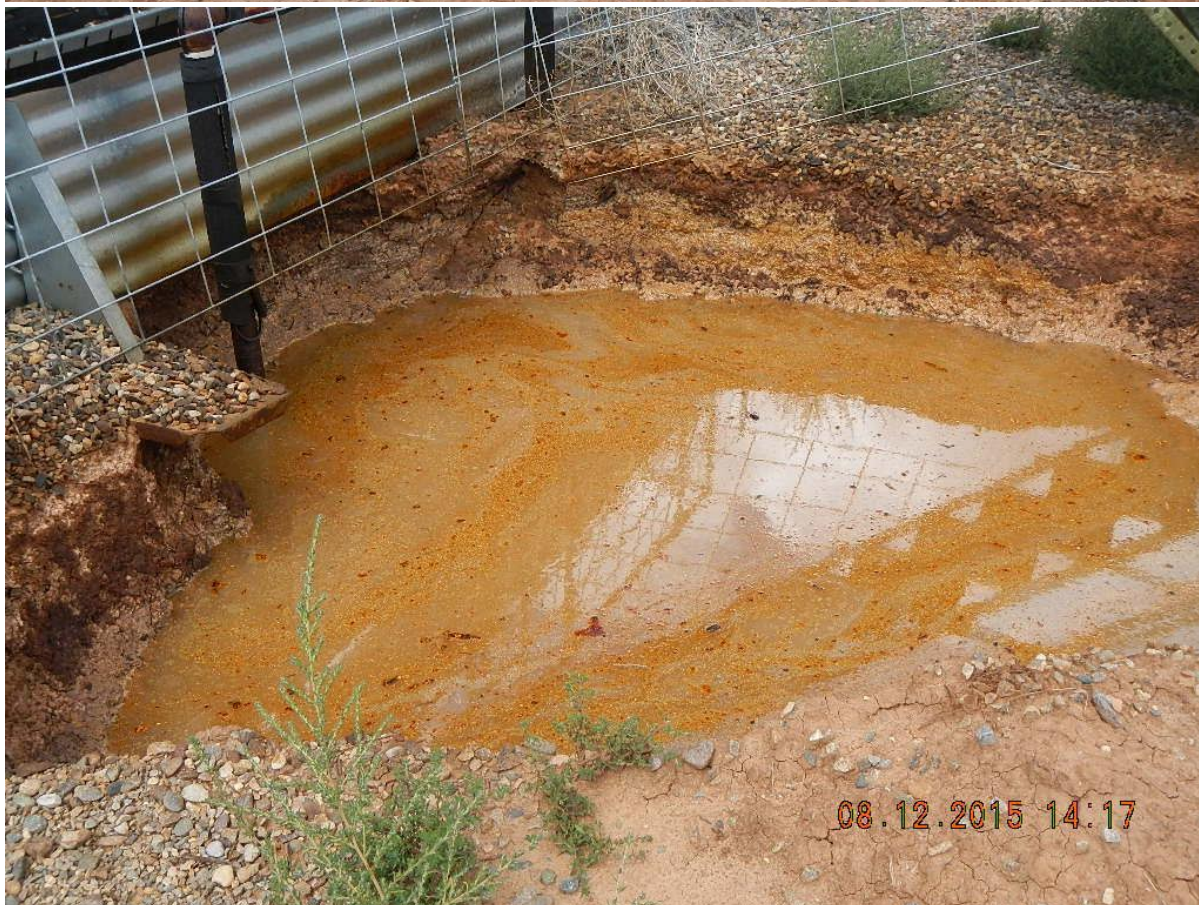
It was reported on March 13, 2015 by the Colorado Oil and Gas Conservation Commission (COGCC) staff, that there is an open excavation where a flow line was repaired. At that time, oil was noted on the fluids in the bottom of the excavation and the corrective actions were to remove impacted material. A recent (August 12, 2015) inspection by COGCC staff indicated the excavation still present with storm water accumulating in the excavation with free phase hydrocarbons on the fluid surface. Additionally, it appears that the walls of the excavation have collapsed undermining the steel secondary containment wall. The undermining may potentially cause failure of the secondary containment.

The Actions Required outlined on the previous field inspection doc #674601776 performed on 04/15/2015 have not been completed. There is no evidence of recent activity at this location. The open excavation/ pipeline repair area on the SW side of the tank battery is accumulating stormwater. Work was completed while on location to slow down additional stormwater accumulations in this excavation (also contains free crude oil). Photo's uploaded.

remove impacted fluid and material;
backfill excavation and stabilize the secondary containment; and
address storm water controls on location.
