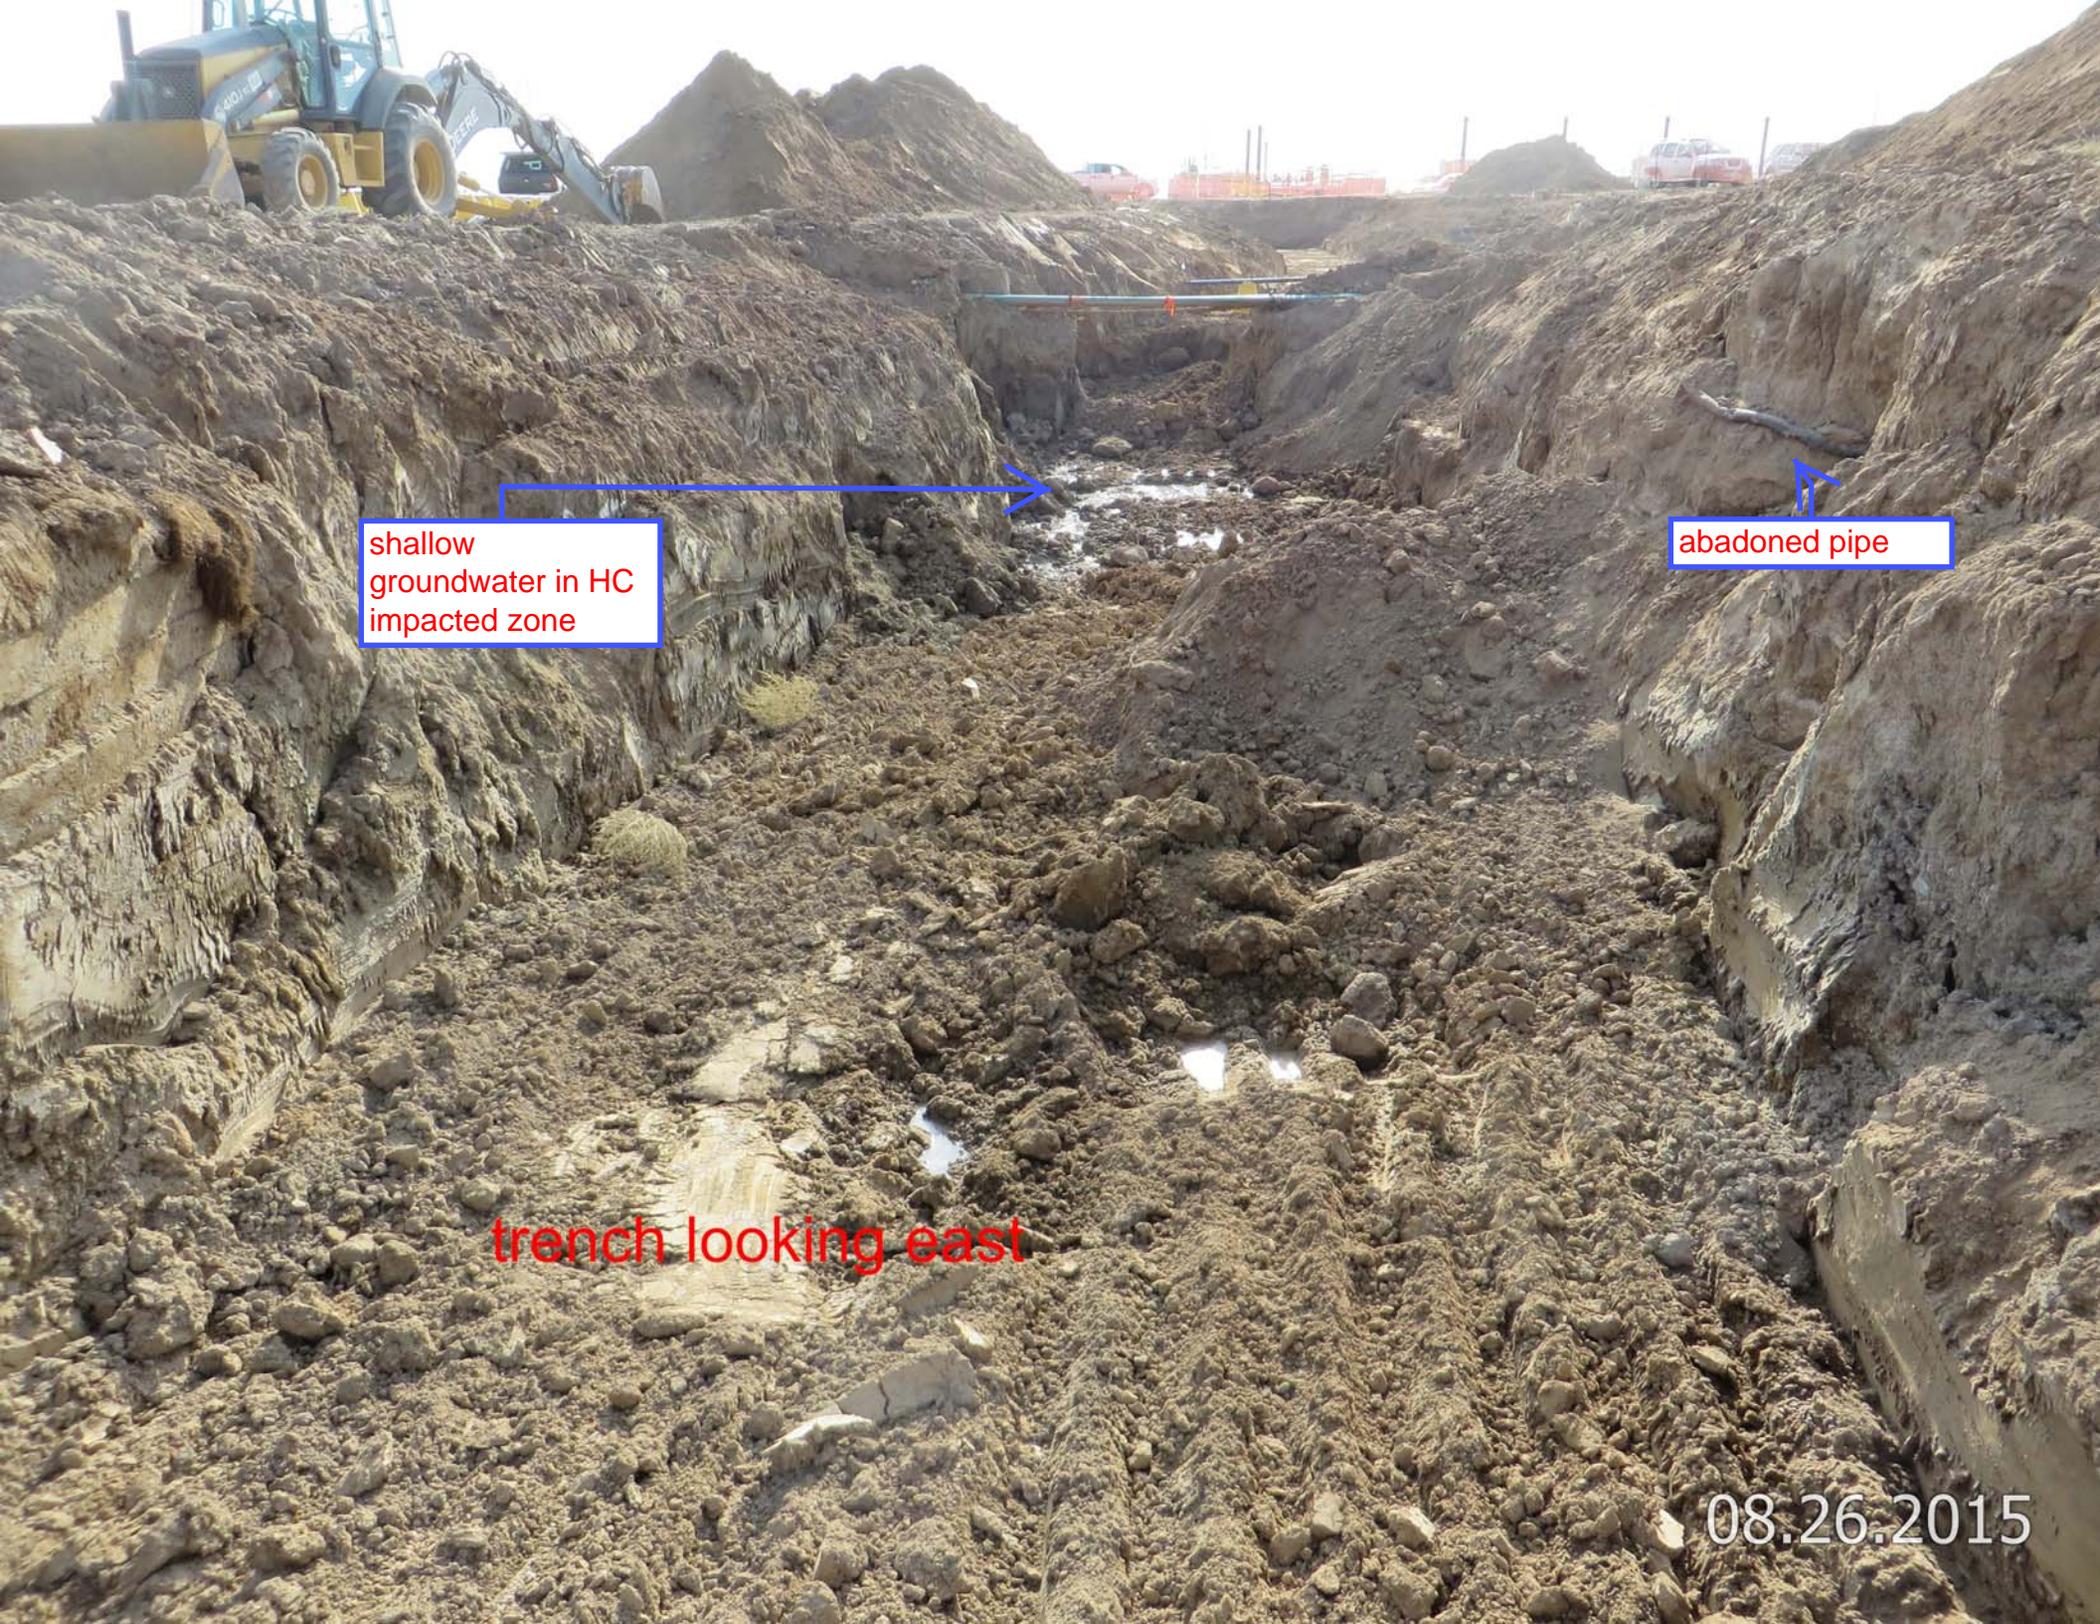
shallow
groundwater in HC
impacted zone

abadoned pipe

trench looking east
