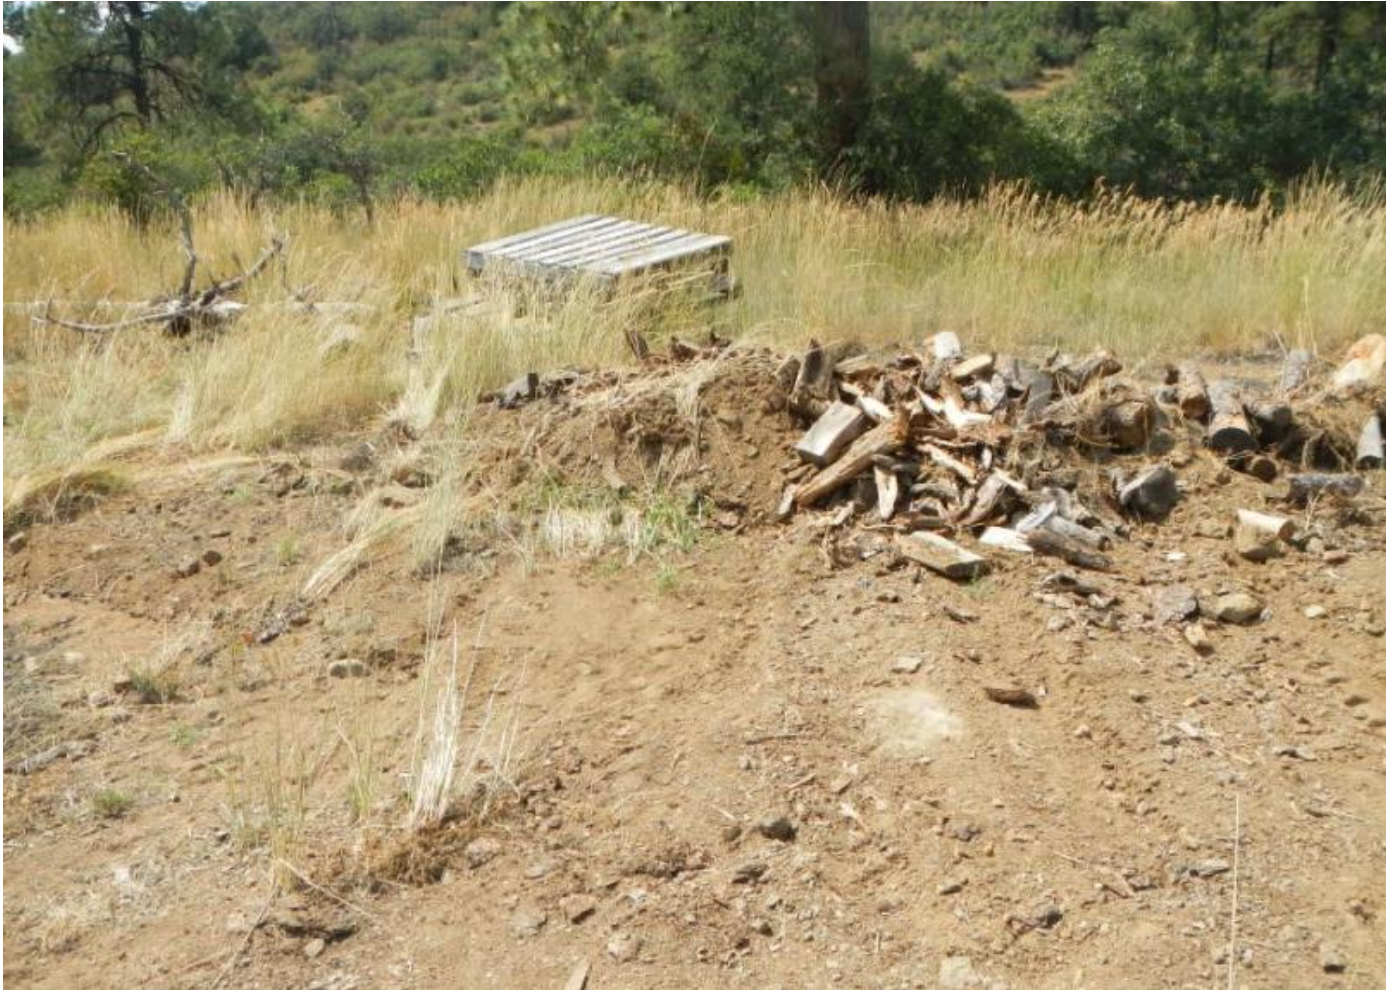
Photo 1. View of junk and debris within the northern portion of the project area.

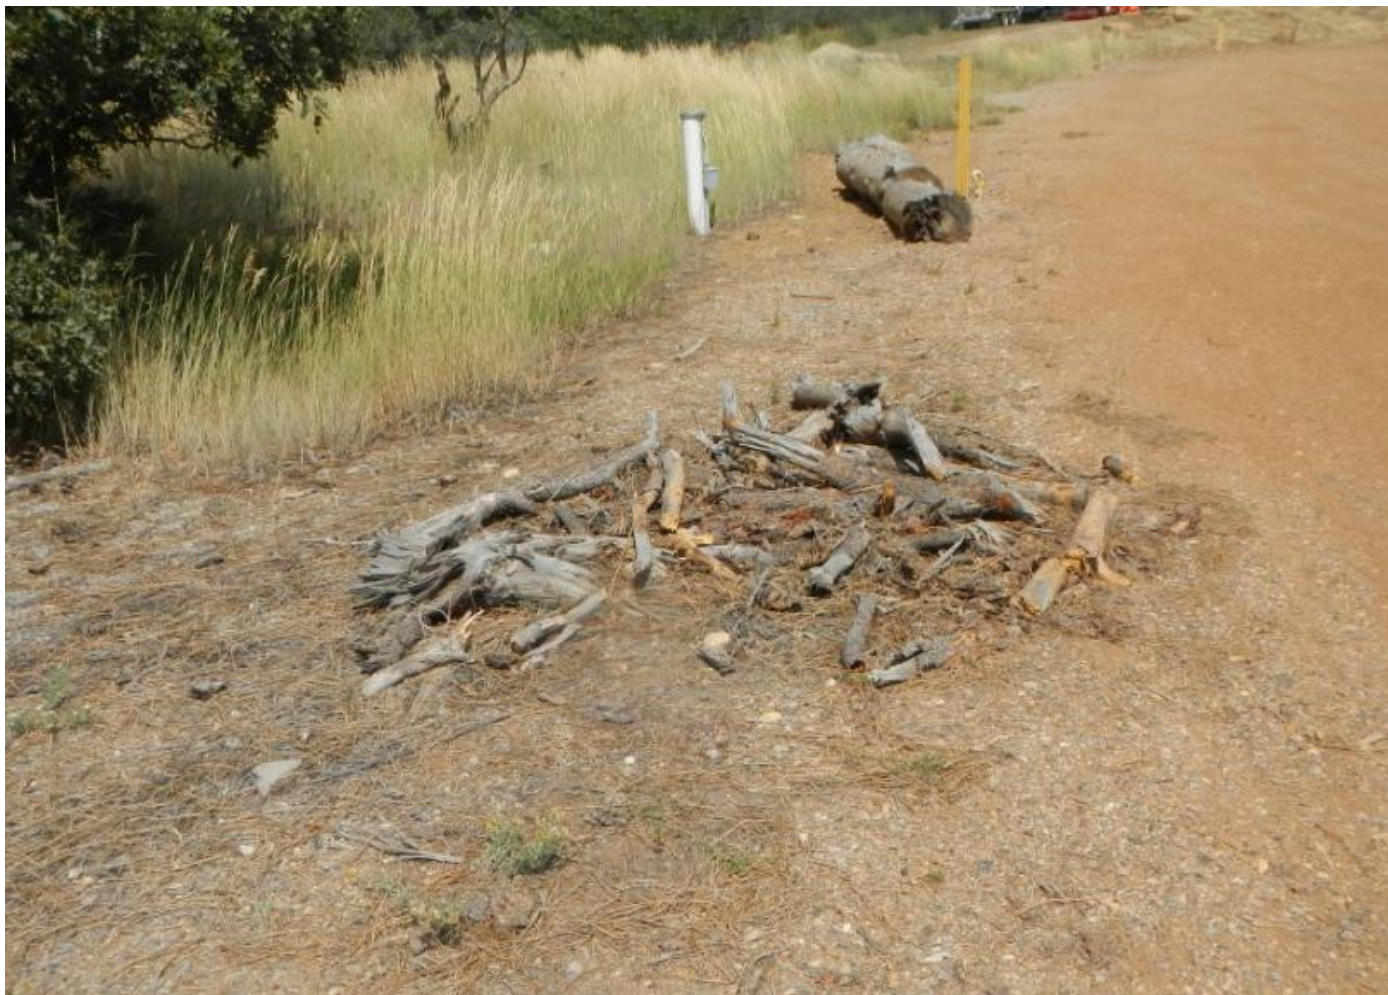
Photo 2. View of woody debris within the northern portion of the project area.

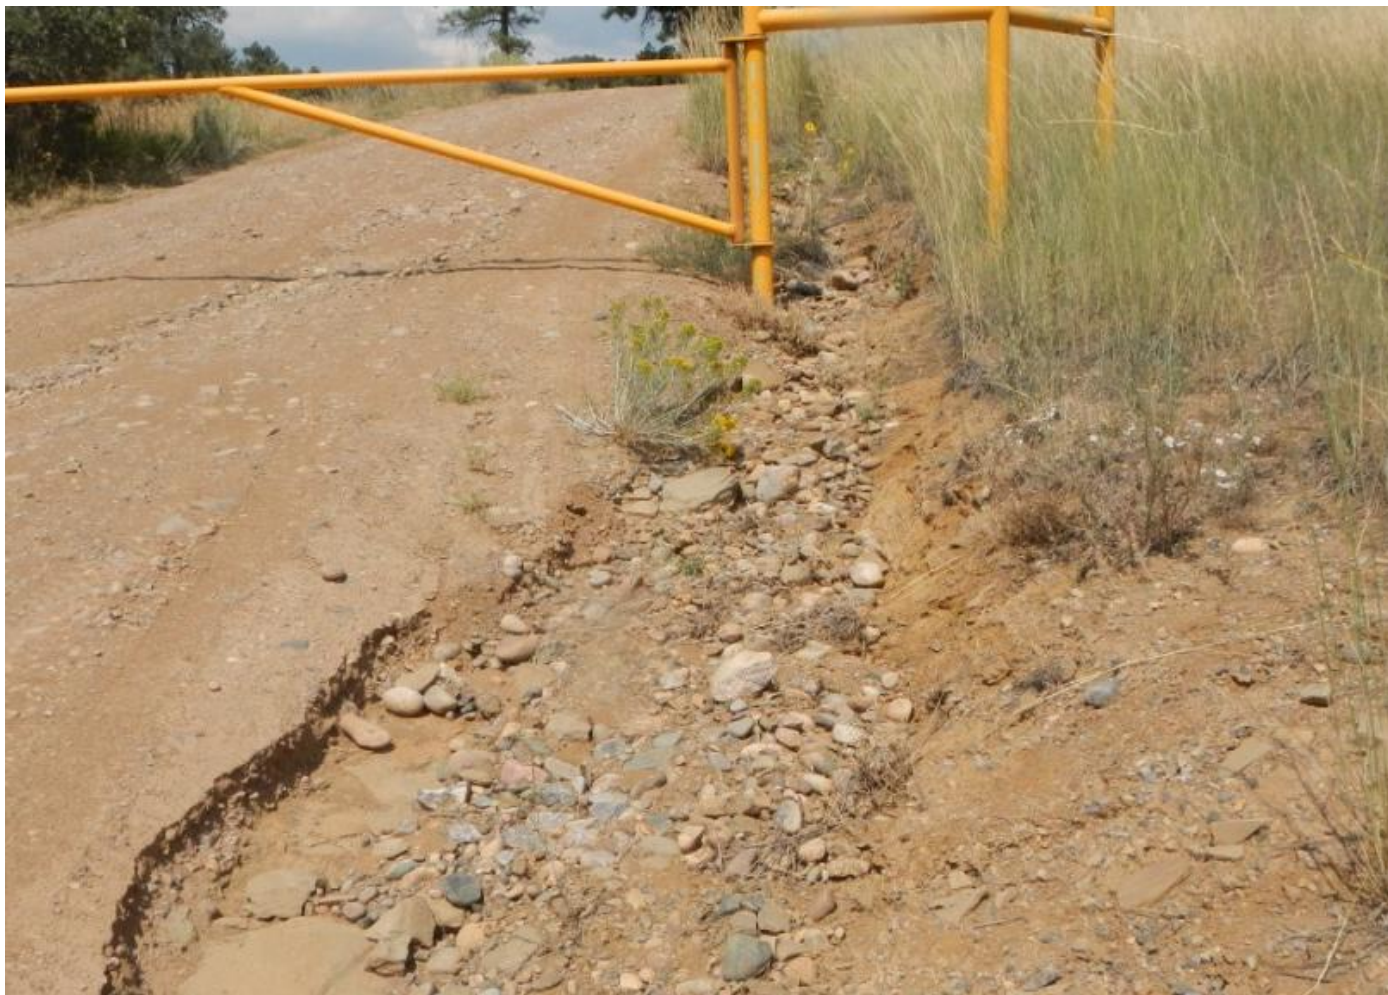
Photo 3. View of erosional channel approximately 3 to 4 feet wide and 1.5 feet deep along access road. Stormwater BMPs are needed to de-energize flows along the access road.

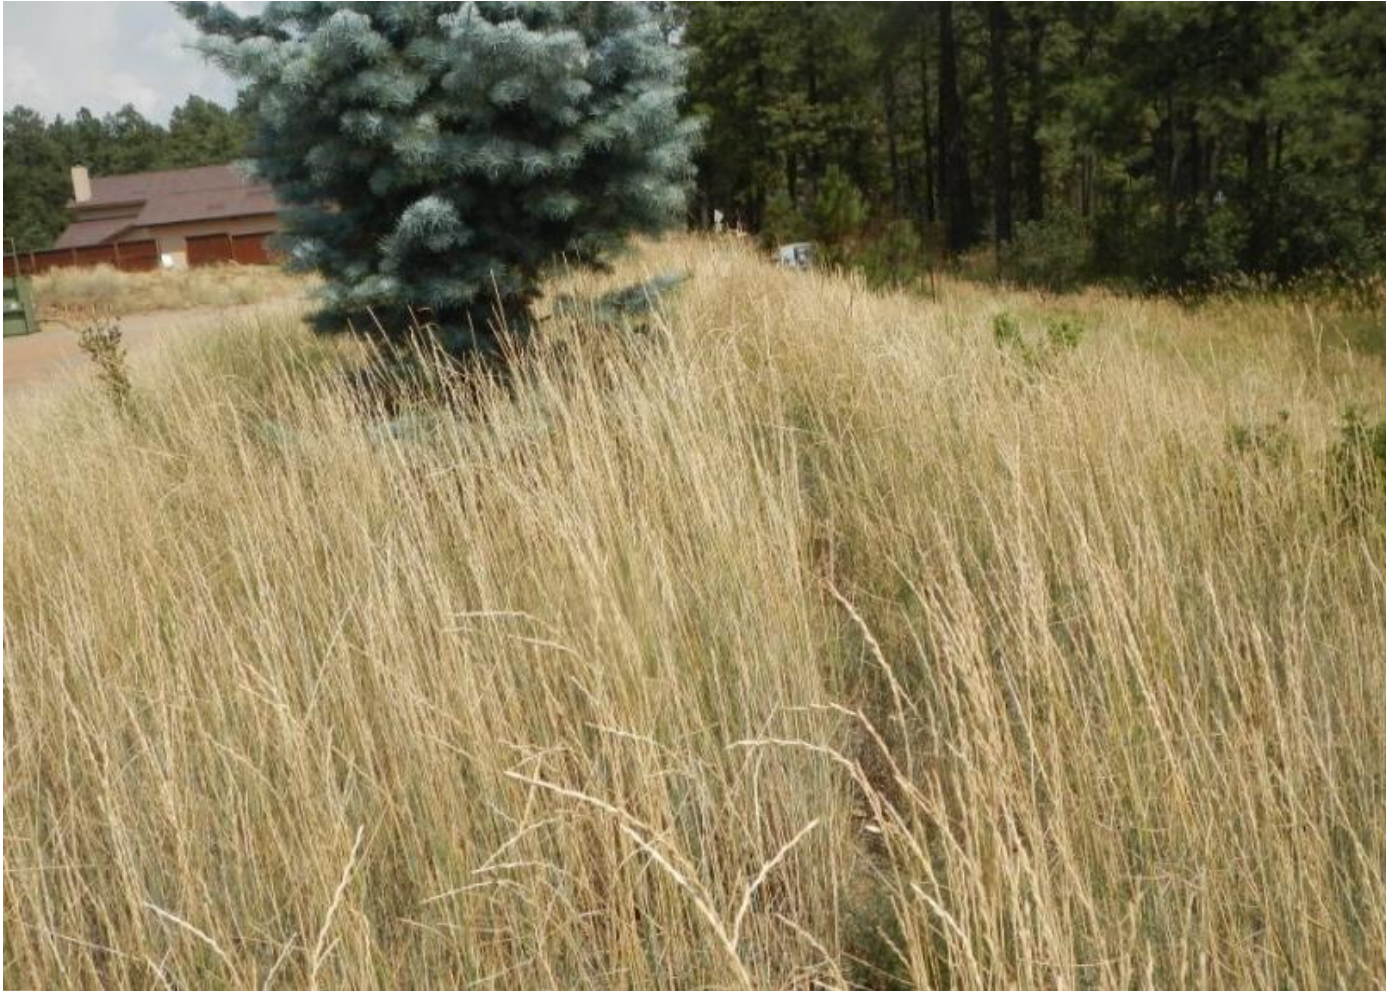
Photo 4. View of southern portion of the project area from southwestern corner facing eastward. Vegetation such as intermediate wheatgrass (*Thinopyrum intermedium*), western wheatgrass (*Pascopyrum smithii*), and white fir (*Abies concolor*) are becoming established here.
