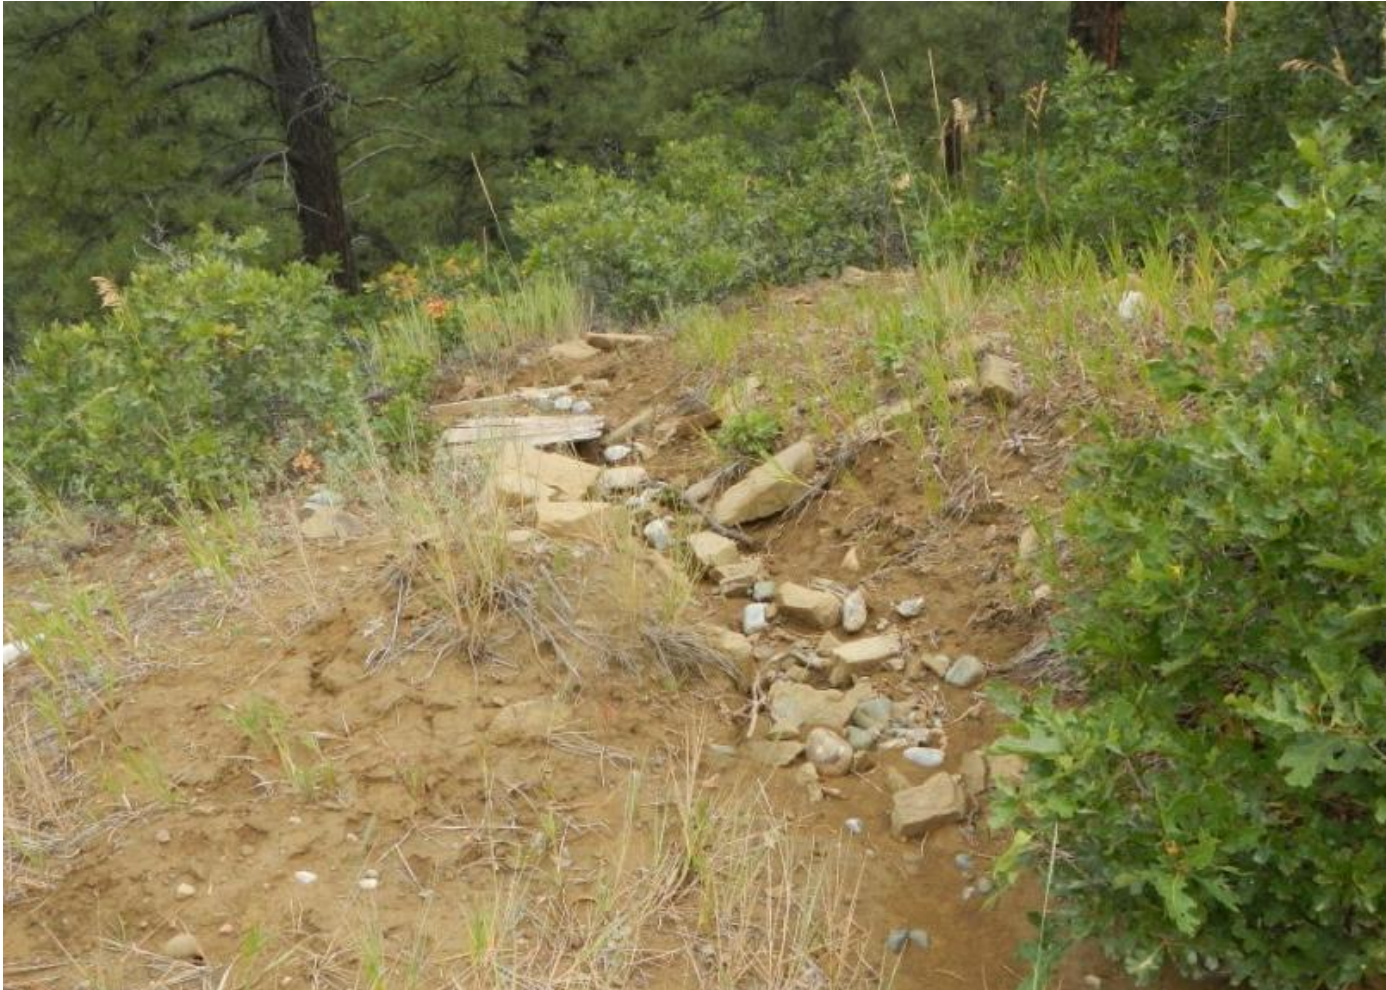
Photo 1. View of erosional channel approximately 2 feet wide and 10 inches deep within northwestern portion of project area. Stormwater flows need to be de-energized here.

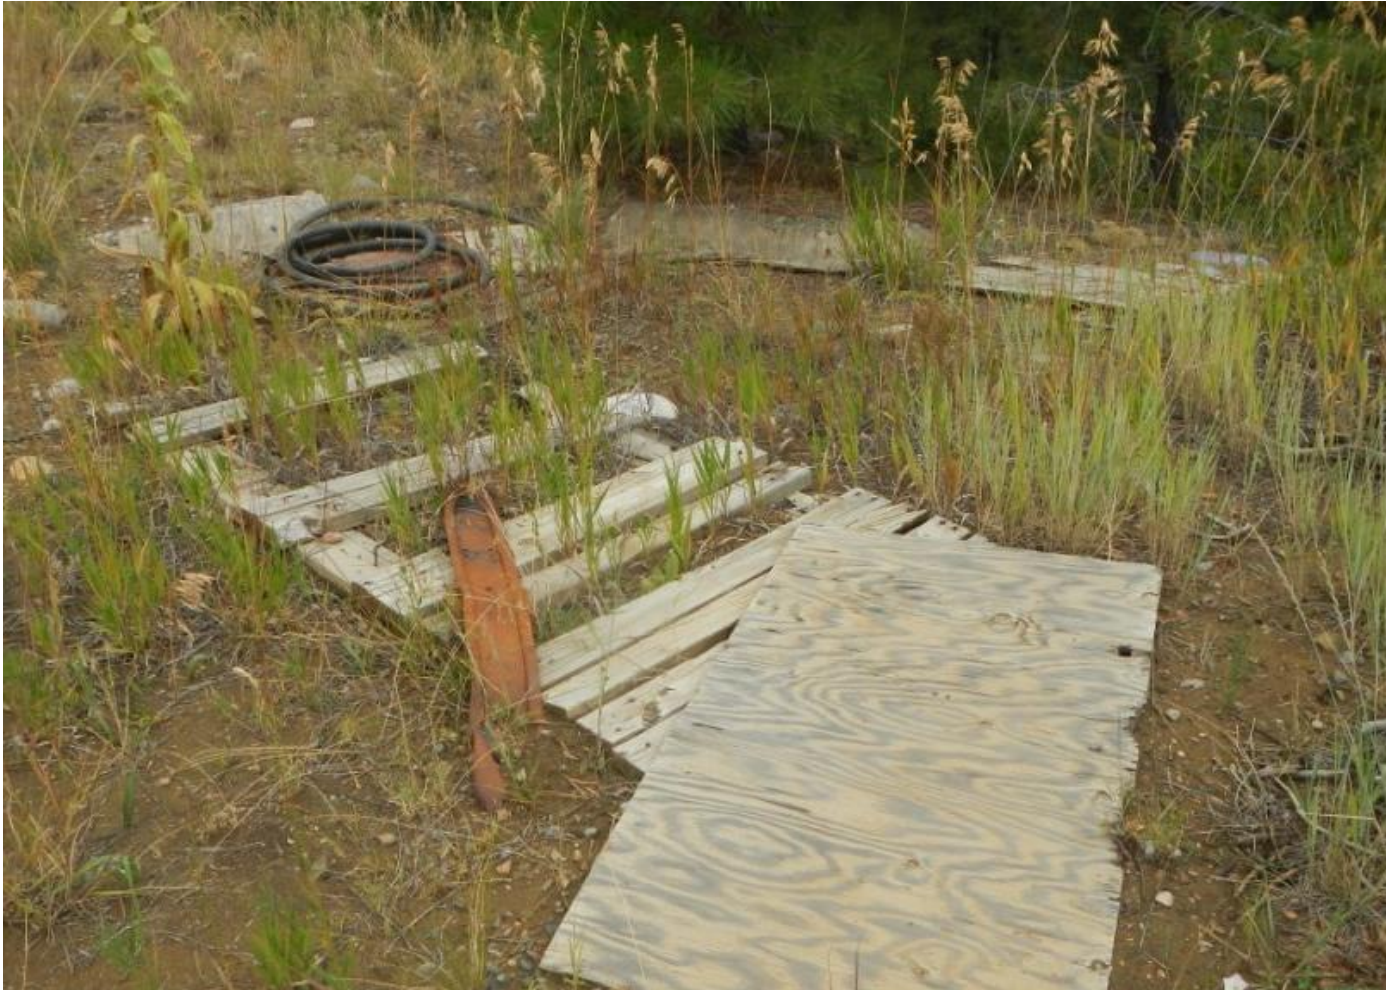
Photo 2. View of junk within northwestern portion of project area that needs to be removed.

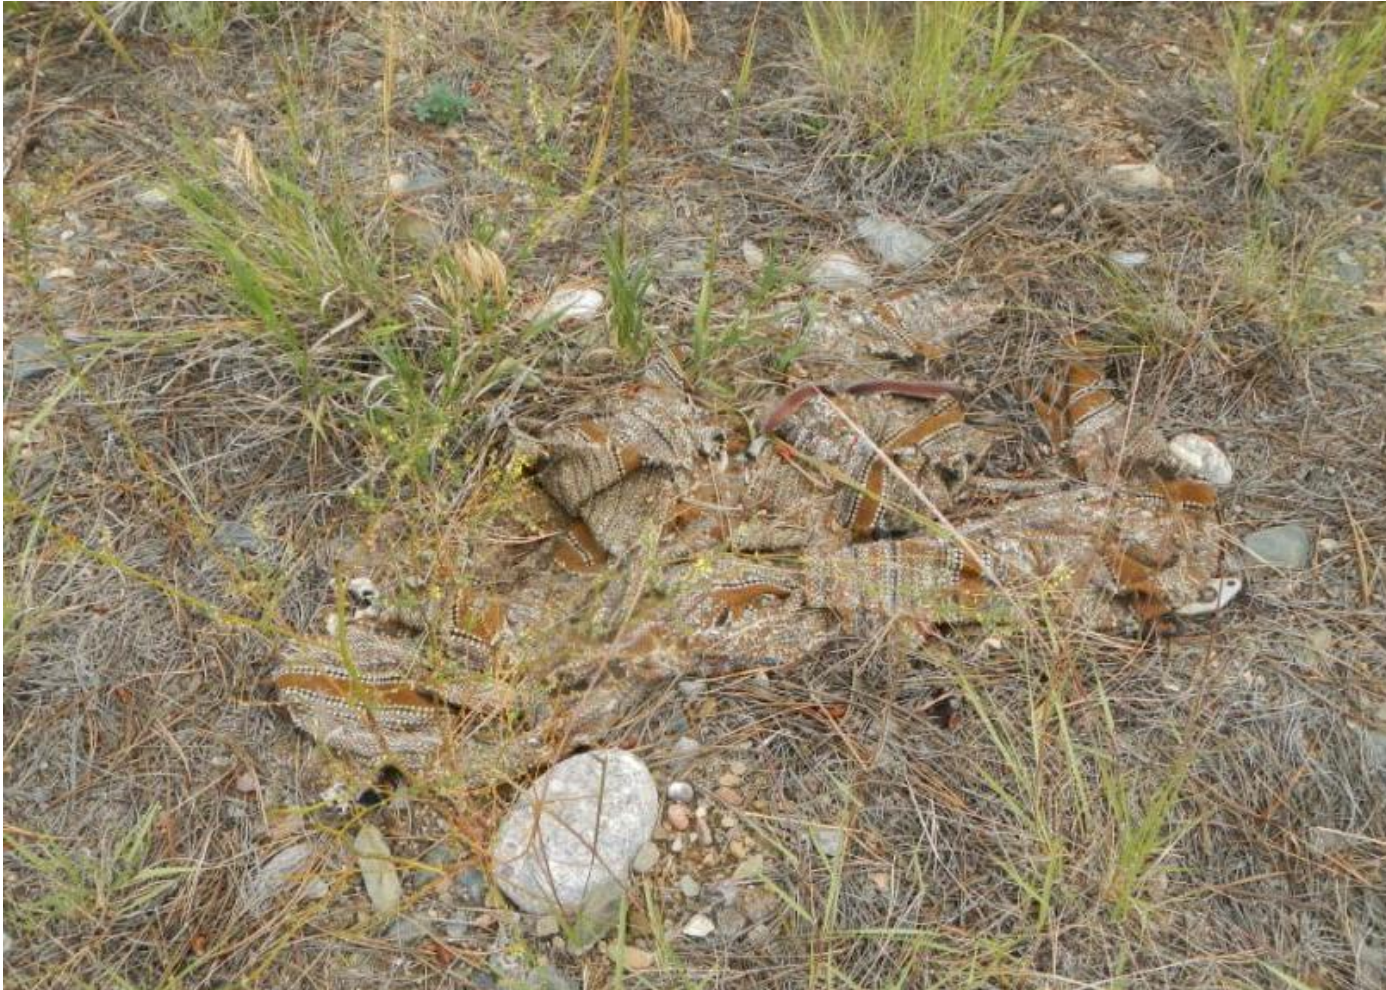
Photo 3. View of junk within northwestern portion of project area that needs to be removed.

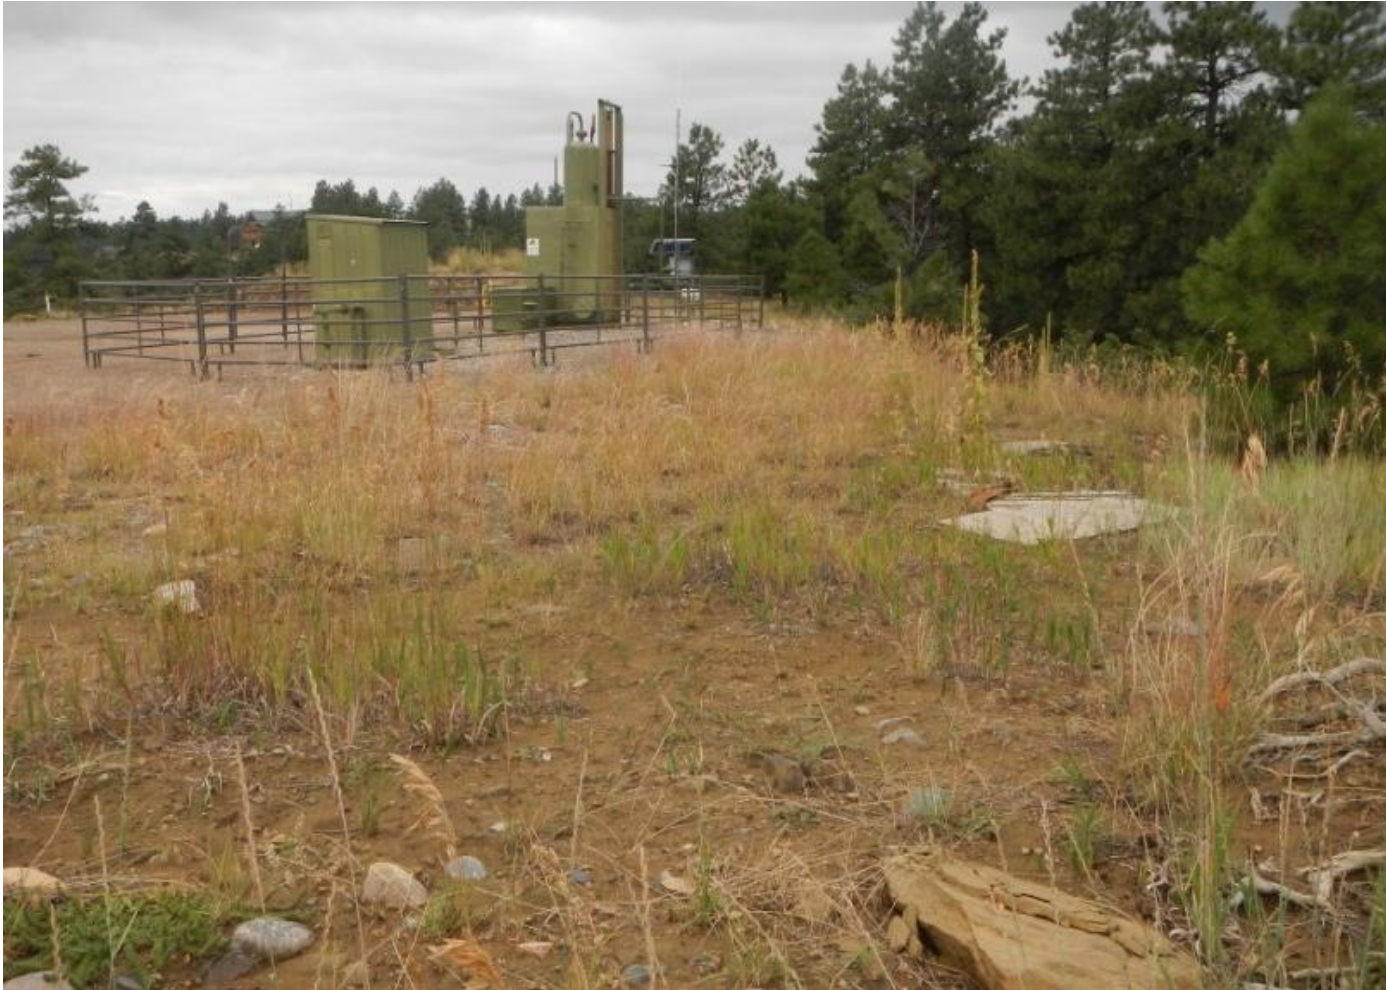
Photo 4. View of northwestern portion of project area from northern corner facing southward. Revegetation is progressing here.

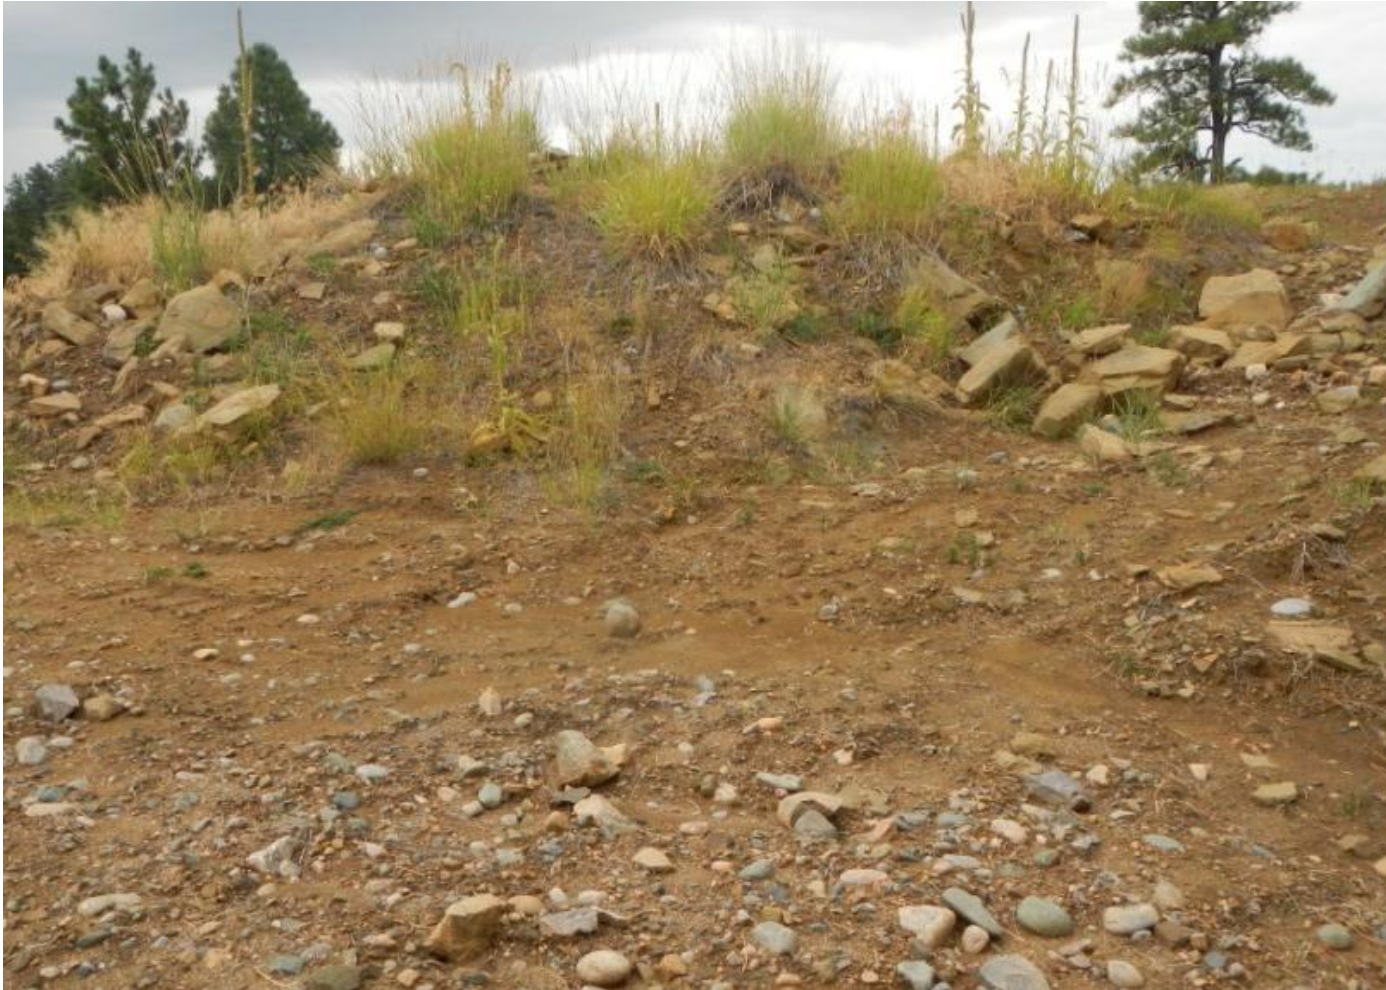
Photo 5. View of vegetated soil stockpile in southern portion of project area.
