## A.P. Urie 1

Inspection# 673402427

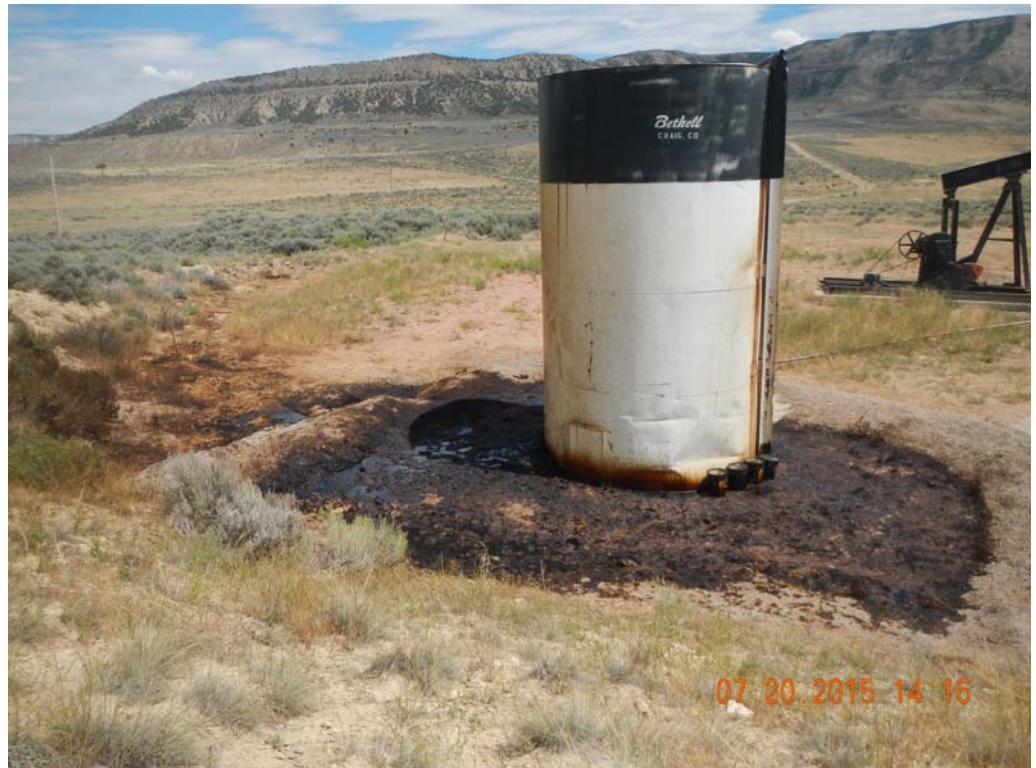
Inspection 673402259  
7/20/2015

Overview of spill area looking east. Breach of berm at base visible in right foreground. Breach of berm with overflow and resultant spill path visible in left background.

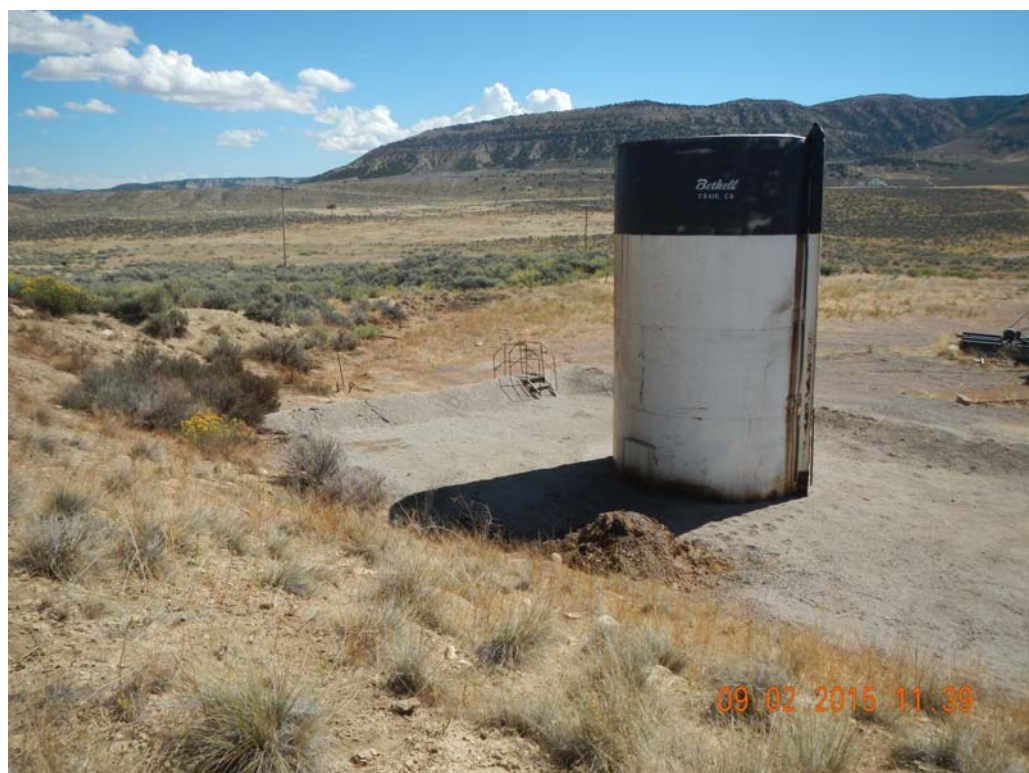
Inspection 673402427  
9/2/2015

Overview of spill area looking east. Expanded berm visible, with trace of spill path still visible. Spill material visible in foreground of berm.
