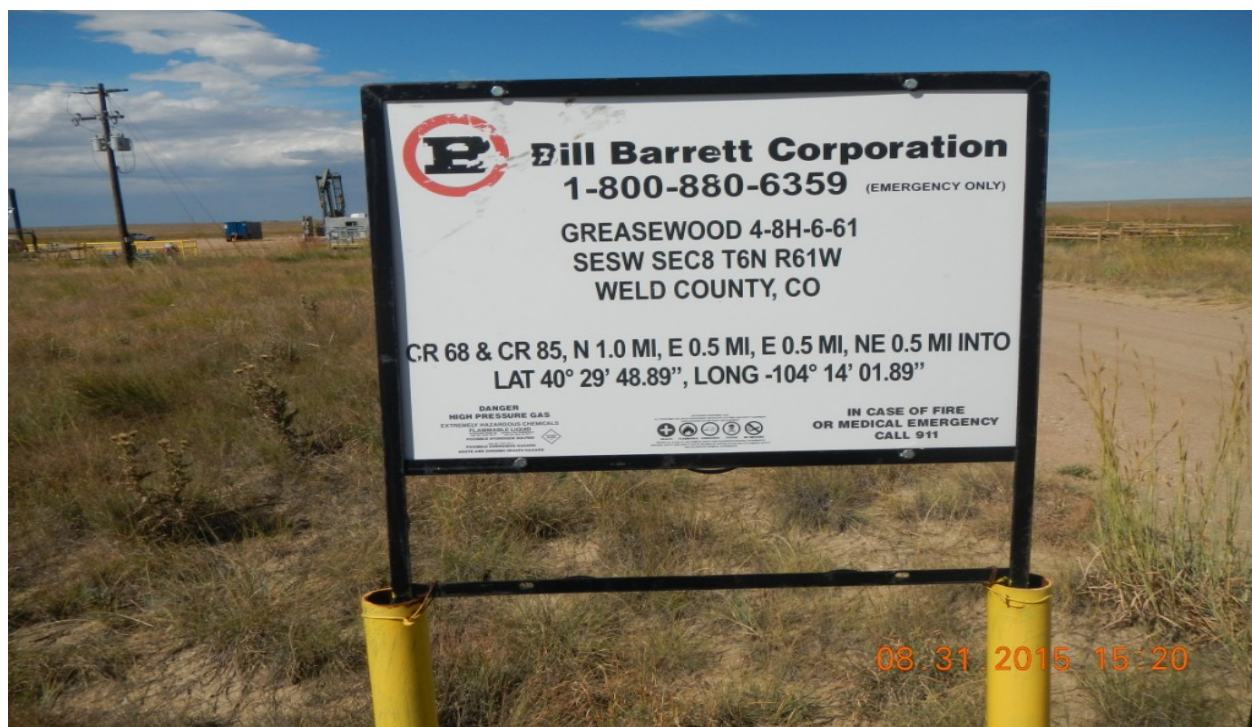
photo 1: Well sign near the location along the access road.

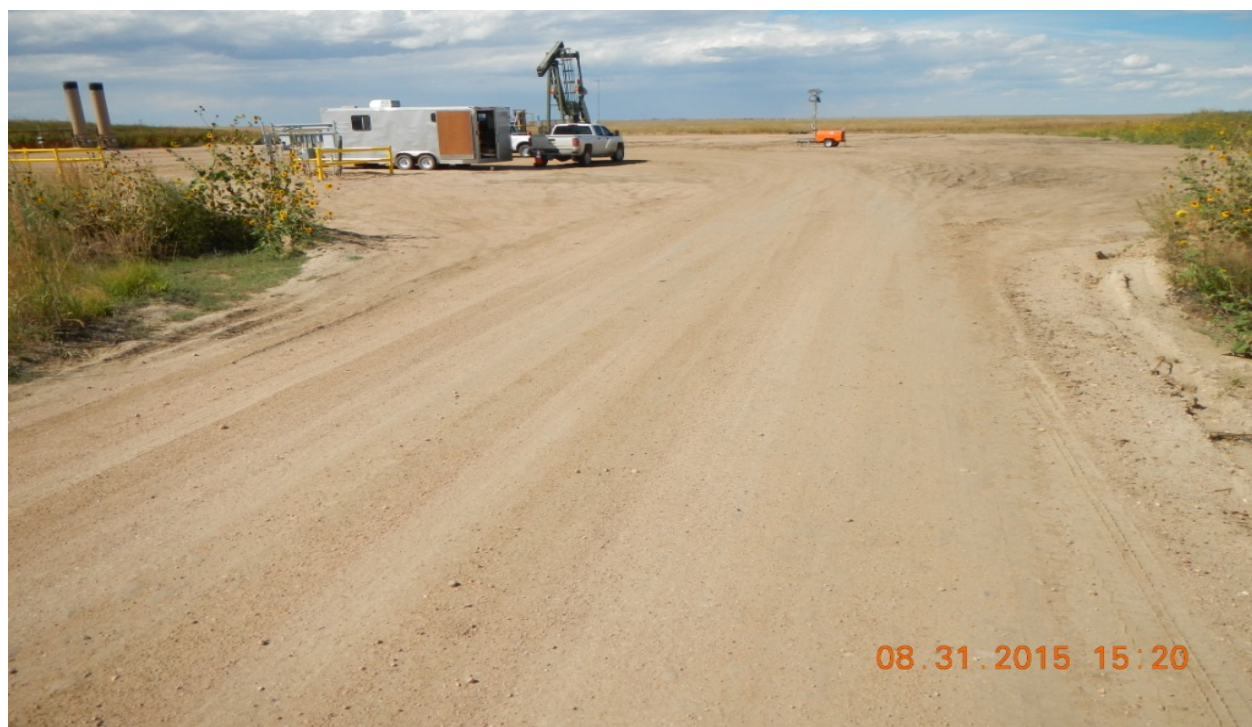
photo 2: Facing north towards the location from the access road.

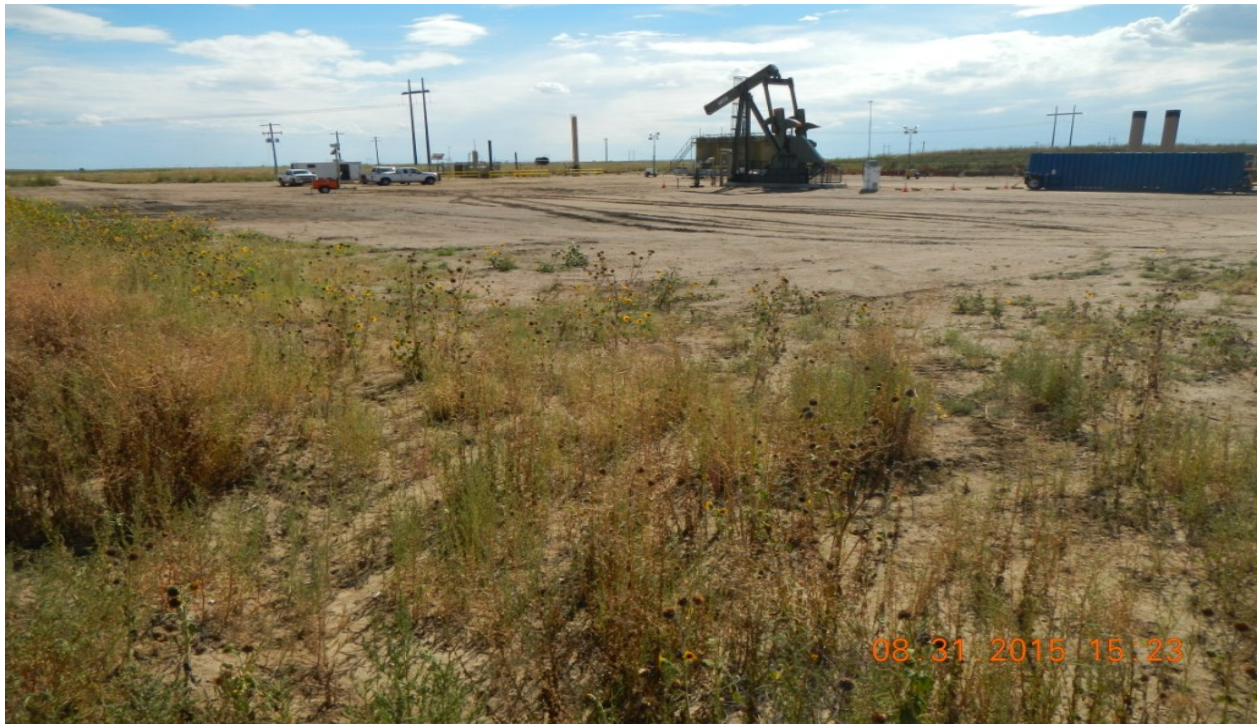
photo 3: Northeast corner of the location facing southwest towards the location.

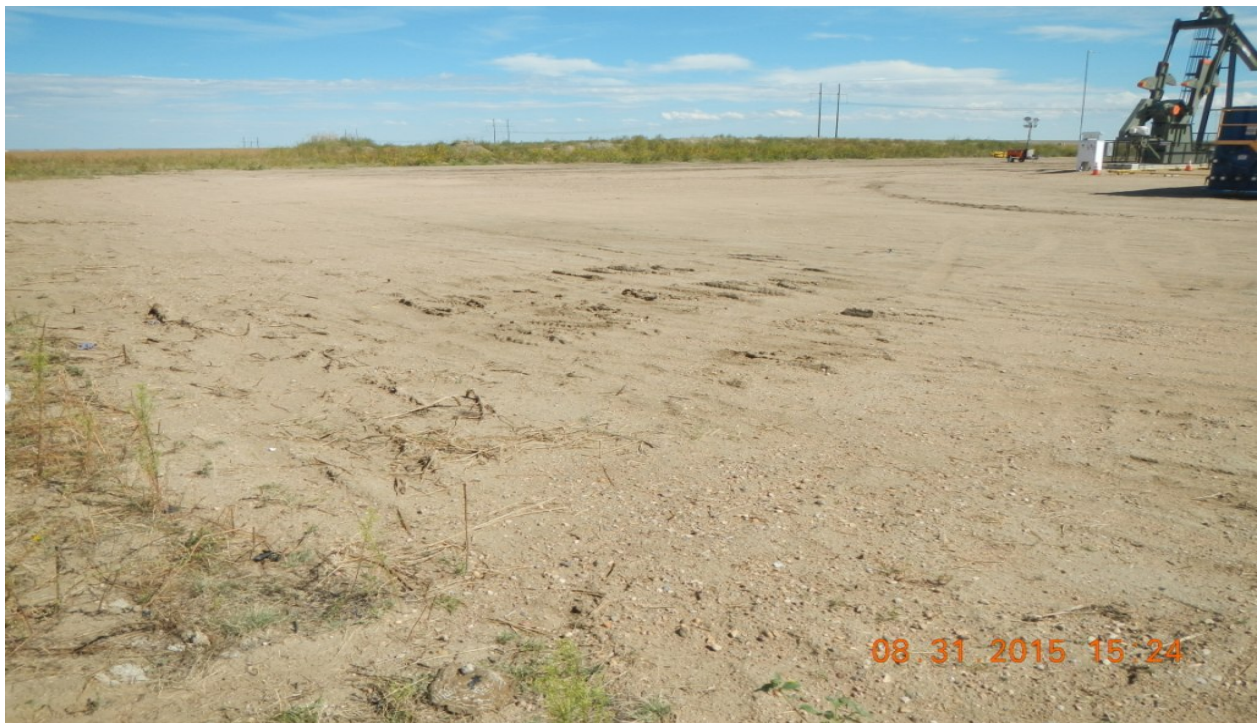
photo 4: North side of location facing southeast. Areas no longer needed have not been reclaimed.

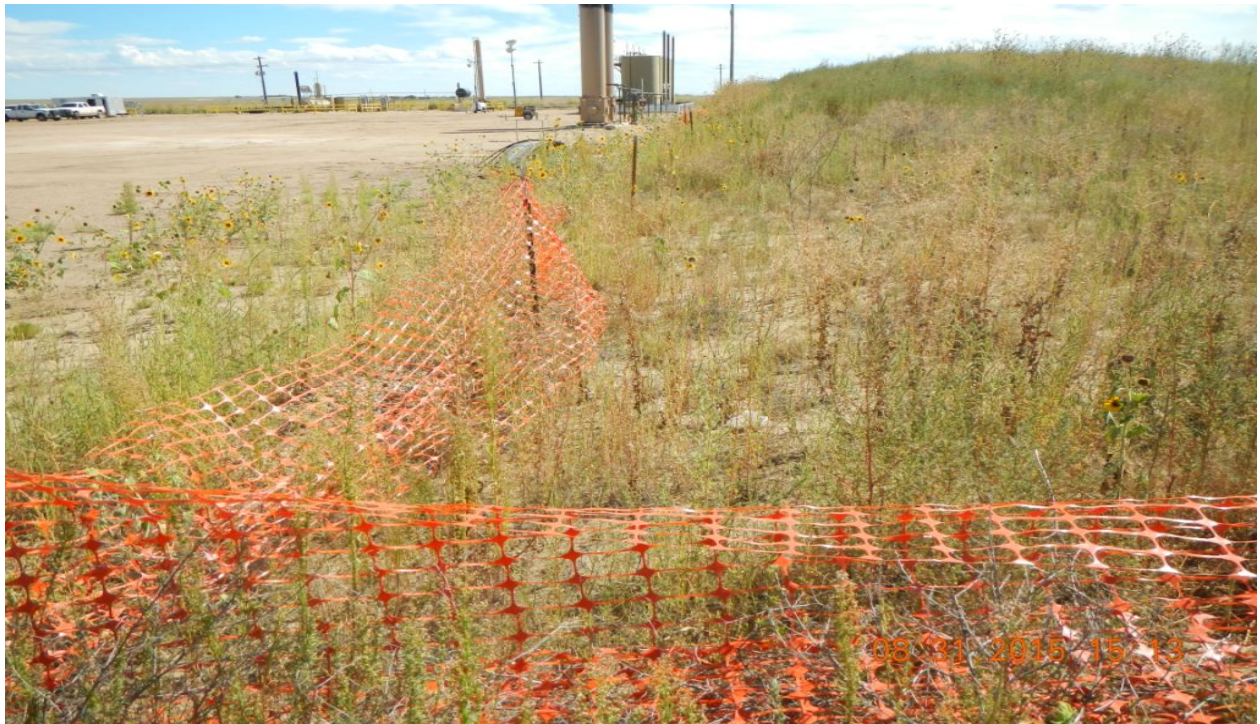
photo 5: Northwest side of the location facing south.

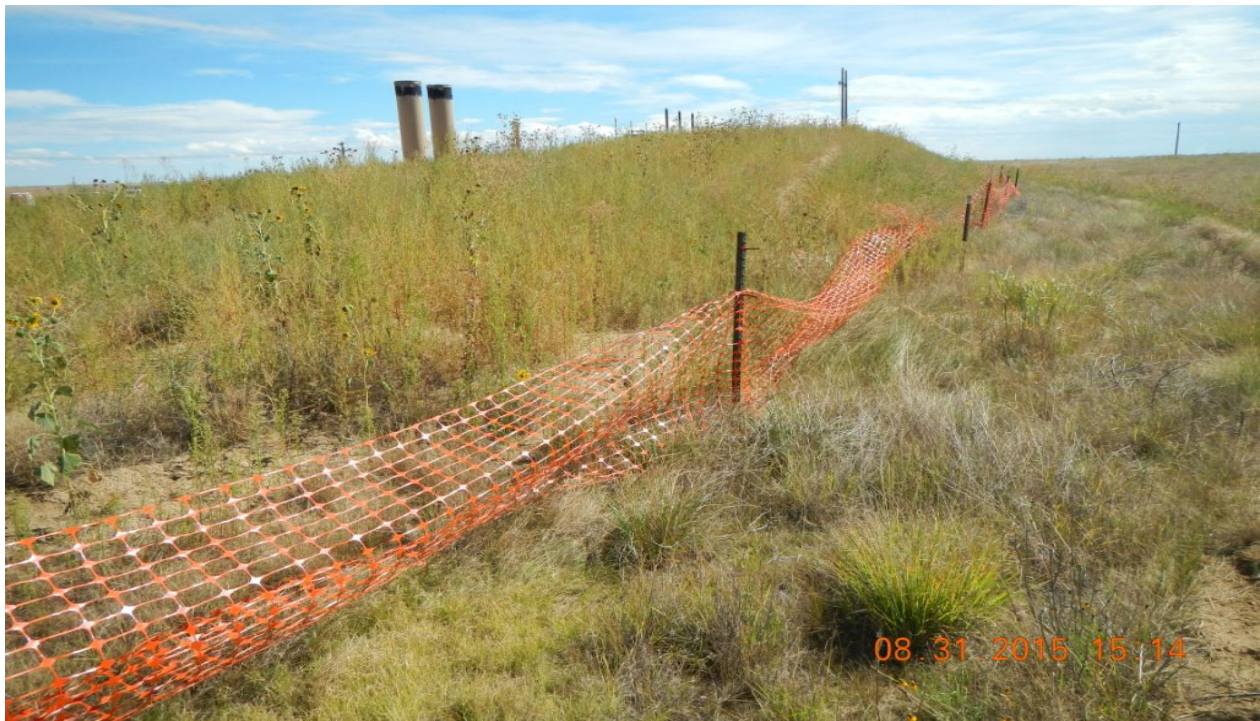
photo 6: Northwest side of the location facing south towards soil stockpile.

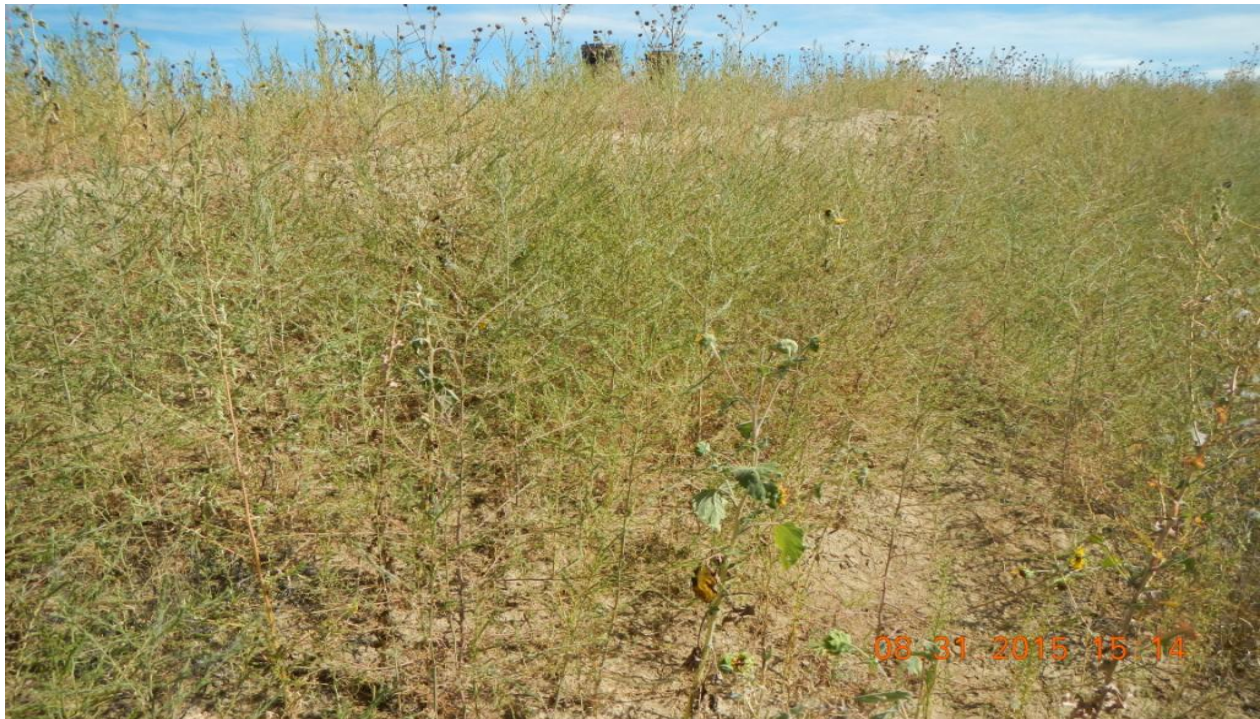
photo 7: Vegetation growing throughout topsoil pile appears to be mostly weeds (kochia, Russian thistle).

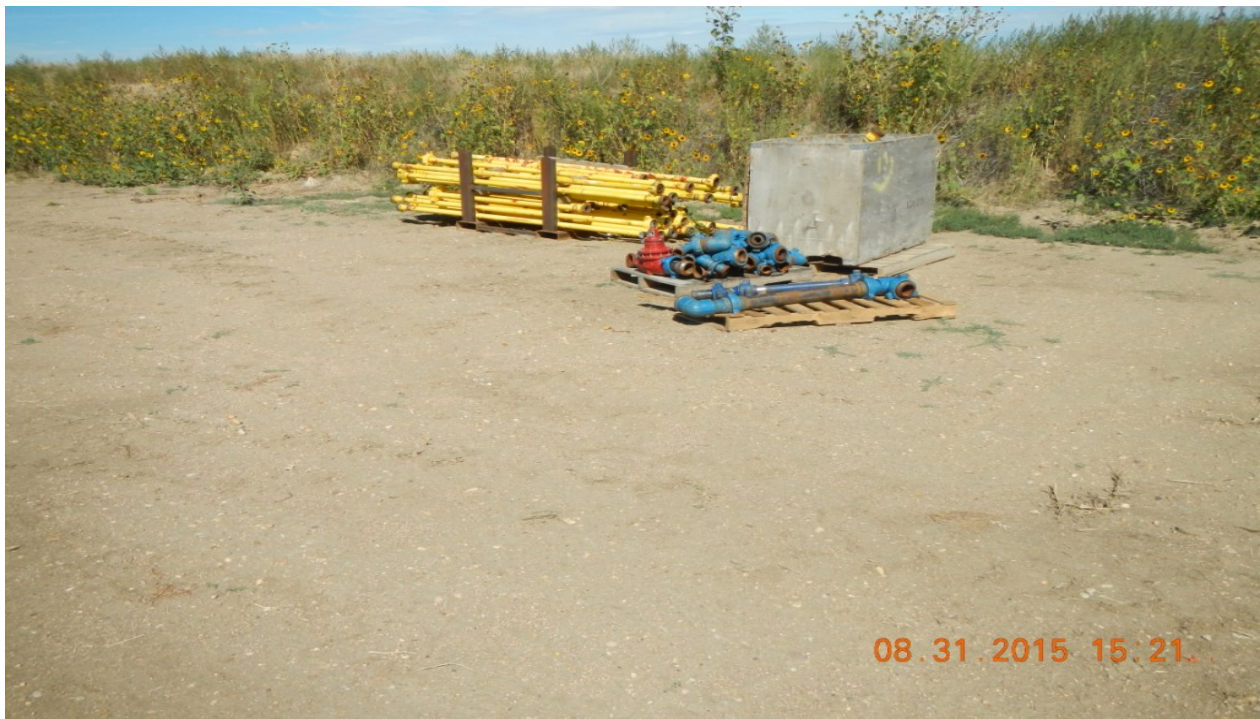
photo 8: Unused equipment at the southeast side of the location.

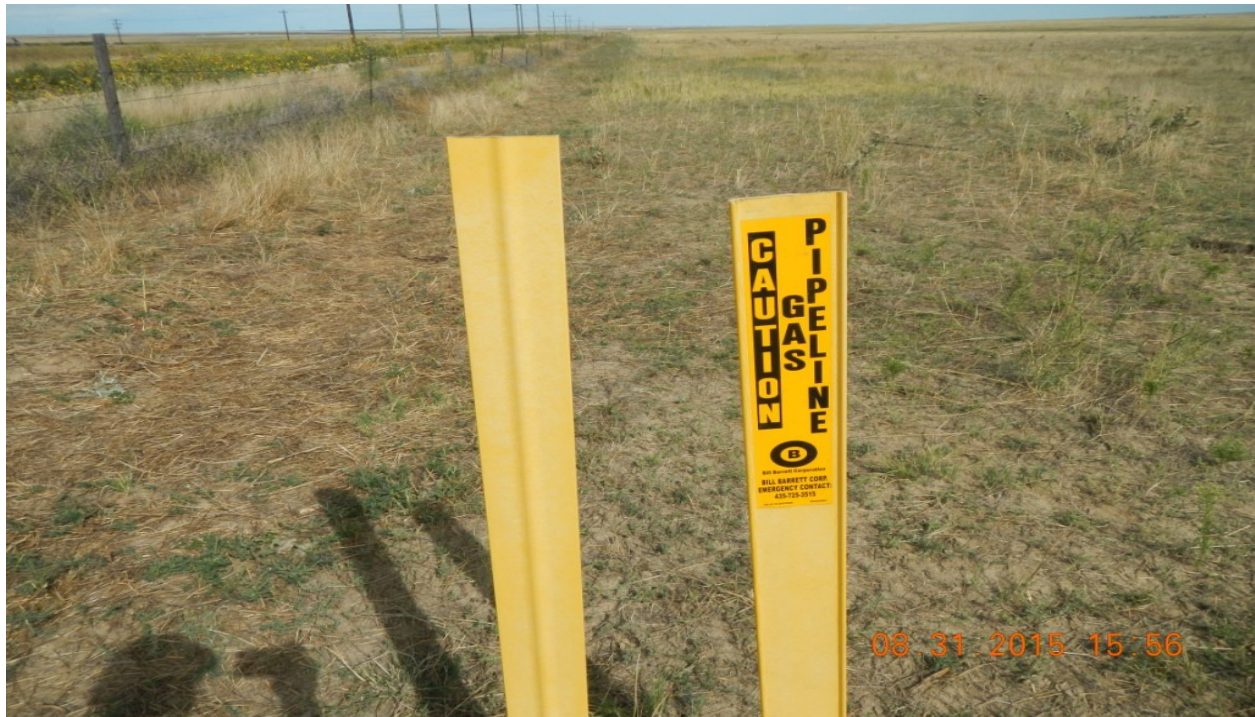
photo 8: Pipeline south of the location which appears to go to the west. Markers labeled "Bill Barrett".

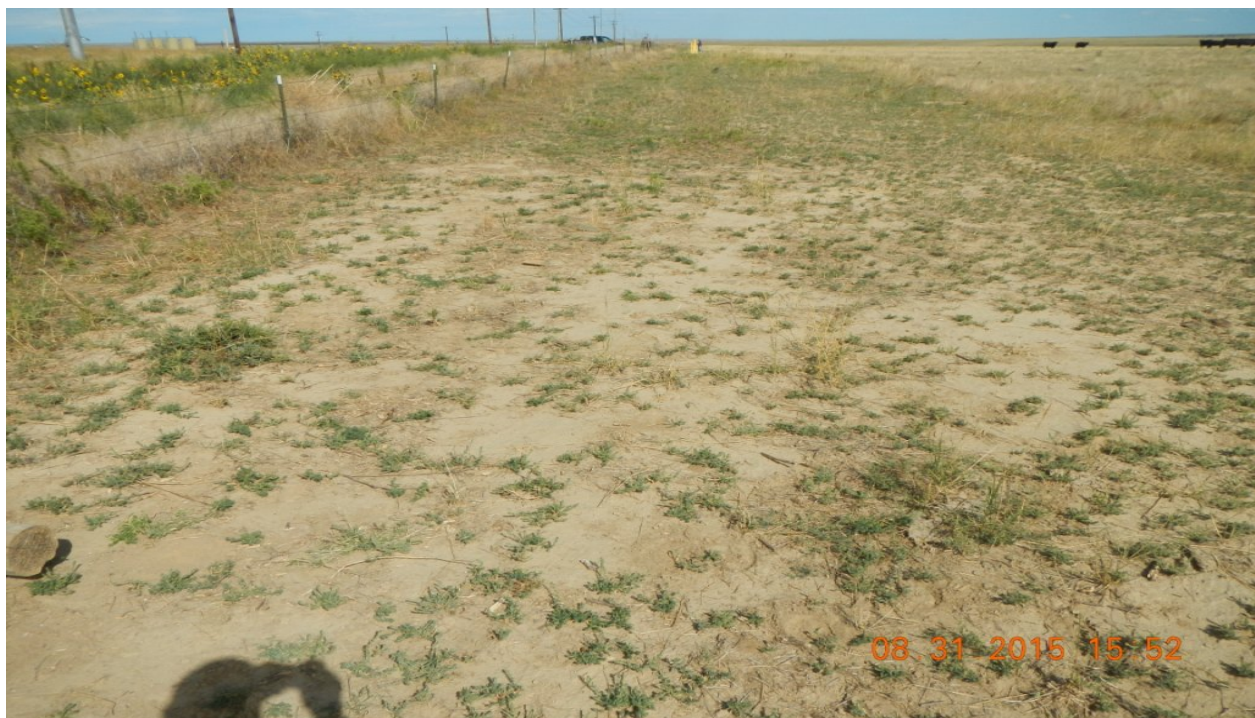
photo 8: Areas along the pipeline in the pasture south of the location have not been properly reclaimed.

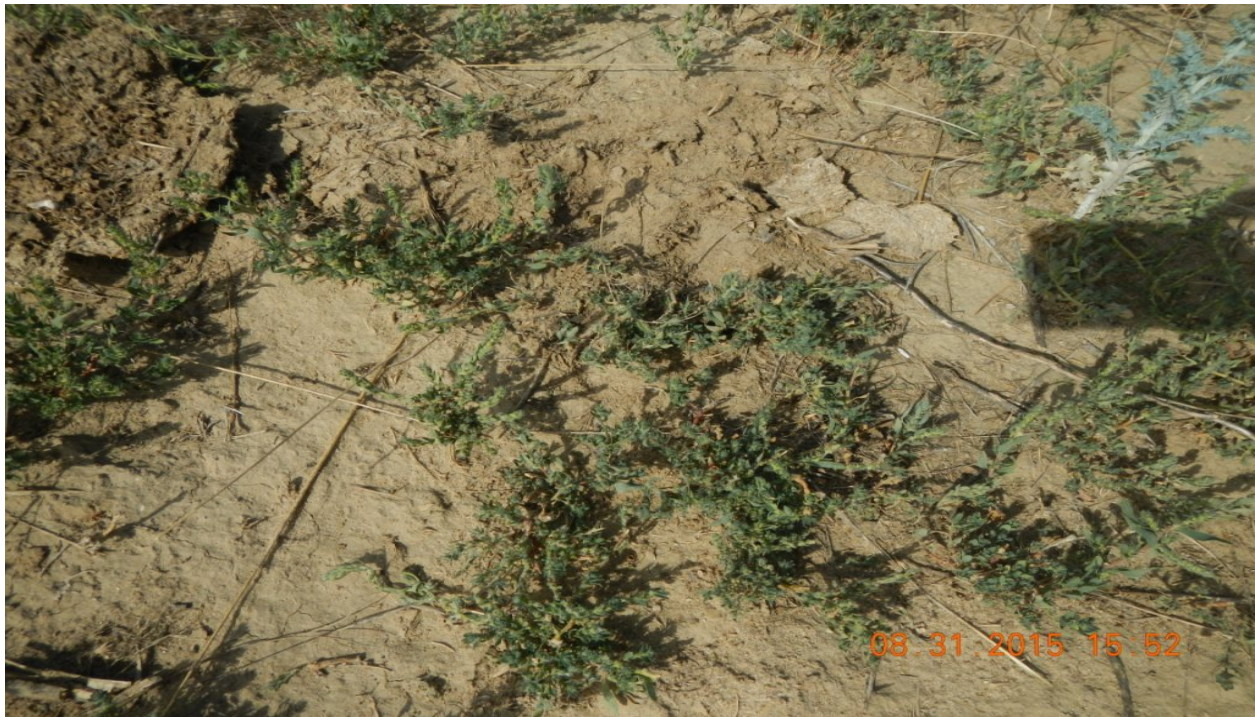
photo 8: Weed growth (kochia) along the pipeline.

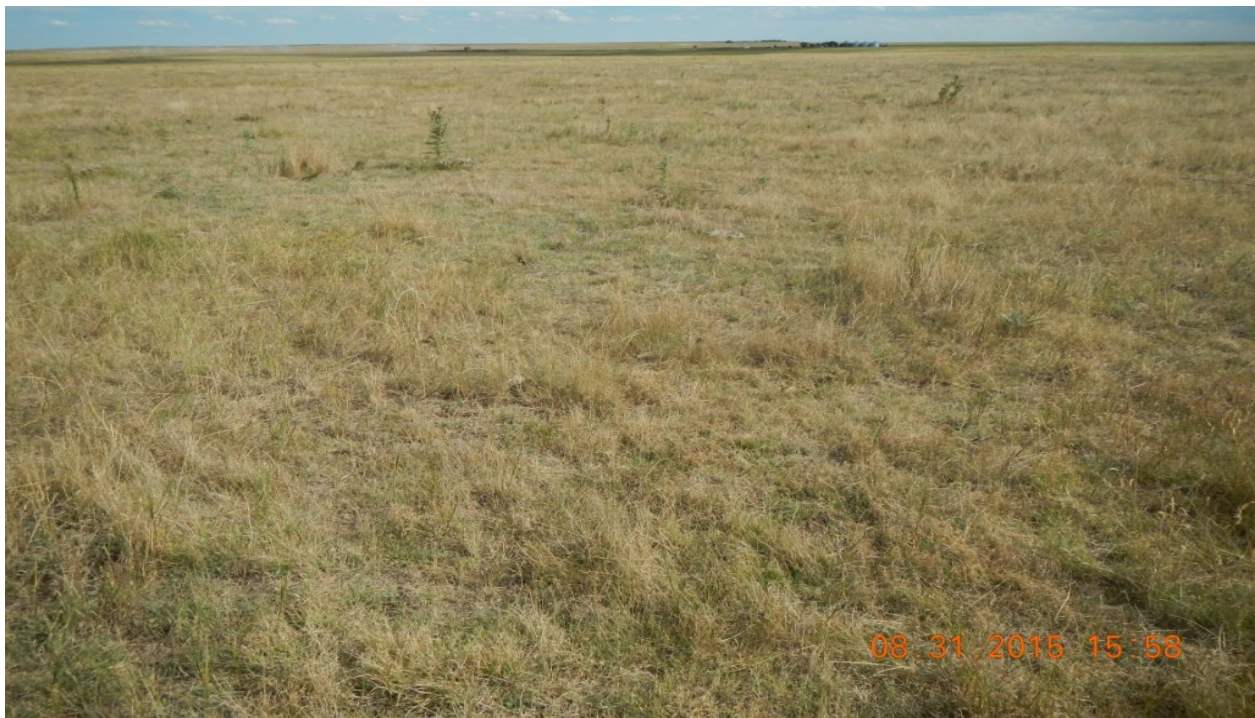
photo 8: Surrounding vegetation in the adjacent landowners pasture near the pipeline.
