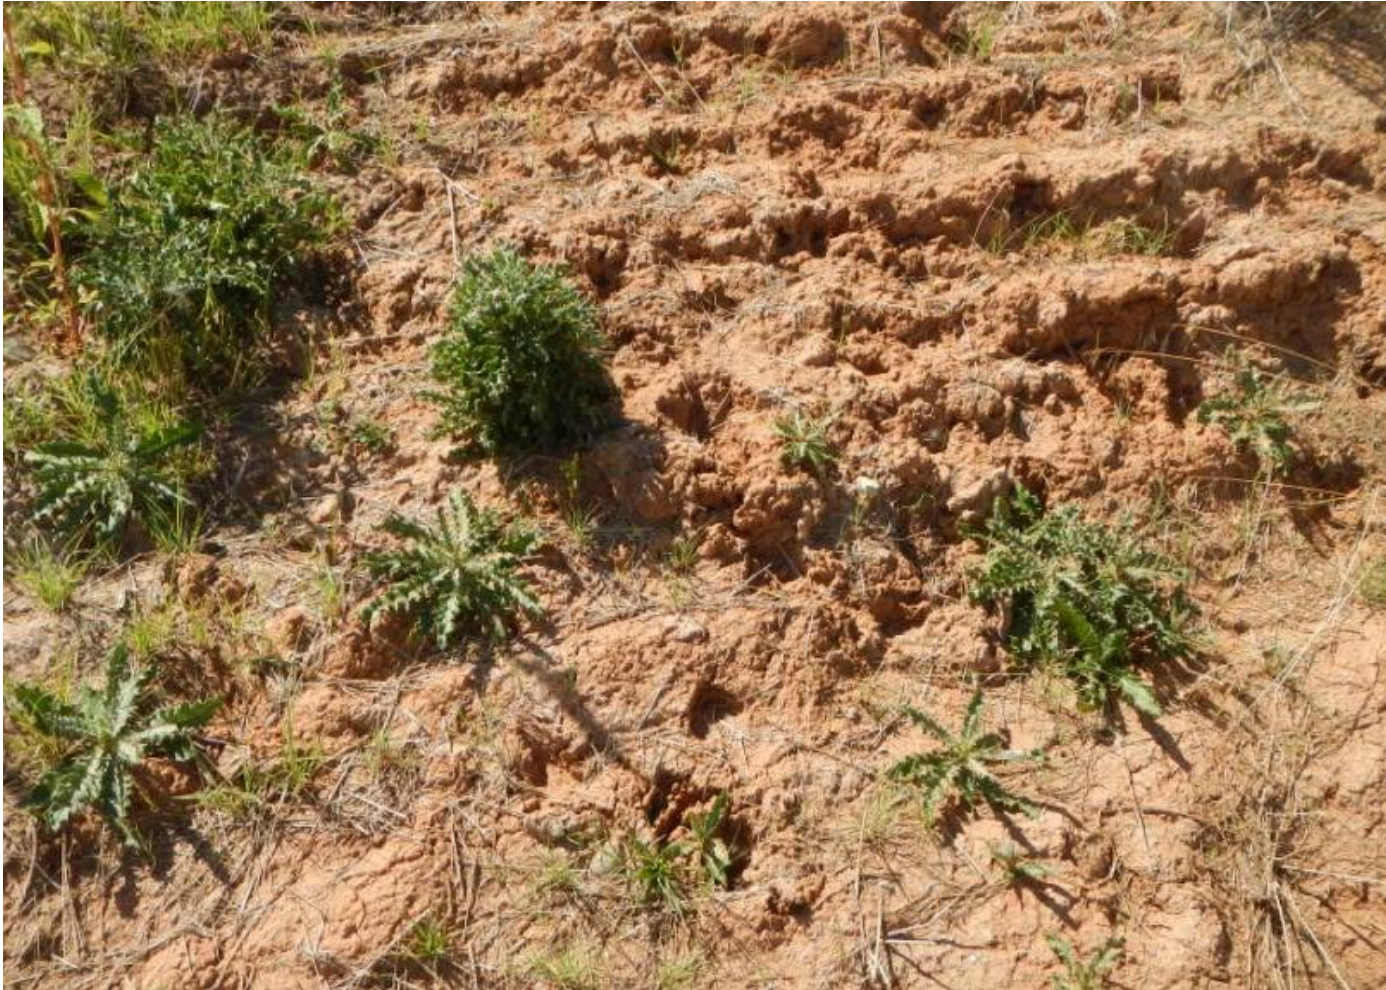
Photo 1. View of young Canada thistle (*Cirsium arvense*) rosettes within the northern portion of the project area.

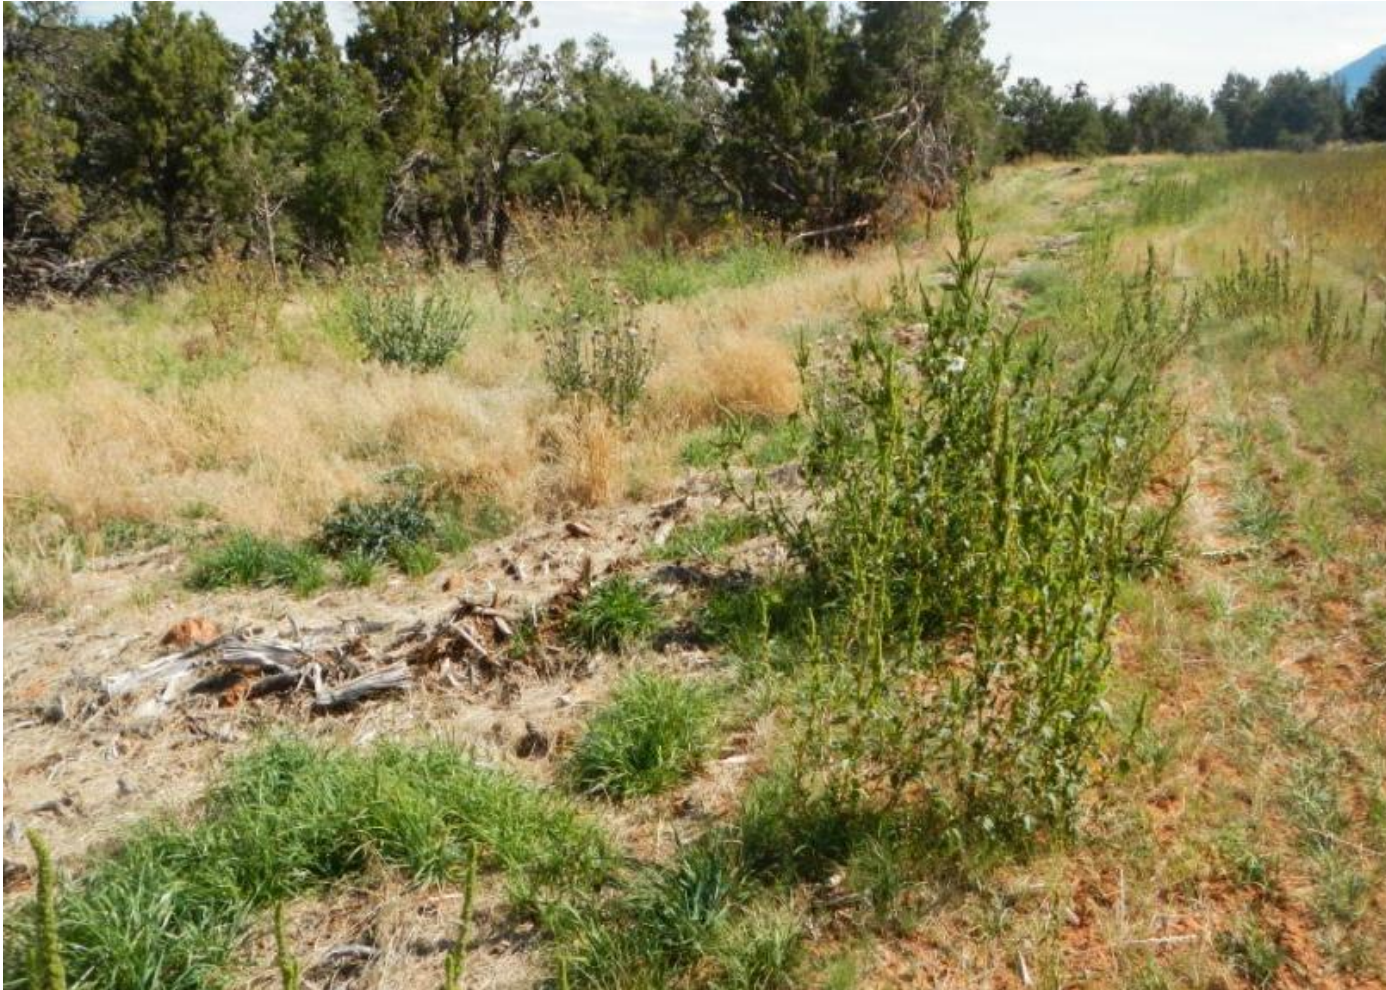
Photo 2. View of Musk thistles (*Carduus nutans*) growing outside of eastern edge of revegetation area (in background).

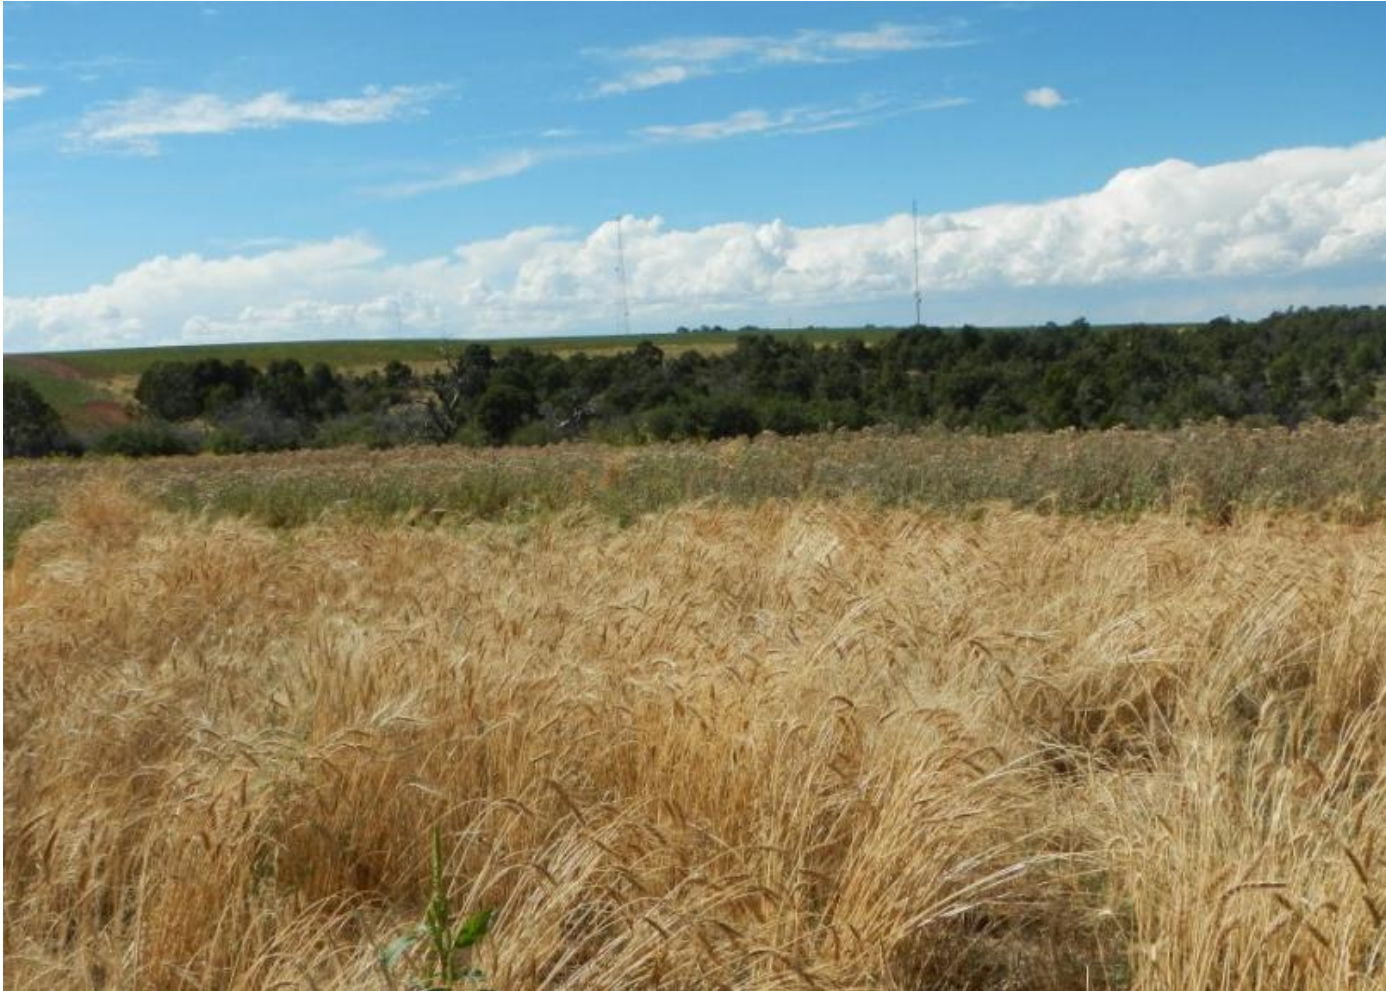
Photo 3. View of Canada thistle infestation outside of project area to the north, from northern edge of well pad facing northwestward. It will be necessary to monitor Canada thistle to prevent further infestation into the well pad area and degradation of desirable revegetation.

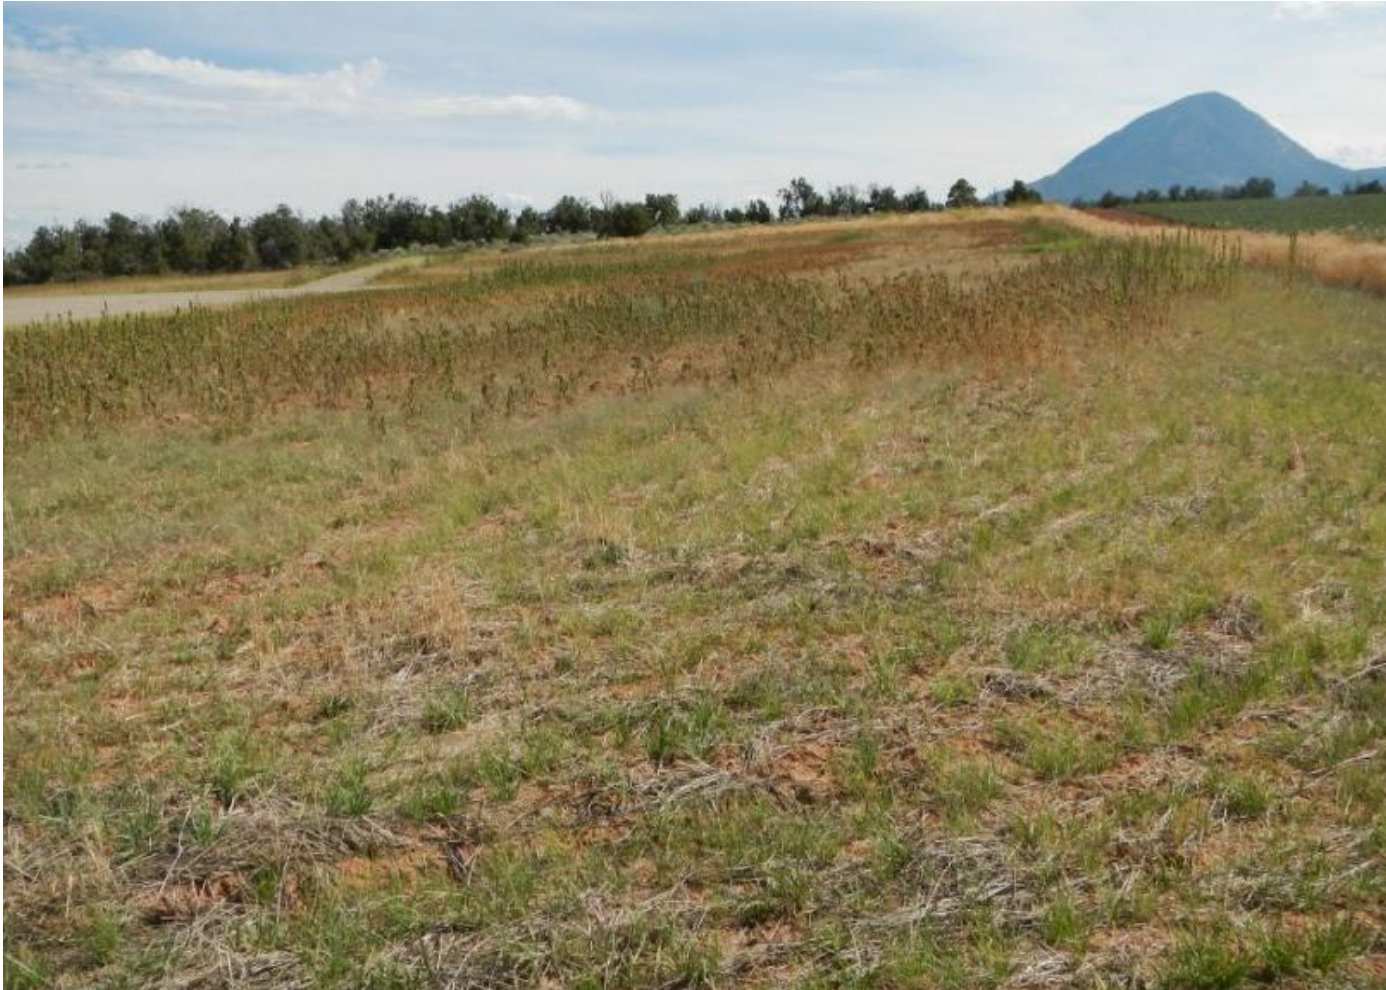
Photo 4. View of western portion of interim reclamation area from northwestern corner facing southward. Many desirable species are becoming established.

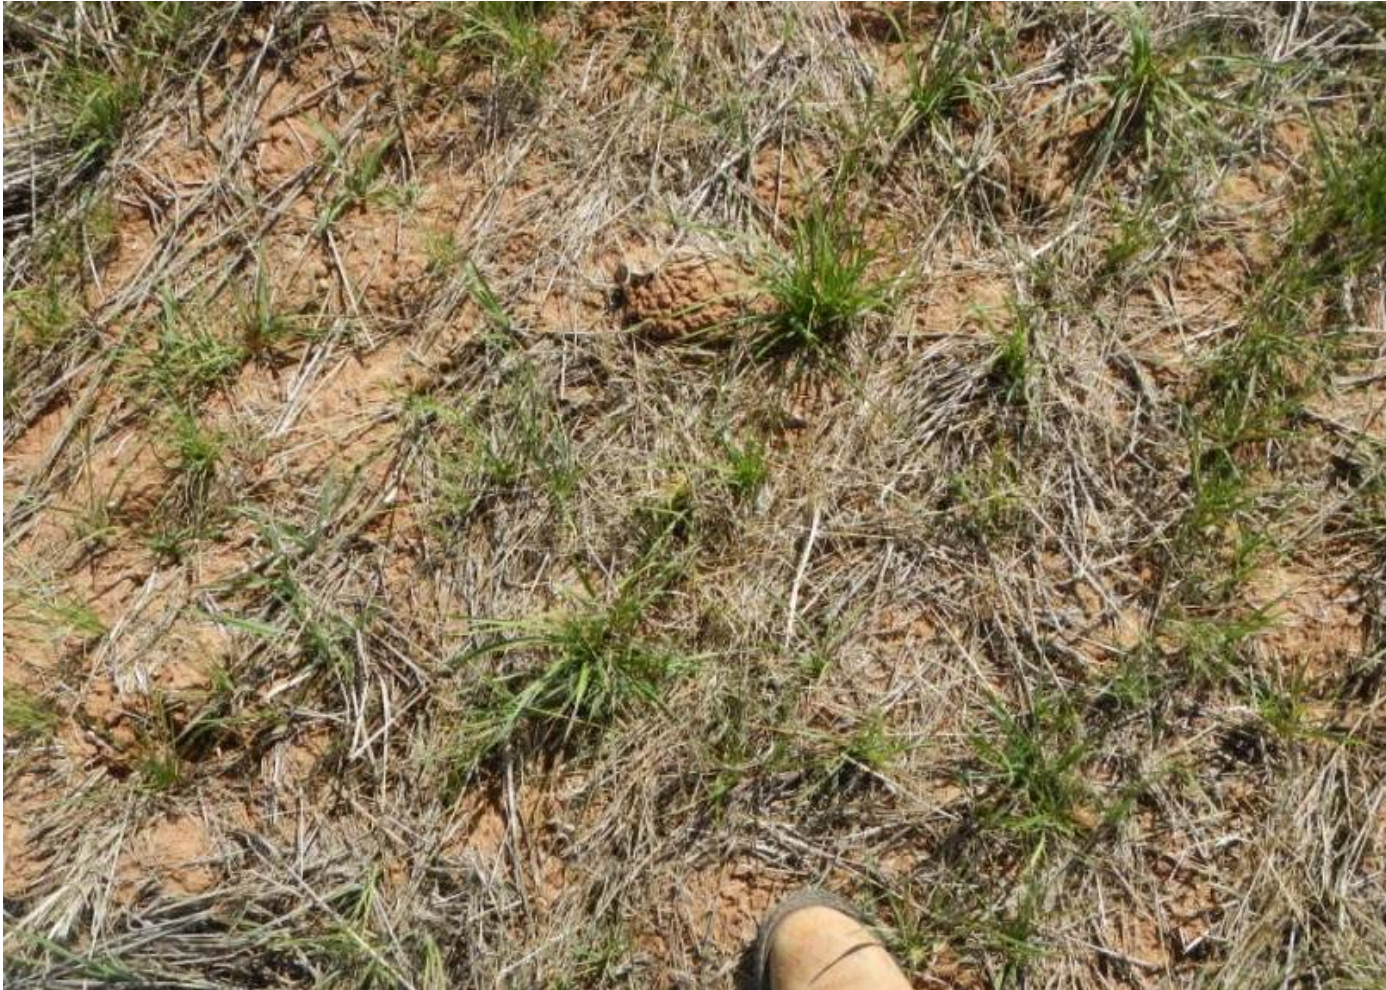
Photo 5. Birdseye view of grasses becoming established within the interim reclamation area as well as straw mulch. These species were not in identifiable form.

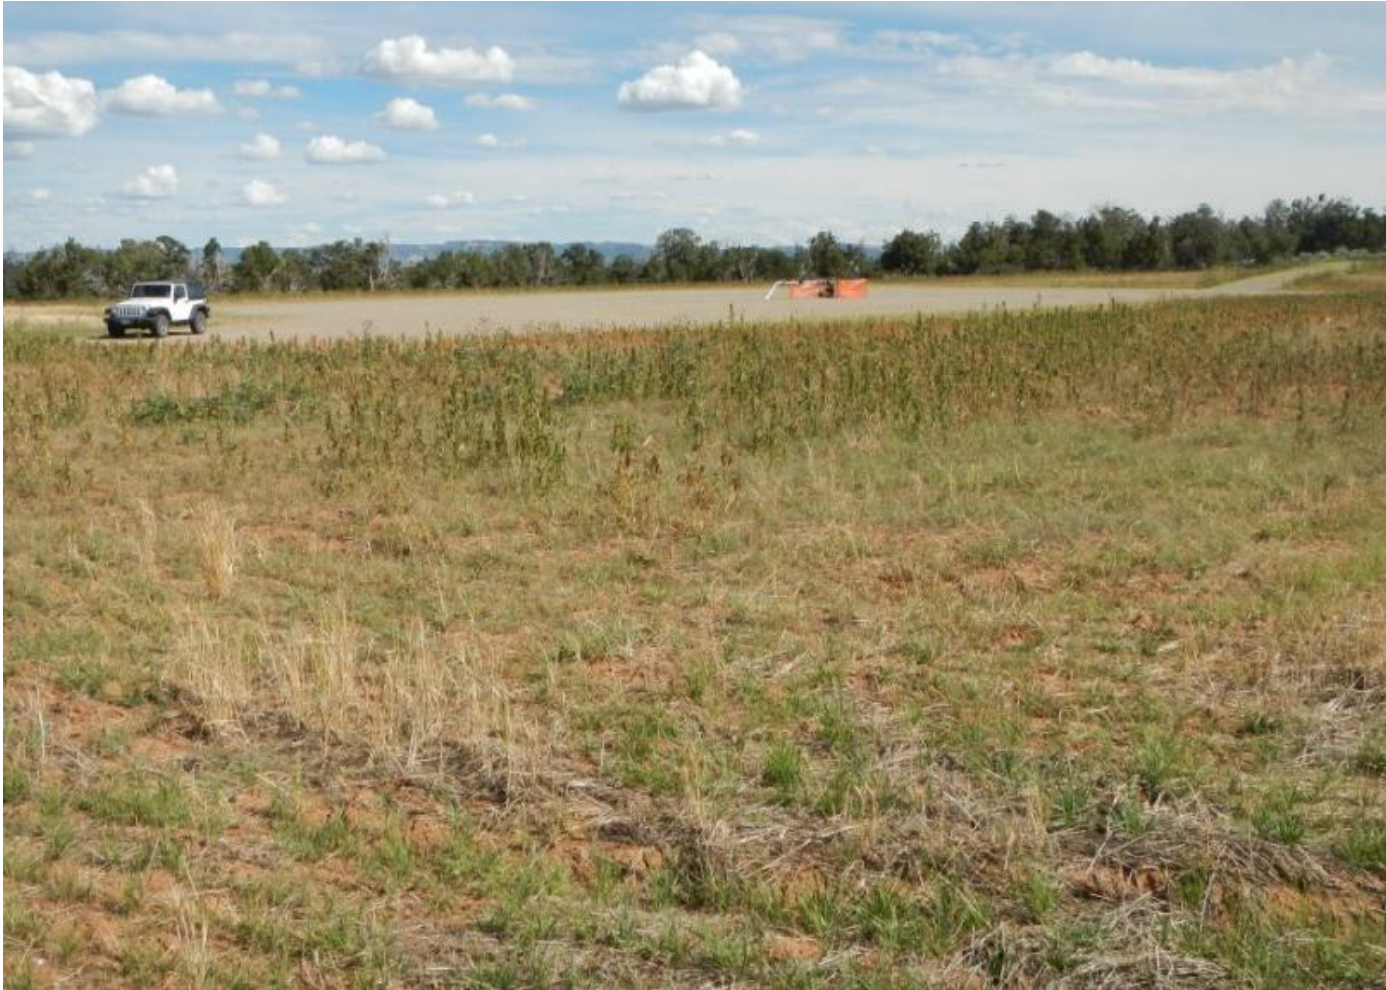
Photo 6. View of well pad and reclamation from northwestern corner facing center.

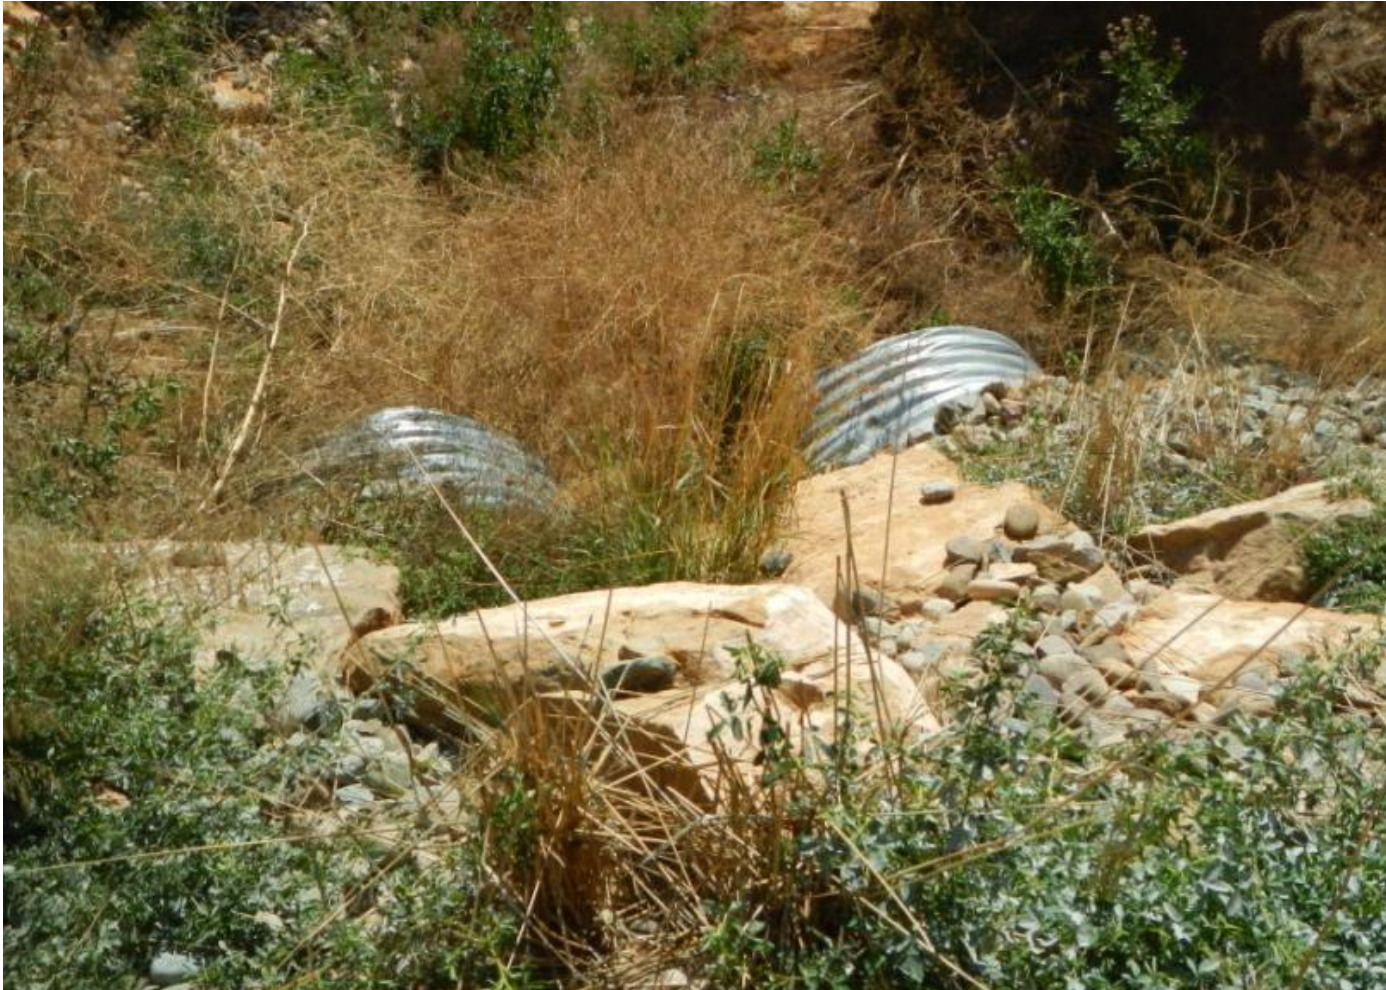
Photo 7. View of rock armor around culverts that appears to be successfully stabilizing potential erosion in this area.

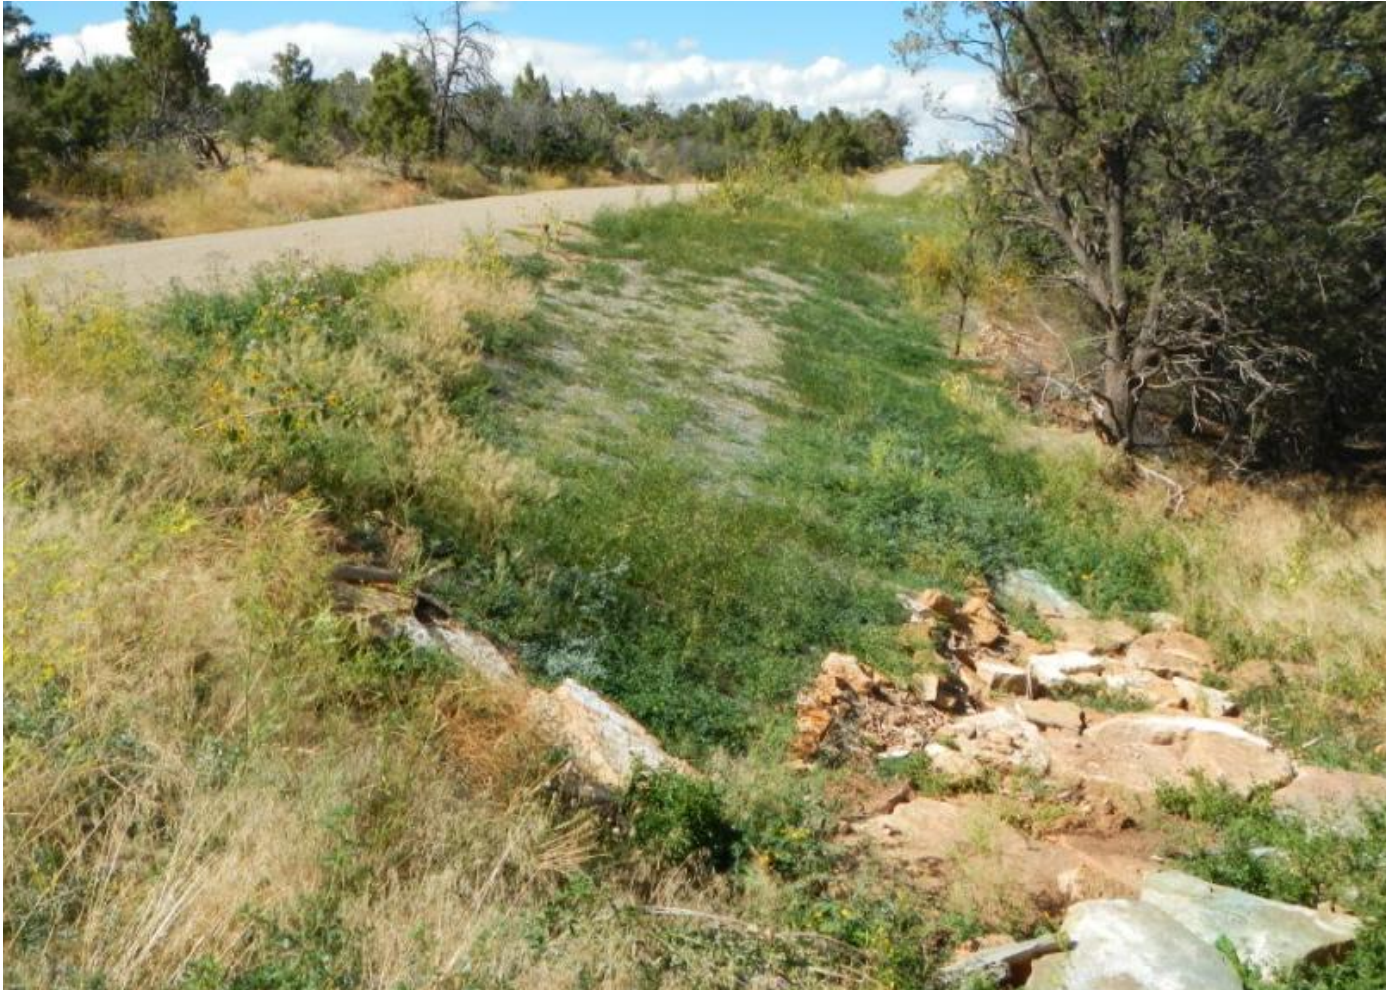
Photo 8. View of revegetation along the pipeline right of way largely appears to be yellow sweetclover (*Melilotus officinalis*).
