Focus Ranch Unit Federal 12-1

Inspection# 673402453

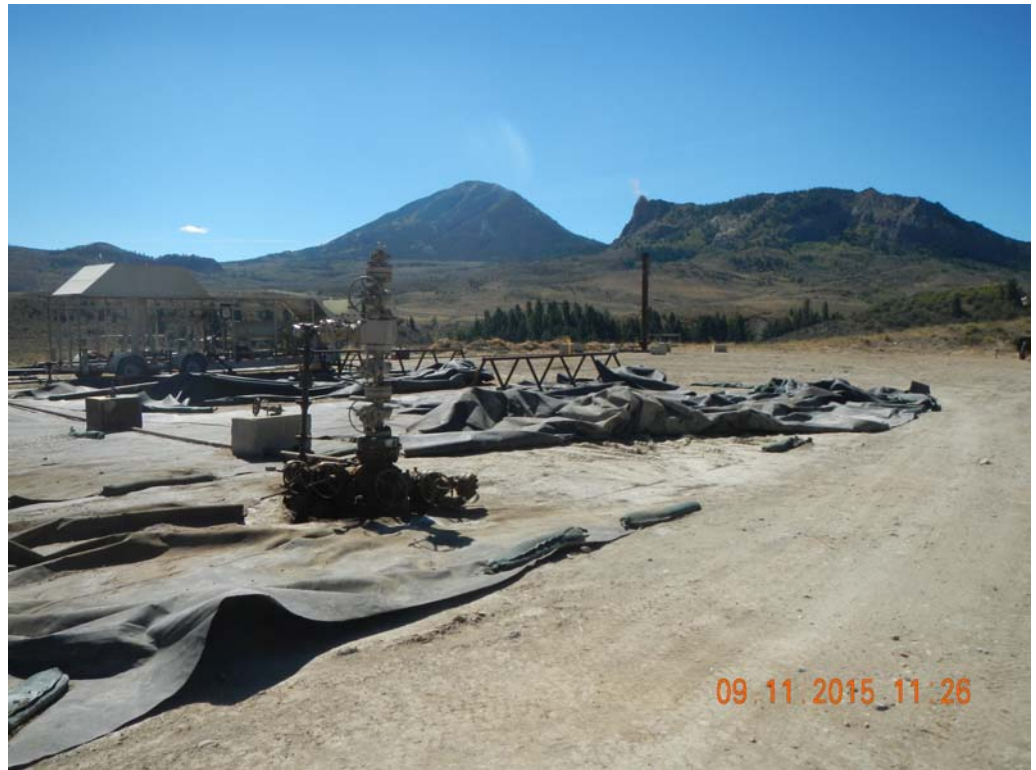
Inspection 673402453

No sign at wellhead. Lit field flare in background.

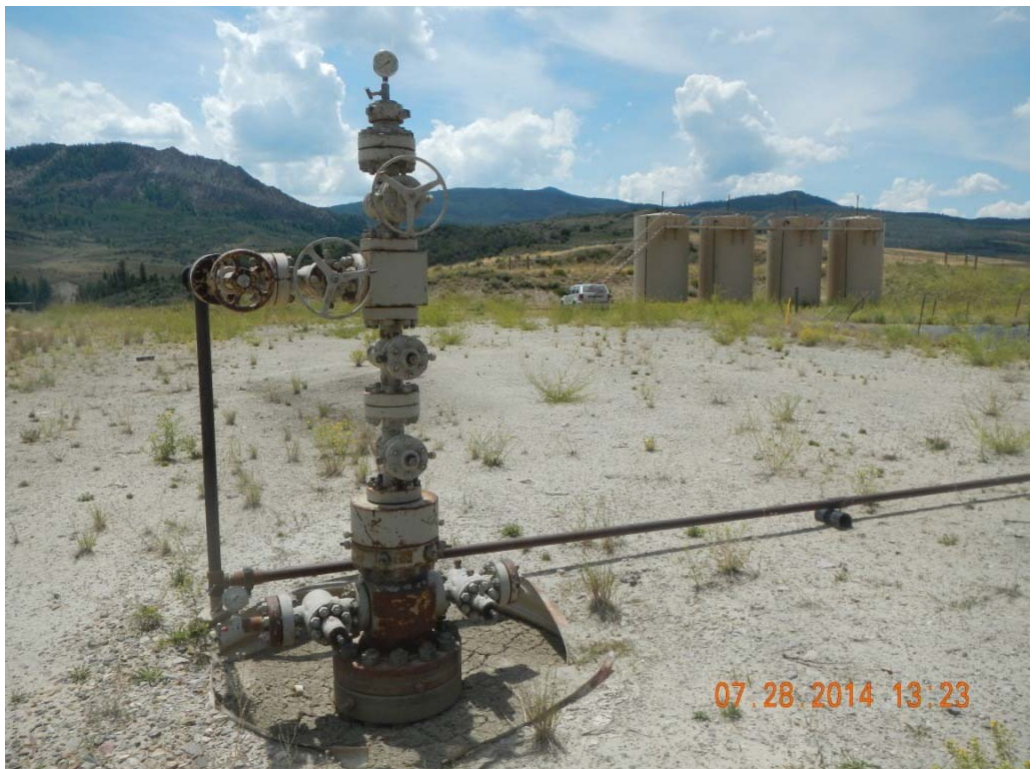
Inspection 673400900

No wellhead sign.

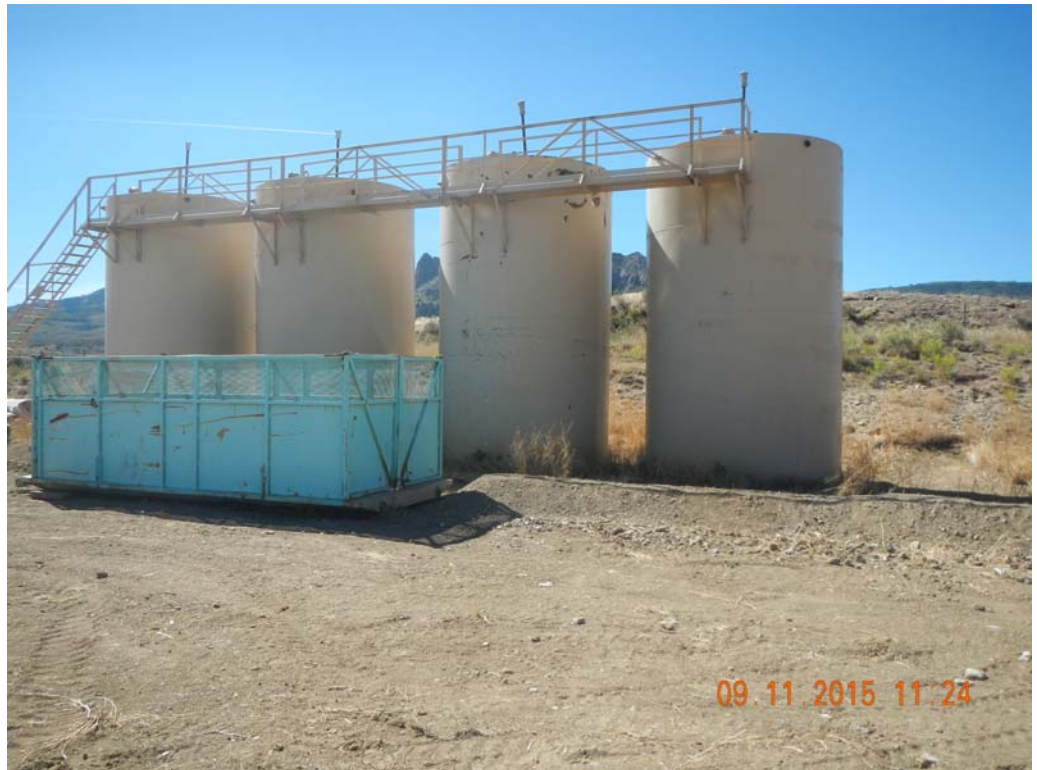
Inspection 673402453

No tank labels. Incomplete,
uncompacted berm.

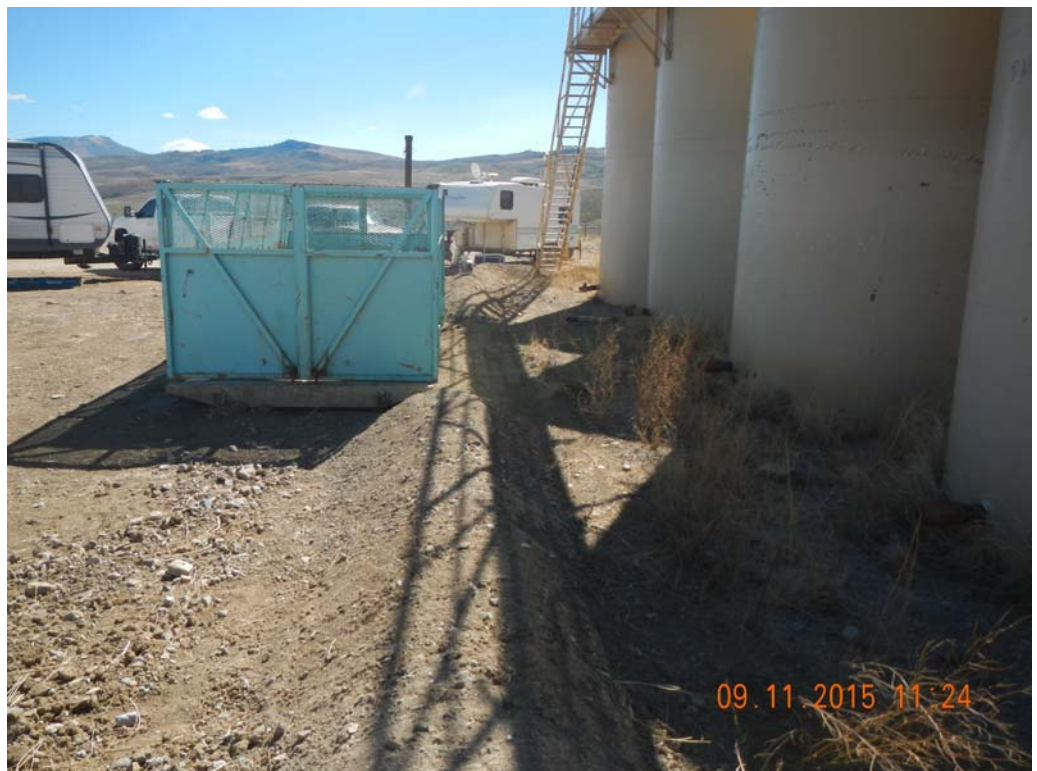
Inspection 673402453

Incomplete, uncompacted
berm. No tank labels.

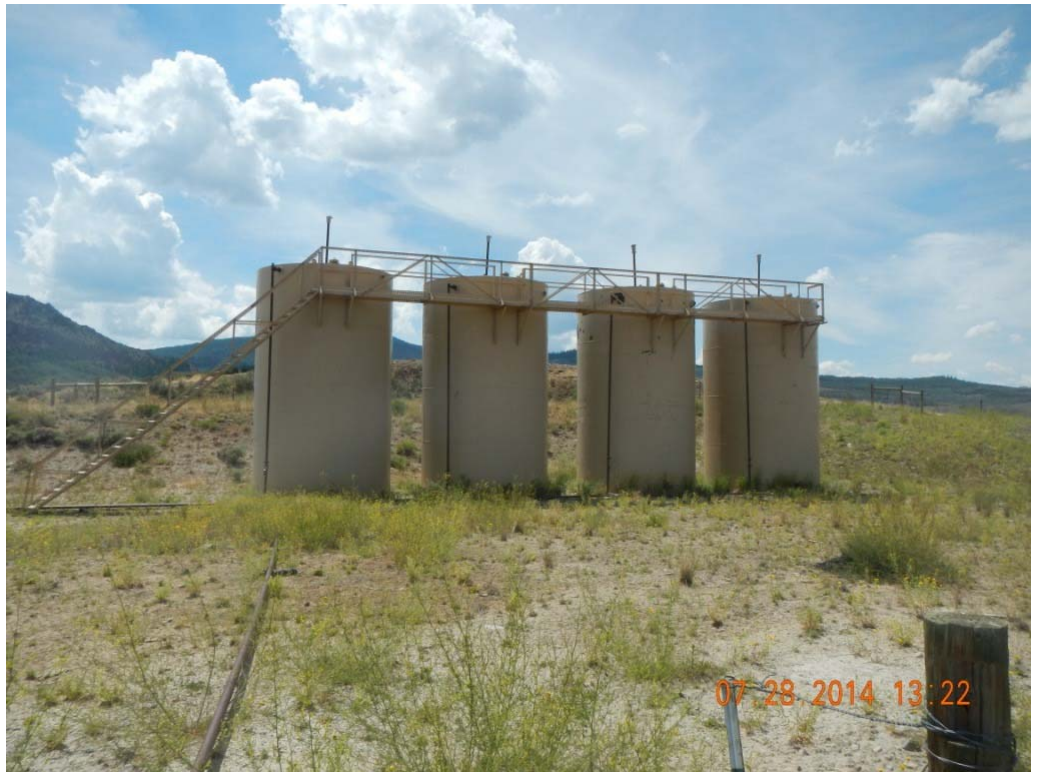
Inspection 673400900

No tank labels, no berm.

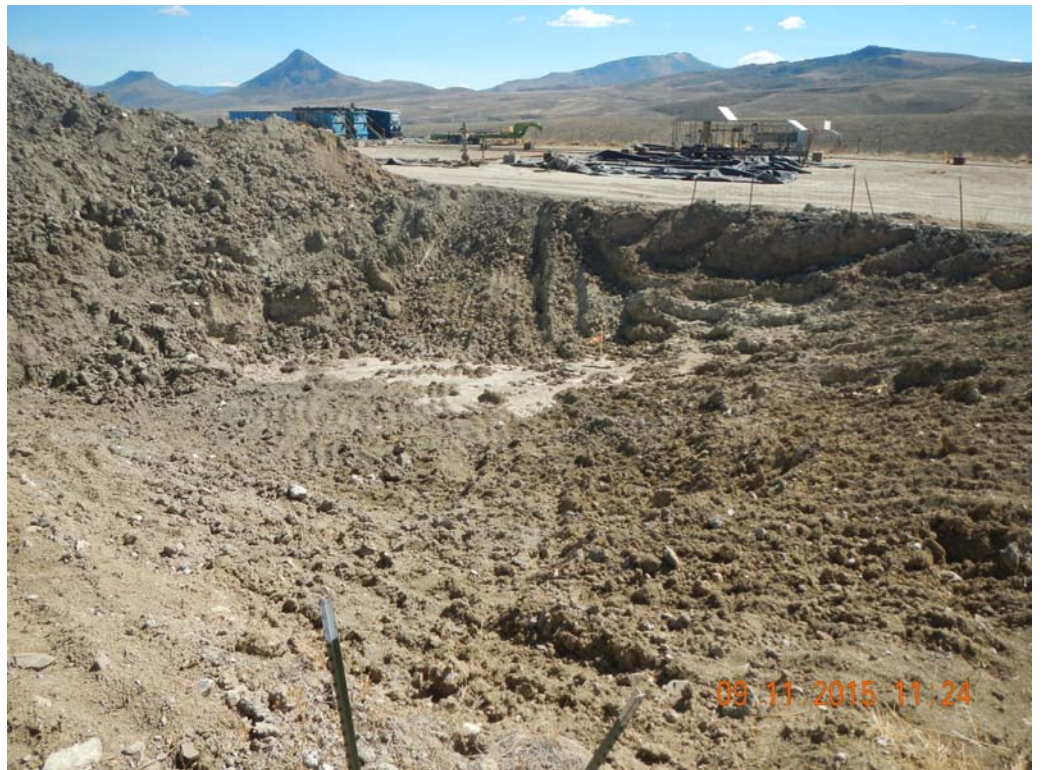
Inspection 673402453

Pit work.

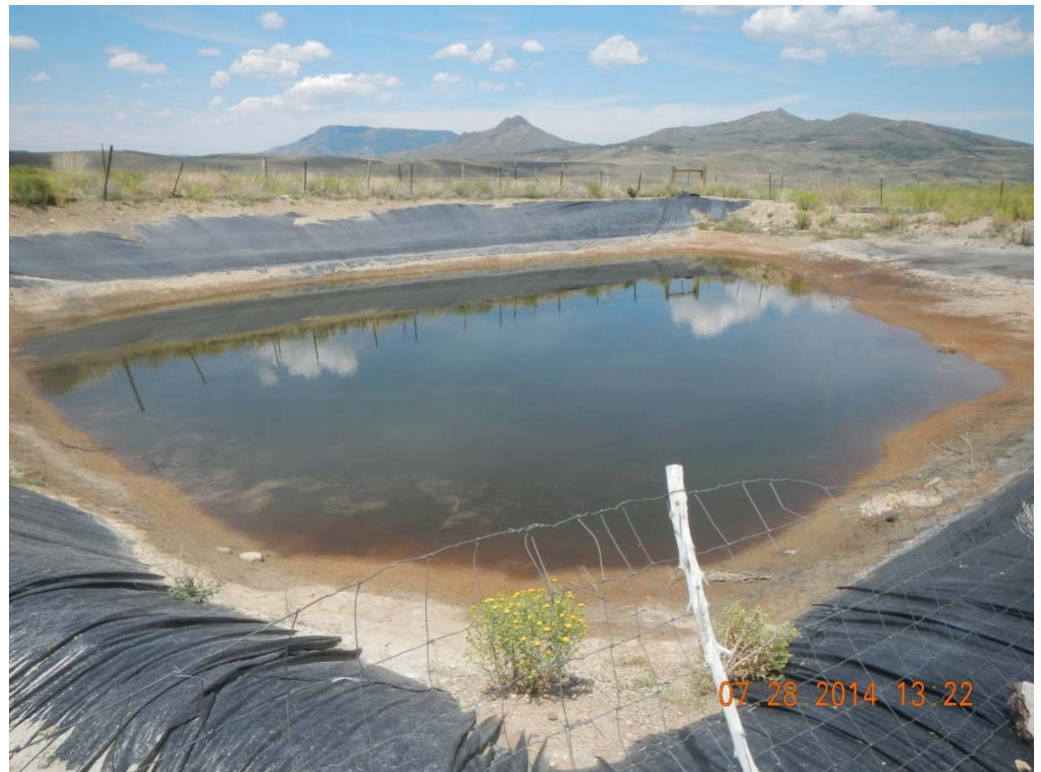
Inspection 673400900

Pit.

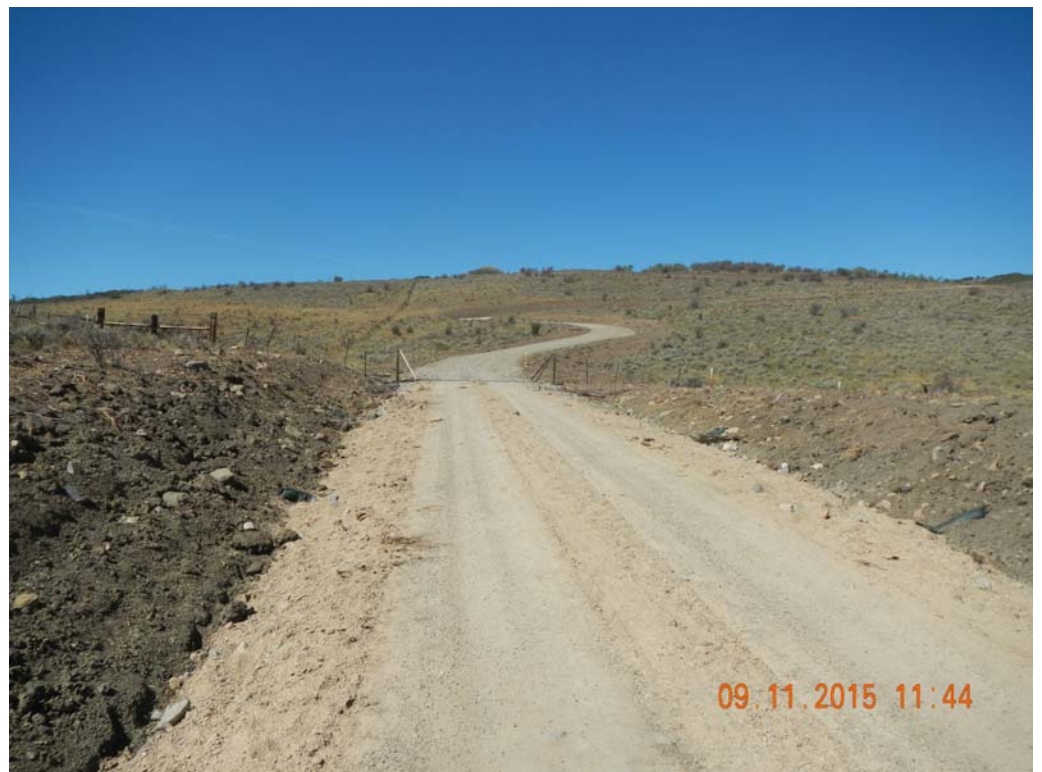
Inspection 673402453

Access road. No stormwater controls for disturbed soil on perimeter. In foreground is completed road, in background is only road base until first switchback turn in far background.

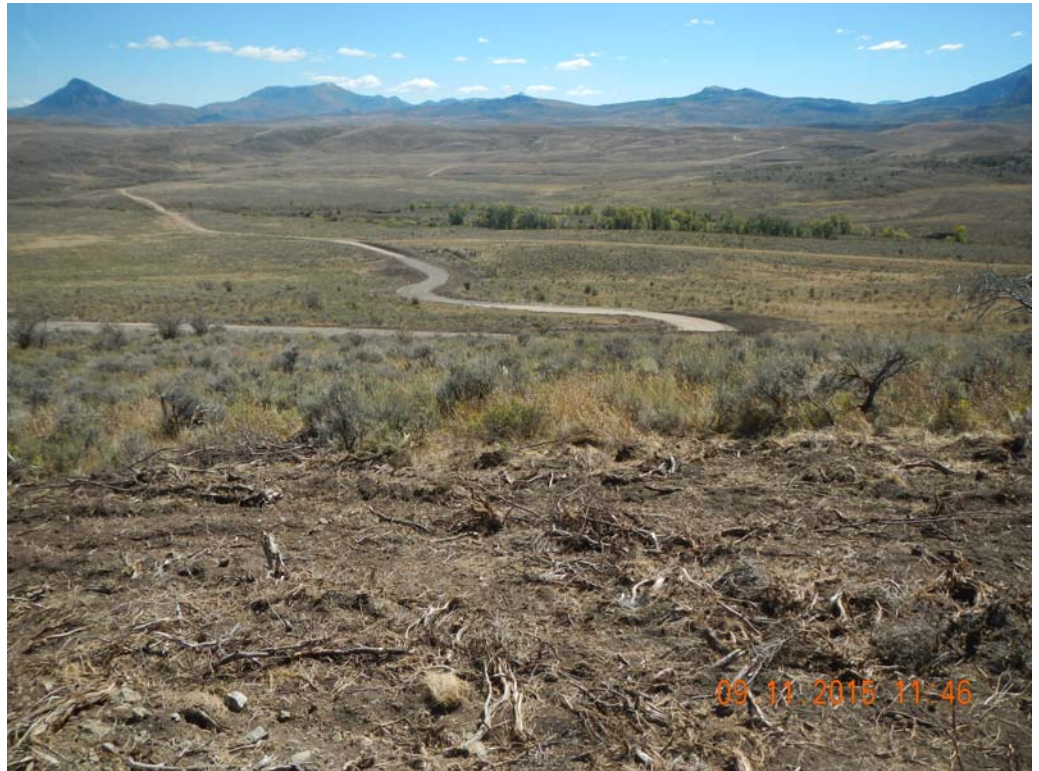
9/11/2015
Inspection 673402453

Newly constructed segment of road. No stormwater controls for disturbed soil. In far background is existing road, moving forward is rough road base only until first switchback turn which is finished road but still without stormwater controls.

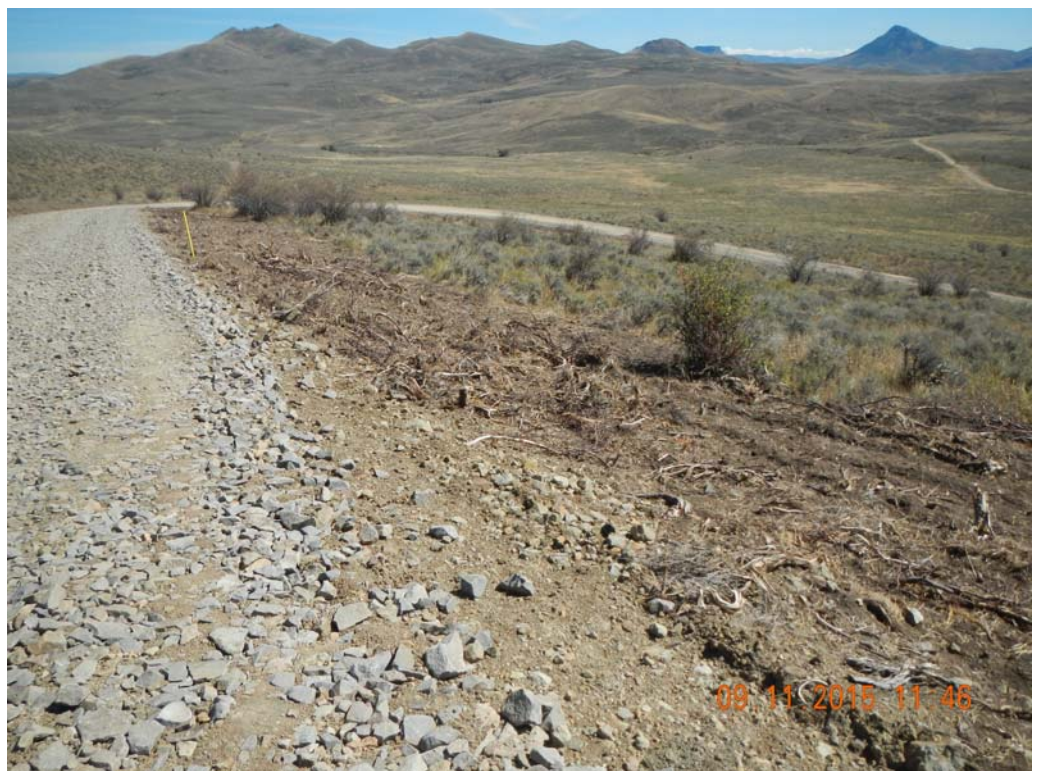
9/11/2015
Inspection 673402453

Newly constructed segment of road. Road is incomplete and road base is beginning to migrate off of the road area. No stormwater controls for disturbed soil.
