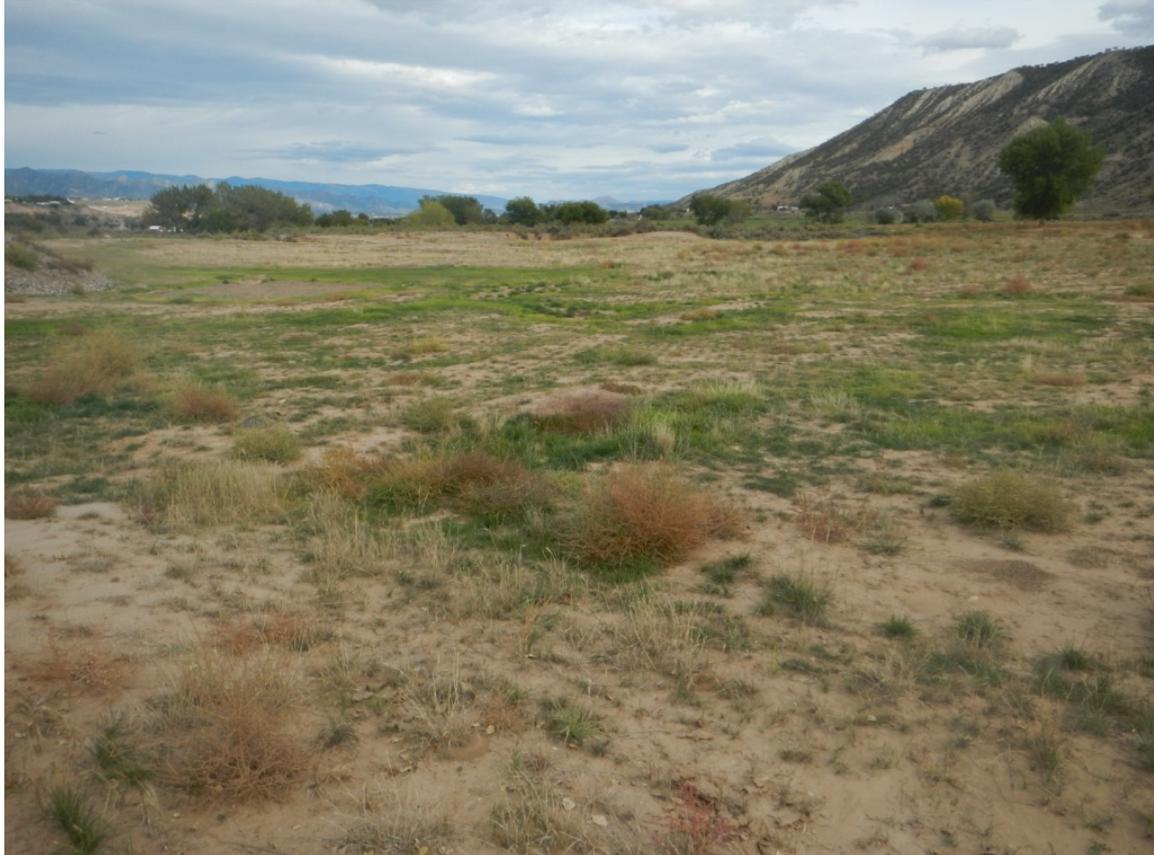
Photo#1: View of location from NW corner.

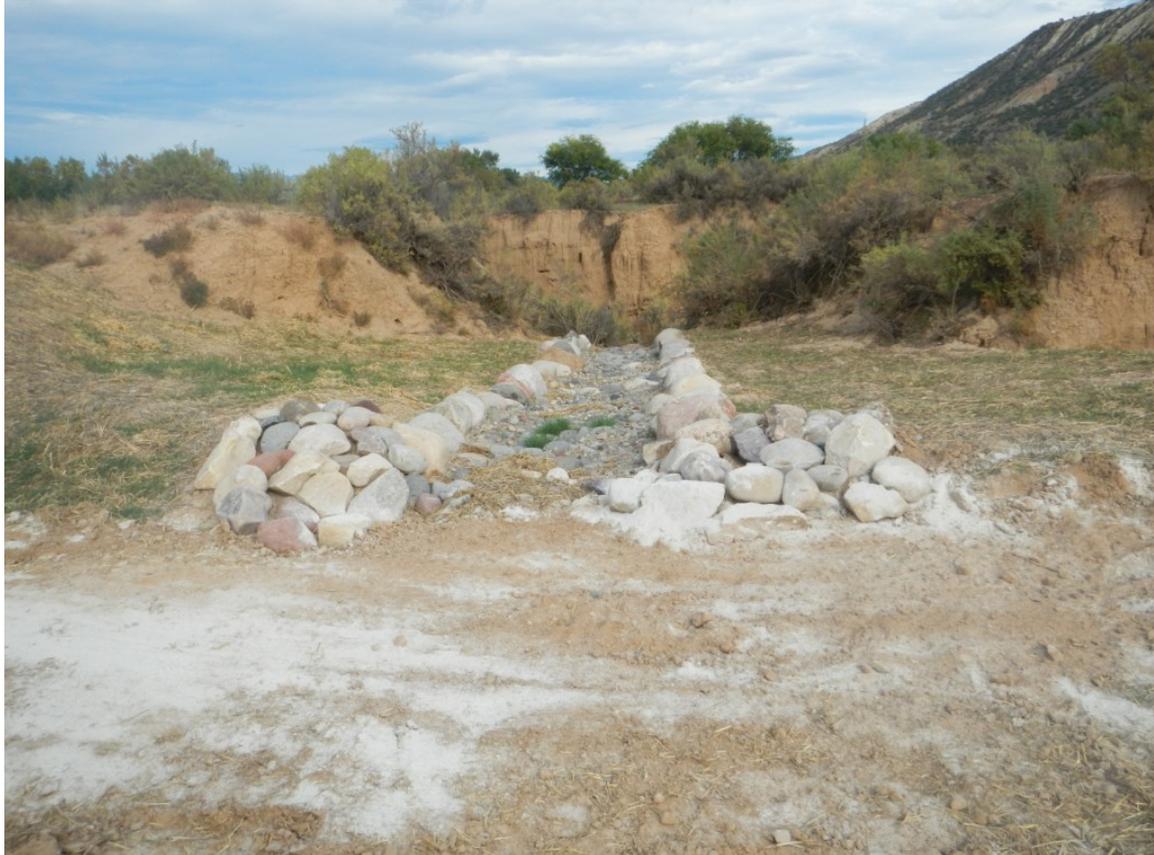
Photo#2: New BMPs installed where there was serious gully erosion; looking East.

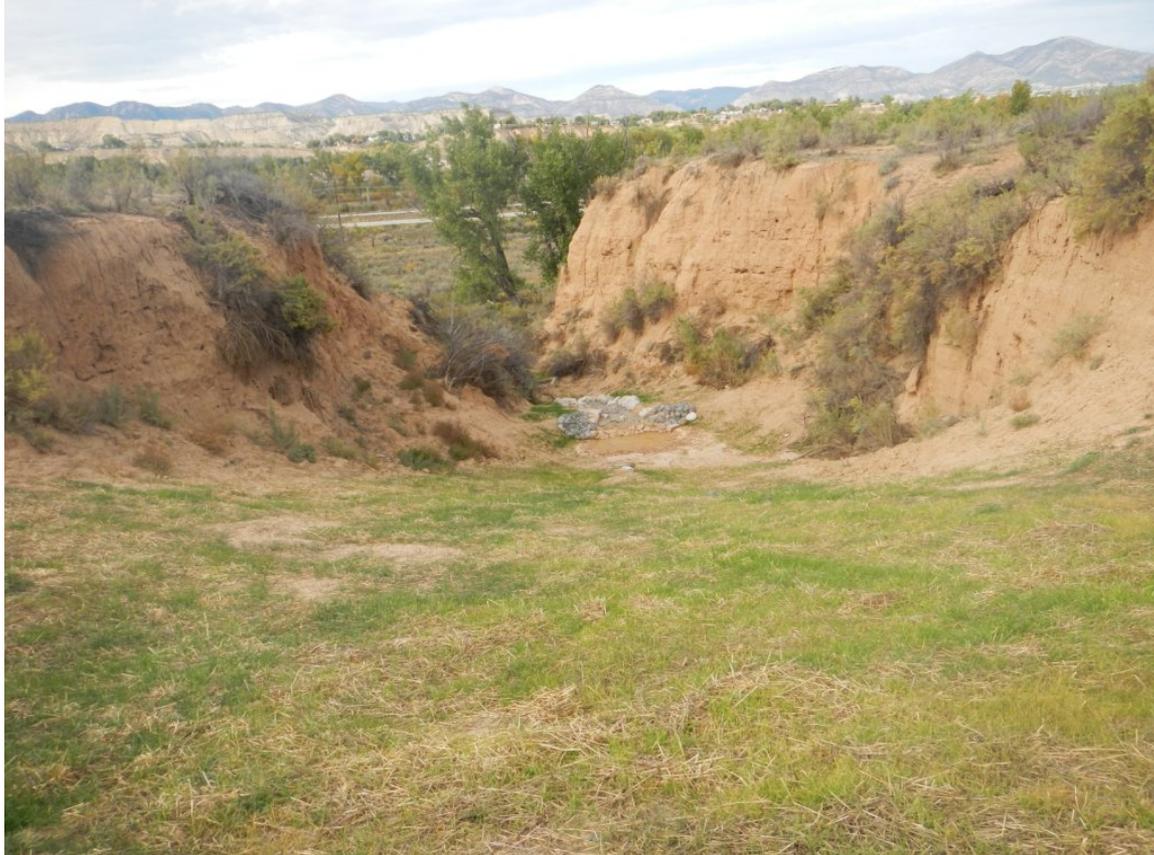
Photo#3: Stormwater controls installed in washout area facing NE.

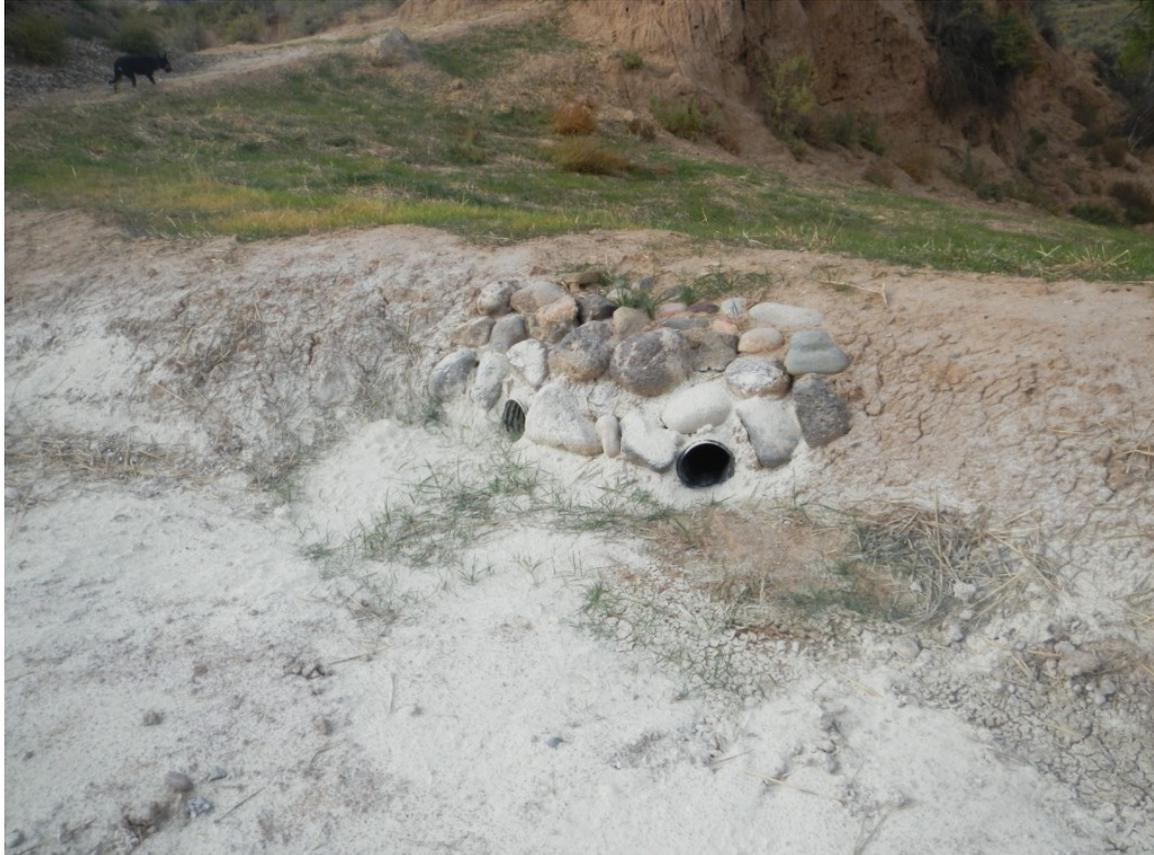
Photo#4: Culverts installed on North perimeter.

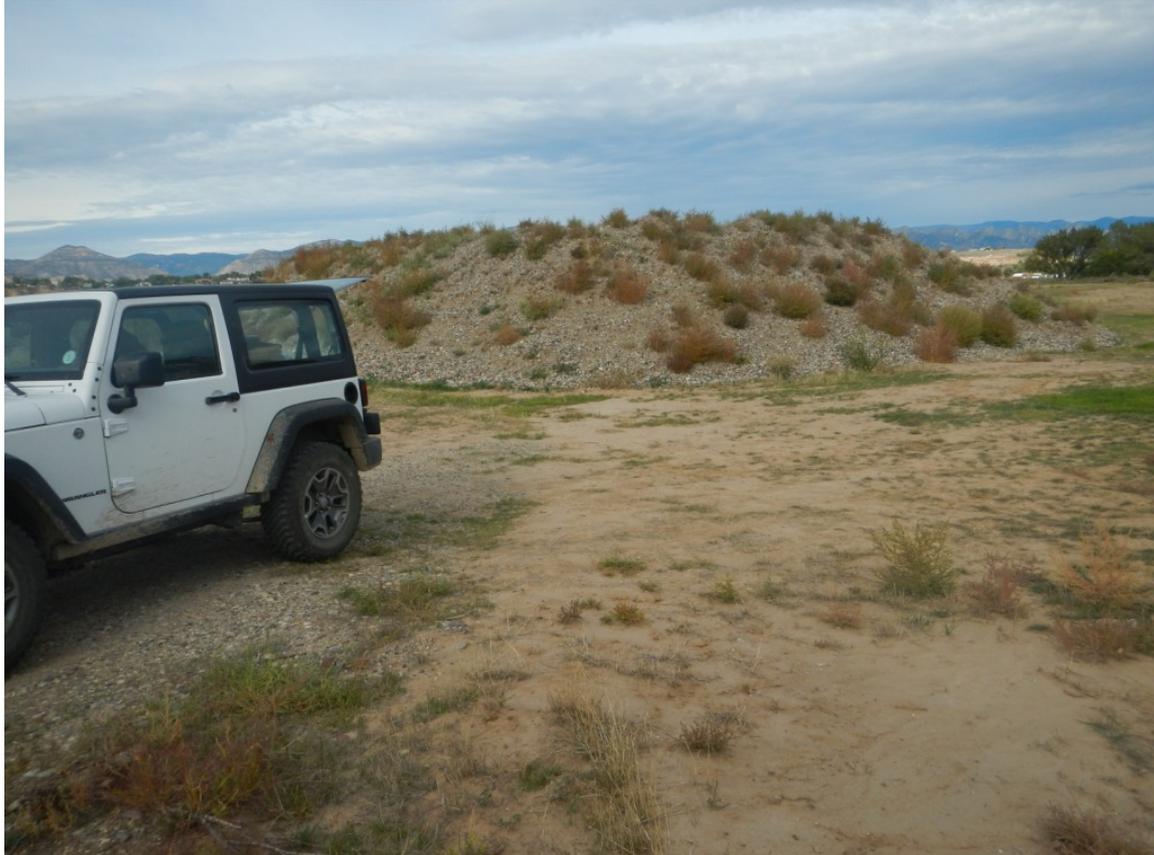
Photo#5: Gravel Pile at NW corner of Location.
