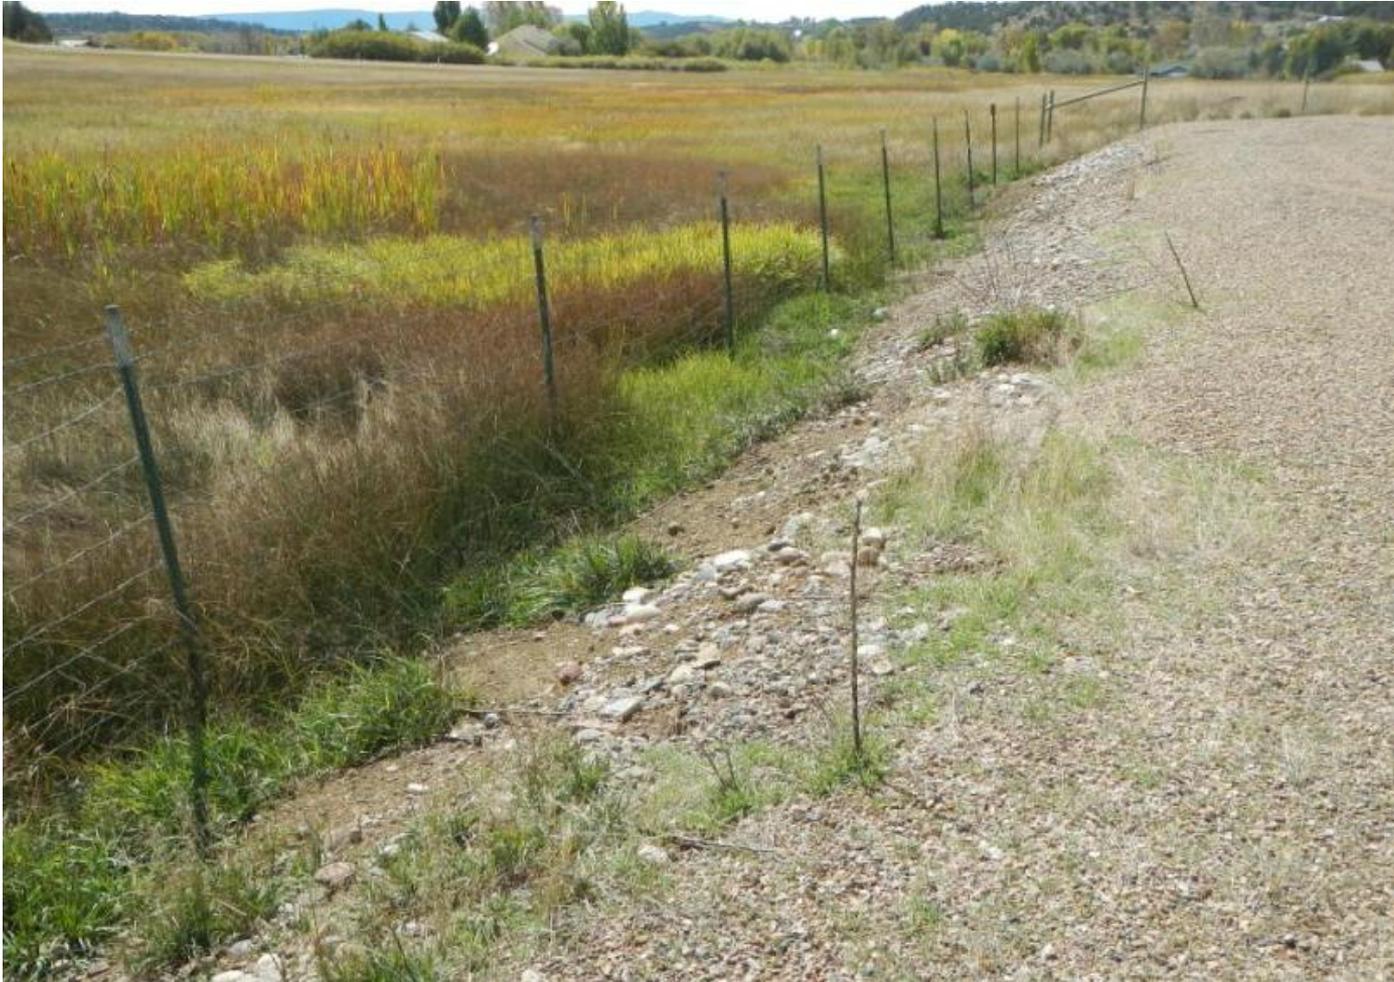
Photo 1. View of eastern portion of project area from northeastern corner facing southward. Sparse revegetation along the fill slopes.

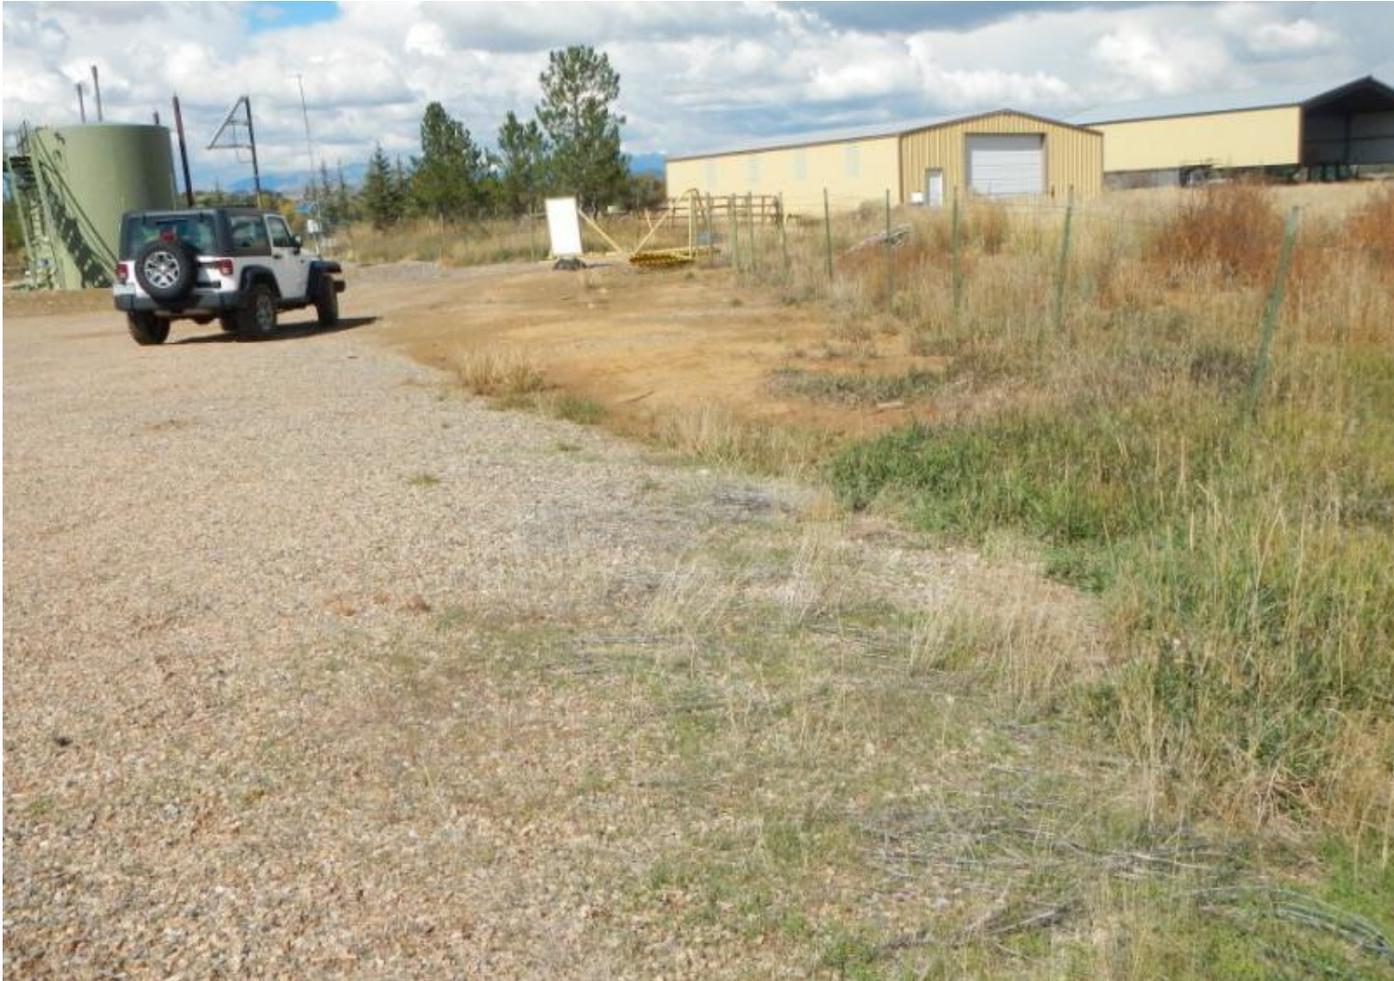
Photo 2. View of northern portion of project area from northeastern corner facing westward.

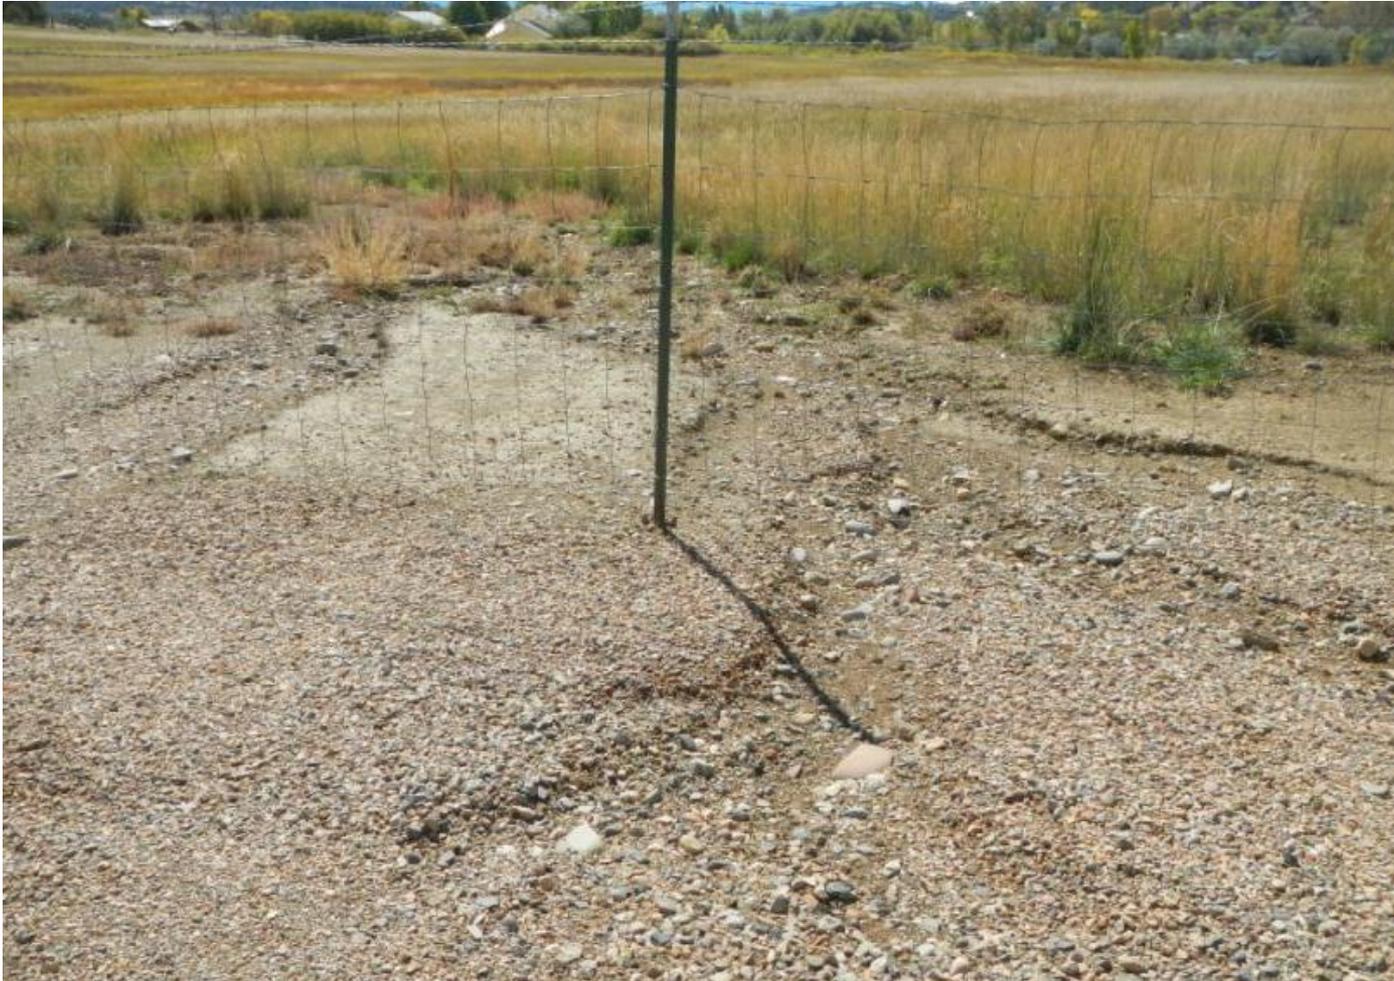
Photo 3. View of southern portion of project area where it appears concentrated stormwater flows are carrying sediment outside of the project area.

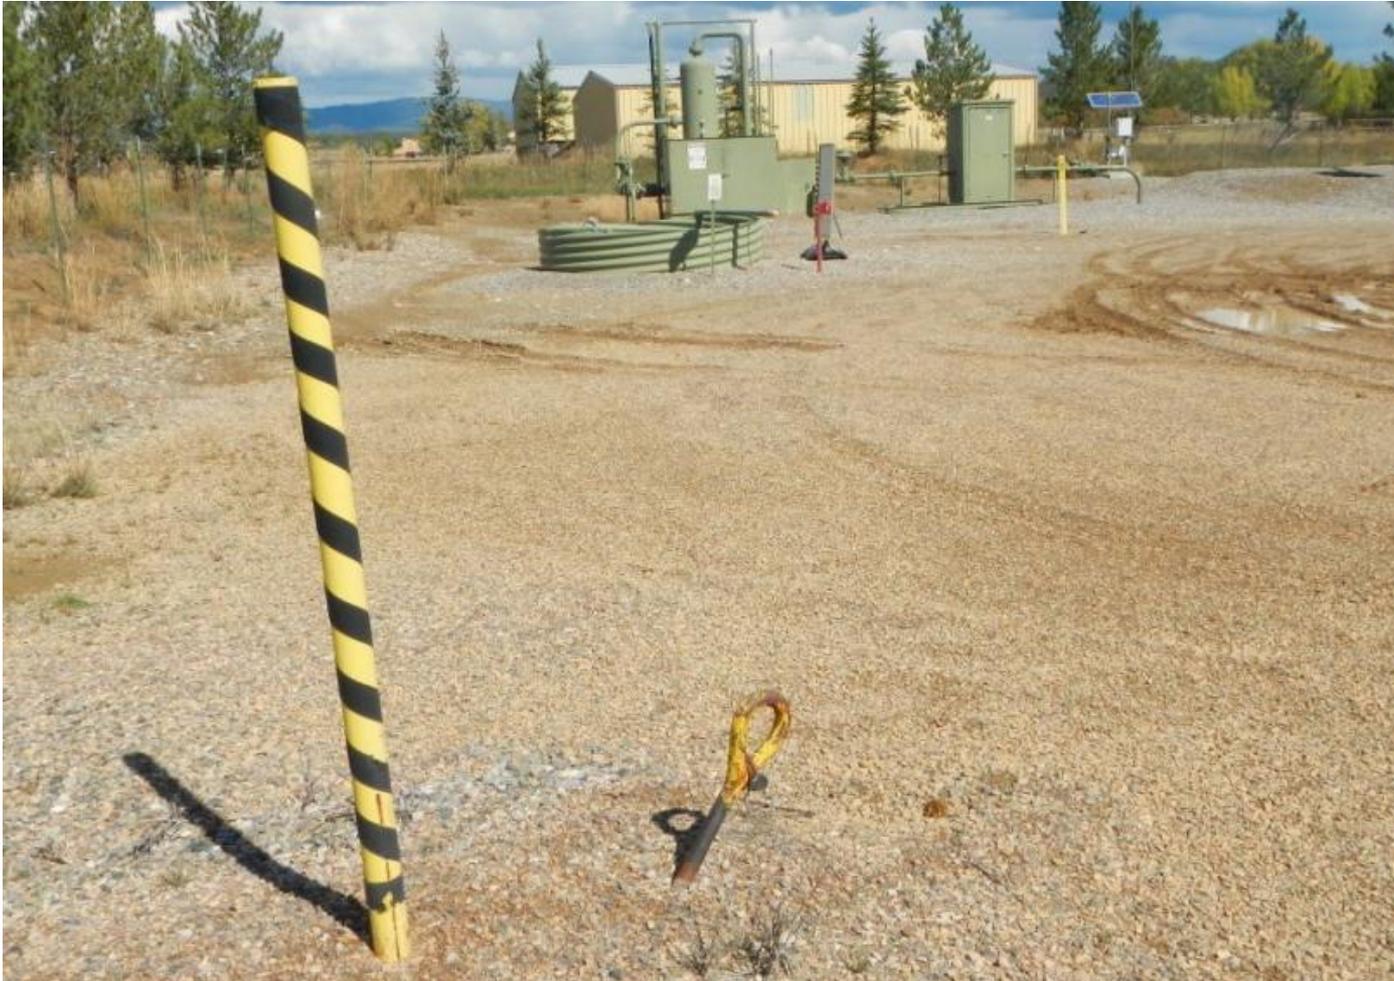
Photo 4. View of western portion of project area from southwestern corner facing northward.

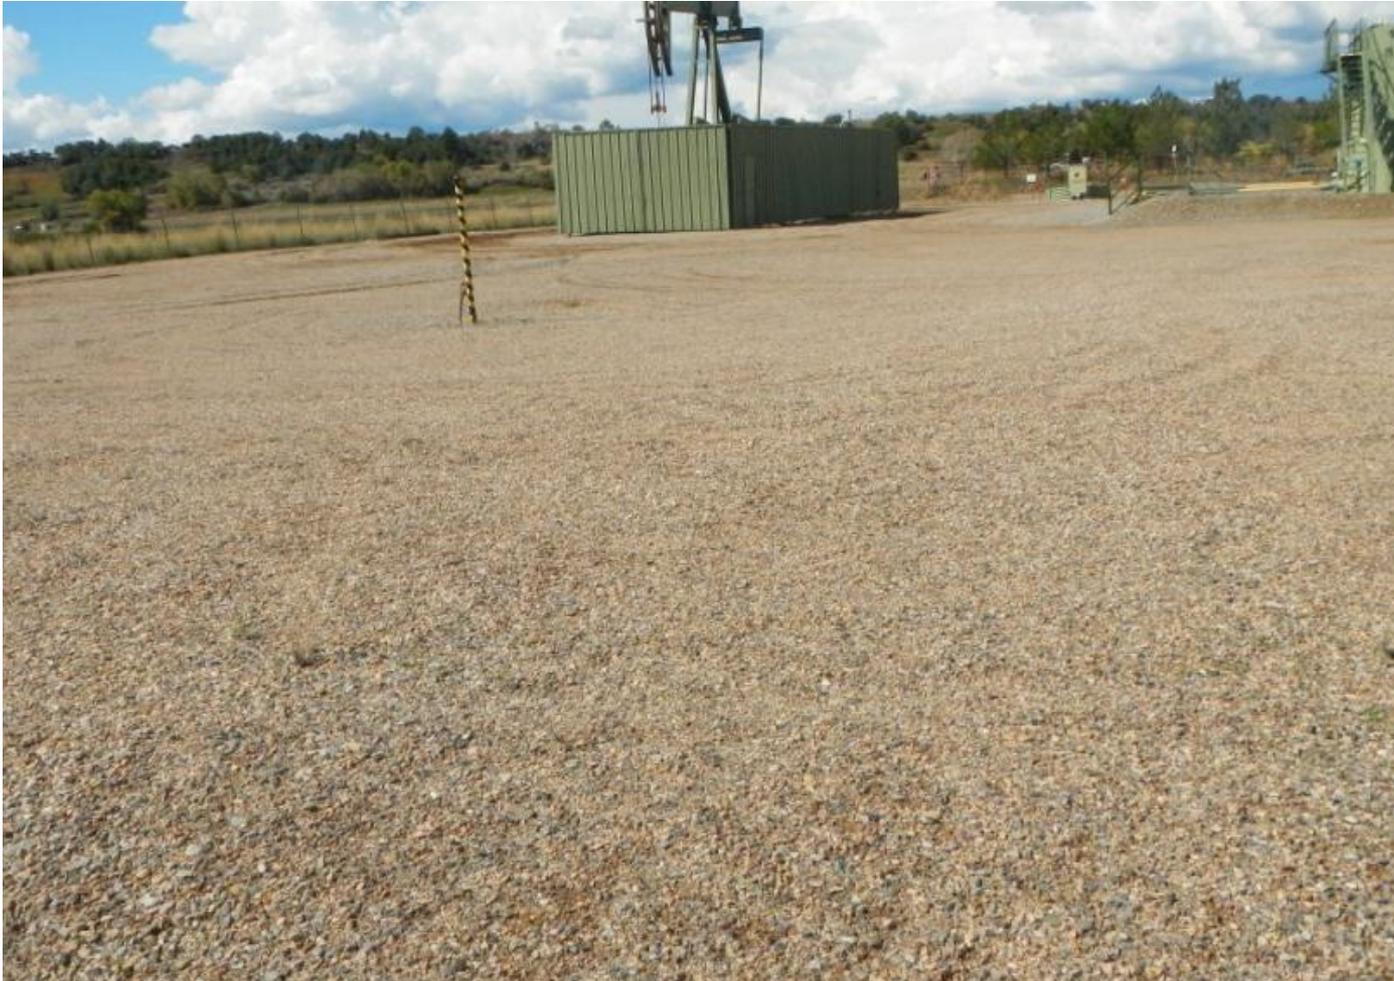
Photo 5. View of project area from northeastern corner facing center.
