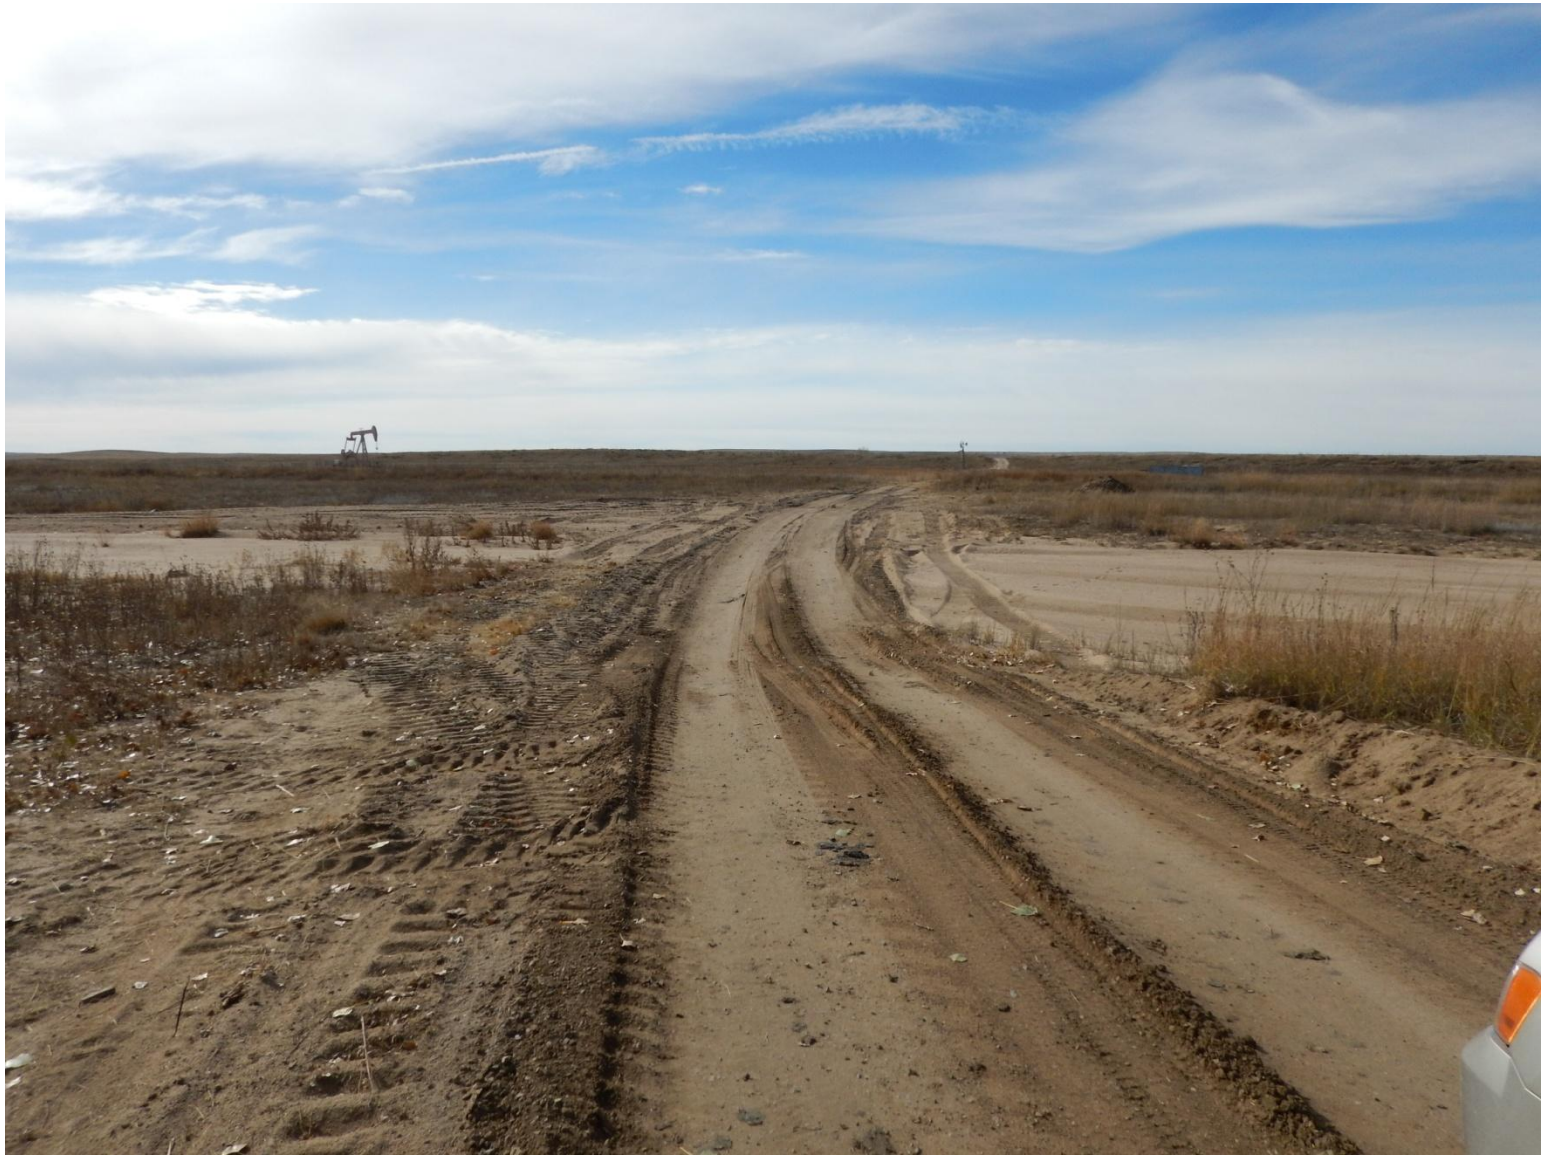
Photo 1: Photo facing South, taken from access road at Sand Creek. Bare soil running left to right in photo is creek bottom. BMPs not installed on road.

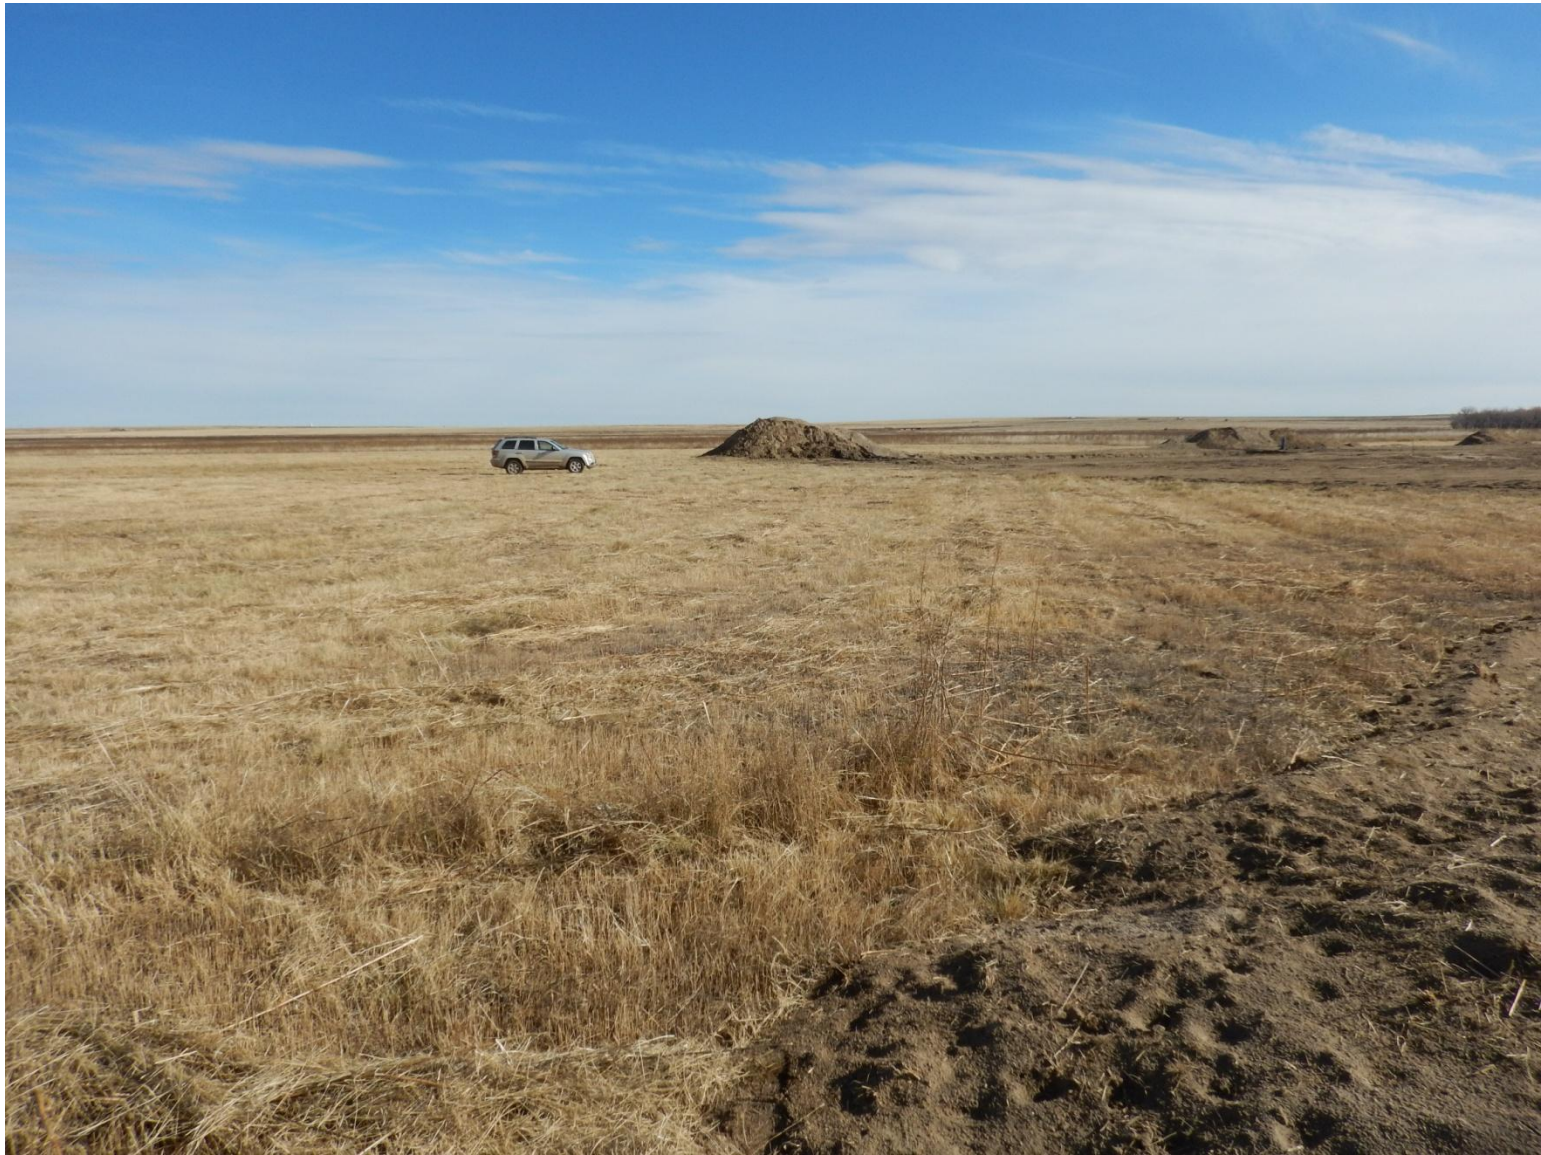
Photo 4: Photo taken from Southwest side of location facing North. Note insufficient storm water BMPs in place along West side of location.

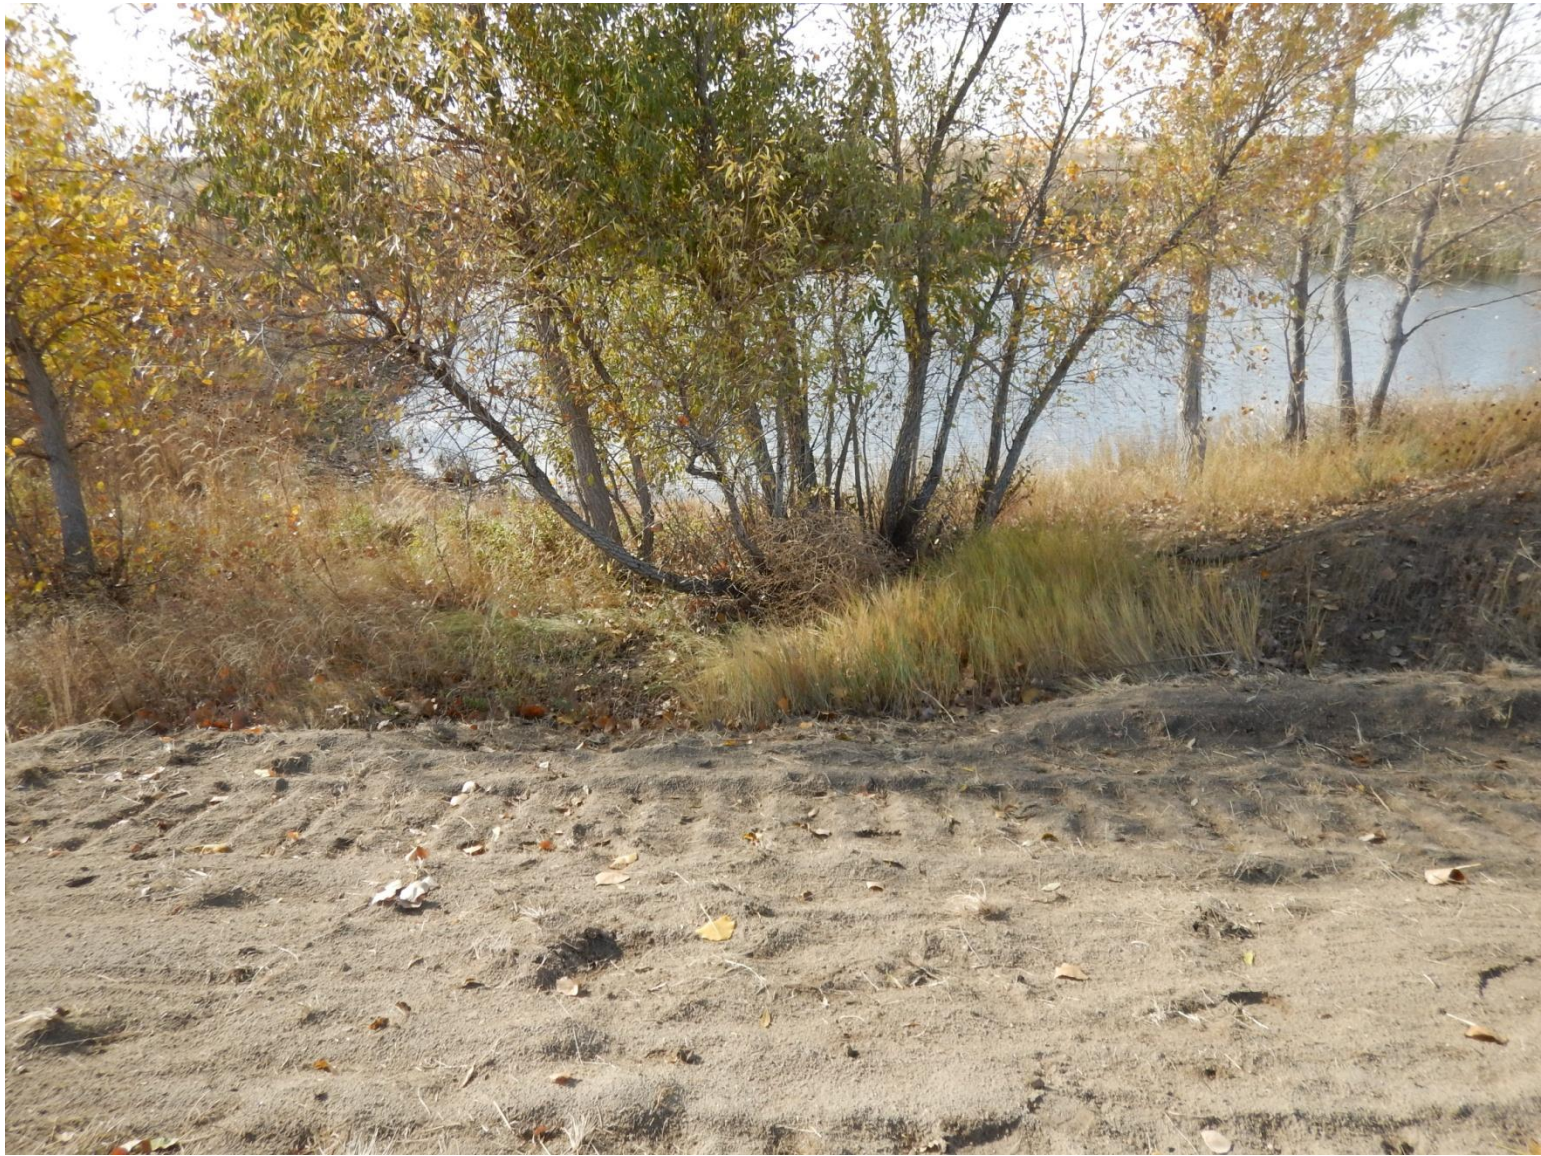
Photo 5: Photo taken from South side of location facing South. Insufficient storm water BMPs in place.

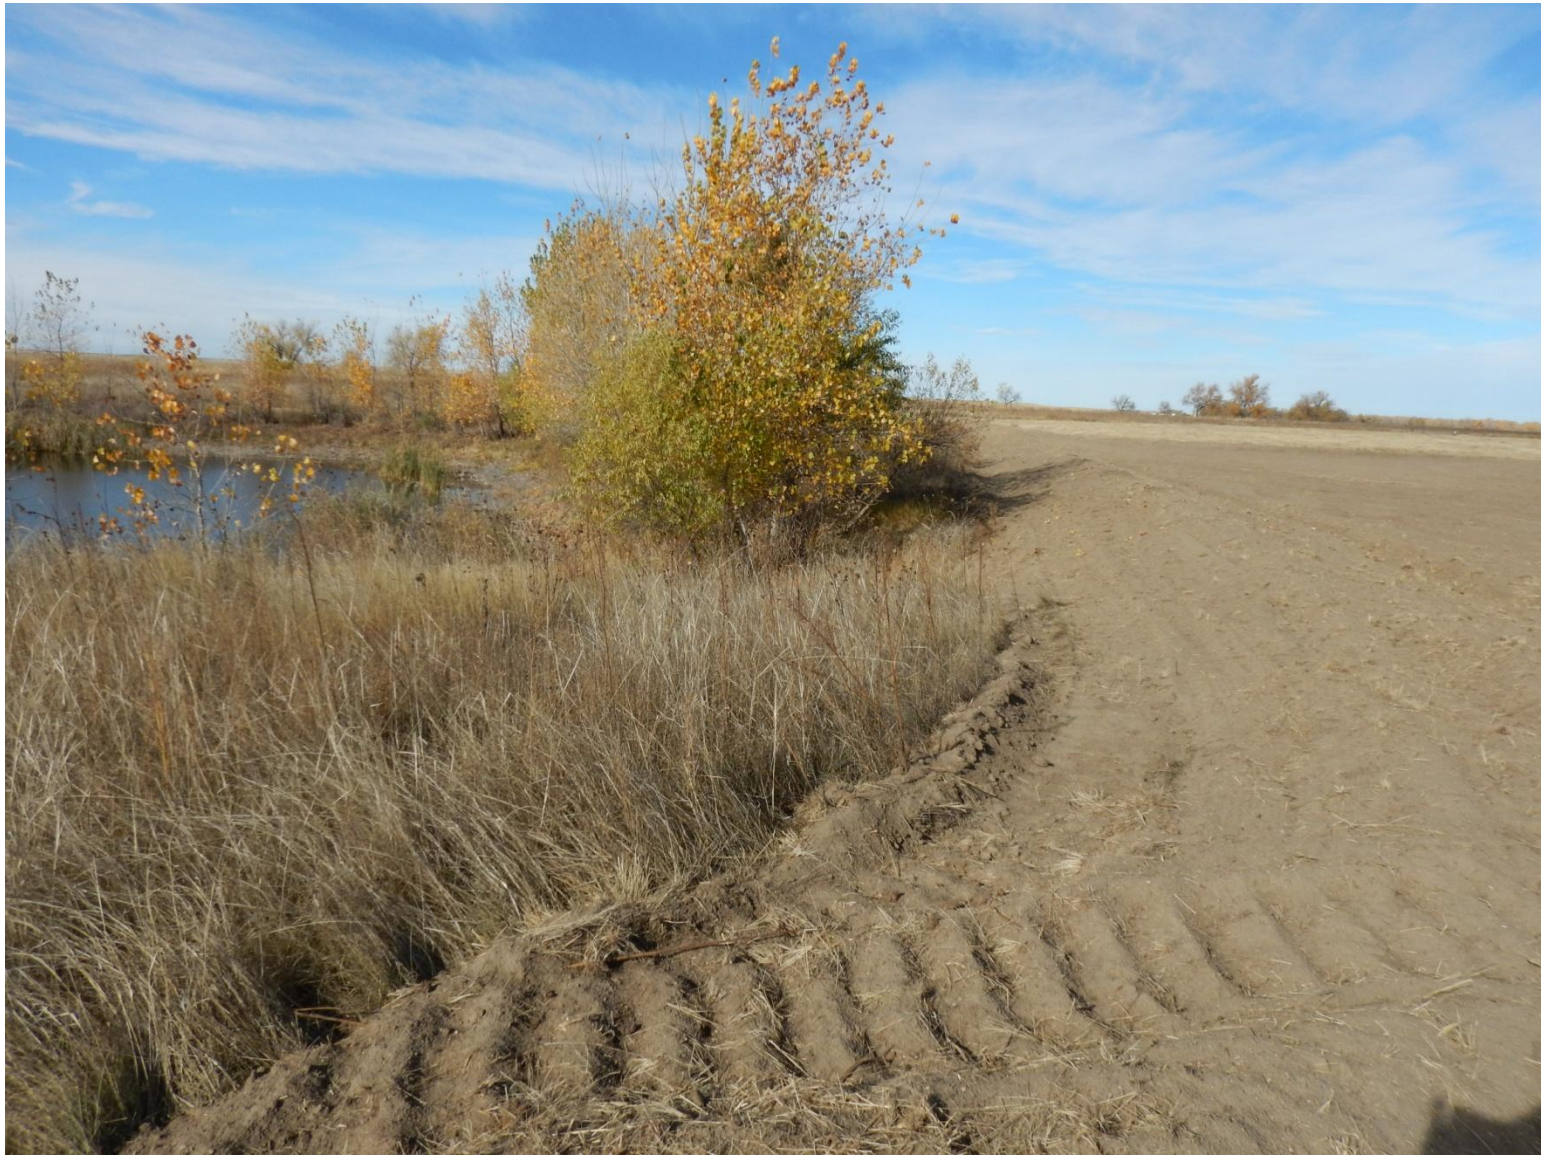
Photo 6: Photo taken from Southeast side of location facing West.
Insufficient storm water BMPs in place.

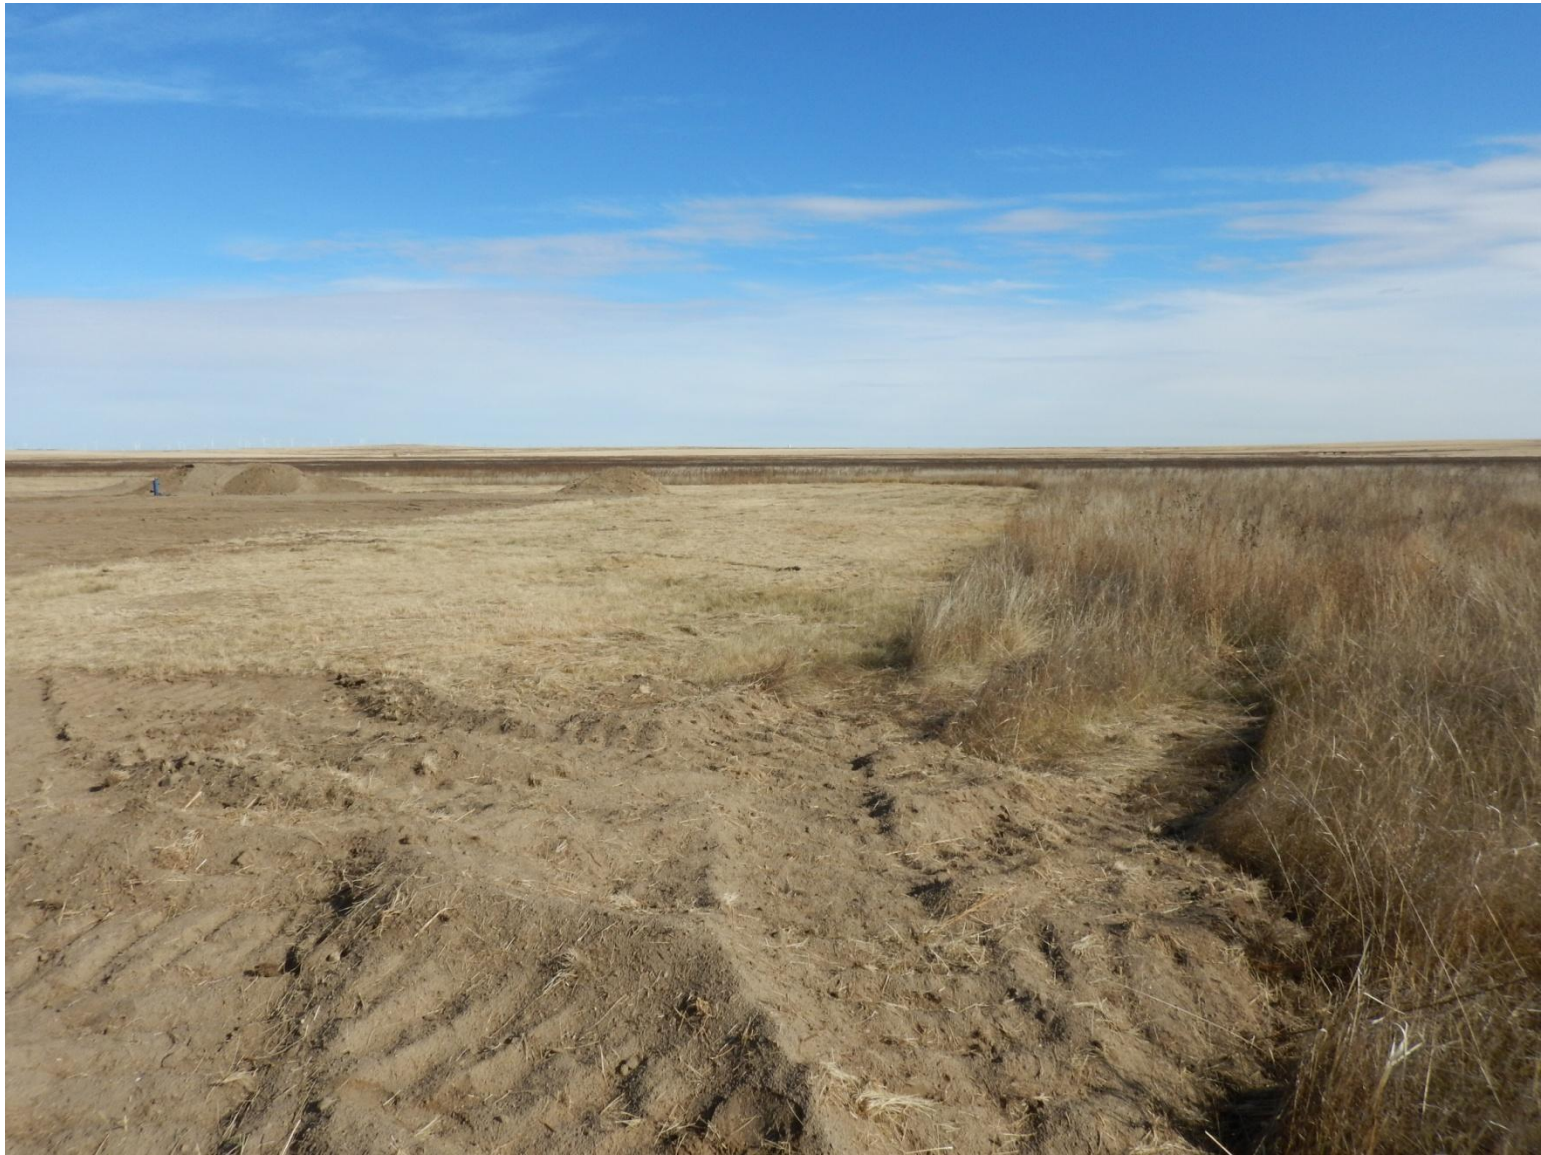
Photo 7: Photo taken from Southeast side of Facing North. Note insufficient storm water BMPs in place.

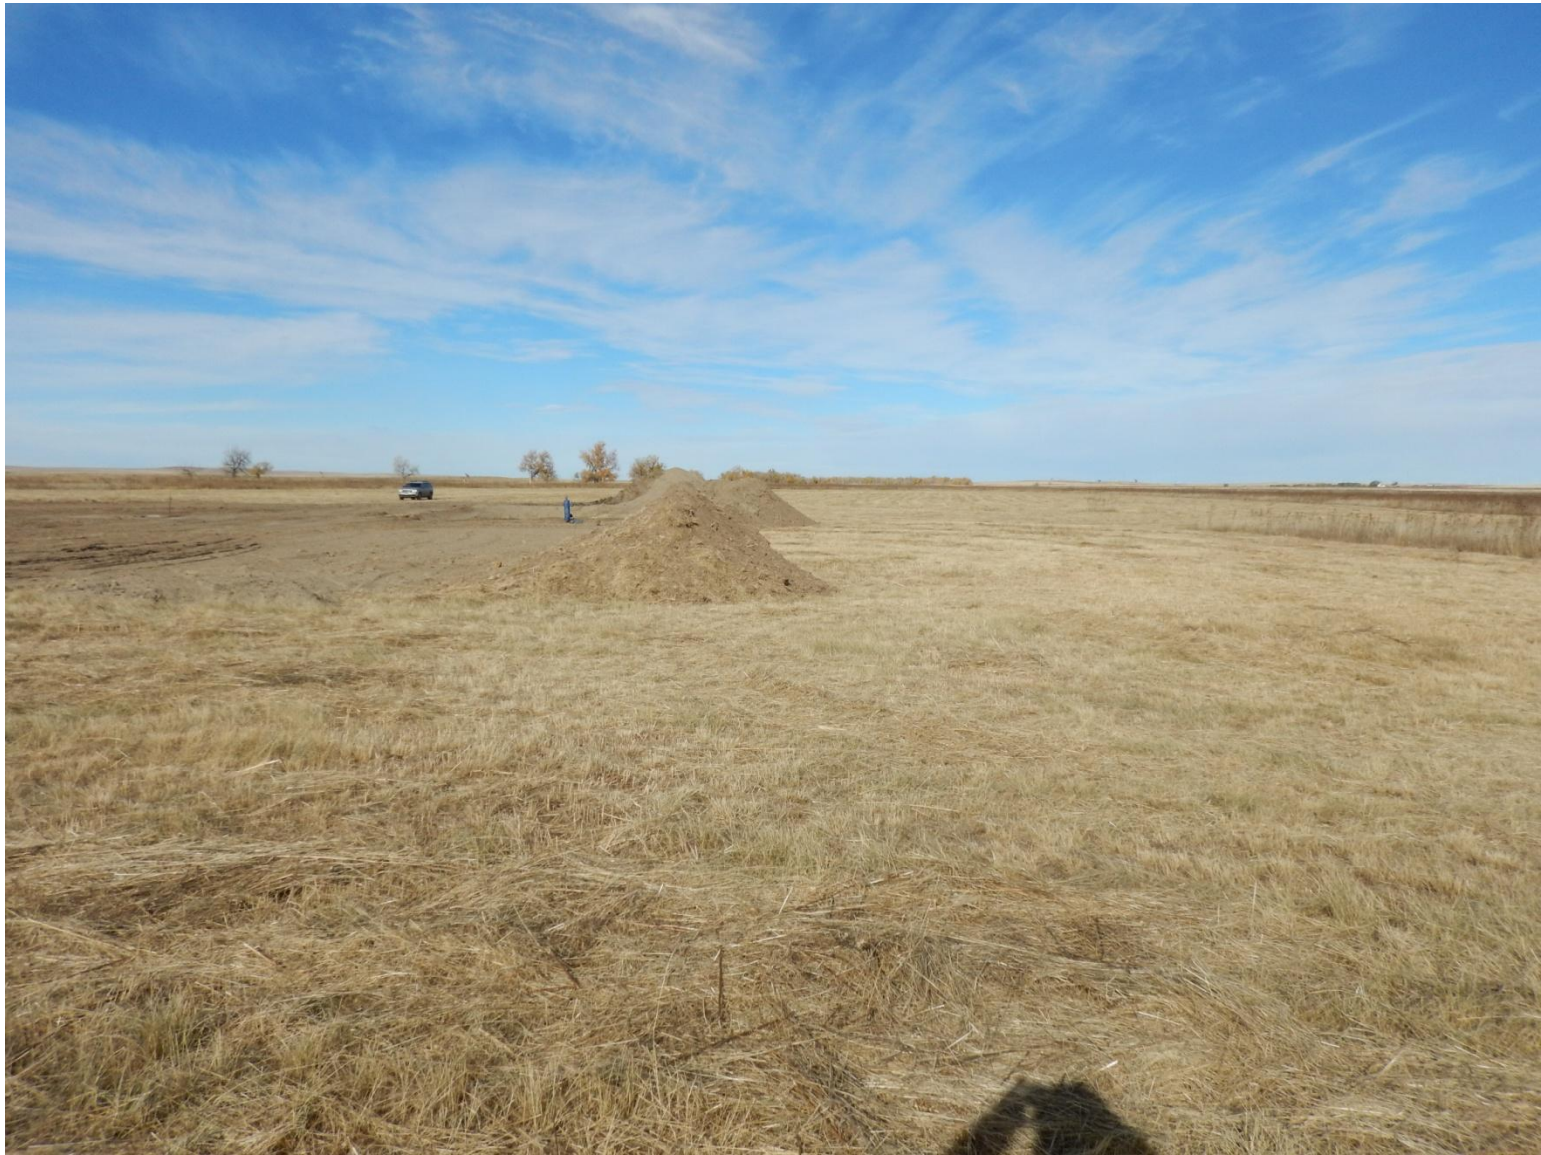
Photo 8: Photo taken from Northeast side of location facing West. Note insufficient storm water BMPs in place along the North side of location.

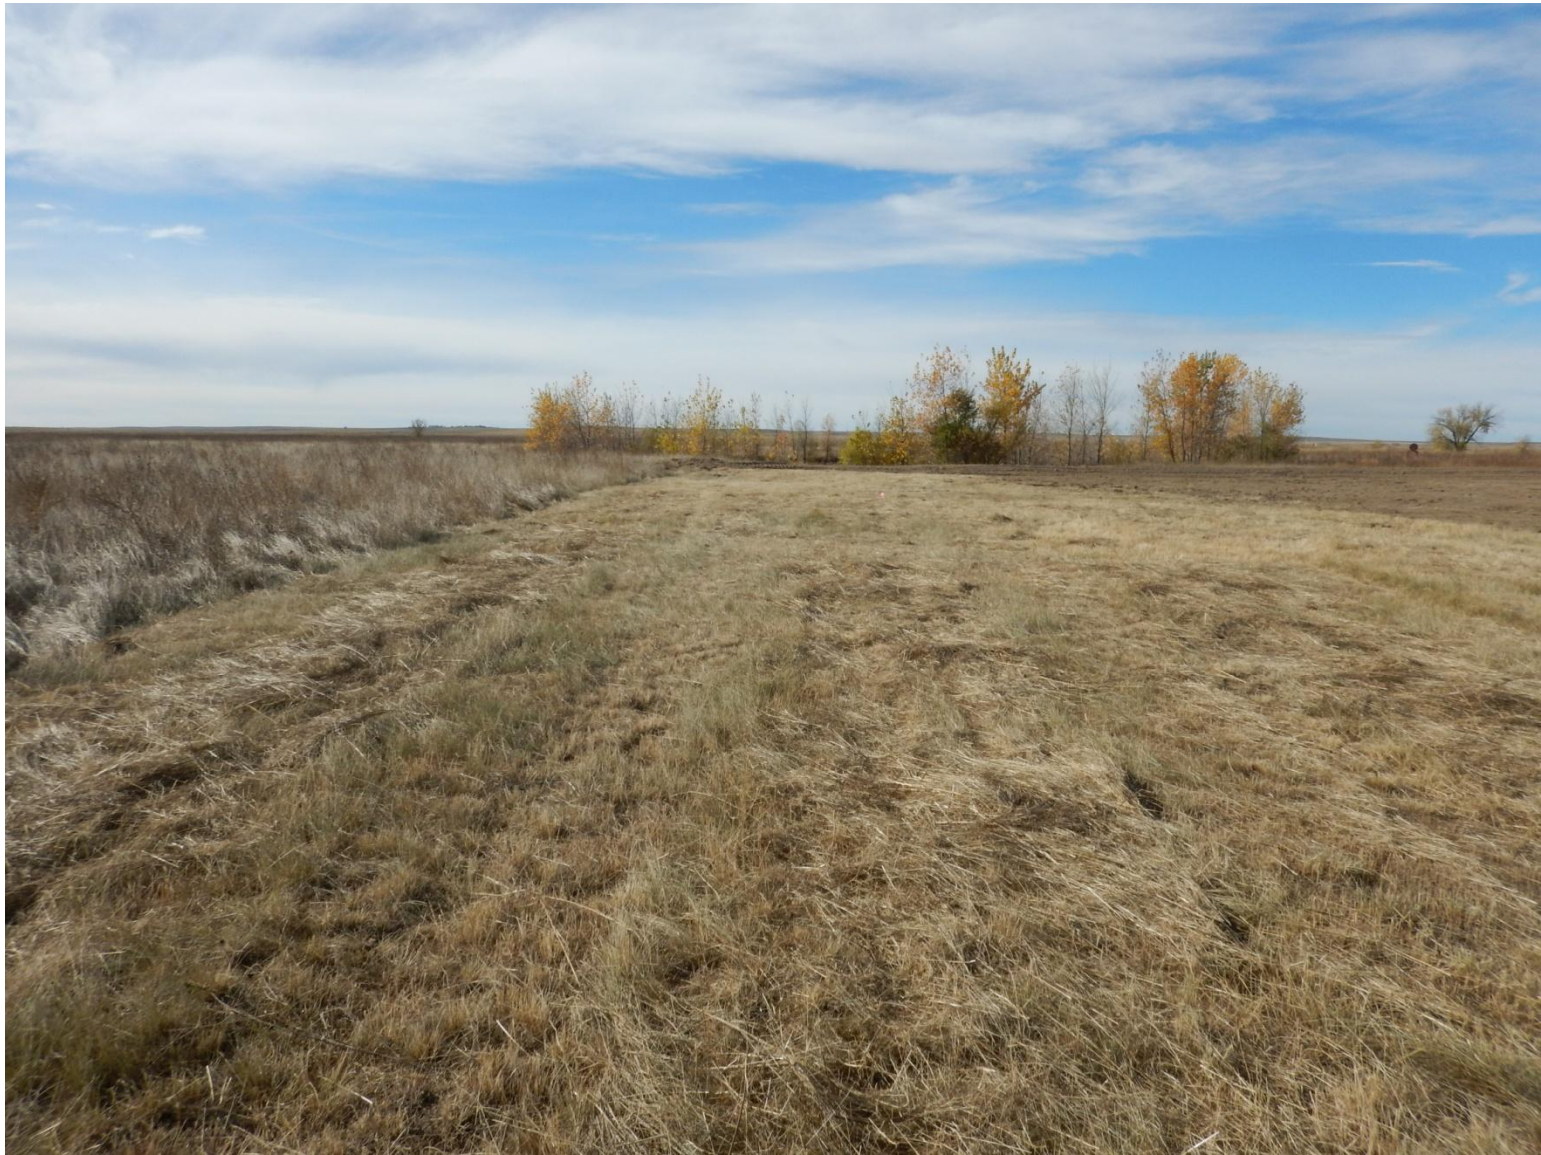
Photo 9: Photo taken from Northwest side of location facing East. Note insufficient storm water BMPs in place along the North side of location.

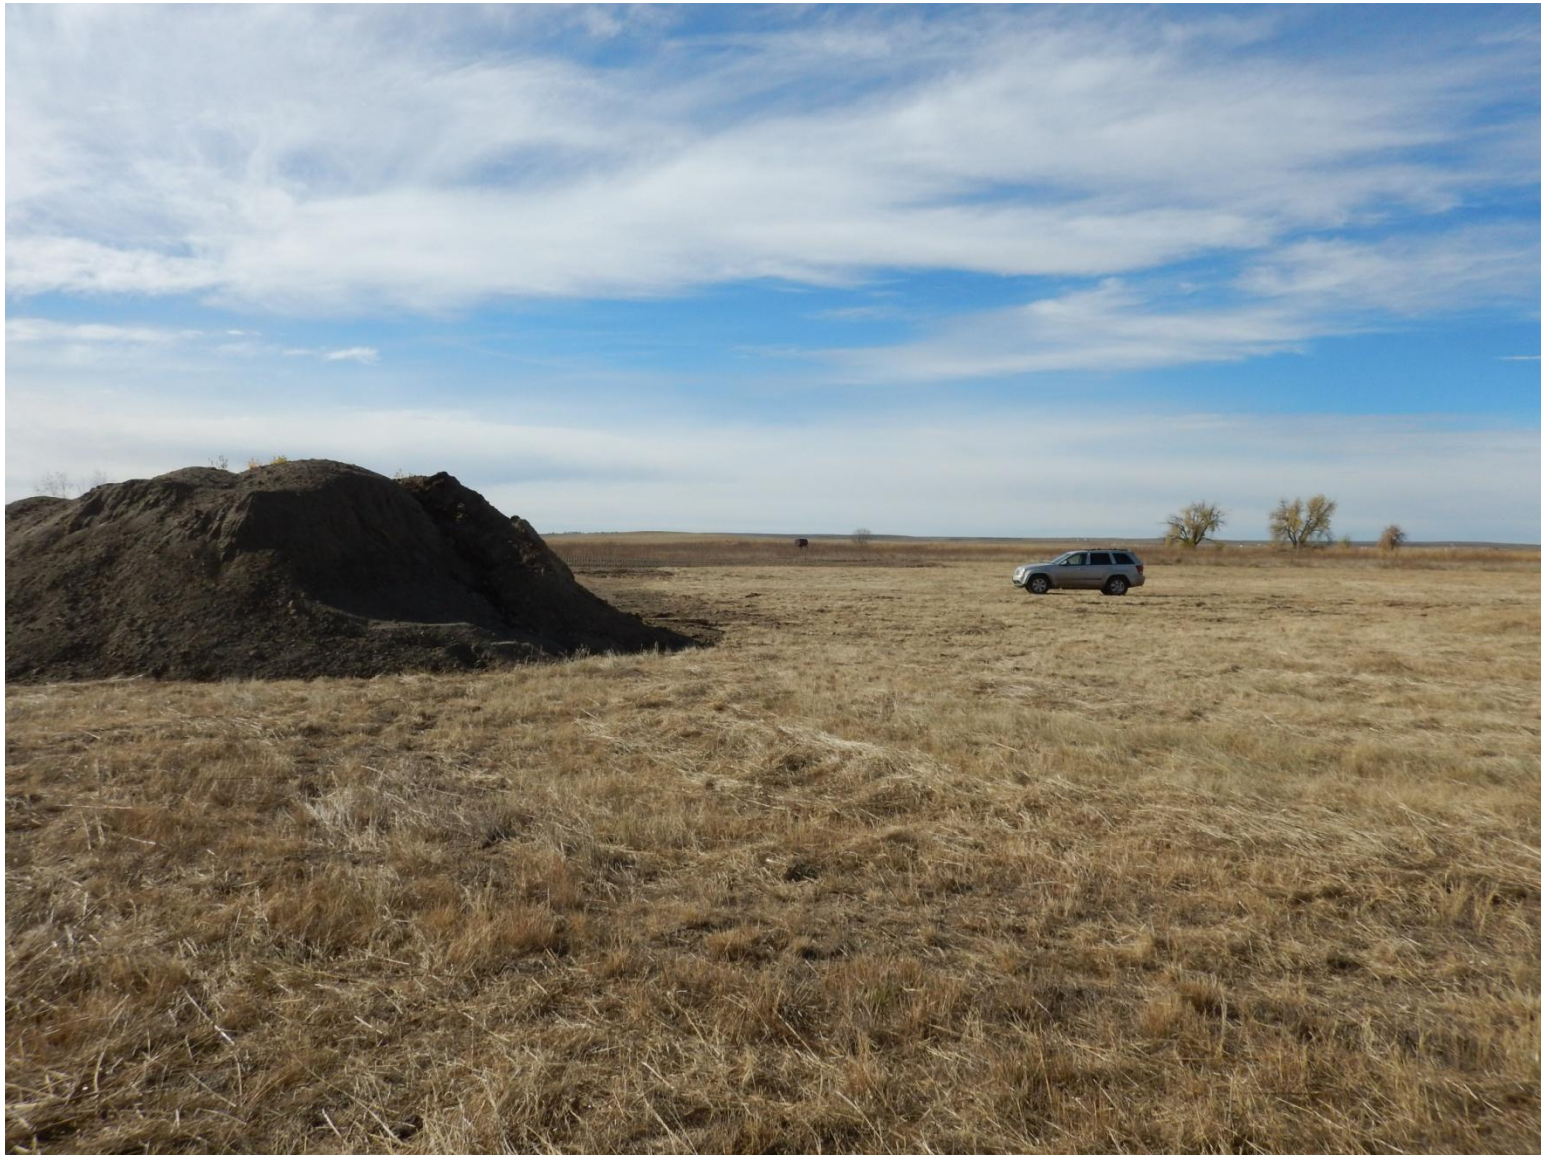
Photo 10: Photo taken from Northwest of location looking South. Note insufficient storm water BMPs in place along the West side of location.
