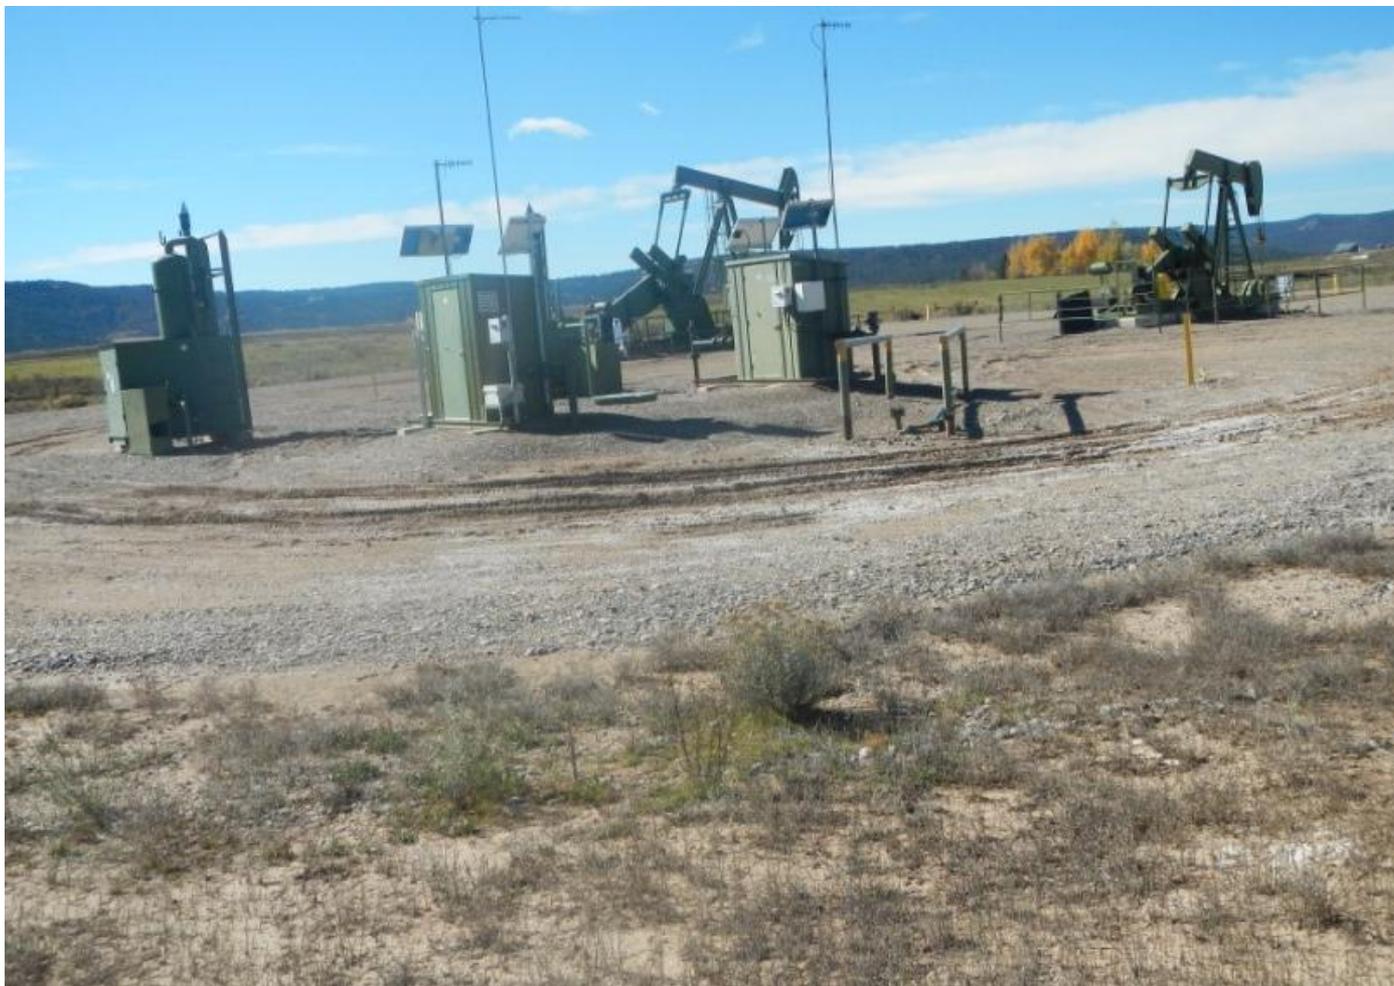
Photo 1. View of project area from northeastern corner facing center. Short (less than 1 foot tall) kochia (*Kochia scoparia*) plants are the gray vegetation in the foreground, and rubber rabbitbrush (*Chrysothamnus nauseosus*) is the shrubby vegetation in the mid-ground.

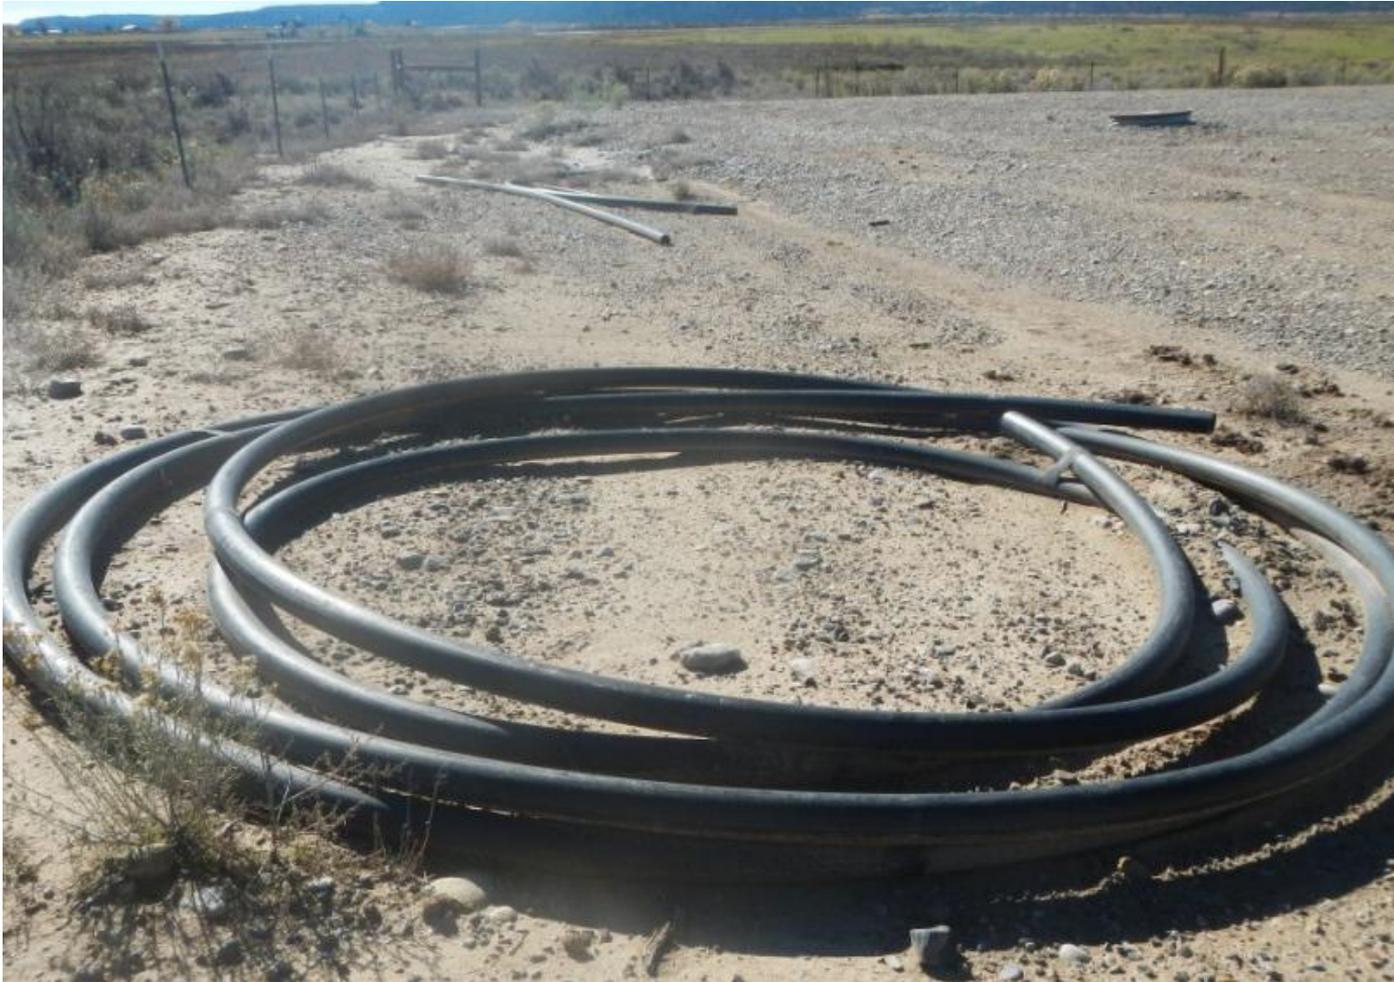
Photo 2. View of eastern portion of the interim reclamation area from eastern edge facing southward. Sparse/poor revegetation here. Unused piping needs to be removed.

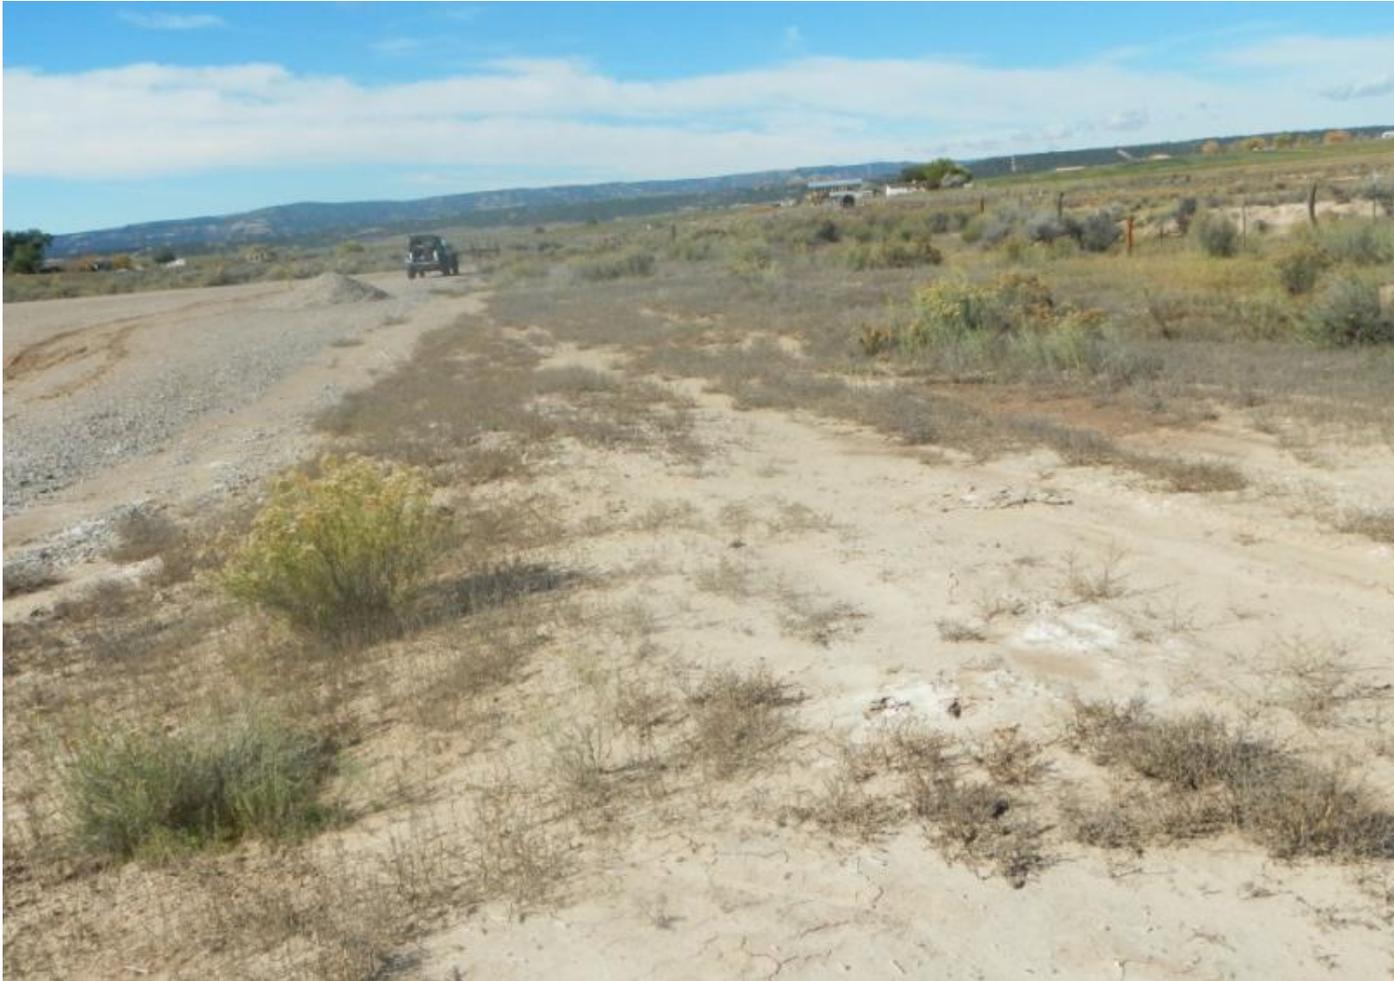
Photo 3. View of northern portion of the project area from northeastern corner facing westward. Poor revegetation here. A two-track crosses through the well pad through the northeastern corner (on right hand side of photo).

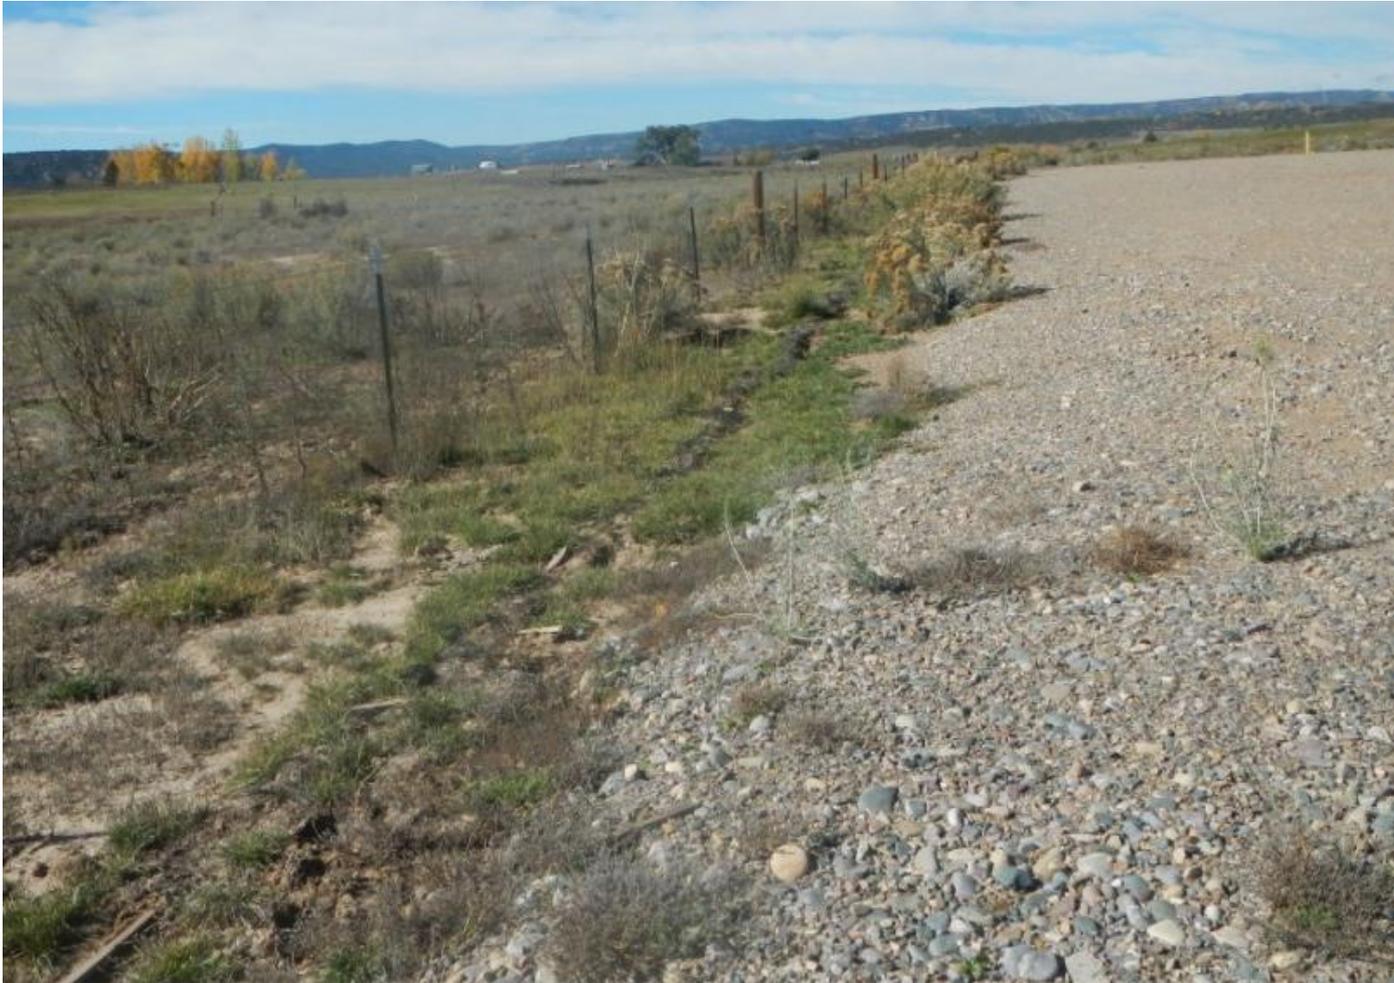
Photo 4. View of southern portion of project area from southeastern corner facing westward. Straw wattle is in disrepair, but vegetation and cobble on the slopes appear to be effectively reducing erosion.
