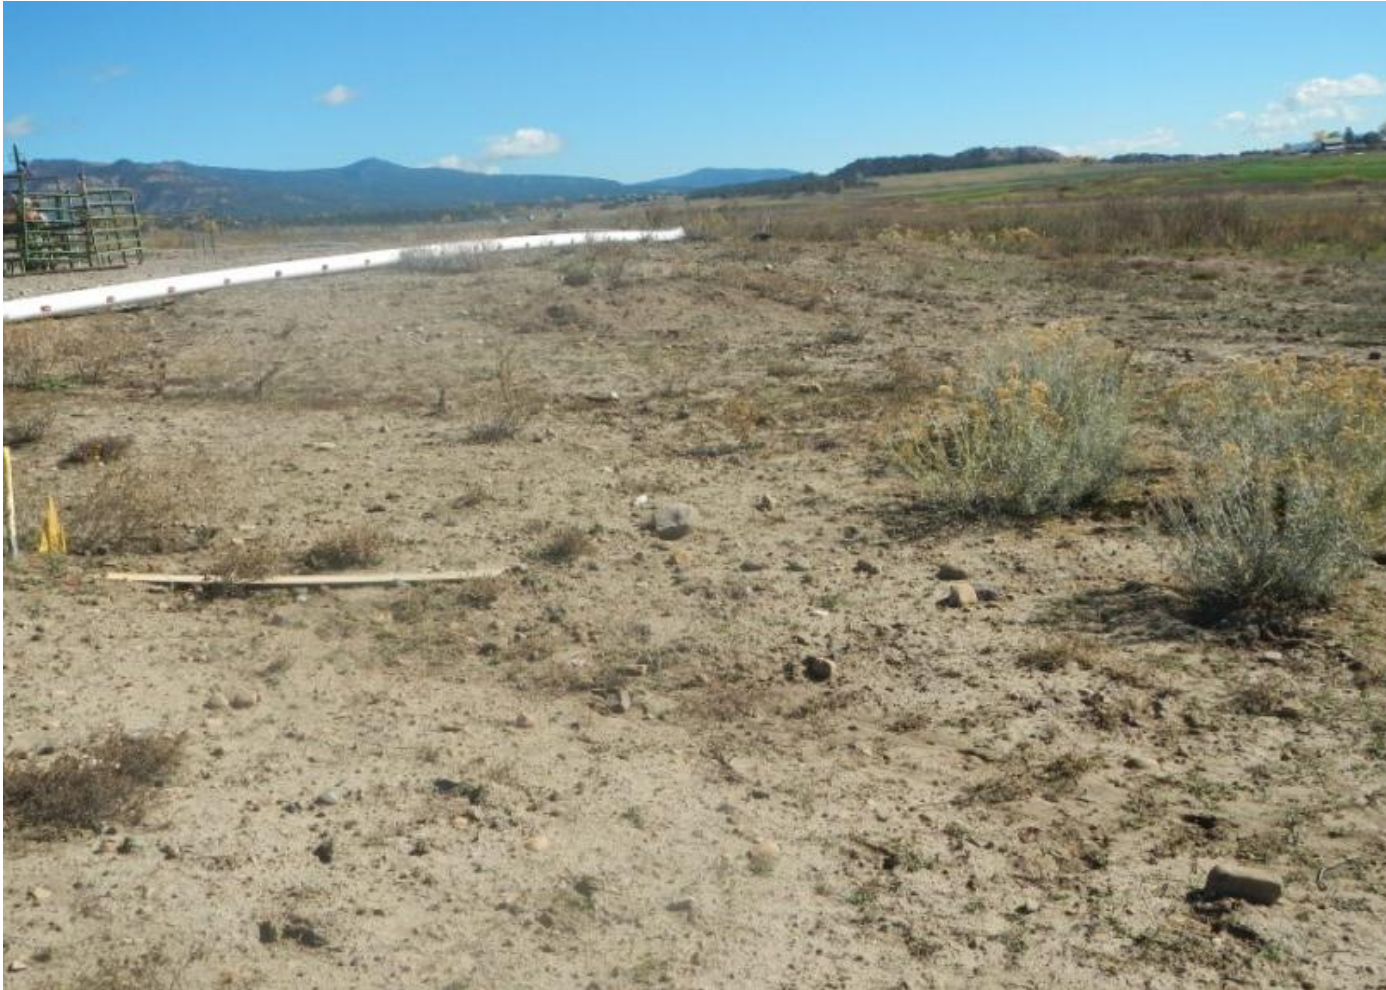
Photo 1. View of southern portion of project area from southwestern corner facing eastward. Revegetation areas are largely comprised of weeds such as Russian thistle (*Salsoa tragus*) and knotweed (*Polygonum arenastrum*) with scattered rubber rabbitbrush (*Chrysothamnus nauseosus*) and Arizona gumweed (*Grindelia arizonica*).

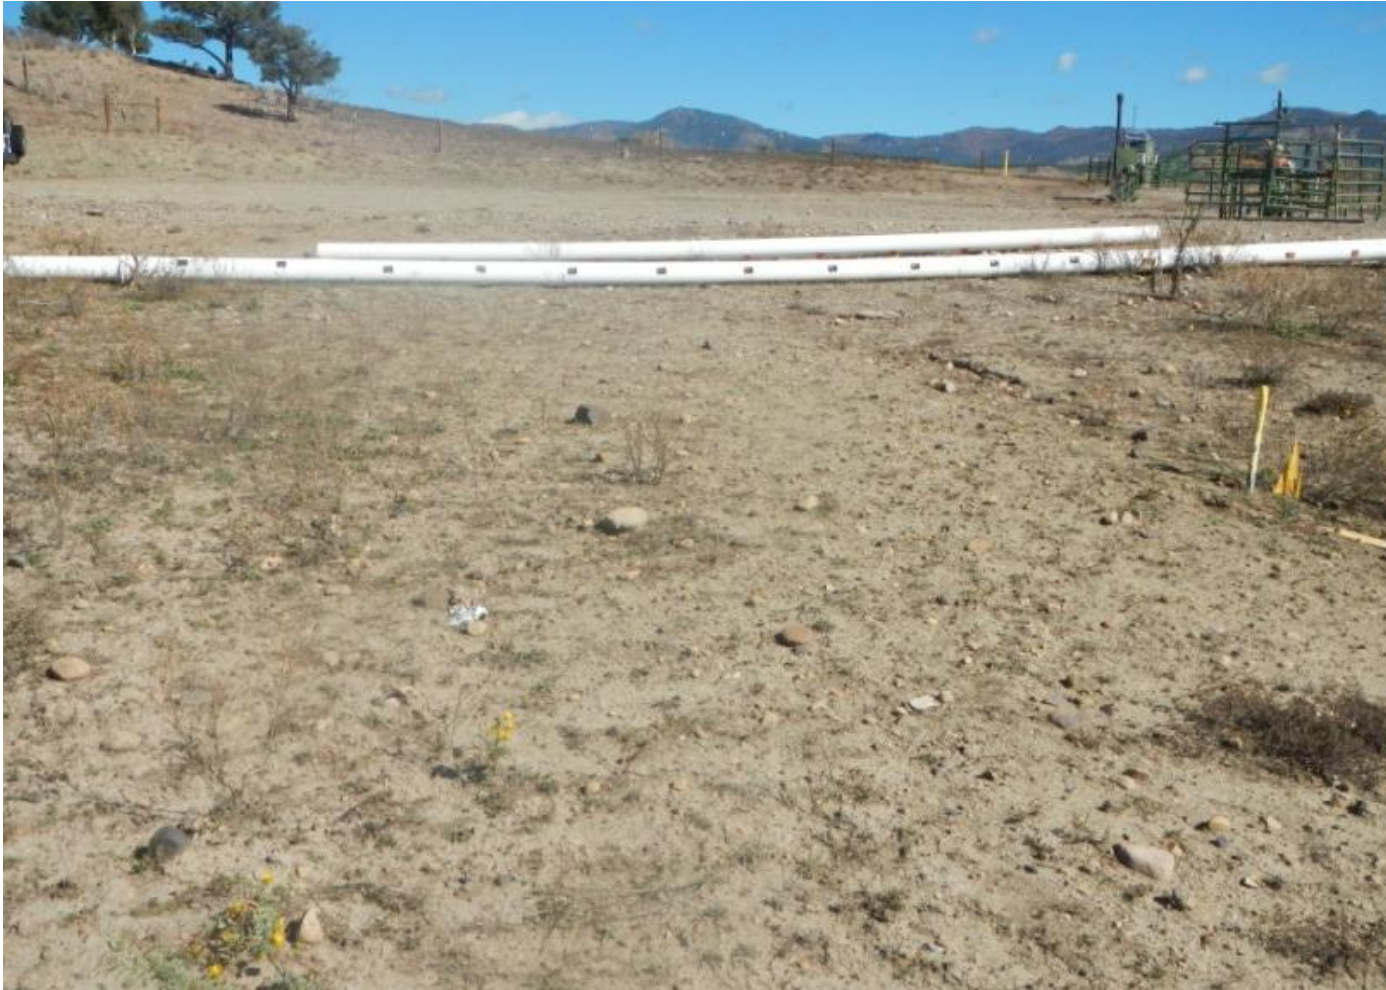
Photo 2. View project area from southwestern corner facing enter. Rill erosion is occurring off of the southern edge of the working area. Vegetation is sparse here.

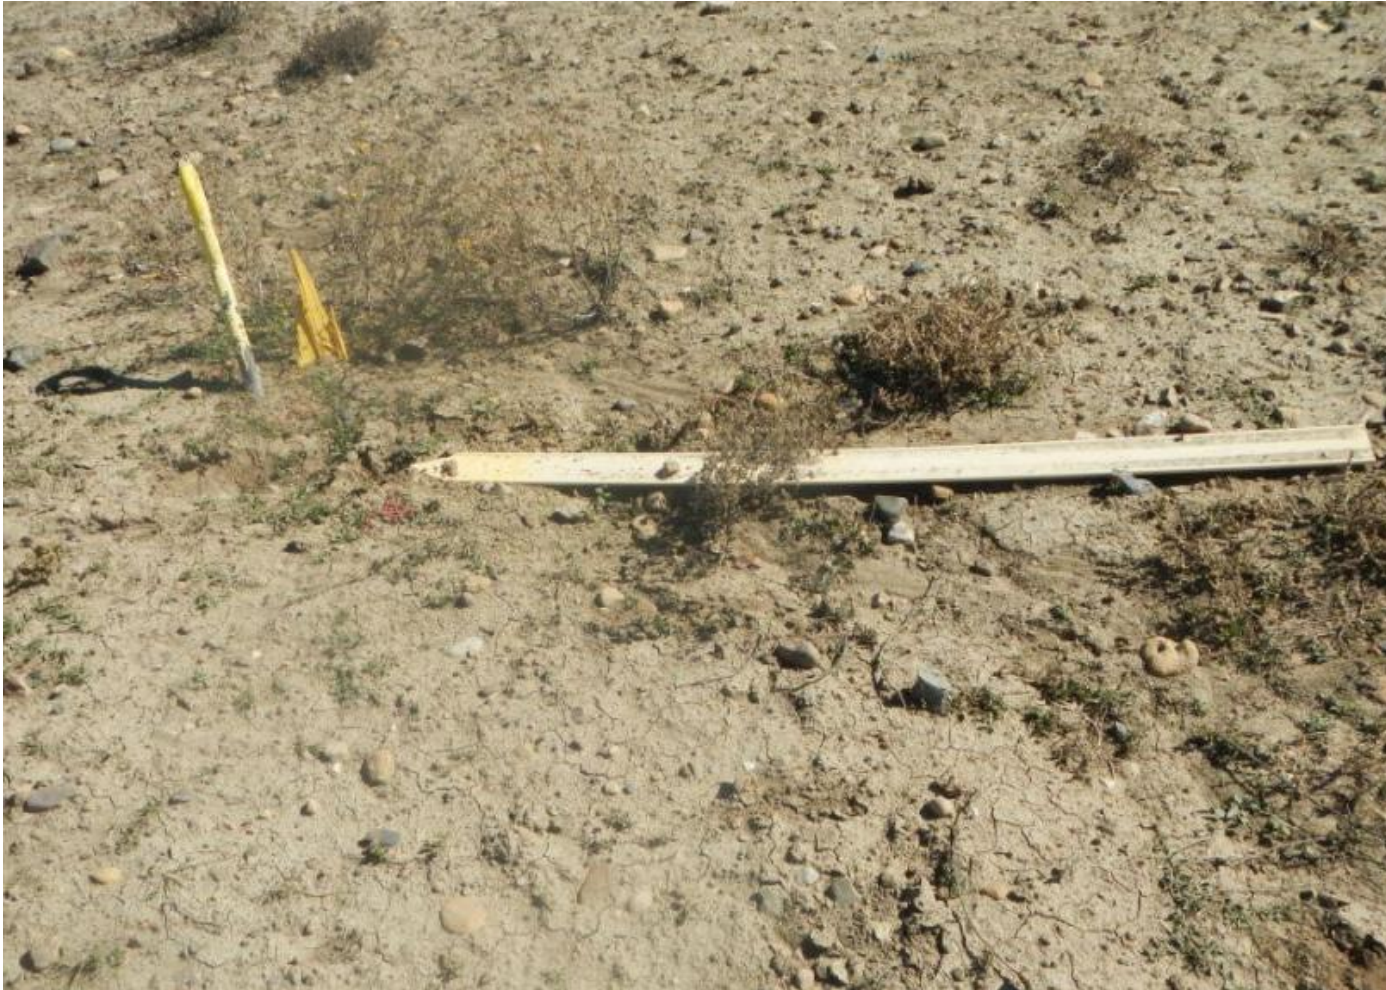
Photo 3. View of broken rig anchor and poor revegetation in southwestern portion of the project area.

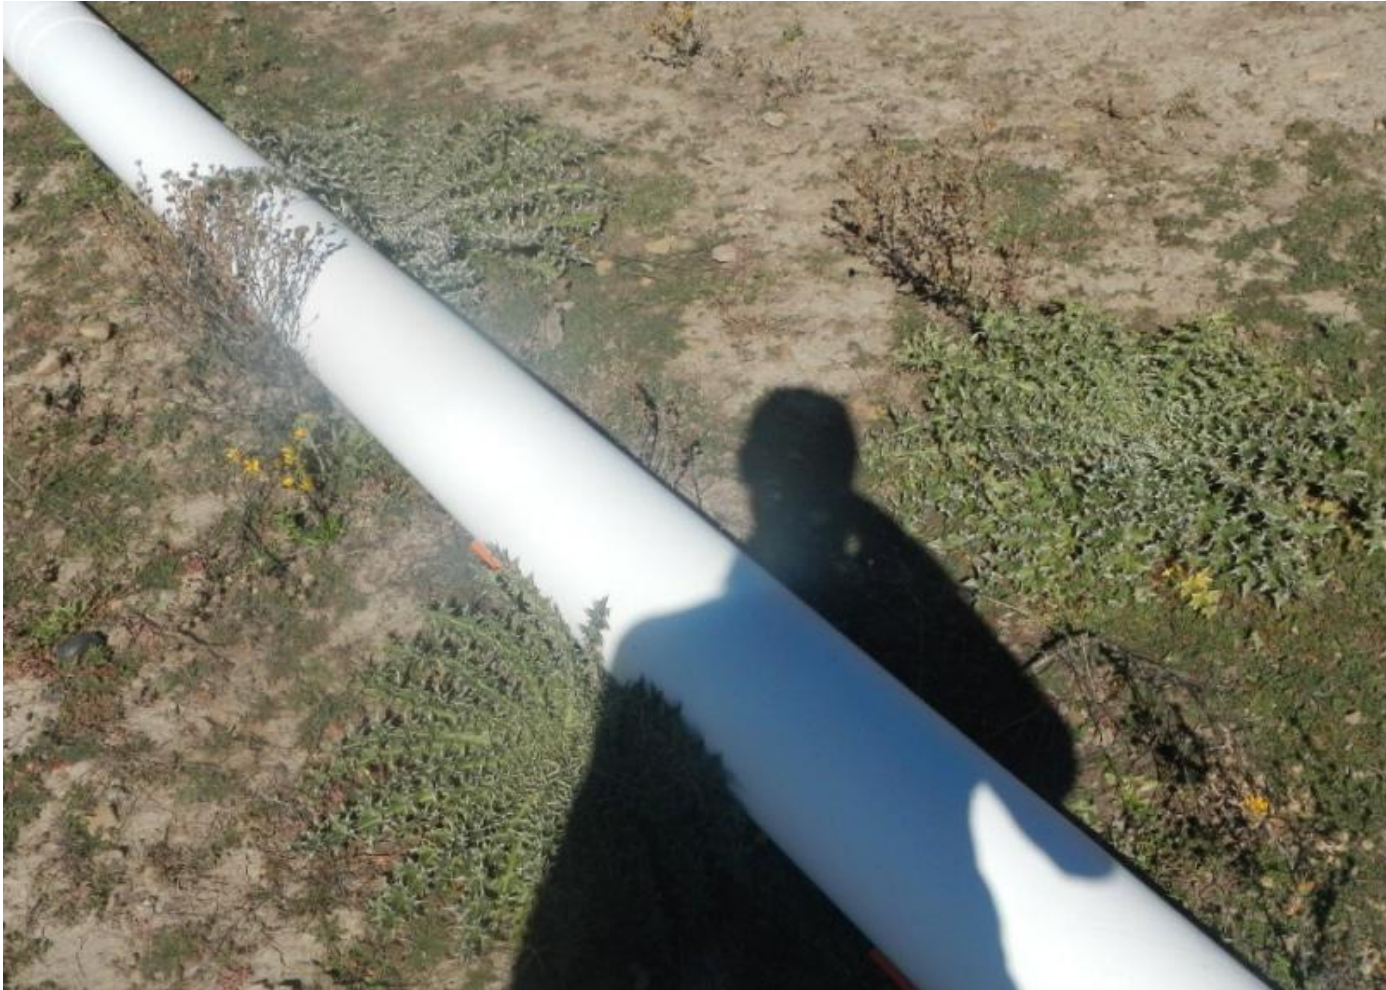
Photo 4. View of musk thistle rosettes within the project area.

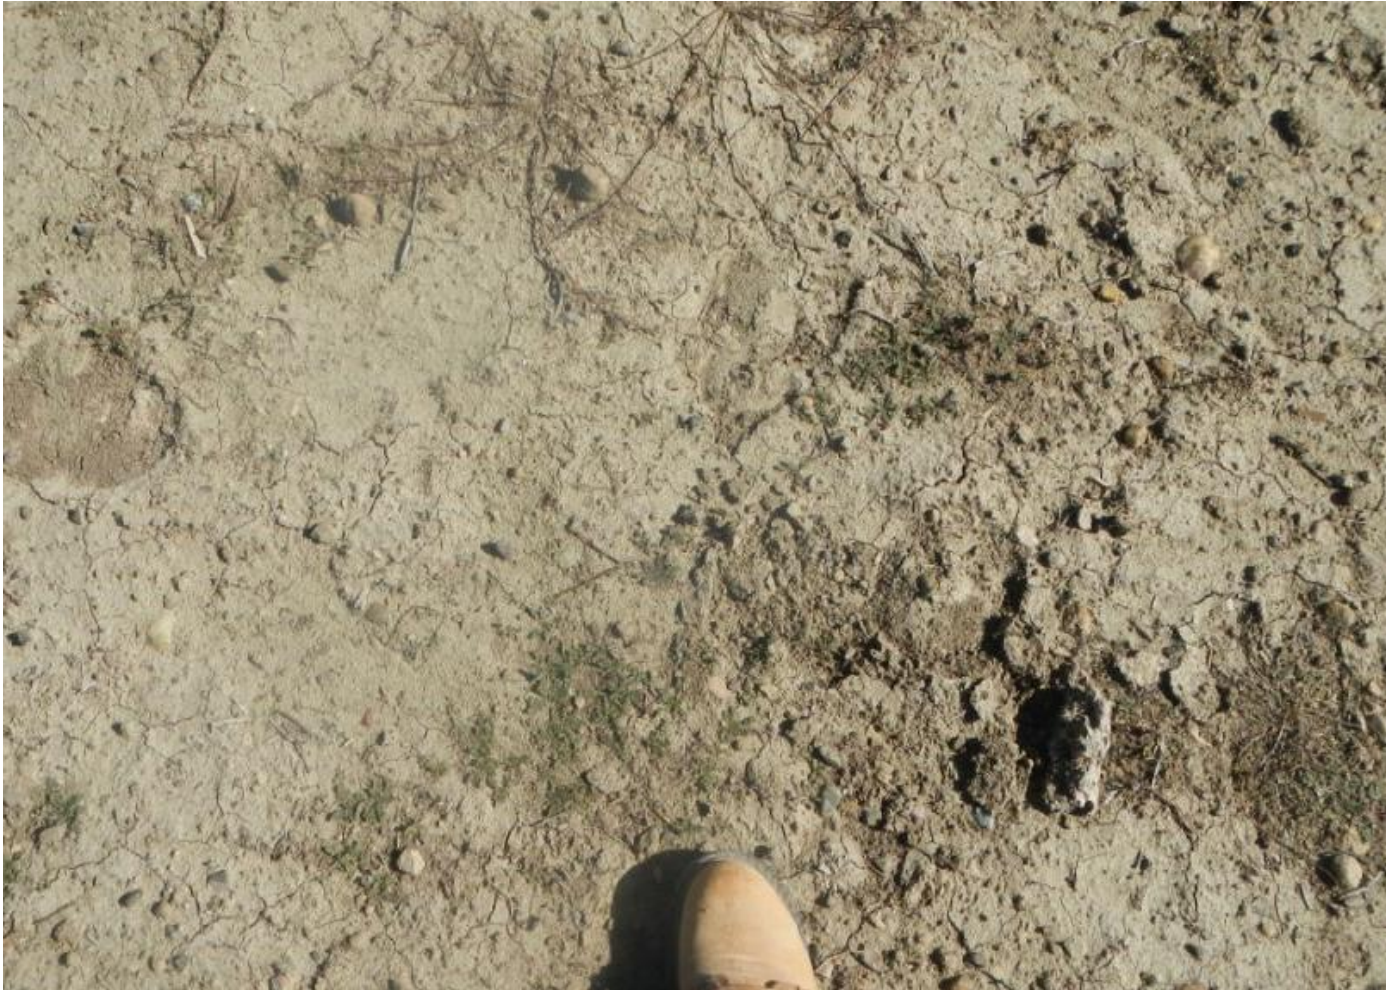
Photo 5. Typical birdseye view of vegetation within the project area. Vegetation here is widely spaced weeds such as knotweed and bindweed (*Convolvulus arvensis*).

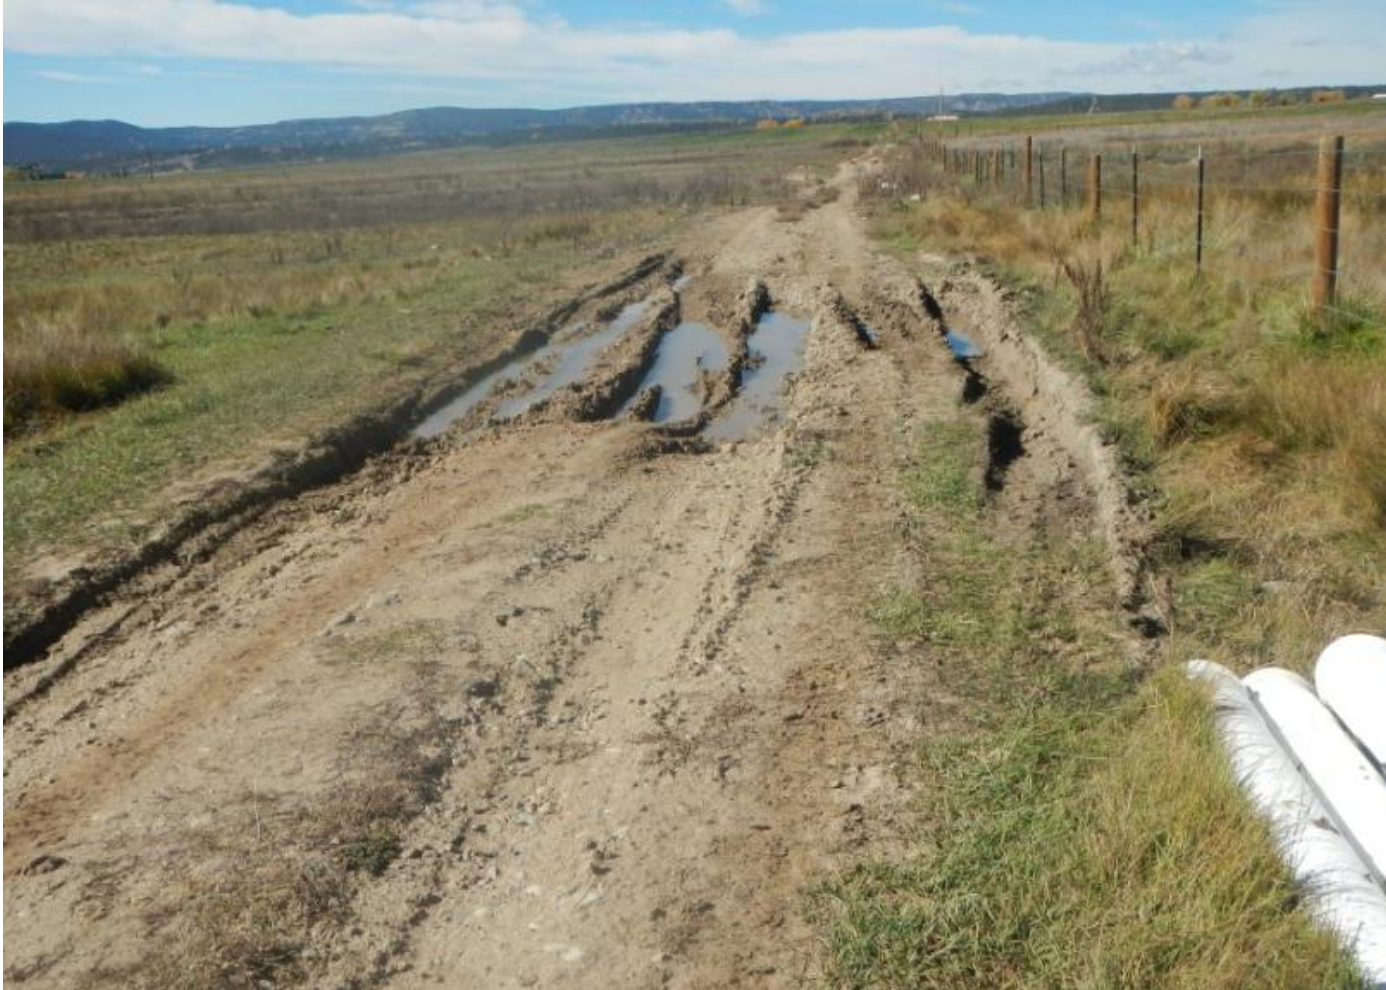
Photo 7. View of ruts (approximately 18 to 20 inches deep) along the access road. It is apparent that vehicles have been driving around to avoid the mud and ruts, as evidenced by tire tracks outside of the driving area.

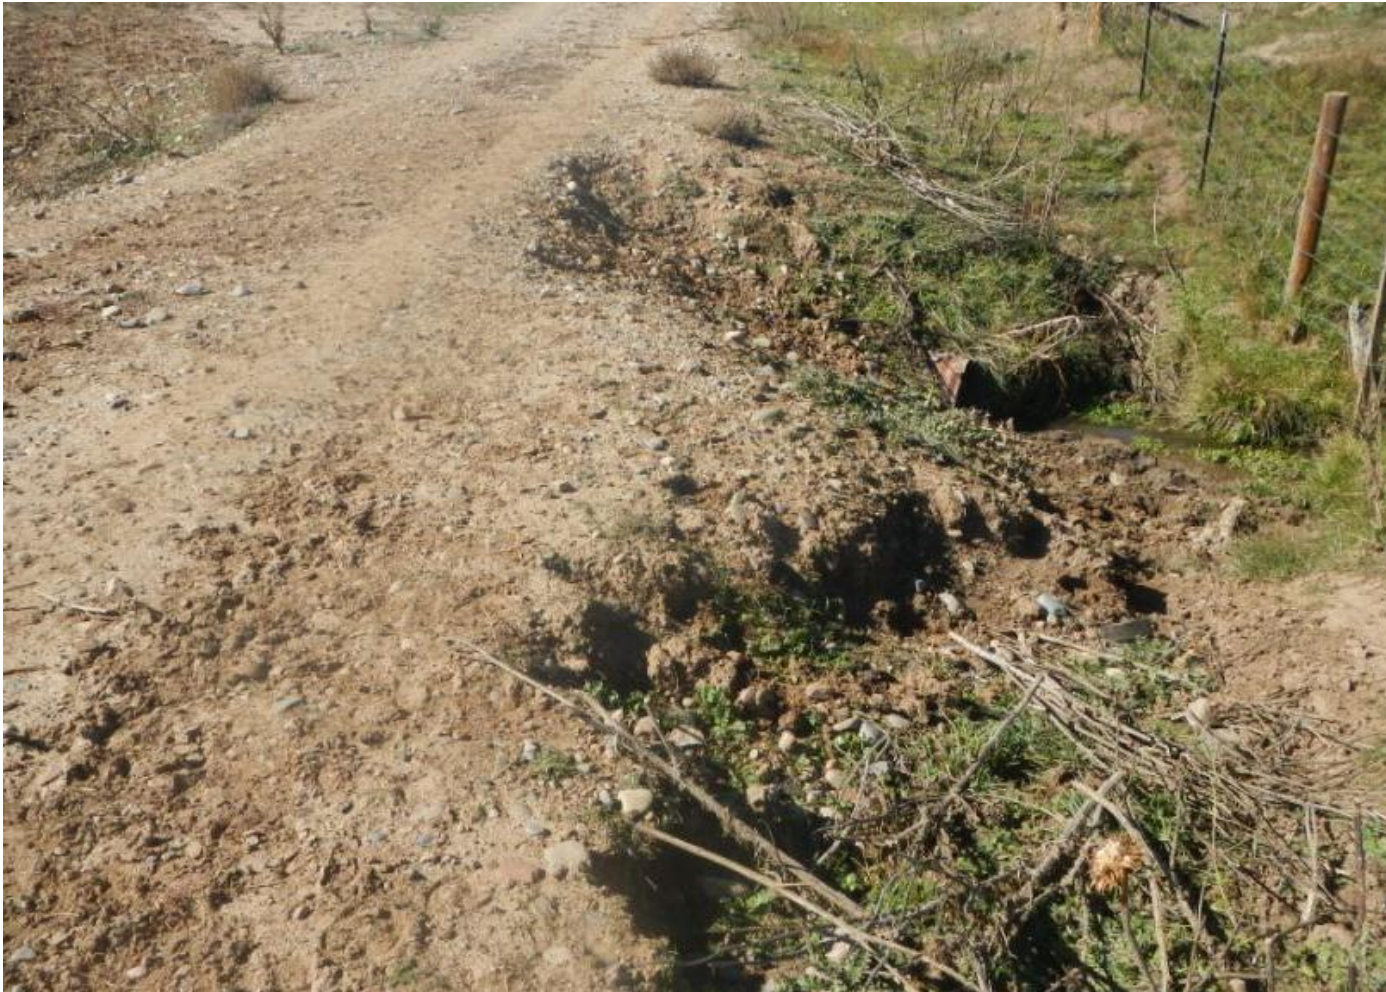
Photo 8. View of erosion occurring around a culvert along the access road.

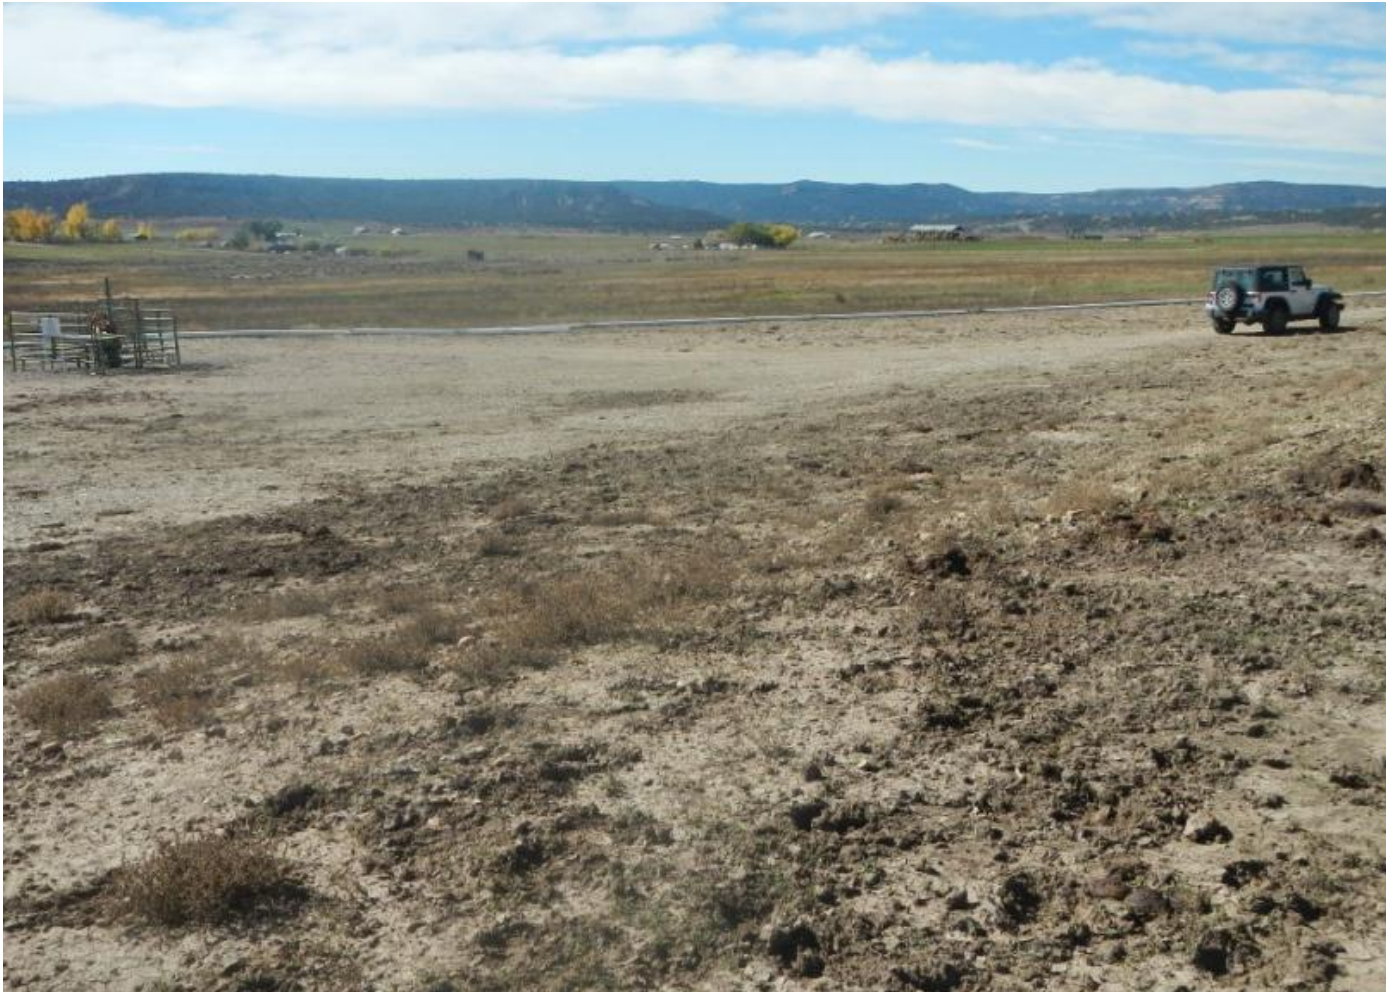
Photo 9. Overview of project area (in fore ground) and adjacent pasture (in background), showing lack of vegetation within the project area. From northern edge facing southwestward.
