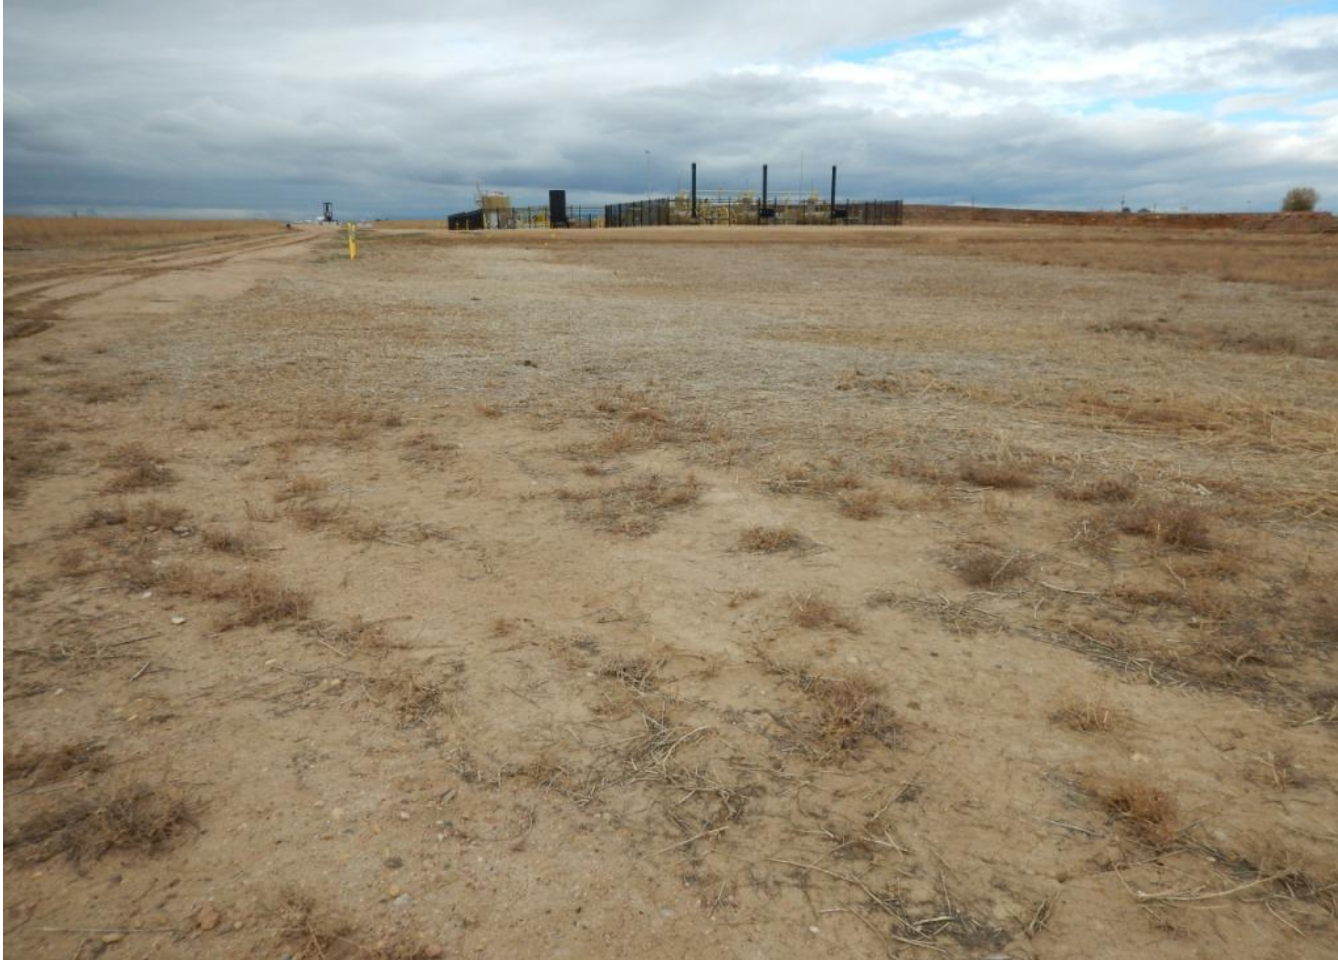
Photo 2. Photo taken from southeast location, facing West. Need to reclaim and minimize areas where production or facilities are no longer necessary.

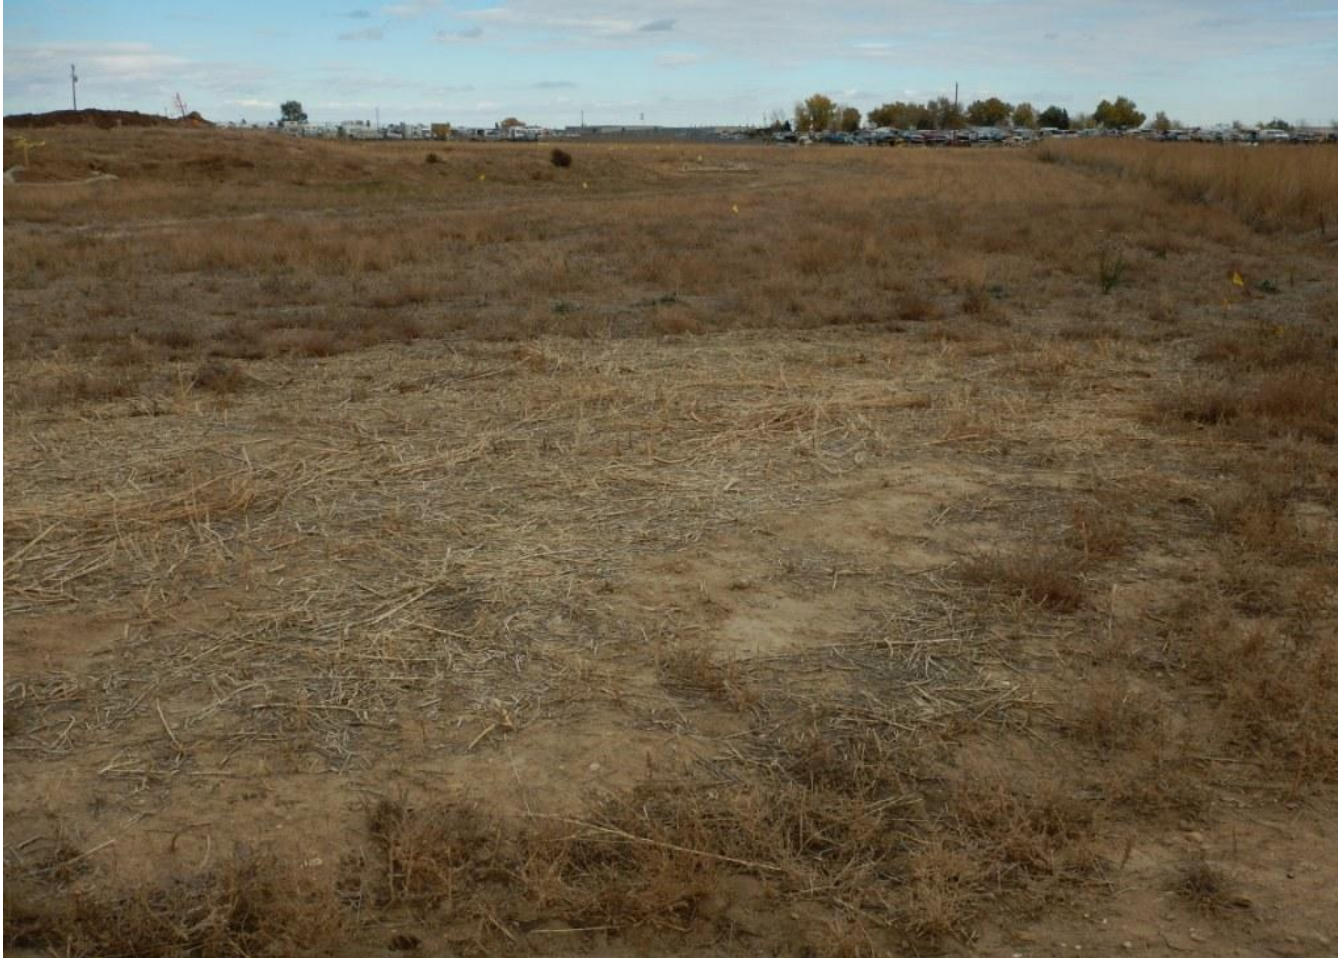
Photo 3. Photo taken from southeast location, facing North. Need to reclaim and minimize areas where production or facilities are no longer necessary.

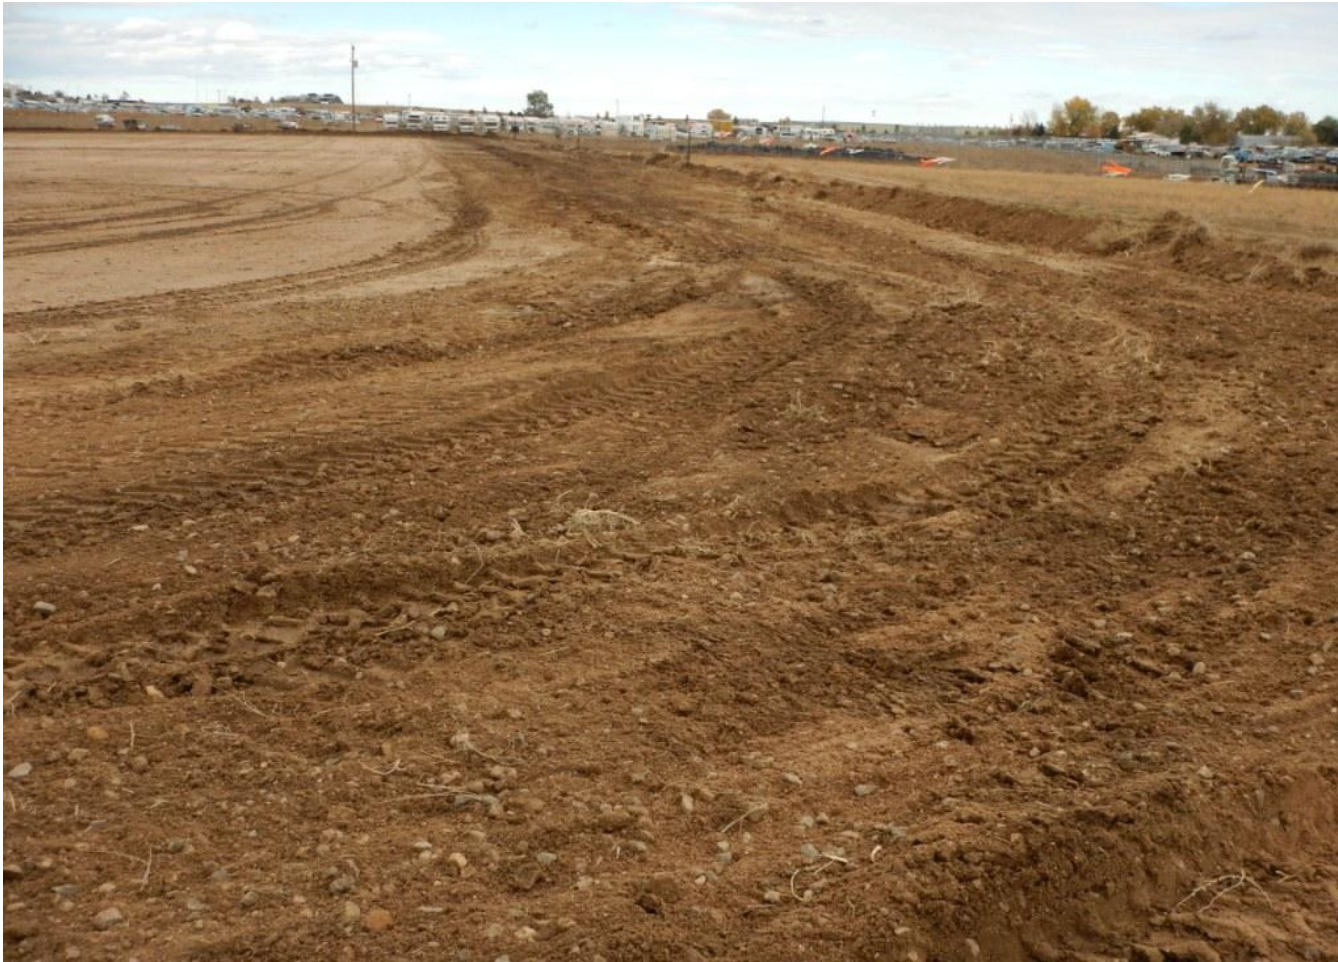
Photo 4. Photo taken from southeast corner of well pad, facing North. Need to reclaim and minimize areas where production or facilities are no longer necessary.

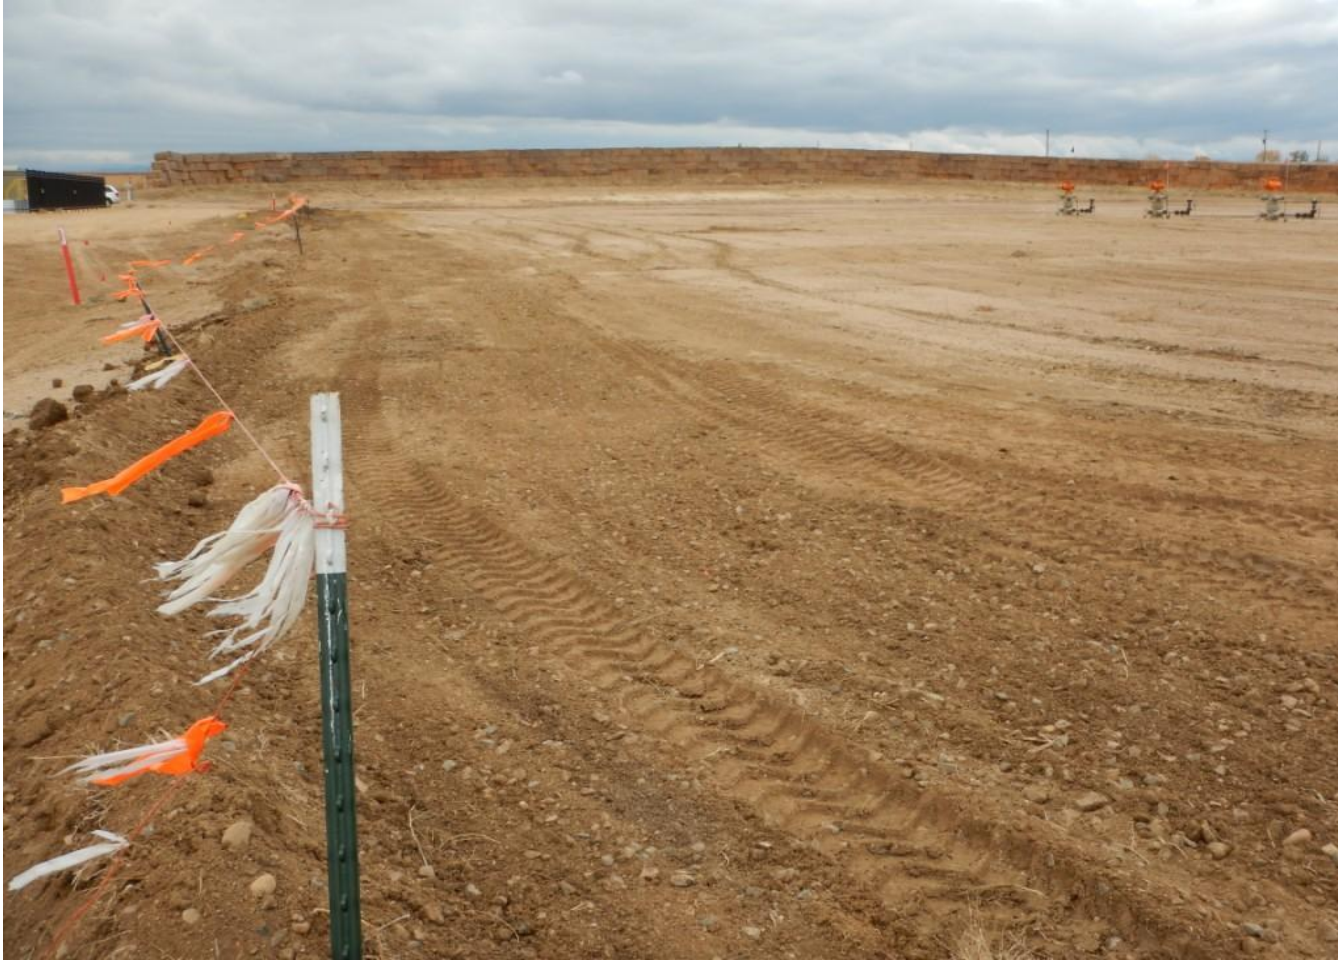
Photo 5. Photo taken from southeast corner of well pad, facing West. Need to reclaim and minimize areas where production or facilities are no longer necessary.

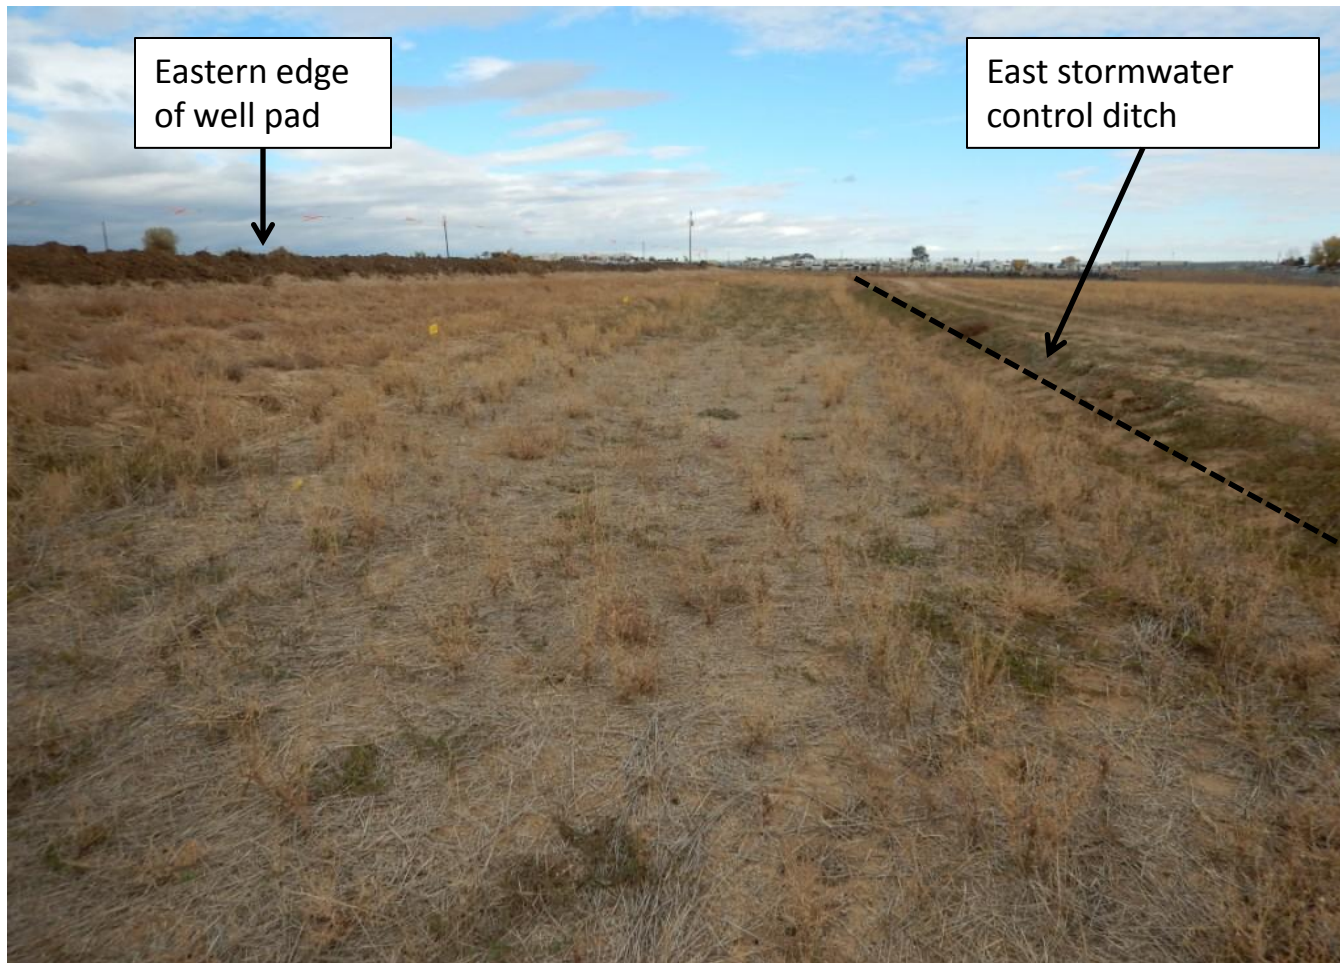
Photo 6. Photo taken from east location, facing North. Need to reclaim and minimize areas where production or facilities are no longer necessary.

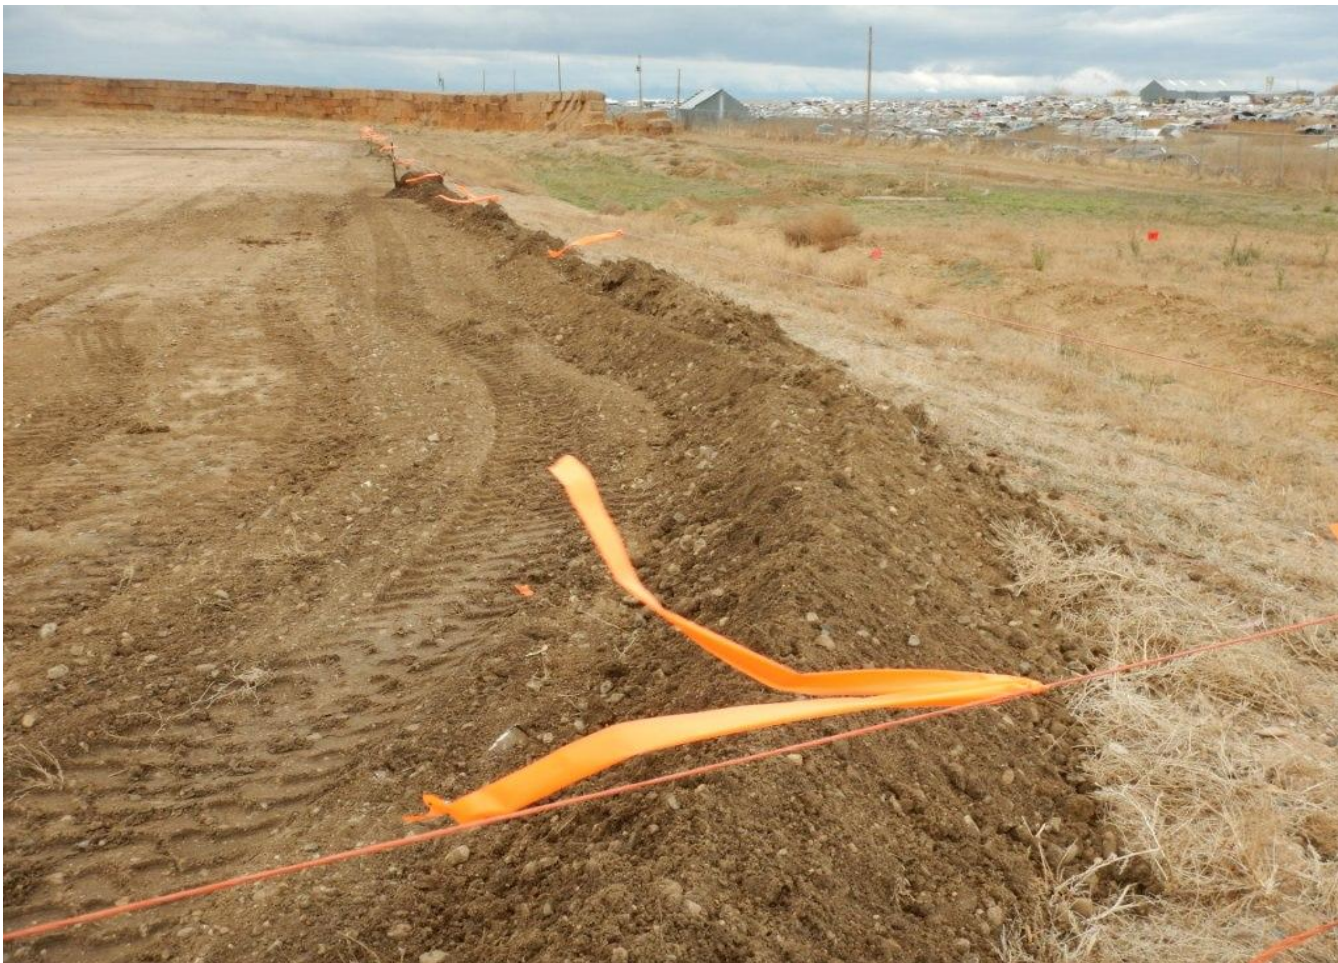
Photo 7. Photo taken from northeast corner of well pad, facing West. Need to reclaim and minimize areas where production or facilities are no longer necessary.

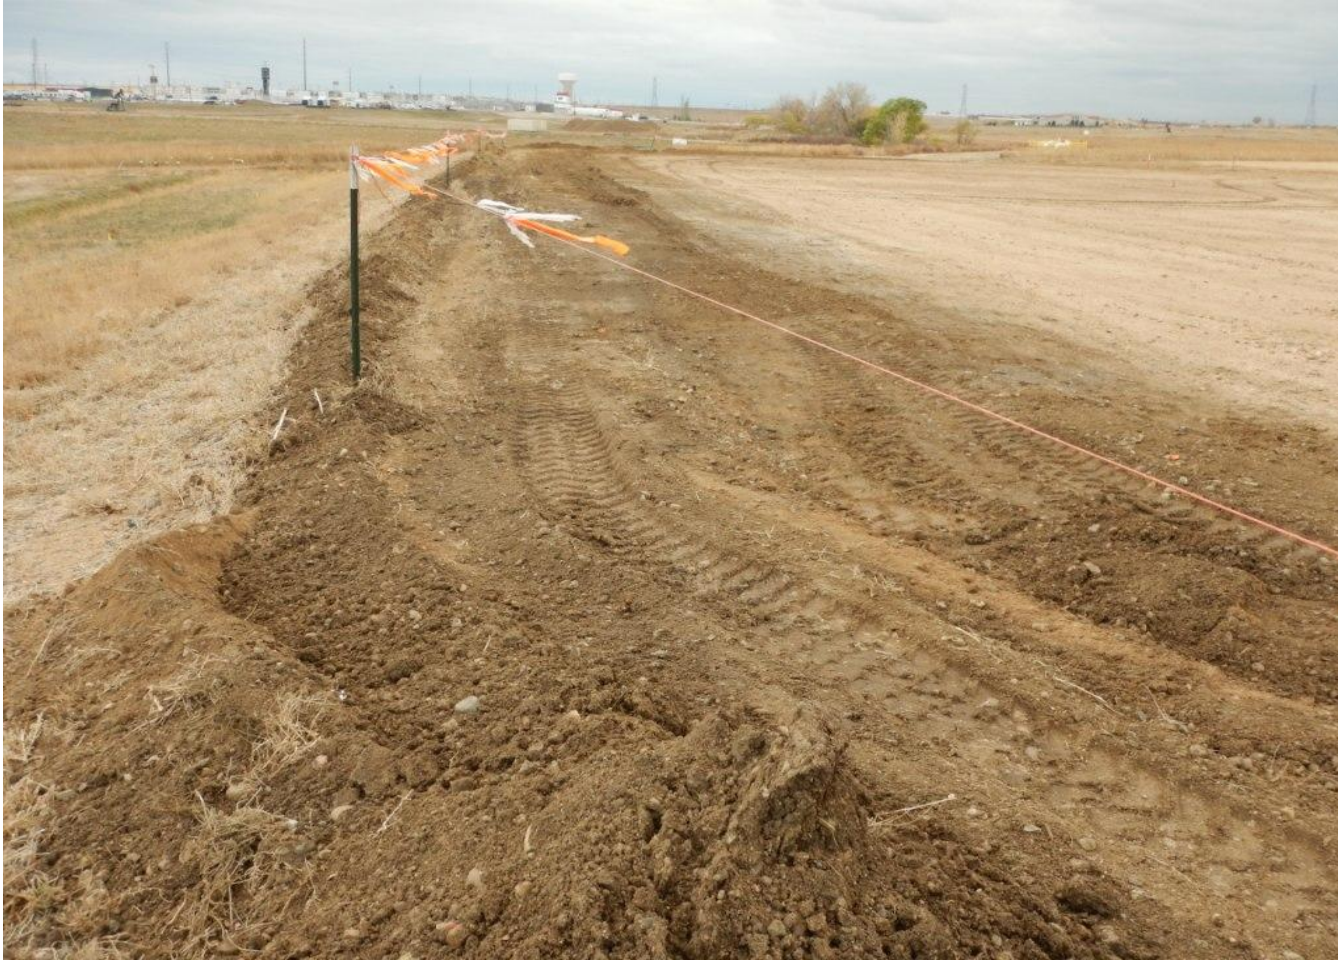
Photo 8. Photo taken from northeast corner of well pad, facing South. Need to reclaim and minimize areas where production or facilities are no longer necessary.

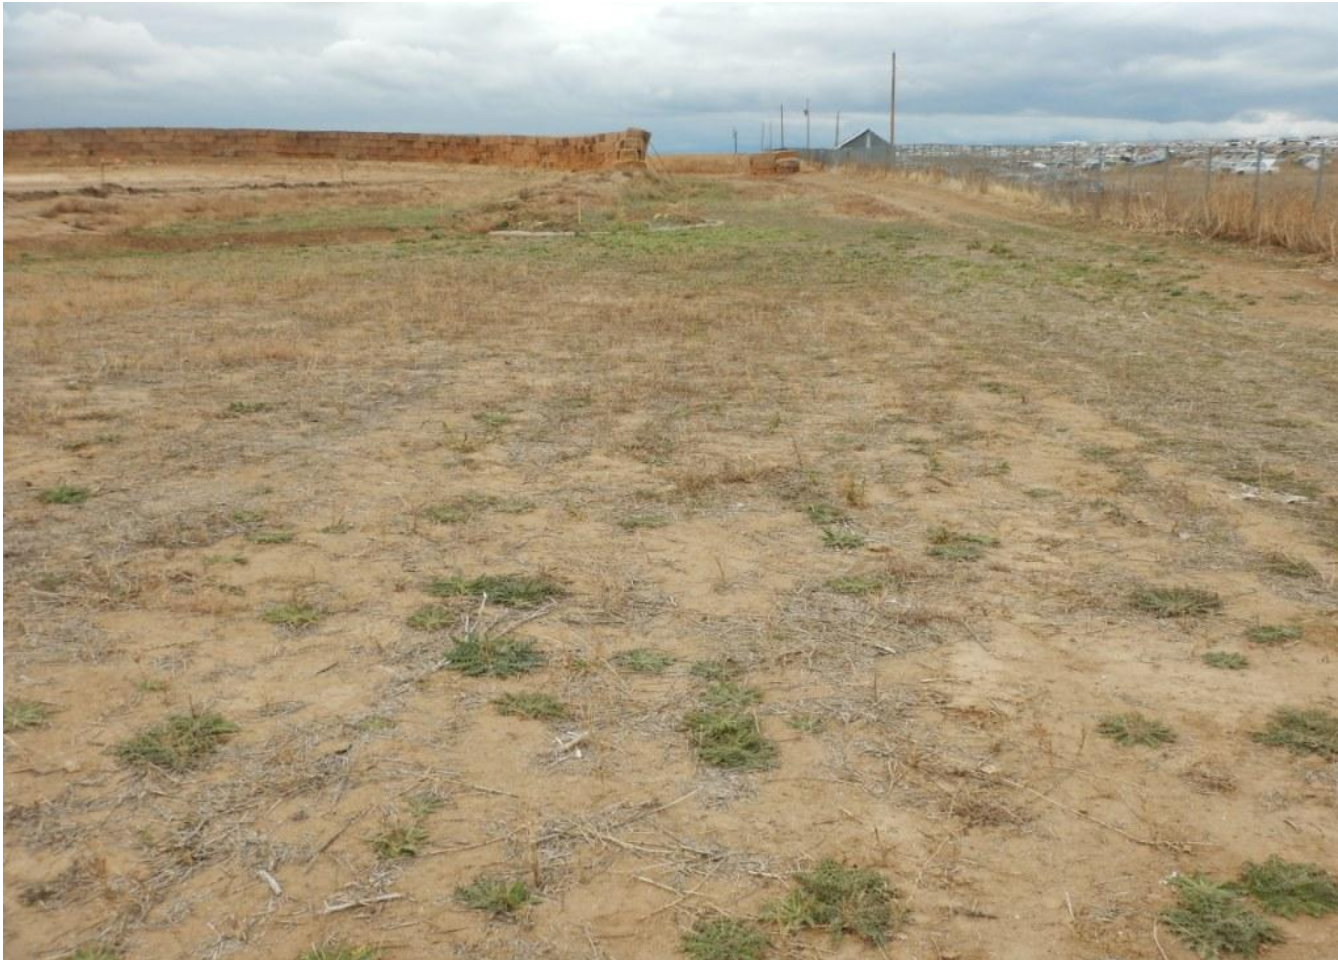
Photo 9. Photo taken from northeast location, facing West. Need to reclaim and minimize areas where production or facilities are no longer necessary.

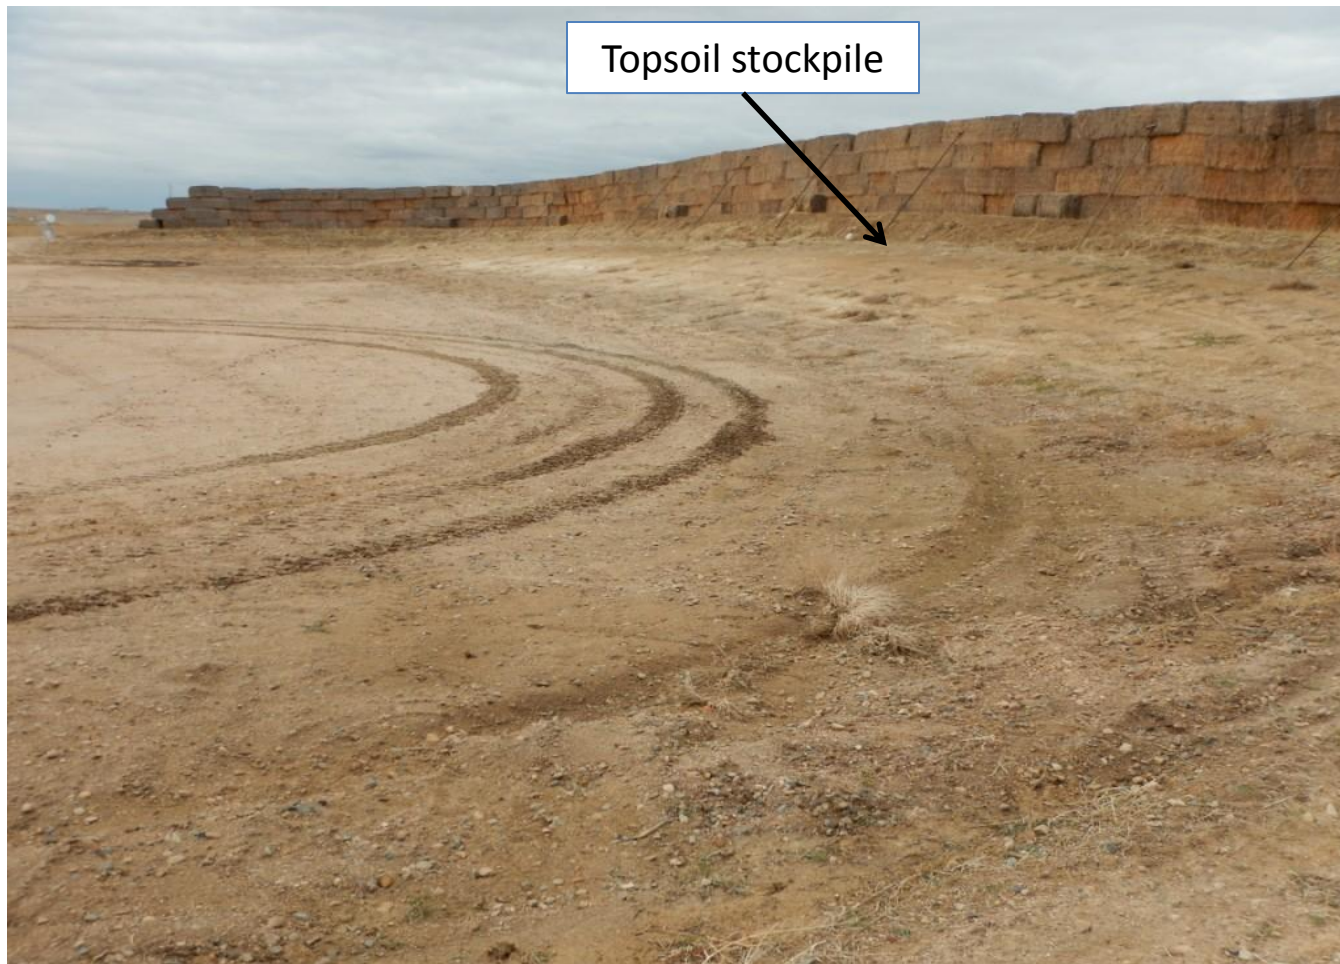
Photo 10. Photo taken from northwest corner of well pad, facing South. Perennial vegetation is required for topsoil stabilization. Need to reclaim and minimize areas where production or facilities are no longer necessary.

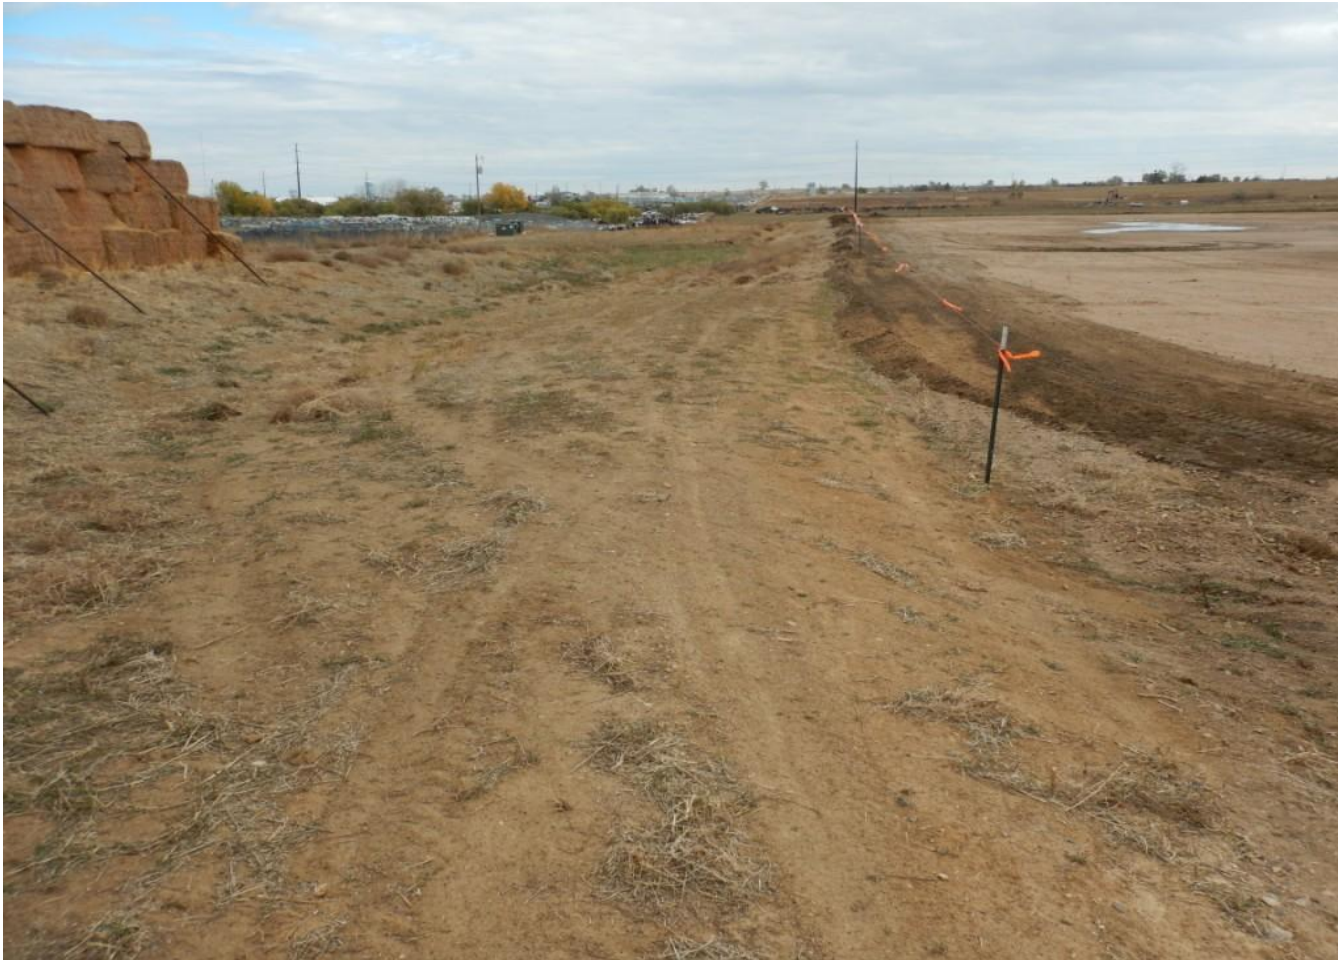
Photo 11. Photo taken from northwest corner of well pad, facing East. Need to reclaim and minimize areas where production or facilities are no longer necessary.

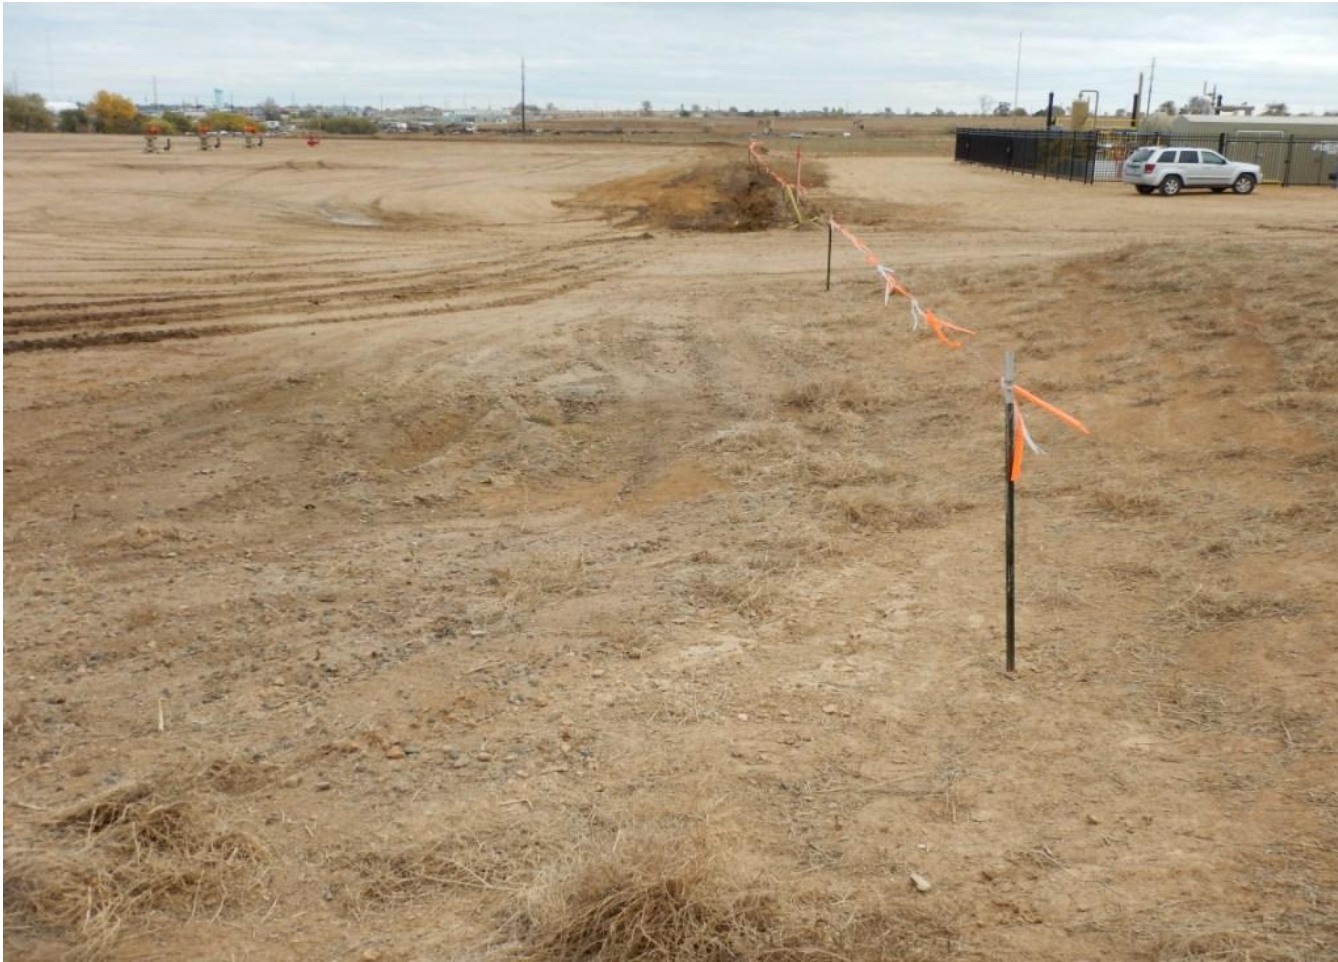
Photo 12. Photo taken from southwest corner of well pad, facing East. Need to reclaim and minimize areas where production or facilities are no longer necessary.

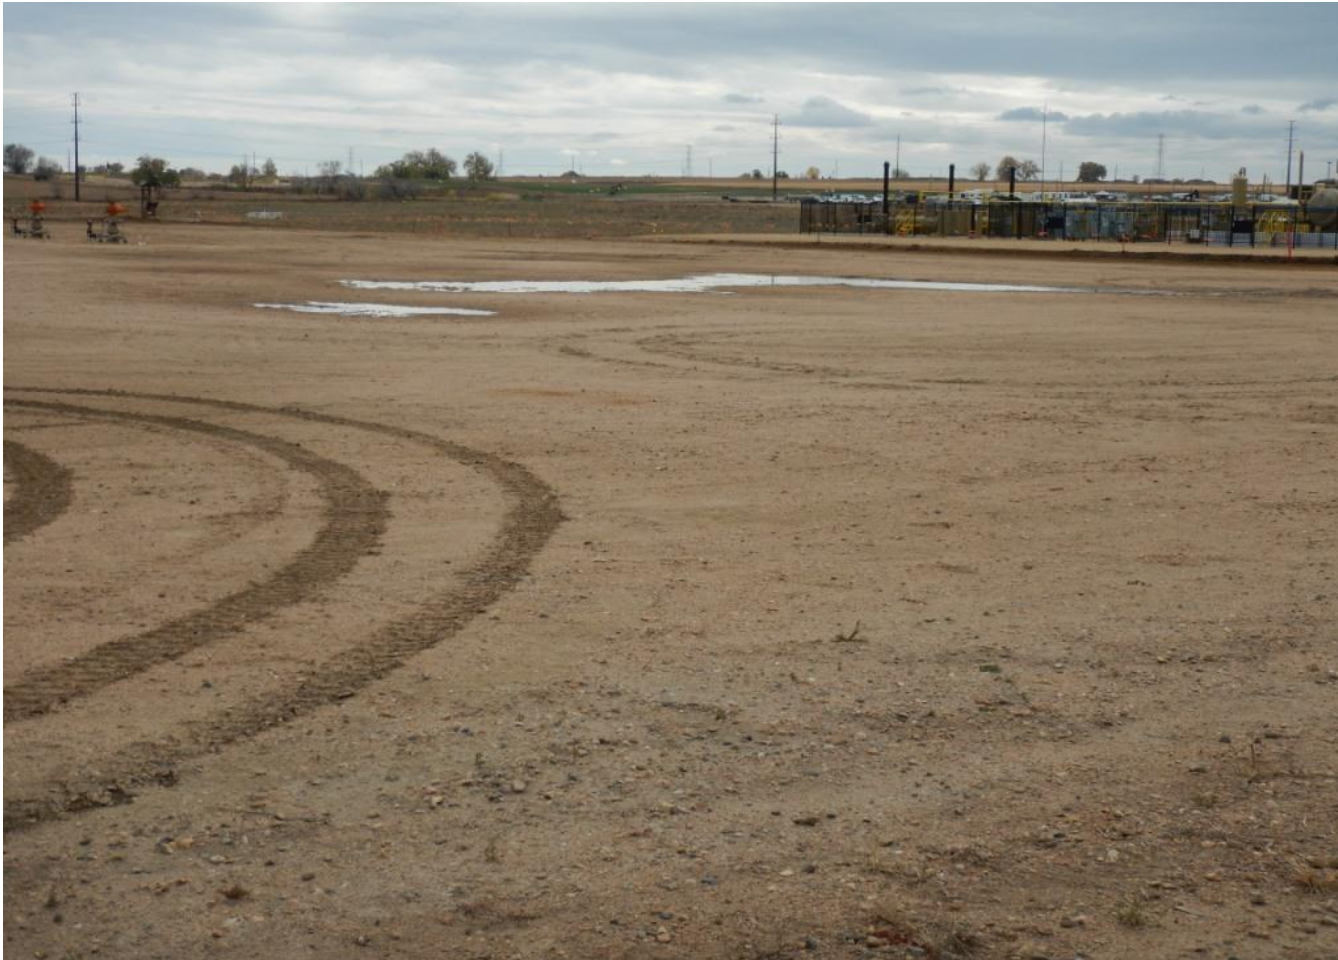
Photo 13. Photo taken from northwest corner of well pad, facing Southeast. Note the pooling of water in central well pad area.

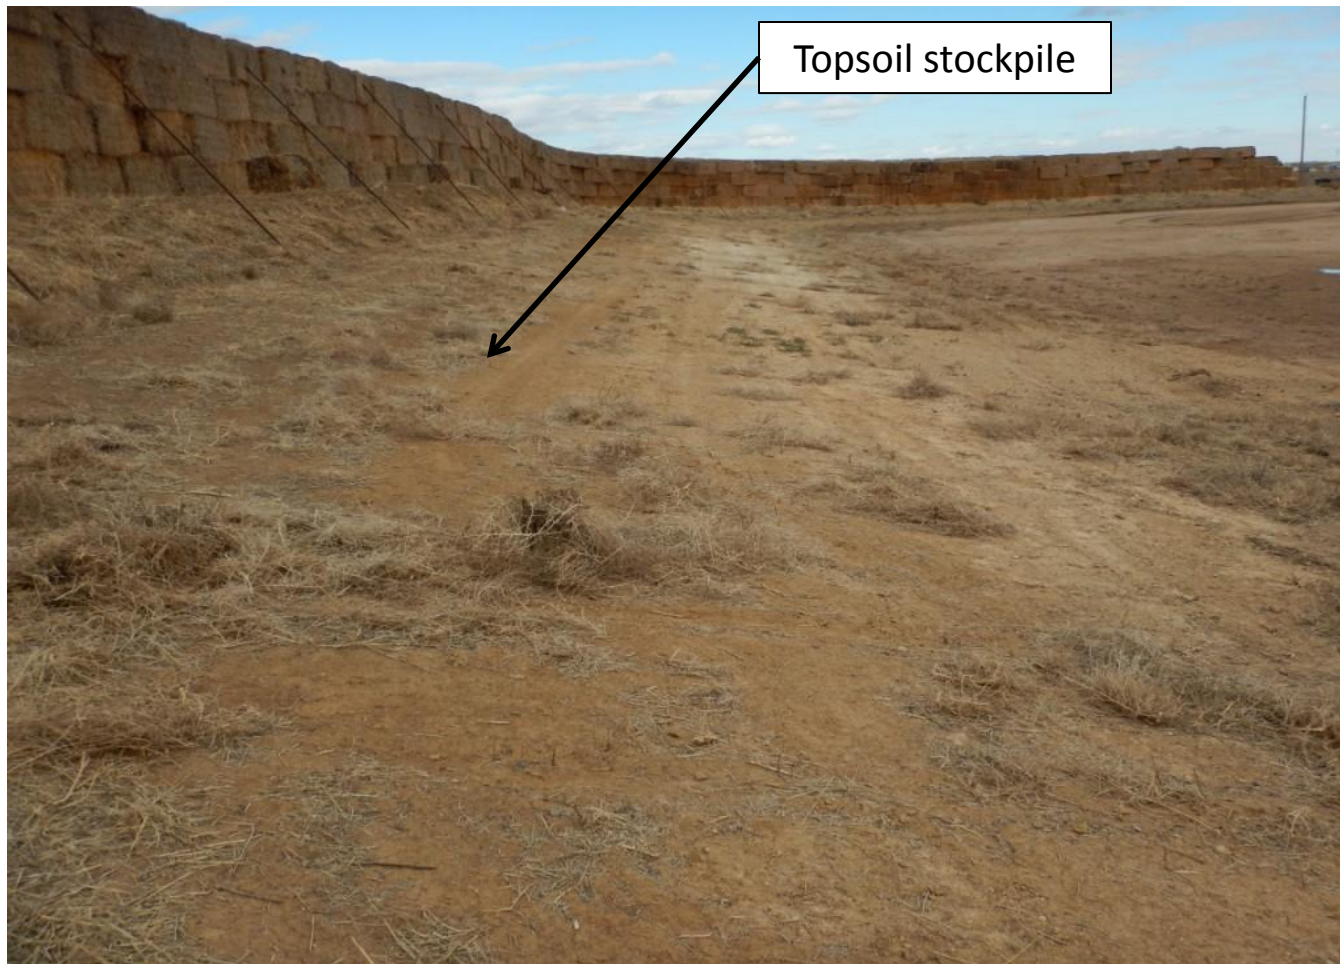
Photo 14. Photo taken from southwest corner of well pad, facing North. Perennial vegetation needs to be seeded on all berms and topsoil stockpiles. Topsoil stockpile lacks vegetative growth and cover at time of this current inspection.

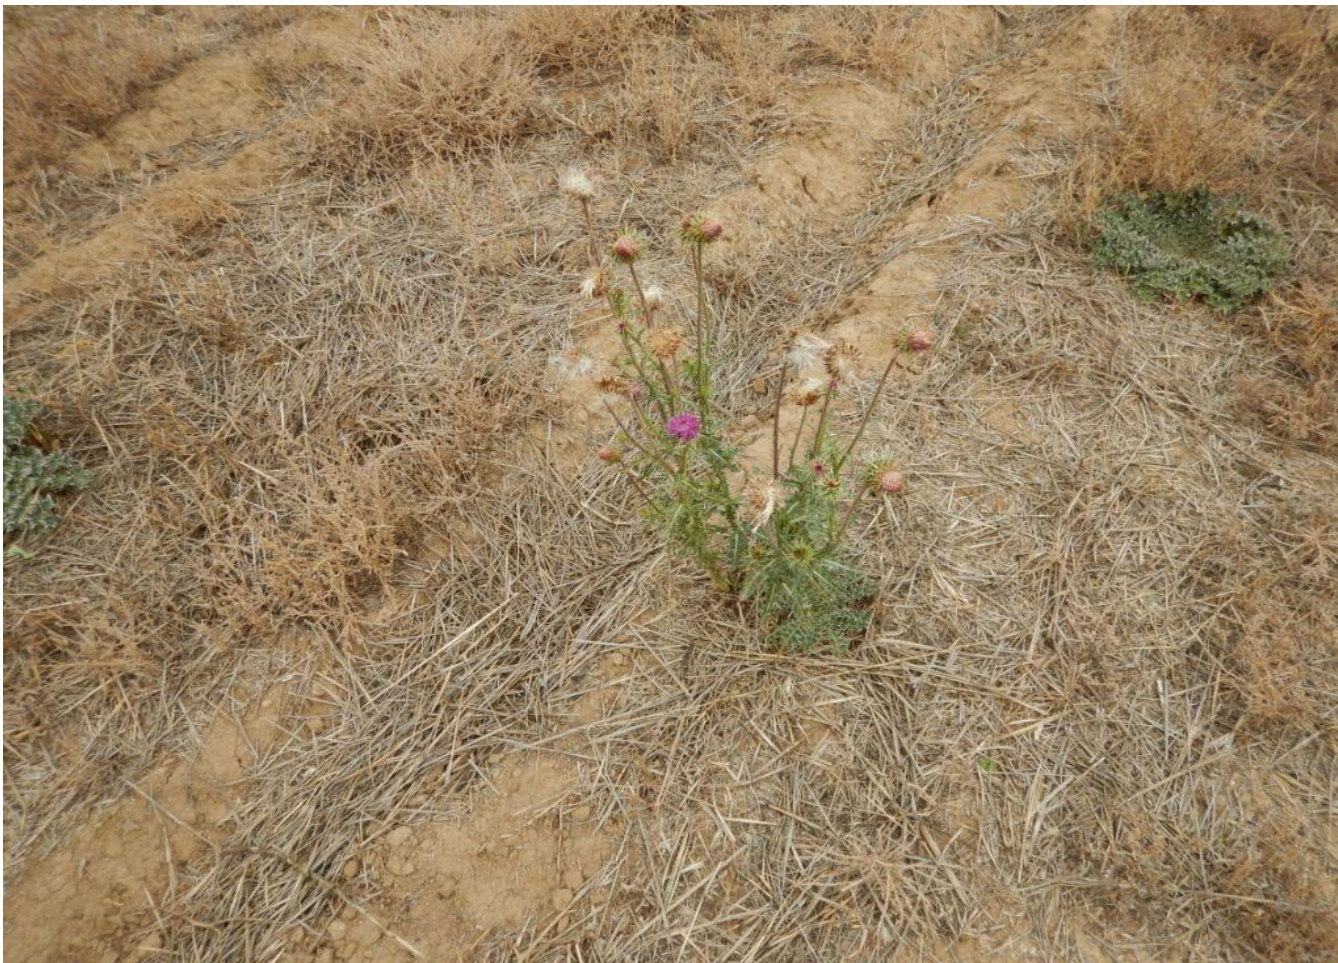
Photo 15. Musk thistle (*Carduus nutans*) observed throughout location. Weed maintenance is needed.

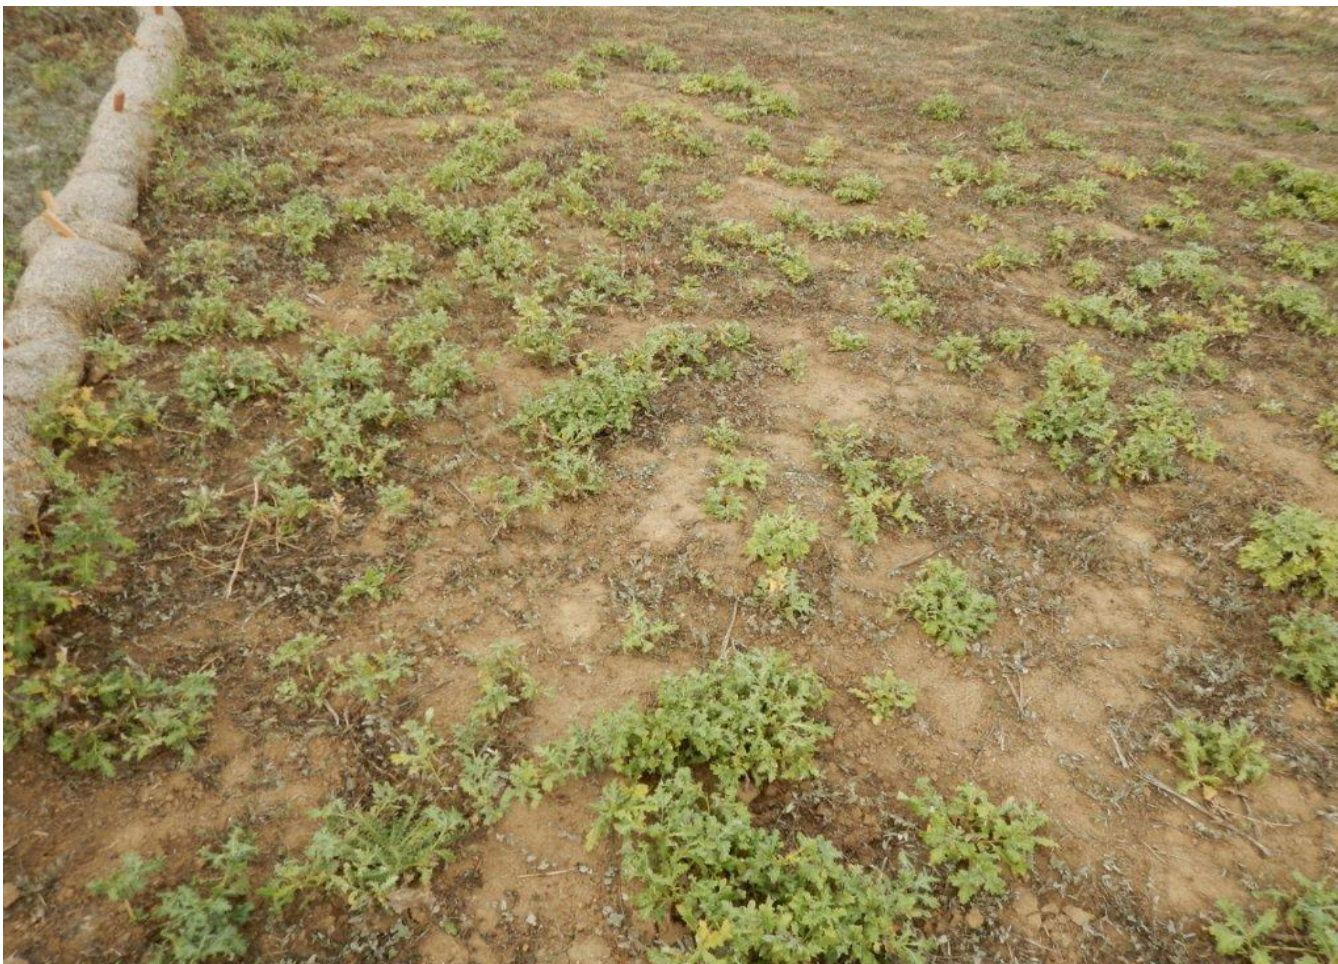
Photo 16. Canada thistle (*Cirsium arvense*) observed throughout location. Weed maintenance is needed.

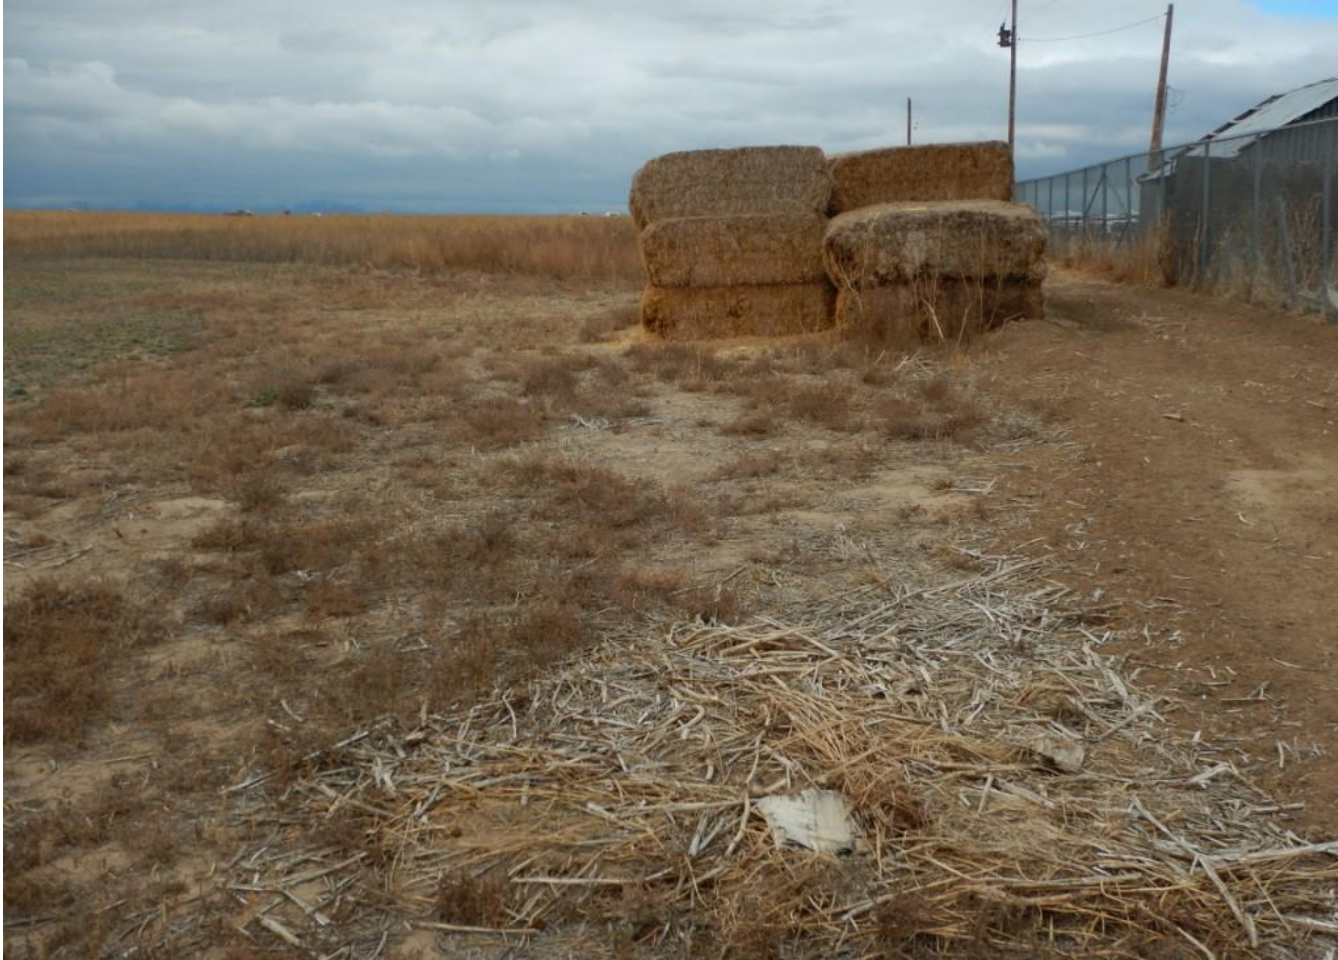
Photo 17. Photo taken from northwest location. Debris leftover needs to be removed.

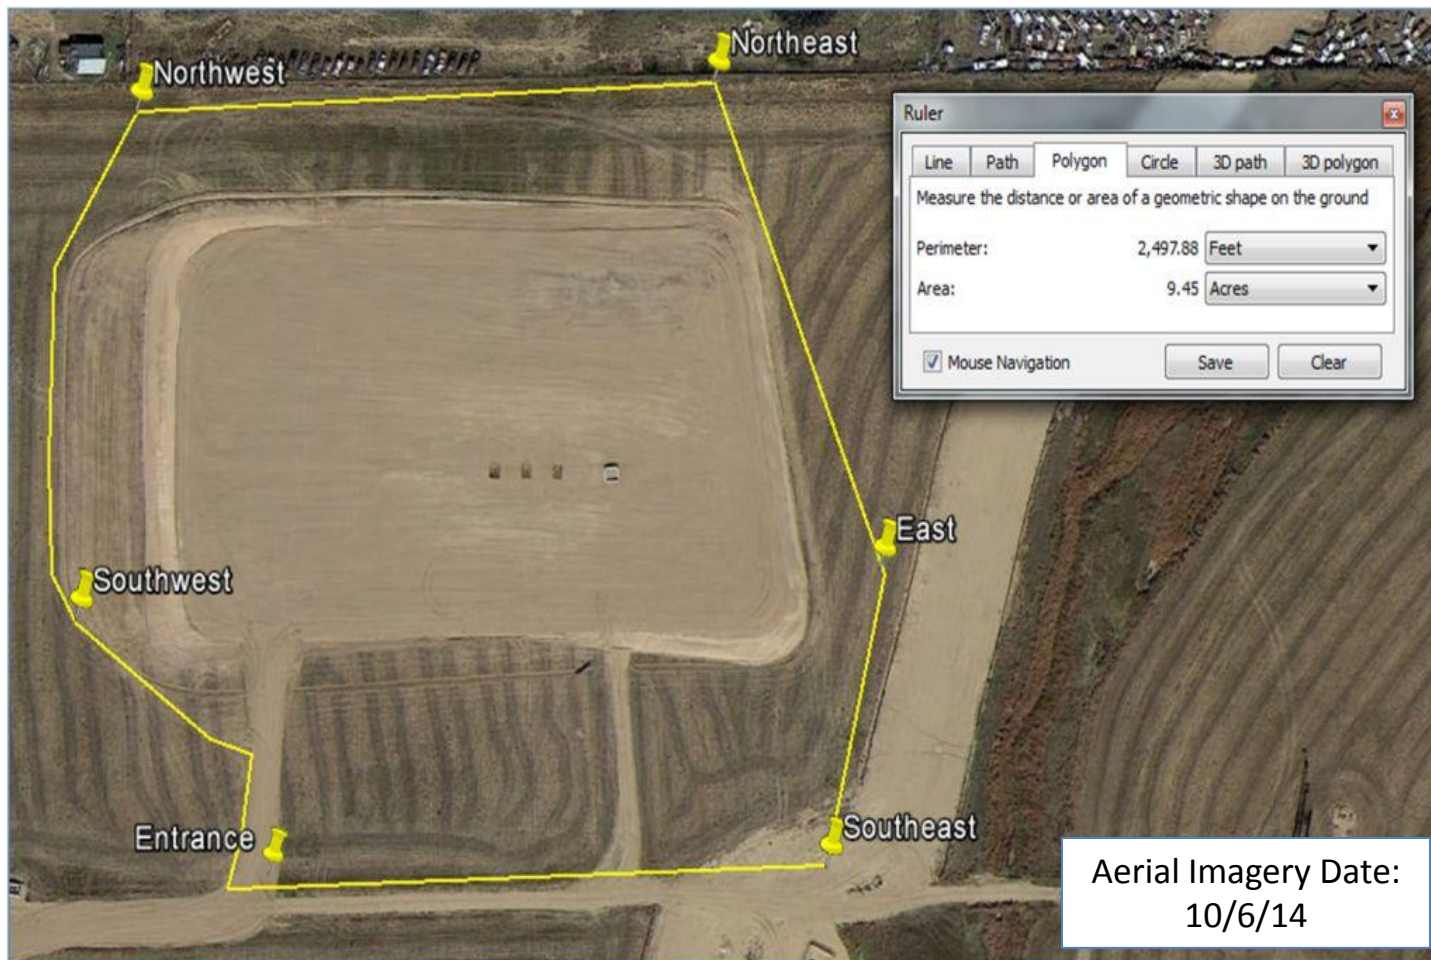
Photo 18. The perimeter, in yellow, illustrates the disturbance boundary as of 10/30/15. Total disturbance equals 9.45 acres.
