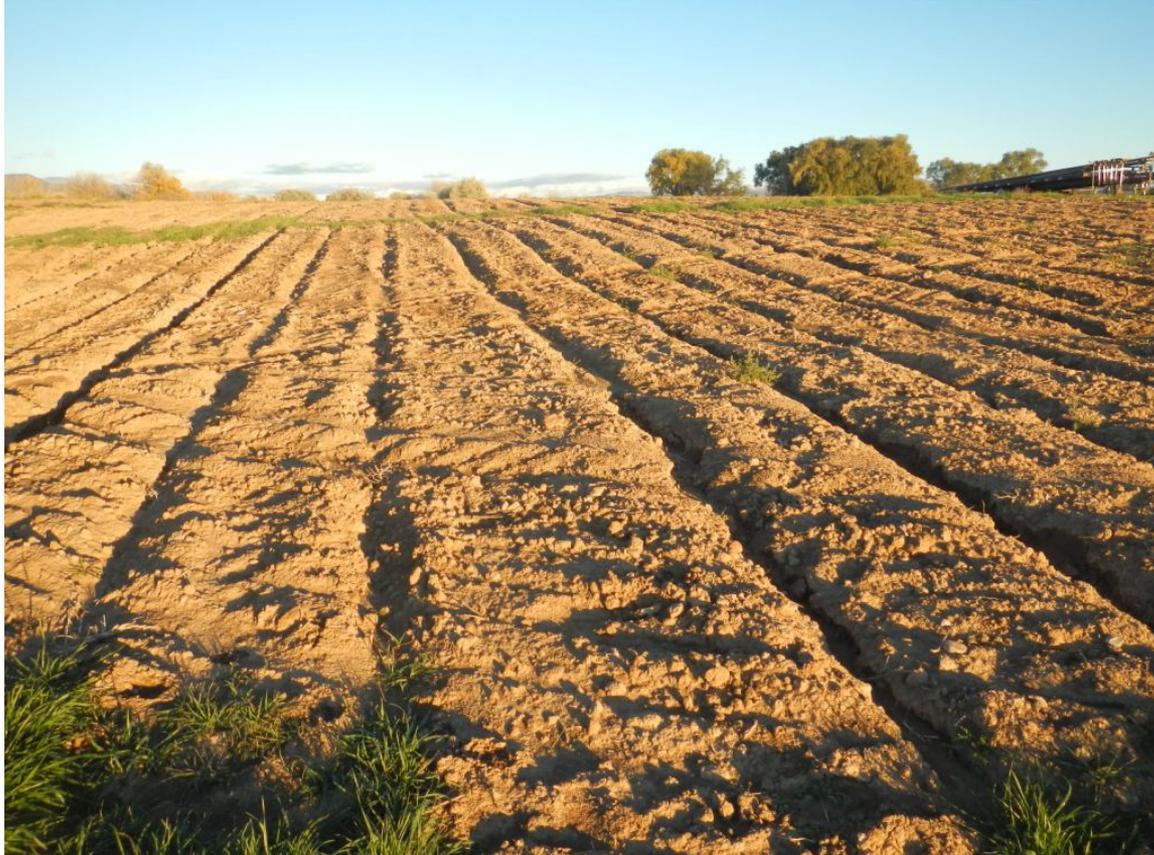
Photo#1: Irrigation furrows for Gated Pipe system running from East to West where they meet edge of Location

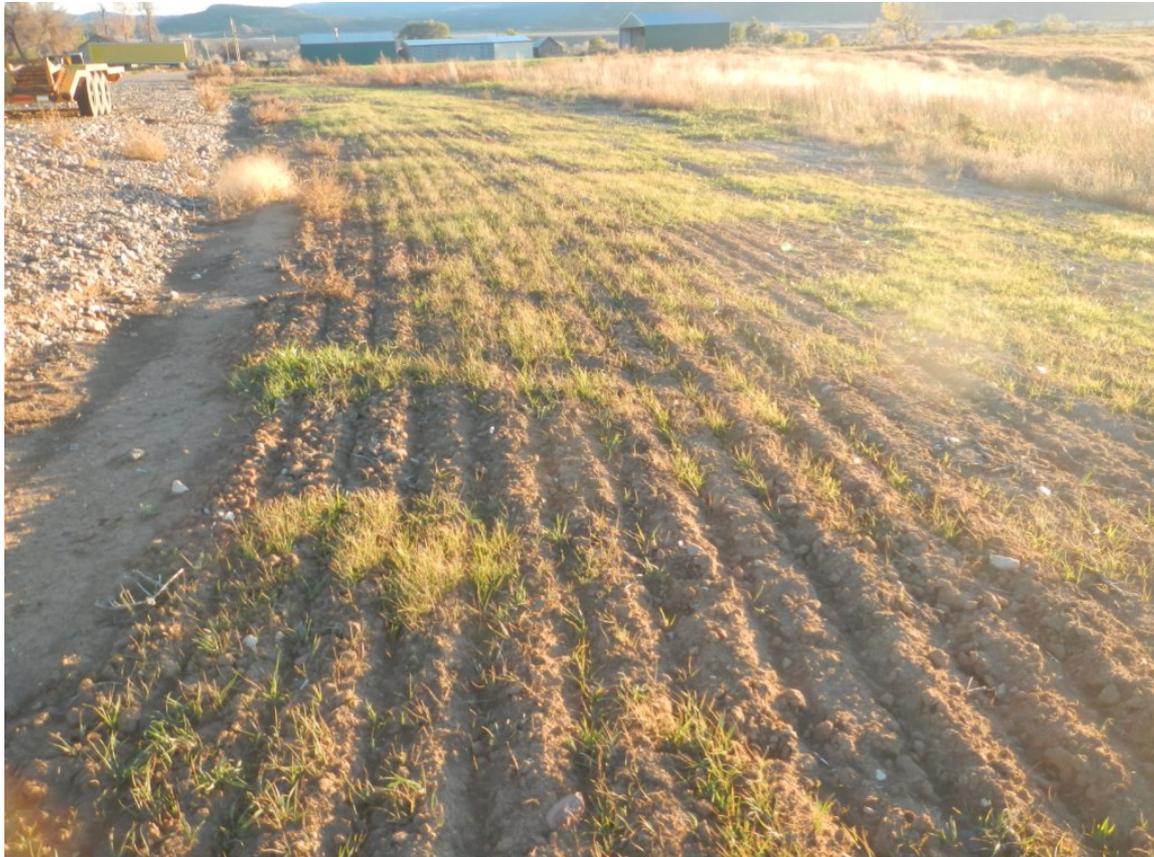
Photo#2: Stabilized area West of access road..

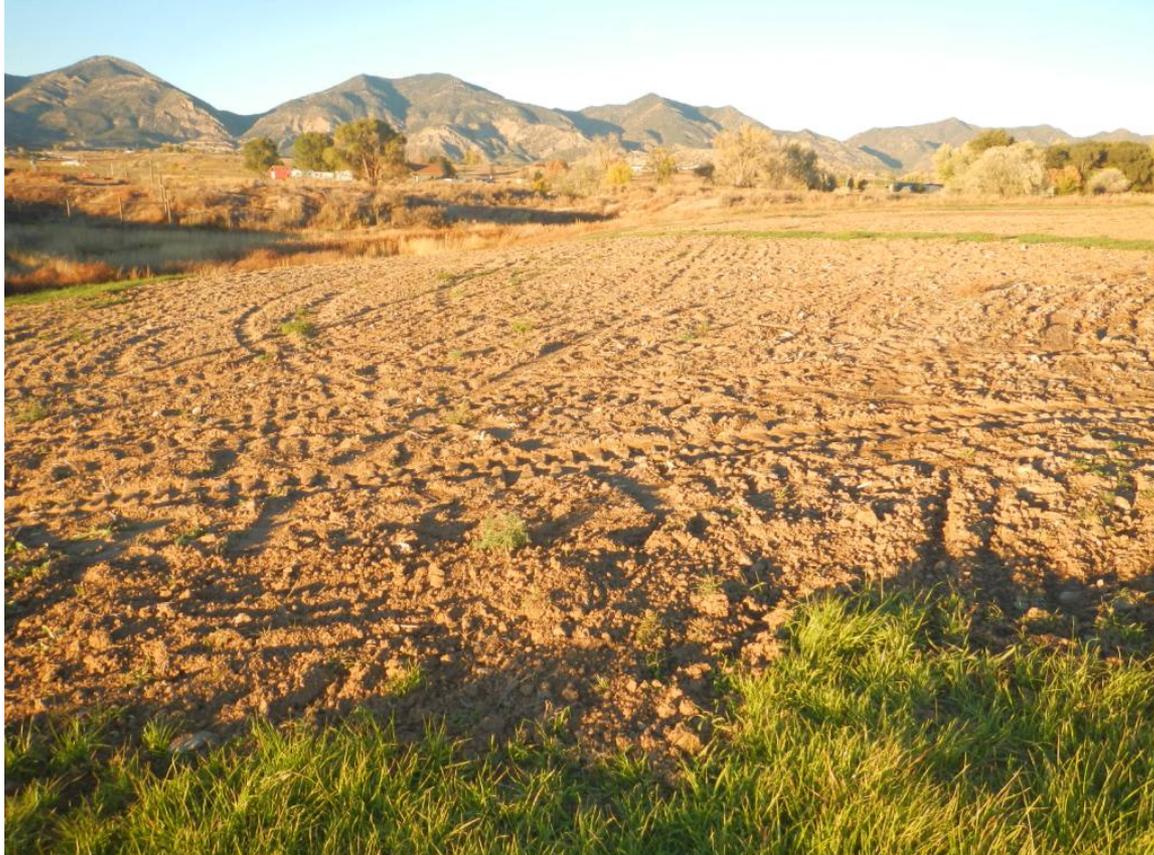
Photo#3: End of Irrigated Field surrounding Location on NE border.

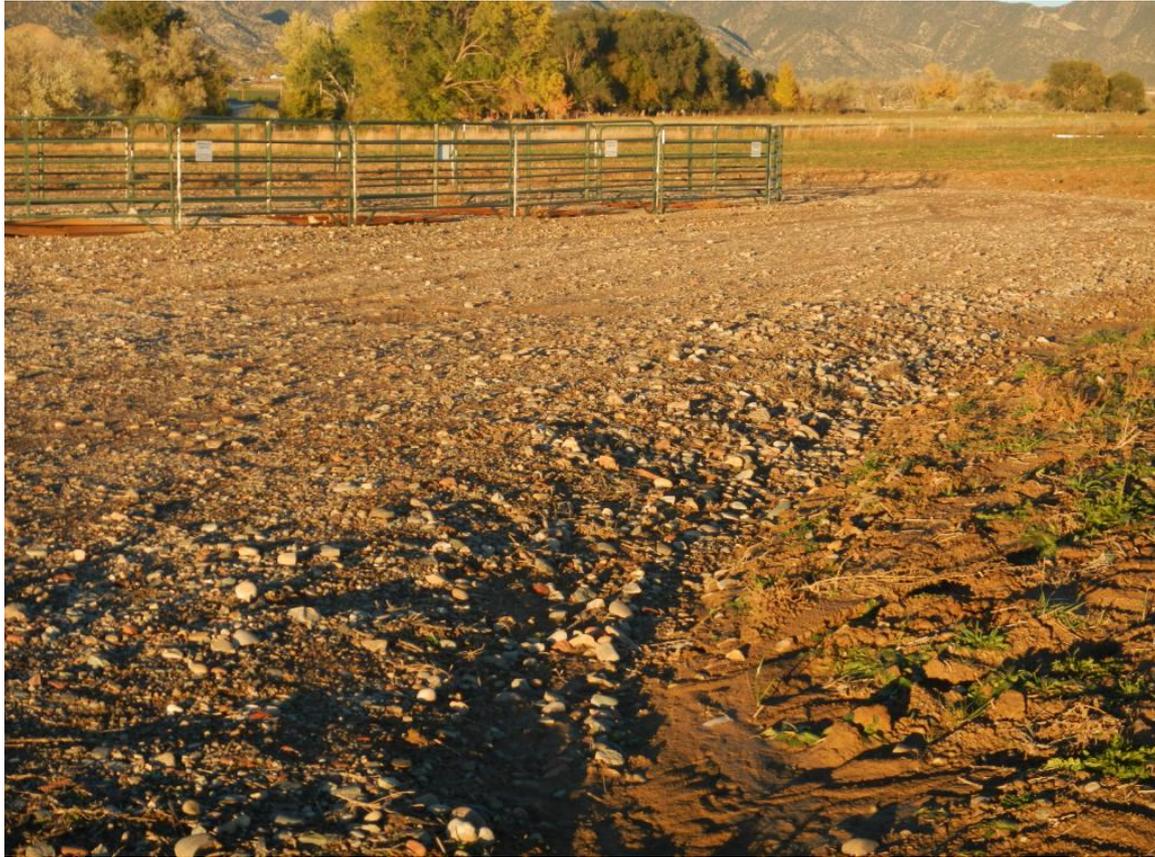
Photo#4: Point where Irrigation furrows meet Location Access road & drainage ditch
