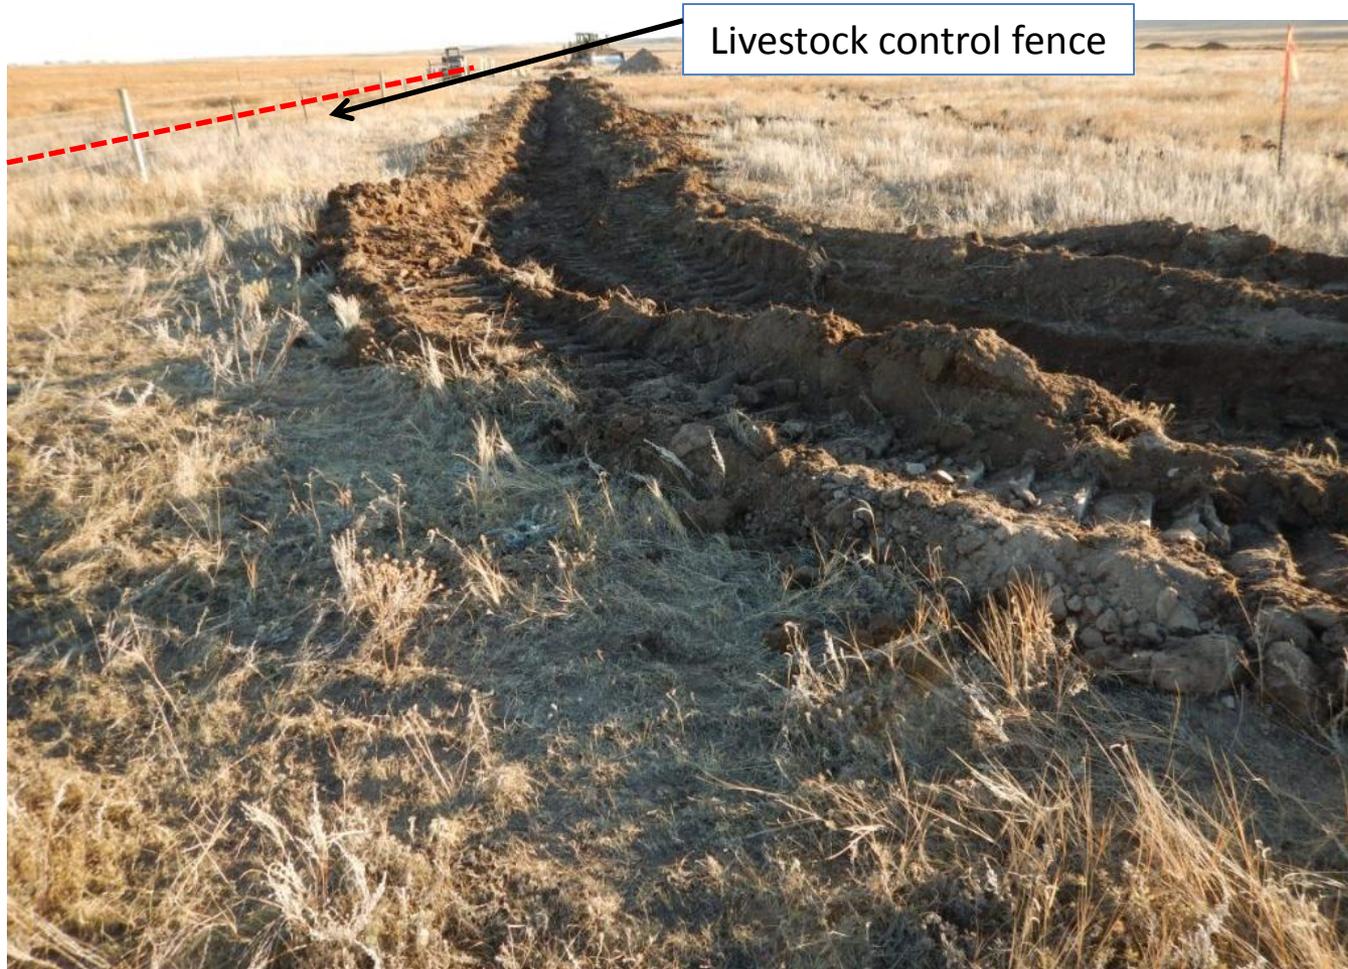
Photo 1. Photo taken from northeast location, facing South. Stormwater control ditch in center of photo. Livestock (cattle) control fence installed around perimeter of disturbance.

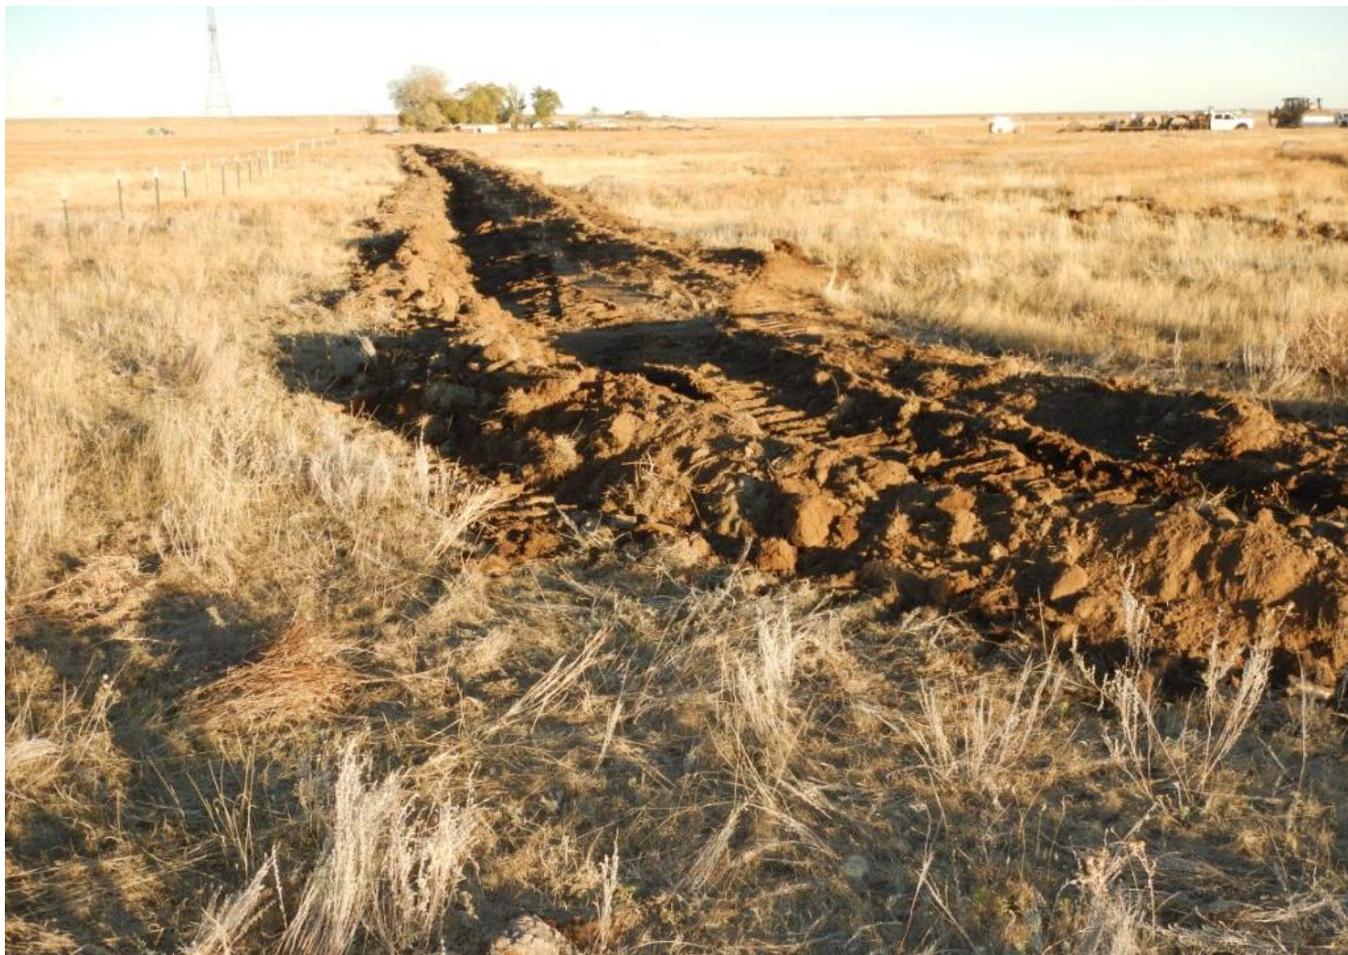
Photo 2. Photo taken from northwest location, facing East. Stormwater control ditch in center of photo.

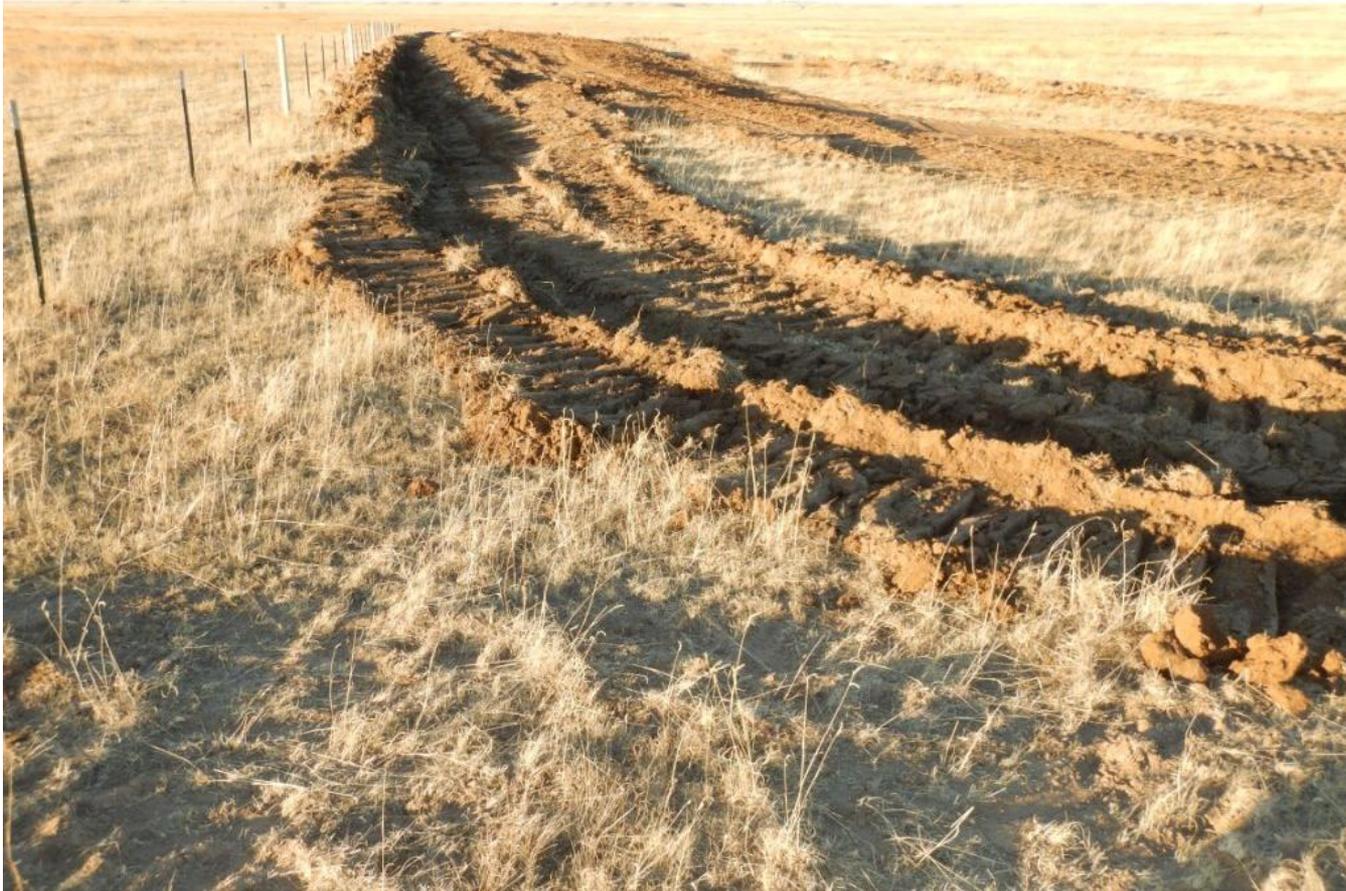
Photo 3. Photo taken from southwest location, facing North. Stormwater control ditch in center of photo.

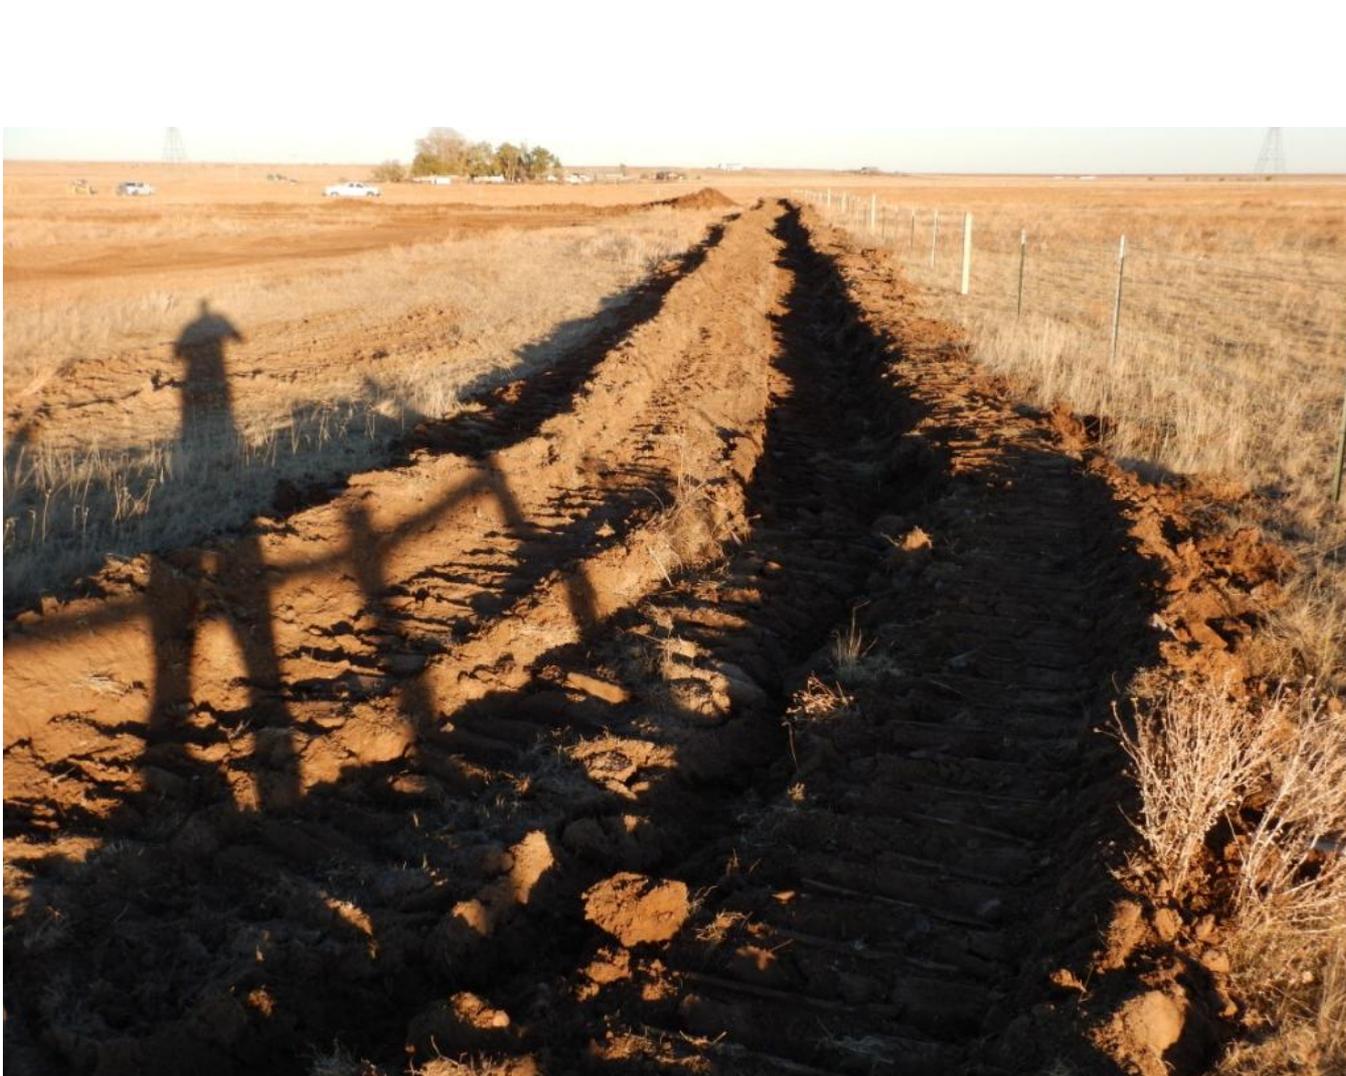
Photo 4. Photo taken from southwest location, facing East. Stormwater control ditch in center of photo.

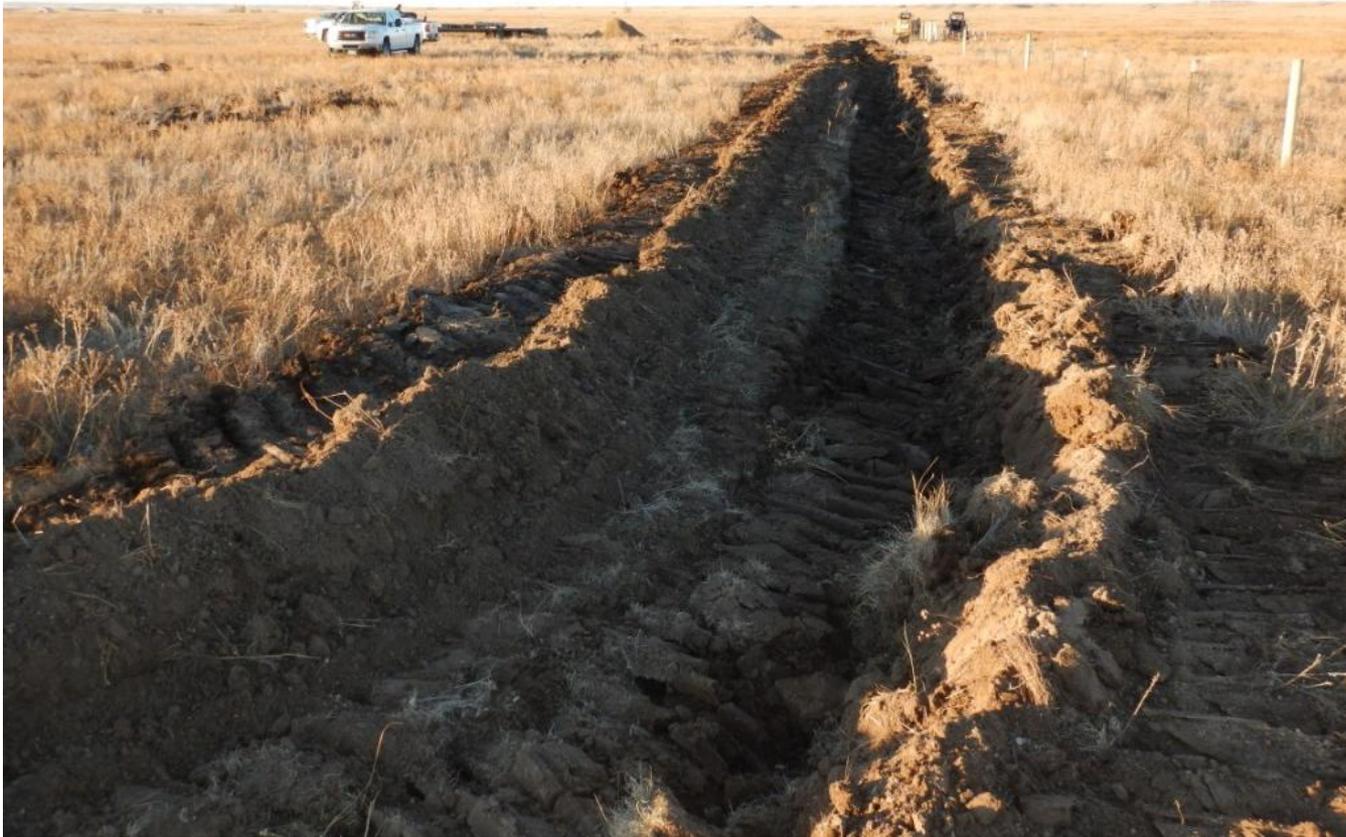
Photo 5. Photo taken from southeast location, facing North. Stormwater control ditch in center of photo.

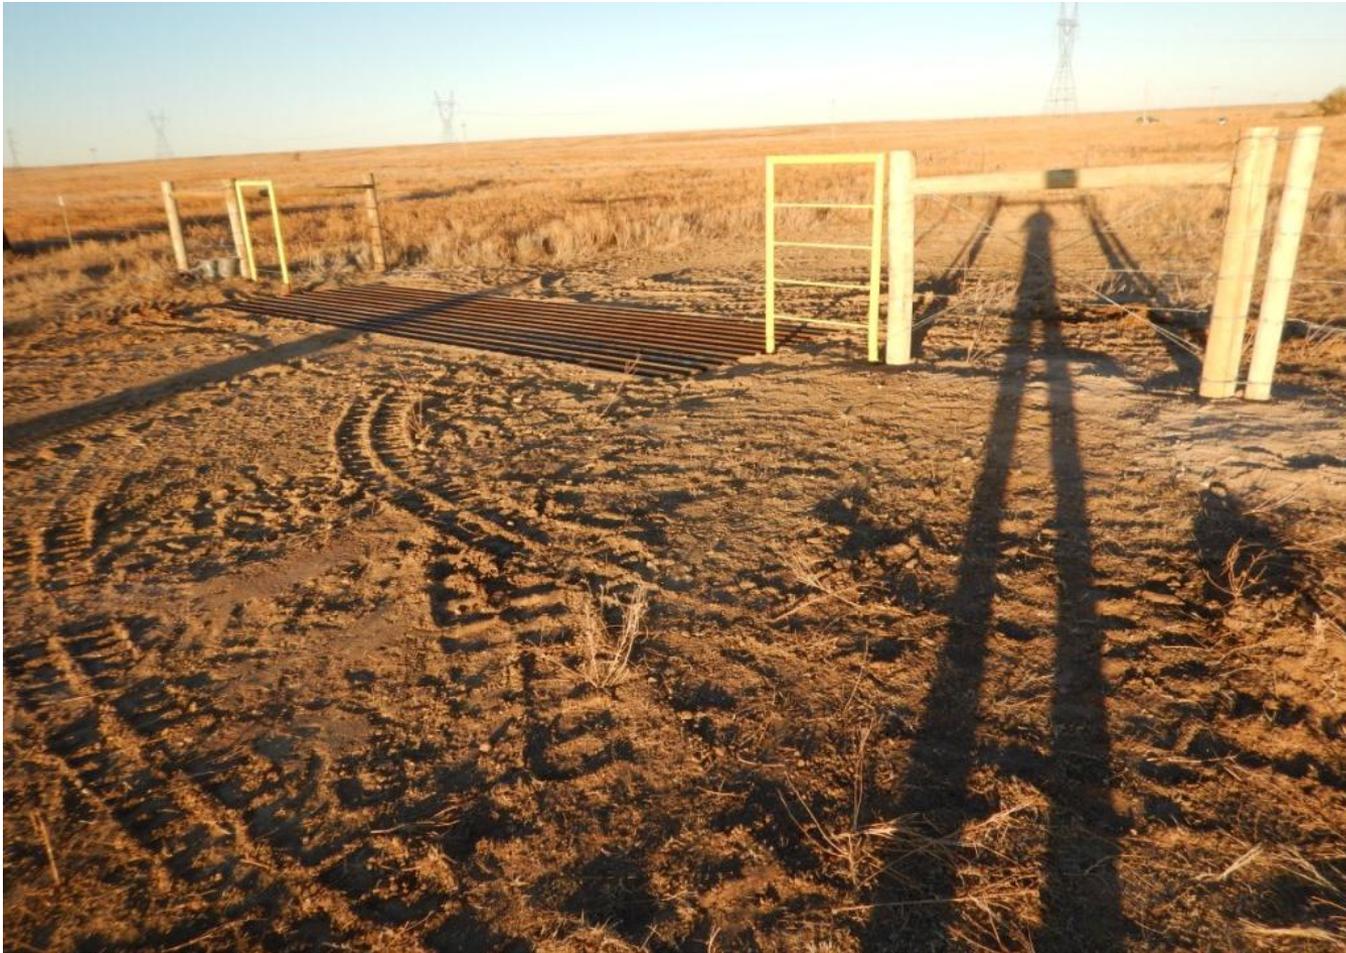
Photo 6. Photo taken from eastern access entrance, facing Northeast. Cattle guard installed in center of photo.

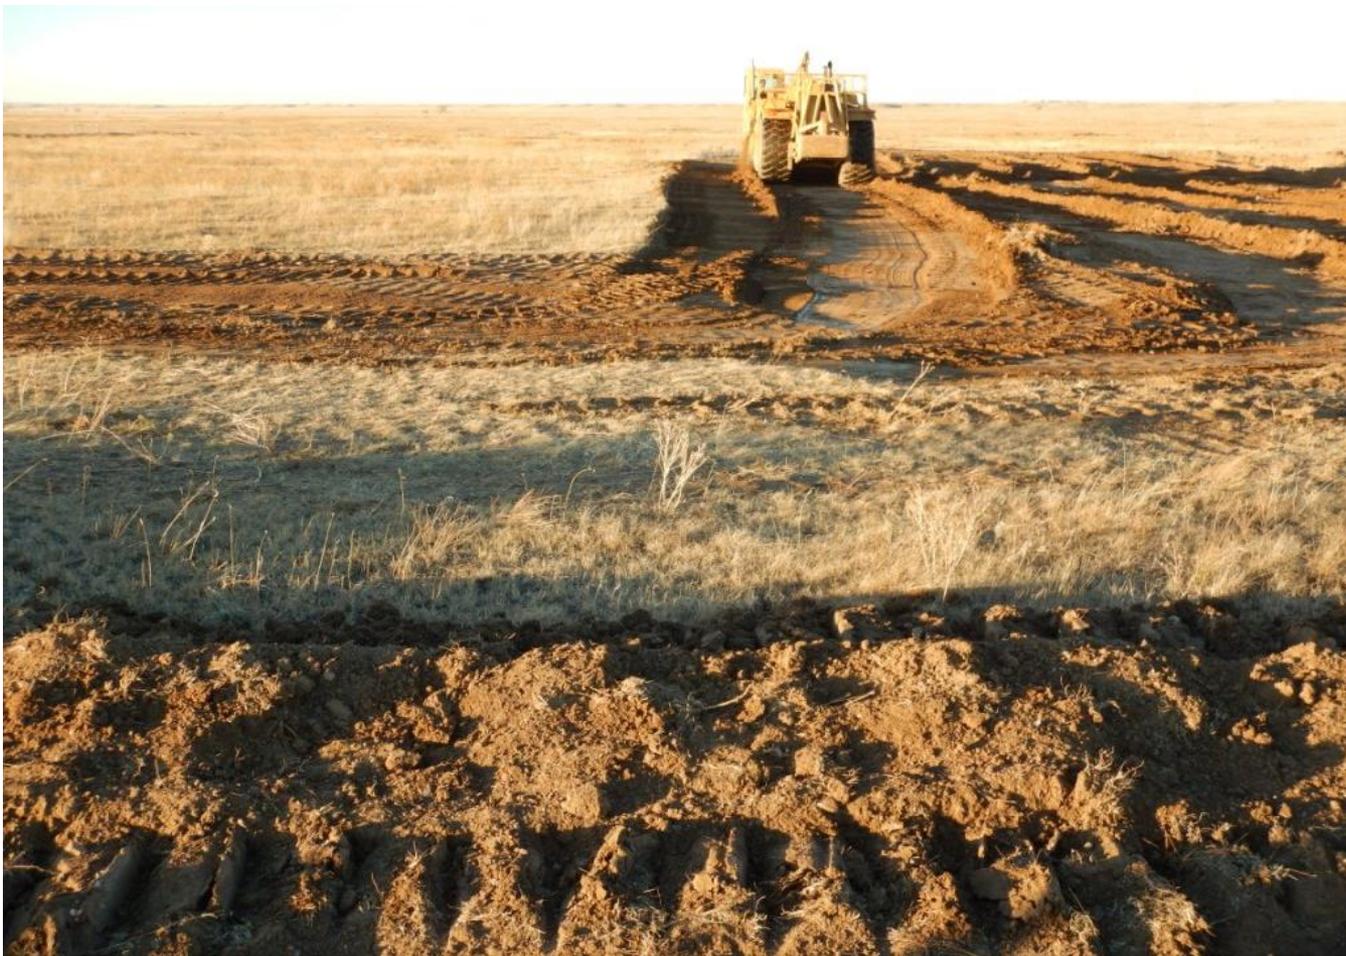
Photo 7. Photo taken from southern location, facing North. Topsoil salvage in process.

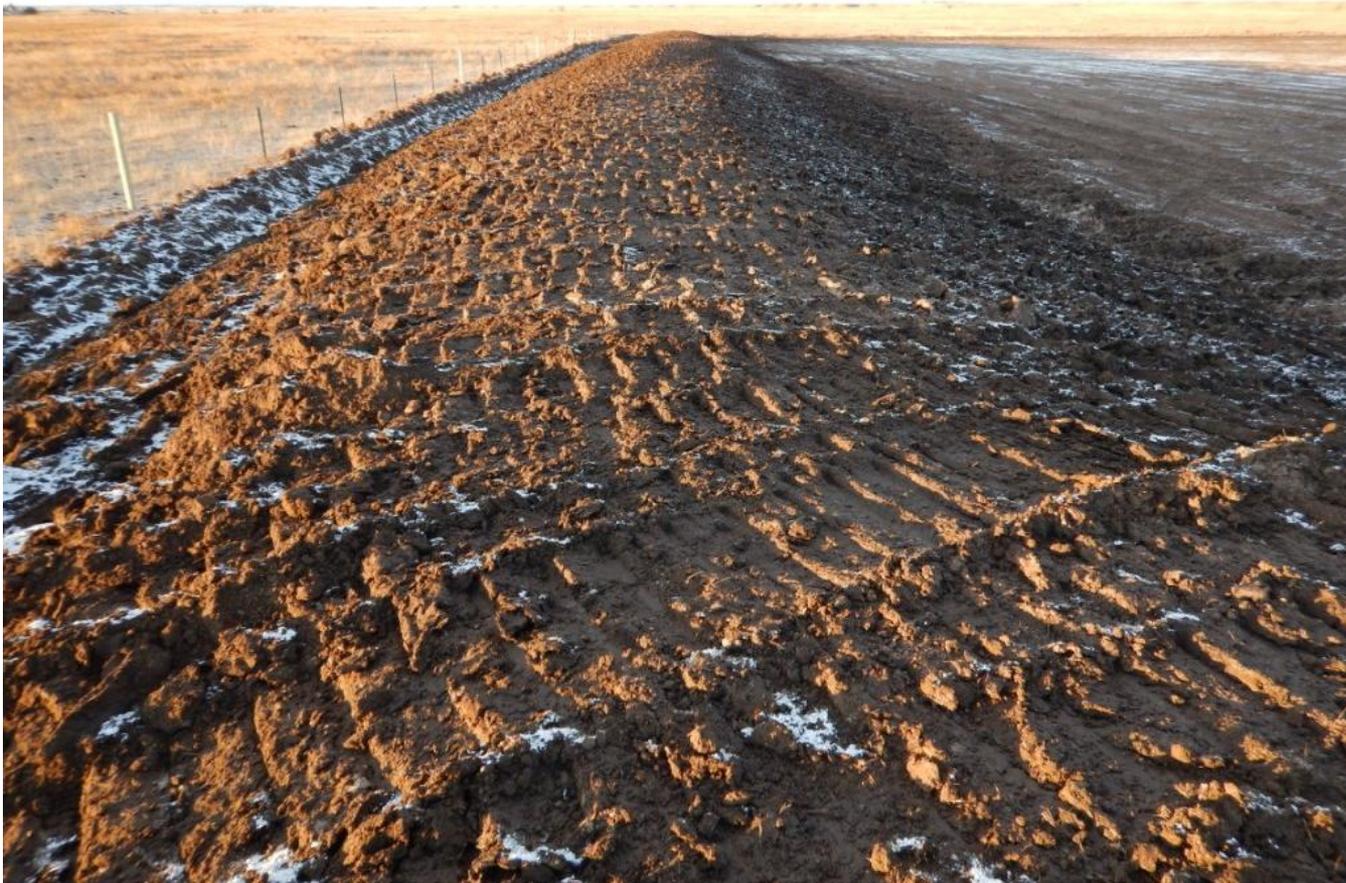
Photo 8. Photo taken from southwest location, facing North. Topsoil salvage pile tracked perpendicular to slope.

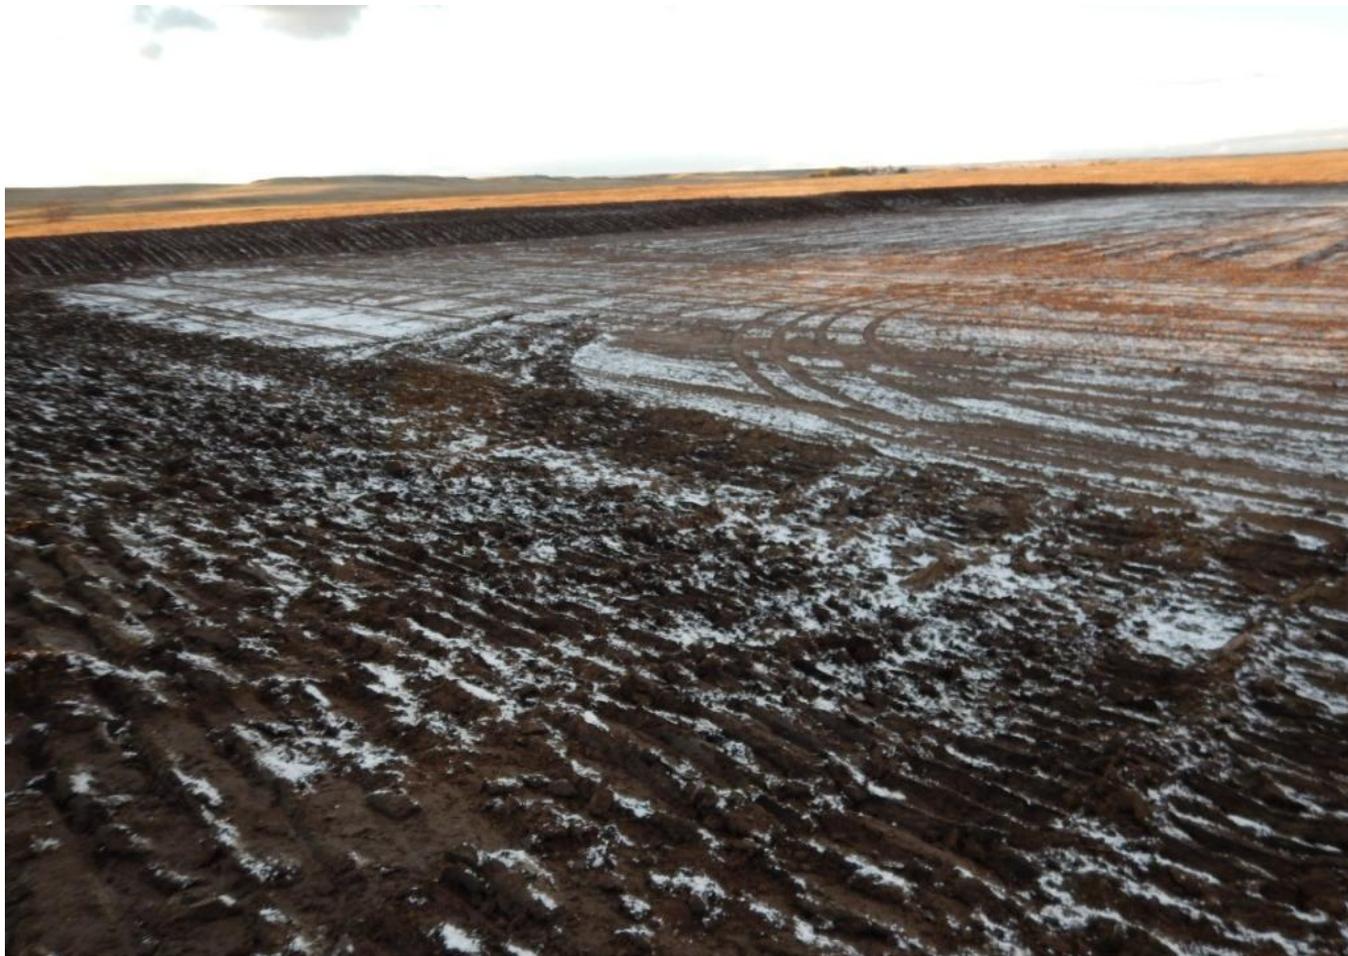
Photo 9. Photo taken from southern location, facing Northwest. Topsoil salvage pile tracked perpendicular to slope.
