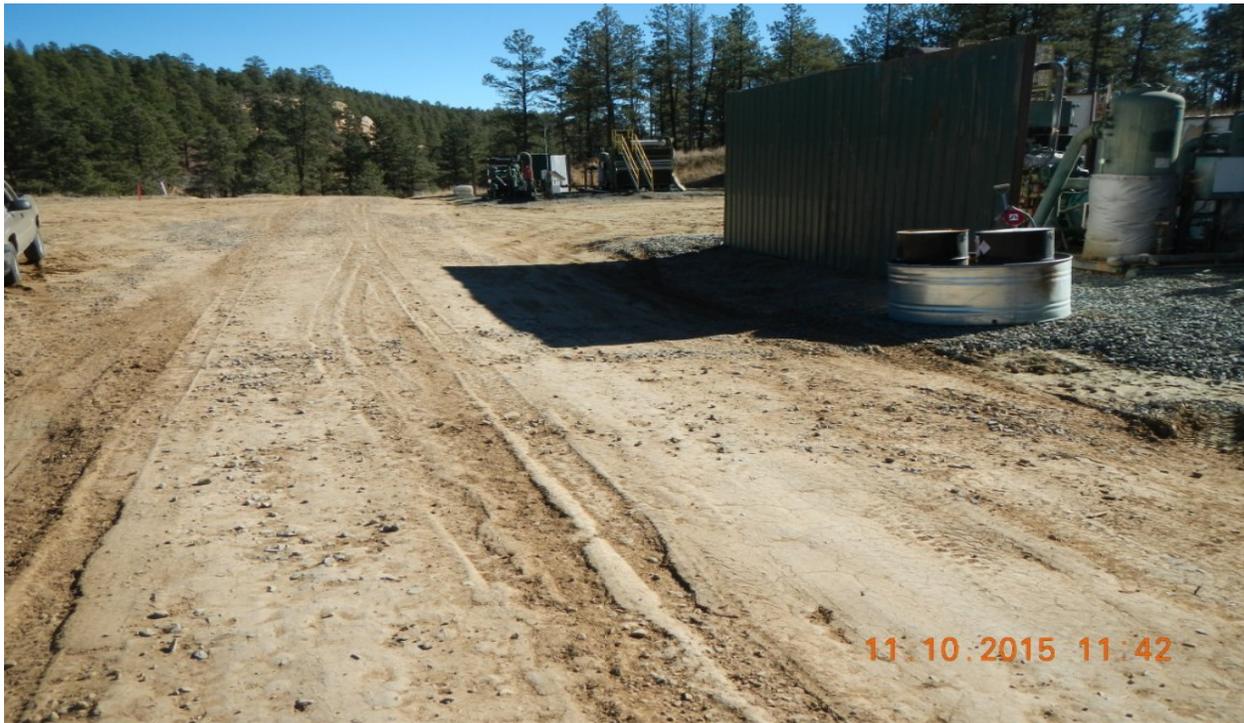
photo 1: West side of the location facing east.

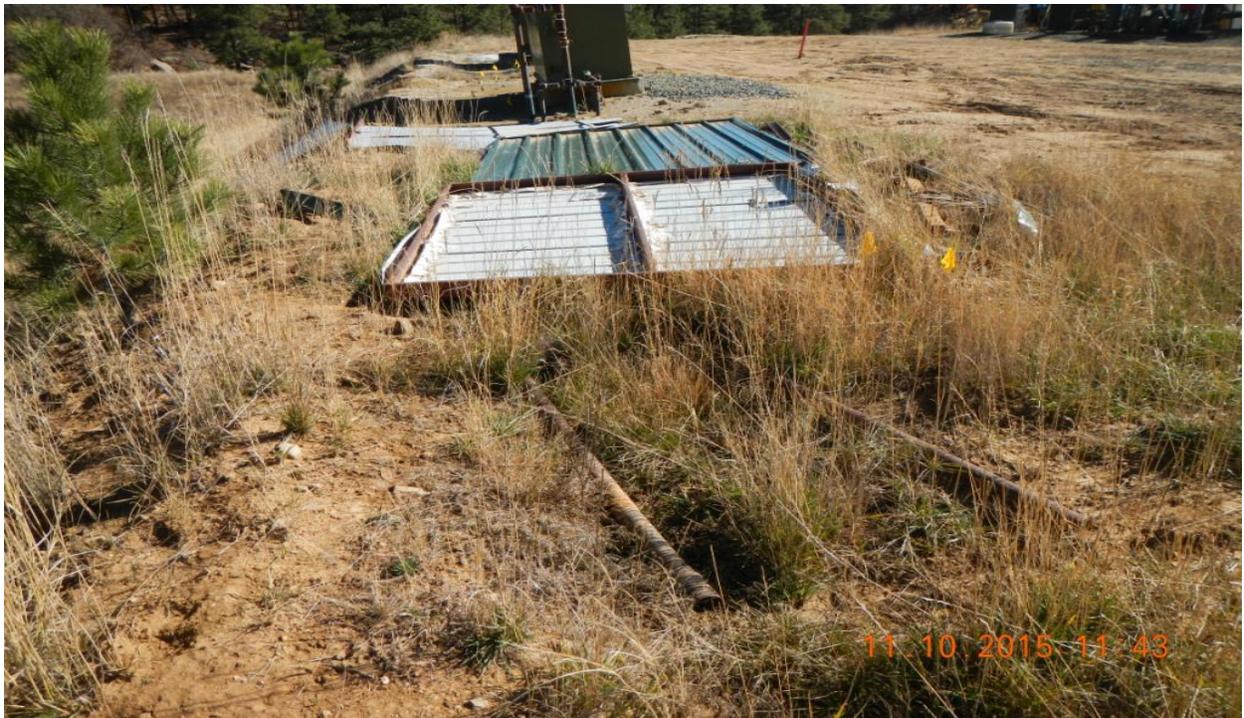
photo 2: North side of the location. Metal panels remain.

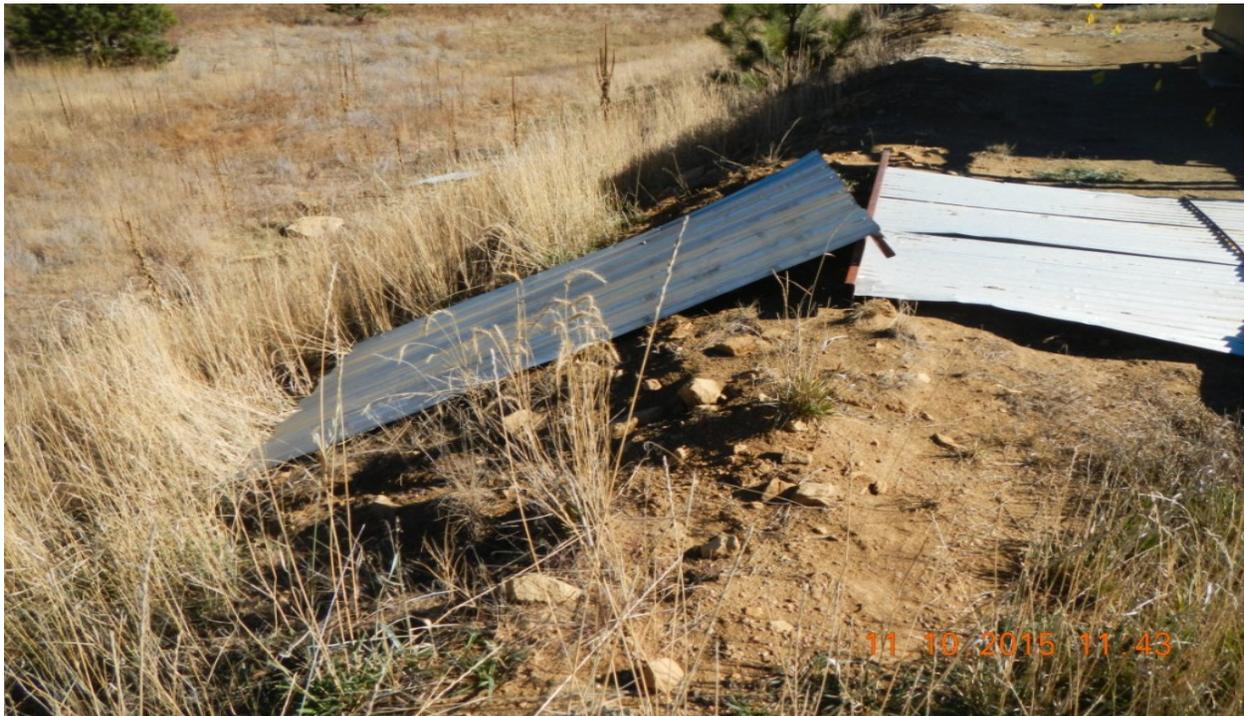
photo 3: North side of the location. Metal panels remain.

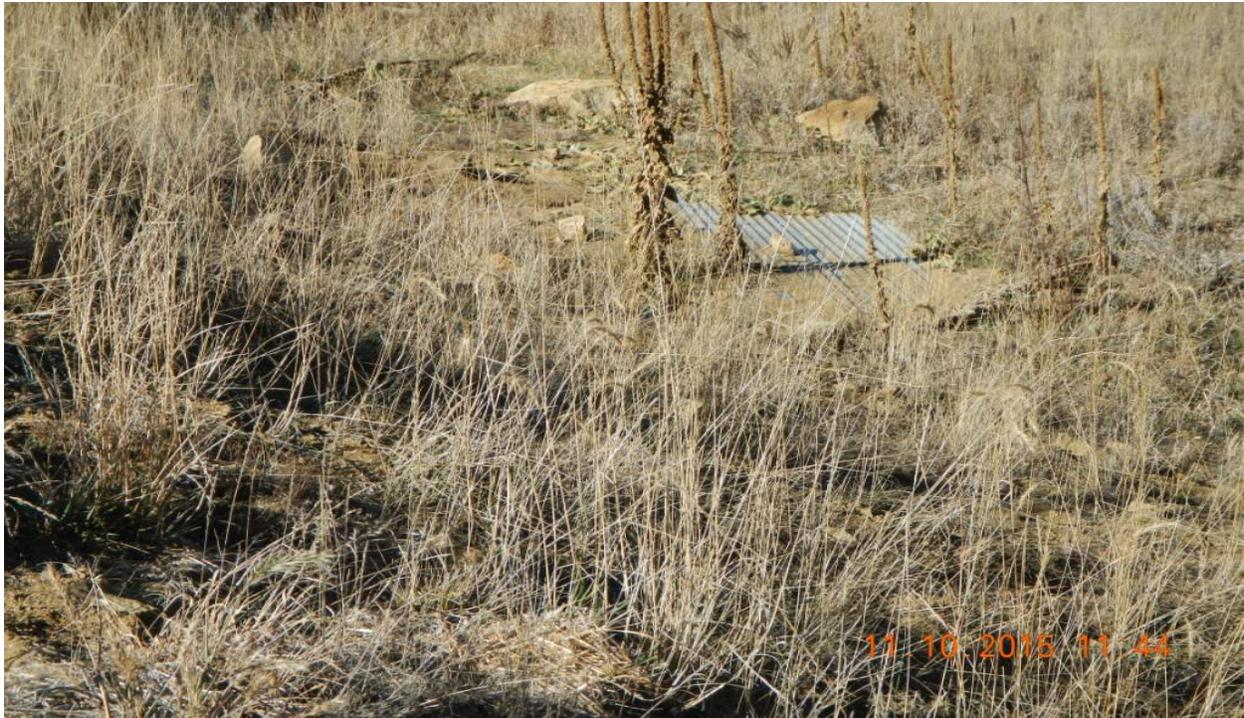
photo 4: North side of the location. Metal panels remains off the well pad.

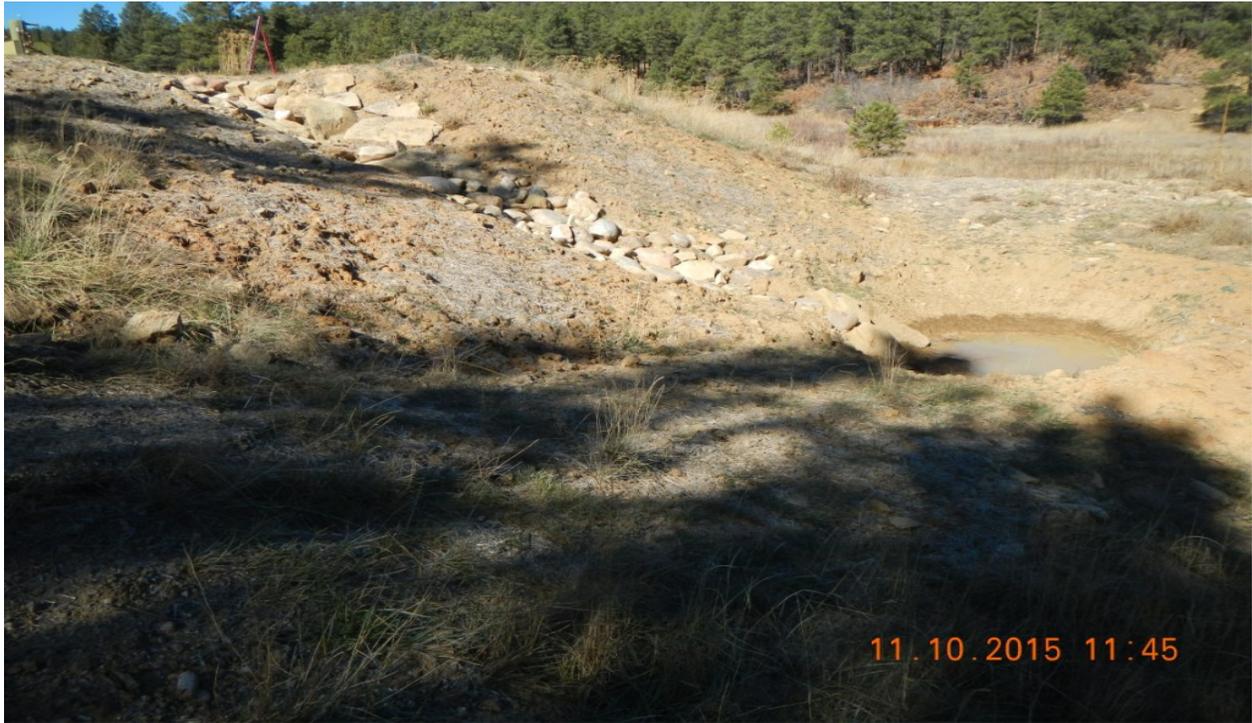
photo 5: East side of the location. Stormwater controls have been installed to prevent erosion.

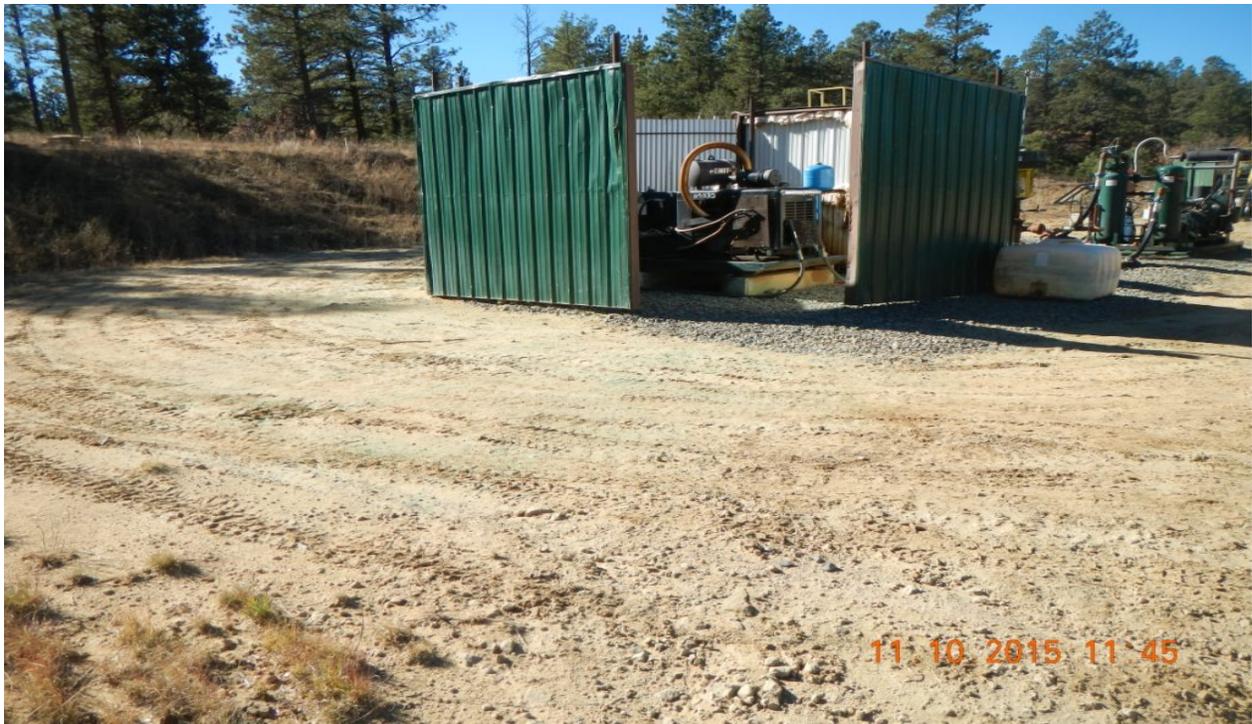
photo 6: East side of the location facing west.

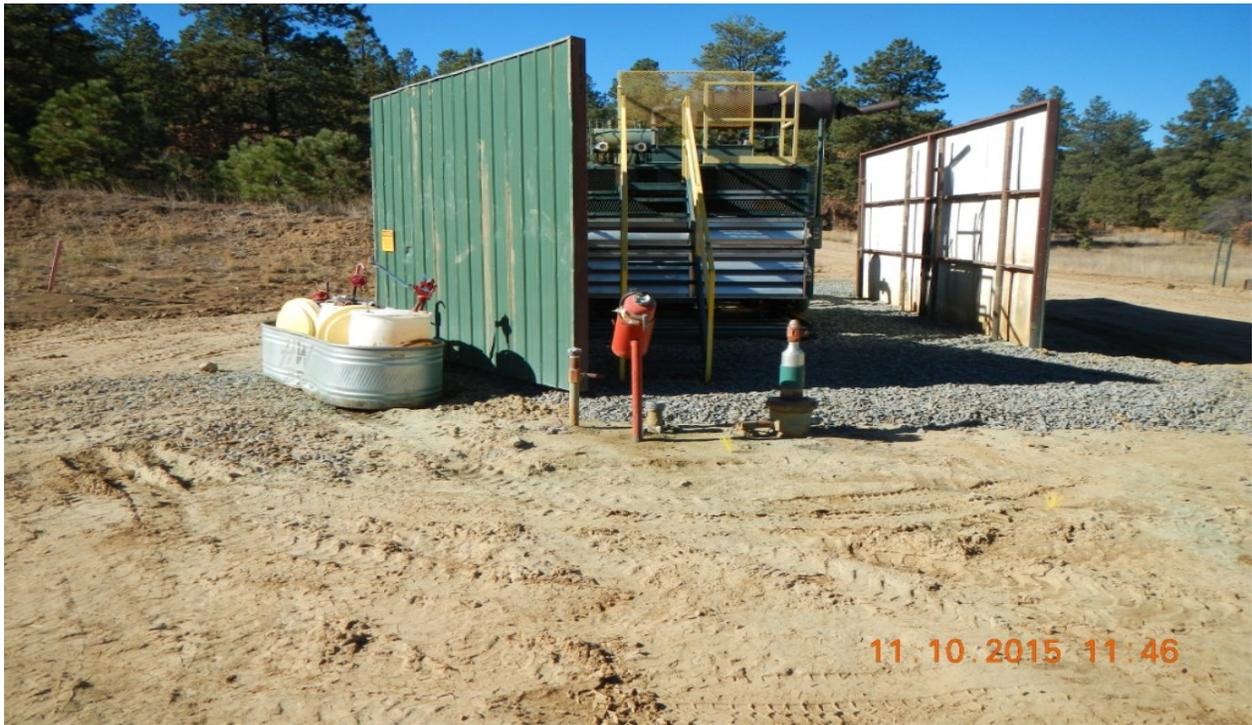
photo 7: Production equipment at the west side of the location.

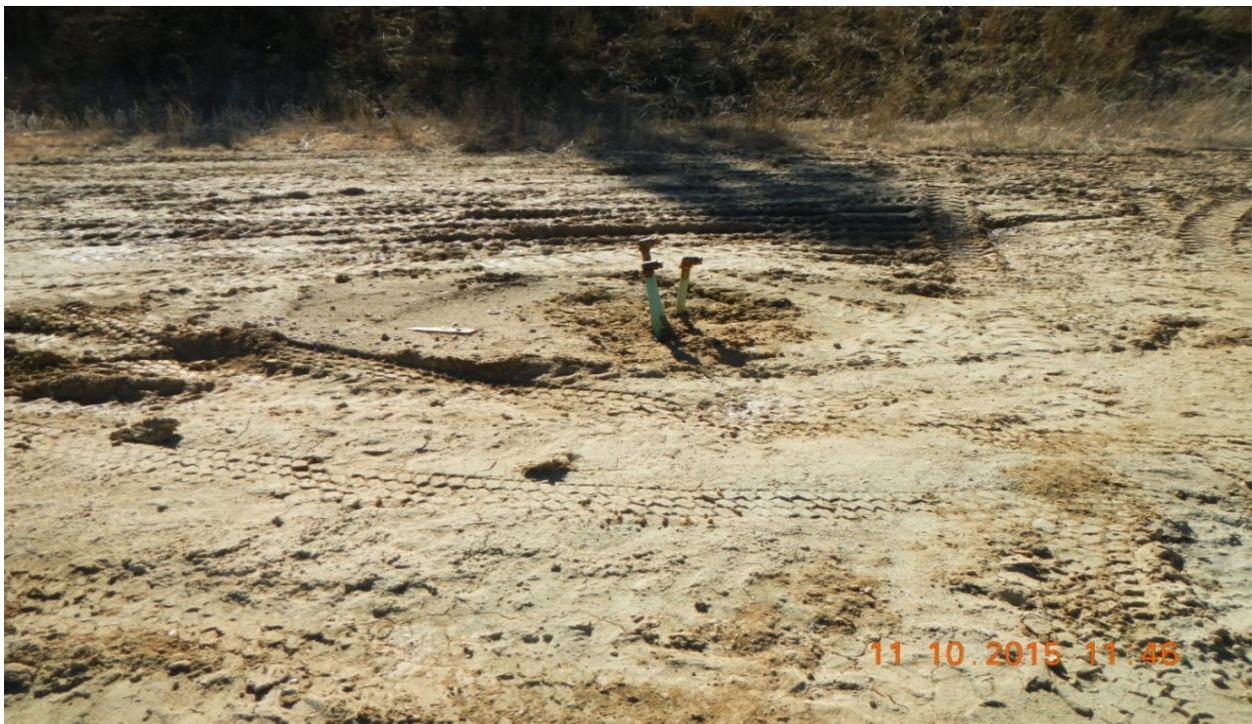
photo 8: Pipe riser found at center of the location are not highly visible.
